**DESCRIPTIVE REPORT**

*Type of Survey*      **Hydrographic Survey**  
*Field No.*                **H11806**  
*Registry No.*          **OPR-J977-FU-08**

*State*                      **Louisiana**  
*General Locality*      **Gulf of Mexico**  
*Sub-locality*          **Vicinity of Quatre Bayou Pass**

**2008 - 2009**

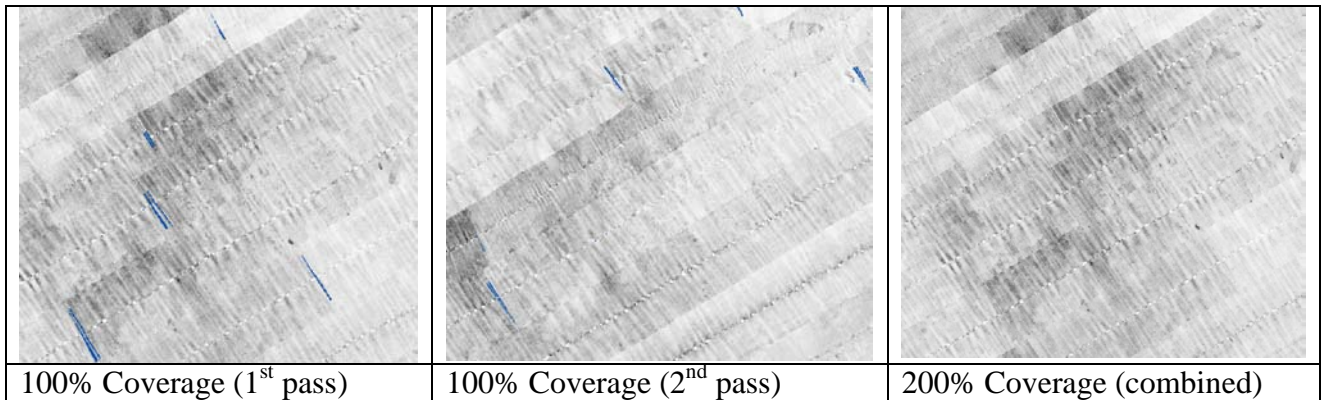
**Figure 3 Holidays in 100% coverages**

The issue was discussed with the NOAA COTR prior to leaving the field; see Appendix V\* (Supplemental Survey Records) for a record. An example is illustrated below.

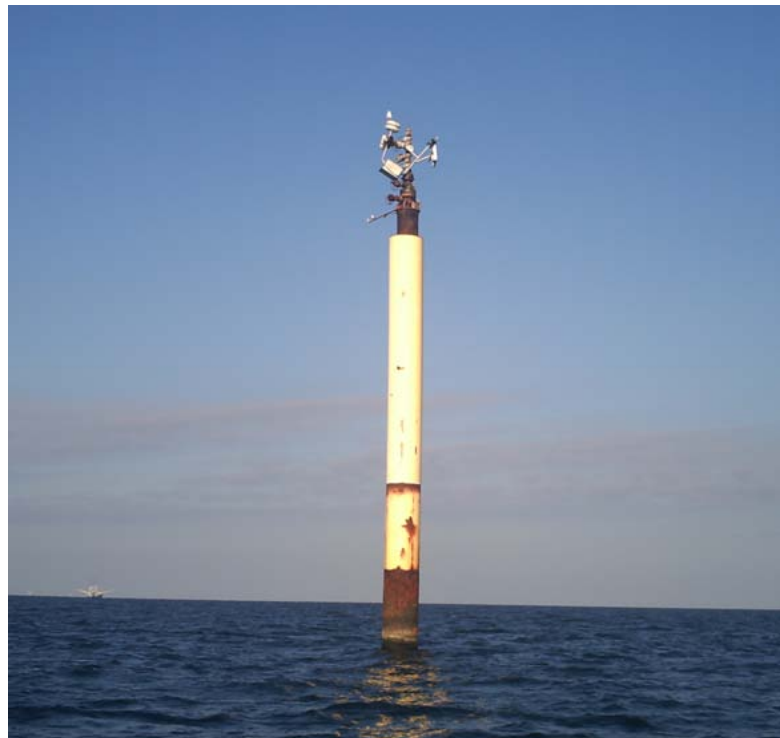
**Figure 6 Item number 5, exposed wellhead**

13. Charted “Pipe” at 29-09-23.87 N, 89-53-54.71 W (Chart 11358) is a product of a DtoN submission by this survey (Report “H11806 DtoN Fugro 121908\_1”). AHB had requested further information be obtained and included in the DR about this feature. The feature is a wellhead with an estimated height of -10m above MHW. A photo of the feature follows. **Concur with clarification – Delete pipe. Add Obstr (wellhead).**

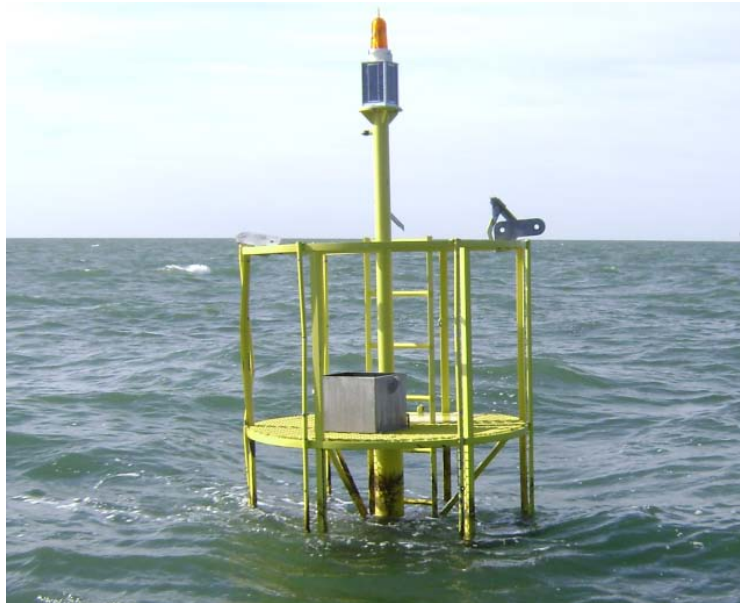
**Figure 7 New Aid to Navigation**

1. A new Aid to Nav was located at 29-10-58.14 N, 89-53-10.97 W, marking the southern edge of the Fish Haven Obstruction Area. It is portrayed in the accompanying S-57 feature file as a BCNSPP / LIGHTS object. ***Concur – Add light.***

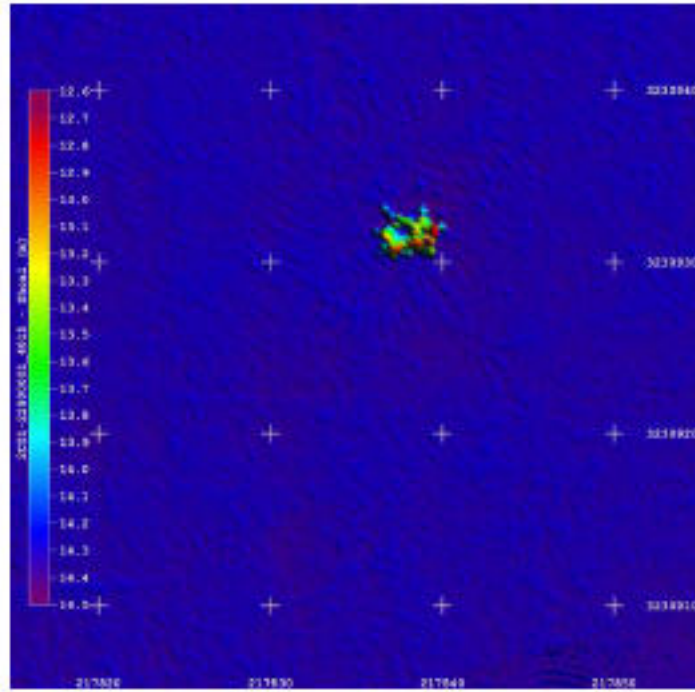
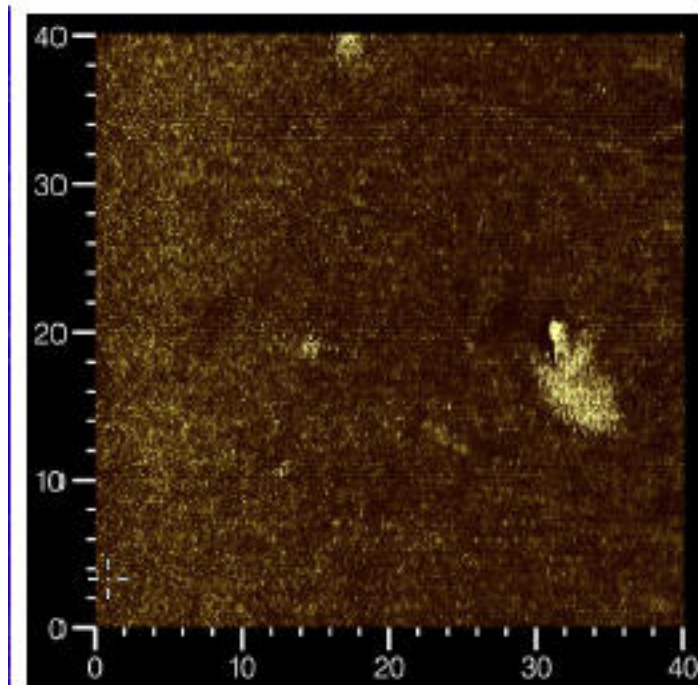
Concur with clarification - Least depth revised to 40 ft during office processing. Delete charted 38 Obstrn (rep 2008) and danger curve. Add 40 Obstrn and danger curve.

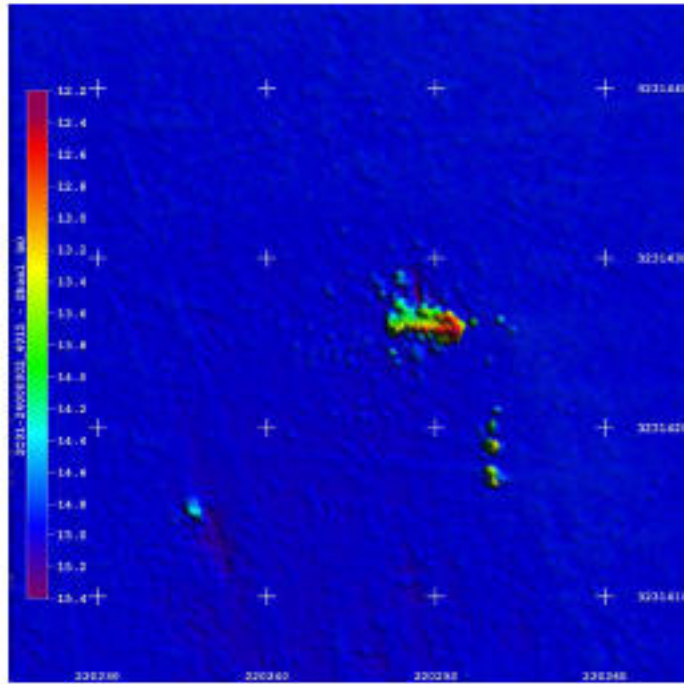
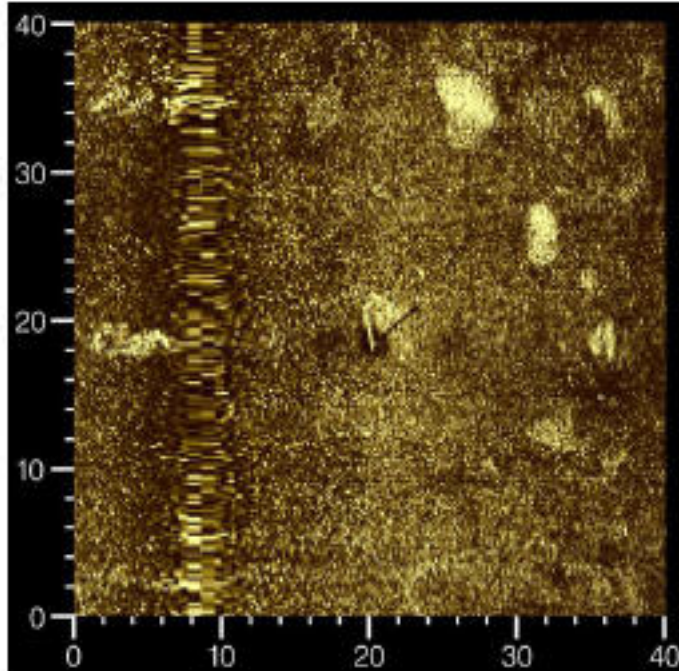
## 1.2) 43-ft Obstruction DtoN # 2.3

Add 42 Obstrn and danger curve.

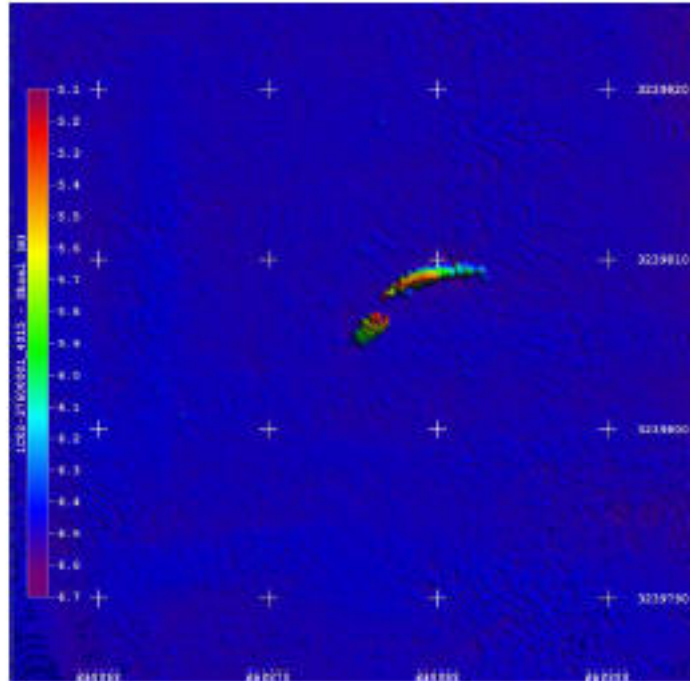
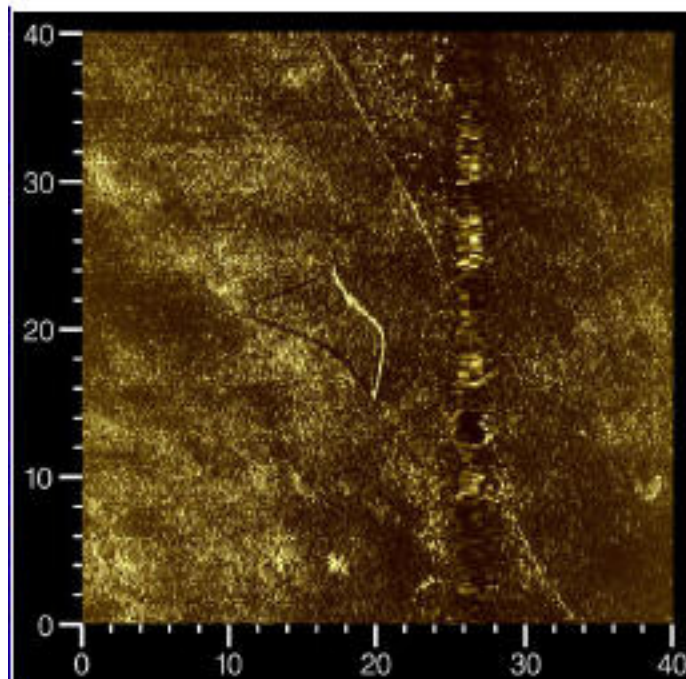
### 1.3) 11-ft Obstruction DtoN# 2.4

Do not concur - Least depth determined to be 16 ft during office processing. Delete 11 Obstn (rep 2008) and danger curve. Add 16 Obstn and danger curve.

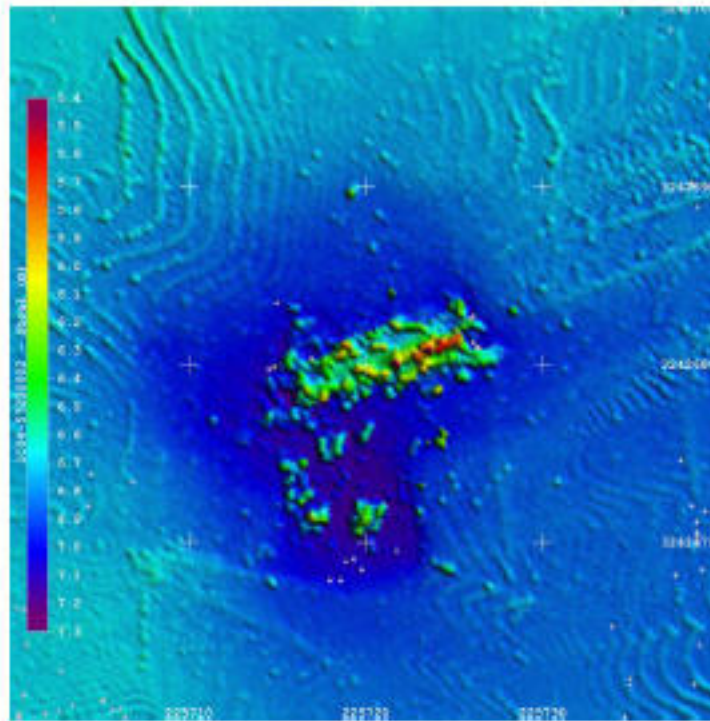
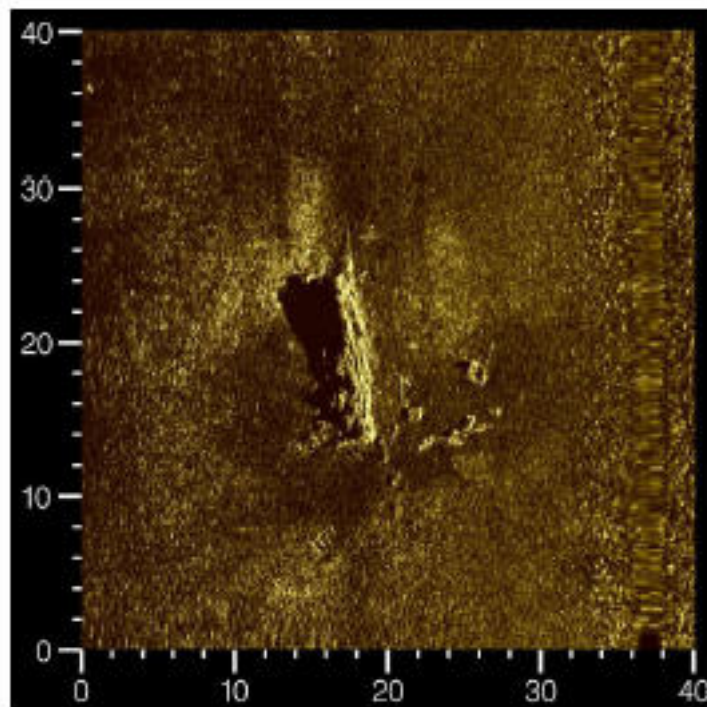
## 1.4) 18-ft Obstruction DtoN #3.1

Concur with clarification - Least depth revised to 19 ft during office processing. Delete 18 Obstn (rep 2008) and danger curve. Add 19 Obstn and danger curve.

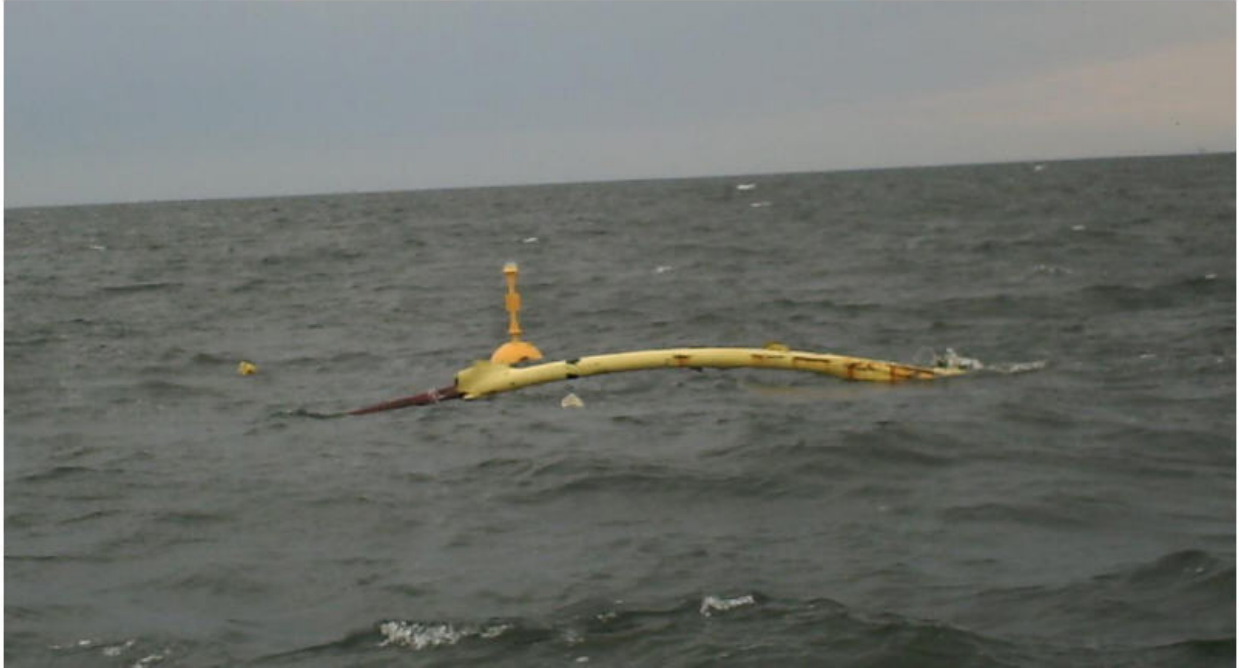
# H11806 DToN#1

Add Obsn and notation (Exposed pipeline).

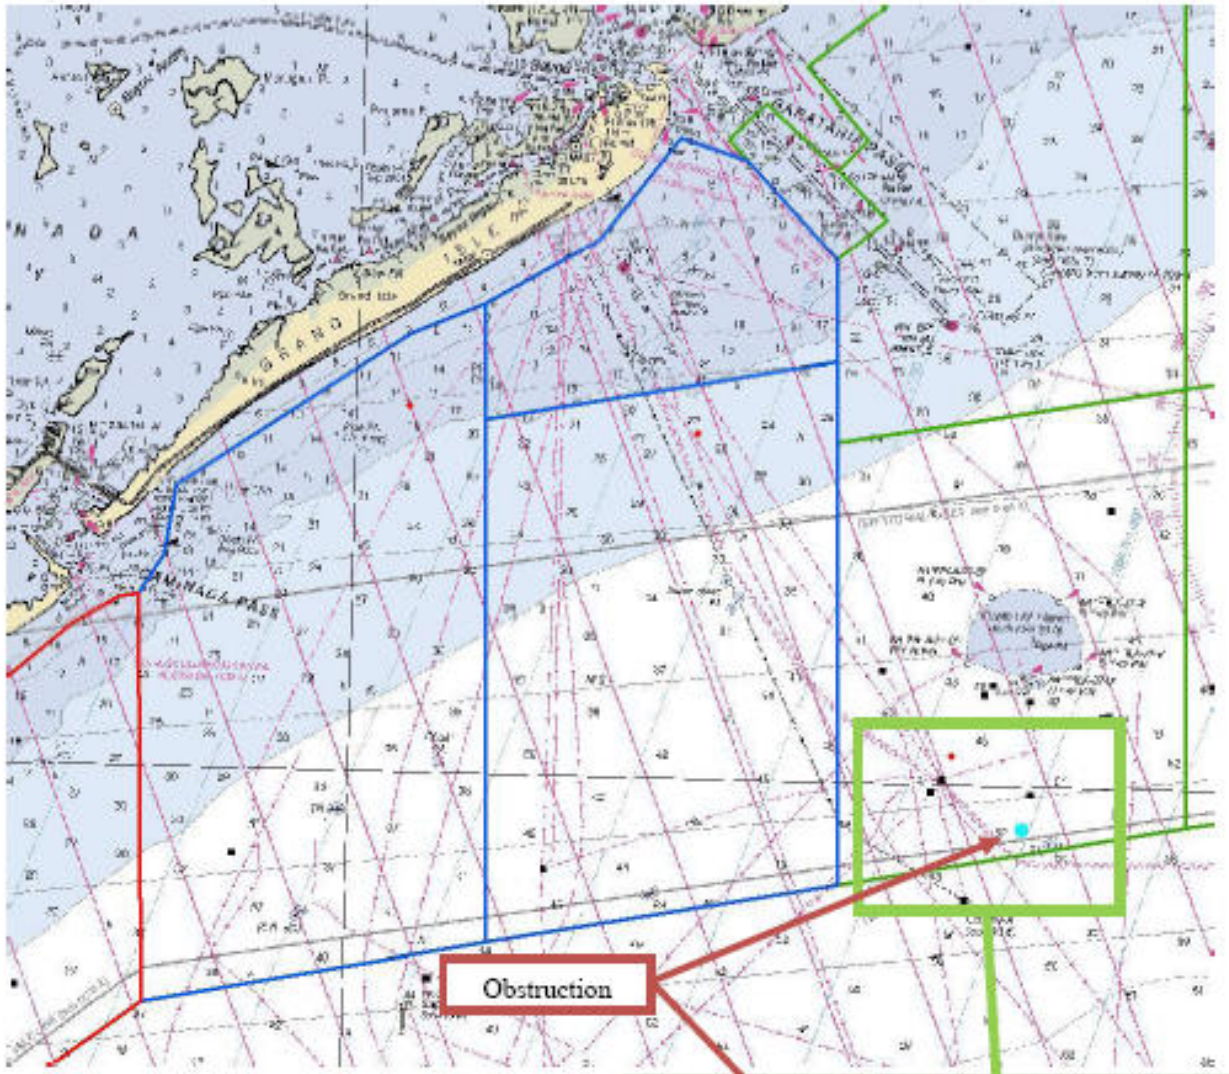
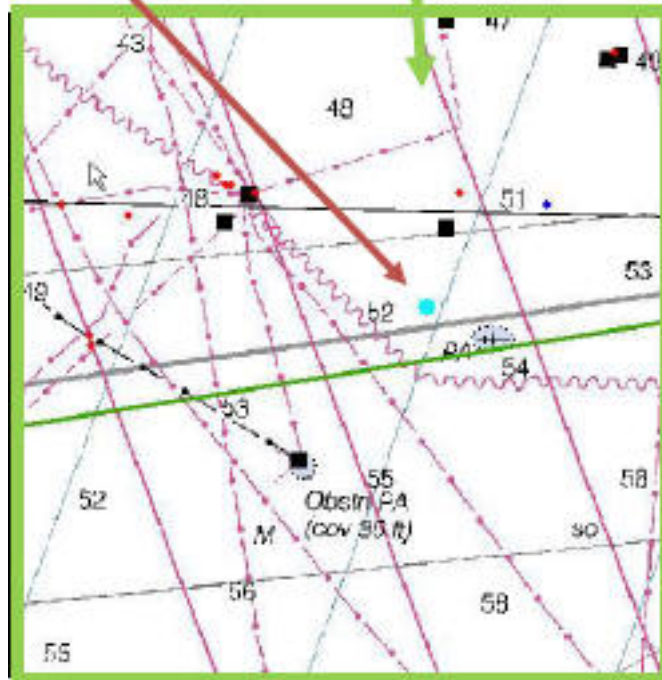
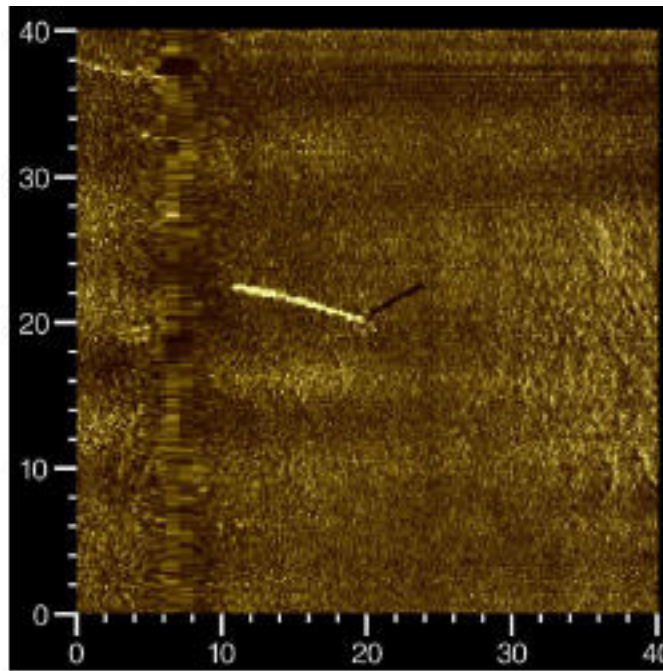
# H11806 DtoN #5

Do not concur - Least depth was determined to be 35 feet during office processing. Delete 22 Obstrn (rep 2009) and danger curve. Add 35 Obstrn and danger curve.

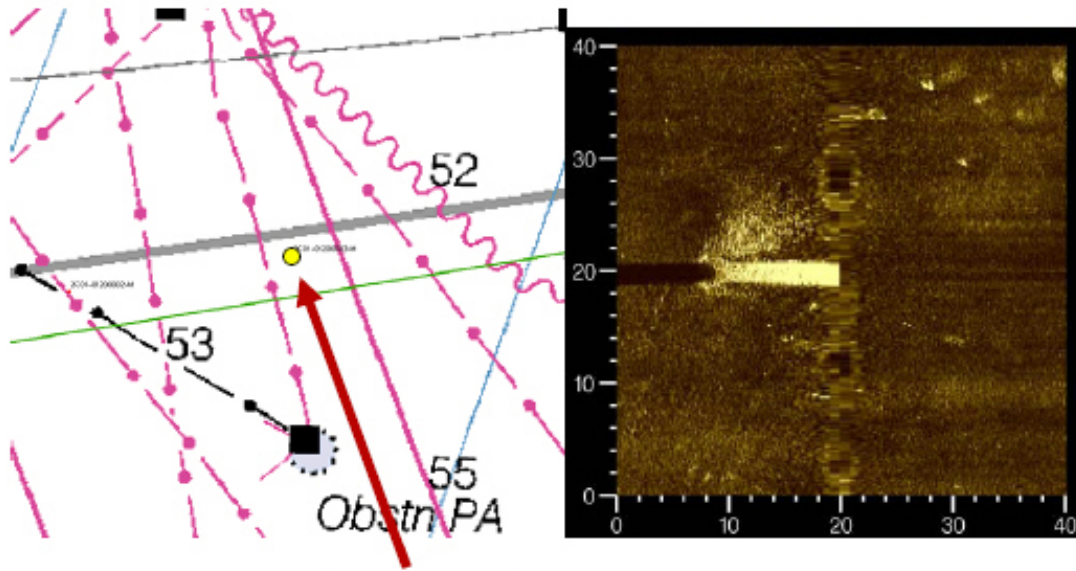
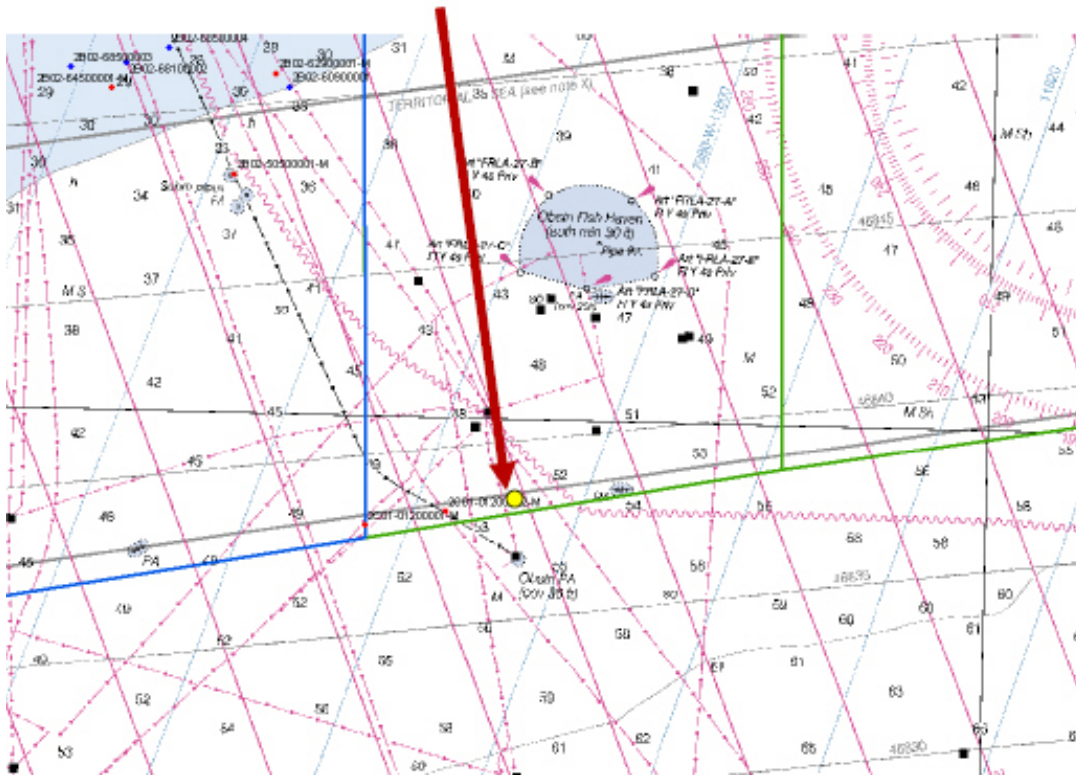
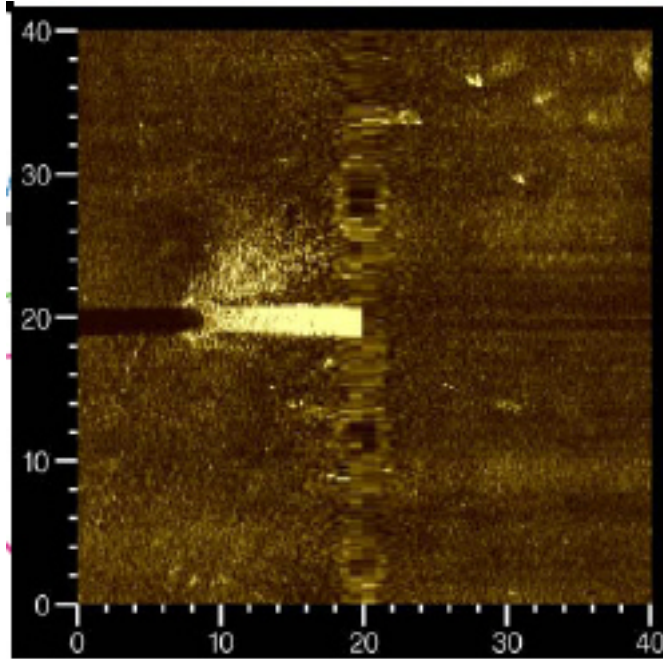
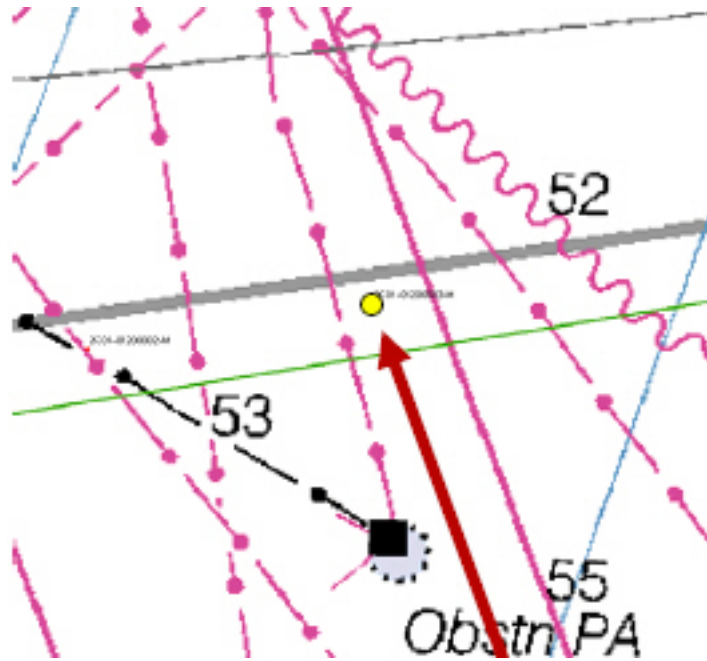
# H11806 DtoN#6

Do not concur - See Descriptive Report for final charting recommendation.

Exposed Pipeline

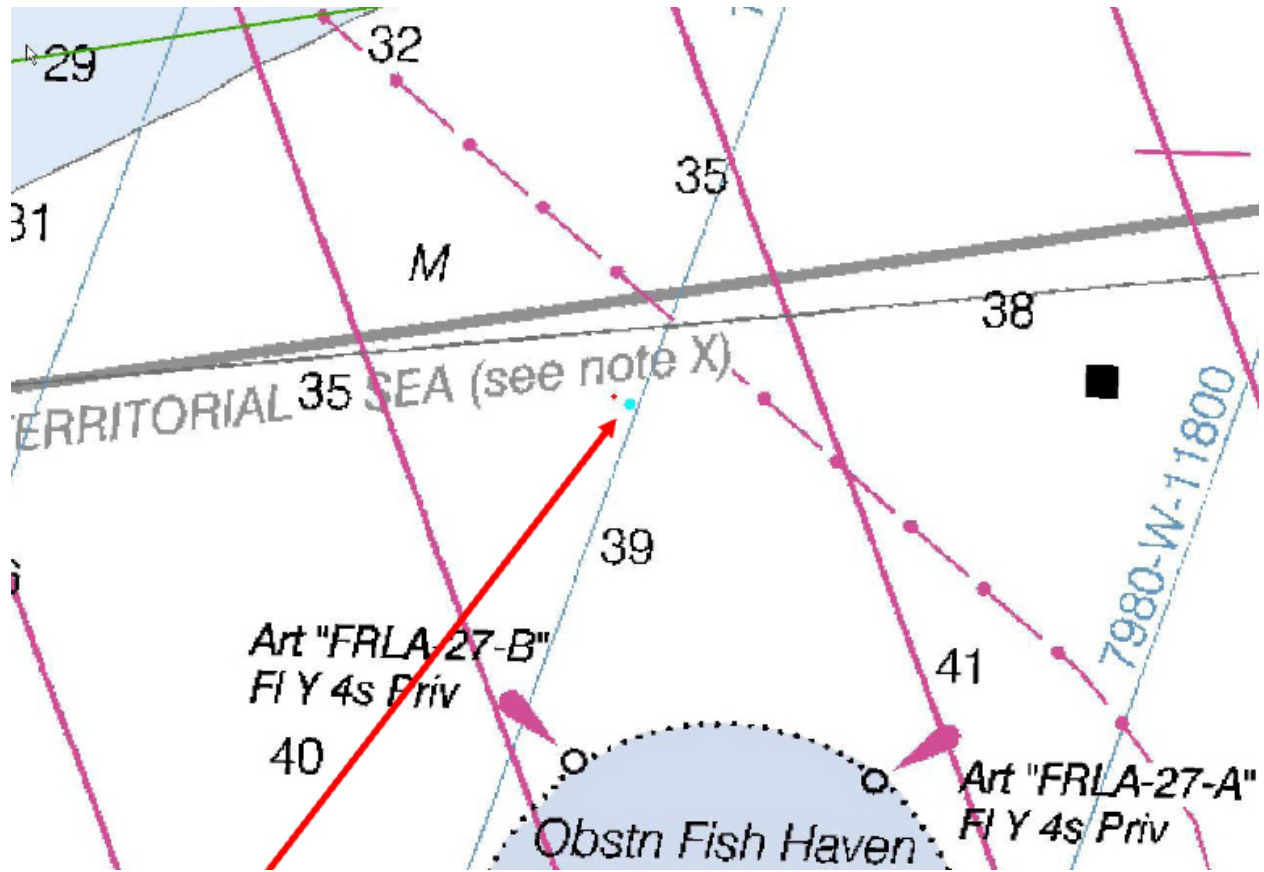
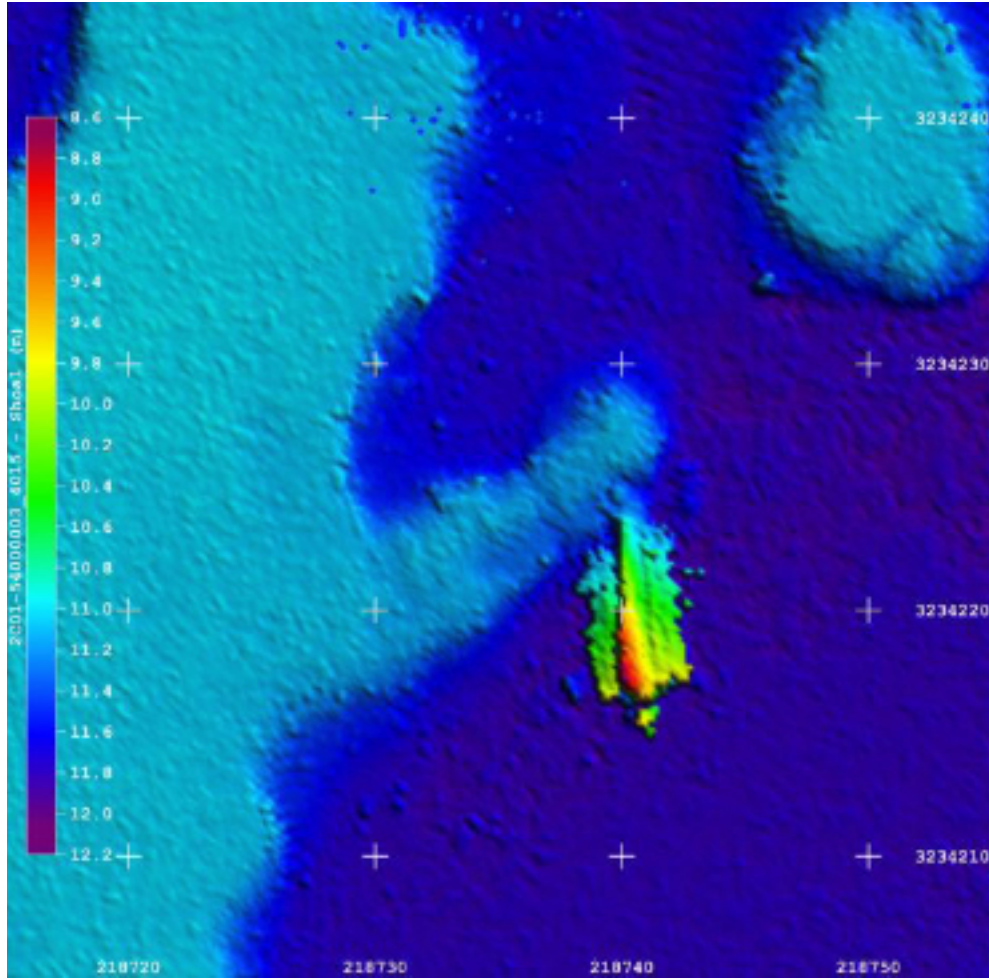
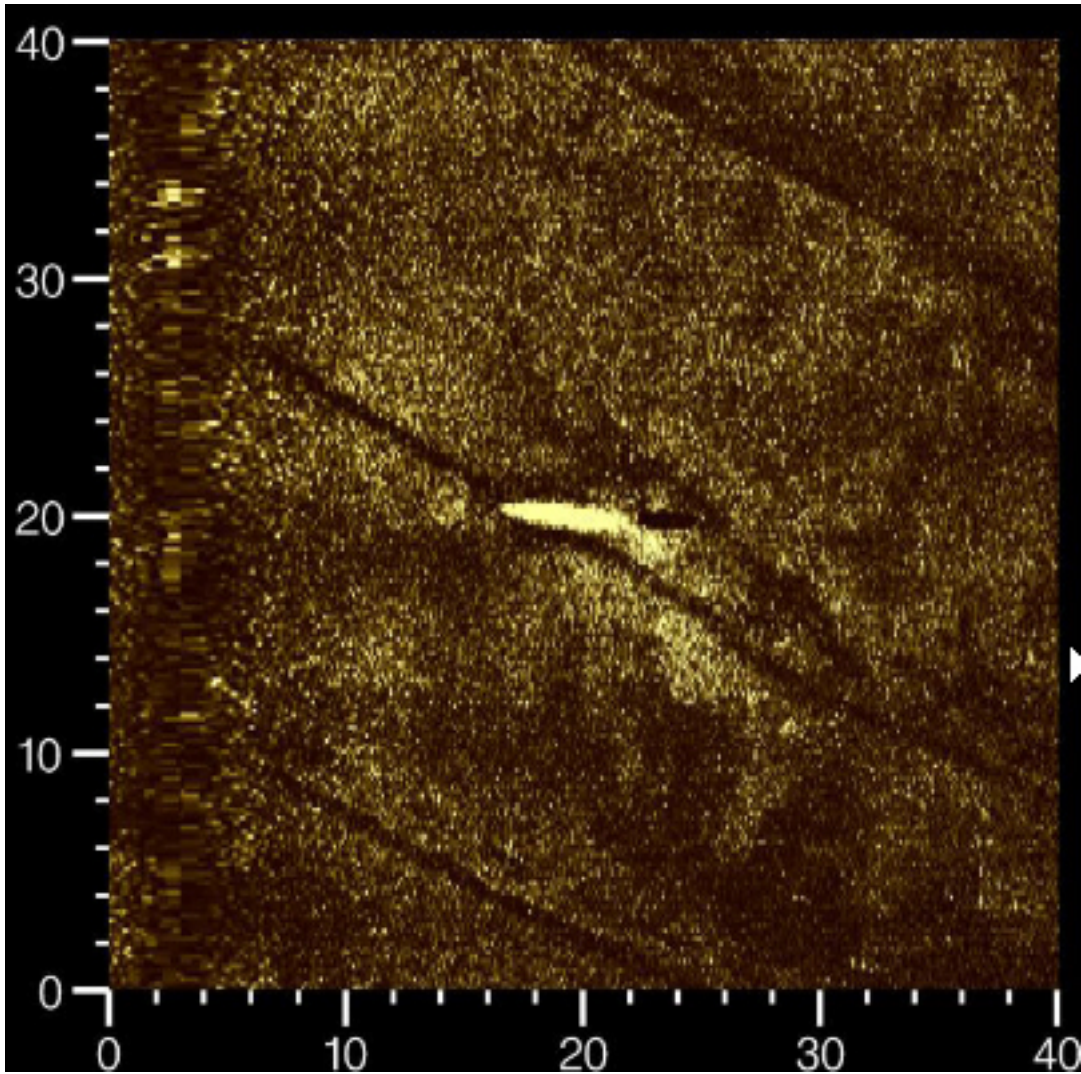
Concur with clarification. Least depth revised during office processing to 32 ft. Delete charted 28 Obstn (rep 1990) and danger curve. Add 32 Obstn and danger curve.

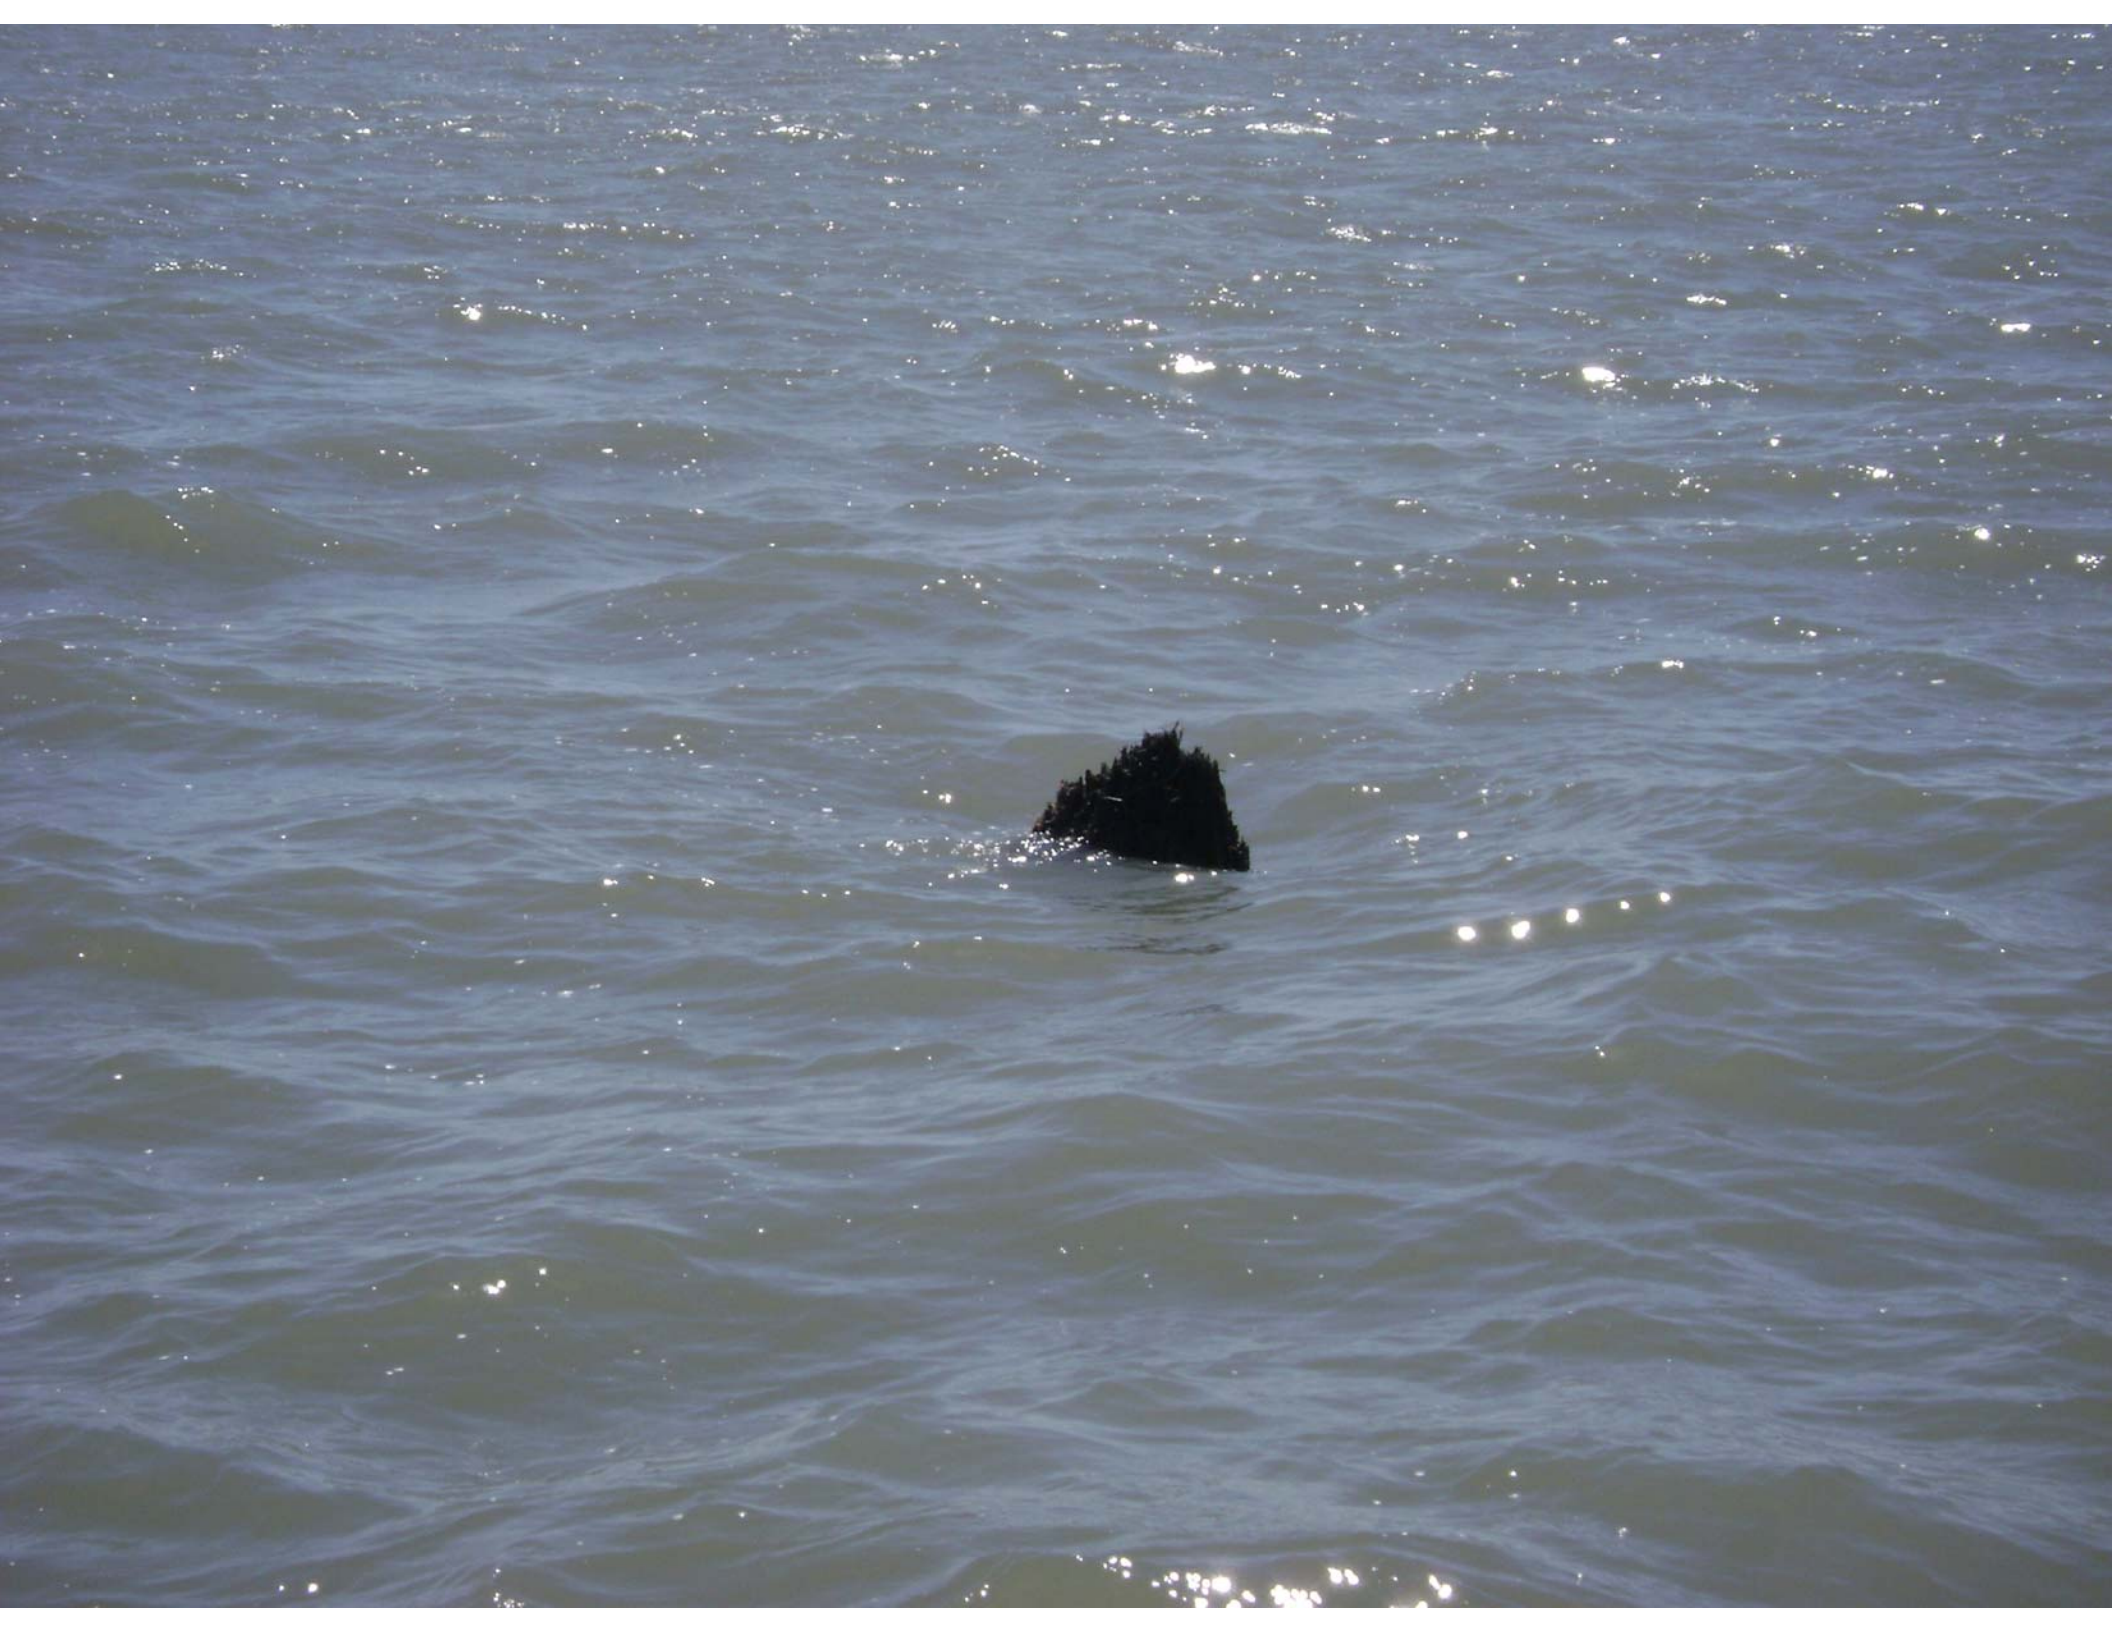
A DTON was submitted by Fugro Pelagos in August pertaining to an uncharted buoy. This buoy has moved from its reported position and can no longer be located. I have attached a copy of the DTON for your reference. Please let me know if you require any additional information or have any questions.

Buoy is not shown on the chart. Buoy is green and marked with a white #1. The buoy appears to be associated with a seabed feature, likely an exposed pipeline.
