H11814

DESCRIPTIVE REPORT

Type of Survey **Hydrographic Survey**
Field No. **H11814**
Registry No. **OPR-J977-TE-08**

State **Louisiana**
General Locality **Breton Sound**
Sub-locality **3 NM E of California Point**

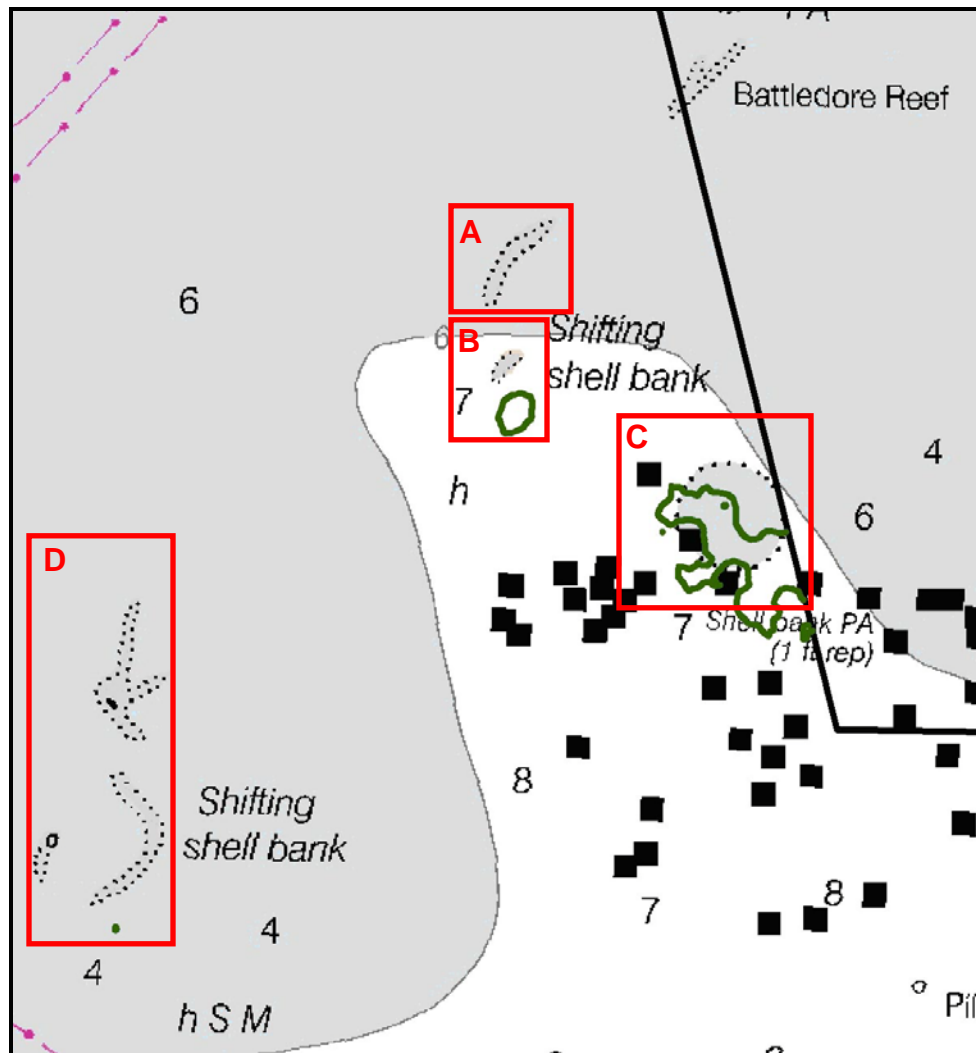
There are four (4) charted area features in H11814 described as “shifting shell banks” or “shell banks.” Two of the features, listed as A and D in Table 9 and illustrated in Figure 6, were not found during the 2008 / 2009 survey and are recommended for removal from the chart (refer to paragraph D.1.3. Disproved Features). *Concur delete intertidal areas and Shifting shell bank notes. Update area based on present survey data.*

Two features, identified as B and C in Figure 6 and Table 9, appear on the chart in close proximity to similar features appearing in the survey data. The data source which produced the charted features was not known at the time of the 2008 / 2009 survey. This limits the validity of speculation regarding any possible migratory trends of the charted features. *Concur with conditions. Both Feature B and Feature C were disproven by the present survey. It is recommended that the intertidal area and shifting shell bank note are deleted. It is further recommended that the obstruction area and the shell bank PA (1 ft rep) note are deleted from the chart. It is also recommended that the area is updated with present survey data.*

Figure 6 - Charted shoal features in H11814. Chart 11364, 42nd Edition. Depths in feet.

Feature	Charted Feature	Charted Depth	Survey Depth	Remarks
A	Shifting Shell Bank	Not specified	8 - 9 ft	Not found. <i>Concur. Delete intertidal area.</i>
B	Shifting Shell Bank	Not specified	7 - 8 ft	Possible shift south. <i>Do not concur. Delete intertidal area and Shifting shell bank note.</i>

Feature	Charted Feature	Charted Depth	Survey Depth	Remarks
C	Shell Bank PA	(1 ft rep)	5 ft	Supported by survey data. <i>Do not concur. Delete obstruction area and the shell bank PA (1 ft rep) note from the chart.</i>
D	Shifting Shell Bank	Not specified	6 – 9 ft	Not found. <i>Concur. Delete intertidal area and Shifting shell bank note.</i>

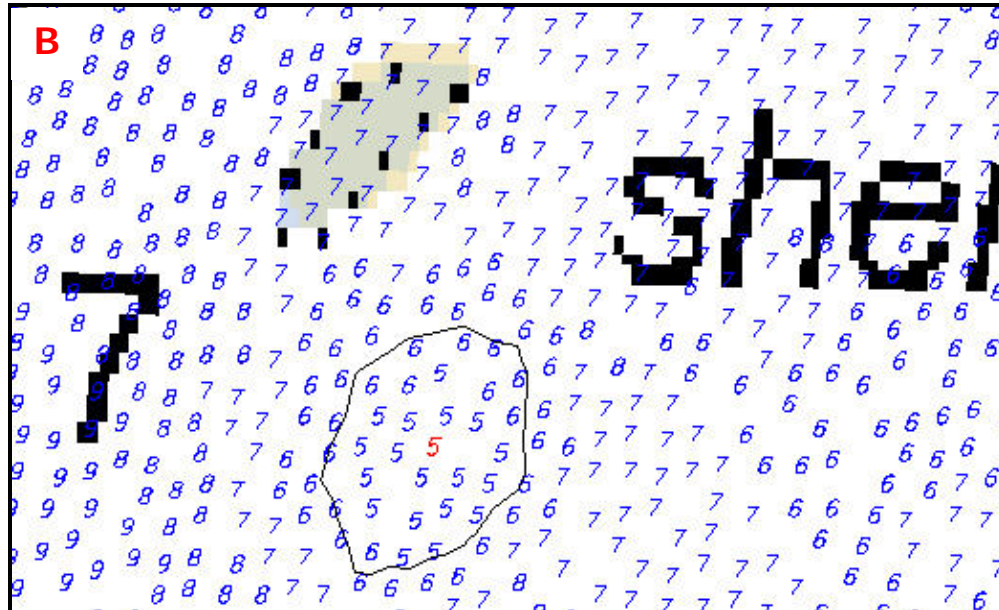
The feature immediately south of charted feature “B”, and shown in detail in Figure 7, may be the current position of the charted feature but it could also represent an entirely new feature. No bottom samples were taken directly on the indicated feature but samples collected in the vicinity were high in shell content and this tends to corroborate the charted “shell bank” attribute. *Do not concur. Insufficient evidence to support existence of shell bank. Recommend to remove feature from the chart and chart shoal sounding data per present survey findings.*

Figure 7- Reported shoaling area "B" in H11814. The 6-foot contour is shown by the grey line. Chart 11364, 42nd Edition. Depths in feet.

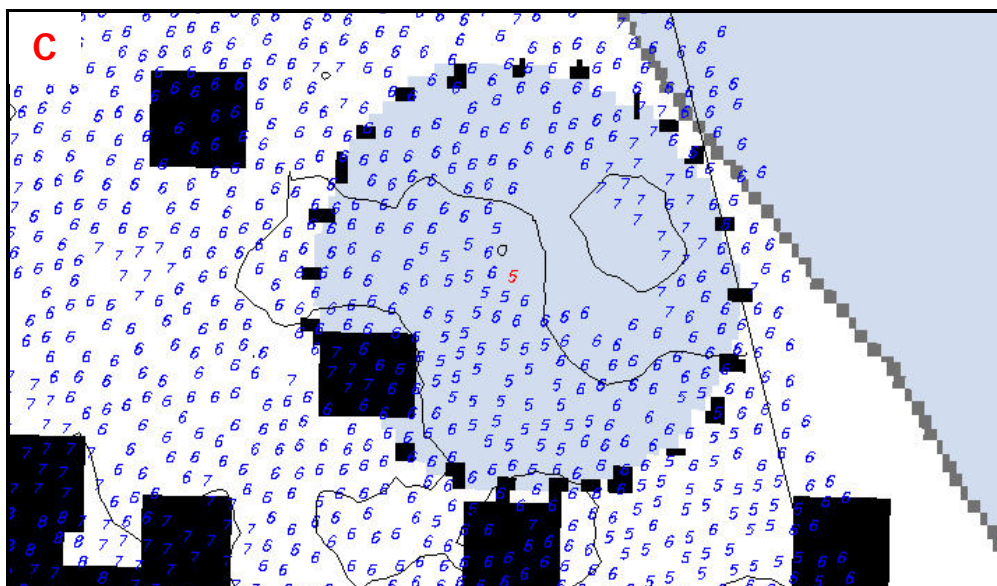
Figure 8- Reported shoaling area "C" in H11814. The 6 and 7-foot contours are shown by the grey lines. Chart 11364, 42nd Edition. Depths in feet. Note: the large blank space in the center of the feature is occupied by a large, multi-platform, oil related structure.

The feature charted as "shell bank PA (1 ft rep)", shown in detail in Figure 8, was found to be generally in the same position as charted. The "1 ft rep" depth was not supported by the 2008 / 2009 survey as the shoalest depth found in the vicinity of the feature during the survey was five (5) feet. It is significant to note that a large, multi-platform, oil related structure was located within the charted feature and the depths within the perimeter of the structure could not be measured. *Concur with conditions. A rea not t thoroughly investigated to disprove its existence. Retain obstruction area feature and Shell bank PA (1 ft rep) note.*

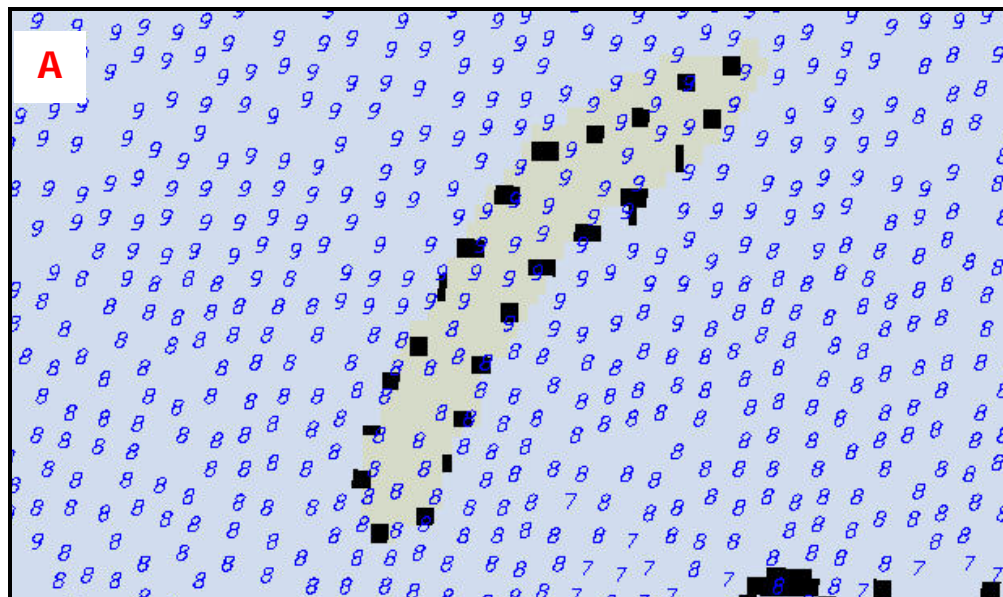
Figure 10- Reported shoaling area "A" in H11814. Chart 11364, 42nd Edition. Depths in feet.

Two (2) shoaling areas, list as “shifting shell banks” are indicated on the raster navigational charts covering H11814. The features, listed as A, Da and Db in Table 11 and shown in detail ~~with~~ *on the latest edition of* chart 11364, ~~41st Edition~~ in Figure 10 through Figure 12, were not found during the 2008 / 2009 survey. The bathymetry in all three locations was uniform and the sounding density was adequate to disprove the existence of shoaling features at the specified locations. The hydrographer recommends that the charted features be removed from chart 11364, ~~41st Edition~~. *Concur, remove intertidal areas listed below and update areas with present survey findings.*

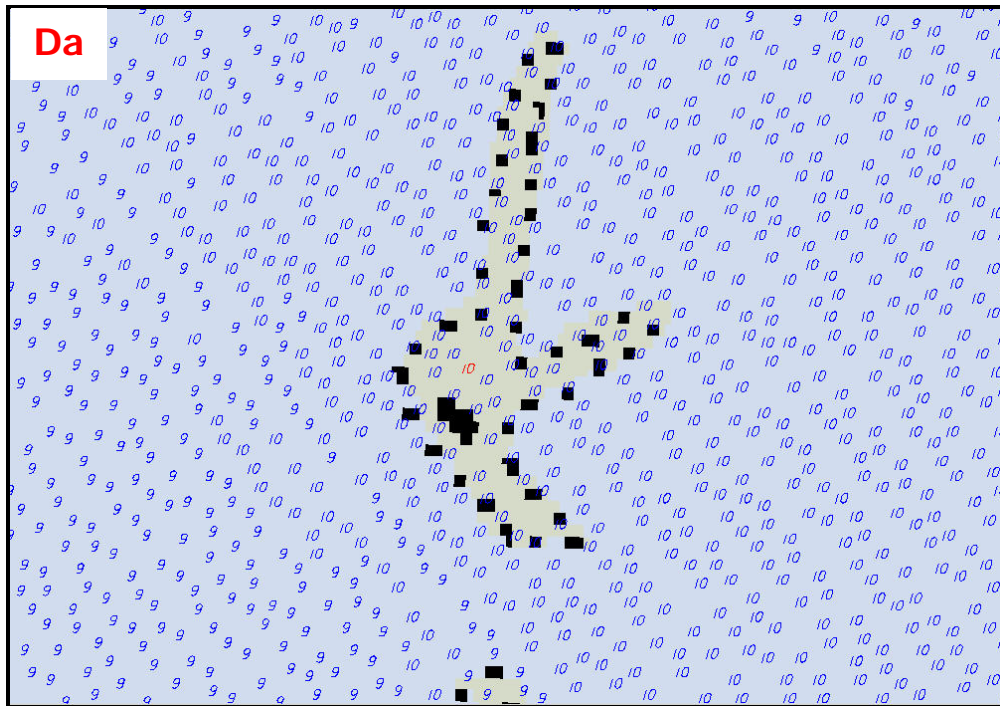
Figure 11- Reported shoaling area "D", northern portion, in H11814. Chart 11364, 42nd Edition.
Depths in feet.

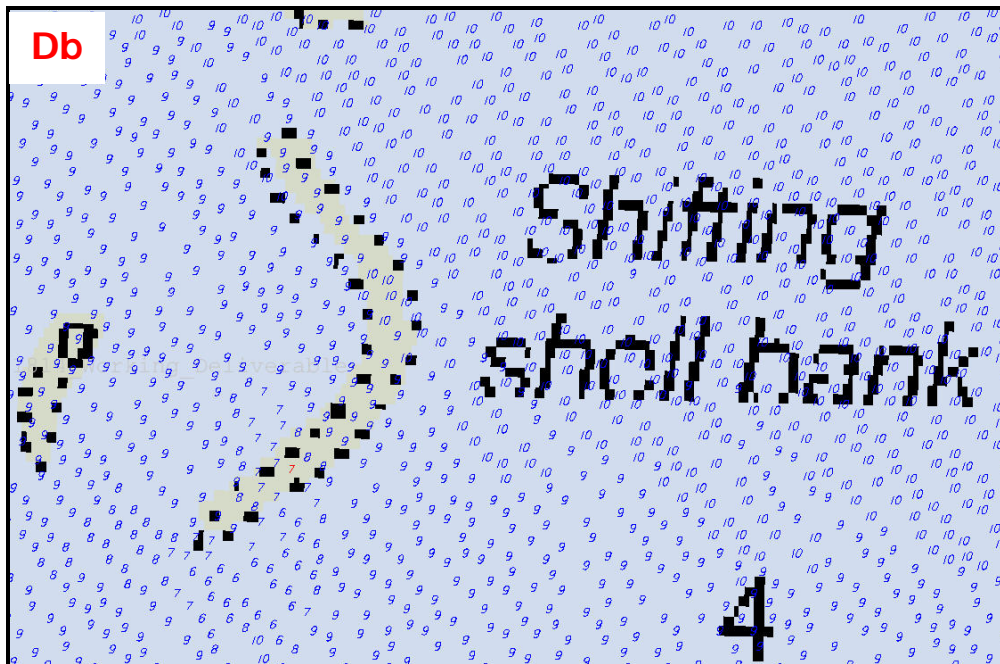
Figure 12 - Reported shoaling area "D", southern portion, in H11814. Chart 11364, 42nd Edition.
Depths in feet.

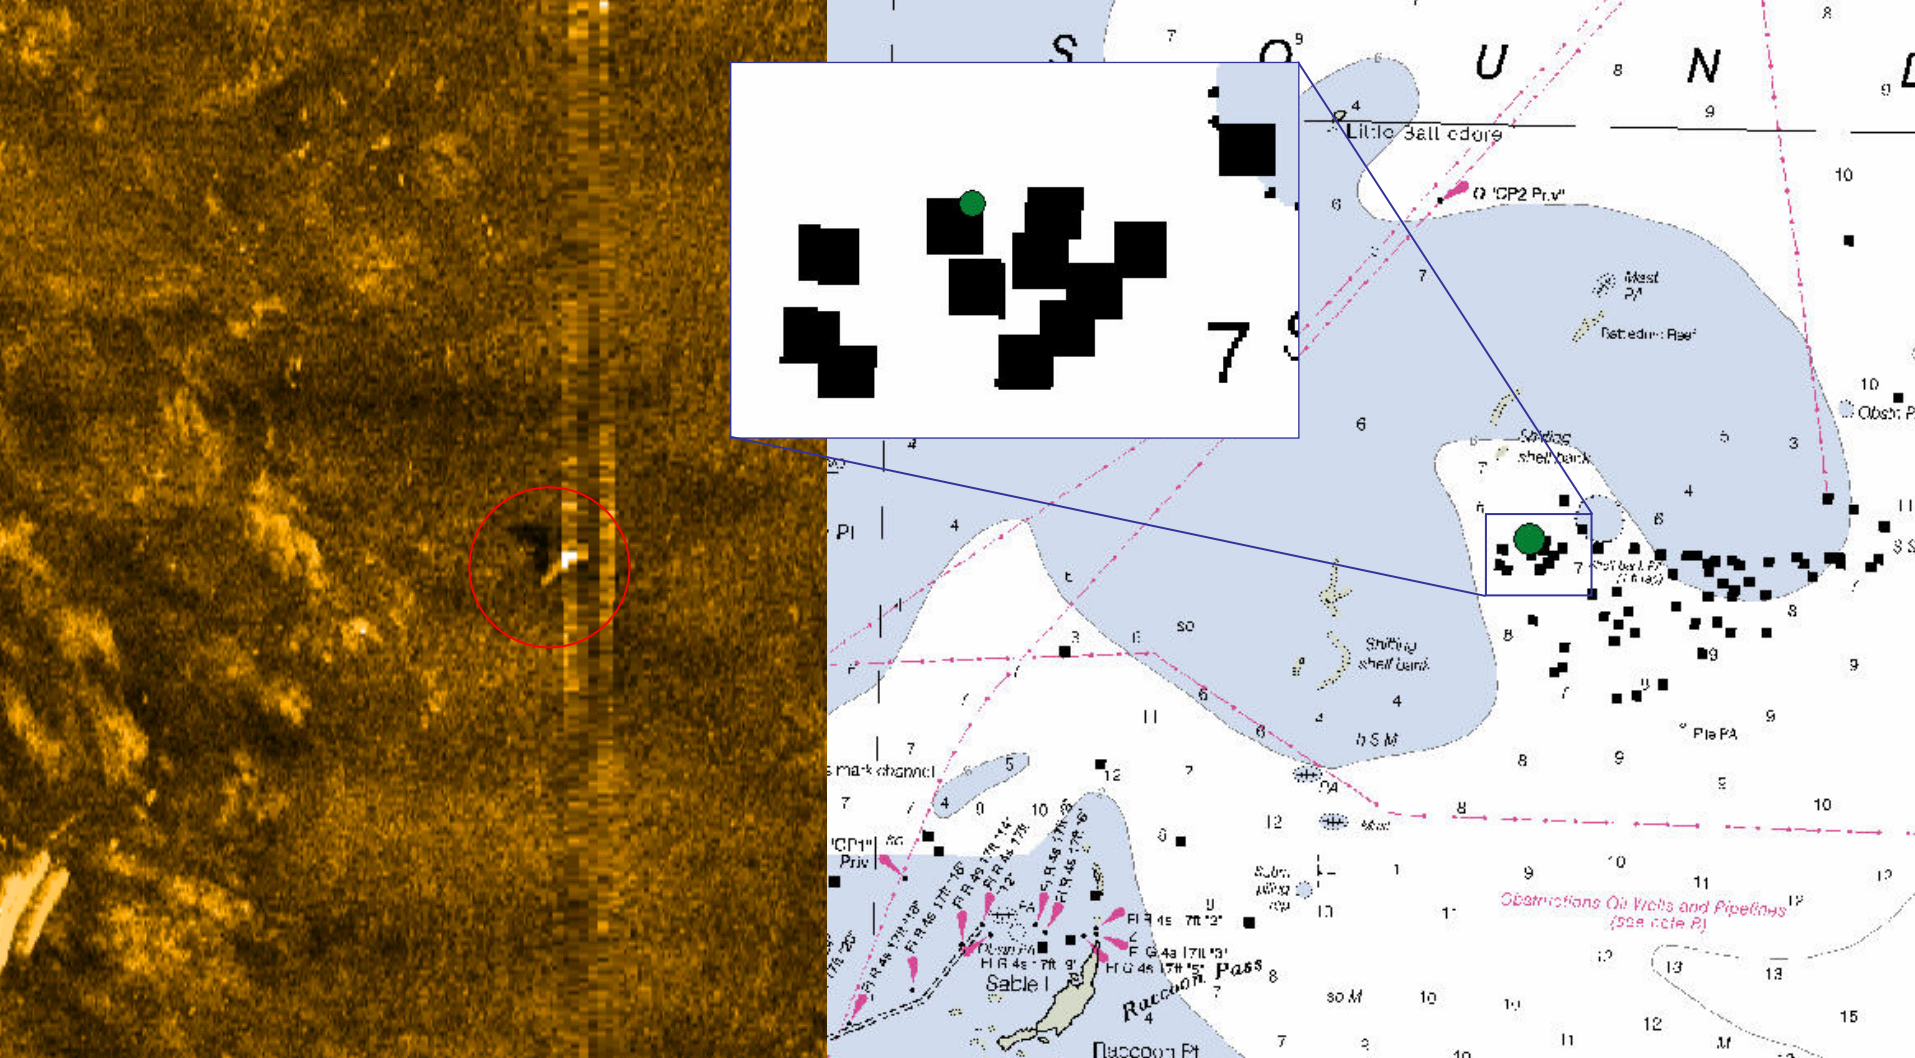
Obstruction found in Breton Sound with least depth of ~~4.4~~ **5.826** feet, corrected using verified NOAA tides.

DTON #3. Not submitted by AHB to MCD due to close proximity to charted platform. No changes to charting recommended.

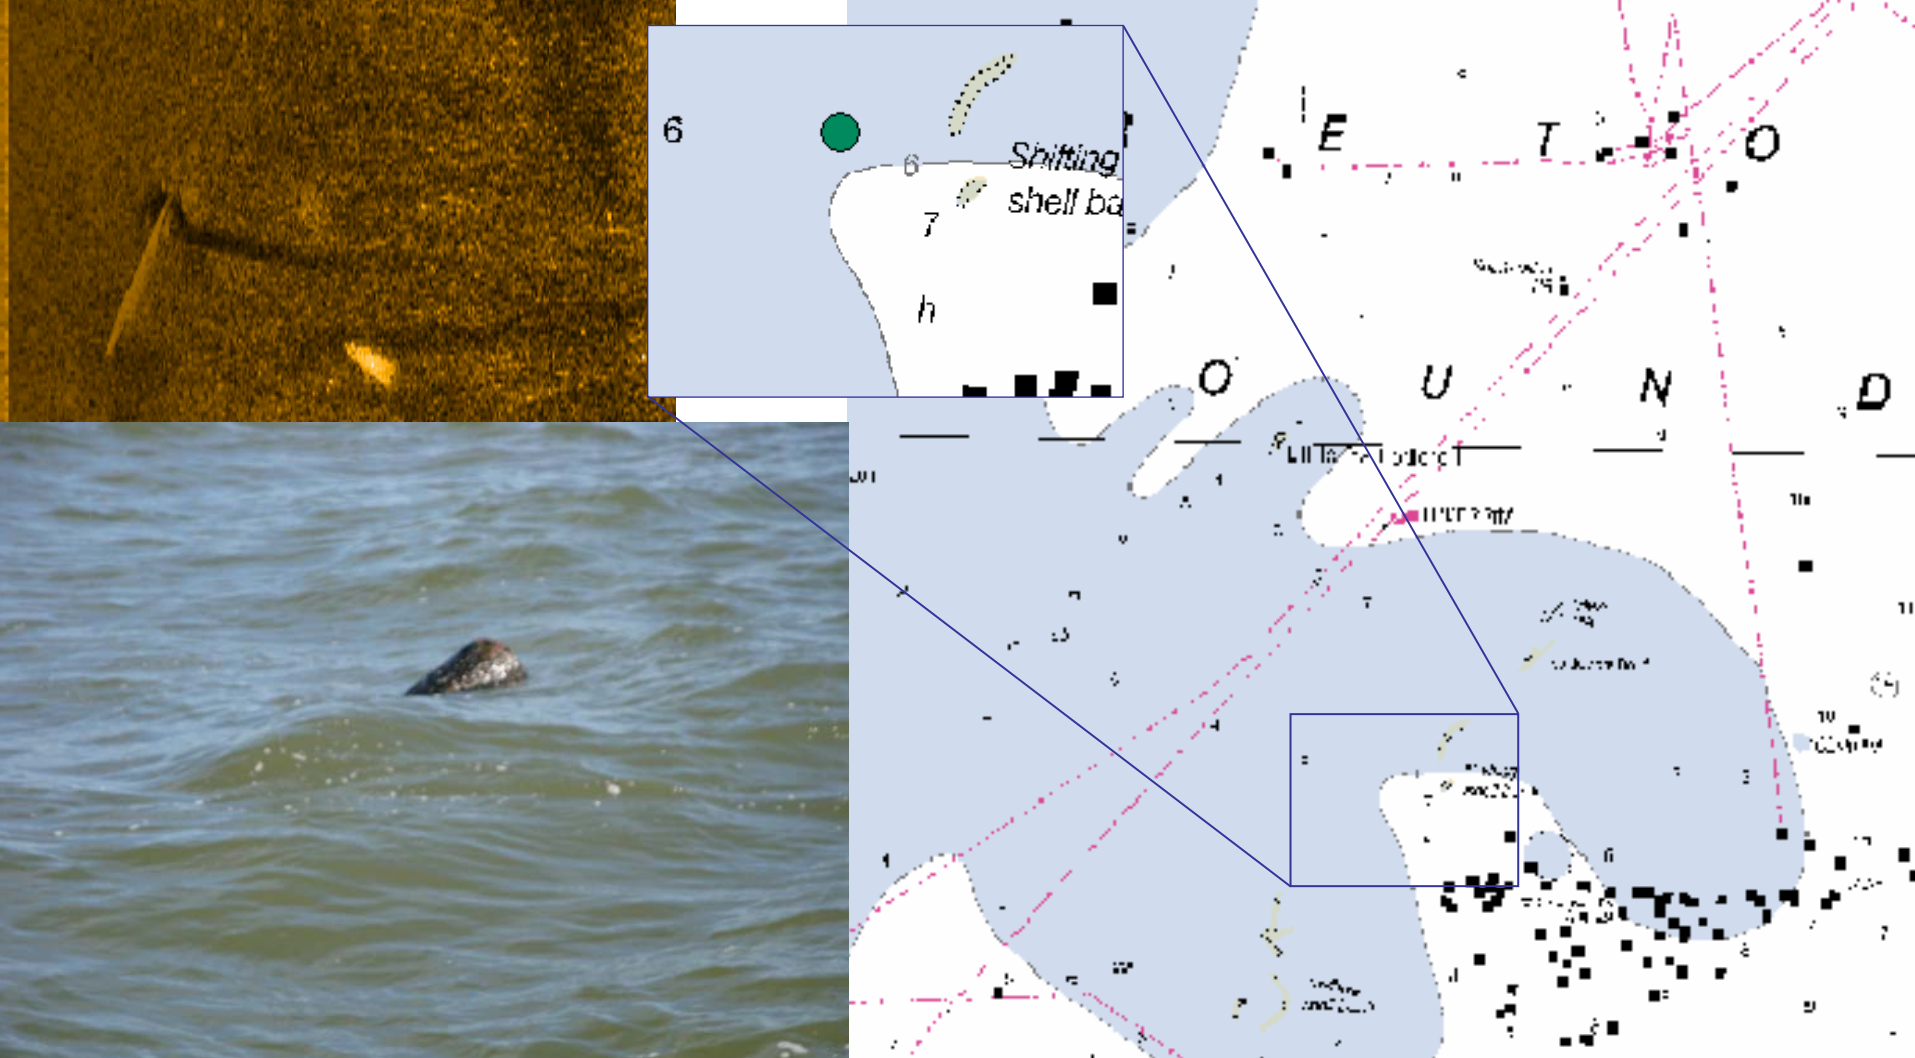
Obstruction found in Breton Sound covers and uncovers.

Concur with clarification. DTON #3A submitted to MCD. This obstruction is shown on the chart as an Obsn symbol at the present survey position. Recommend to delete charted obstruction symbol and add an obstruction symbol and the note (uncovers) Rep 2009 at the present survey position.

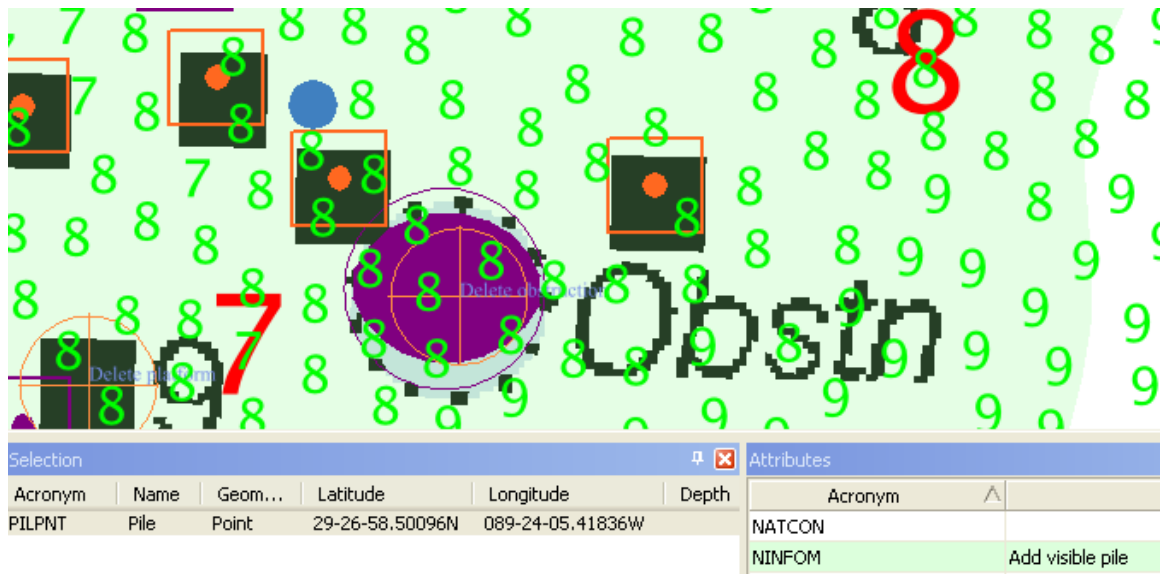
a. Feature D57 was submitted by the field as an uncharted pile in Latitude 29° 26' 58.5010"N, Longitude 89° 24' 05.4184"W. This feature was not submitted as a DTON and it is not written up in Appendix 1. The feature is, however, mentioned in the Descriptive Report. This feature is in close proximity to two charted platforms and a new 5 foot dangerous obstruction feature. There is no background information to support this pile nor is there any side scan sonar indication of this feature, so it was likely found through a visual sighting. It is visible on up to date orthoimagery of the area. It is recommended that a visible pile is charted in the above present survey location.

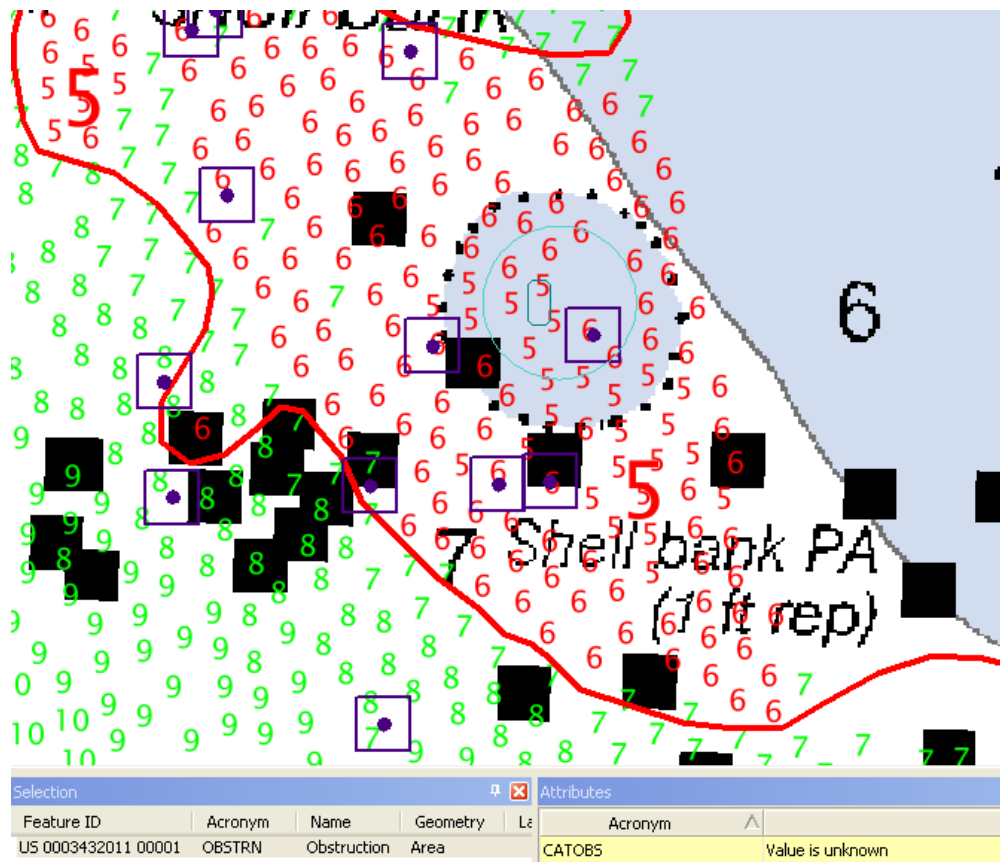
c. Feature D65 is listed as an uncharted obstruction in Latitude 29° 27' 22.44"N, Longitude 89° 25' 01.67"W in the Descriptive Report. There was no DTON submitted by the field for this feature and it has not been applied to the chart. This feature is in close proximity to a charted platform and an Obstruction (Shell bank PA, 1 ft reported). Present survey depths in the area are 5 and 6 feet. This feature is not recommended for charting. No changes to charting are necessary.

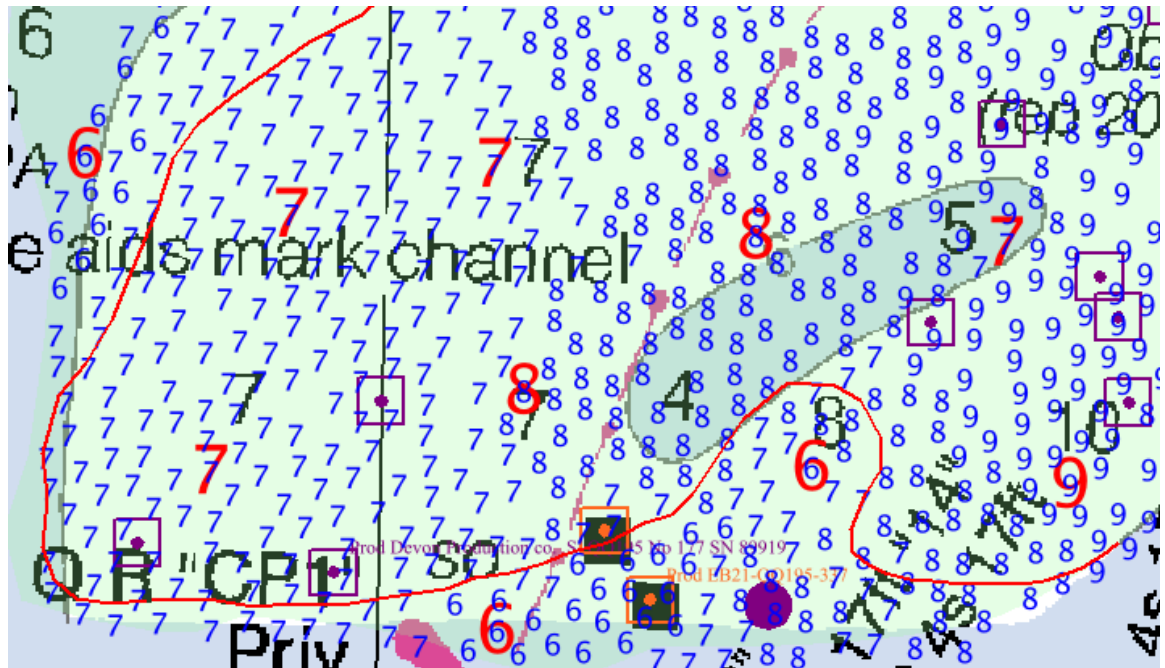
c. To the southwest, present survey depths and charted depths agree within 0 to 4 feet. Present survey depths of 6 to 10 feet are in areas with charted depths of 4 to 12 feet.

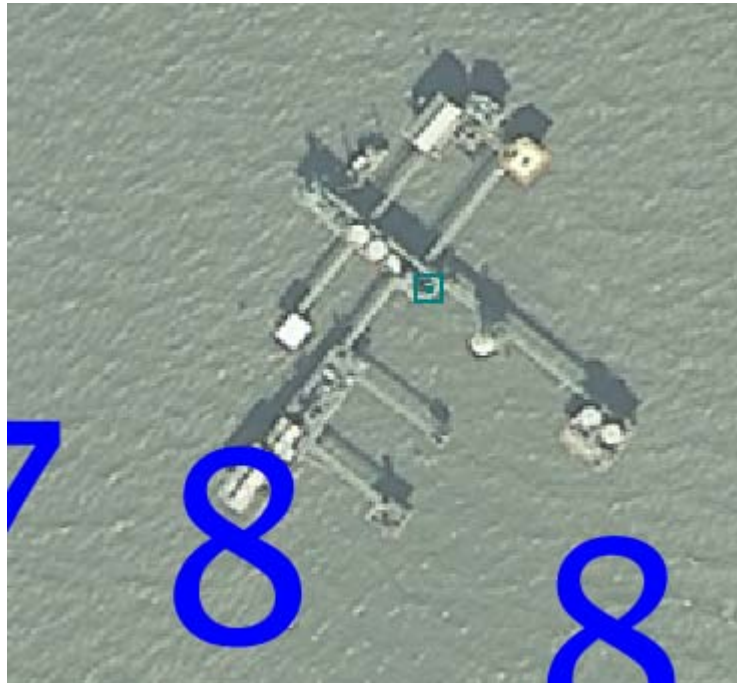
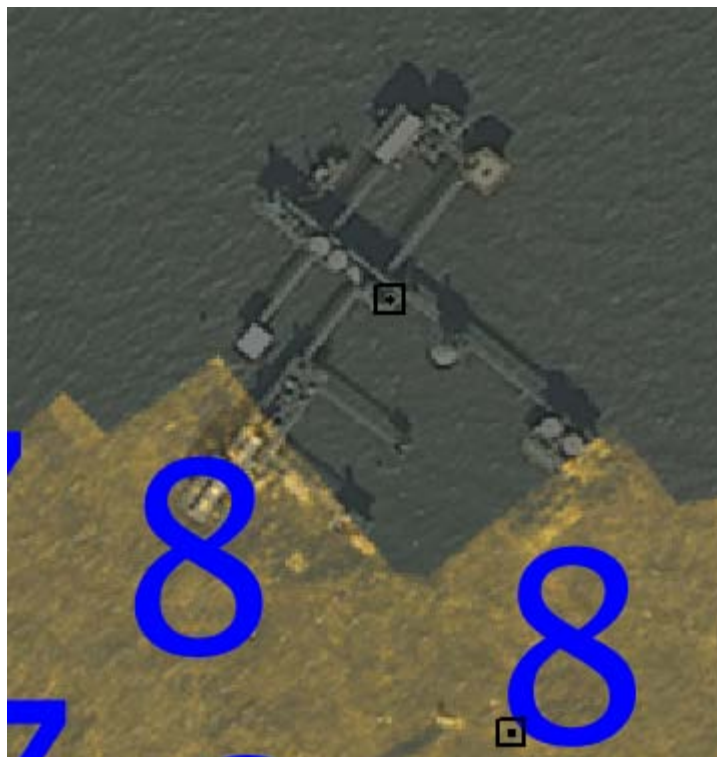
c. Also, in addition to the listing in Appendix II, a platform in Latitude 29°27'04.22221"N, Longitude 089°24'11.60706"W is not charted and was not designated as a new platform by the field. This platform was seen in side scan sonar imagery collected during the present survey and orthoimagery of the survey area. It is recommended that this platform is added to the chart and ENC in the present survey location.
