H11929

DESCRIPTIVE REPORT
to accompany
HYDROGRAPHIC SURVEY H11929

Scale of Survey: 1:10,000
Year of Survey: 2008
NOAA Navigation Response Team 5
LT(jg) Matthew Jaskoski, OIC

E. APPROVAL SHEET**OPR-B301
Providence
Rhode Island****Providence River and North Narragansett Bay
Survey Registry No. H11929**

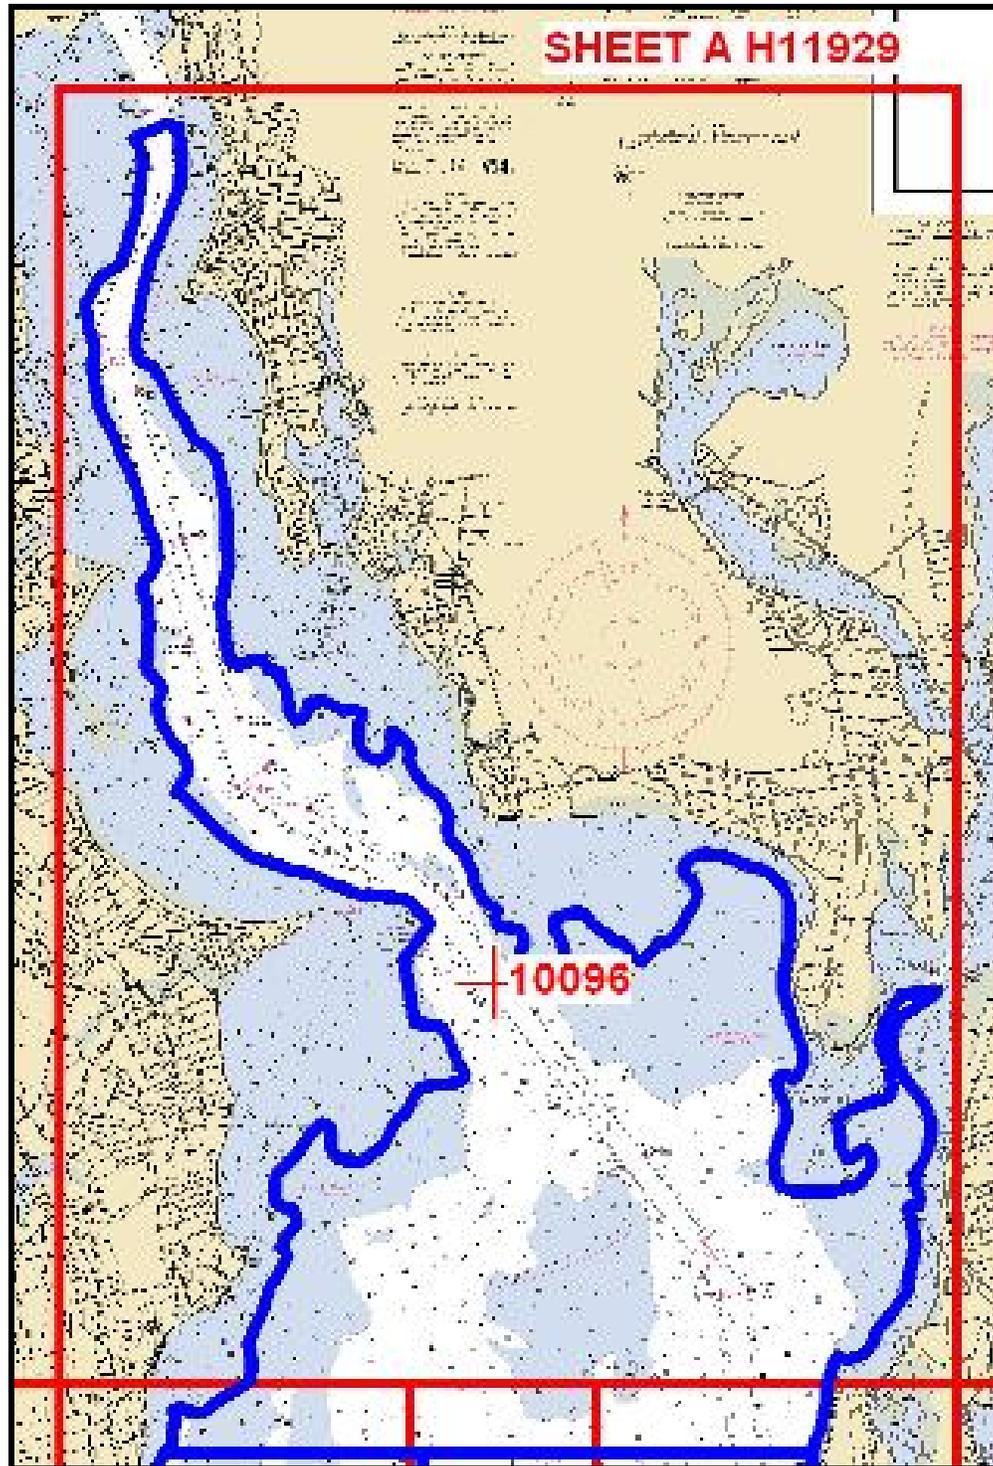
Figure A-1: Outline of survey area

This Descriptive Report pertains to an area of approximately 7.5 SNM, of North Narragansett Bay from the Providence River in the north, to Prudence Island in the South. The assigned registry number for this sheet is H11929, as prescribed in the Letter Instructions*. **Filed with original field records.*

For complete survey limits, see figure A-1 on the following page.

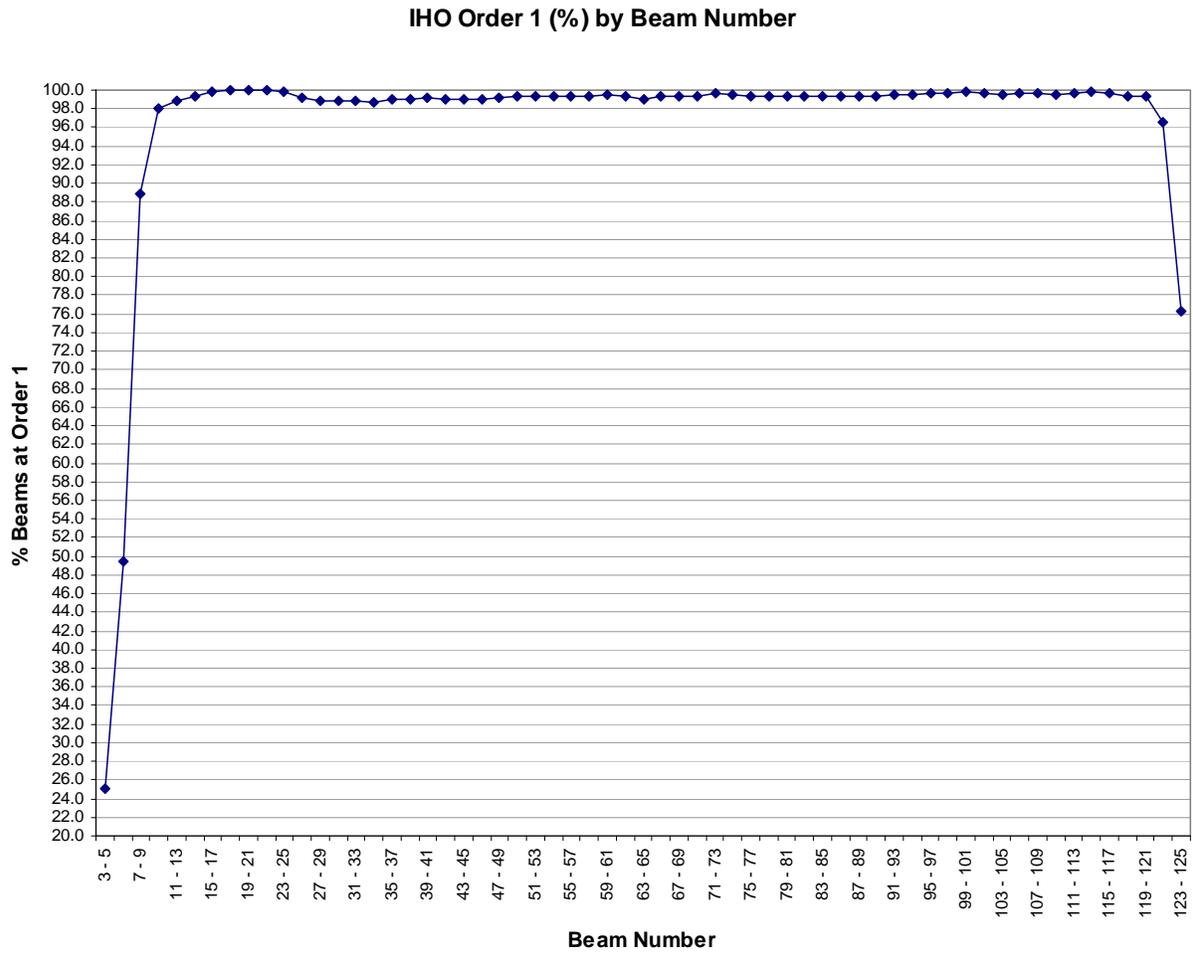
Figure B-1: Caris QC report, IHO order oneness v Beam Number. Note outer beams: 1-8, and 123-127, these beams were filtered from the dataset.

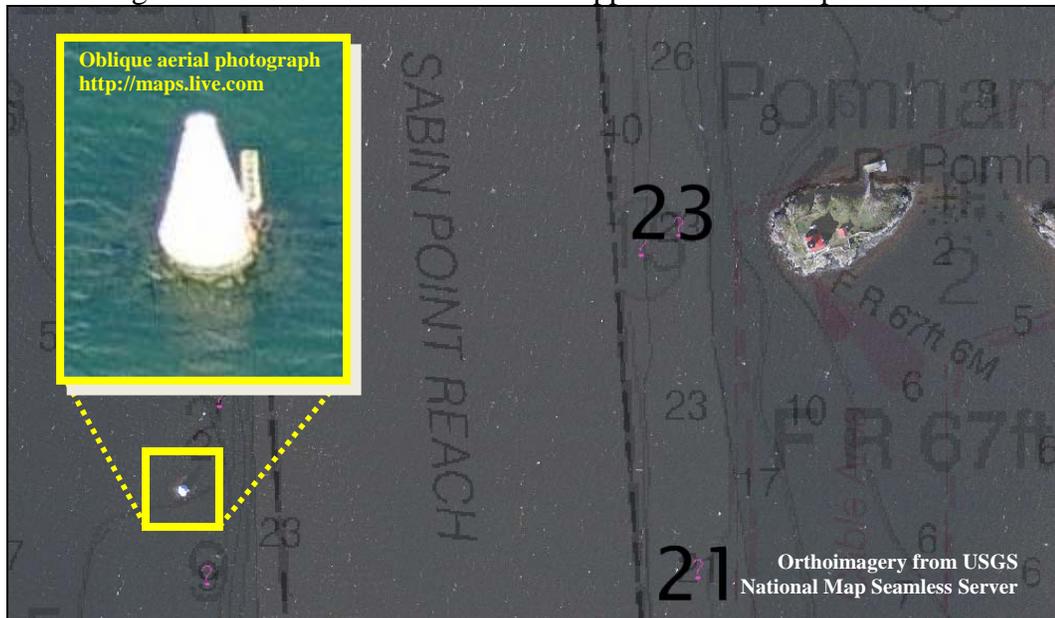
- As documented in the DR, the hydrographer reported an uncharted cairn. The DR-position of the cairn is based on a side scan sonar contact; however, the final position of the cairn, as included in the H-Cell, was digitized from orthoimagery, which was used to supplement documentation provided by the hydrographer. The ortho-image and the associated metadata are appended to this report.

Figure 1: Uncharted cairn

An uncharted cairn was noted within the survey limits of H11929, the object is a whitewashed stone and brick masonry structure located outside the channel on a shoal. Due to the objects location it was determined by the hydrographer not to represent a hazard to safe navigation and was not submitted as DToN. No other AToNs within the survey limits of H11929 were found to be significantly off station. See Appendix V*, section V.3. *See Evaluation Report.*

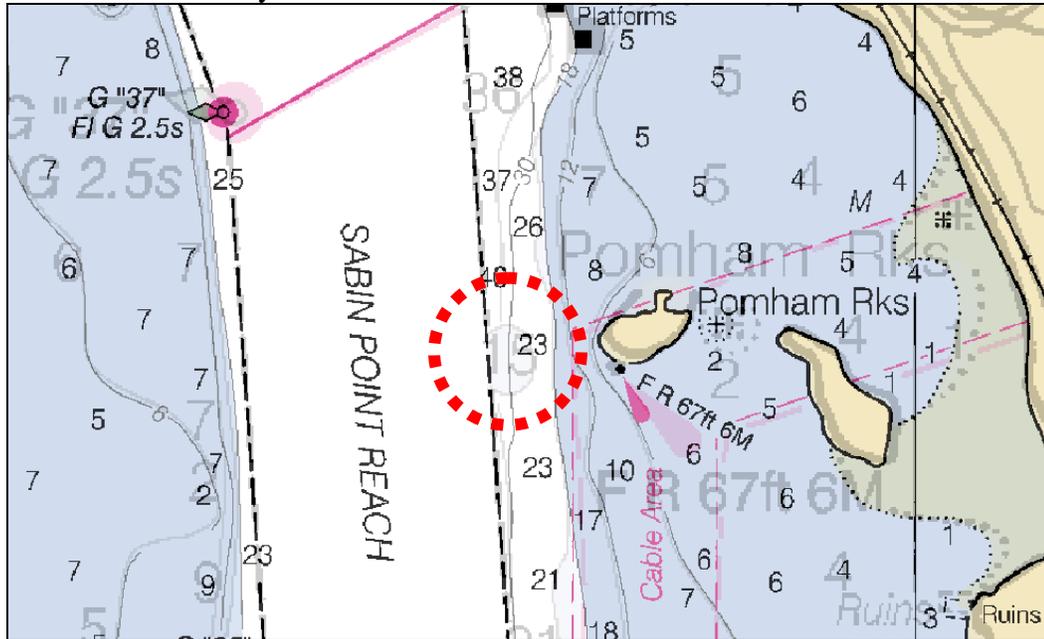
- The hydrographer did not address the charted 15-ft depth at 41°46'39.491" N, 071°22'14.242" W on RNC 13224 (1:20,000); however, the 15-ft depth is not charted on RNC 13225 (1:10,000) (see Fig. 2). The position was not developed to be able to disprove or verify a 15-ft depth. Add a 15-ft depth to RNC 13225 to maintain consistency between RNC 13224 and RNC 13255.

Figure 2: Discrepancy between RNC 13224 & RNC 13225. (Both charts are shown, one transparent over the other.)
