**DESCRIPTIVE REPORT**

Registry Number: H11930

General Locality: Narragansett Bay

Project Number: **OPR-B301-NRT5-11**

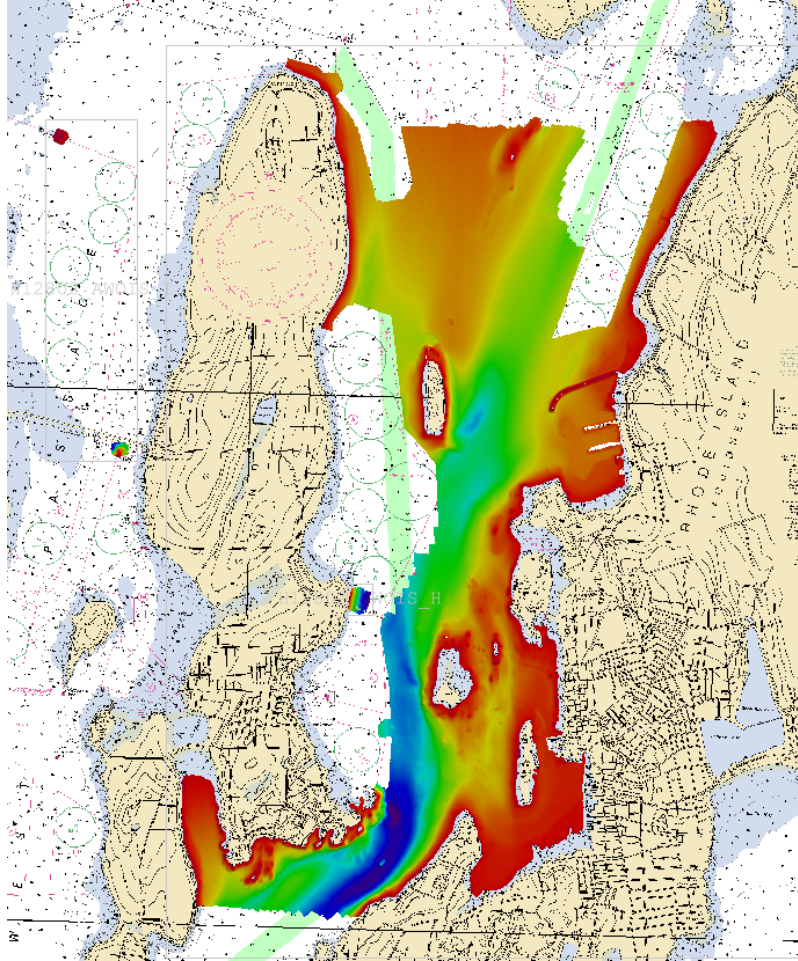
*Figure 1: H11930 Survey Limits*

The survey limits of H11930 encompass a large portion of East Passage, from approximately .5 nautical miles north of Castle Hill light to the Northern tip of Conanicut Island. East Passage is the principal passage in Narragansett Bay, extending between Rhode Island on the east and Conanicut and Prudence Islands on the west. It is the most direct route to Newport, Bristol, Providence, Mount Hope Bay, and Taunton River. Two AWOIS items lying outside of the survey limits of H11930 in the West Passage were also investigated.

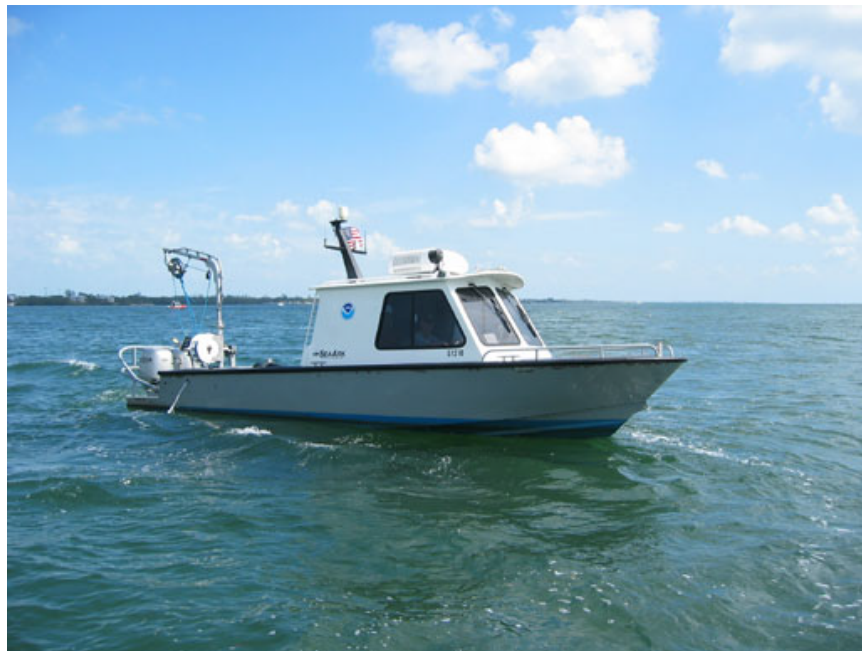
*Figure 3: S3002*

S3002 is a 30 ft aluminum hulled SeaArk Commander, powered by twin 200hp outboard engines.

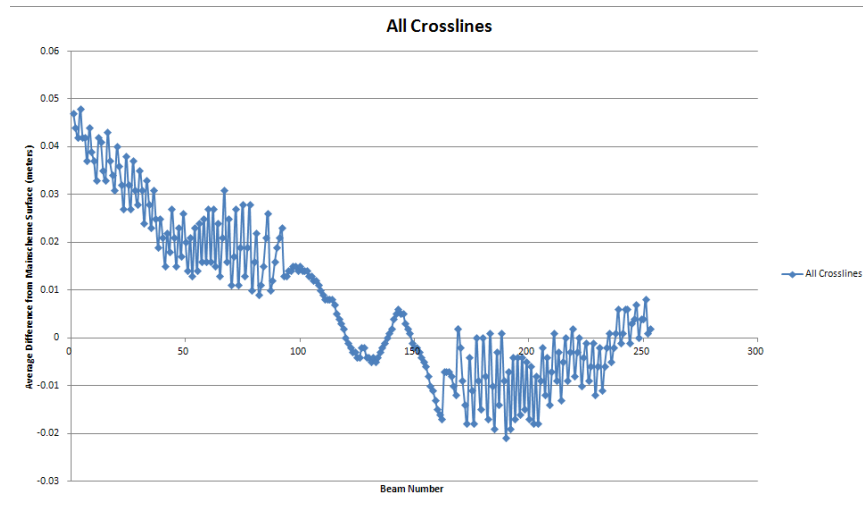
Figure 6: Caris QC Report selecting all Crosslines

A crossline comparison was also performed using Caris QC Report. A one meter reference surface was created using only mainscheme lines. A QC Report by beam number was then created considering all crosslines together. Several additional QC reports were also created for individual crosslines. The QC report generated for all crosslines shows a maximum beam average deviation from the reference surface of less than five centimeters. The beam averages have a sloping trend, indicating that there is a slight residual roll bias. The QC reports for individual crosslines show that the majority of beam averages fall within five centimeters of the reference surface. The crossline 019\_1417 has a maximum beam average deviation of more than 15 centimeters, and is one of the lines from Mackerel Cove.

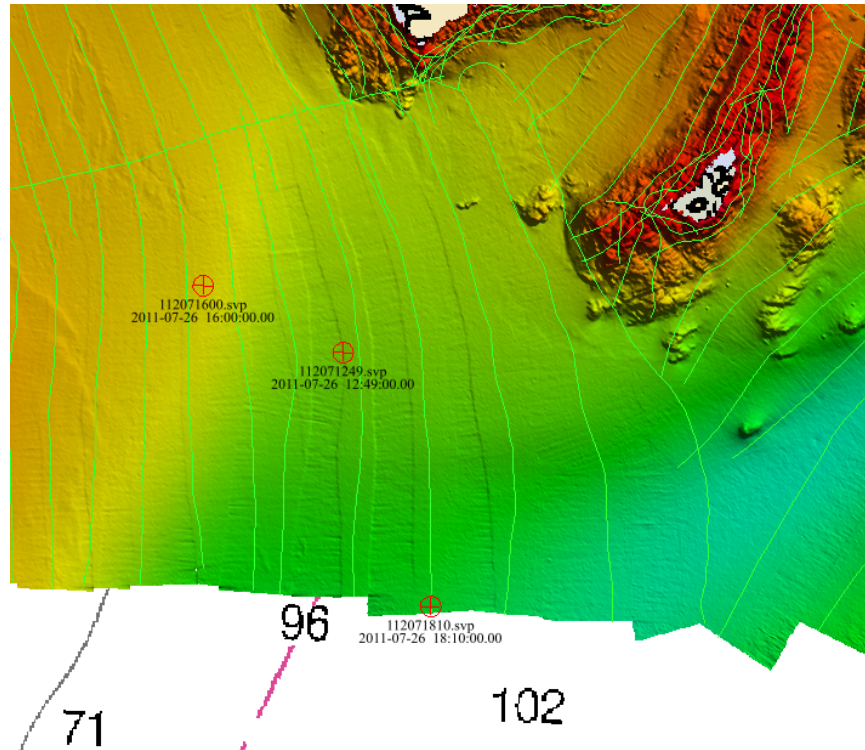
Figure 8: SVP error between Mackerel Cove and Kettle Bottom Rock

There are sound velocity errors evident in the area southwest of Kettle Bottom Rock. An adequate number of casts were taken in the area, however, there was a significant change in sound velocity between Mackerel Cove and the deeper waters where the SVP error is visible. The image below shows the locations of the casts taken that day. The cast being used for real time SVP correction at the time was the one taken closest to Mackerel Cove. Due to the system configuration of S3002, it is not possible to post process SVP corrections, otherwise the SVP error could have been corrected using one of the casts farther to the south and east. An SVP error was also visible in crosslines taken north of Gould Island, which is detailed in the crosslines section of this report.

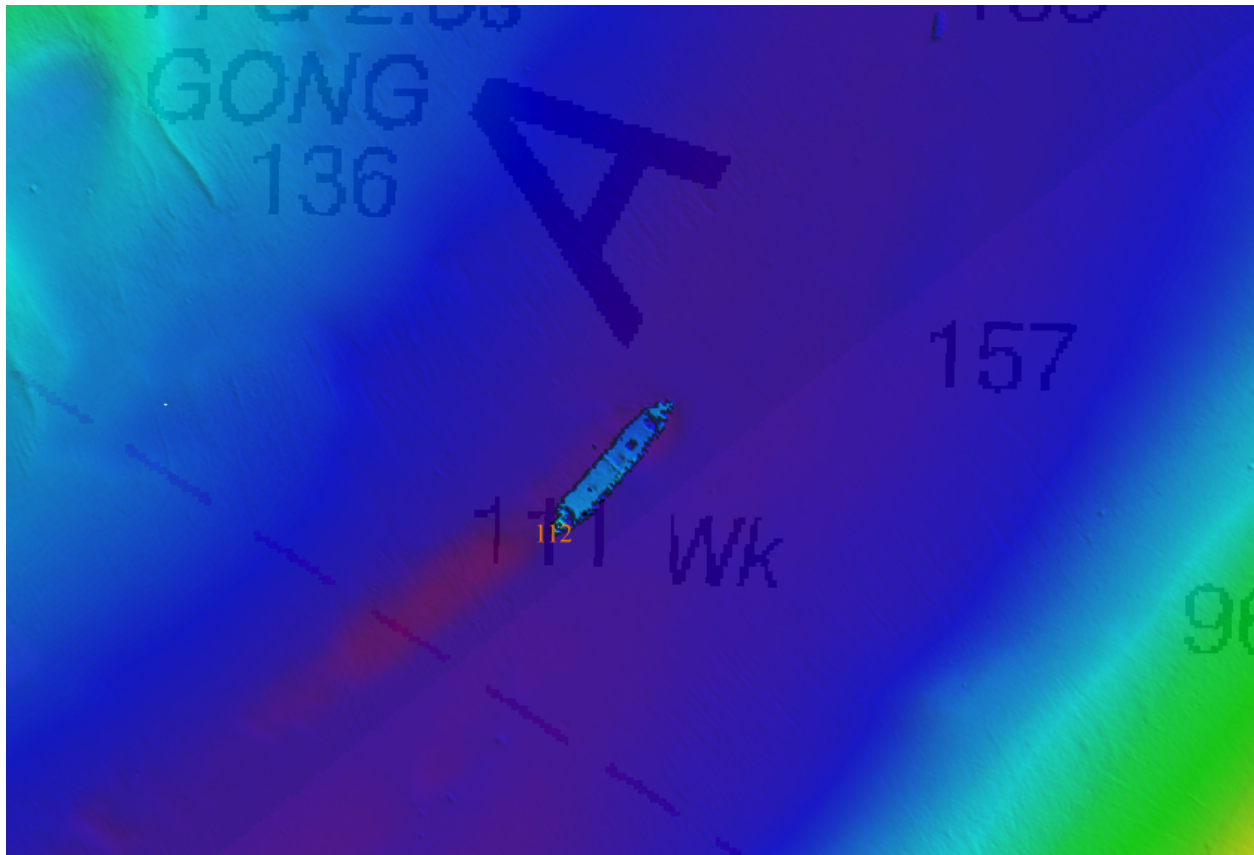
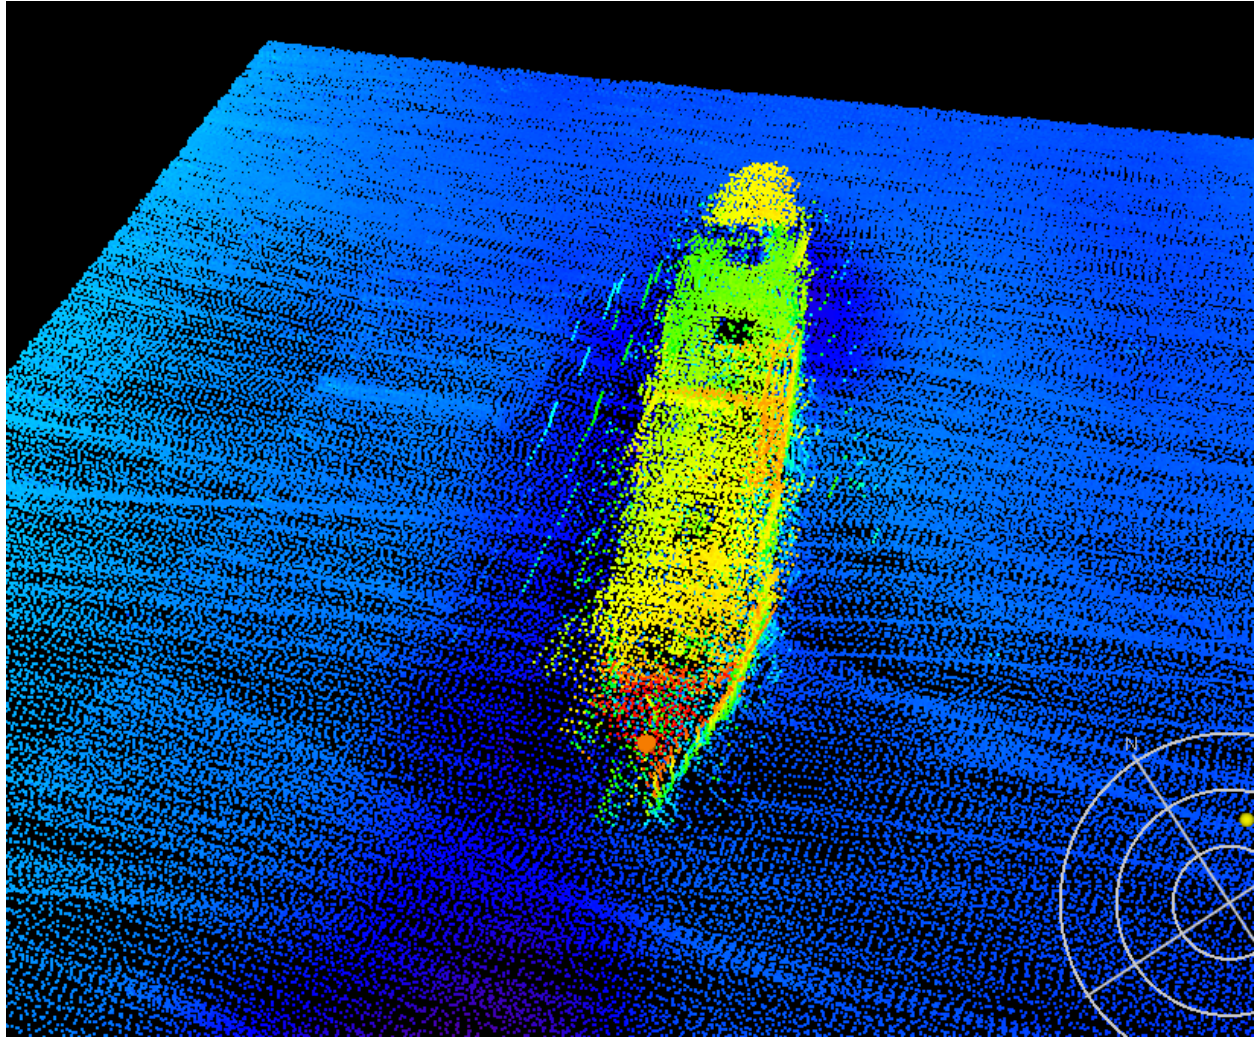
Figure 1.1.1

**Geo object 1:** Wreck (WRECKS)  
**Attributes:** CATWRK - 1:non-dangerous wreck  
 QUASOU - 1:depth known  
 SORDAT - 20110919  
 SORIND - US,US,graph,H-11930  
 TECSOU - 3:found by multi-beam  
 VALSOU - 34.356 m  
 WATLEV - 3:always under water/submerged

It's Recommended getting a diver to verify least depth when possible. Update wreck position and least depth with current survey data.

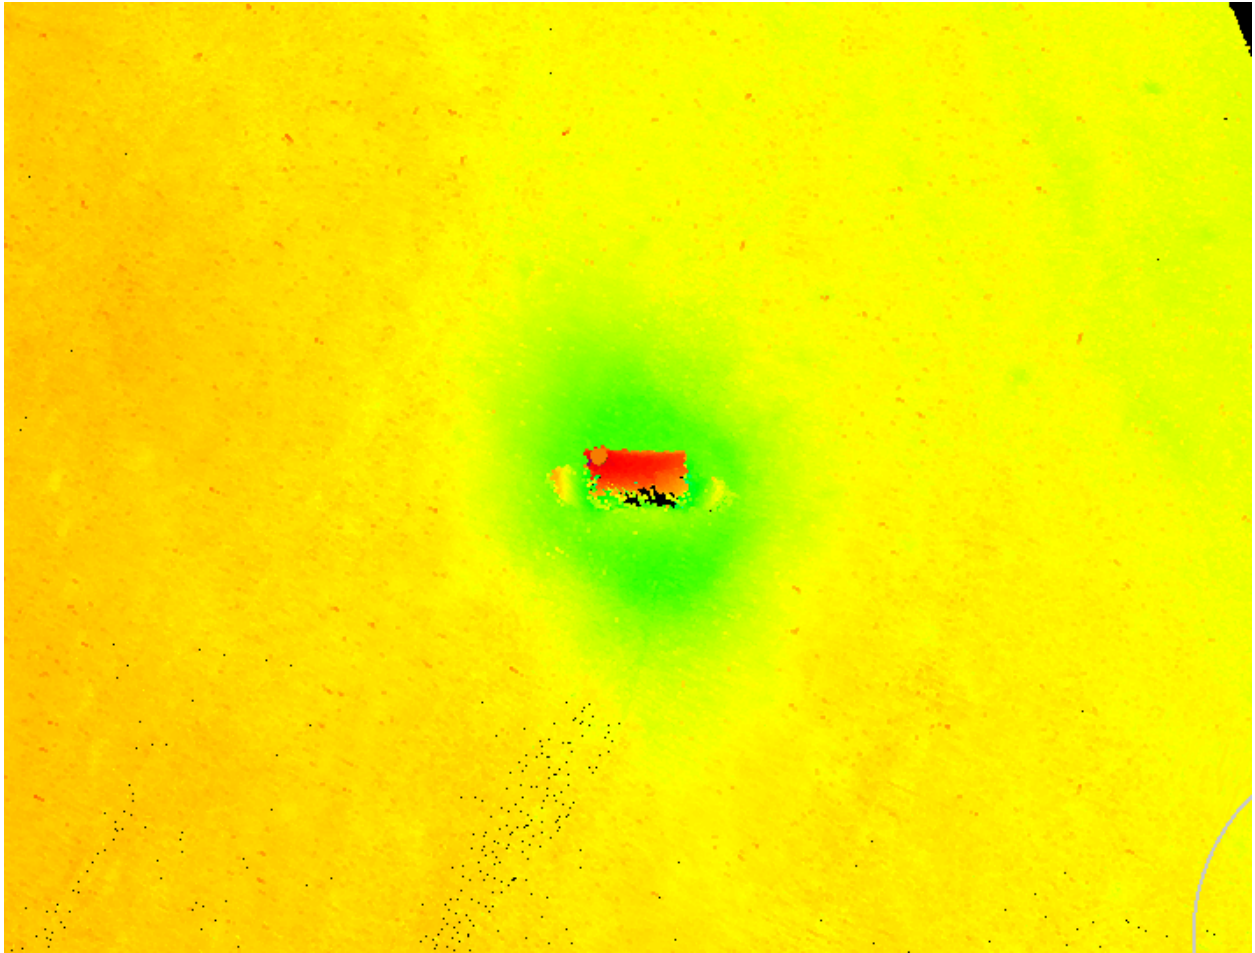
*Figure 1.3.1*

**Geo object 1:** Obstruction (OBSTRN)  
**Attributes:** CATOBS - 1:snag / stump  
QUASOU - 6:least depth known  
SORDAT - 20110919  
SORIND - US,US,graph,H-11930  
TECSOU - 3:found by multi-beam  
VALSOU - 6.244 m  
WATLEV - 3:always under water/submerged

Update position and least depth of obstruction, AWOIS item #14107. Chart feature per H11930.

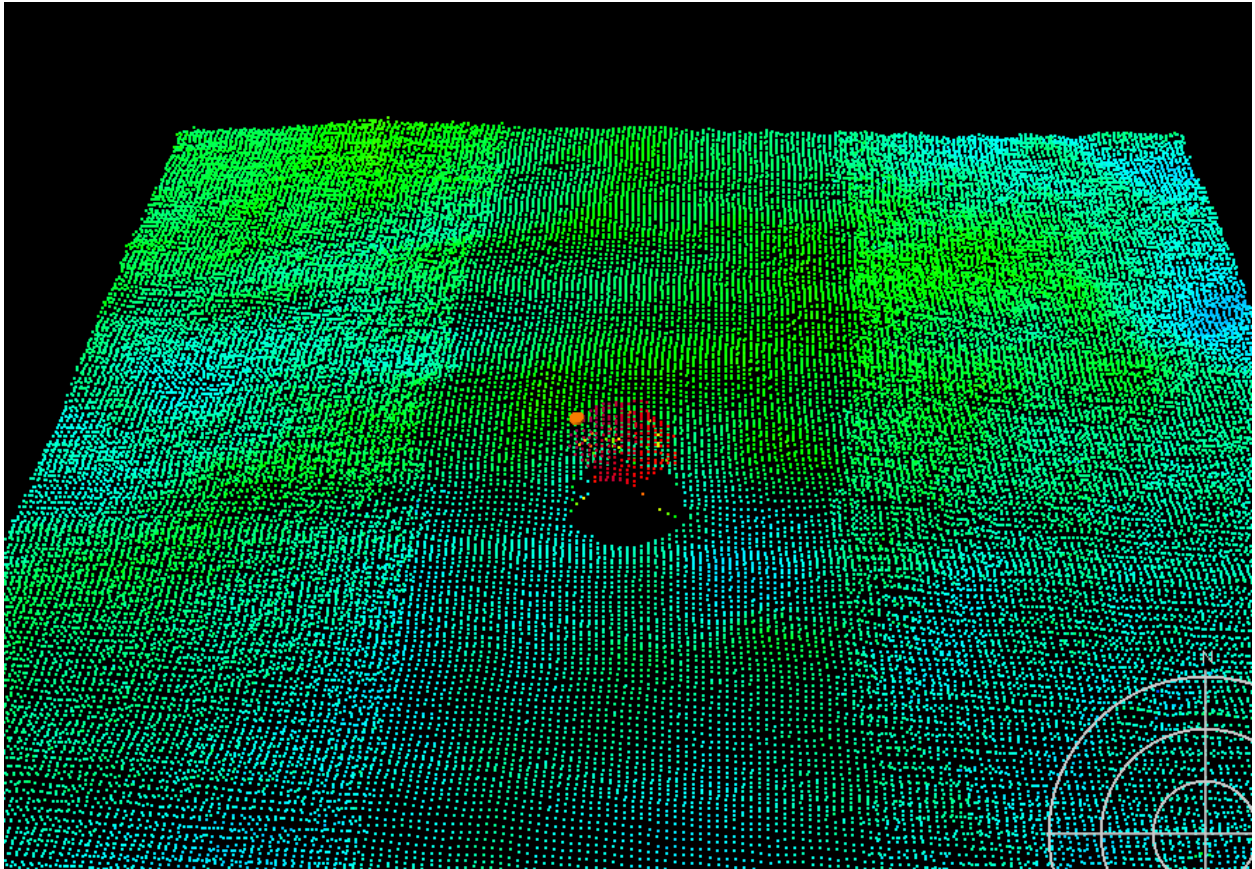
Figure 1.6.1

**Geo object 1:** Obstruction (OBSTRN)  
**Attributes:** QUASOU - 1:depth known  
SORDAT - 20110919  
SORIND - US,US,graph,H-11930  
TECSOU - 3:found by multi-beam  
VALSOU - 14.355 m  
WATLEV - 3:always under water/submerged

It's Recommended getting a diver to verify least depth when possible. Update obstruction position and least depth with current survey data. AWOIS Item # 13838

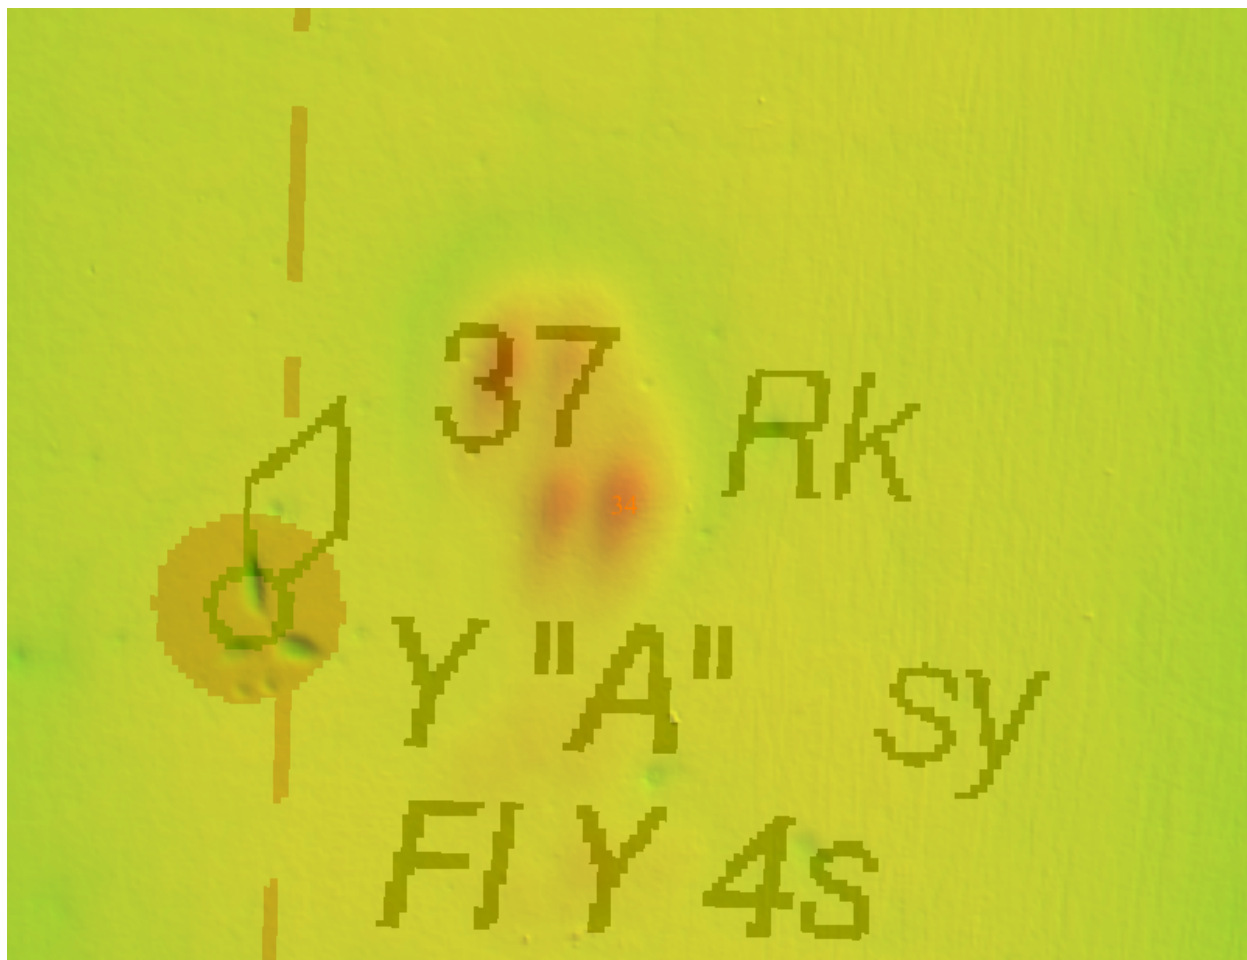
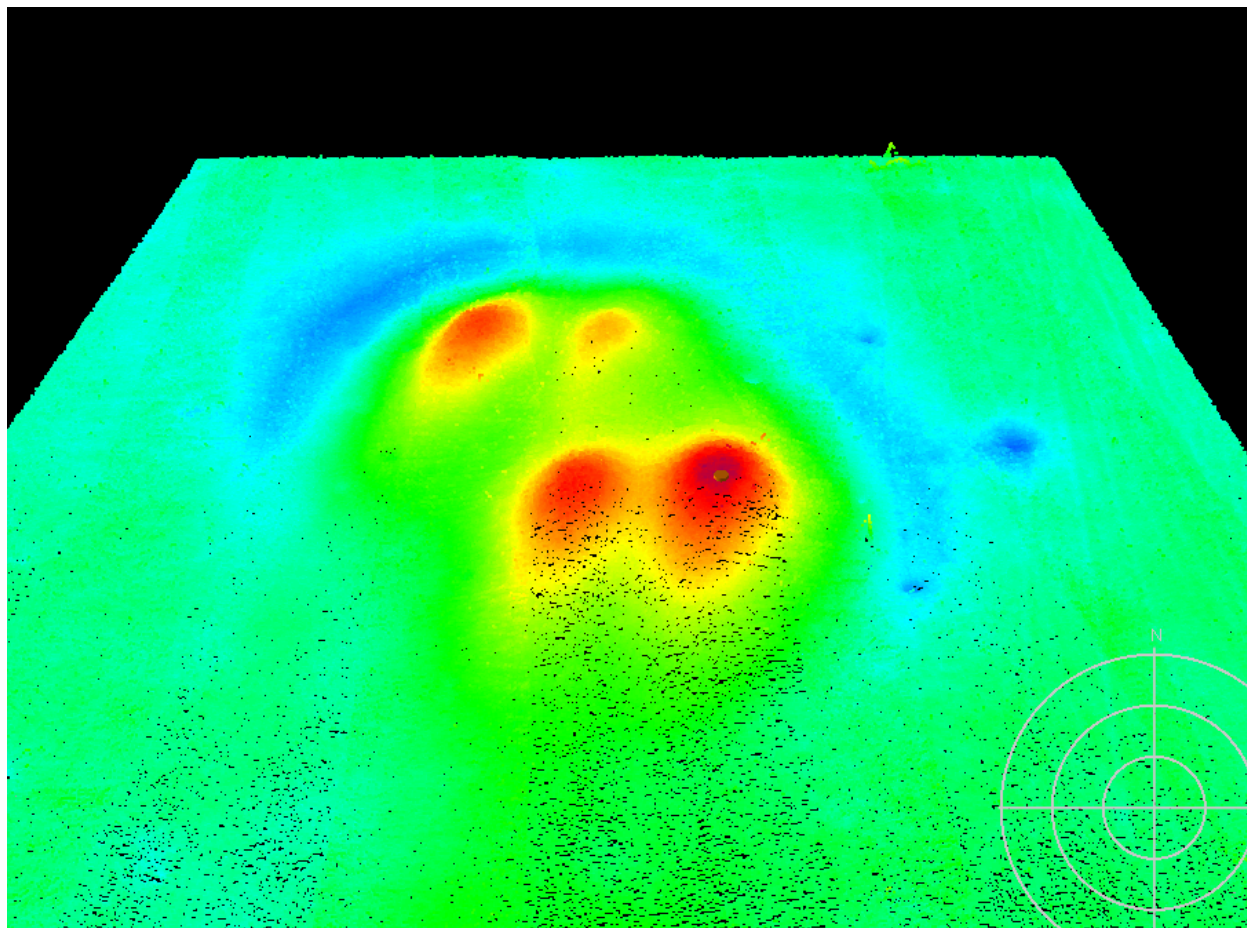
Figure 1.11.1

**Geo object 1:** Obstruction (OBSTRN)  
**Attributes:** QUASOU - 6:least depth known  
SORDAT - 20110919  
SORIND - US,US,graph,H-11930  
TECSOU - 3:found by multi-beam  
VALSOU - 10.559 m  
WATLEV - 3:always under water/submerged

Replace 37 ft rock with 34 ft obstruction centered on designated sounding. Update position and description of item # 7890 in AWOIS database.

Chart AWOIS item #7890 per HCell.

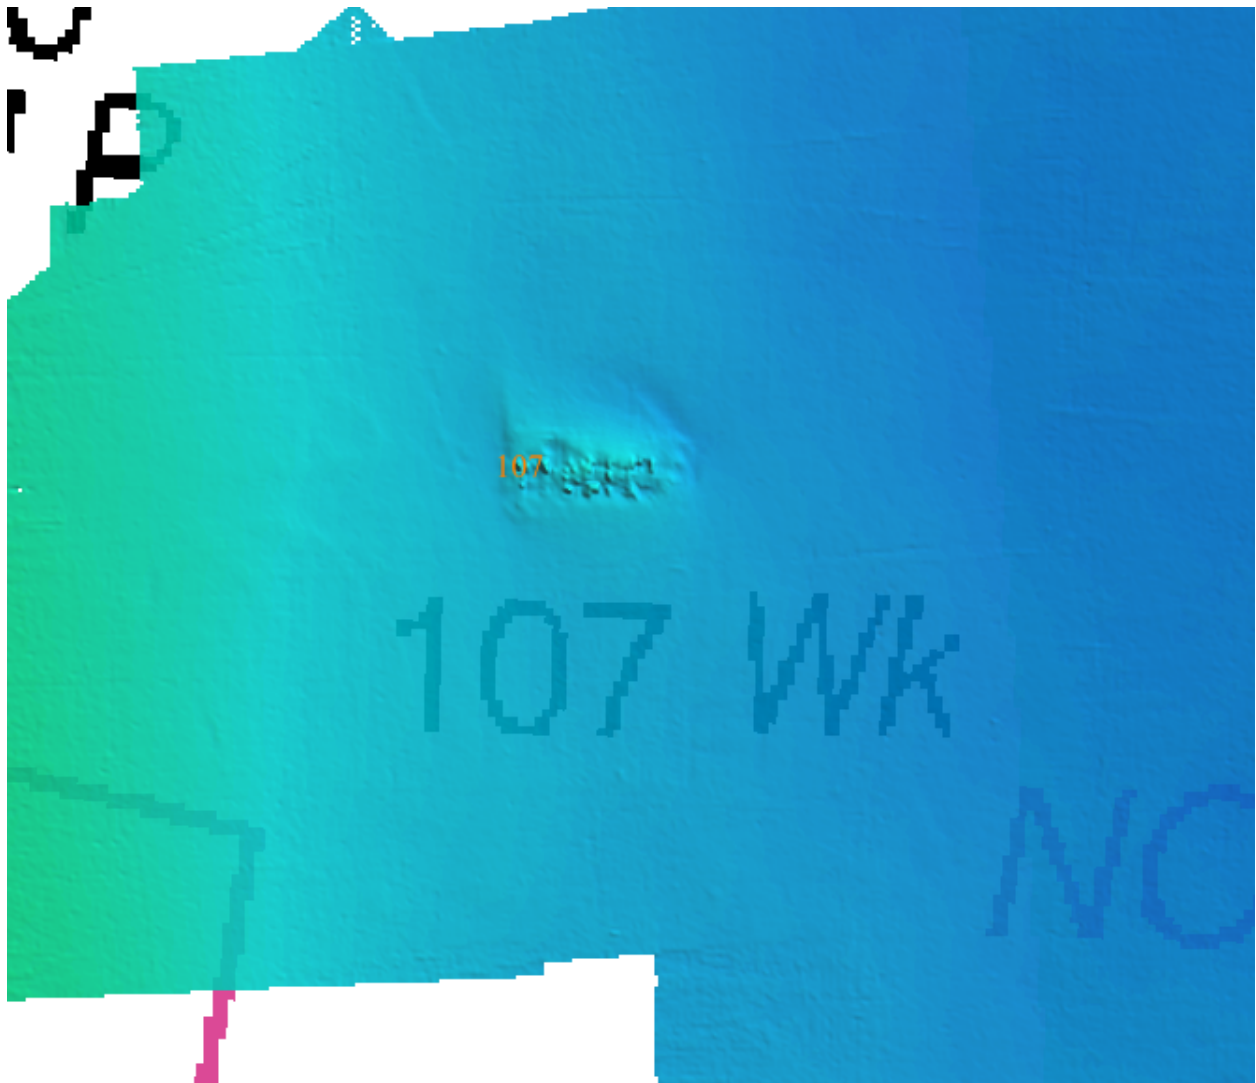
Figure 1.14.1

**Geo object 1:** Wreck (WRECKS)  
**Attributes:** CATWRK - 1:non-dangerous wreck  
 QUASOU - 1:depth known  
 SORDAT - 20110919  
 SORIND - US,US,graph,H-11930  
 TECSOU - 3:found by multi-beam  
 VALSOU - 32.674 m

It's Recommended getting a diver to verify least depth when possible. Update wreck position and least depth with current survey data.

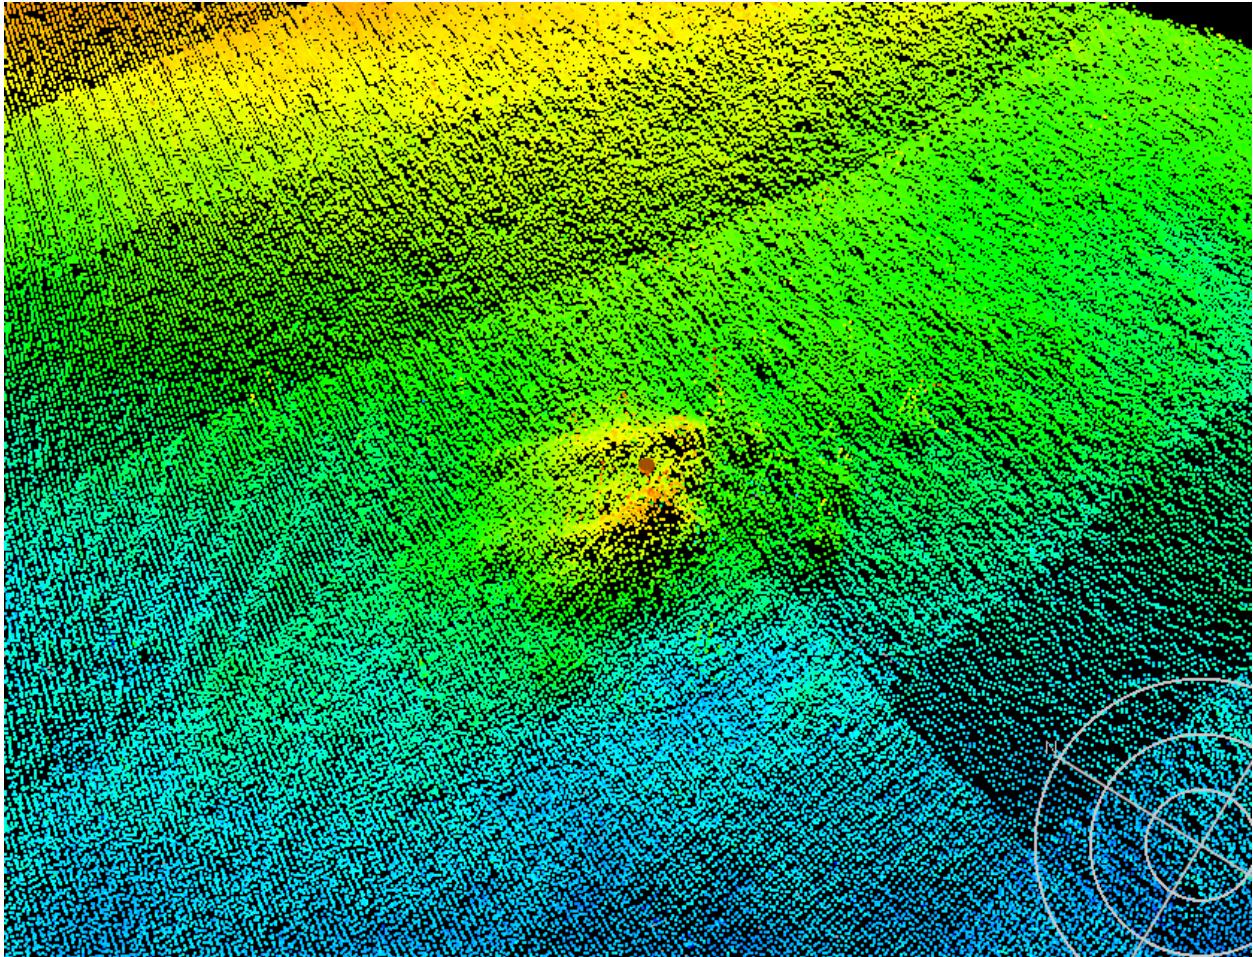
*Figure 1.17.1*

20 ft least depth on feature found near charted automobile. Found with MBES. Feature rises approximately 2 ft from the surrounding seafloor. It is unclear whether the feature is an automobile.

Update Obstruction least depth and position with current survey data. AWOIS Item #14578.

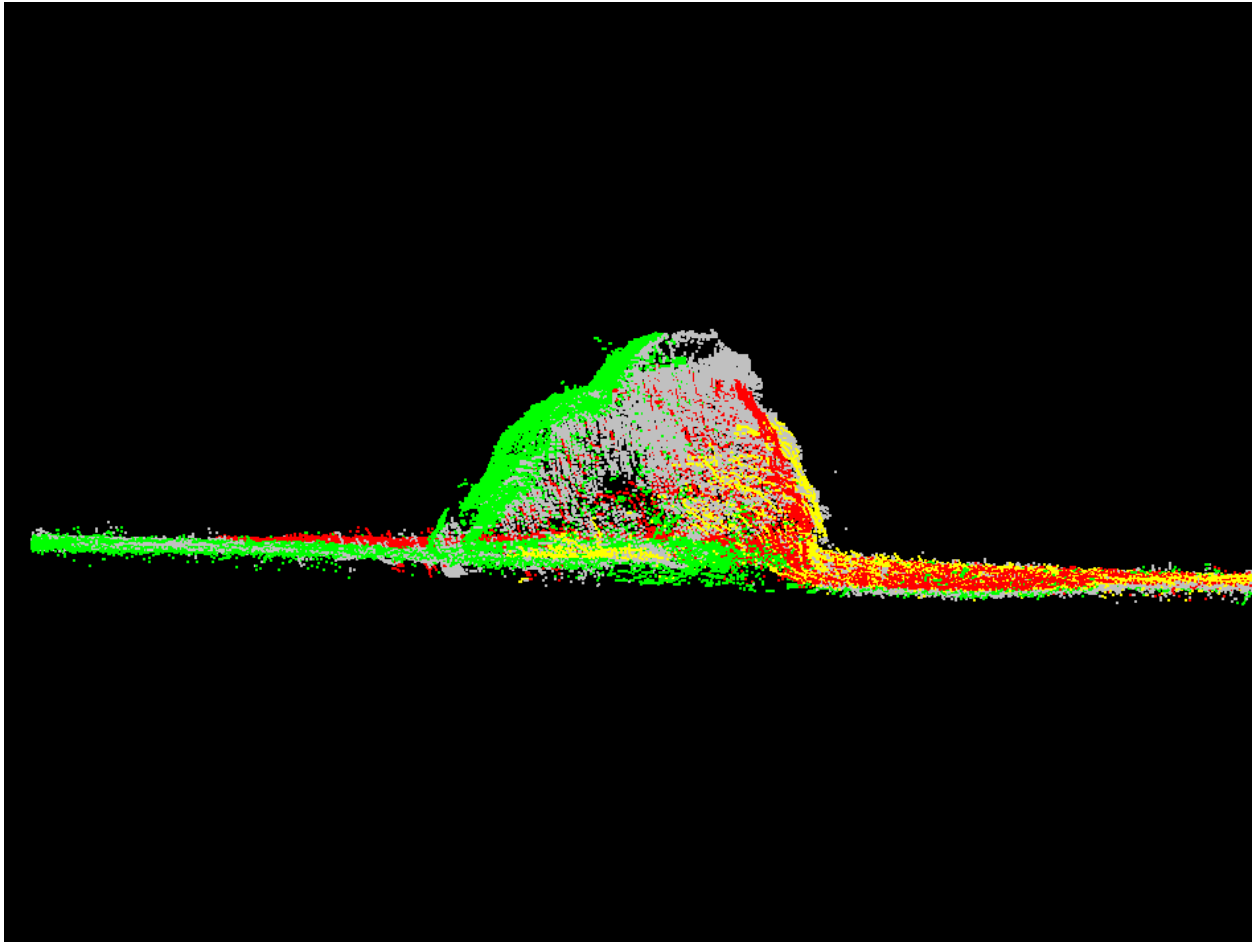
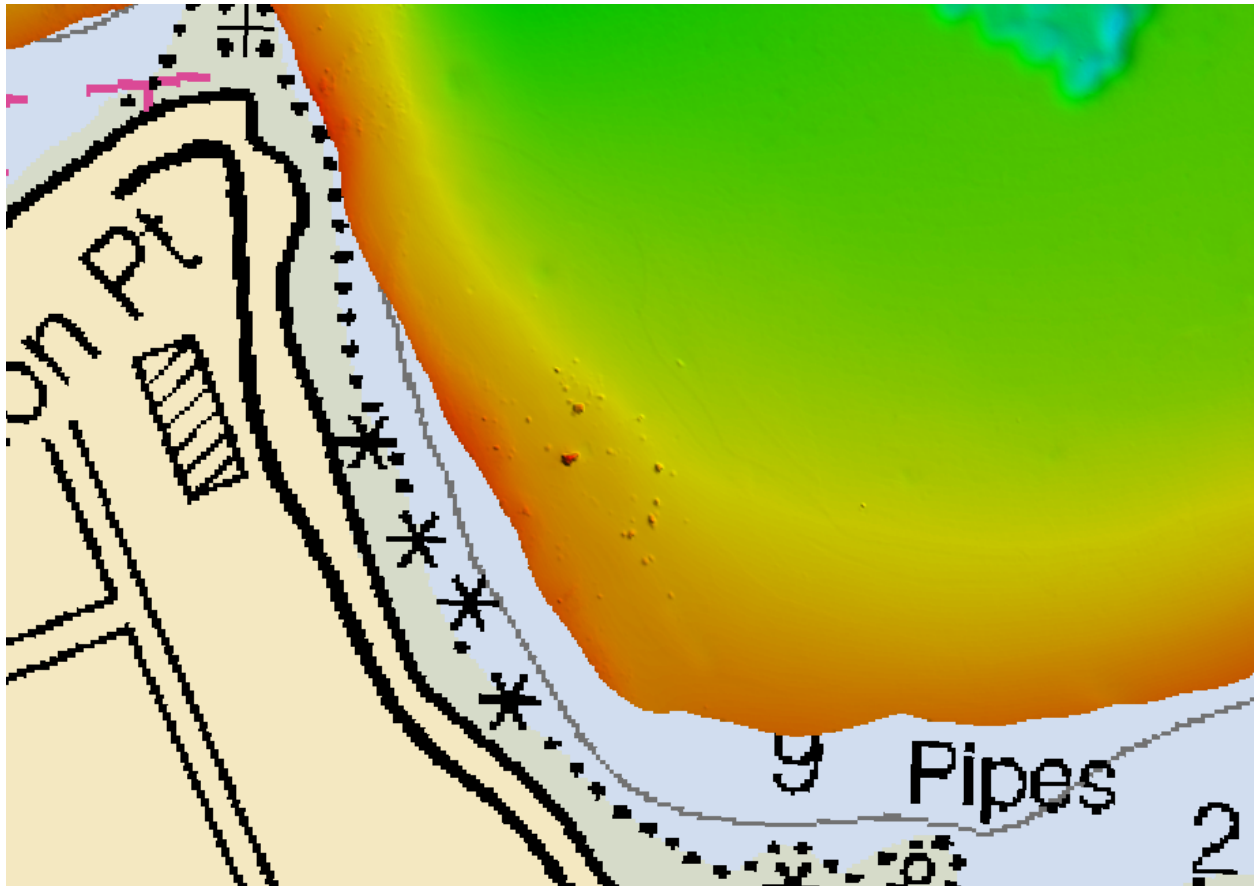
*Figure 1.1.1*

Sounding is least depth on rock. Rock rises 10 ft above surrounding seafloor. Rock has least depth of 3 ft which lies 60 meters seaward of 6 ft curve, and near charted 10 ft sounding. Found with MBES. Final tides have been applied.

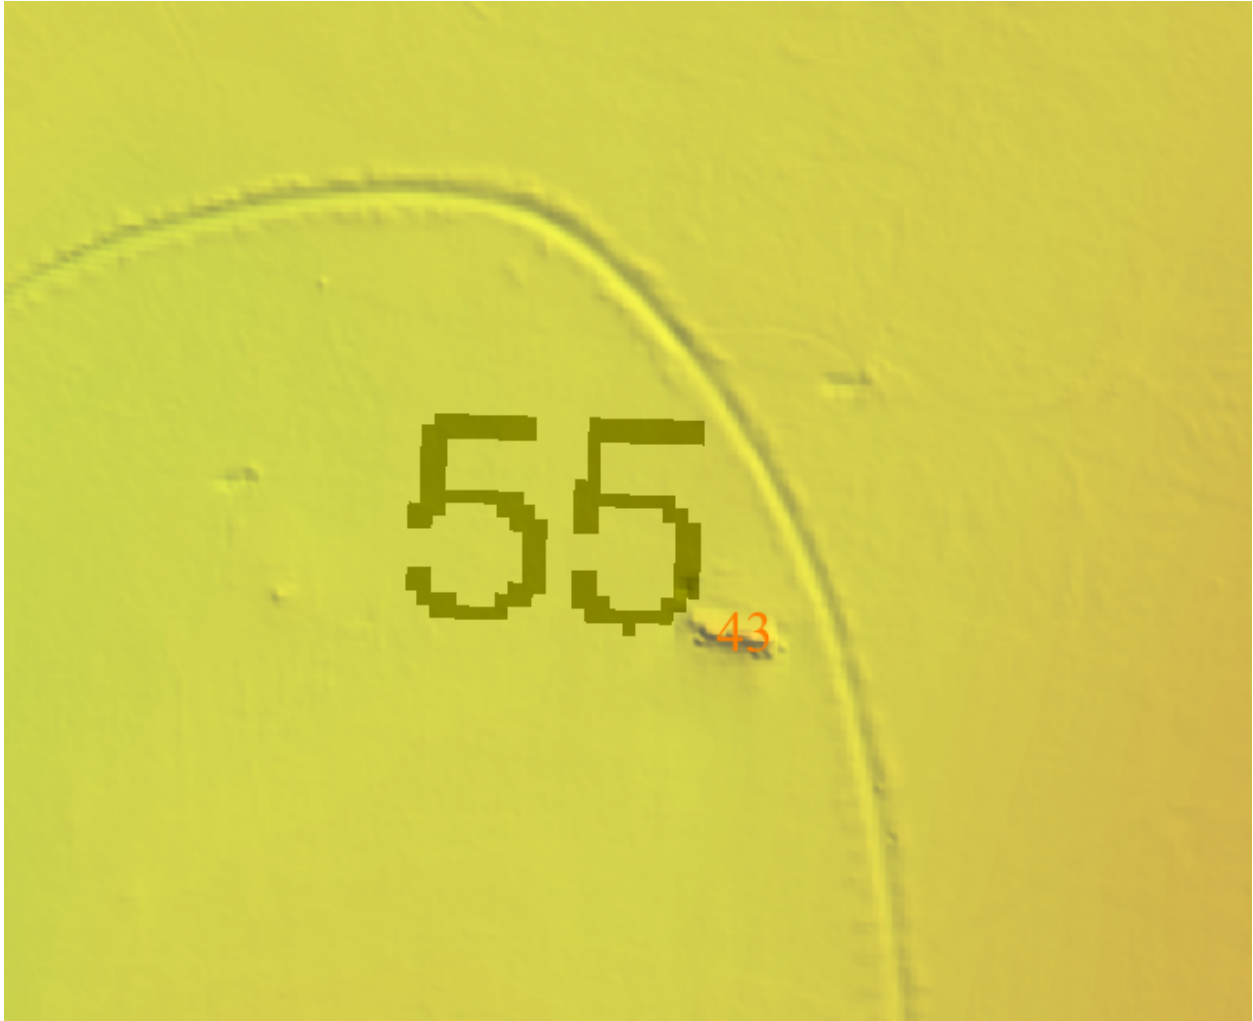
*Figure 1.3.1*

**Geo object 1:** Obstruction (OBSTRN)  
**Attributes:** CATOBS - 1:snag / stump  
 QUASOU - 1:depth known  
 TECSOU - 3:found by multi-beam

WATLEV - 3:always under water/submerged

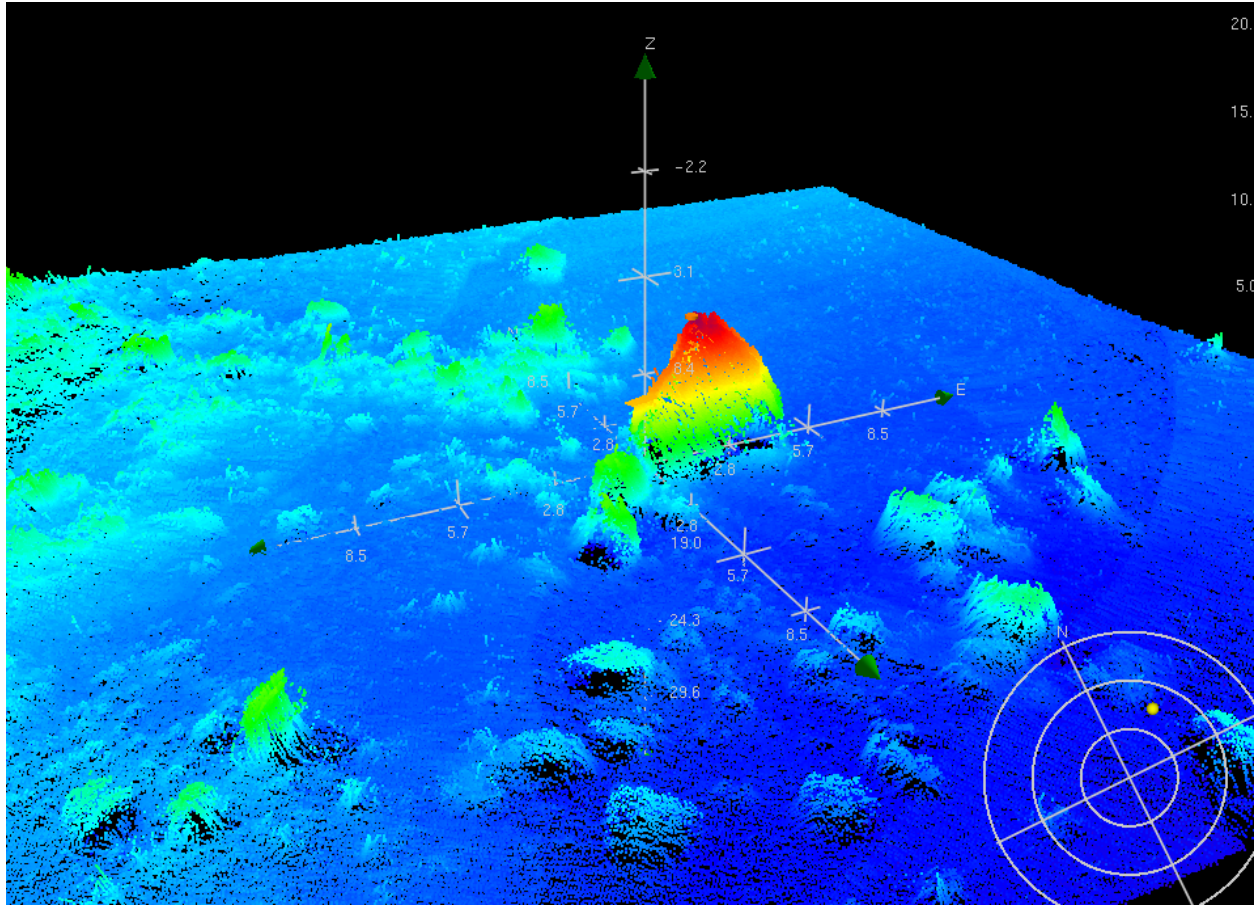
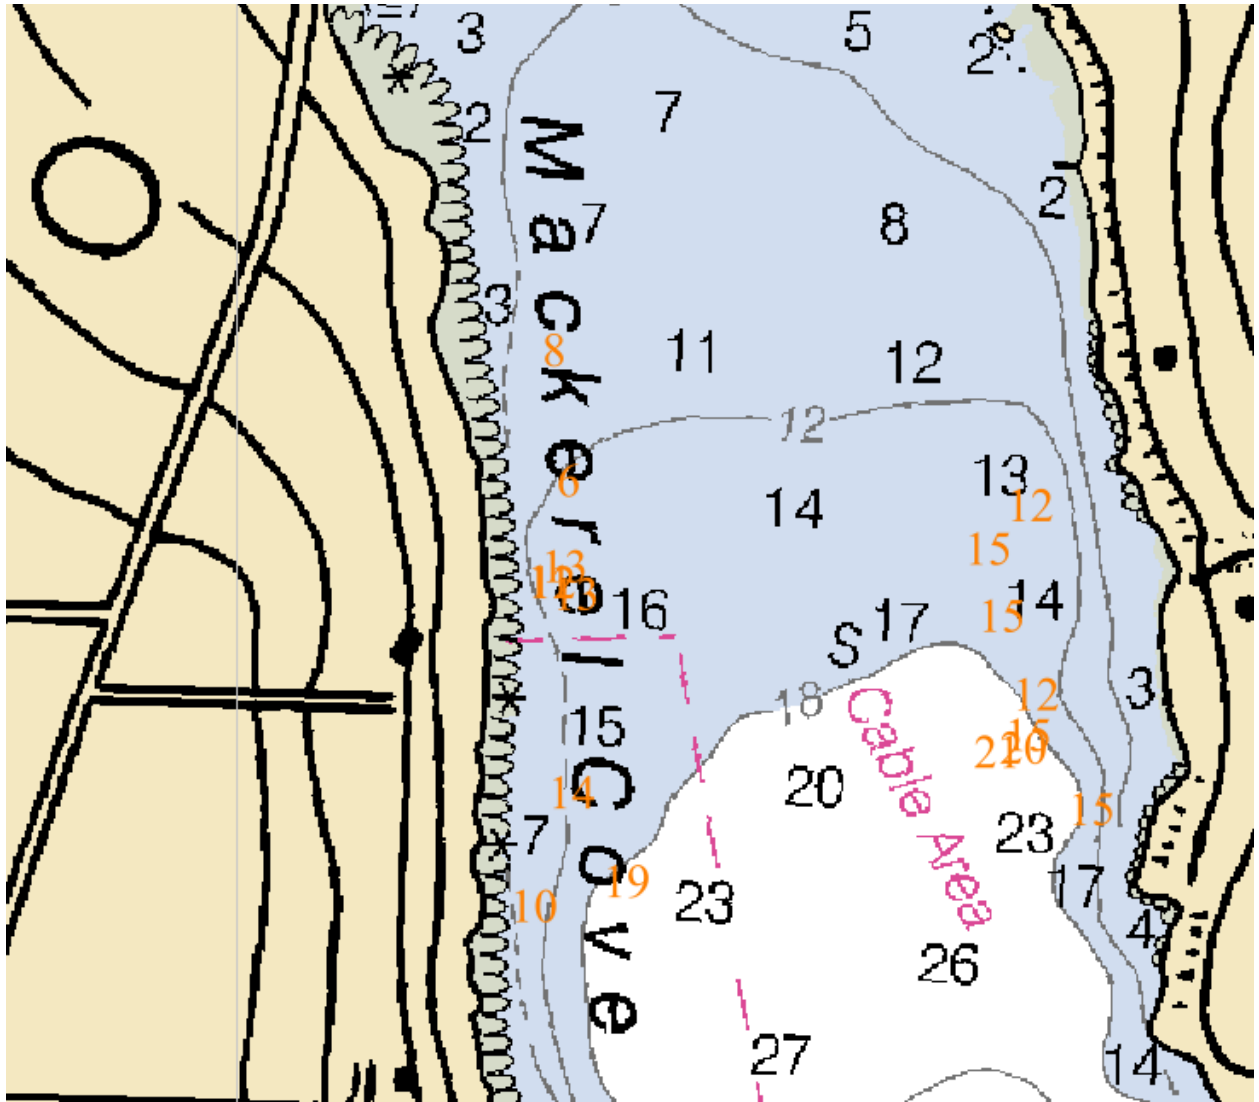
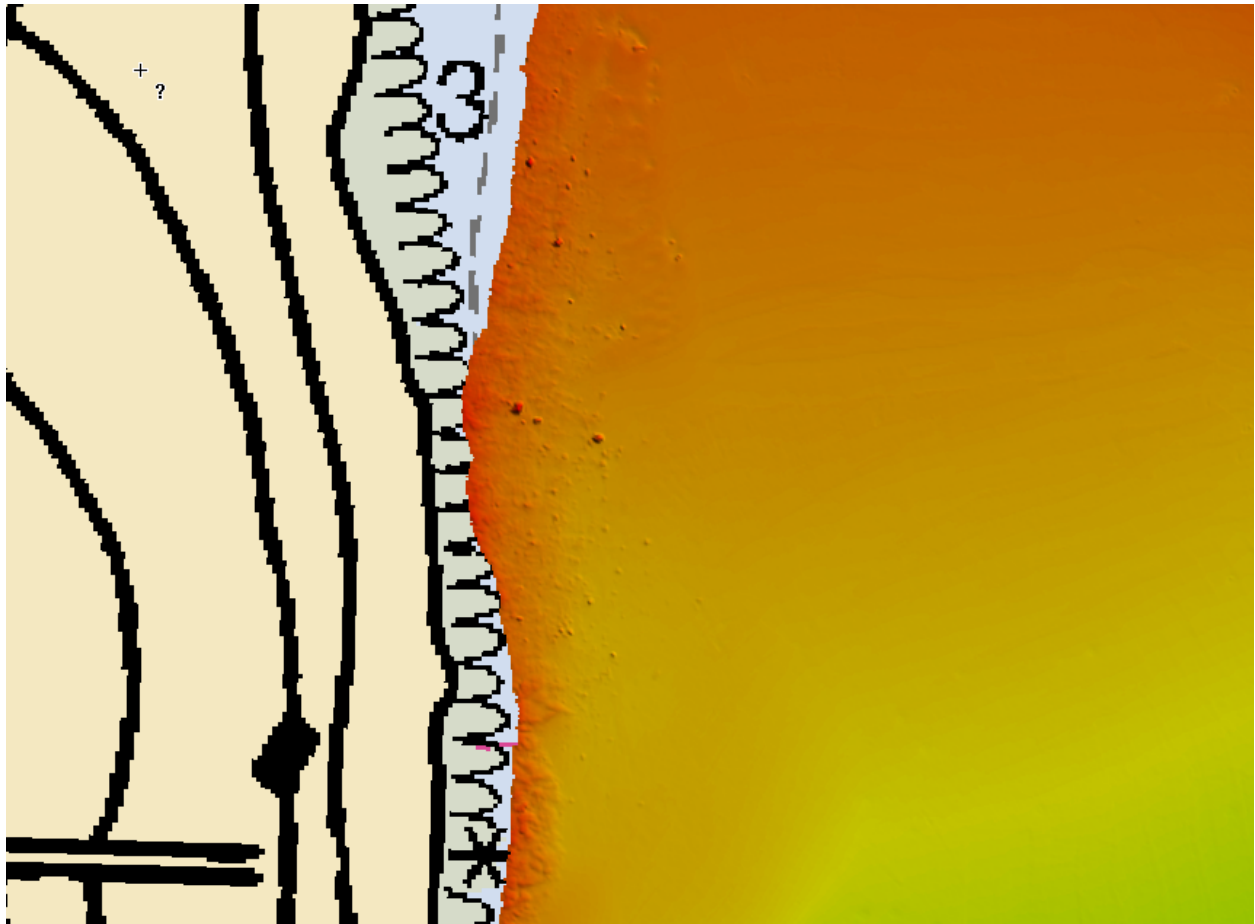
Figure 1.4.1

**Geo object 1:** Underwater rock / awash rock (UWTROC)  
**Attributes:** QUASOU - 1:depth known  
 TECSOU - 3:found by multi-beam

Chart submerged rock. There are many other smaller rocks in this area. Recommend that a note of "rky" also be added to chart in this area.
