DESCRIPTIVE REPORT

Registry No. H12063

OPR-O322-FA-10
Chatham Strait, Alaska

Scale: 1:20,000
05 October 2010 - 08 November 2010
NOAA Ship *Fairweather*
CAPT David O. Neander

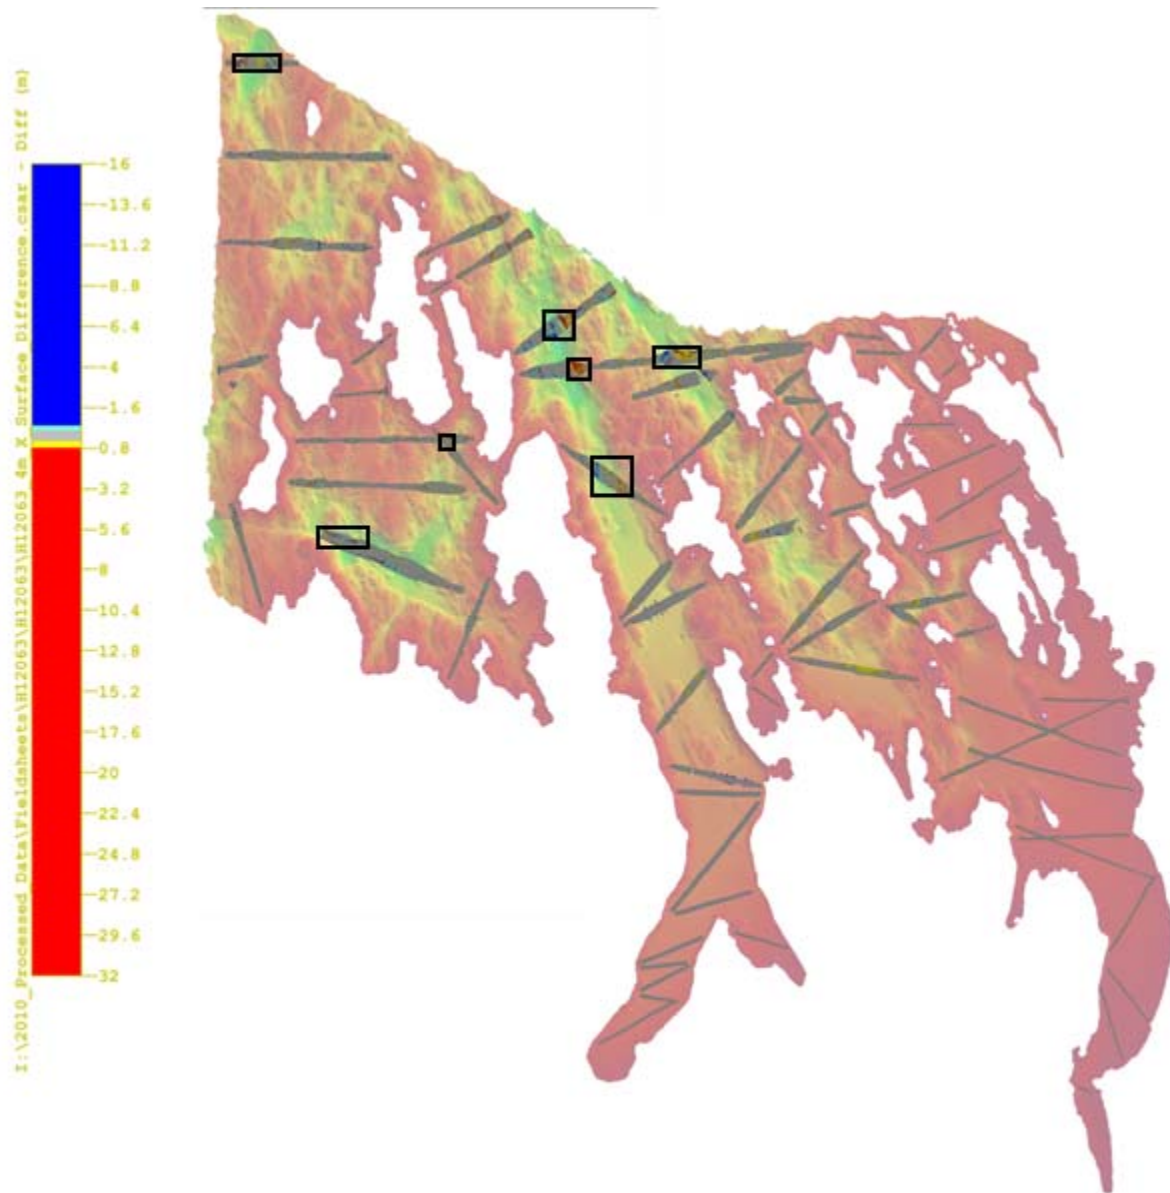
Surface differencing in CARIS Bathy DataBase was used to assess crossline agreement with main scheme lines. Figure 2 depicts a difference surface between an 4-meter surface made with main scheme lines only and an 4-meter surface made with crosslines only. This difference surface is submitted digitally in the in Separates IV folder.

The areas with the greatest disagreement between crosslines and main scheme lines are areas where the seafloor is very dynamic.⁴ Areas in the survey where this is most prevalent are outlined in black in Figure 2.

Figure 2: Crossline and main scheme differences (gray indicates agreement, cool colors indicate crosslines shoaler than main scheme and warm colors indicate crosslines are deeper).

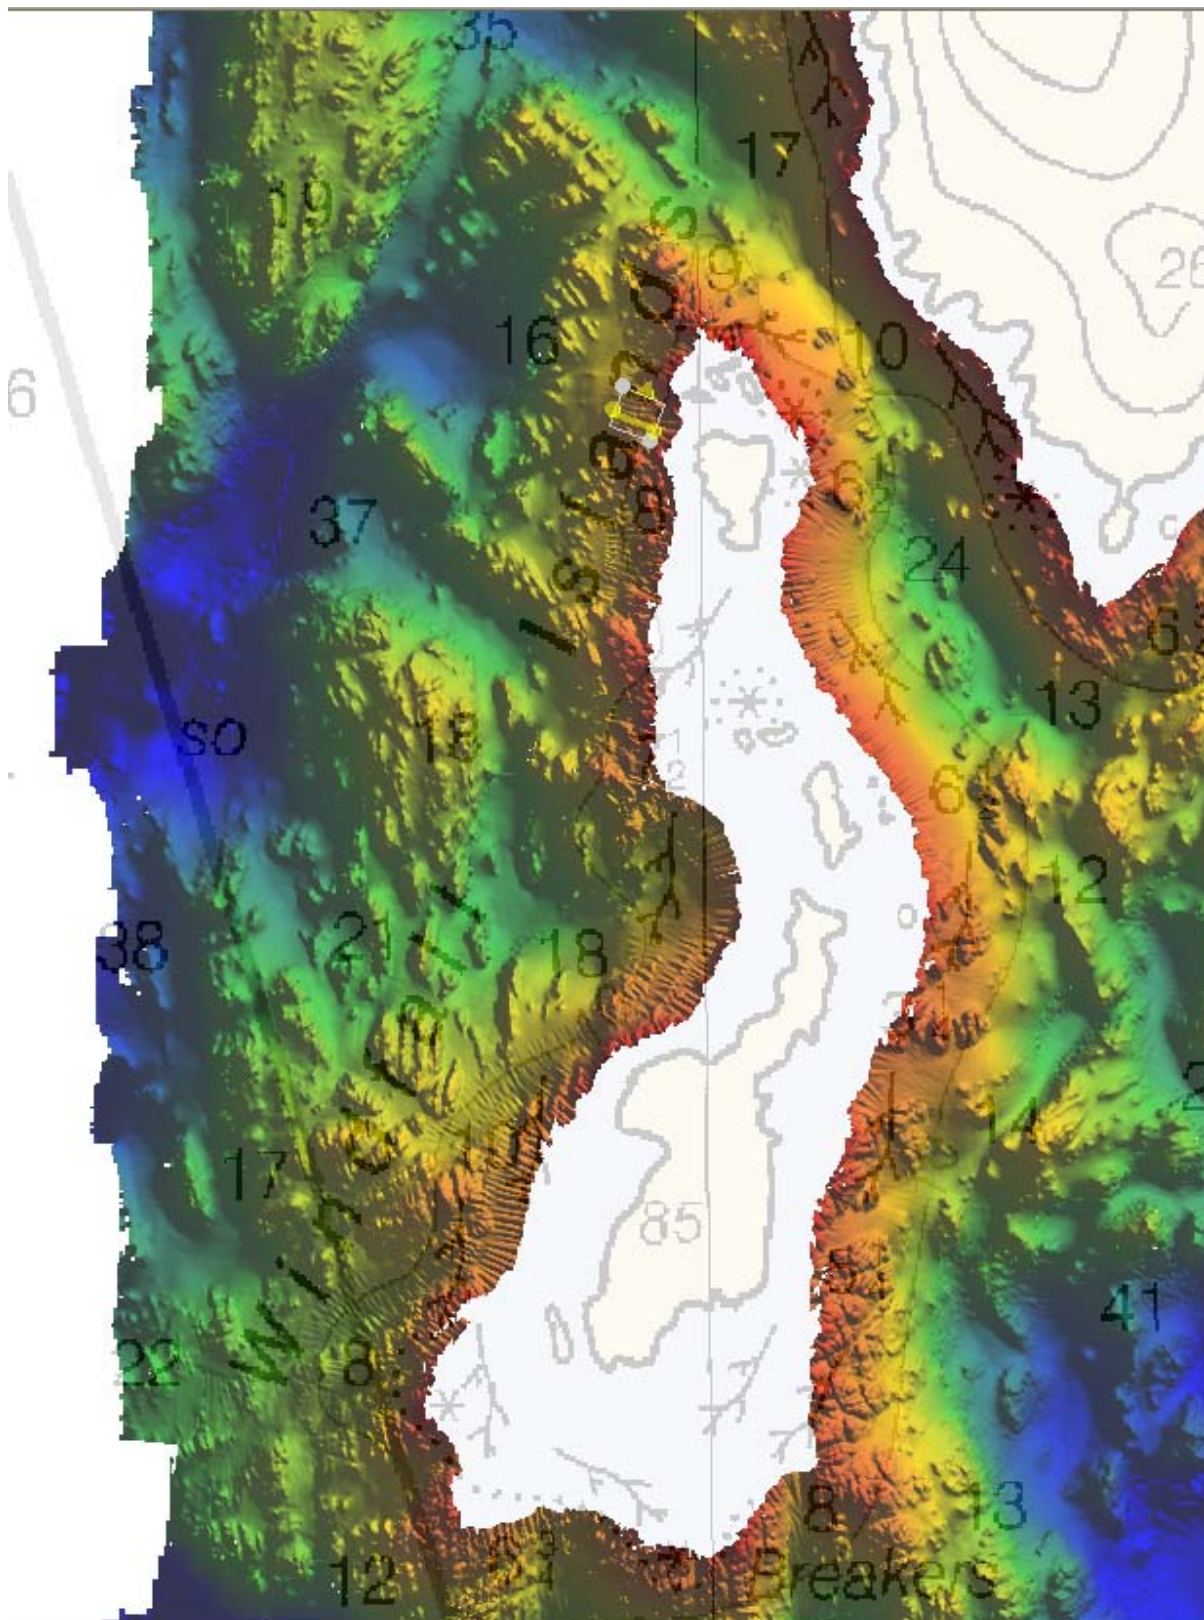
A roll artifact is apparent in some Reson 8125 data, located predominantly in surfaces to the west and northwest of the Windfall Islands as well as to the east side of Explorer Basin and south of Step Island. The artifact is thought to be due to disabled roll stabilization in the Reson 8125 processor set-up. The areas were manually cleaned in CARIS Subset Editor to remove all spurious soundings. The finalized surfaces follow the soundings more closely (Figure 4 and 5) as opposed to the 8-meter combined surface (Figure 6) that trends toward the shoaler soundings.⁷

Figure 4: Reson 8125 roll artifact found predominantly in the 1-meter finalized surface near Windfall Island. Vertical exaggeration is 5.

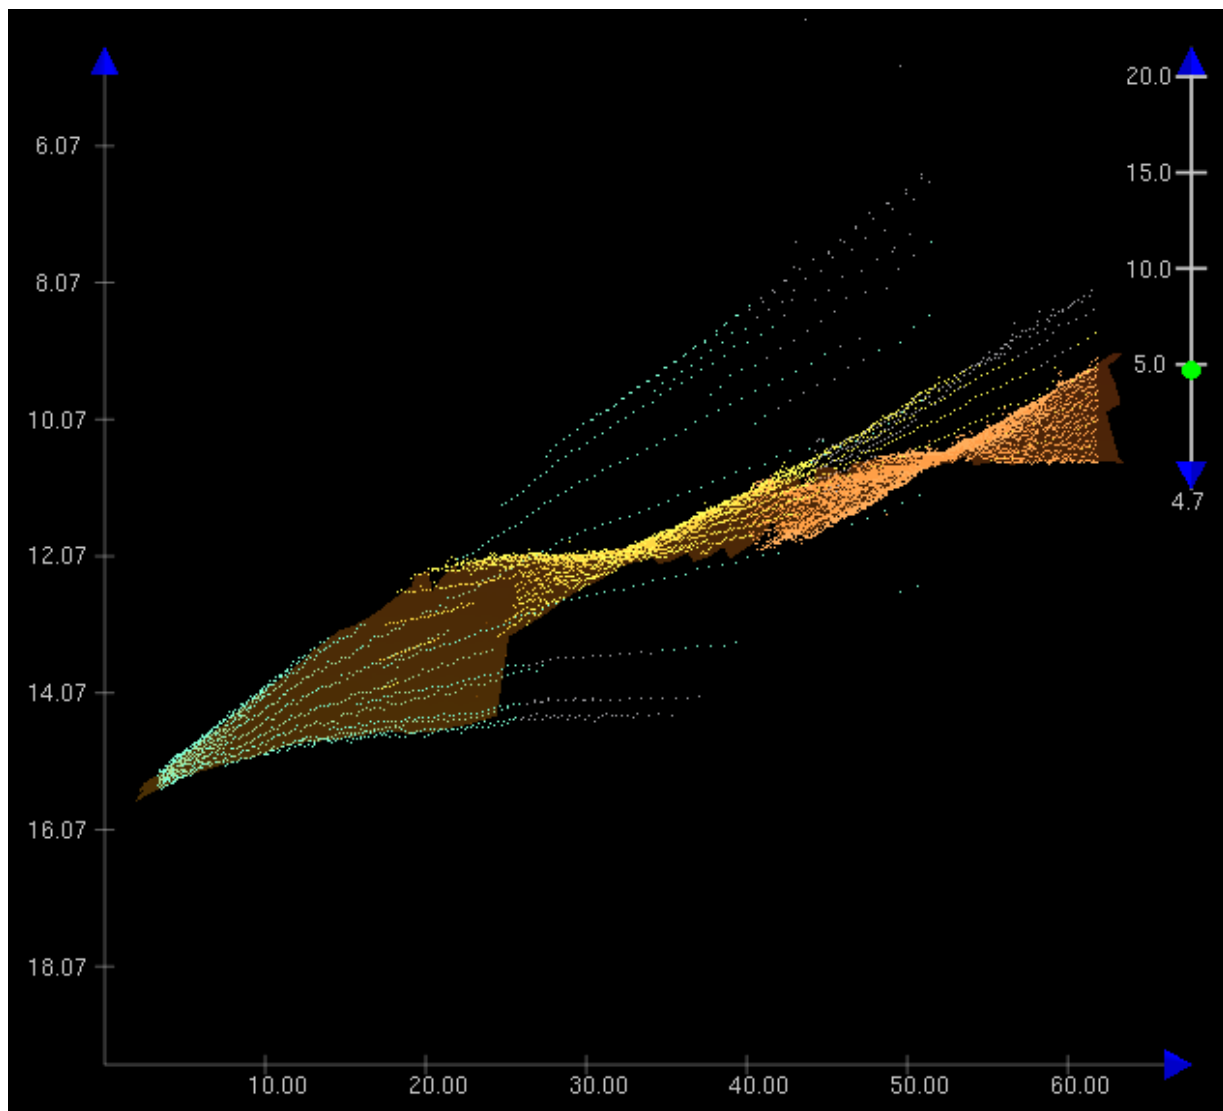
Figure 5: Roll artifact, located in Figure 4's Subset Editor box. Launch 2808 roll attribute value is 11 degrees to port and starboard.

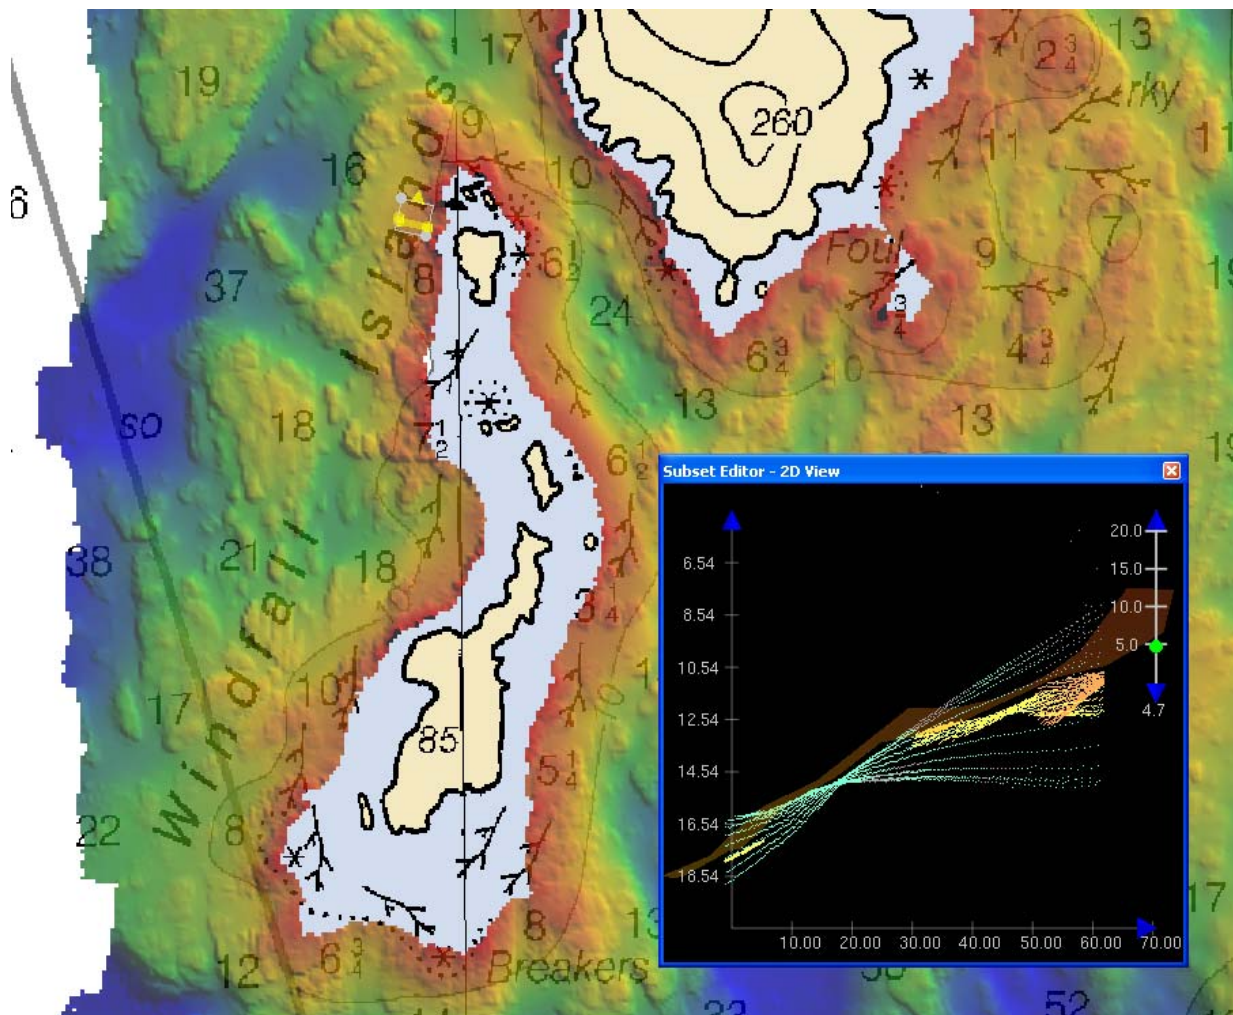
Figure 6: Reson 8125 roll artifact shown in the 8-meter combined surface that trends toward the shoaler soundings.

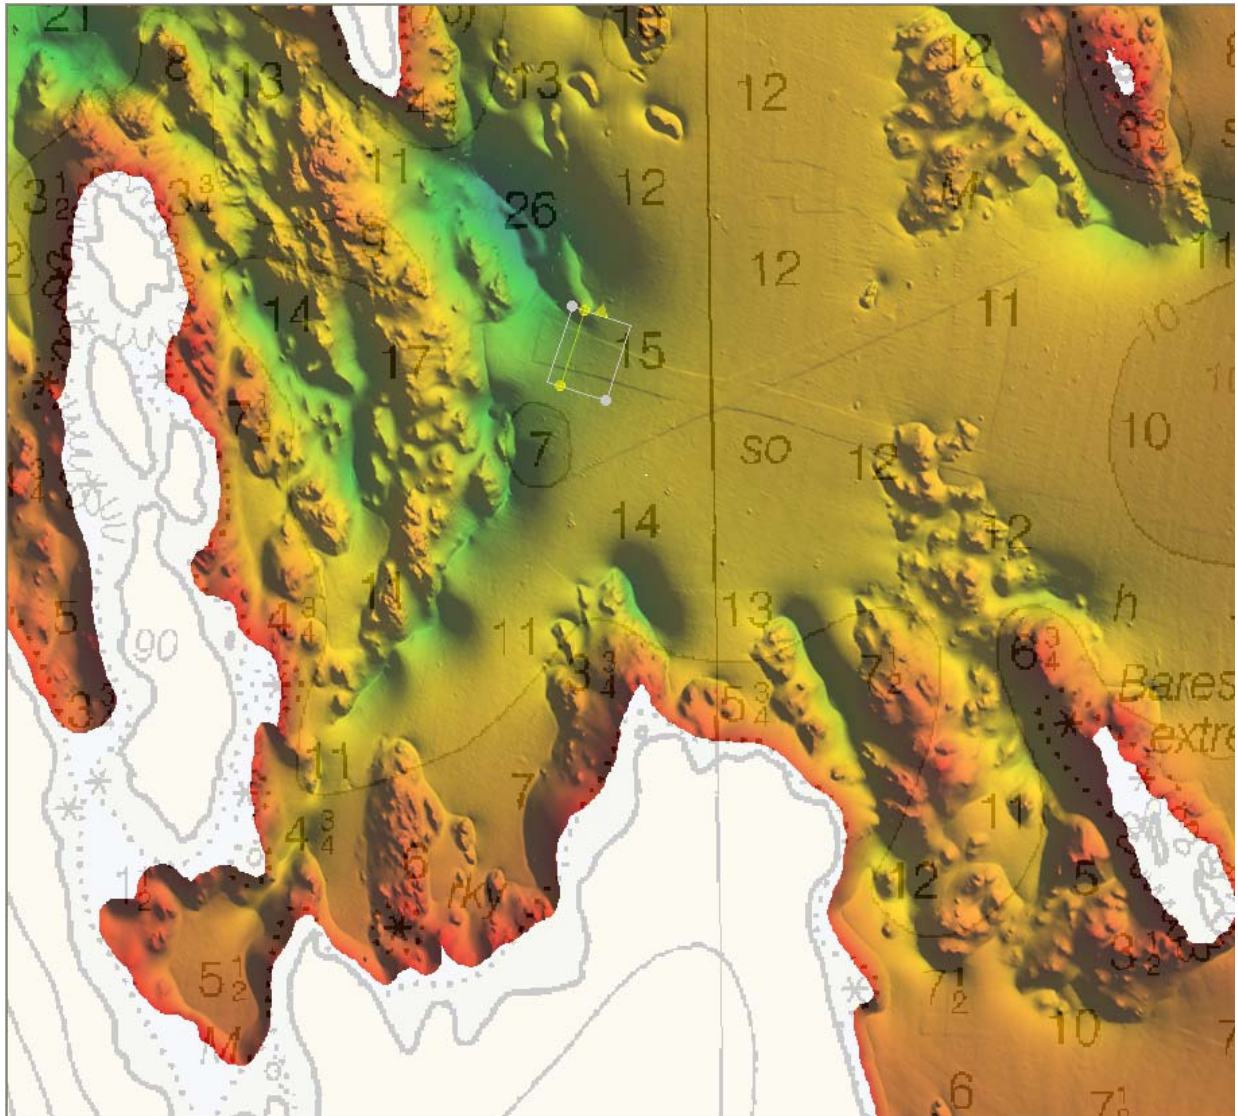
Vertical tide offsets ranging from 10 to 40 centimeters are found between main scheme data and crosslines from Launch 2806 on DN 310 in the eastern half of H12063 but the disagreement is within the total allowable vertical uncertainty of the depth range.⁹

Figure 7: Example of vertical tide offset found northwest of Petrof Bay. Crossline in CARIS Subset Editor box was acquired by Launch 2806 on DN 310 and main scheme lines were acquired by Launch 2807 on DN 278. Vertical exaggeration is 5.

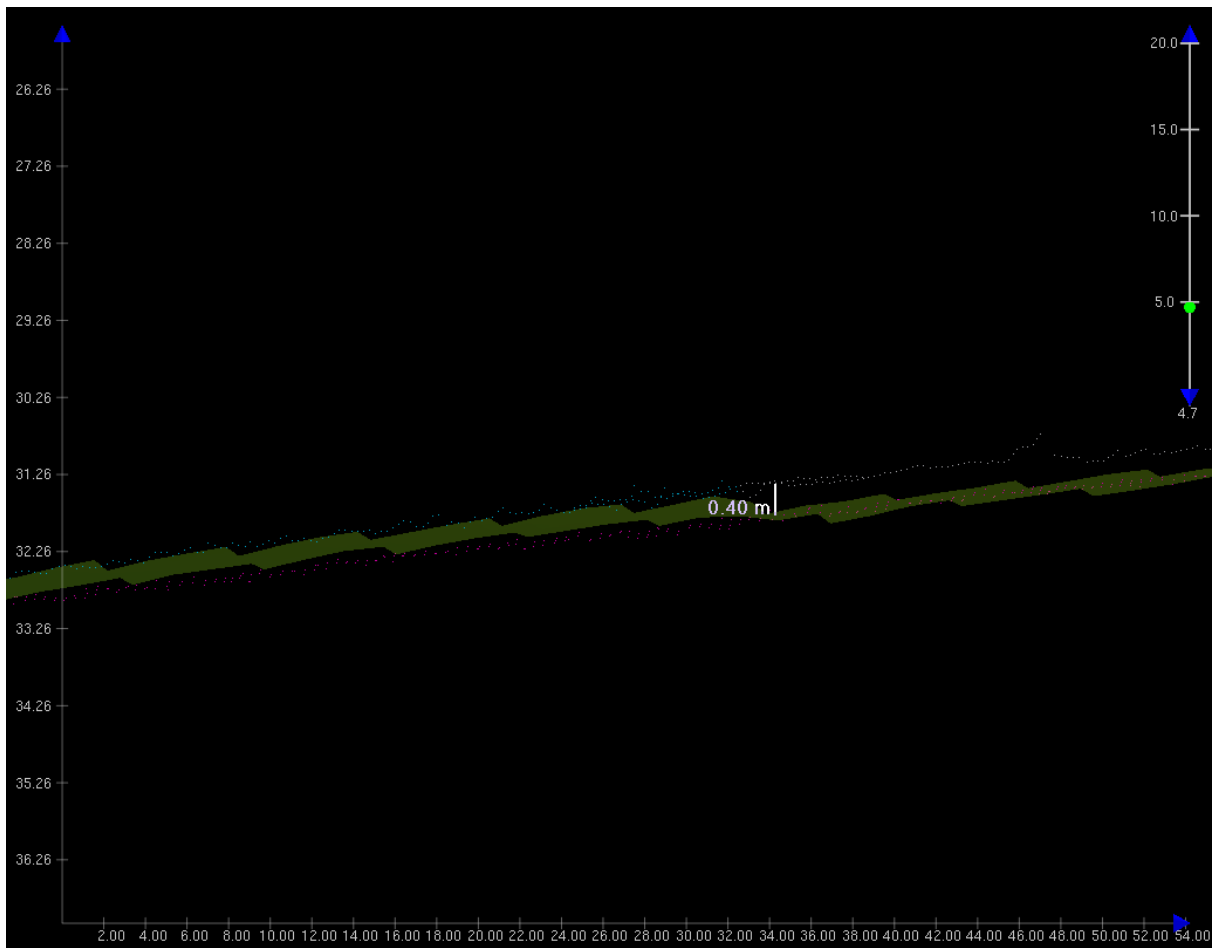
Figure 8: Vertical tide offset of 40 centimeters northwest of Petrof Bay, located in Figure 7's Subset Editor box.

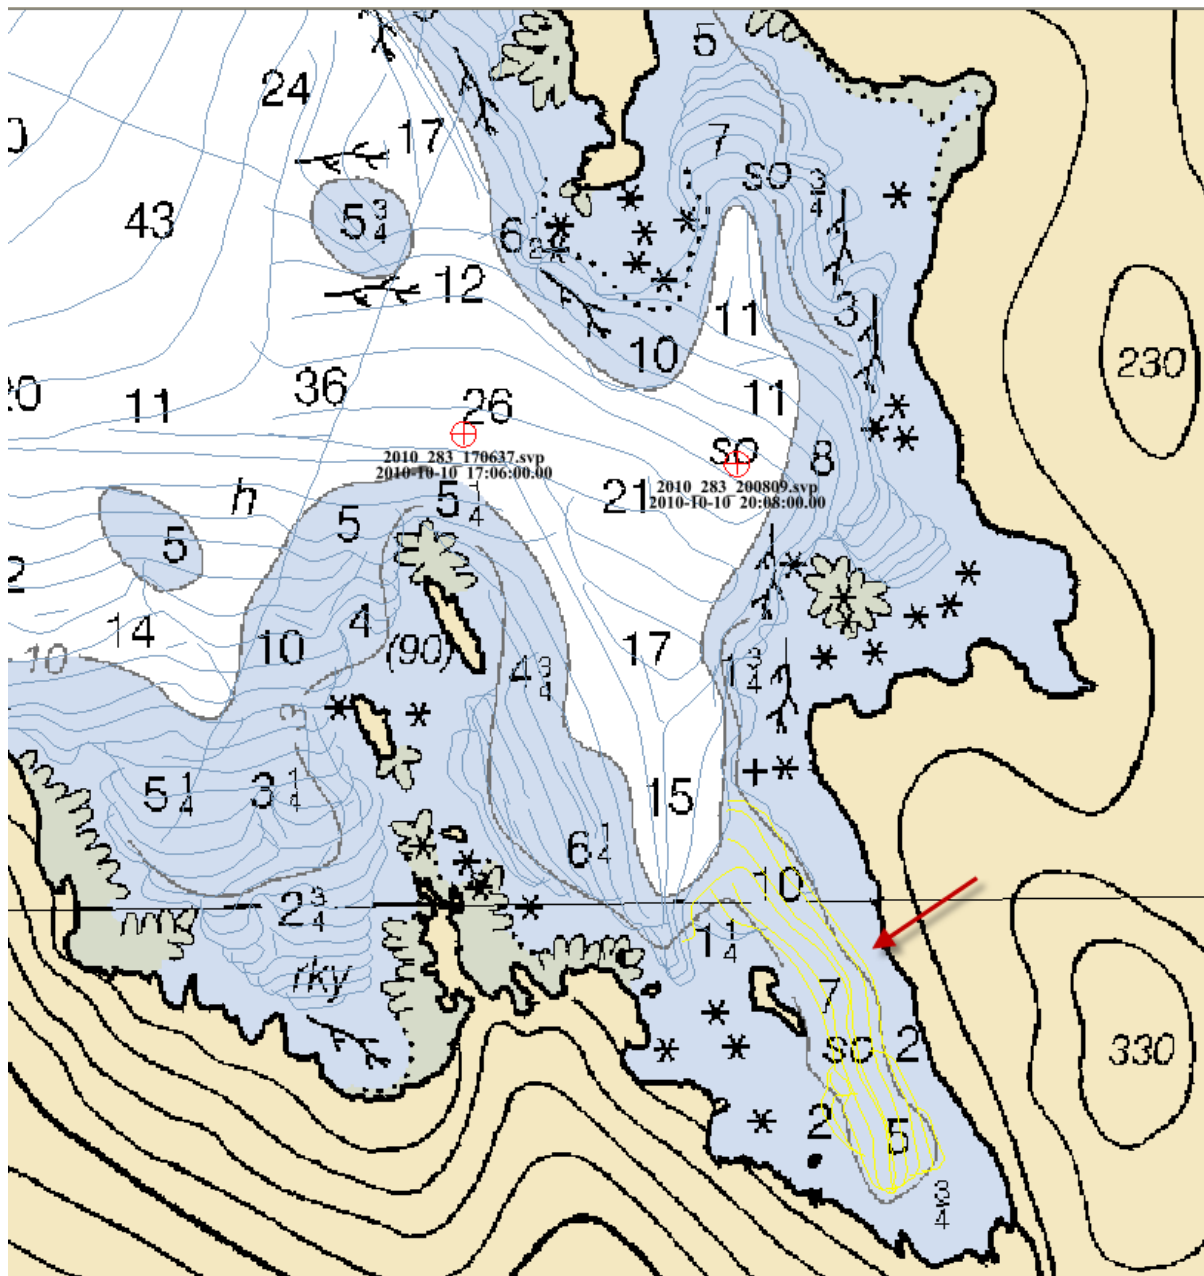
On DN 283 Launch 2808 acquired MBES data in the southeast portion of Explorer Basin but did not take an SVP cast which resulted in sound speed artifacts exclusively in the southeast portion of Explorer Basin. Casts 2010_283_170637 as well as 2010_283_225319 collected by Launch 2806 on DN 283 were both applied on separate occasions to localized lines (Figure 9), but the SV artifact was not resolved (Figure 10). The concatenated file from Launch 2808 was reapplied to launch lines. Generally the depth ranges from eight to twelve meters. The areas were manually cleaned in CARIS Subset Editor to remove all spurious soundings. Refraction artifacts of up to seven meters were seen between outer beams. Despite this issue the Hydrographer feels the soundings are adequate to supersede charted soundings in this area.¹⁰

Figure 9: Sound speed casts in southeast Explorer Basin acquired on DN 283 by Launch 2808. Launch 2808 lines, with SV artifact, are highlighted in yellow.

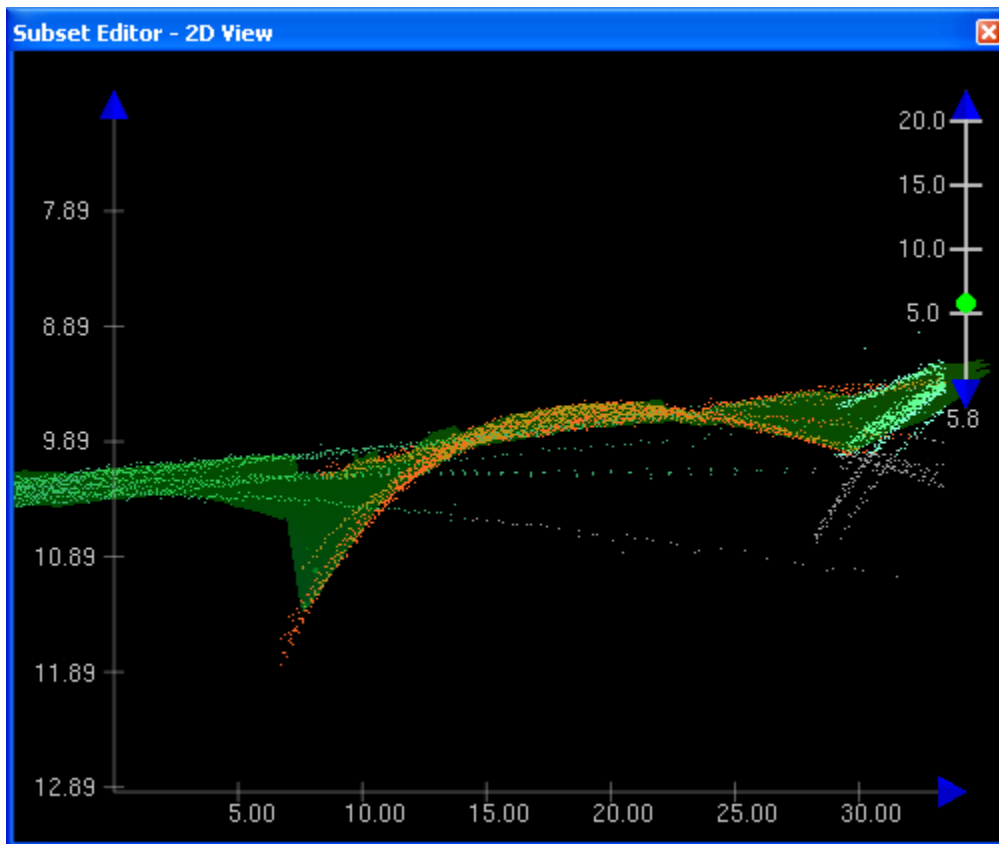
Figure 10: Sound speed error present in southeast Explorer Basin collected on DN 283 from the side mounted 8125.

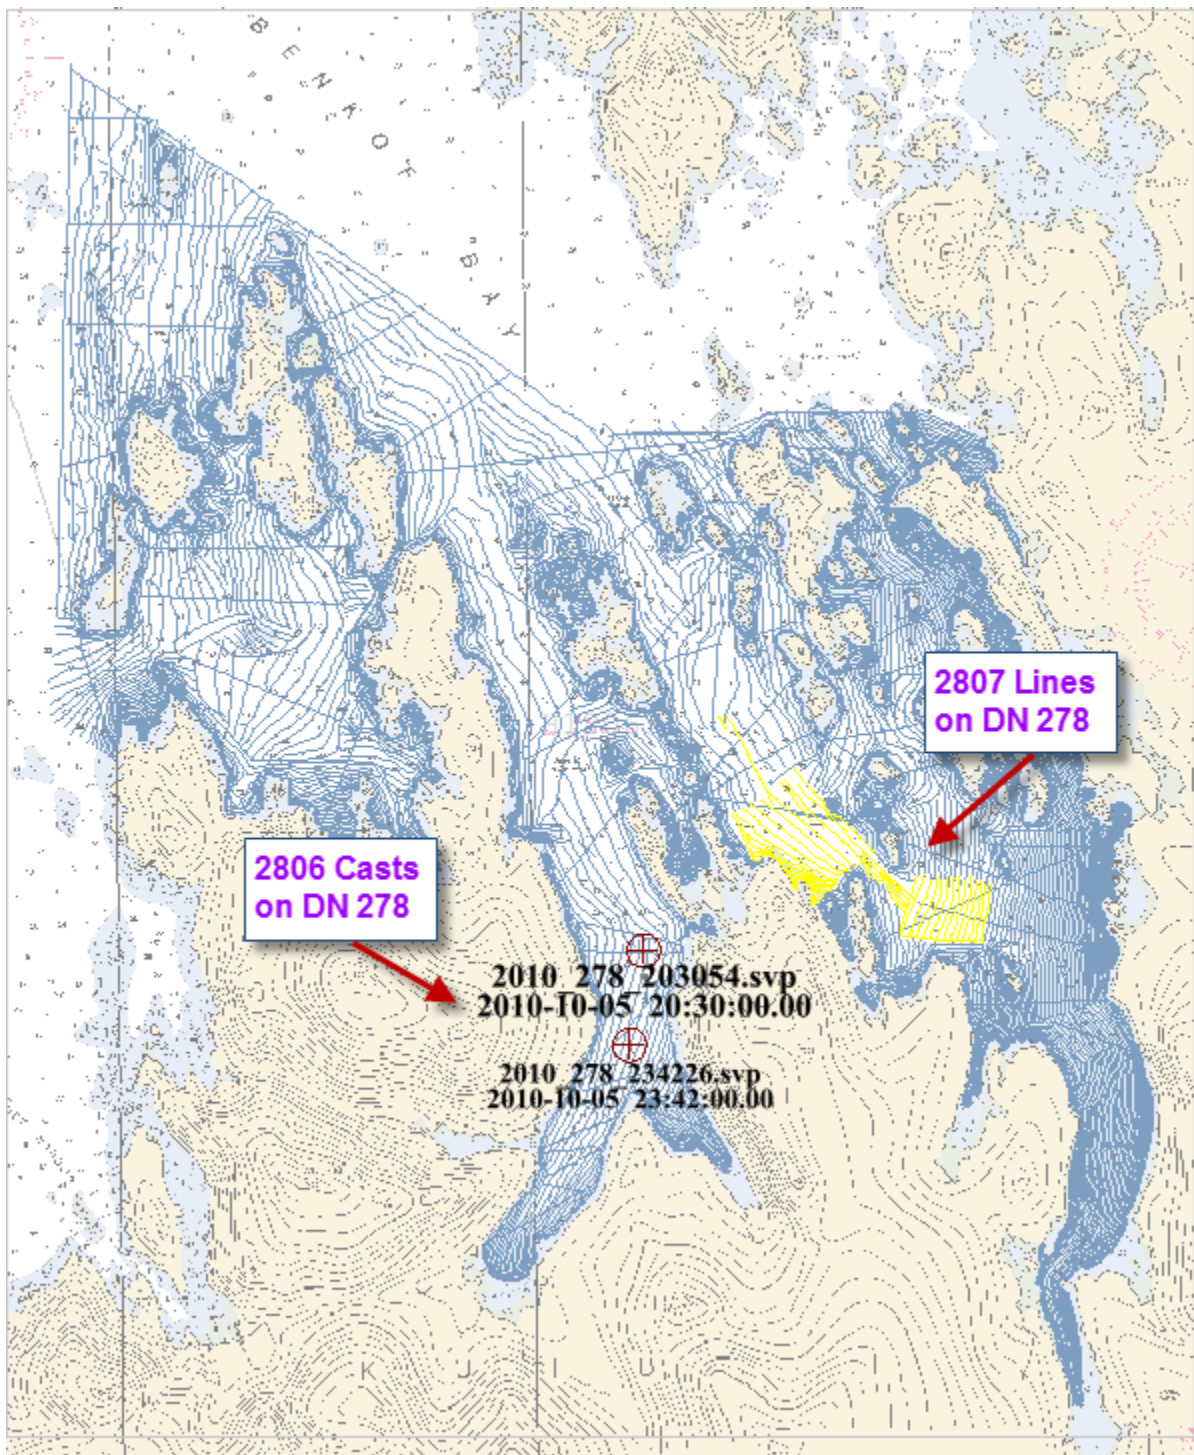
On DN 278 the CTD aboard Launch 2807 was inoperable so the concatenated SVP file acquired from Launch 2806 was used to correct Launch 2807's MBES data acquired on DN 278. Launch 2806 acquired CTD casts in the adjacent bay on DN 278; Thetis Bay (Figure 11). The method of Nearest in Distance within Time (3 hours) was used to process Launch 2807's DN 278 lines successfully.¹¹

Figure 11: Sound speed casts for Launch 2807 acquired by 2806 in adjacent bay on DN 278. Launch 2807 lines are highlighted in yellow.

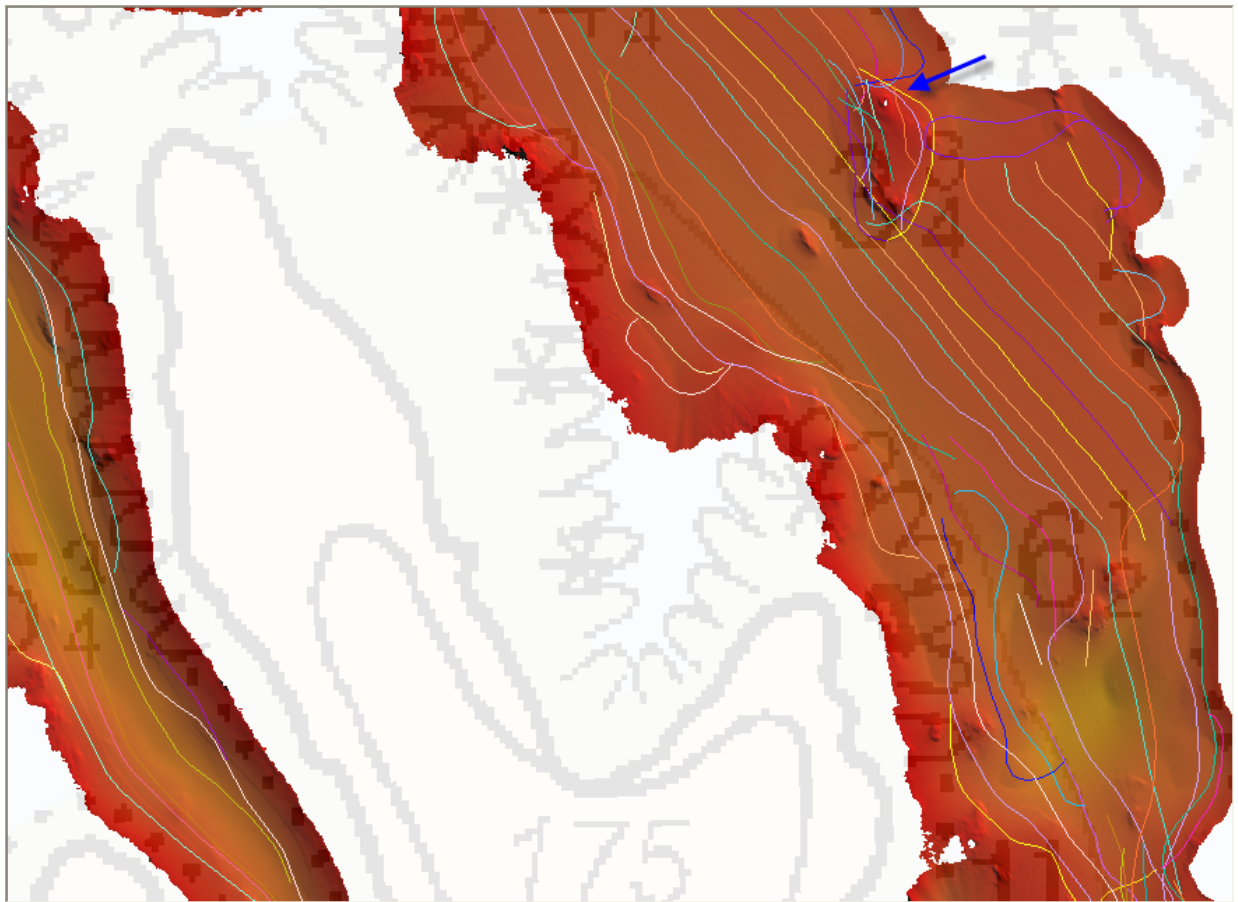
The navigationally significant feature not represented was due to a holiday created on the top of a rock by line spacing being too far apart east of East Island (figure 12 and 13). On the last day of field operations MBES data acquisition was attempted over the rock but was unsuccessful due to low tides at the time of acquisition.¹⁴

Figure 12: Navigationally significant feature creating holiday east of East Island missing the top of the rock which does not have the least depth represented.

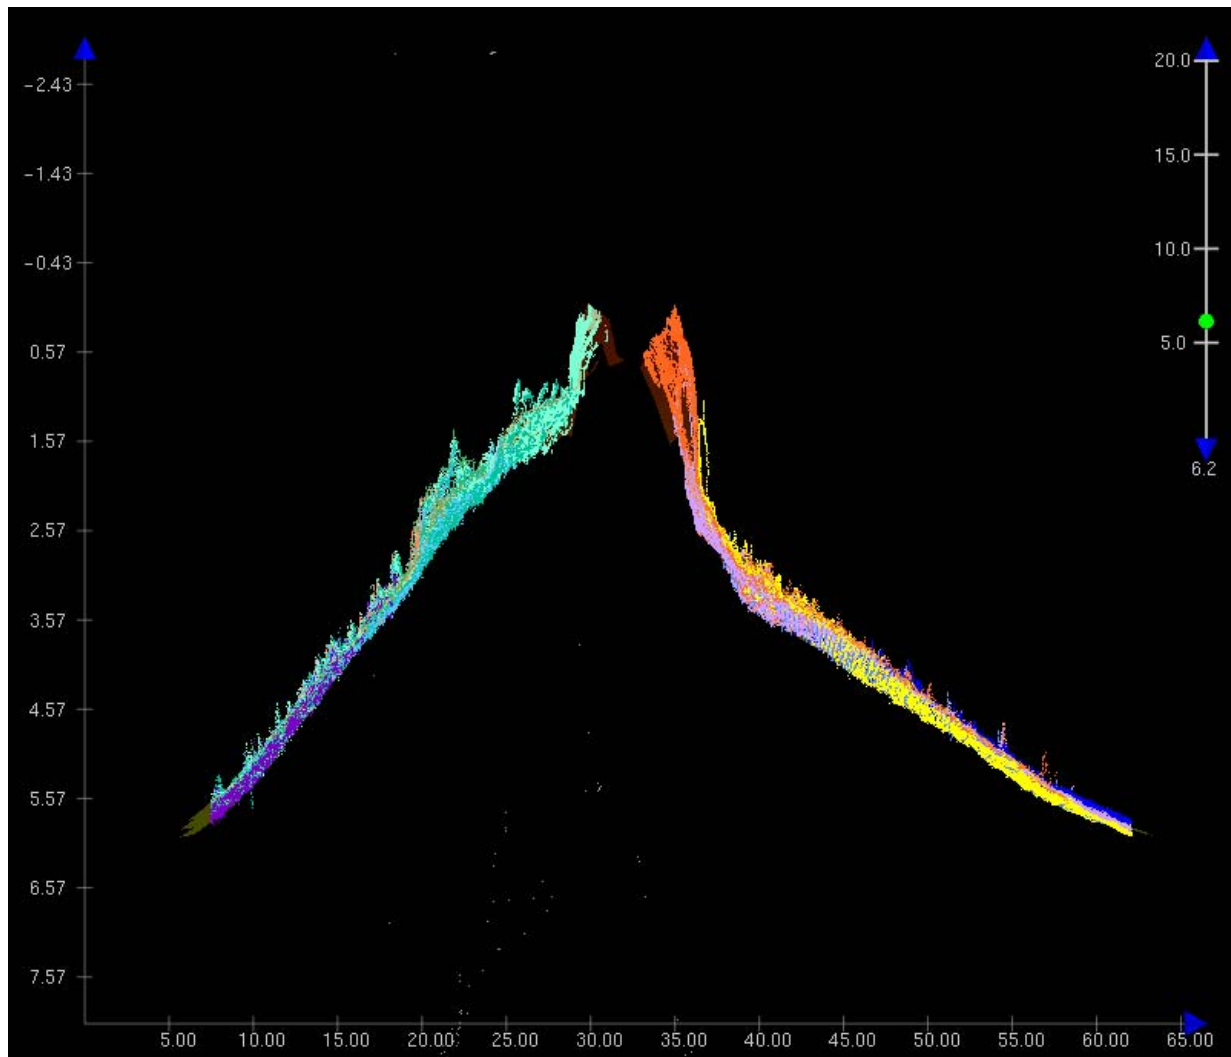
Figure 13: Line spacing too far apart creating holiday east of East Island, missing the top of the rock; shown in subset.

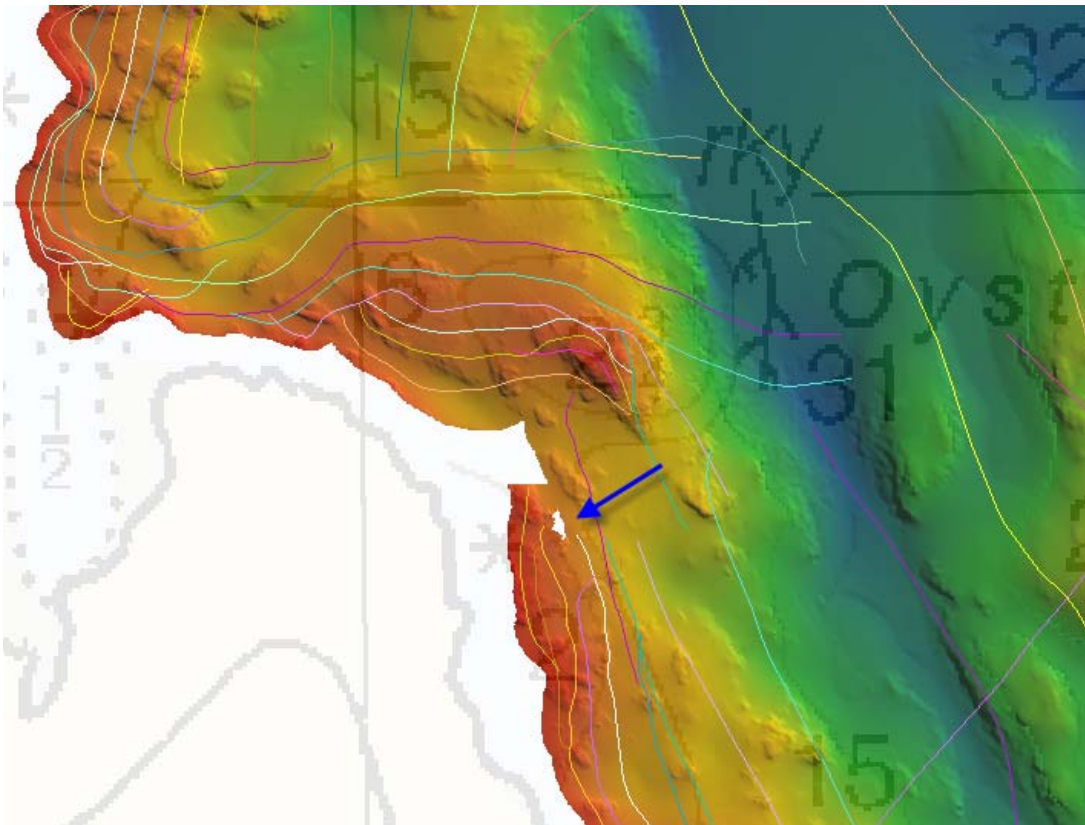
Two other holidays were created due to line spacing being too far apart; one southwest of Oyster Rock (Figures 14 and 15) and another being inside a new foul area south of a small islet SSE of Step Island (Figures 16 and 17). Both holidays are in areas where the seafloor surface trend was sloping downward so the Hydrographer believes the least depth is accurately represented.¹⁵

Figure 14: Line spacing too far apart creating holiday southwest of Oyster Rock has the least depth represented.

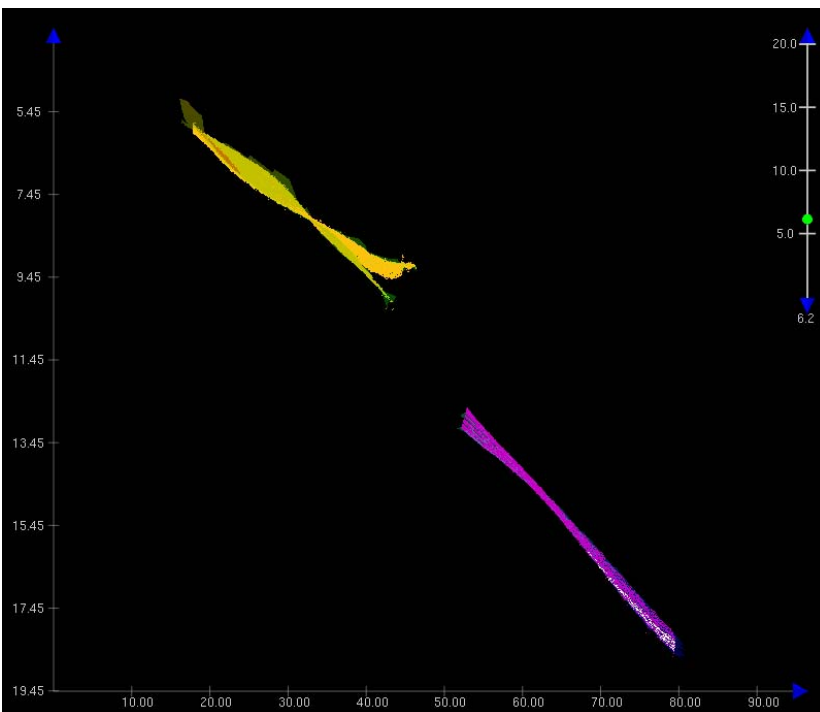
Figure 15: Line spacing too far apart creating holiday east of Oyster Rock; shown in subset.

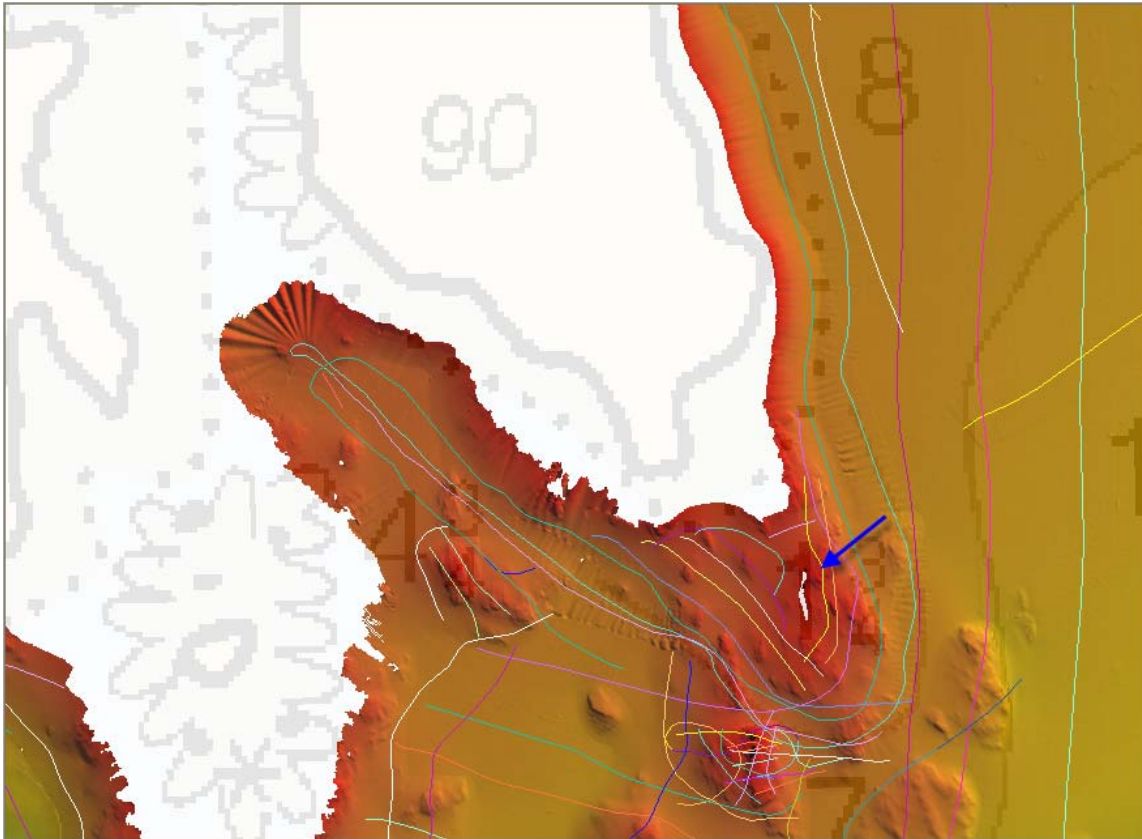
Figure 16: Line spacing holiday too far apart creating holiday south of small islet SSE of Step Island, has the least depth represented. Acquisition was acquired on last day of field operations near feature.

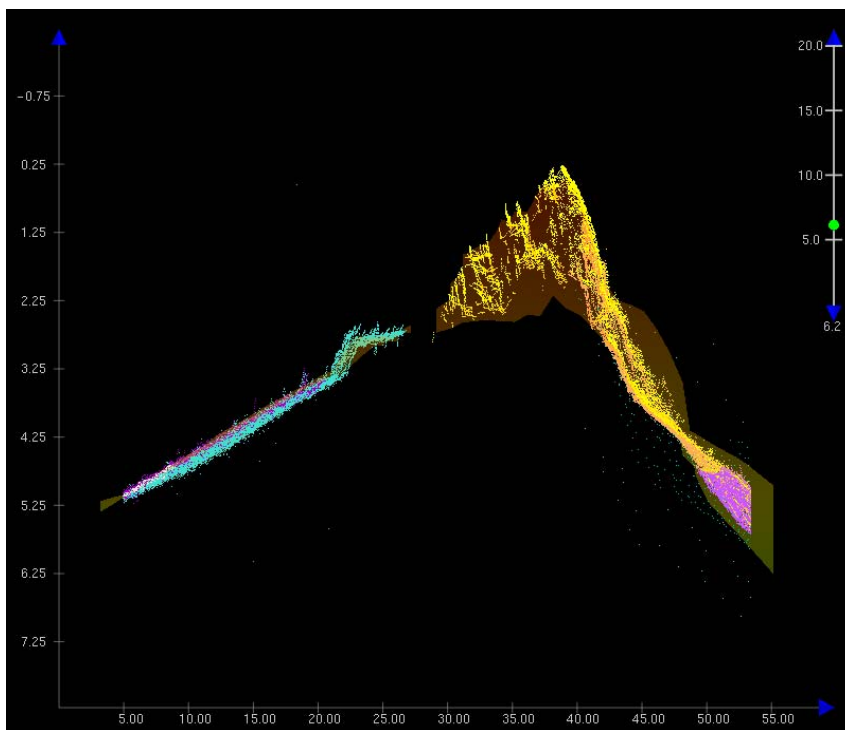
Figure 17: Line spacing is too far apart creating a holiday off a small islet SSE of Step Island. The side of the rock is the location of the holiday, the least depth is represented as shown in subset.

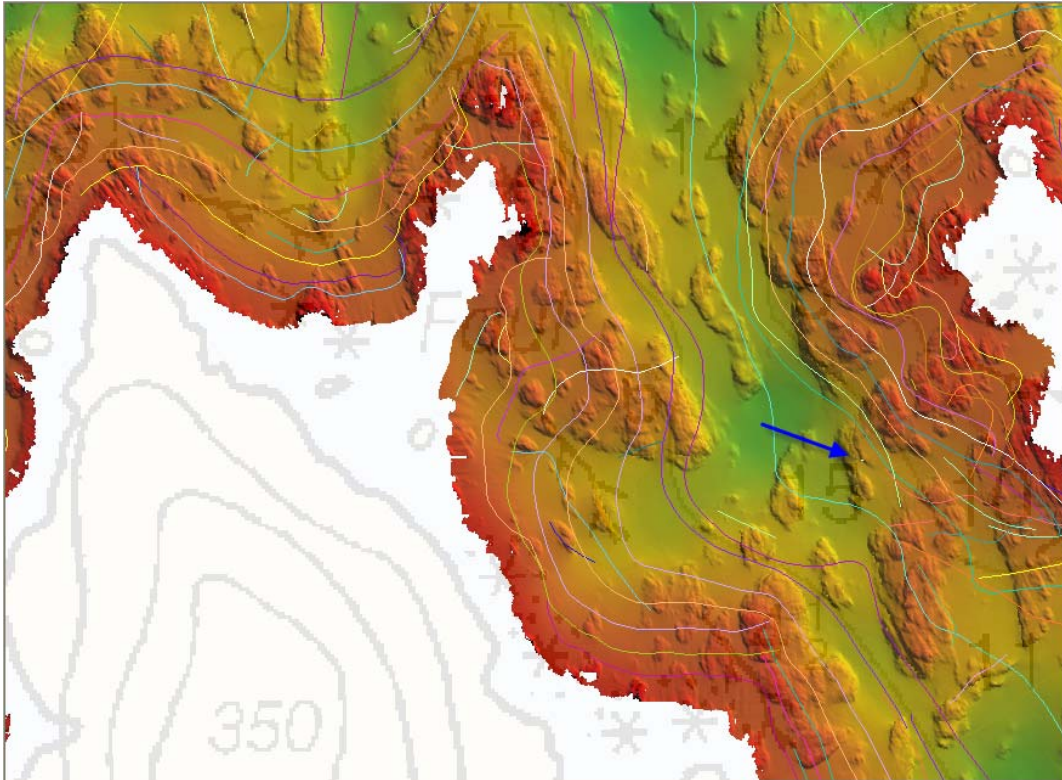
Several small acoustic shadow holidays created from beams not reaching downslope of features were created predominantly in the zero to 22 meter depth range on the eastern portion of H12063.¹⁶ See Figure 18 and 19 for example.

Figure 18: Example of acoustic shadow creating holiday in northern pass of Windfall Islands has the least depth represented.

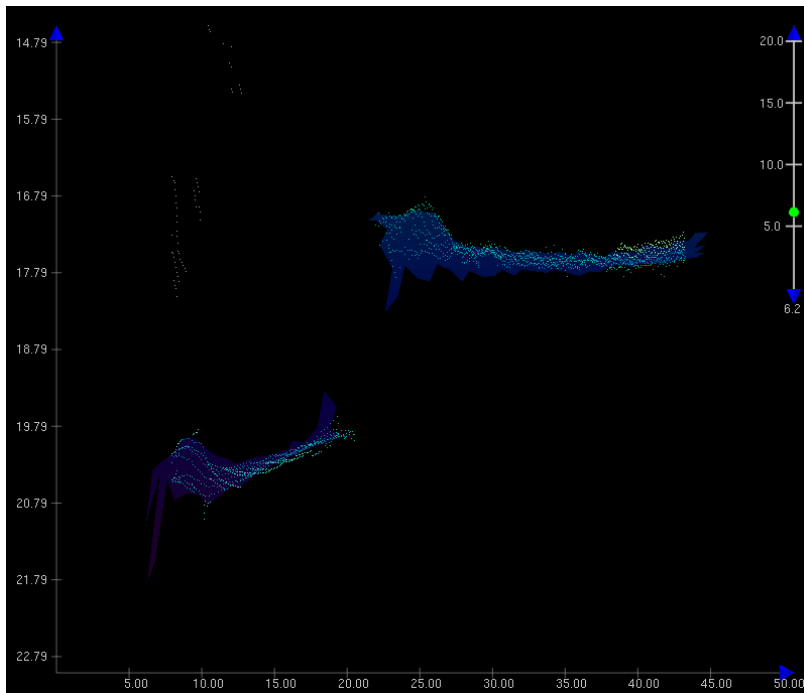
Figure 19: Area of downslope creating holiday in northern pass of Windfall Islands; shown in subset.

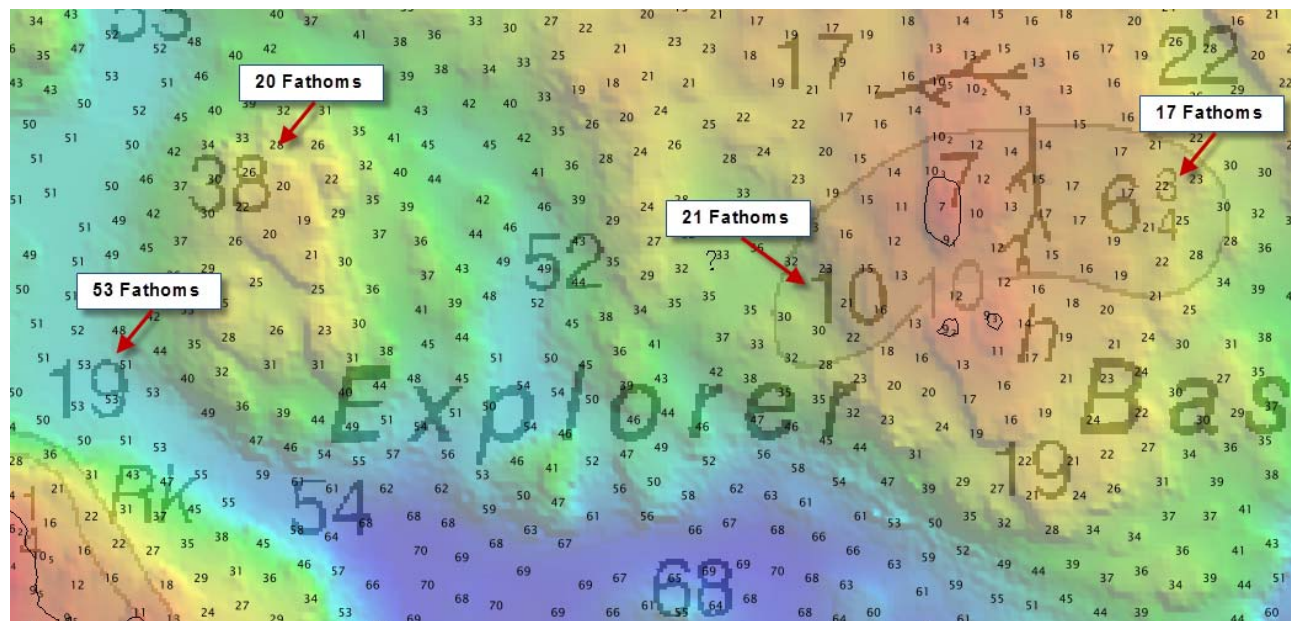
Figure 21: Disagreement between charted depths (17376) and surveyed soundings in the center of Explorer Basin.

Recommendation: Soundings from survey H12063 generally do not agree within one to two fathoms with charted depths on chart 17376 and contours generated in CARIS HIPS vary generously from the charted three and ten-fathom contours.²³ Throughout the survey there are numerous rocky shoals that are not depicted accurately by the charted depths and contours. Some examples are listed and shown in the figures below. Center of Explorer Basin: a 10-fathom contour surrounds a 10-fathom charted depth with a surveyed sounding of 21-fathoms and a 6 3/4-fathom charted depth with MBES soundings at 17-fathoms (Figure 21). West off the entrance of Petrof Bay: a 10-fathom contour and 7-fathom charted depth was surveyed with MBES at 15-fathoms with no soundings less than 10-fathoms in the area (Figure 22). Southwest of Step Island: 10-fathom contour lines vary generously from surveyed MBES contour lines (Figure 23).
