DESCRIPTIVE REPORT

Registry No. H12063

OPR-O322-FA-10
Chatham Strait, Alaska

Scale: 1:20,000
05 October 2010 - 08 November 2010
NOAA Ship *Fairweather*
CAPT David O. Neander

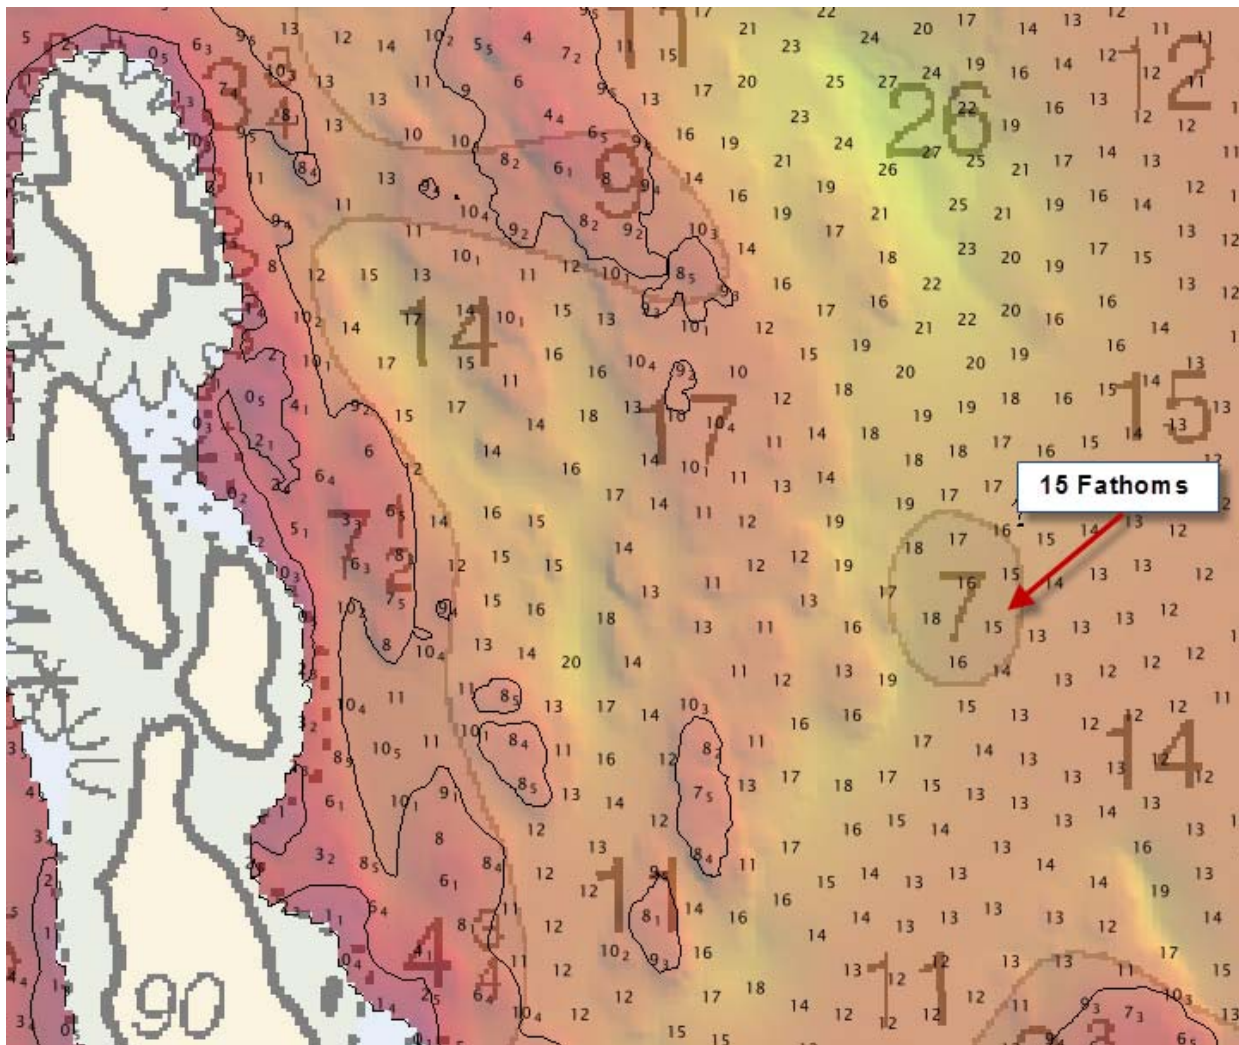
Figure 22: Disagreement between charted depths (17376) and surveyed soundings north of Swain Point.

Recommendation: Soundings from survey H12063 generally do not agree within one to two fathoms with charted depths on chart 17376 and contours generated in CARIS HIPS vary generously from the charted three and ten-fathom contours.²³ Throughout the survey there are numerous rocky shoals that are not depicted accurately by the charted depths and contours. Some examples are listed and shown in the figures below. Center of Explorer Basin: a 10-fathom contour surrounds a 10-fathom charted depth with a surveyed sounding of 21-fathoms and a 6 3/4-fathom charted depth with MBES soundings at 17-fathoms (Figure 21). West off the entrance of Petrof Bay: a 10-fathom contour and 7-fathom charted depth was surveyed with MBES at 15-fathoms with no soundings less than 10-fathoms in the area (Figure 22). Southwest of Step Island: 10-fathom contour lines vary generously from surveyed MBES contour lines (Figure 23).

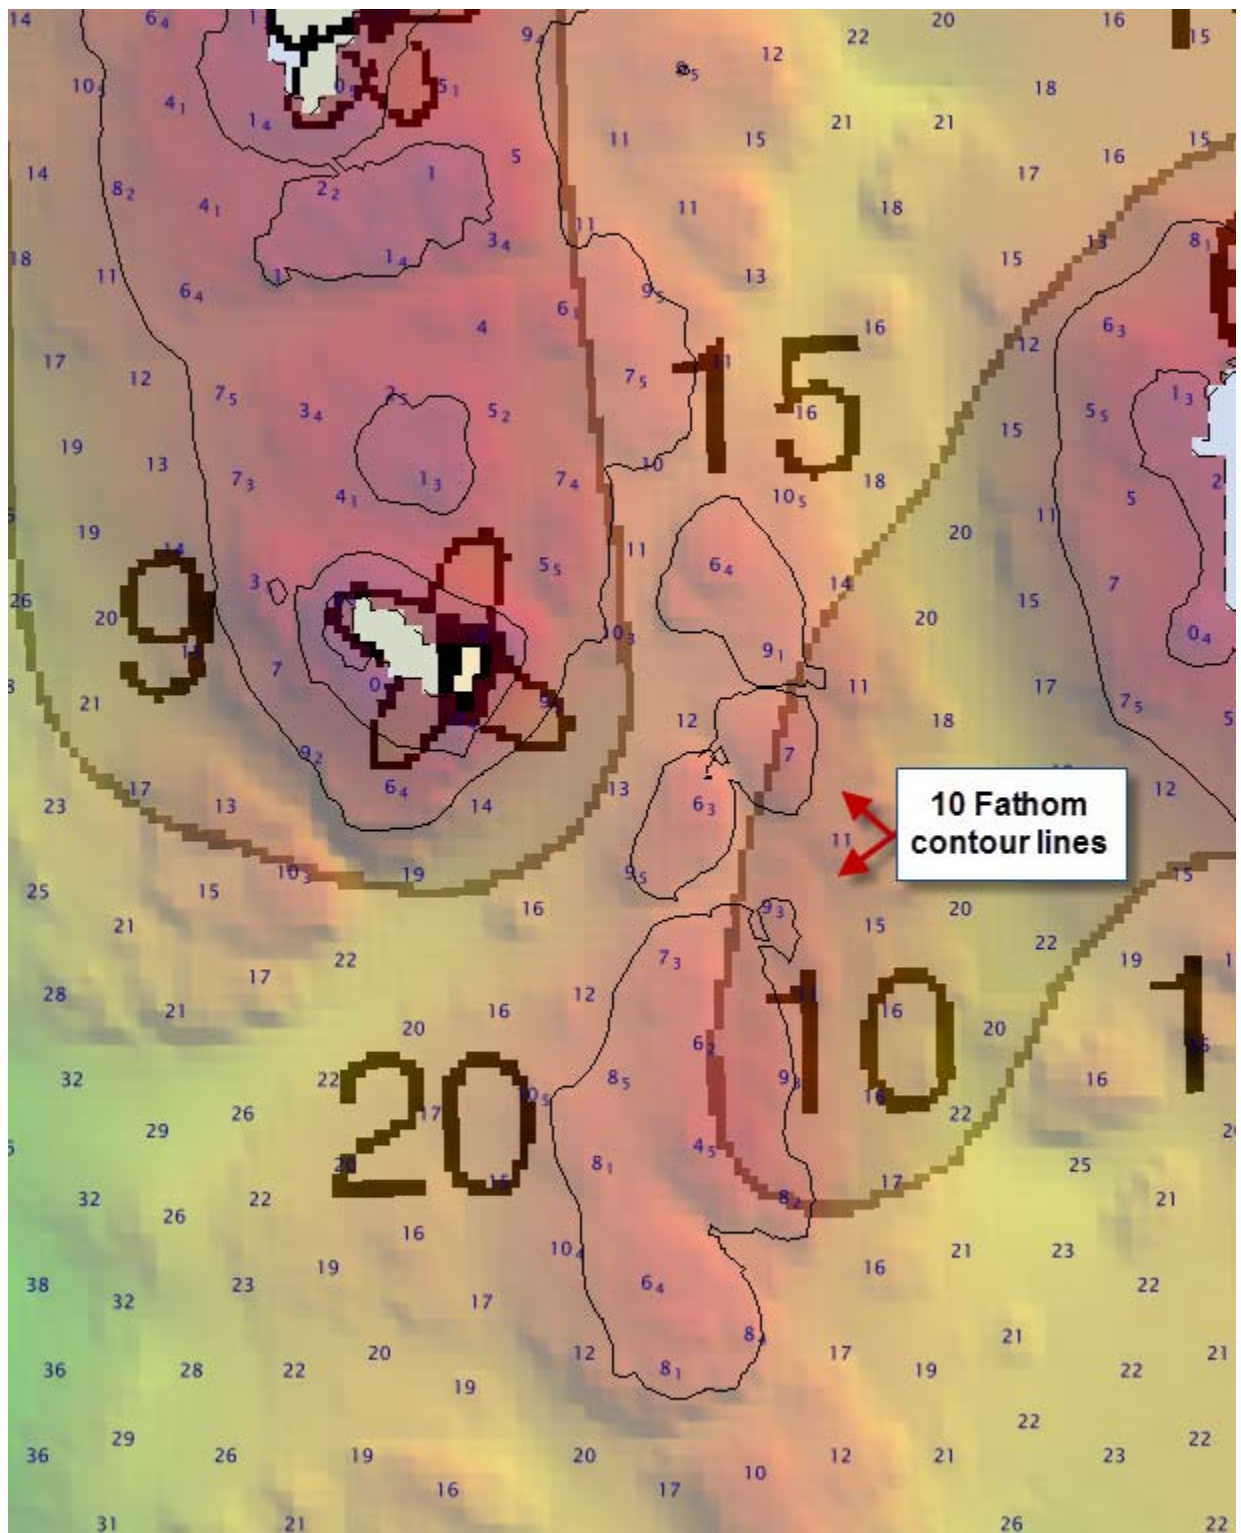
Figure 23: Disagreement between charted contours (17376) and surveyed contours southeast of Step Island.

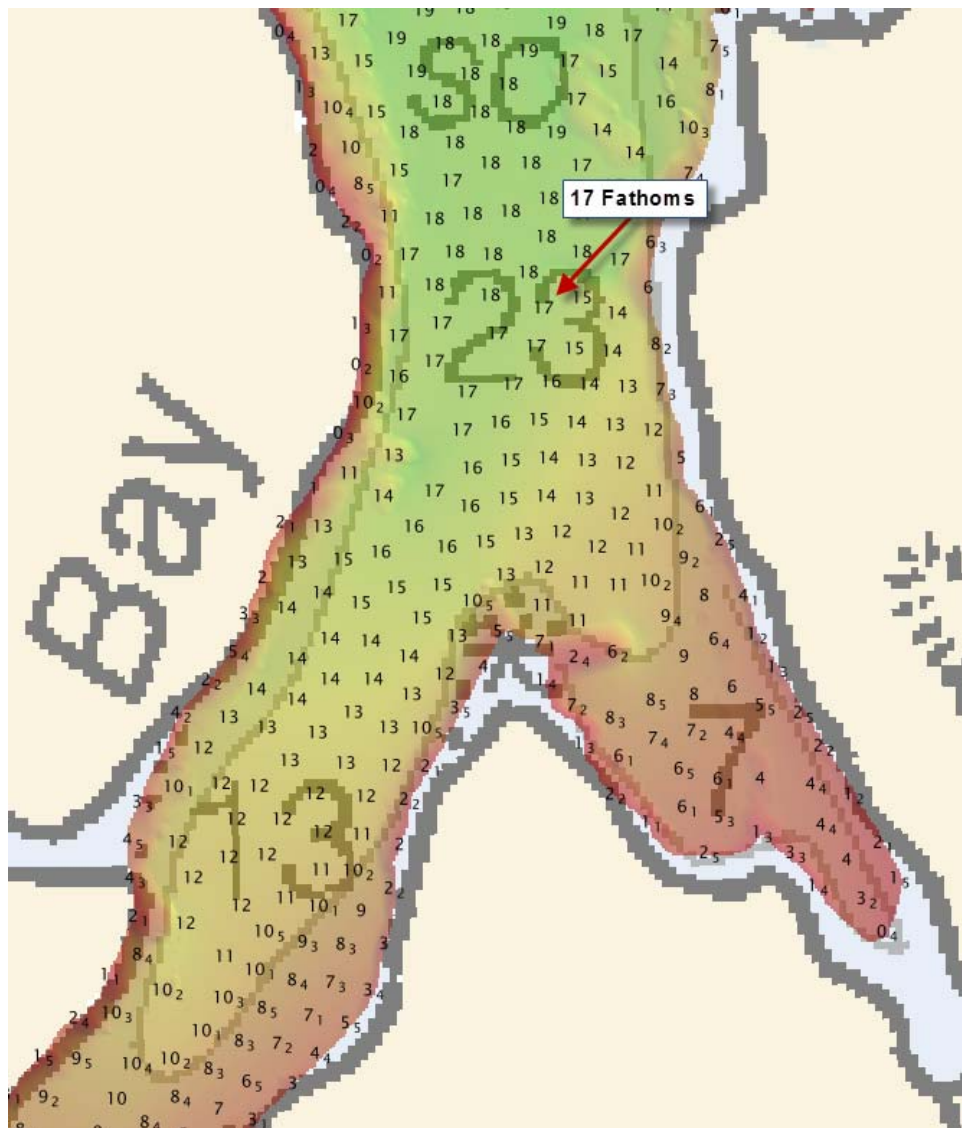
Figure 24: Disagreement between charted depth (17320) and surveyed soundings mid Thetis Bay.

Recommendation: Soundings from survey H12063 generally agreed within one to two fathoms with charted depths on chart 17320. A notable exception to this general agreement is listed and shown in Thetis Bay (Figure 24). A 23-fathom charted depth was surveyed by MBES at 17-fathoms.²⁴ Contours generated in CARIS HIPS closely approximated the charted 3 and 10 fathom contours. Throughout the survey there are numerous rocky shoals that are not depicted accurately by the charted contours.²⁵

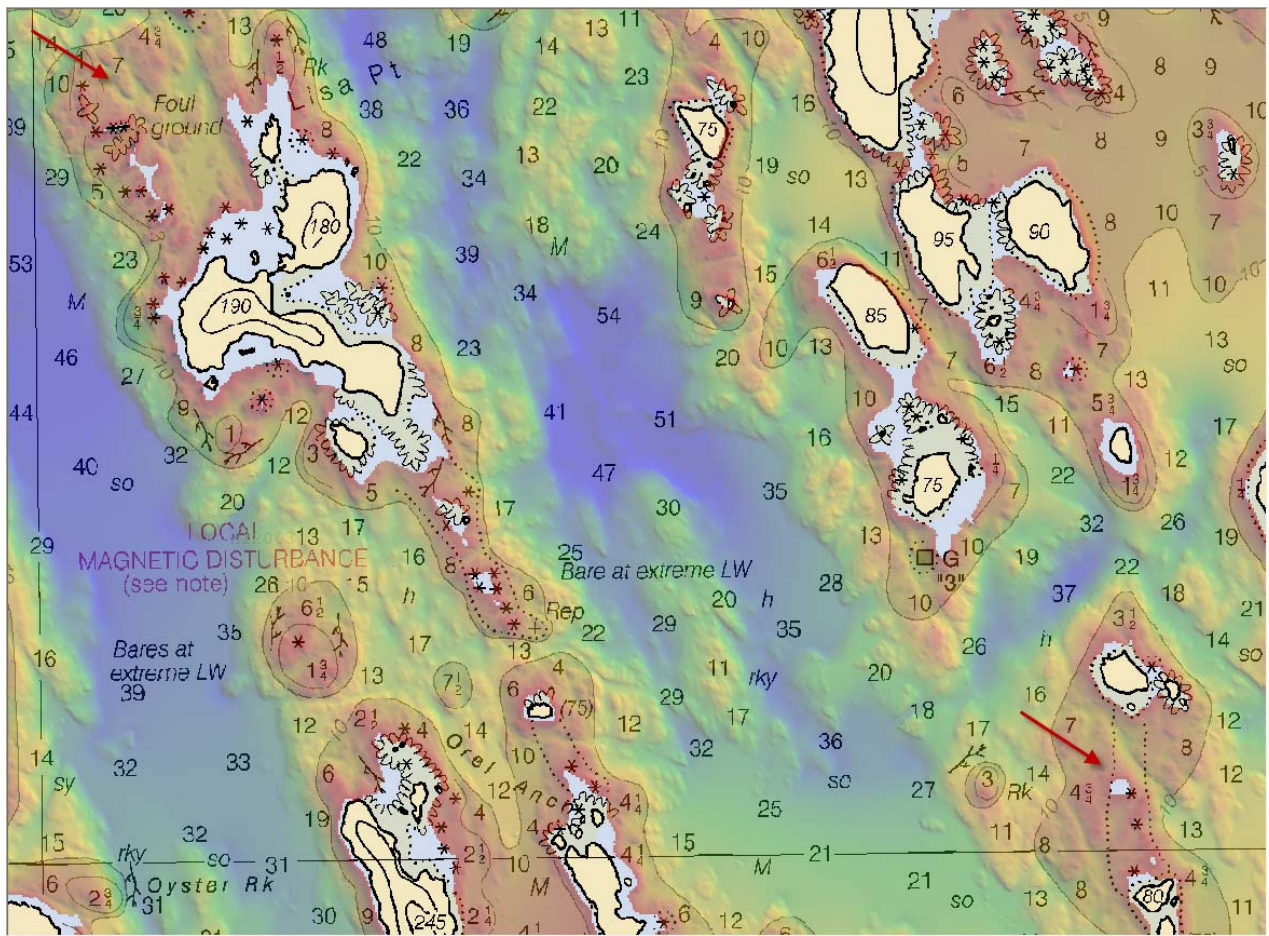
Examples of major discrepancies disproved by MBES are the foul ground areas, west of Lisa Pt, as well as the foul ground area between islets, southeast of green day marker "3" (Figure 25).²⁸

Figure 25: Disproved, by MBES foul ground areas to west of Lisa Pt and between islets, southeast of green day marker "3".

²⁸ Both the foul ground area west of Lisa Pt and the foul area between the islets southeast of green daymarker “3” have been blue noted to be removed. Chart features and depths as depicted in the HCell.

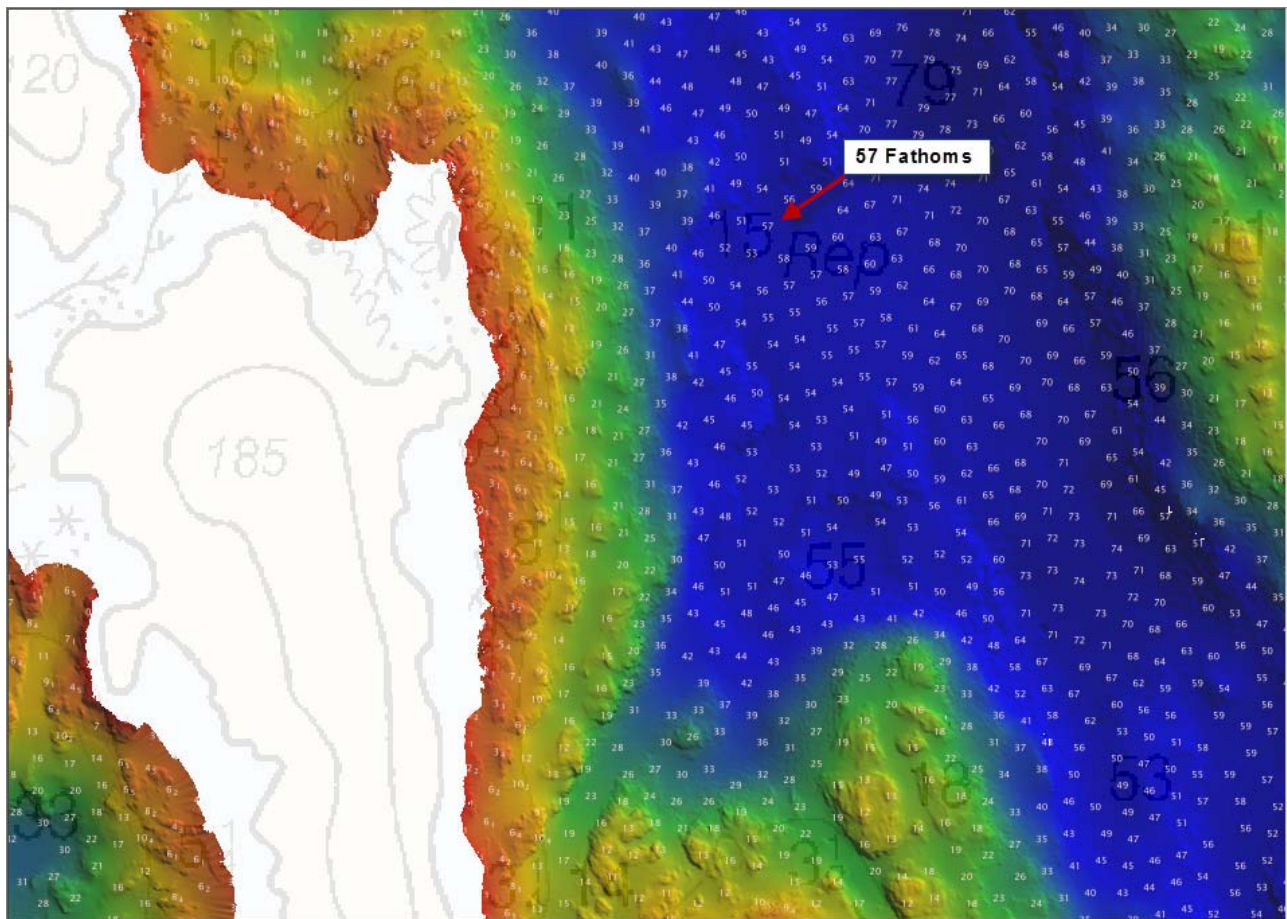
The 15-fathom sounding reported N of Helianthus passage was surveyed by MBES at 57 fathoms (Figure 26).²⁹

Figure 26: Reported 15-fathom sounding disproved by MBES N of Helianthus passage.

²⁹ The 15 fathom reported sounding has been blue noted to be removed. Chart depths as depicted in the HCell.

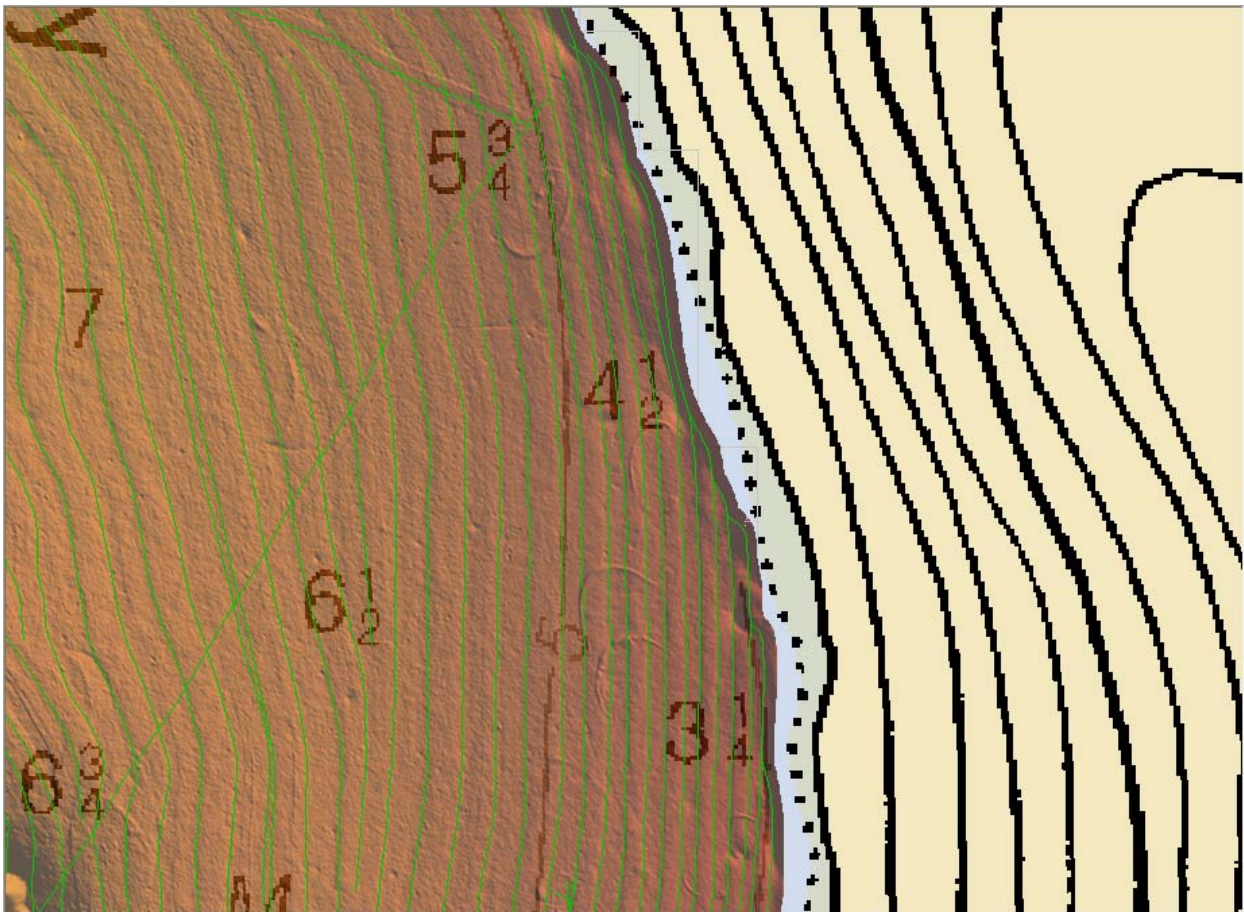
On western side of Petrof Bay crescent shaped features were observed in MBES data; these features are approximately 50cm proud of the bottom (Figure 27).³⁹

Figure 27: Half-meter high meter crescent shaped features observed in western side of Petrof Bay MBES.
