**DESCRIPTIVE REPORT**

Type of Survey: Hydrographic Survey  
Registry Number: **H12065**

State: Alaska  
General Locality: Southwest Peninsula  
Sub-locality: 10 NM SE of Unimak Island

**OPR-P188-TE09**

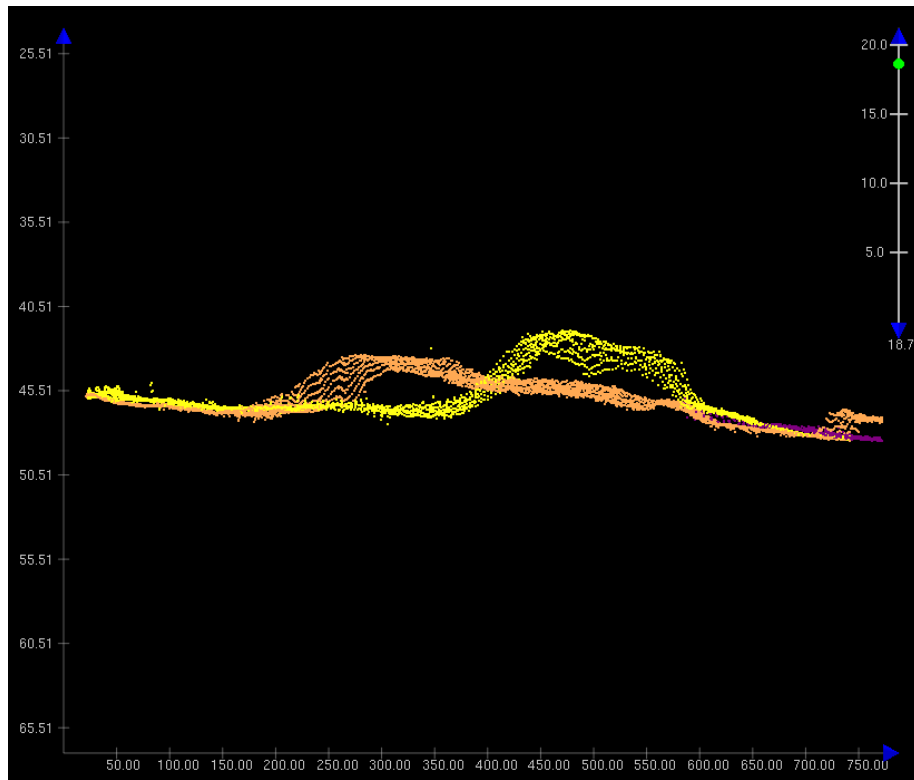
*Figure 4 - Data processed to the ellipsoid*

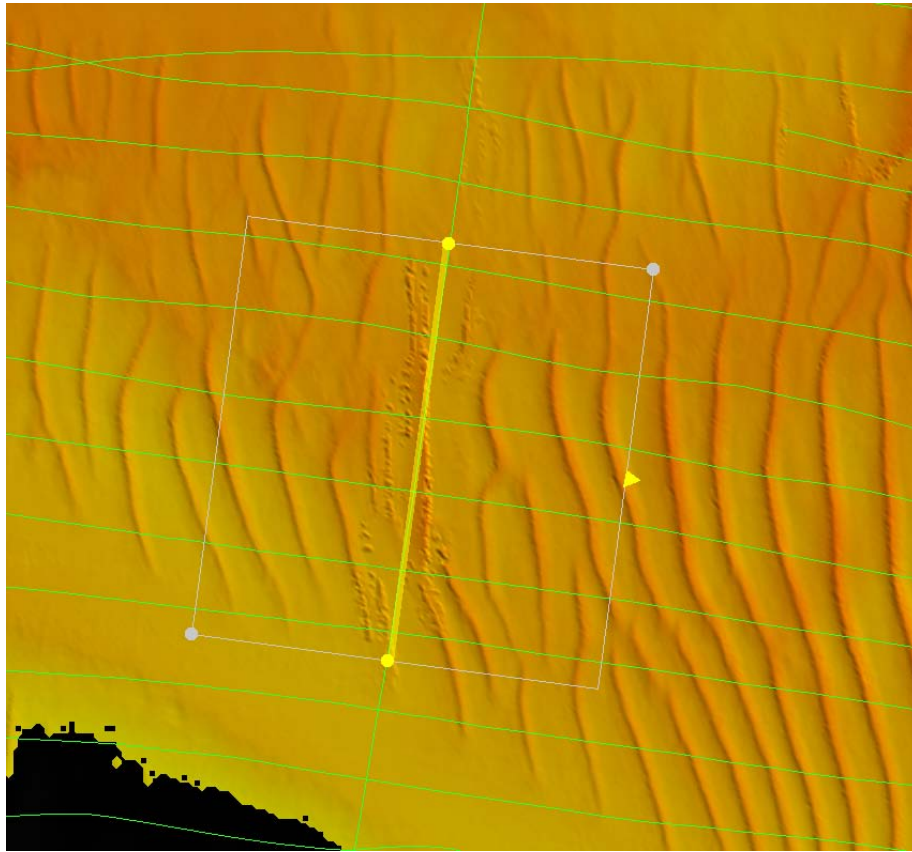
Figure 5 - Area represented by figures 3 and 4

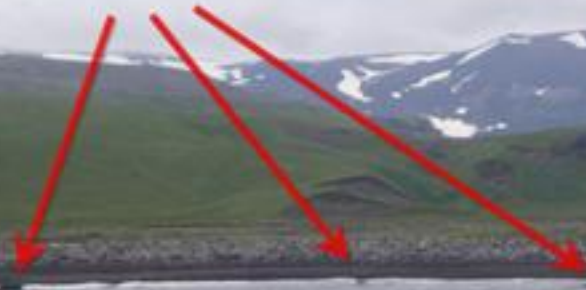
P0762\_DP028

THESE ROCKS ARE NOT NOTED ON OUR SHEETS

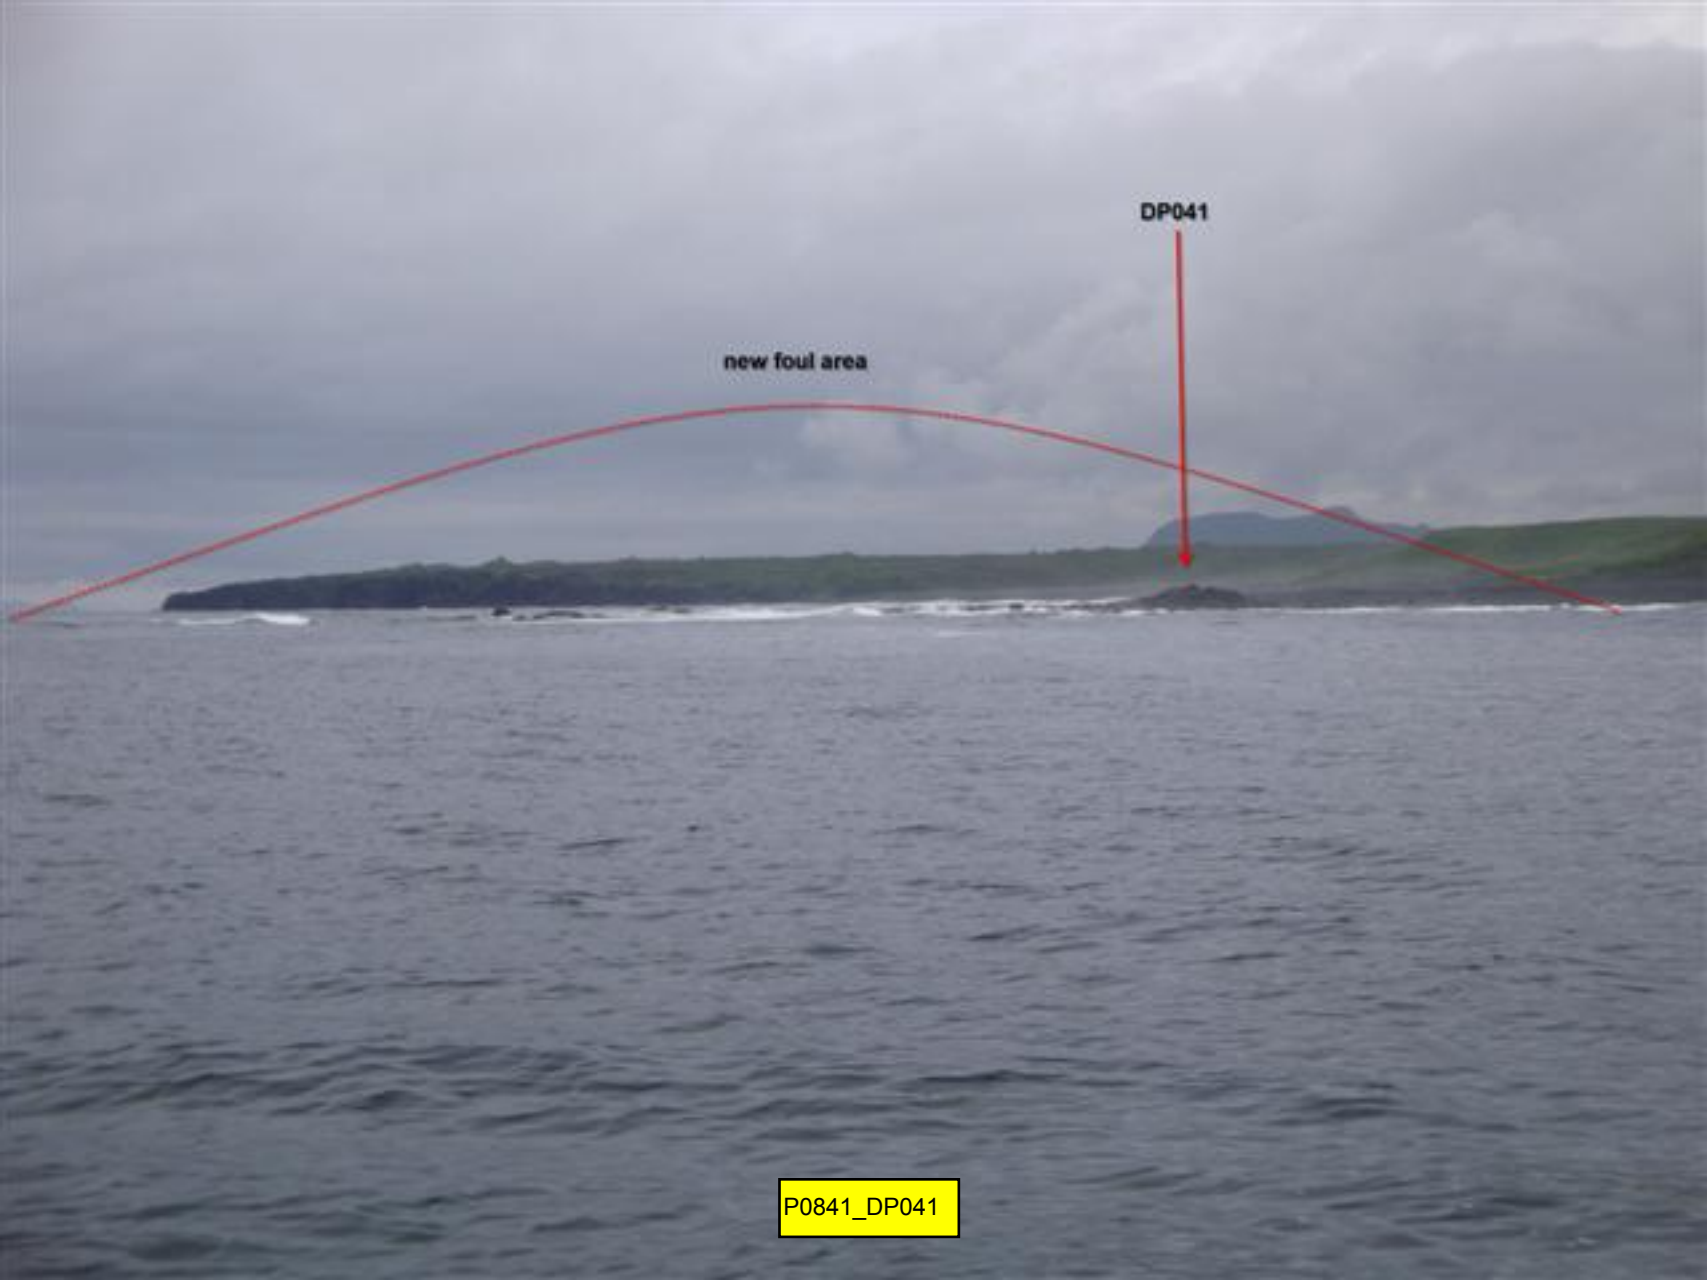
DP041

new foul area
