Descriptive Report

Type of Survey Shallow Water Multibeam
Hydrographic and Side Scan Sonar Survey

Project No. OPR-J364-KR-10-2

Registry No. H12237

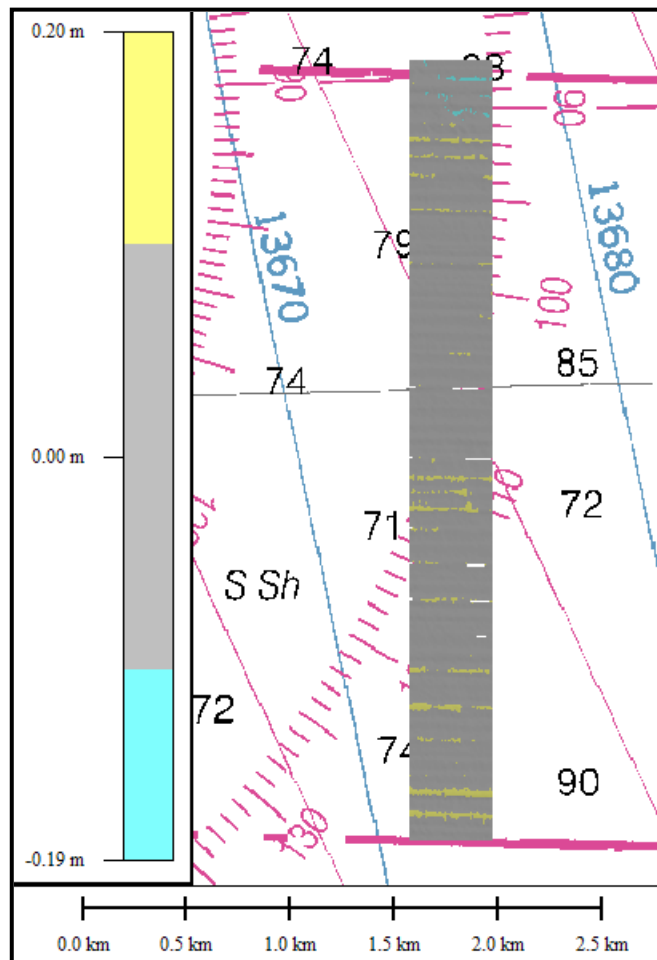
Figure 3. Surface-to-surface difference map comparing depths from Survey H12237 to depths from Survey H12236 overlaid on RNC 11388. Difference values are based on 10-meter by 10-meter data sampling. Grey areas represent depth differences of less than 0.10 meters. The maximum difference between surfaces is 0.20 meters.

There is an approximate overlap of 0.4 kilometers between bathymetric data from Surveys H12237 and H12236. Depths from the final combined 2-meter BASE surfaces from Surveys H12237 and H12236 were compared in CARIS HIPS. Further analyses consisting of a surface-to-surface comparison (Figure 3) and statistical analysis (Figure 4) were performed using 10-meter by 10-meter surfaces. Depths from H12237 showed excellent agreement with depths from H12236. Depth discrepancies equaled 20 centimeters or less and the mean difference between survey depths equaled 0.018 meters. *Concur with clarification. Office processing determined a depth difference of 20 to 50 centimeters between depths in surveys H12237 and H12236.*

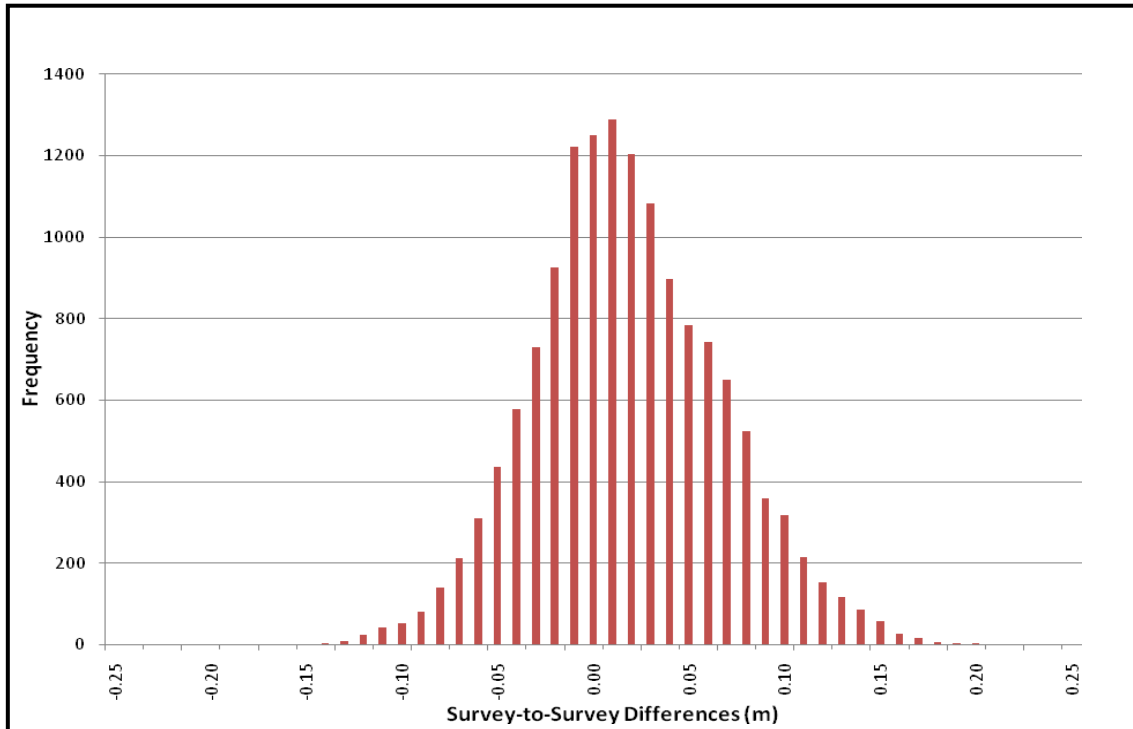
Figure 4. Surface-to-surface difference histogram comparing Survey H12237 to Survey H12236. Difference values are based on 10-meter by 10-meter data sampling. Average difference between surveys is 0.018 meters with a standard deviation of ± 0.05 meters. Ninety-four (94) percent of the difference values were within 2 sigma of the mean.

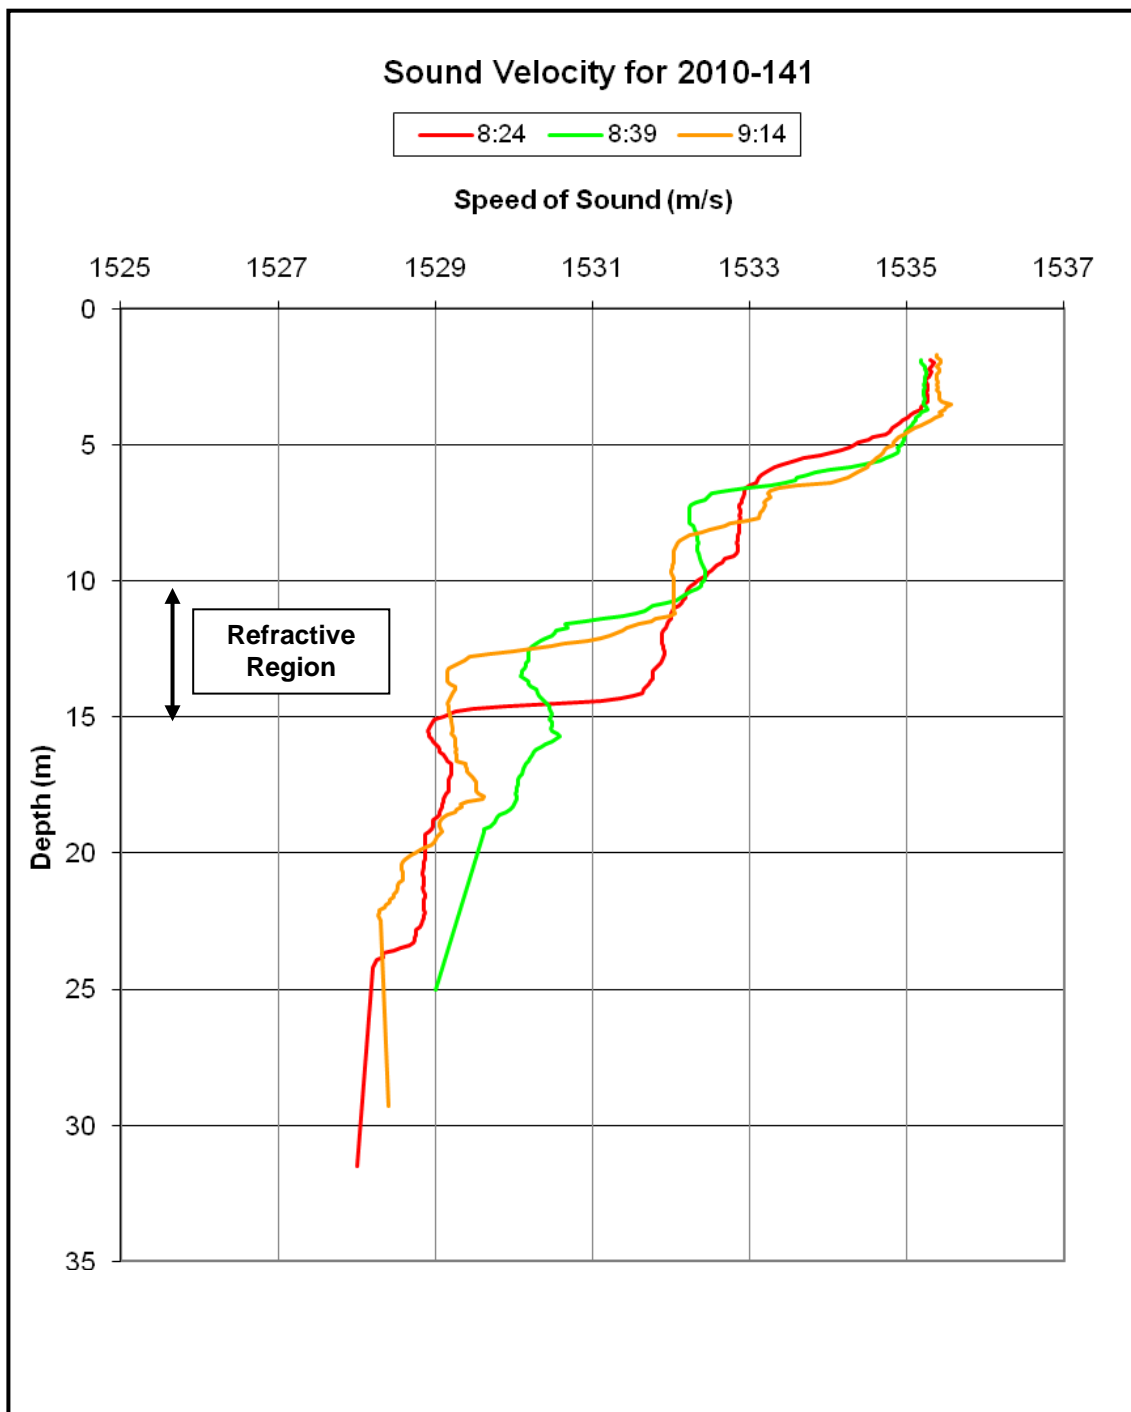
The sound speed profiles measured throughout the limits of Survey H12237 showed high variability. The predominant trend observed in the MVP profiles was a decrease in sound speed of approximately 8 to 15 m/s between depths of 5 and 25 meters. Sound speed profiles were viewed in real time during acquisition to assist in identifying the depths in the water column where refraction may be more severe due to rapid changes in sound speed. “Plateaus” and “bulges” in the profile served as indicators of depths prone to higher refraction and the SSS operator attempted to fly the towfish at depths below the refractive lens (Figure 5). In some areas, adjustments to towfish height did not help eliminate refraction in the side scan imagery. In these instances, the SSS data were rejected from the line record and rerun at a later time.

Figure 5. Sample sound speed profiles from May 21 (DN 141) demonstrate rapid decreases in sound speed, or “plateaus,” observed in the water column between approximate depths of 10-15 meters. Side scan operators reviewed profiles in real time to assist in determining an optimal height at which to fly the towfish to reduce refraction effects.

The SSS range scale was maintained at 100 meters except in the southeastern section of the survey area where the range scale was reduced to 75 meters to avoid refraction effects in the outer swath. The line plan was adjusted accordingly to ensure that full 200% coverage was obtained. All changes in SSS range settings were recorded in the Acquisition Log located in Separate I*.

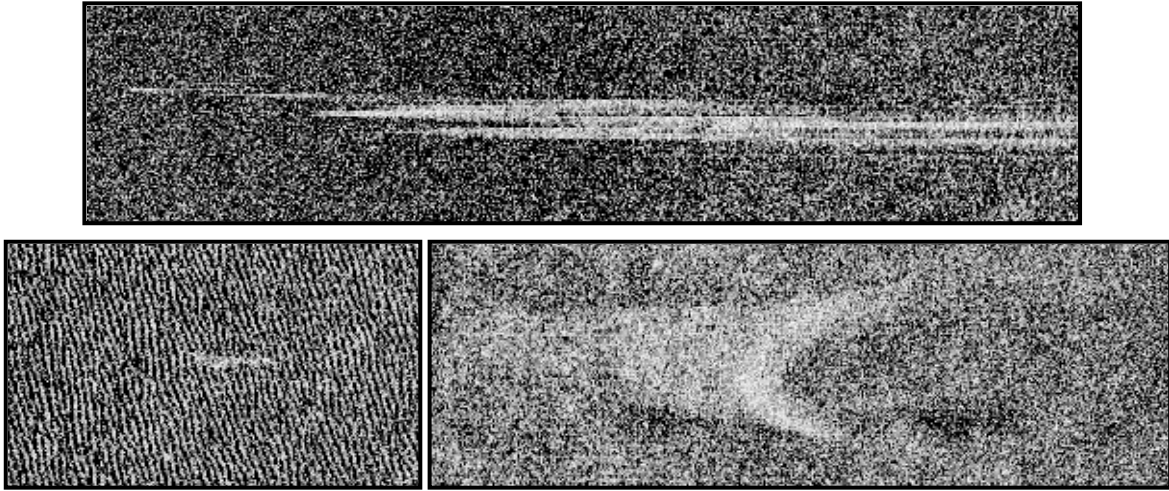
Fish were frequently seen in both the multibeam and SSS data (Figure 6). Fish were noted in the Acquisition Log by the field team, and these areas were carefully reviewed during data processing. If seen on only one side scan line, the contact was designated as fish. If the contact was visible in 200% side scan coverage and had a significant height, it was investigated with object detection multibeam coverage to verify or disprove the presence of a feature. In some instances, where the fish obscured a significant portion of the seafloor, SSS data were rejected and rerun at a later time.

Figure 6. Examples of fish seen in the side scan imagery.

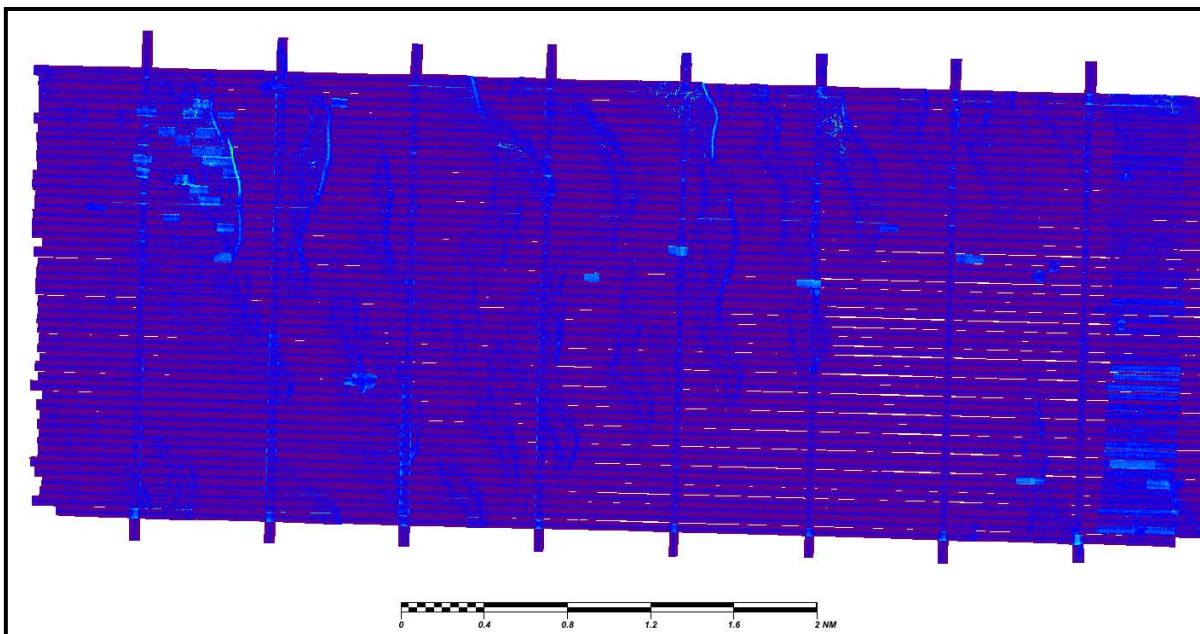
A vertical offset is apparent in the BASE surface standard deviation layers where mainscheme SWMB lines overlap fill-in and object investigation SWMB lines collected May 26th through 27th (DNs 146-147) (Figure 7). Multibeam data collected on these dates were approximately 0.10-0.15 meters deeper than the overlapping mainscheme survey lines (Figure 8). The offset appears to be tidal and it did not exceed the allowable IHO Order 1 error budget of 0.55 to 0.65 meters at the survey depths of 17-32 meters.

Figure 7. A subset of the standard deviation layer of the final combined BASE surface is displayed with the color range set between 0 and 0.3 meters to better isolate areas of higher standard deviation. Fill-in and contact investigation lines collected on May 26-27 (DNs 146-147) appear light blue among the mainscheme lines. Numerous seafloor ridges are also visible as bright areas in the standard deviation layer.

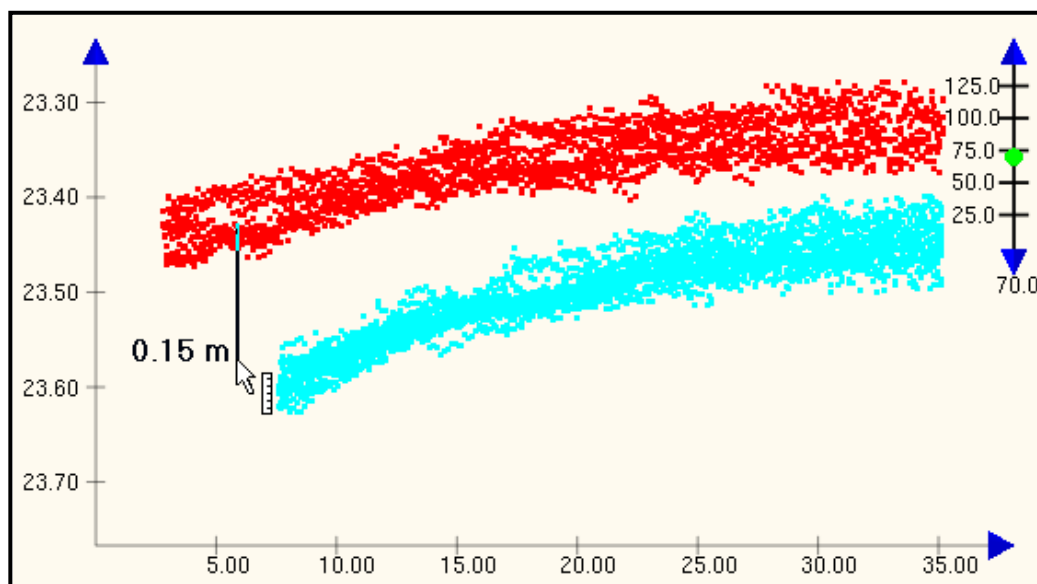
Figure 8. An example of the vertical offset between a mainscheme SWMB line collected on May 19 (DN 139) (red) and a fill-in SWMB line collected on May 26 (DN 146) (cyan) displayed in CARIS HIPS Subset Editor. Depths and distances are in meters.

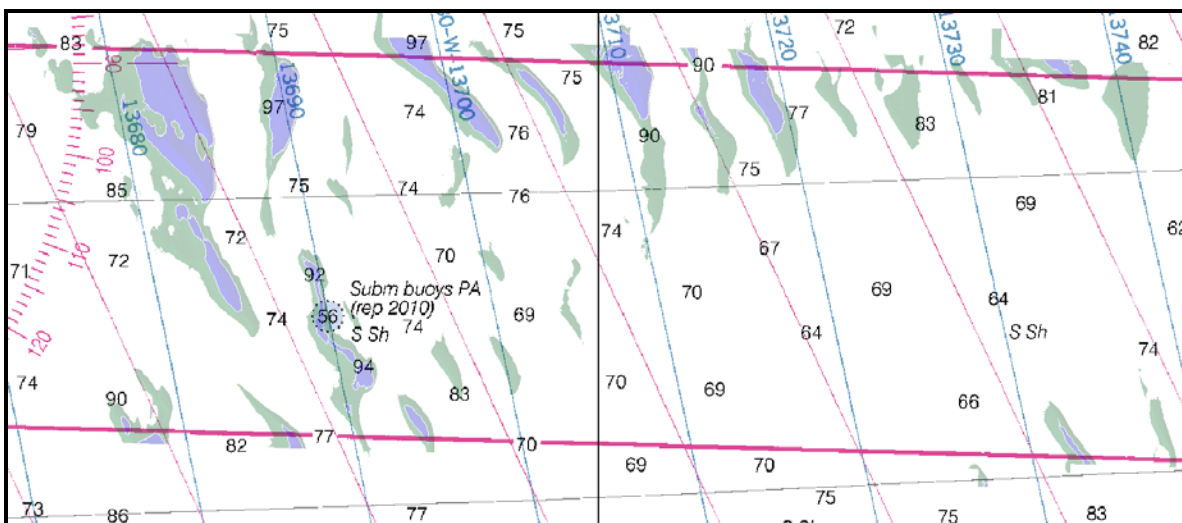
Figure 11. In the western reaches of the survey, deep areas surveyed between charted soundings on RNC 11388 are highlighted using CARIS BASE surfaces finalized by depth. Surveyed depths between 85 and 90 feet are colored in green and surveyed depths greater than 90 feet are colored in blue. Charte soundings are in feet.

Concur.

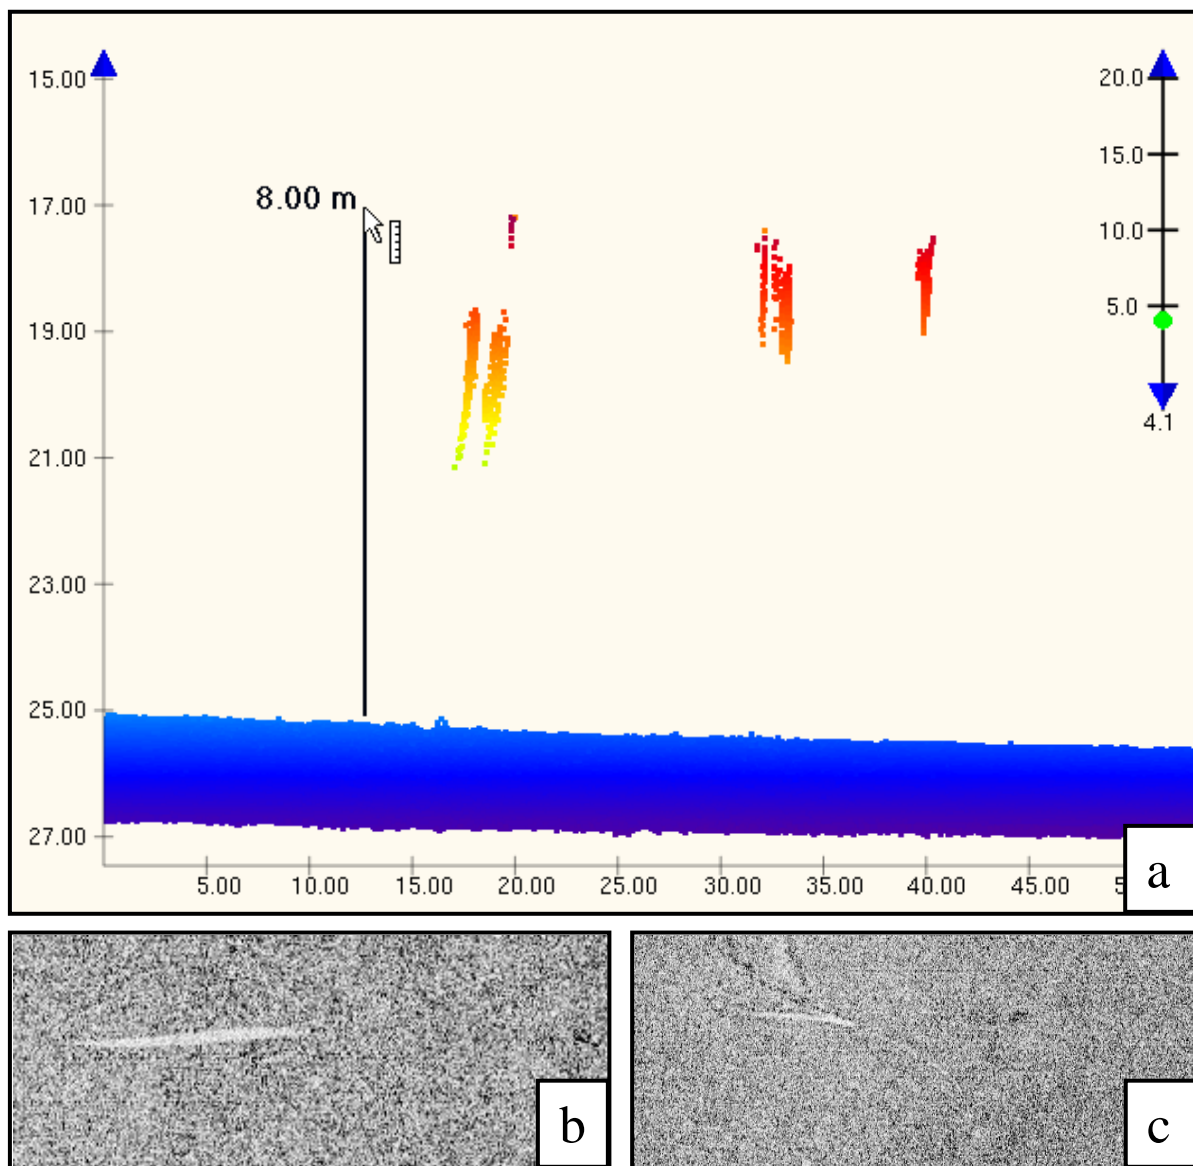
Figure 13. (a) View of the floating obstruction in CARIS Subset Editor with soundings colored by line. Depth and distance are in meters. (b, c) Side scan sonar imagery of the obstruction, Contacts 140-09260001 and 140-10120001, respectively.

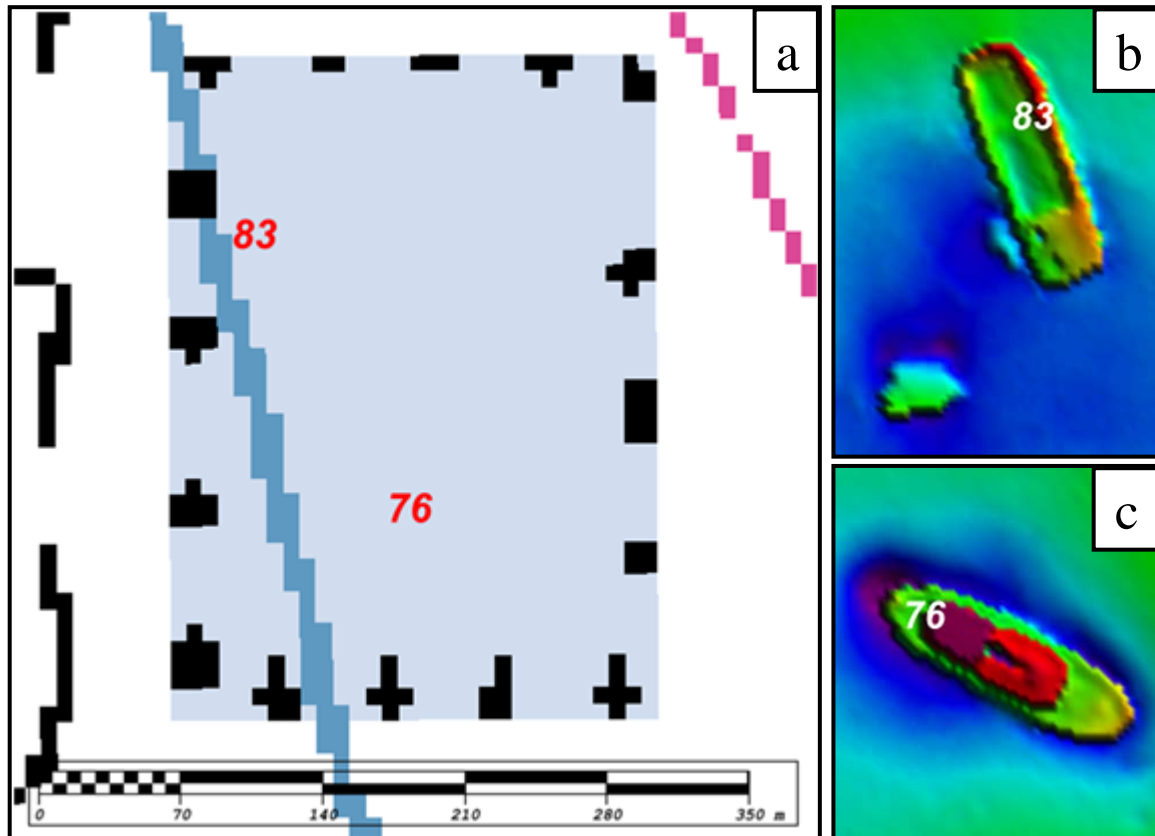
- H12237-3: Two wrecks were verified within a charted Obstr Fish Haven (auth min 50ft) with 200% SSS and object detection coverage SWMB (Figure 14). A least depth of 83.4 feet (25.4 meters) was developed on the “northern” wreck at 30-15-55.26N, 86-23-09.83W. The wreck measures approximately 77 feet (23.5 meters) long by 26 feet (7.9 meters) wide and 12.5 feet (3.8 meters) high. A piece of debris is evident approximately 40 feet (12.2 meters) southwest of the northern wreck. The debris does not have significant height. The “southern” wreck is positioned at 30-15-50.86N, 86-23-06.97W with a least depth of 76.7 feet (23.4 meters). The wreck measures approximately 88 feet (26.8 meters) long by 25 feet (7.6 meters) wide and 21 feet (6.4 meters) high. The wrecks are included in the S-57 feature file (H12237_S57_Feature.000) and described in Appendix II* as AWOIS Item 14789. No other obstructions were identified in the Fish Haven. It is recommended that the Obstr Fish Haven remain as charted.

Figure 14. (a) Wreck least depth positions are shown in red in reference to the Obstr Fish Haven as charted on RNC 11388. Depths are in feet. (b) The northern wreck has a least depth of 83 feet. (c) The southern wreck has a least depth of 76 feet.

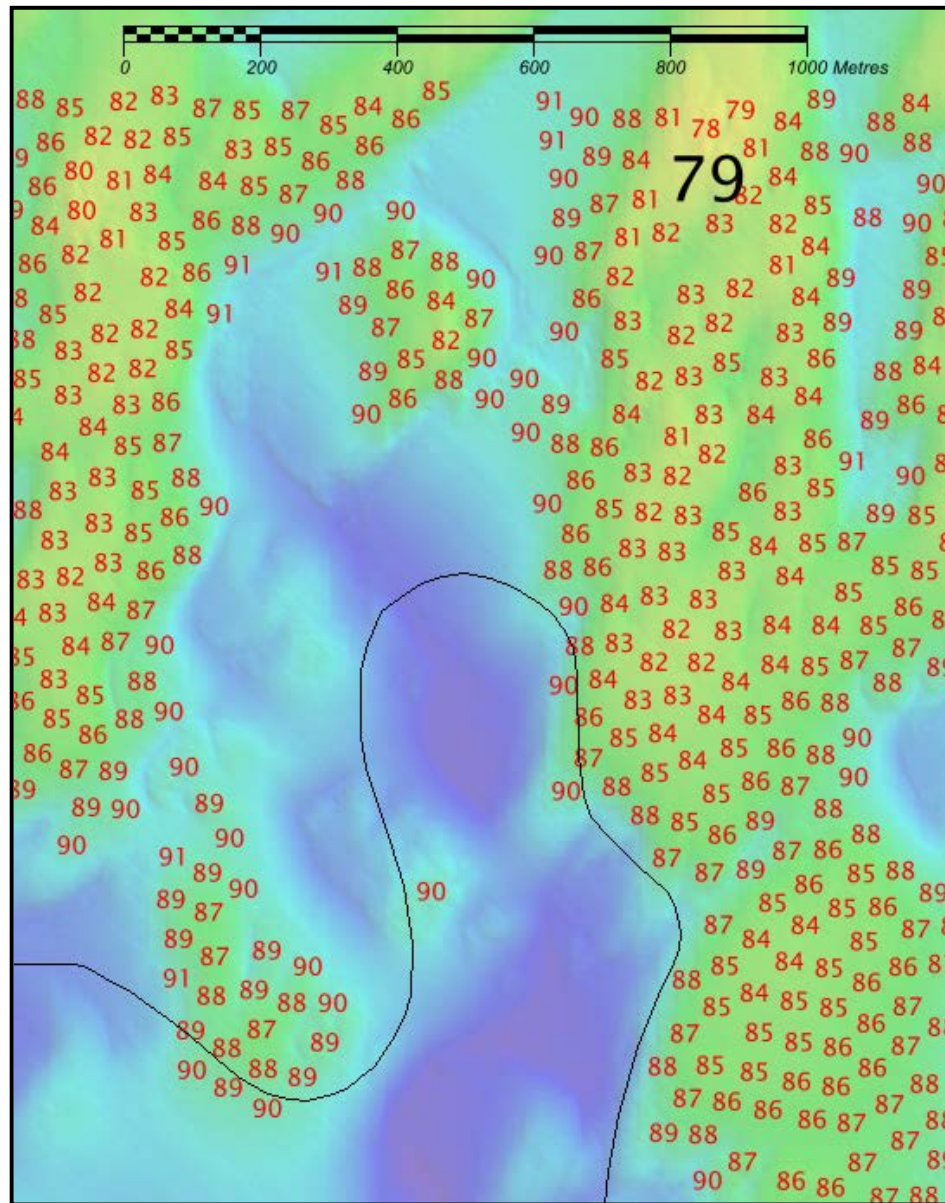
H12237-4: The charted 90-foot contour has shifted significantly inshore in the vicinity of 30-15-49.82N, 86-19-28.59W (Figure 15). Survey depths are up to 9 feet (2.7 meters) deeper than the charted 90-foot contour in this area. It is recommended that the charted contour be updated with survey depths.

Figure 15: Survey soundings ≤ 90 feet are shown in red in reference to the charted 90-foot contour on ENC US4FL74M, in black. The surveyed 90-foot contour has shifted inshore of its charted position. A 2-meter resolution BASE surface colored by depth is shown in the background.

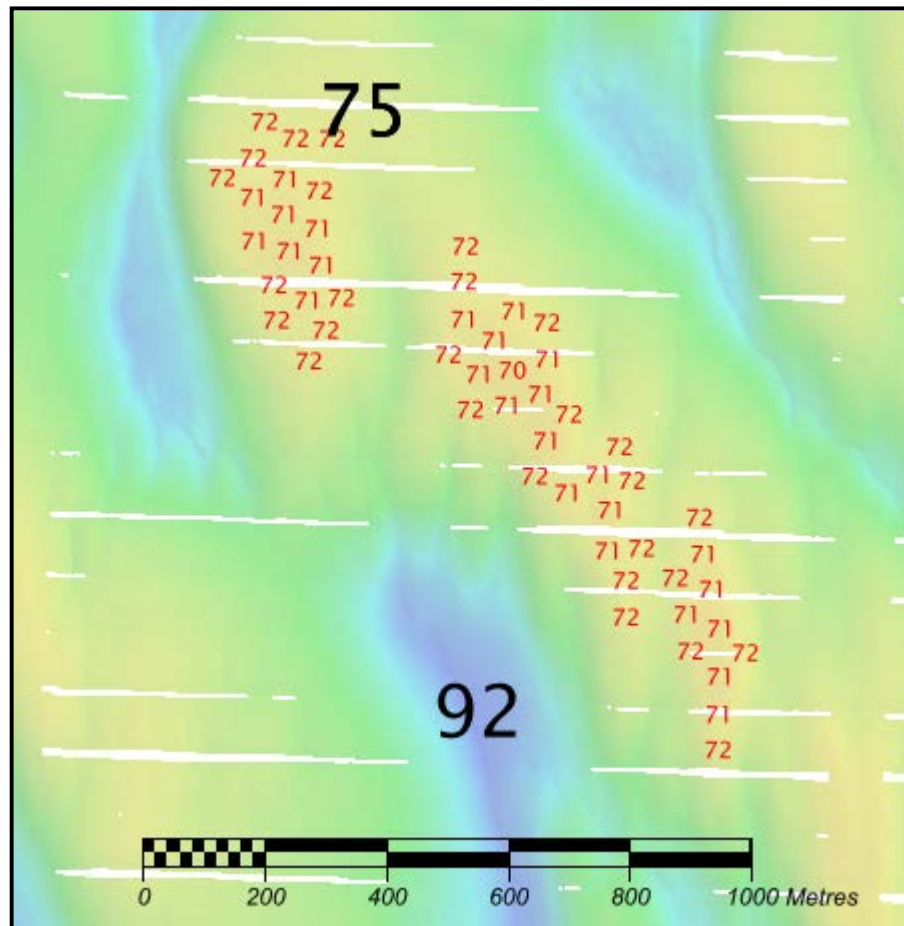
- H12237-5: There were two instances where significant shoaling was observed over charted soundings. These discrepancies are listed below.
 - Depths between 79 and 85 feet (24.1 and 25.9 meters) were developed over a charted 90-foot sounding located at 30-16-29.10N, 86-32-54.55W.
 - Depths between 78 and 84 feet (23.8 and 25.6 meters) were developed over a charted 90-foot sounding located at 30-18-14.19N, 86-29-21.54W. *Concur.*
- H12237-6: Survey depths between 85 and 93 feet (25.9 and 28.3 meters) were surveyed over a charted 81-foot sounding located at 30-16-11.38N, 86-23-40.08W. *Concur.*
- H12237-7: Shoaling was surveyed between charted soundings of 75 and 92 feet (Figure 16). A least depth of 70.6 feet (21.5 meters) was developed over the shoal at 30-17-24.31N, 86-31-41.04W. *Concur.*

Figure 16. Survey depths ≤ 72 feet developed over the shoal are highlighted in red and overlain on a 2-meter resolution BASE surface colored by depth. Charted soundings from ENC US4FL74M are shown in black. All depths are in feet. *Concur.*

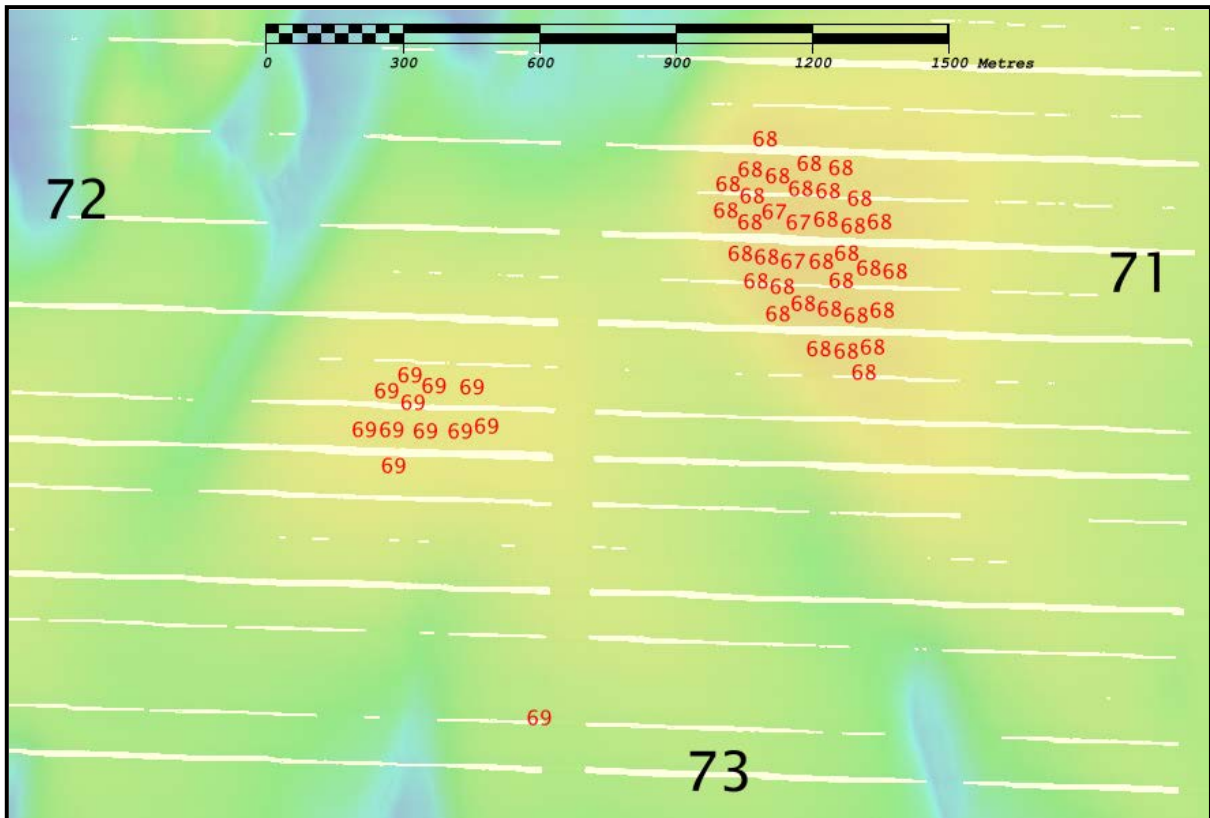
- H12237-8: Two shoals were surveyed between charted soundings of 71, 72, and 73 feet (Figure 17). Least depths of 67.6 feet (20.6 meters) and 69.4 feet (21.2 meters) were developed at positions 30-17-39.98N, 86-22-53.42W and 30-17-26.53N, 86-23-20.60W over the east and west shoals respectively. A rock with a least depth of 69.3 feet (21.1 meters) was located in the vicinity of the charted 73-foot depth, positioned at 30-17-08.77N, 86-23-10.12W. *Concur.*

Figure 17. Survey depths developed over the shoals are highlighted in red and overlain on a 2-meter resolution BASE surface colored by depth. Charted soundings from ENC US4FL74M are shown in black. All depths are in feet. *Concur.*

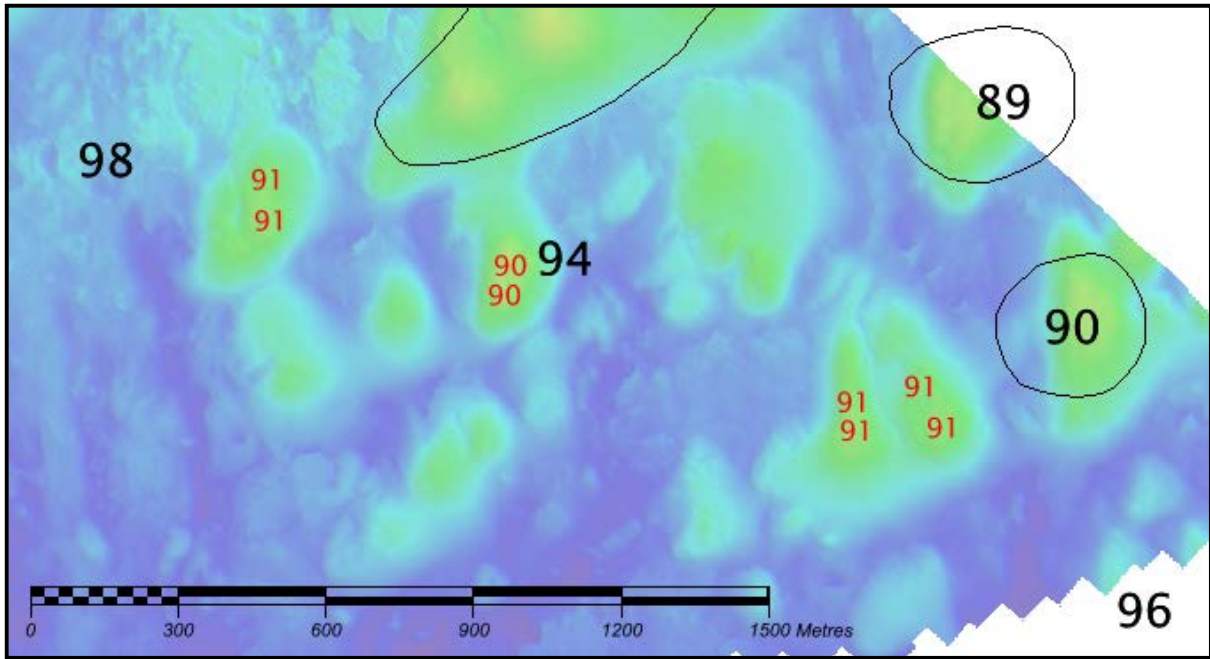
- H12237-10: Several shoals were surveyed between charted soundings of 94, 96, and 98 feet (Figure 19). A depth of 91.2 feet (27.8 meters) was developed at 30-15-33.45N, 86-17-50.19W over a shoal located between charted soundings of 94 and 98 feet. A least depth of 90.1 feet (27.5 meters) was developed at 30-15-30.96N, 86-17-34.19W in the vicinity of a charted 94-foot sounding. A least depth of 91.1 feet (27.8 meters) was developed at 30-15-21.41N, 86-17-11.66W over a shoal located between charted soundings of 94 and 96 feet. *Concur.*

Figure 19. Several shoals were developed between charted soundings of 94, 96, and 98 feet. Surveyed least depths over the shoals are displayed in red over a 2-meter resolution BASE surface colored by depth. Soundings and contours from ENC US4FL74M are shown in black. All depths are in feet. *Concur.*

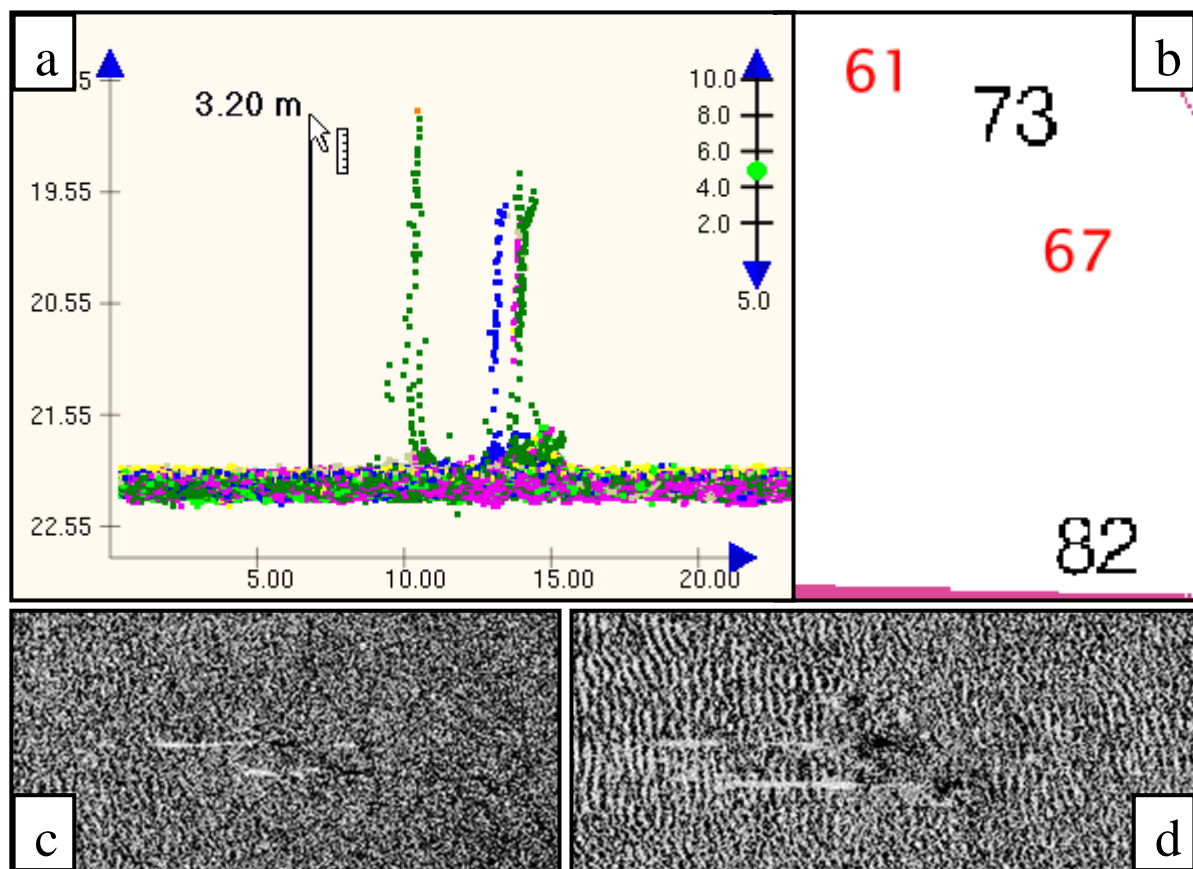
Figure 22. (a) The 61-foot obstruction* displayed in CARIS HIPS Subset Editor with soundings colored by survey line; depth and distance units are in meters. (b) H12237-12 obstructions (least depths) are displayed in red in reference to RNC 11388. Depths are in feet. (c, d) Side scan sonar imagery of the two 10-foot tall features from overlapping survey lines, Contacts 142-12080004 and 142-11190007, respectively. **See also Appendix II*

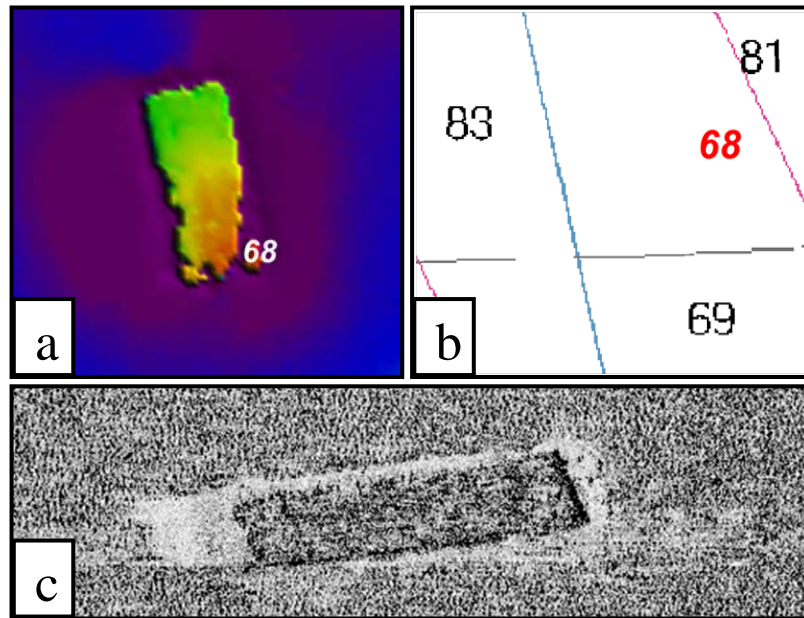
- H12237-13: A low, flat wreck was surveyed at position 30-17-53.05N, 86-27-22.90W. The wreck has a least depth of 68.4 feet (20.8 meters) and is located approximately 400 meters south of a charted 81-foot sounding. The wreck measures approximately 74 feet (22.6 meters) long by 38 feet (11.6 meters) wide and 7.5 feet (2.3 meter) high. The wreck is illustrated in Figure 23 and included as a WRECKS object in the S-57 feature file (H12237_S57_Feature.000). *

Figure 23. (a) The wreck displayed in a 50-centimeter resolution BASE surface colored by depth. The location of the wreck least depth is shown in white. (b) The obstruction least depth is displayed in red in reference to RNC 11388. All depths are in feet. (c) Side scan sonar imagery of the wreck, Contact 139-14010004. *

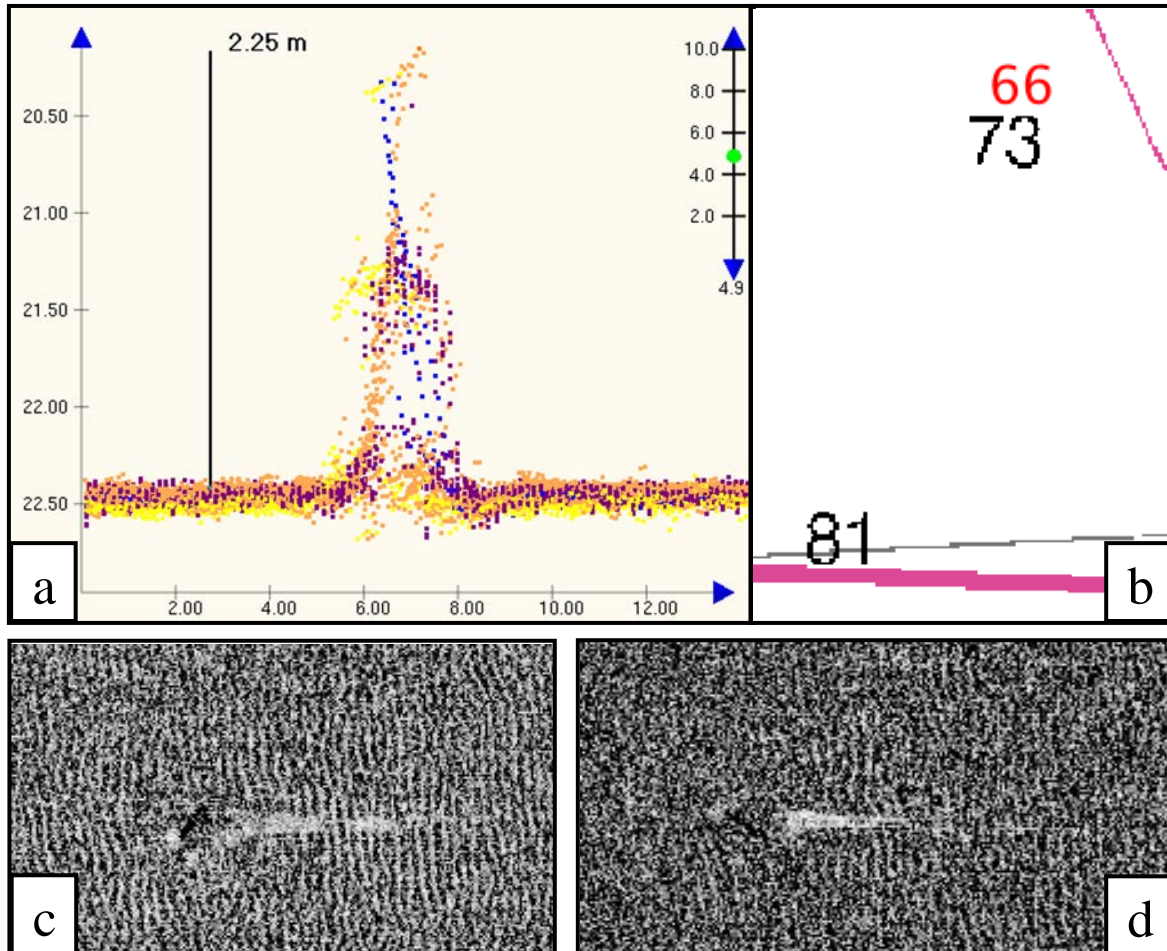
H12237-14: A spire-like obstruction (Figure 24) with a least depth of 66.1 feet (20.1 meters) was observed at position 30-16-48.56N, 86-24-43.13W, 150 meters north of a charted 73-foot sounding on RNC 11388. It is included as an OBSTRN object in the S-57 feature file (H12237_S57_Features.000).

Figure 24. (a) The 66-foot obstruction displayed in CARIS HIPS Subset Editor with soundings colored by survey line; depth and distance units are in meters. (b) The obstruction least depth is displayed in red in reference to RNC 11388. Depths are in feet. (c, d) Side scan sonar imagery of the obstruction from two overlapping survey lines, Contacts 142-10320001 and 142-11190005, respectively. *Concur with clarification; this features was found to be navigationally insignificant and was generalized as a sounding during office processing.*

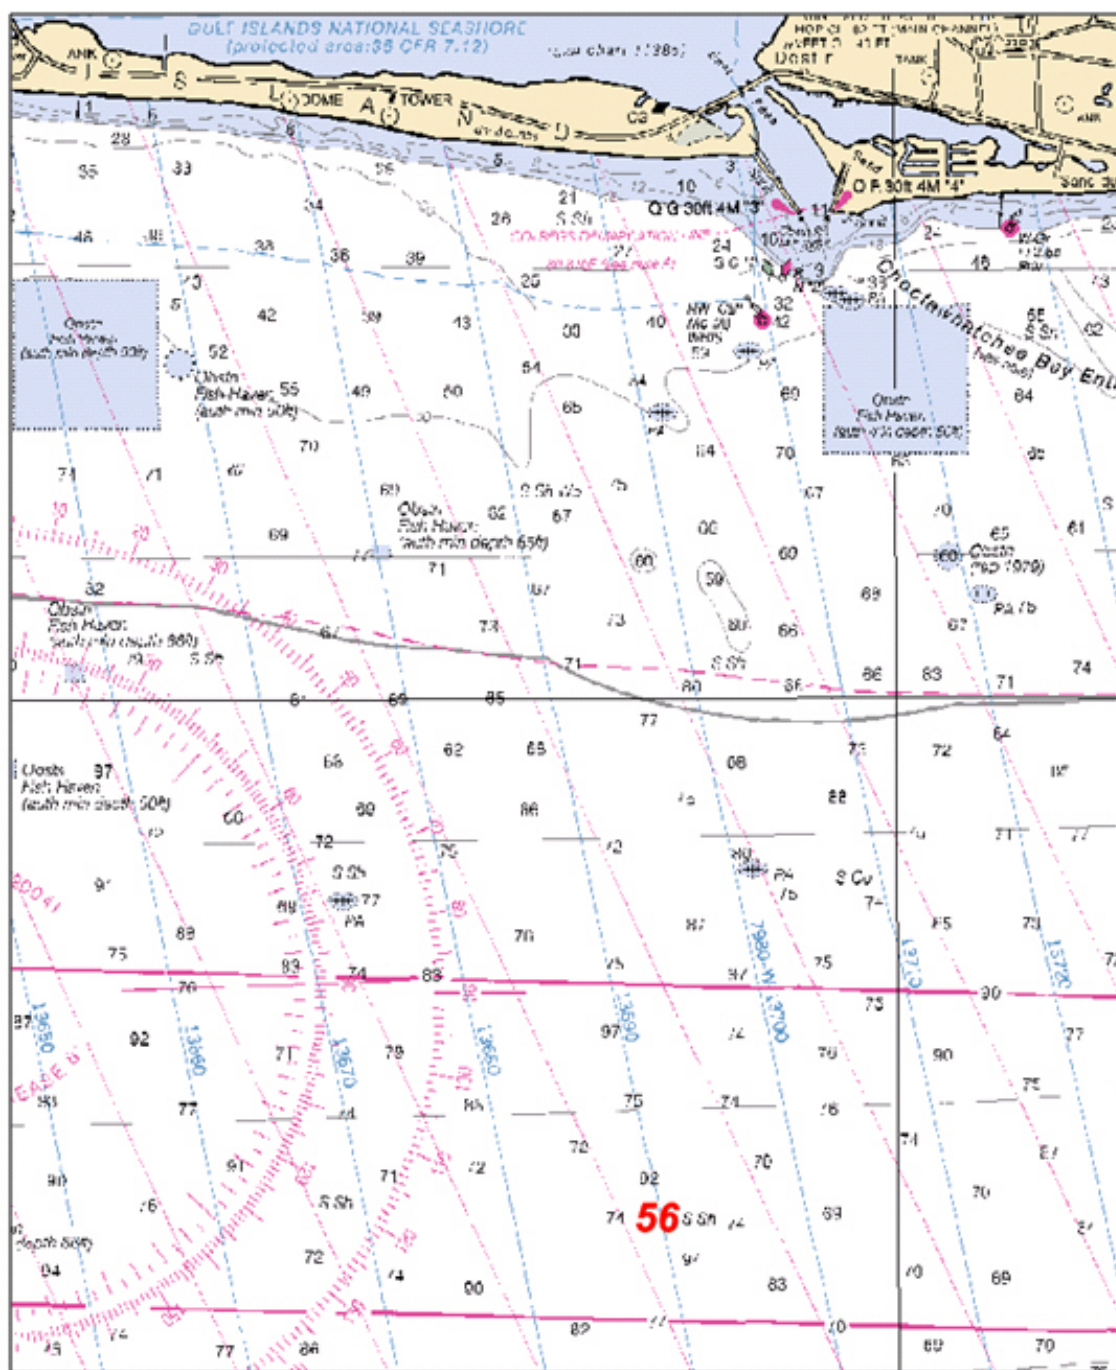
Figure 1.1.1

Figure 1. The position of the DtoN reflects the shoaler of the two obstructions, in reference to NOS RNC 11388. The surveyed sounding is in red and all depths are in feet.

Recommend charting 56ft Obstruction at the Latitude 30-16-55.03N and Longitude 86-31-38.12W.

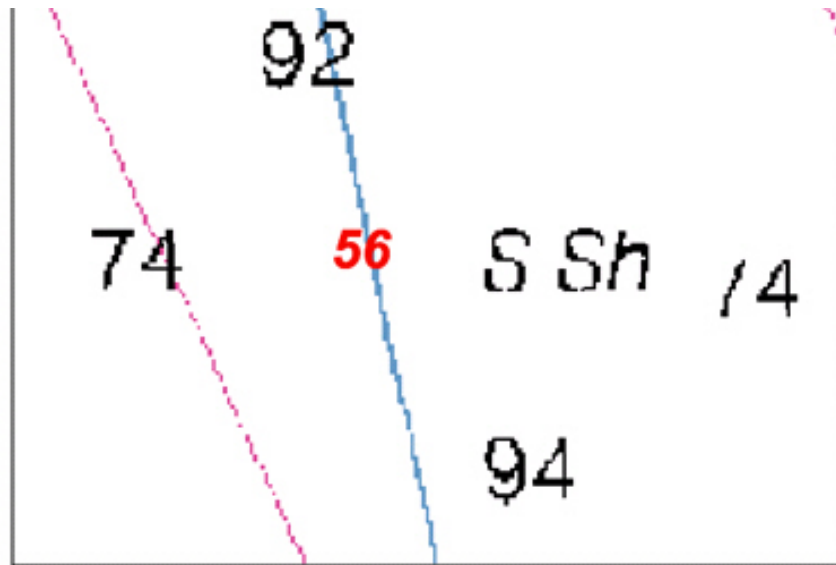
Figure 1.1.2

Figure 2. The least depth of the DtoN (red) is shown in relation to the surrounding charted depths from RNC 11388. All depths are in feet.

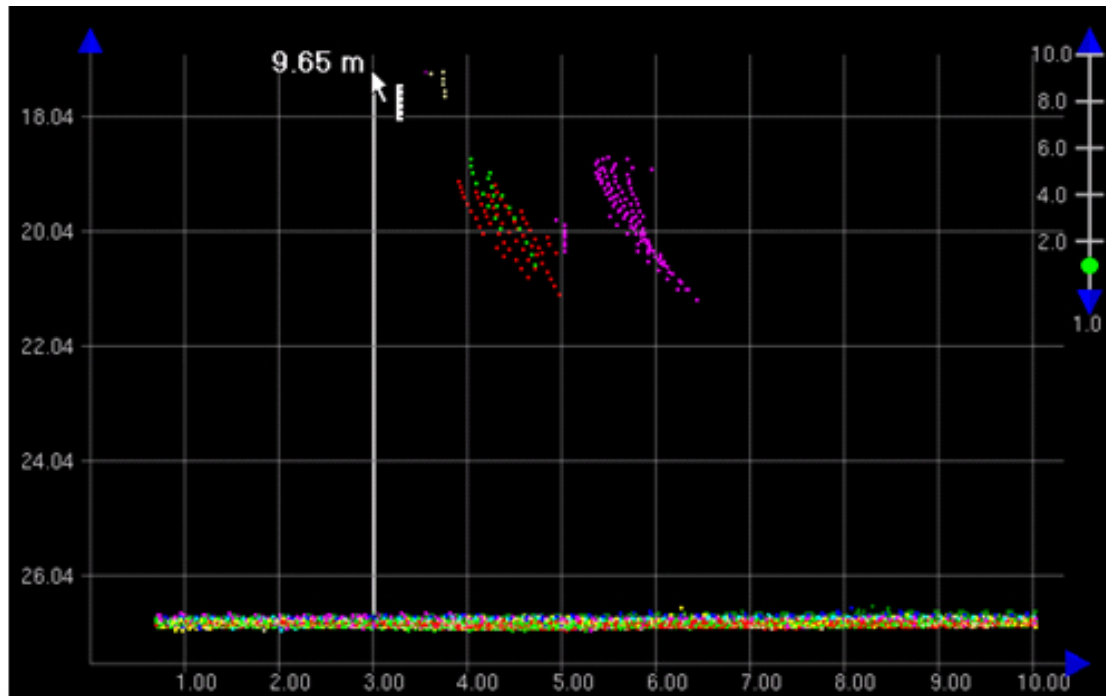
Figure 5. Northwest buoy displayed in CARIS Subset Editor 3D View. Soundings are colored by survey line and all units are in meters.

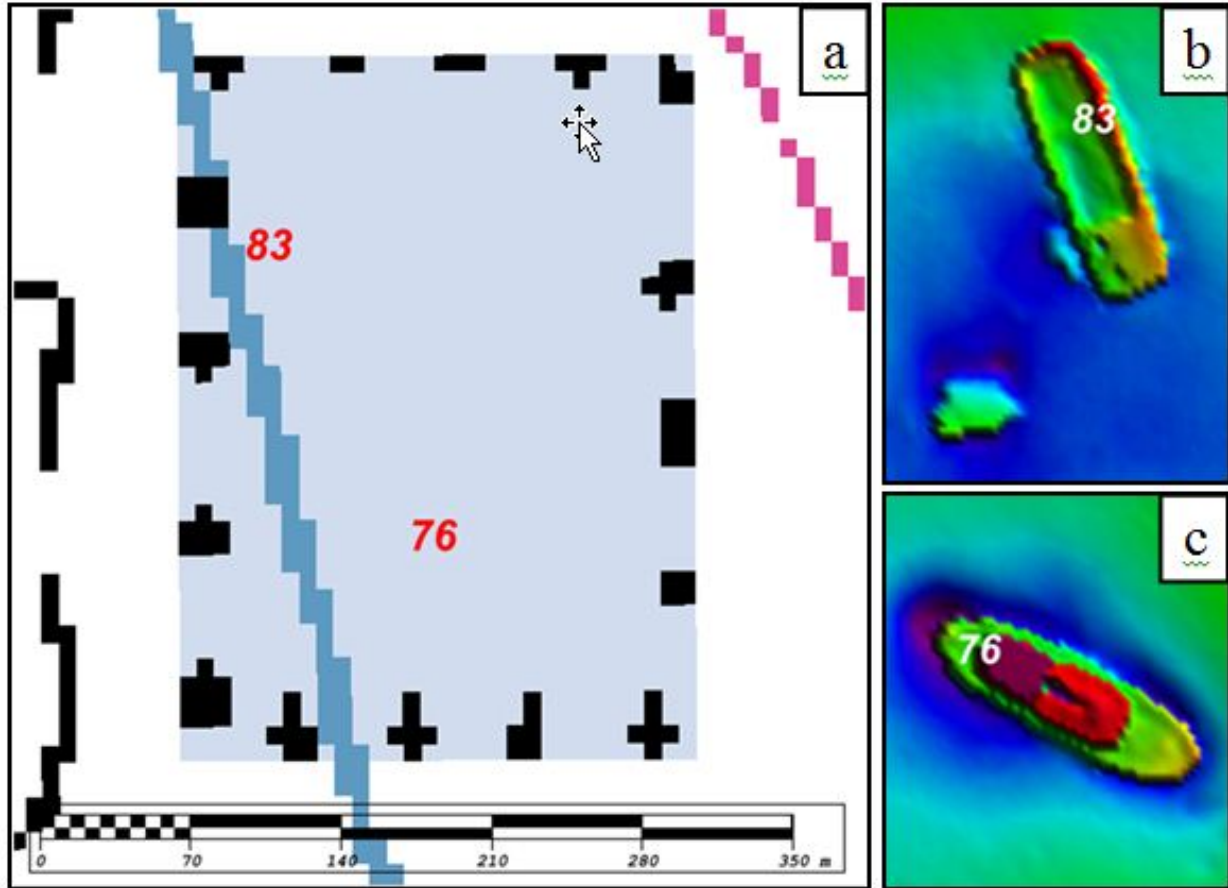
Figure 1.1.1

Figure 14. (a) Wreck least depth positions are shown in red in reference to the Obstin Fish Haven as charted on RNC 11388. Depths are in feet. (b) The northern wreck has a least depth of 83 feet. (c) The southern wreck has a least depth of 76 feet.

Wreck least depth is deeper than Obstn Fish Haven auth min depth of 50ft. It is recommended that the fish haven remains as charted.

Compile: 83 ft wreck is located in a charted fish haven with a least depth that is deeper than Obstn Fish Haven auth min depth of 50ft. It is recommended that the the Wk is not charted and the fish haven remains as charted.
