General Locality Columbia River

Sublocality Harrington Point to Three Tree Point

Descriptive Report to Accompany Hydrographic Survey H12276

Project OPR-N338-NRT3-10
Columbia River Harrington Point to
Three Tree Point Scale 1:10,000
October 2010 to January 2011
NOAA NRT-3 (S1212)

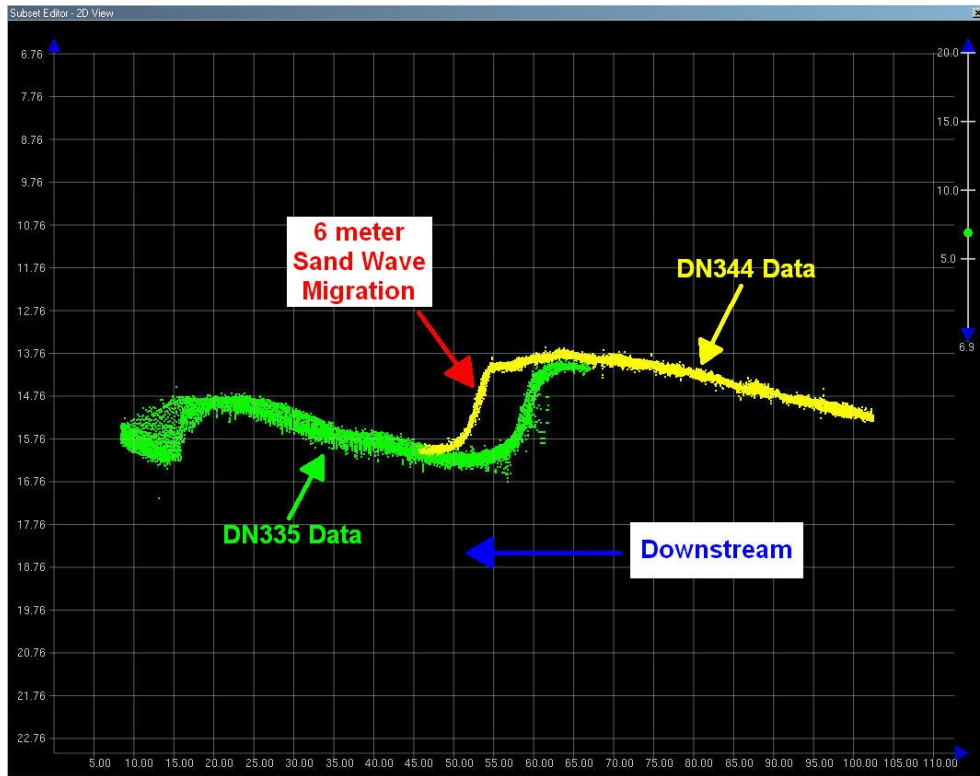
Due to the dynamic nature of the Columbia River, strong currents, significant sediment transport, sand wave migration and other related factors, data quality was adversely affected in some areas of the survey. The greatest evidence of this is found where overlapping data was acquired many hours to days apart, as with crosslines. For this reason, crosslines were not incorporated into BASE surfaces but were used for analysis. Figures 6 and 7 illustrate a six-meter horizontal offset and BASE surface artifacts caused by sand wave migration over a nine (9) day period.³

Figure 6: six-meter horizontal sand wave migration.

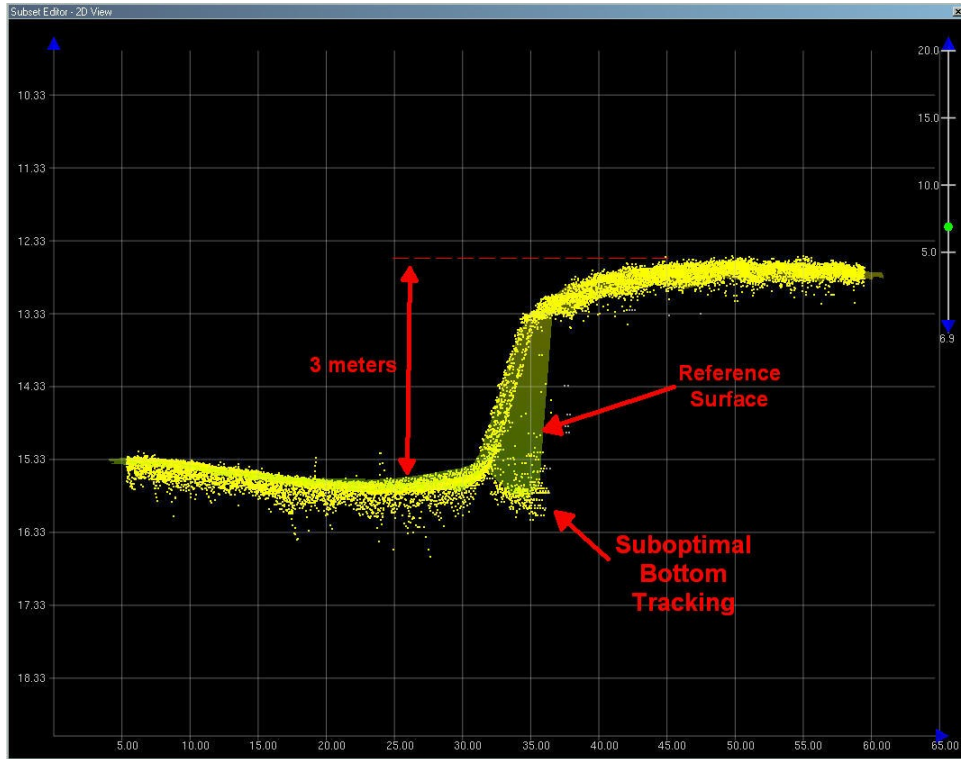
Occasional instances of suboptimal sonar bottom tracking were noted when acquiring data over the face of sand waves. Examined in CARIS 2D Subset Editor, “clouds” of soundings appear to deviate from the regular slope profile, misdirecting the BASE reference surface as shown in Figure 9. Where possible, the errant soundings were rejected resulting in an artifact free surface. In other cases, holidays resulted from rejecting these errant soundings; therefore they were reaccepted, resulting in artifacts as shown in Figure 10.

Figure 9: Subset editor view of suboptimal bottom tracking.

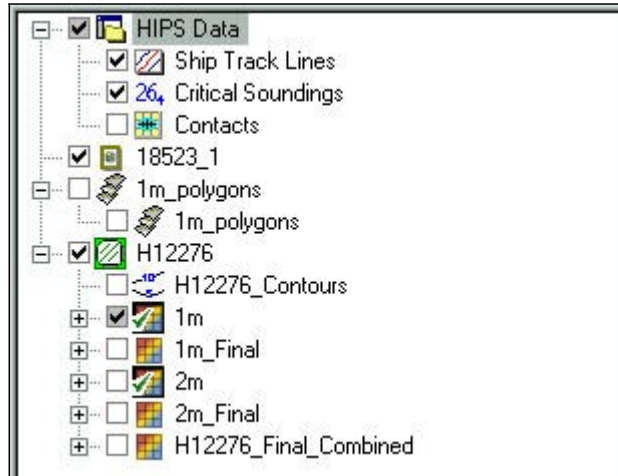
Figure 12: Field sheet and BASE surfaces submitted with H12276.

One field sheet, two single-resolutions, two finalized and one final combined CARIS BASE surface was created to process this survey.⁶ Final BASE surface resolutions and depth ranges were set according to Table 7 below. CUBE surfaces were processed using the file “CUBEParams_2010.xml” which is included with the data deliverables. The submission Field Sheet and BASE Surface structure are shown in Figures 11 and 12. Crosslines were not included in the creation of BASE surfaces but were used for analysis purposes.

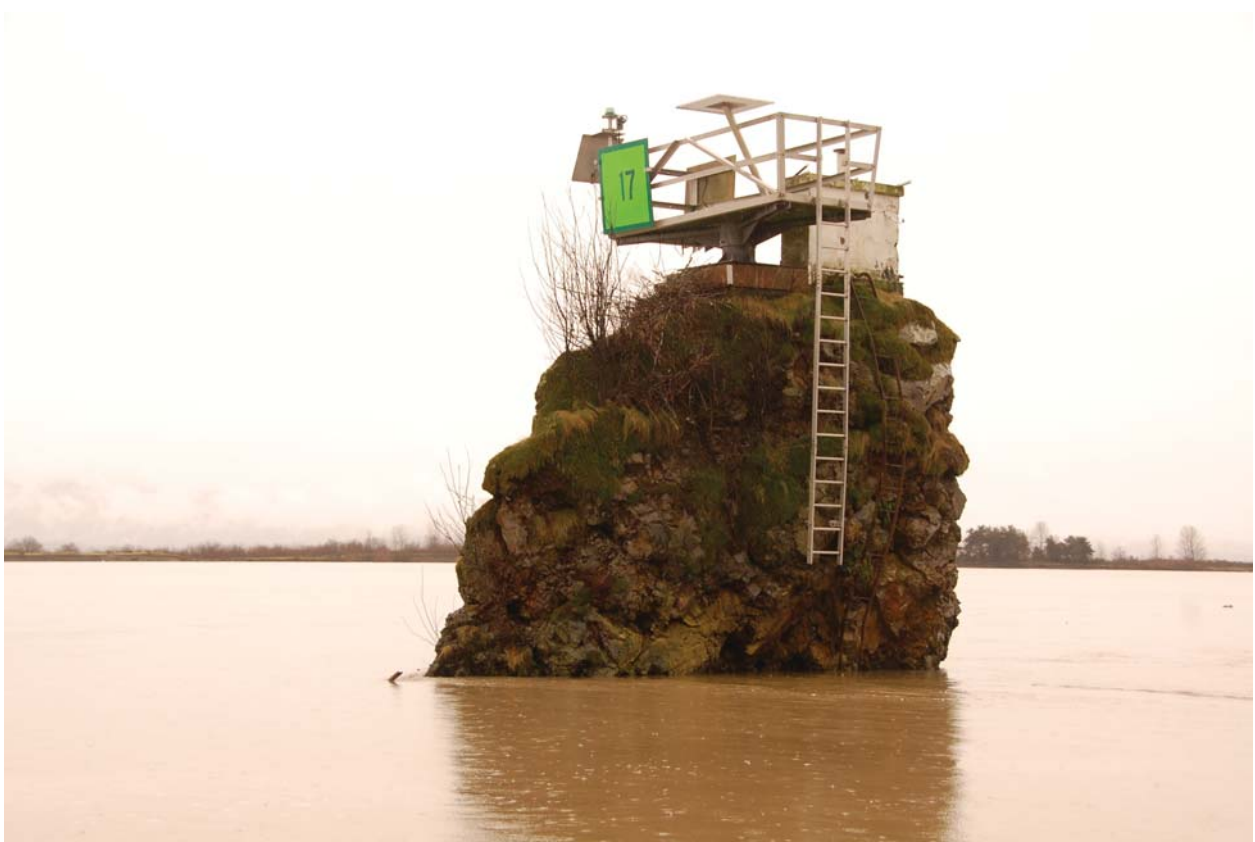
Figure 3.2.1

Geo object 1: Land area (LNDARE)
Attributes: SORDAT - 20110123
SORIND - US,US,survy,H12276
STATUS - 1:permanent
