H12285

**DESCRIPTIVE REPORT**

General Locality: Southern Chesapeake Bay

Sub-locality: Eastern Branch to Money Point

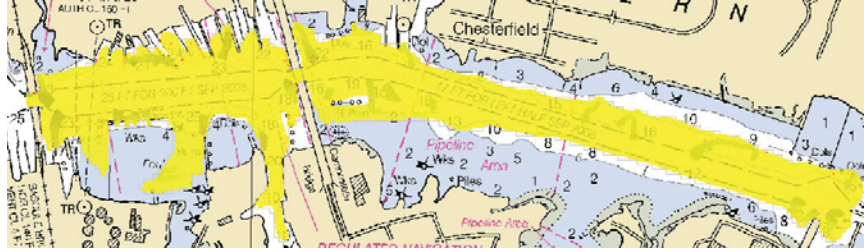
Figure 4: East \_Std\_Dev

A list of accepted cross lines can be found H:\Surveys\H12285\Descriptive Report\Separates\IV\_Crossline\_Comparisons. The images show standard deviation as Yellow less than 0.3m . Red greater than 0.3m 0.02% of the mainscheme multibeam soundings were greater than .3m. Vertical beam soundings that were were greater than .3m amounted to 0.06% The differences seen were attributed to slopes, ruins, obstructions and on-going dredging in the main channels.

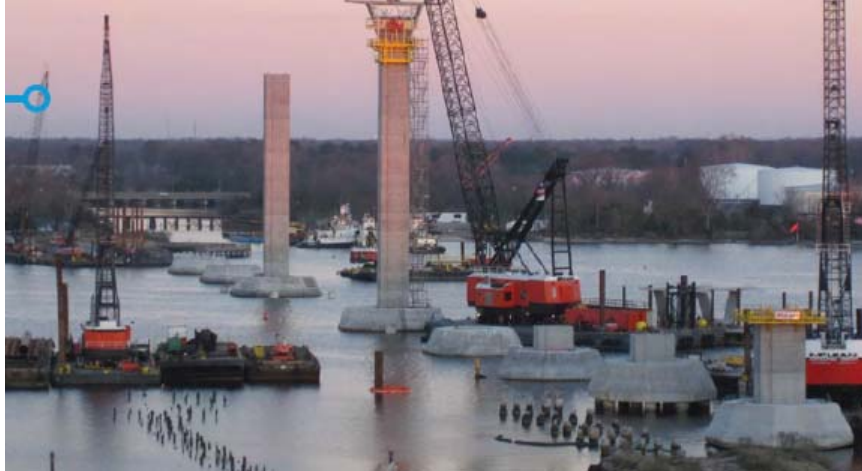
*Figure 13: Jordan Bridge*

The Jordan Bridge was removed and being rebuilt approximately 15 meters south of its original position. The location of the bridge supports on either side of the channel are further apart. The prescribed channel depth in the area may not show a true representation of the depths in this area. There may be future

relocation of the buoys marking the channel as construction continues. A notice should be made in Coast Pilot to use caution while transiting between these areas.

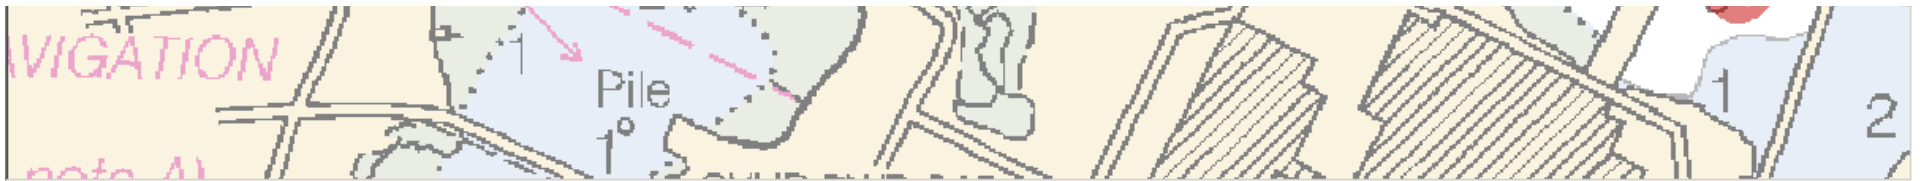
This is an overview of the channel in the Eastern Branch, showing its tabulated depth of 17ft. The multibeam grid coverage is divided into green for deeper than 17ft and red for shoaler than 17ft.

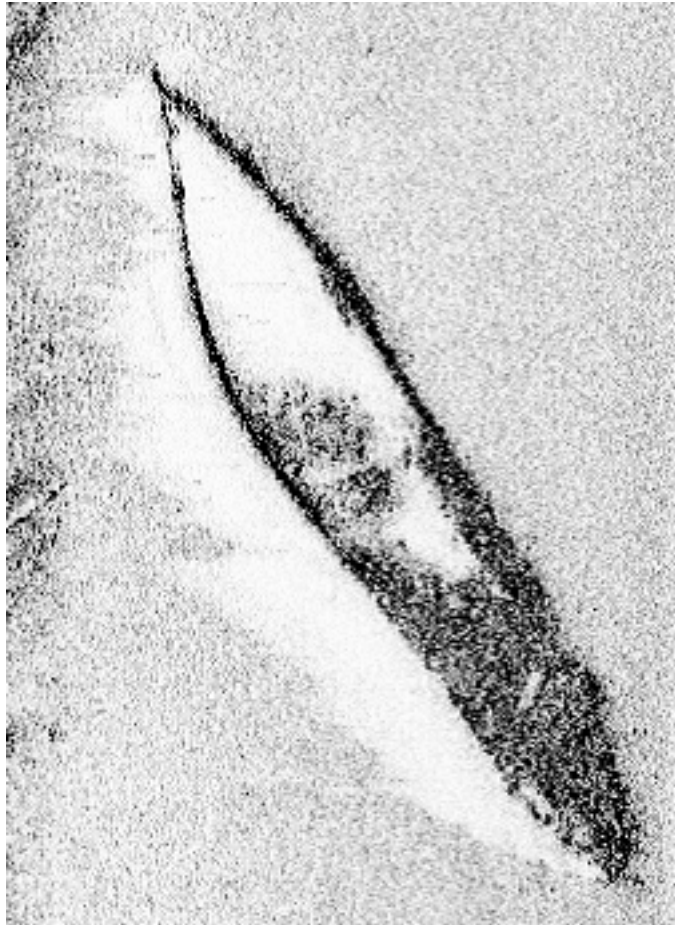
*Figure 2.1.1*

SAR: Feature located at survey position with sidescan sonar. Compile: Add wreck with depth unknown.

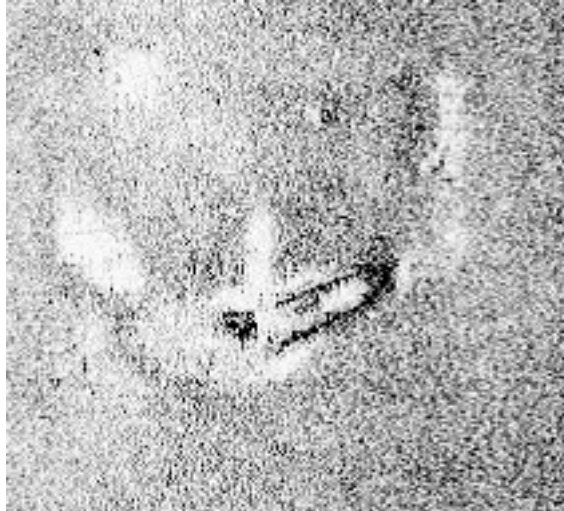
Figure 2.2.1

SAR: Feature located at survey position with sidescan and multibeam sonar. Compile: Add wreck.

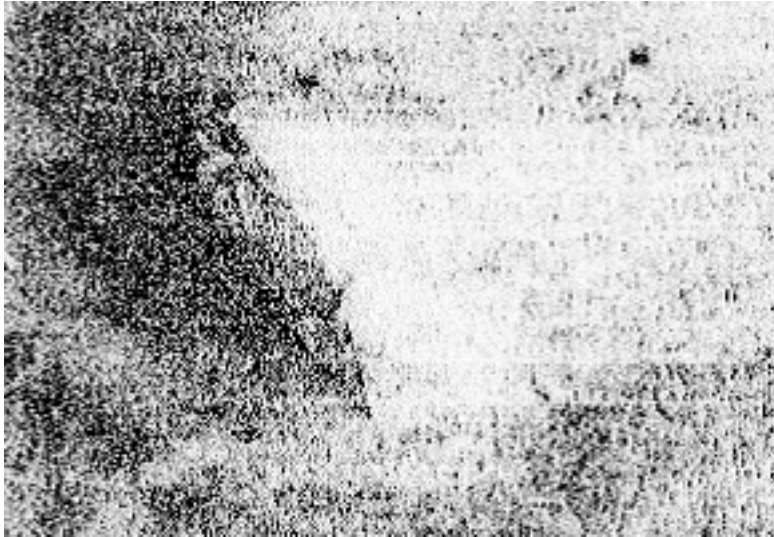
*Figure 2.3.1*

SAR: Feature located at survey position with sidescan sonar. Compile: Add wreck with depth unknown.

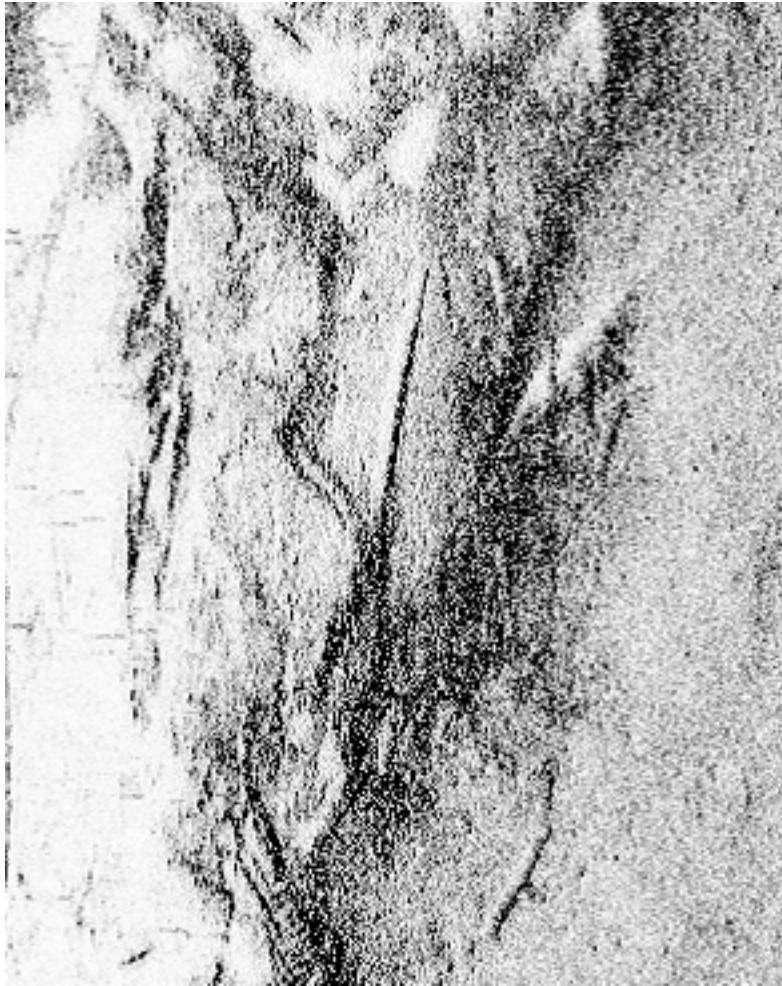
Figure 3.5.1

SAR: Scattered debris is present but does not have significant shadow height, nor does the SSS and MB data provide evidence of a wreck. Charted symbology extents not fully ensonified with multibeam. Recommend to retain. The wreck may be sunken into the river sediment with no clear identification of wreck. Compile: Add distributed remains of wreck.

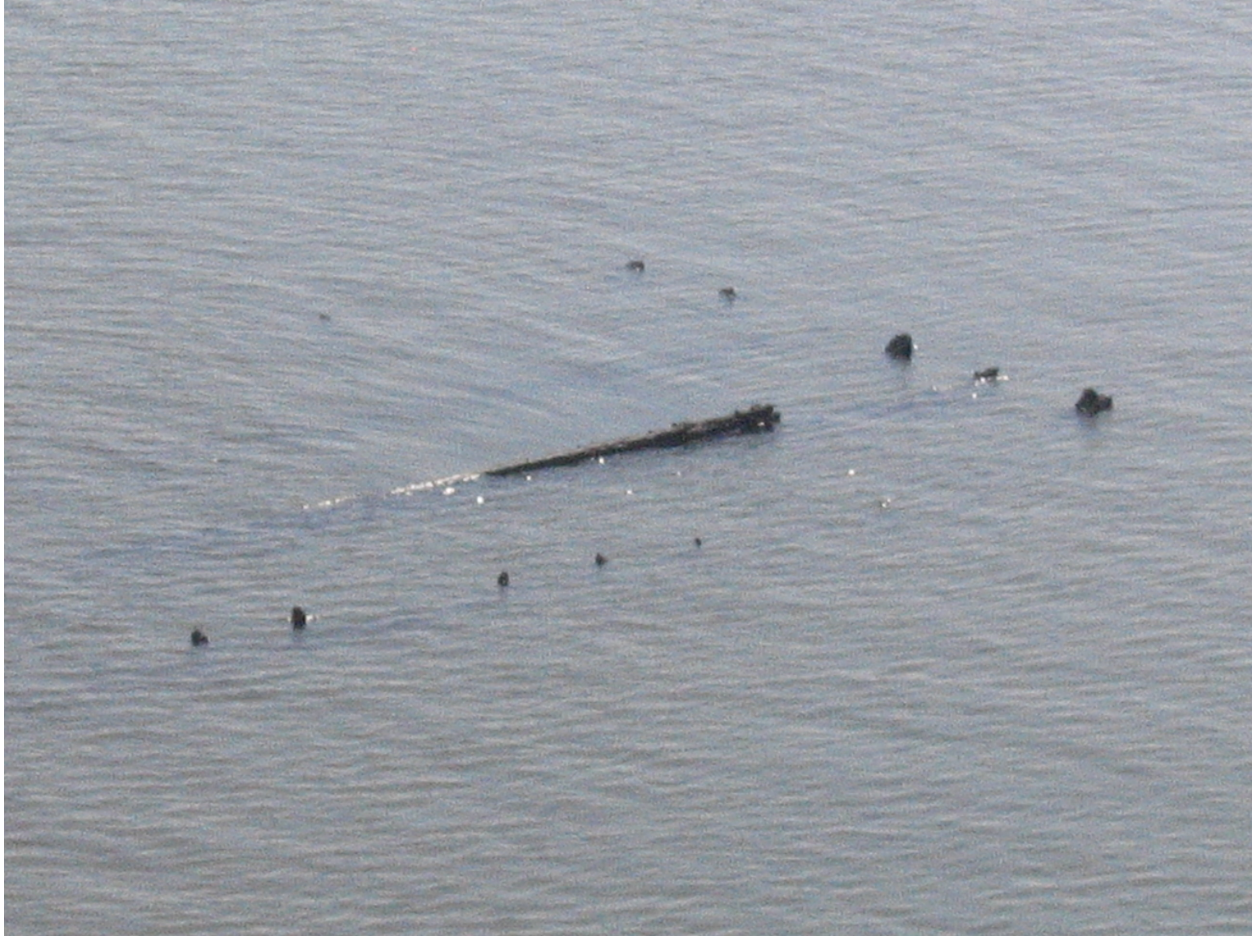
*Figure 3.7.1*

WRECKS/remrks: Wreck observed cover uncovers

SAR: Feature located at survey position with sidescan sonar and digitized based on sidescan imagery.  
Compile: Add wreck.

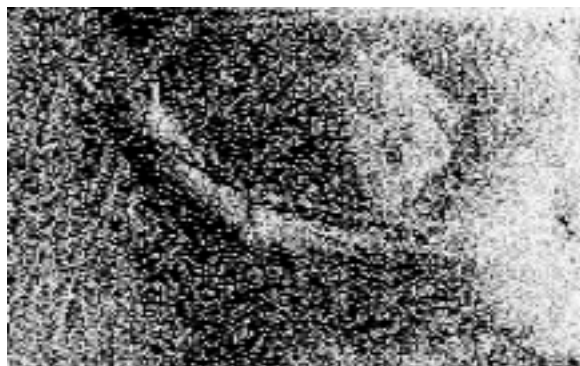
Figure 4.3.1

OBSTRN/remrks: Obstn found

SAR: Feature located at survey position with sidescan and multibeam sonar. Compile: Add obstructions.

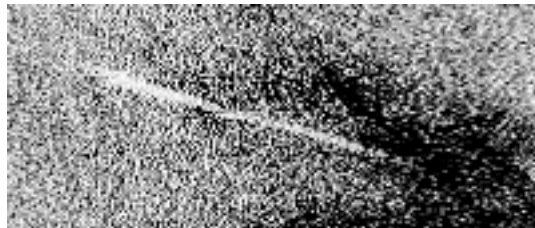
Figure 4.4.1

SAR: Feature located at survey position with sidescan and multibeam sonar. Compile: Add obstruction.

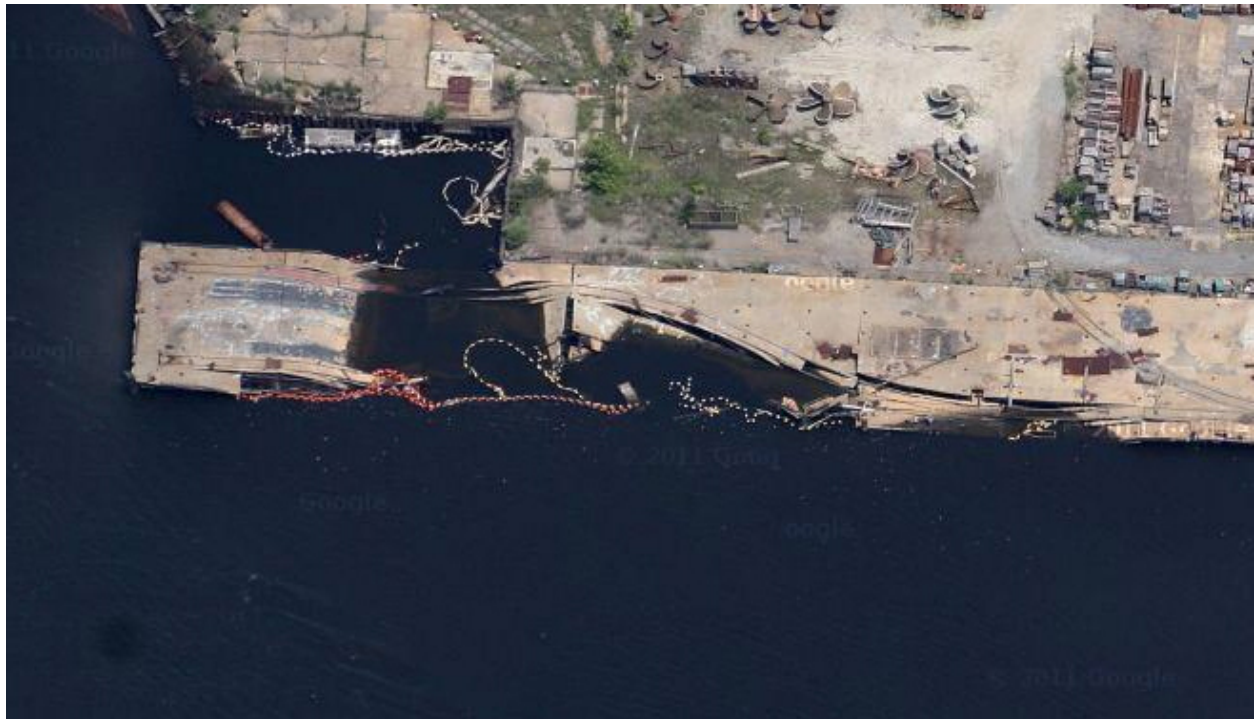
Figure 4.5.1

SAR: Feature located at survey position with sidescan and multibeam sonar. The survey feature is offshore and seaward of a collapsed bulkhead. Compile: Add obstructions.

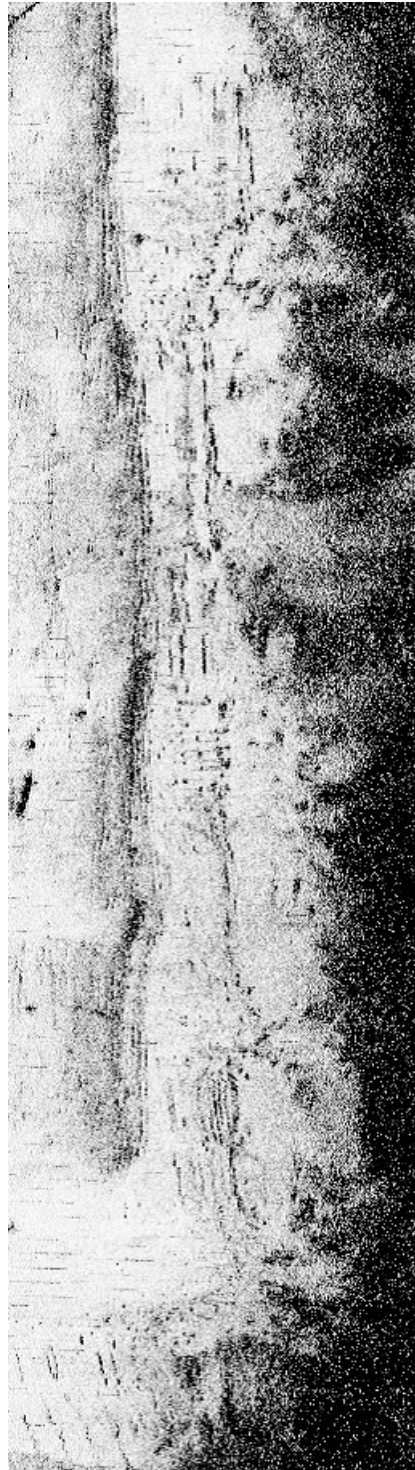
Figure 4.8.1

SAR: Feature located at survey position with sidescan and multibeam sonar. Compile: Add pier in ruin.

Recommend expanding the ruins.

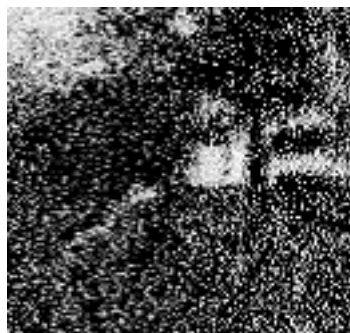
Figure 4.9.1

SAR: Feature located at survey position with sidescan and multibeam sonar. Possible bridge construction debris. Compile: Add obstruction.

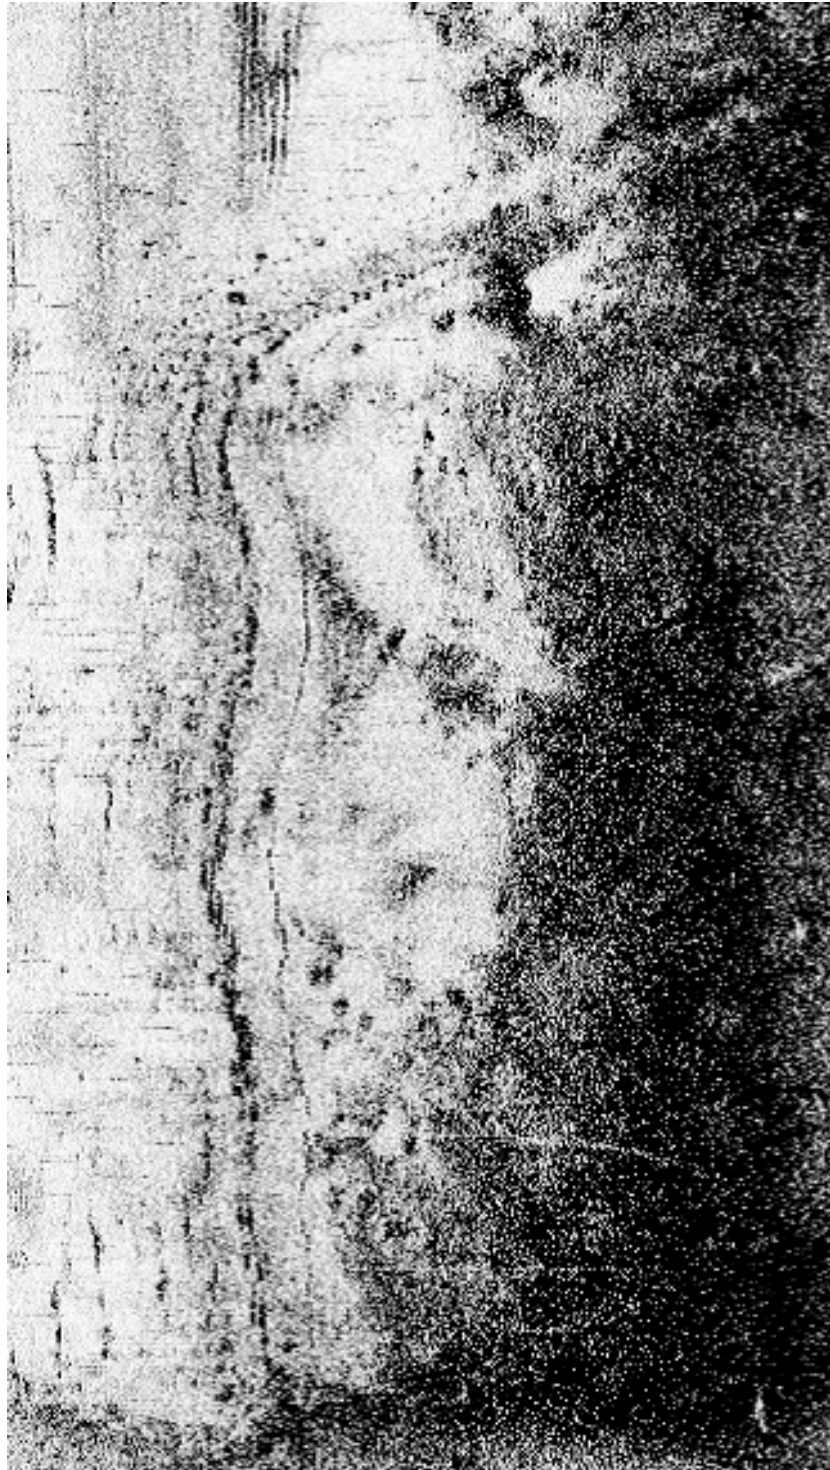
Figure 4.10.1

SAR: Feature located at survey position with sidescan and multibeam sonar. Compile: Add pier in ruin.

Recommend expanding the ruins

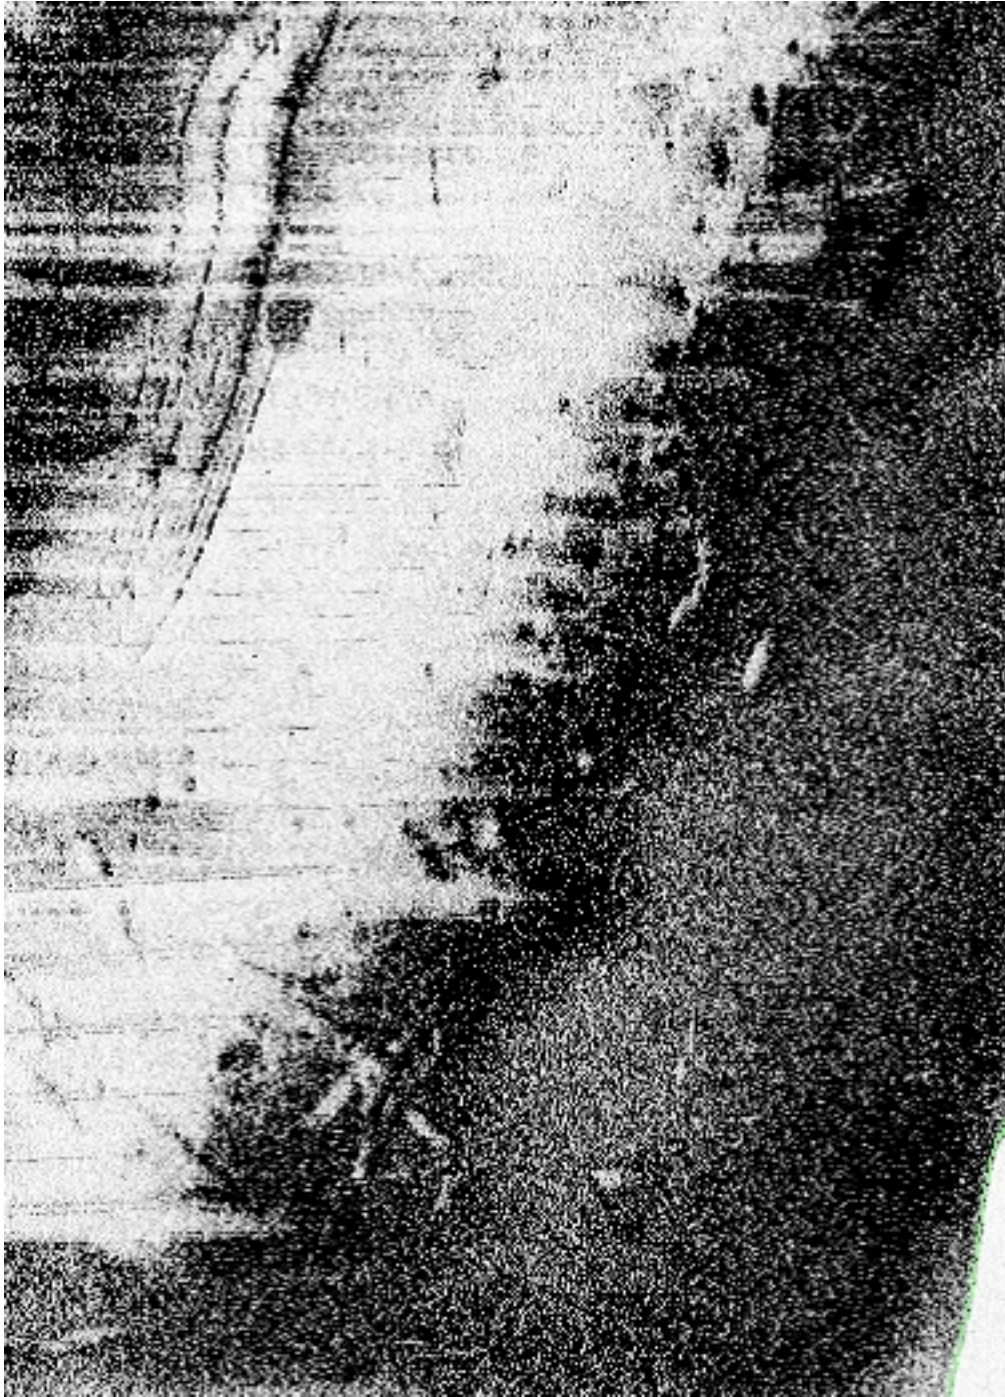
Figure 4.12.1

SAR: Feature located at survey position with sidescan and multibeam sonar. Compile: Add pier in ruin.

Recommend adding ruins.

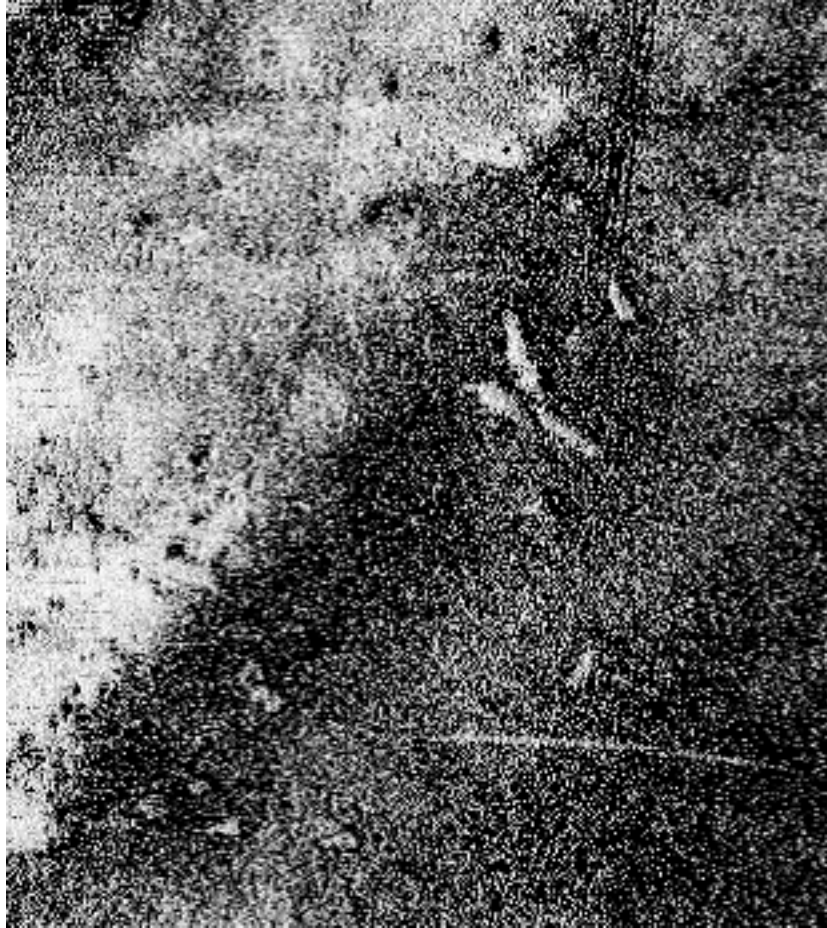
Figure 4.14.1

SAR: Feature located at survey position with sidescan and multibeam sonar. Compile: Add pier in ruin.

Recommend adding ruins.

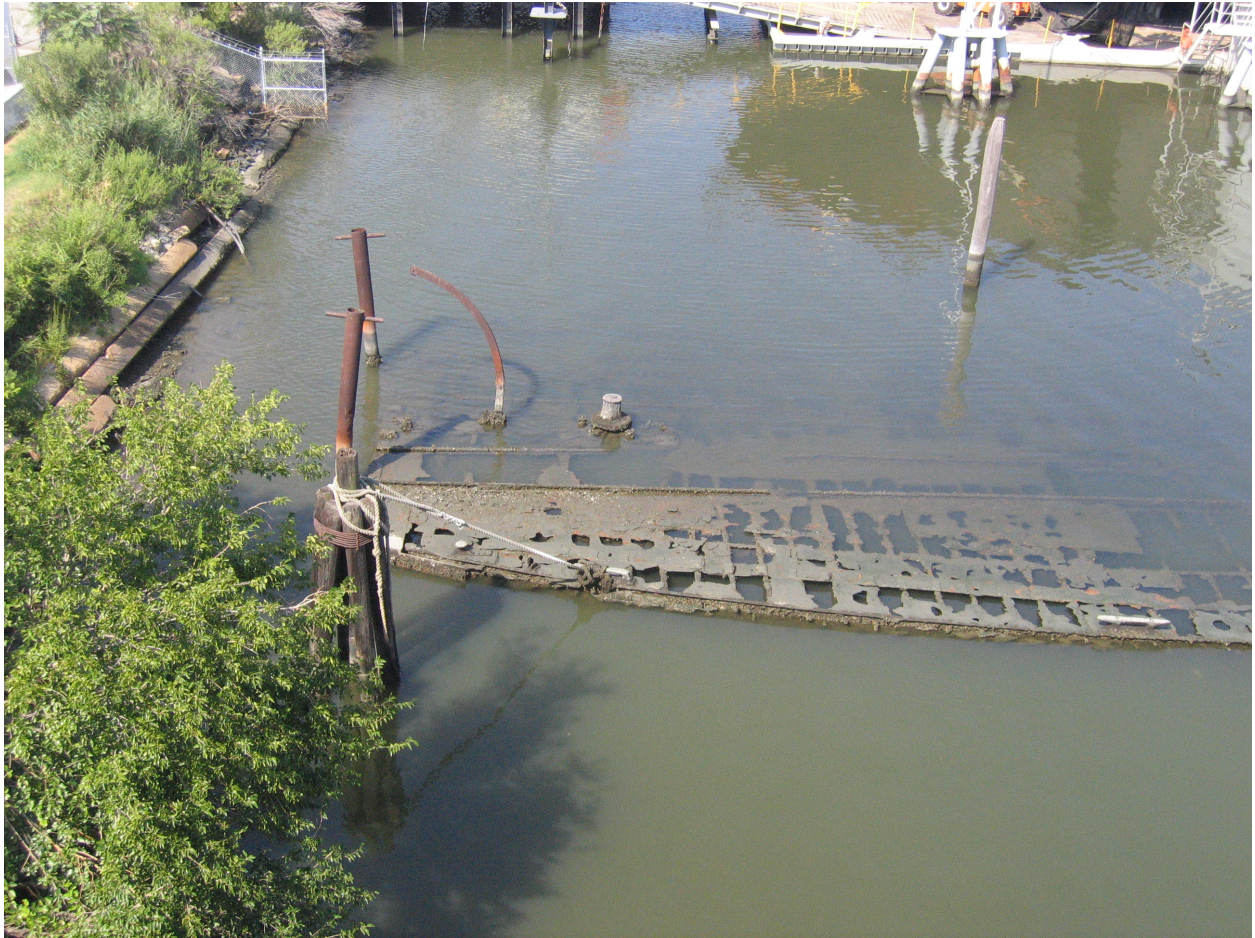
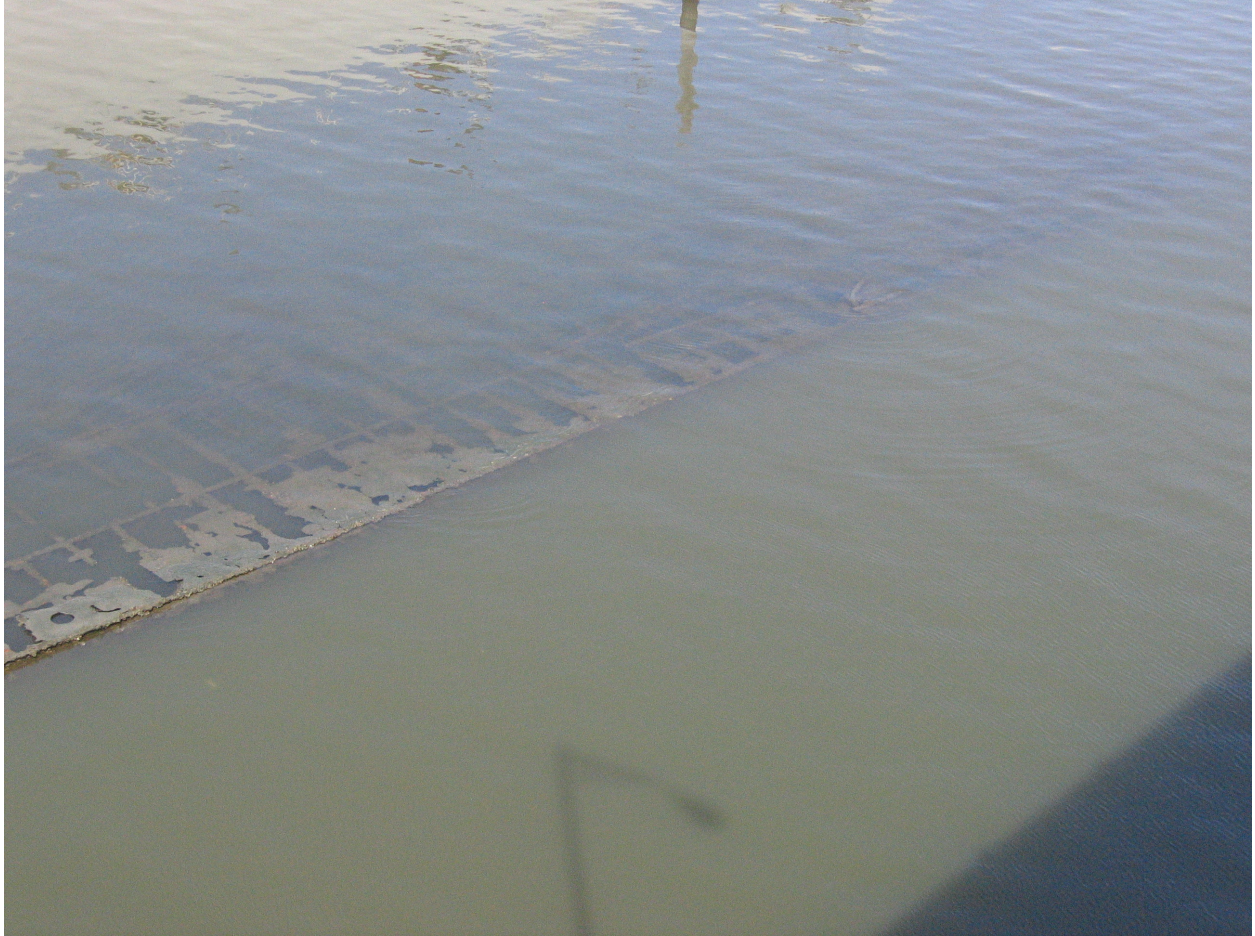
Figure 4.16.1

WRECKS/remrks: End of Wk found below surface, portions of Wk on south side are exposed 2.0m above MLLW

Add wreck.
