DESCRIPTIVE REPORT

Type of Survey: Navigable Area

Registry Number: H12317

Sub-locality: Ouzinkie Harbor to Southern Portion of Marmot Bay

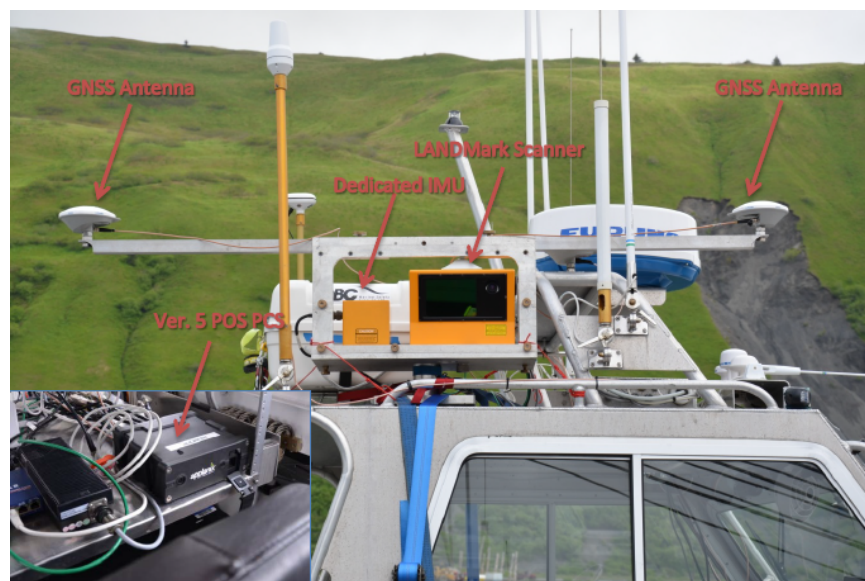
Figure 2: Launch 2808 With Mounted LANDMark Marine Laser Scanner

A LANDMark Marine Laser Scanner was mounted on survey launch 2808 to gather point cloud data of shoreline features while concurrently acquiring multibeam data. The mounting configuration for the laser scanner is illustrated in Figure 2. For more specific information refer to Applannix LANDMark Marine Test Report prepared by Physical Scientist Grant Froelich of Pacific Hydrographic Branch and included in Appendix V of this report.

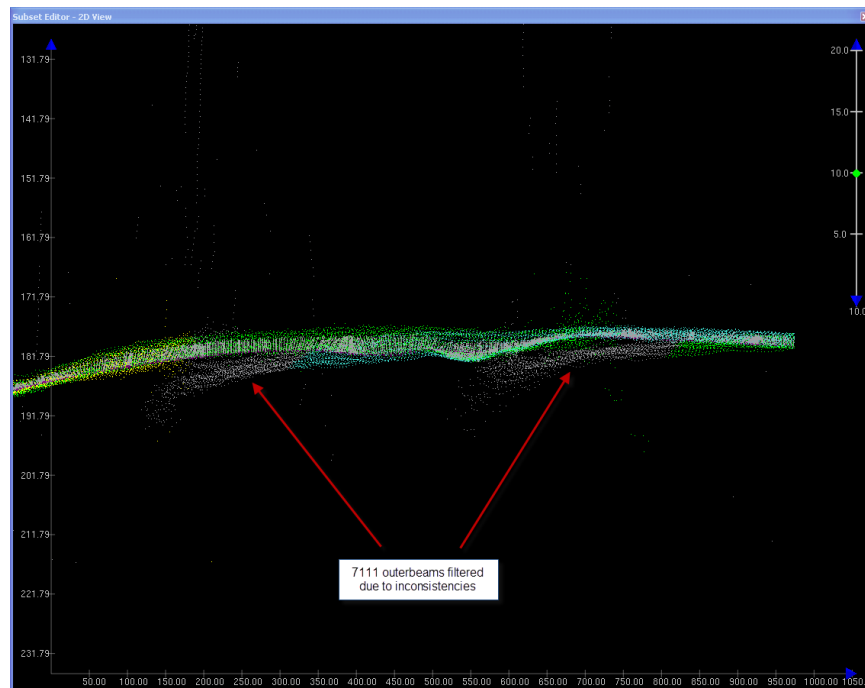
Figure 9: RESON 7111 data on sheet H12317 displayed using CARIS Subset Editor with a vertical exaggeration of 10.

Data acquired on sheet H12317 with the RESON 7111 system installed on Fairweather S220 displayed occasional inconsistencies. In particular the outermost RESON 7111 beams frequently had characteristics that did not agree with other overlapping data. For this reason all survey lines conducted using the RESON 7111 were filtered to exclude data outside nadir by more than 68 degrees on both the port and starboard sides of the swath. Filtering of this nature did result in some coverage gaps. To minimize these gaps some filtered data was re-accepted after close inspection in CARIS HIPS Subset mode. An example of the 7111 outerbeam issue is pictured in Figure 9.

Data is adequate for charting.

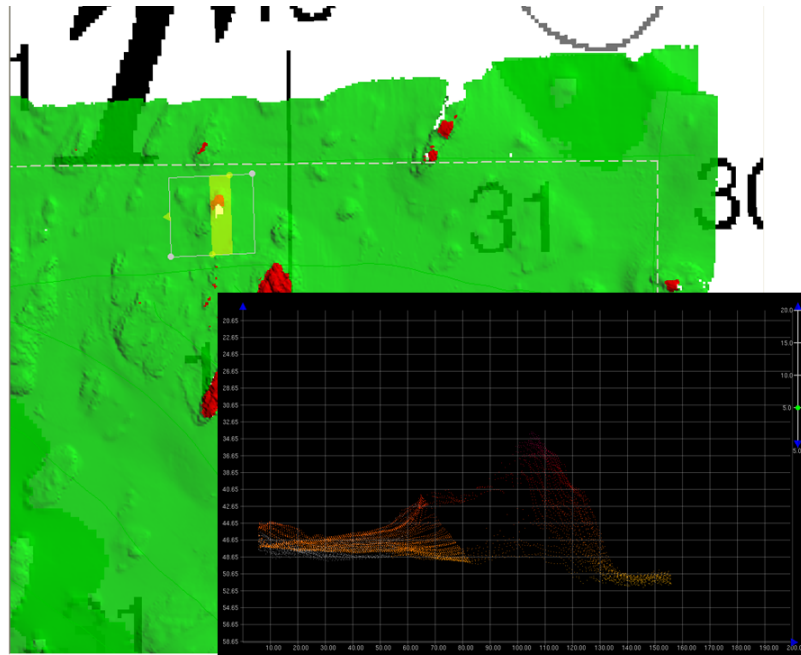
Apparent holidays found on sheet H12317 are depicted in Figures 12 through 15.

Figure 12: Holiday in the NE corner of sheet H12317

Figure 13: Holiday in the NE corner of sheet H12317

Figure 14: Holiday in the NE corner of sheet H12317

Figure 15: Holiday existing E of North Cape

Data is adequate for charting.

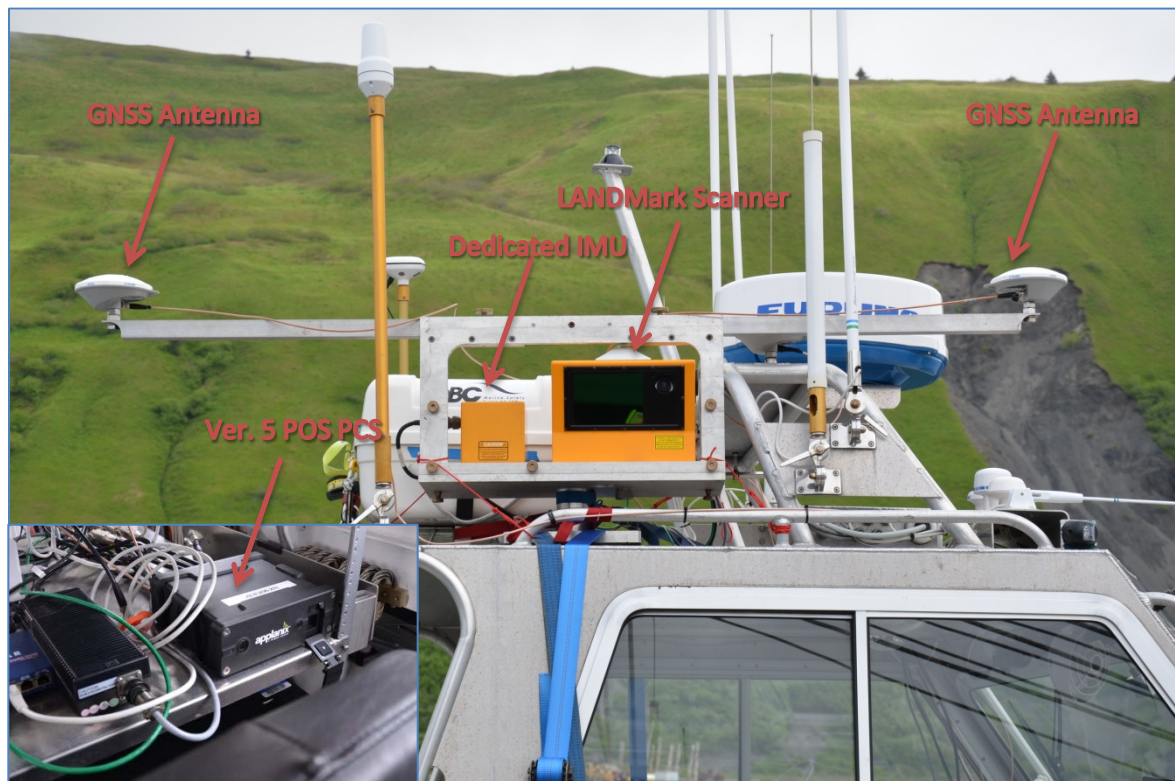
Figure 1. LANDMark Laser installed on 2808

On the weekend of July 17th-19th, Bruce Francis from Applanix, LT Matthew Jaskoski, ENS Steven Loy and I installed and tested the Applanix LANDMark Marine Laser Scanner on *Fairweather* Launch 2808 during the Kodiak inport. The installation began on Saturday afternoon and consisted of assembling and mounting the prefabricated mounting platform to the cabin roof of 2808, installing the dedicated IMU and GNSS antennae to the mounting platform, installing the laser, and installing two POS PCS systems (see Figure 1). The laser itself is mounted with only a single bolt through the bottom. The second PCS was a backup for the primary PCS system which was a new Version 5 PCS being tested. Installation of the hardware was completed in less than two hours. Installation and configuration of the software to account for a starboard side mount took an additional couple of hours. The system was completely installed and troubleshot by Sunday morning, giving ample time to train operators on how to collect data.

For a permanent installation, the additional GNSS antennae, IMU and PCS would not be needed. The existing POS MV systems could be utilized once the offsets between the laser and the IMU are determined.

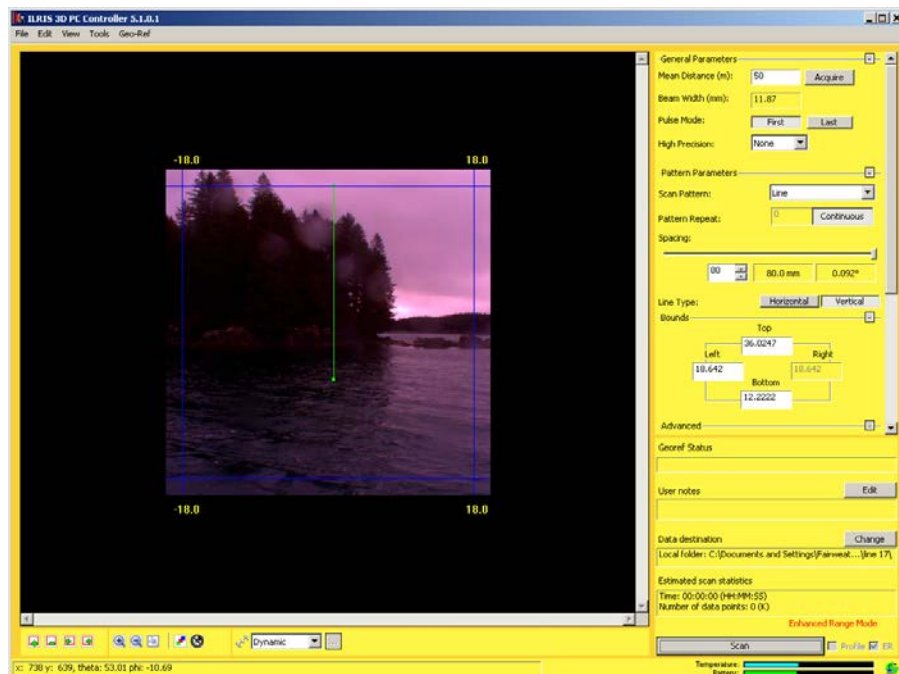
Figure 2. Screenshot of LANDMark logging software.

The LANDMark system was very easy to learn. The logging software was contained in a single window with minimal configuration settings (see Figure 2). Setting up the logging software consisted of 6 one mouse click steps, which could be skipped if you saved your settings previously. Logging data consisted of two clicks. The simplicity of the logging software had both advantages and disadvantages. While it was extremely easy to learn and to then teach operators, it provided almost no information in real time about the data being collected other than a counter that showed the number of data points collected so far. There was no indication if the feature of interest had been completely captured until the data was processed later in the evening. While a Hypack driver exists to show the laser data in real time as a Side Scan channel, this was not able to be tested on 2808 due to fears of corrupting the 7125 MBES data being collected concurrently. A similar driver exists for QPS' QINSy and the Reson PDS2000 logging software. While having these 3rd party drivers available is a plus, the native logging software should be able to display the laser returns in a similar fashion to the sonar wedges found in MBES logging software provided by manufacturers such as Reson or Kongsberg in order to provide real time quality assessment and ensure features of interest are being completely captured.

Note: The image shown in the middle is static and is not updated after the initial scan occurs.

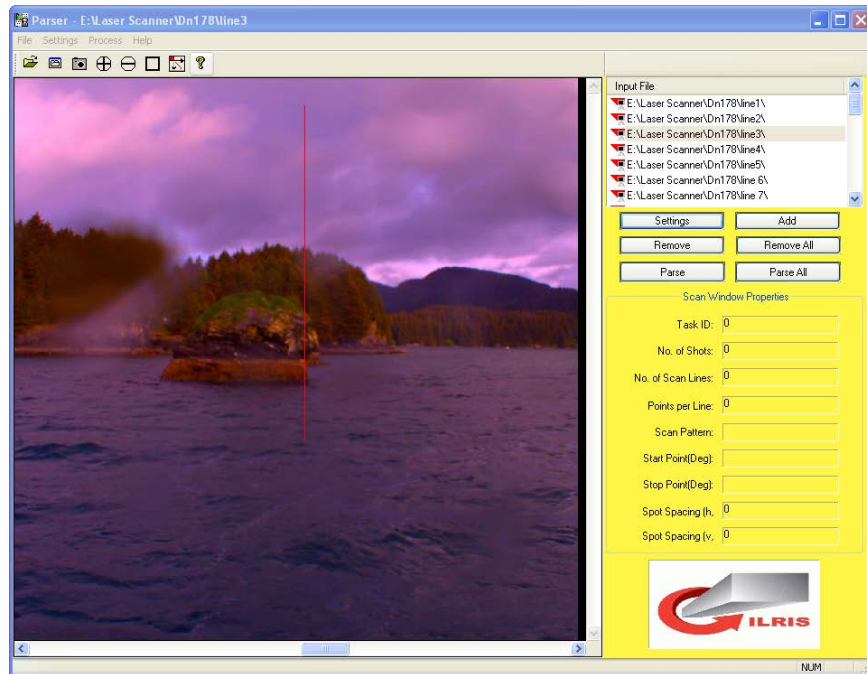
Figure 3. Screenshot of processing software

Processing the data was also very easy to learn. Again, this was mostly due to the spartan nature of the software (see Figure 3). The raw laser files were added to a queue, an SBET referenced to the laser location was selected to provide georeferencing, and an output format with selected messages was chosen. The raw files were converted to an ASCII XYZ format with GPS Time, Easting, Northing, Elevation and 8-bit Scaled Intensity values. The parsing to XYZ was very quick usually lasting seconds to minutes for each line collected. The XYZ files were then imported in Bathy DataBase as a CSAR point cloud using a custom .info file created for this project. The .info file was created using the BDB_Information_File_Editor.exe program available at CARIS' support website. This process was equally as fast as the parsing of the raw file to XYZ, usually lasting seconds to minutes for each line.

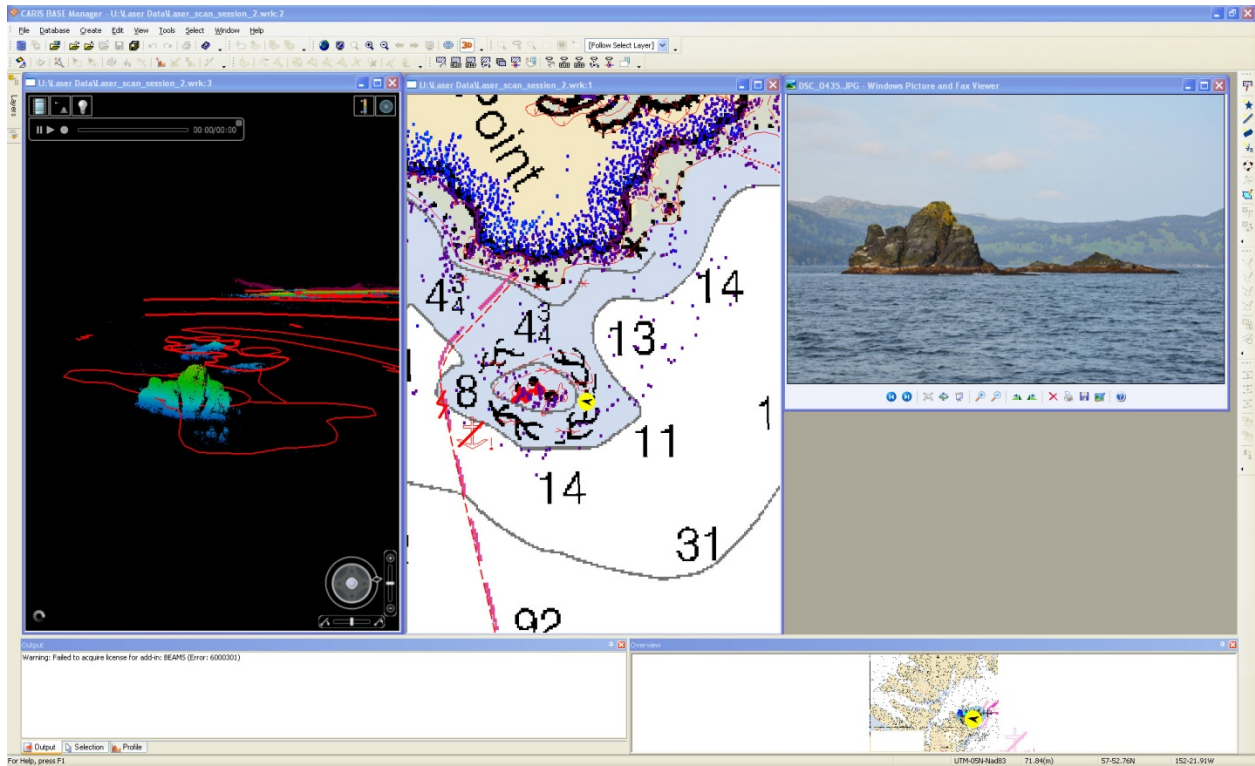
Figure 4. Using 3D mode with a georeferenced photo to examine data. Photo is being displayed in Windows Picture and Fax Viewer, not in Bathy DataBASE.

This is where the geotagged photos proved to be absolutely indispensable. While the point cloud data was extremely dense, it was sometimes difficult to recognize what a feature was without a photo providing some additional data. This was often true of features near the shoreline that were grouped with other features.

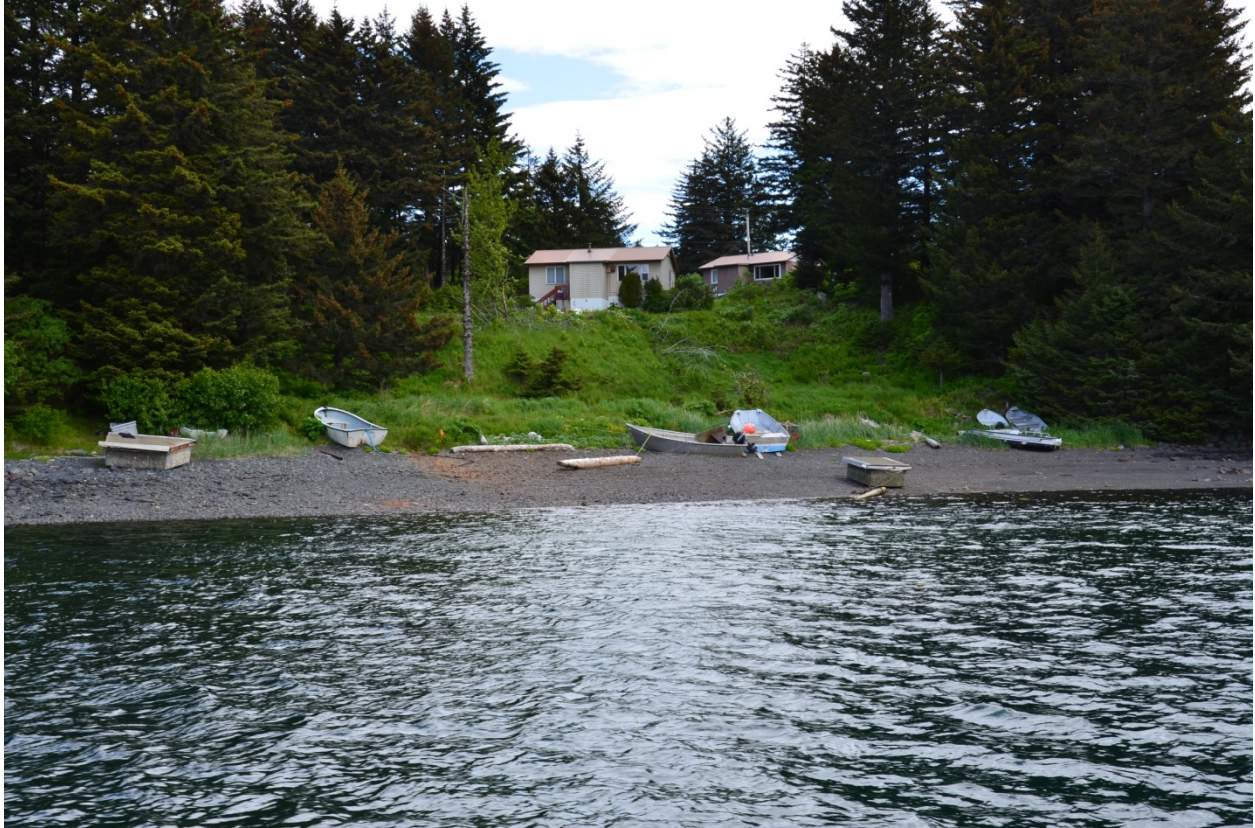
Viewing the data colored by intensity was also helpful in determining features. In some areas you could only tell the difference between points when viewed in this way. On a stretch of beach in Ouzinke Harbor there are many boats, kayaks and square plastic totes hauled up on the beach. While not navigationally significant, it was difficult to determine what they were without the help of the pictures and coloring by intensity (see Figures 5 & 6).

Figure 5. Photo of hauled out boats, kayaks and plastic totes

Figure 6. 3D mode view of laser data colored by intensity looking down at same area as Figure 5

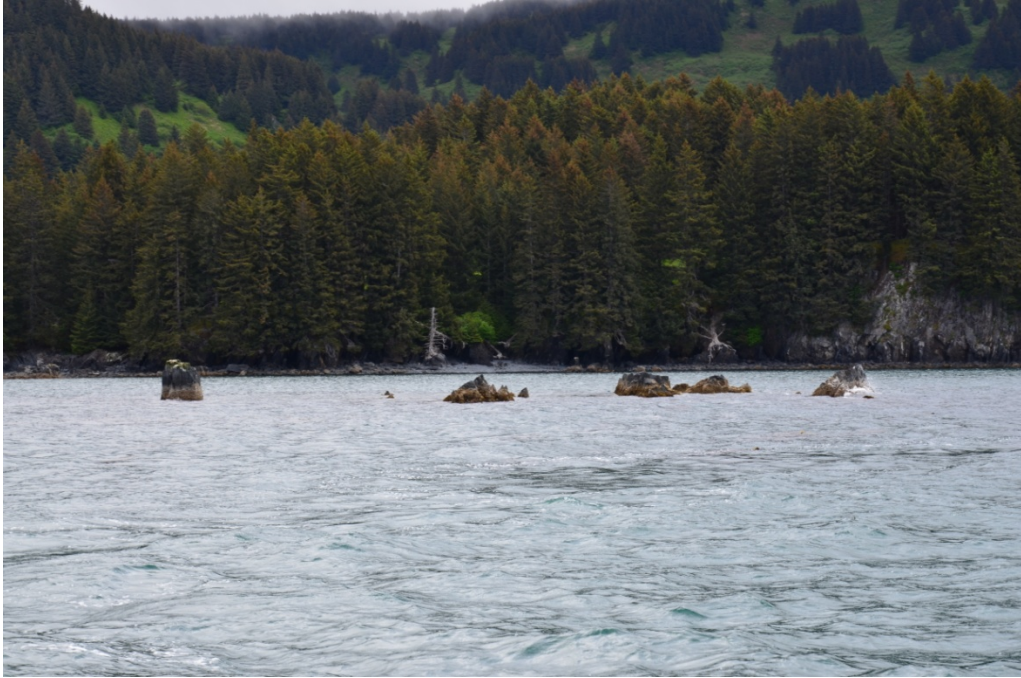
While there were many examples found during this test, the best example of how valuable this data could be was a navigationally significant rock cluster south of Sunny Cove. It is depicted on the RNC as a Dangerous Underwater Rock with Uncertain Depth and two ink blobs resembling land areas (see Figure 7). In reality it is very different looking with four distinct rock clusters; with the northwestern-most rock being the highest (see Figure 8). The laser data clearly shows all the rocks, even some hidden from view in the photo and provides coordinates for the high points and extents, which vary greatly from the chart (see Figures 9 & 10). Traditional shoreline methods resulted in retaining the center and eastern rock but with no additional height information. The northwestern-most rock was not addressed. Spending no additional time in the field and staying at a safe stand-off distance the laser data was able to determine least depths and extents for the charted center rock and the two outer charted rocks could be disproved.

Figure 7. RNC depiction of rock cluster south of Sunny Cove

Figure 8. Photo of rock cluster looking north

Figure 9. 3D mode view of laser data of rock cluster

Figure 10. Laser data in 3D mode with ENC positions of rock cluster and traditional shoreline evaluation of features

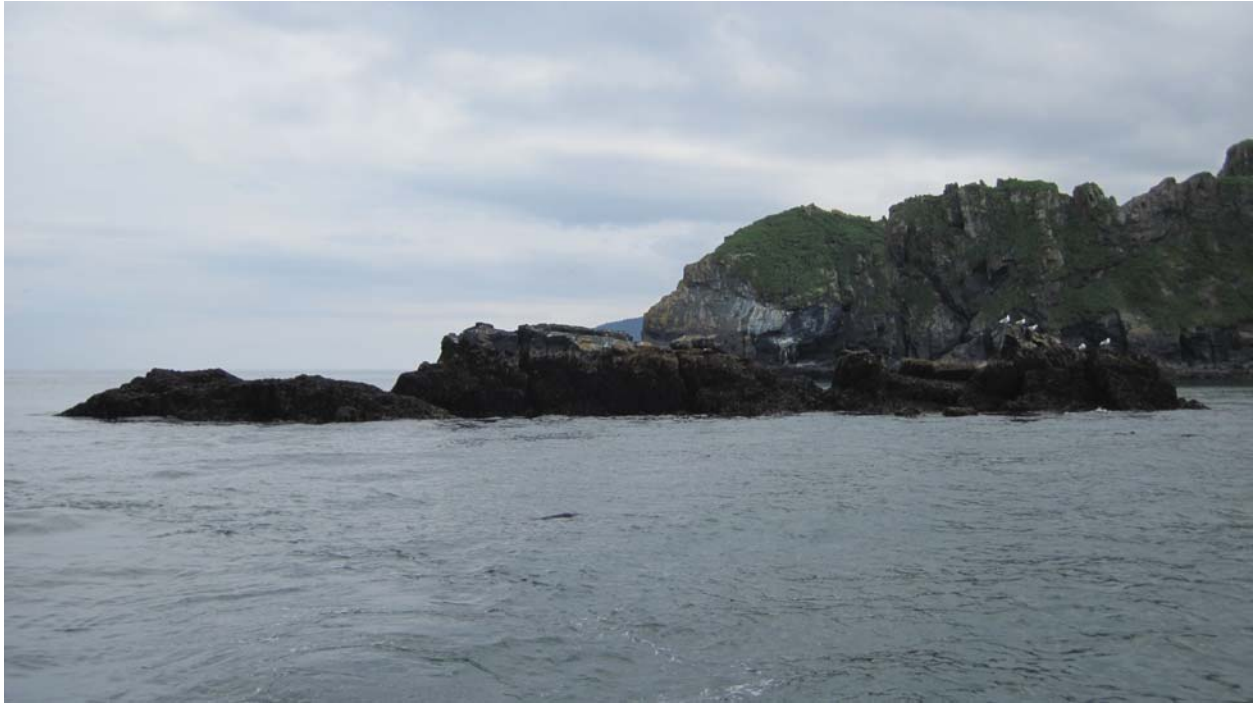
Figure 3.6.1

Office Note: Concur with clarification. New seaward most extent of ledge is located at 57-59-38.2N, 152-28-11.1W
