## DESCRIPTIVE REPORT

Type of Survey ..... HYDROGRAPHIC LIDAR

Registry No. .... H12377

General Locality ..... Florida Keys National Marine Sanctuary

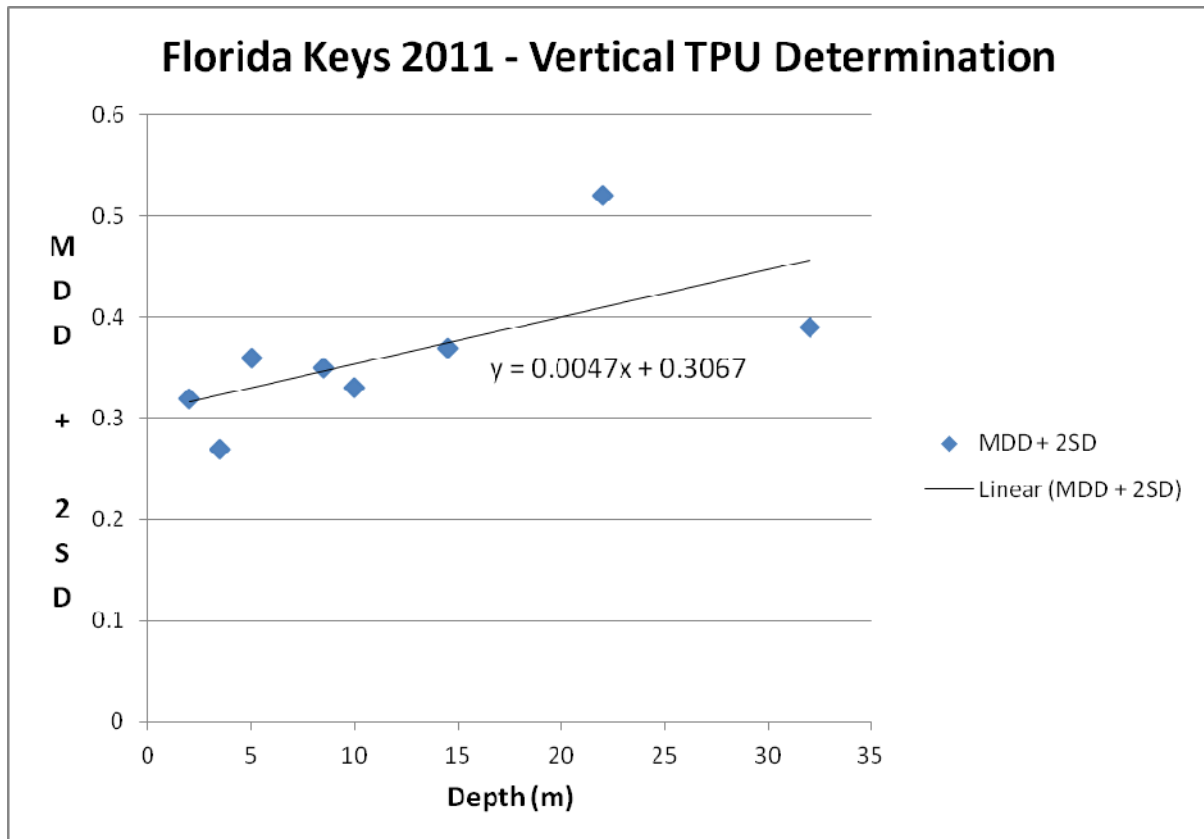
**Figure 3 – Vertical TPU Determination**

For simplicity, the relationship between depth and data accuracy was considered linear and a trend line was fitted to the scatter plot. The resultant equation was derived for vertical accuracy of the OPR-H355-KRL-11 project:

As described under Section B.2.1.2, a total propagated uncertainty line was designed and flown on 16 separate occasions in order to determine the repeatability of the SHOAL-1000T and assign accurate vertical TPU for all depth data acquired throughout the project. The results of the mean depth differences and standard deviations of gridded surface comparisons are presented in Table 5. As ALB data accuracy is related to depth, the benchmark area depths were plotted against the MDD + 2SD value observed at each location.

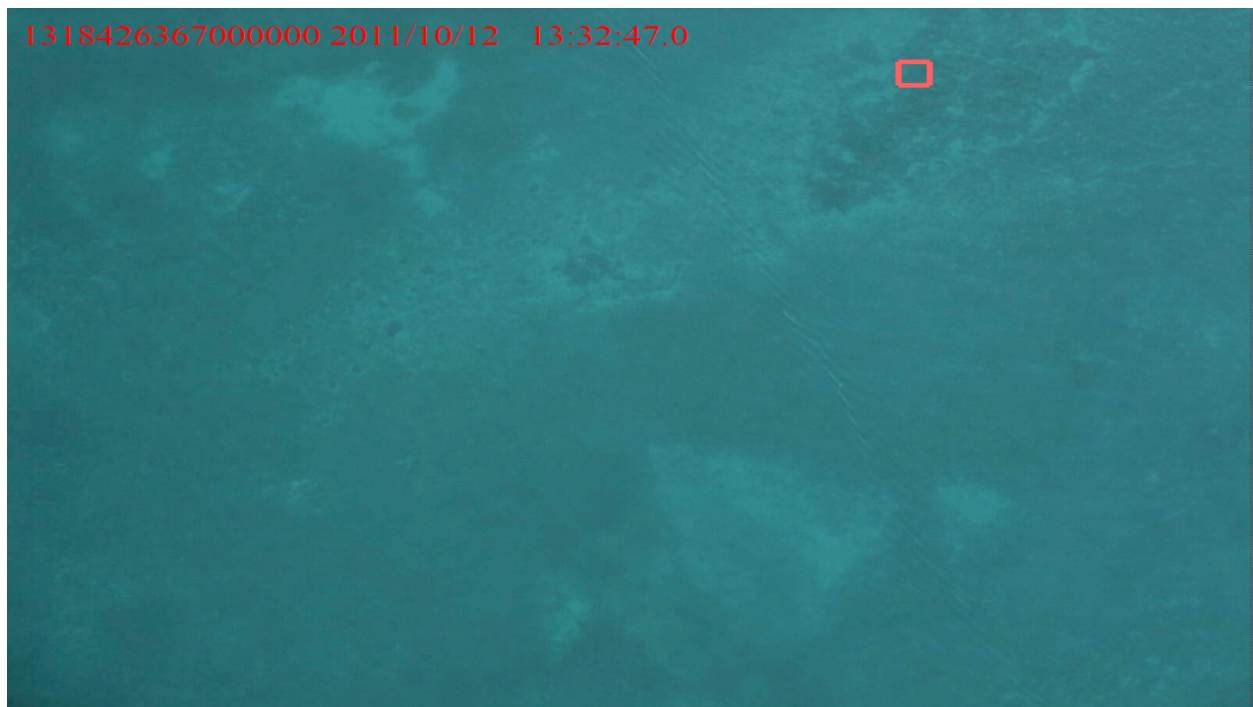
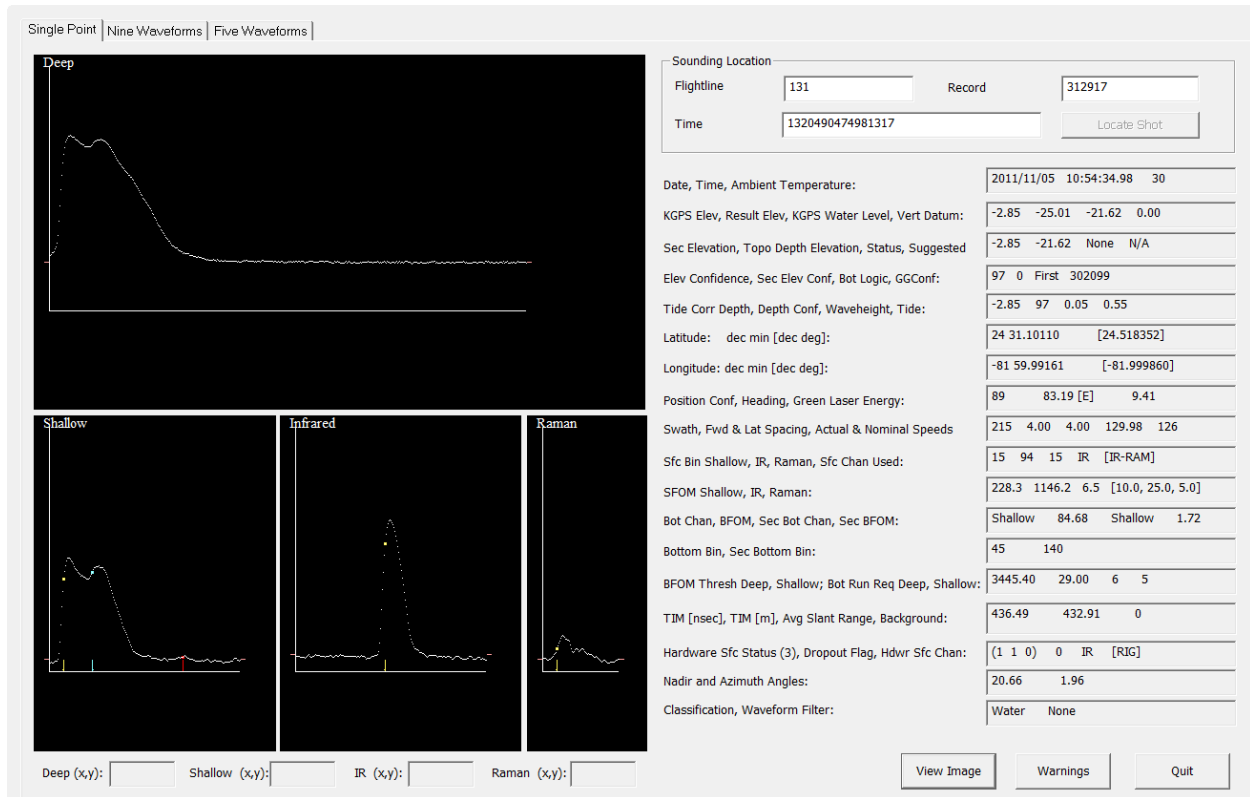
Figure 1.1.1

WRECKS/remrks: Least depth found on submerged wreck

Update charted position and depth on wreck. Least depth cannot be confirmed with LIDAR. Chart with WATLEV = Value reported (not confirmed).
