# DESCRIPTIVE REPORT

*Type of Survey* Hydrographic  
*Field No.* David Evans and Associates, Inc.  
*Registry No.* H12468

**Descriptive Report to Accompany Hydrographic Survey H12468**

Project OPR-J348-KR-12

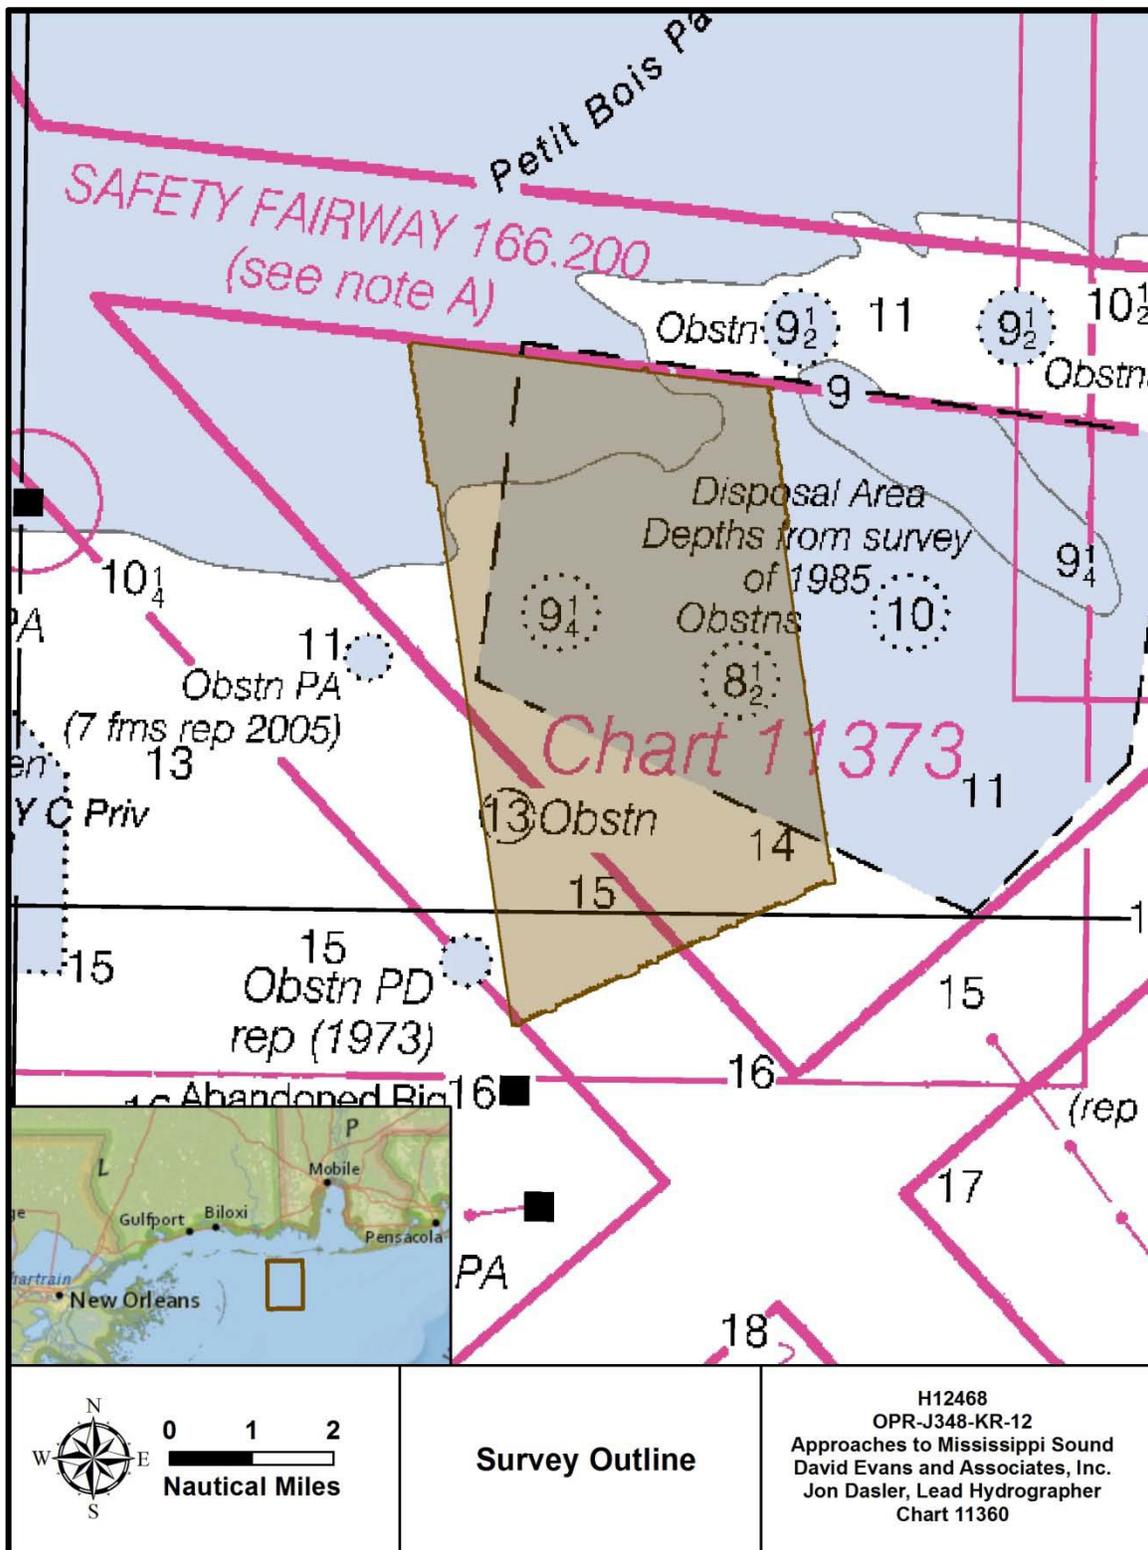
Figure 1. H12468 Survey Outline

The survey consisted of 200% side scan sonar coverage with concurrent multibeam. The survey polygon depicted in the Project Reference File (PRF) *OPR-J348-KR-12\_PRF.000*, which was included with the *Hydrographic Survey Project Instructions* (April 16, 2012), was used to define the limits for each survey. The survey was conducted over 180-meter set line spacing per 100% coverage (100-meter side scan sonar range). Automated Wreck and Obstruction Information System (AWOIS) items and significant side scan contact investigations were acquired to meet object detection coverage requirements for multibeam surveys. The coverage area (Figure 1) totaled 30.2 square nautical miles using a combination of side scan and multibeam survey methods.

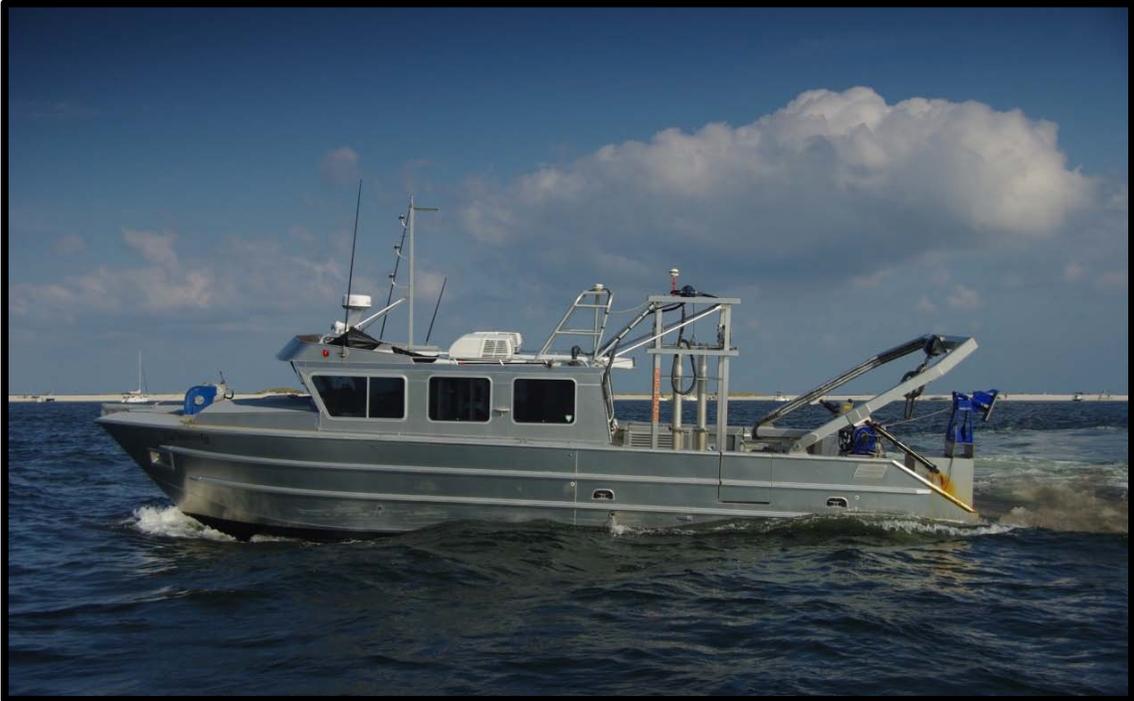
R/V <i>Westerly</i>

IMO Number	1AR38CATK011
Official Number (O/N)	1231991
Builder	Armstrong Marine
Design	Catamaran
Year Built	2011
Weight	13 gross tons, 10 net tons
Length Overall	38'
Beam	16.5'
Draft, Maximum	4.6'
Cruising Speed	26 knots
Max Survey Speed	9 knots

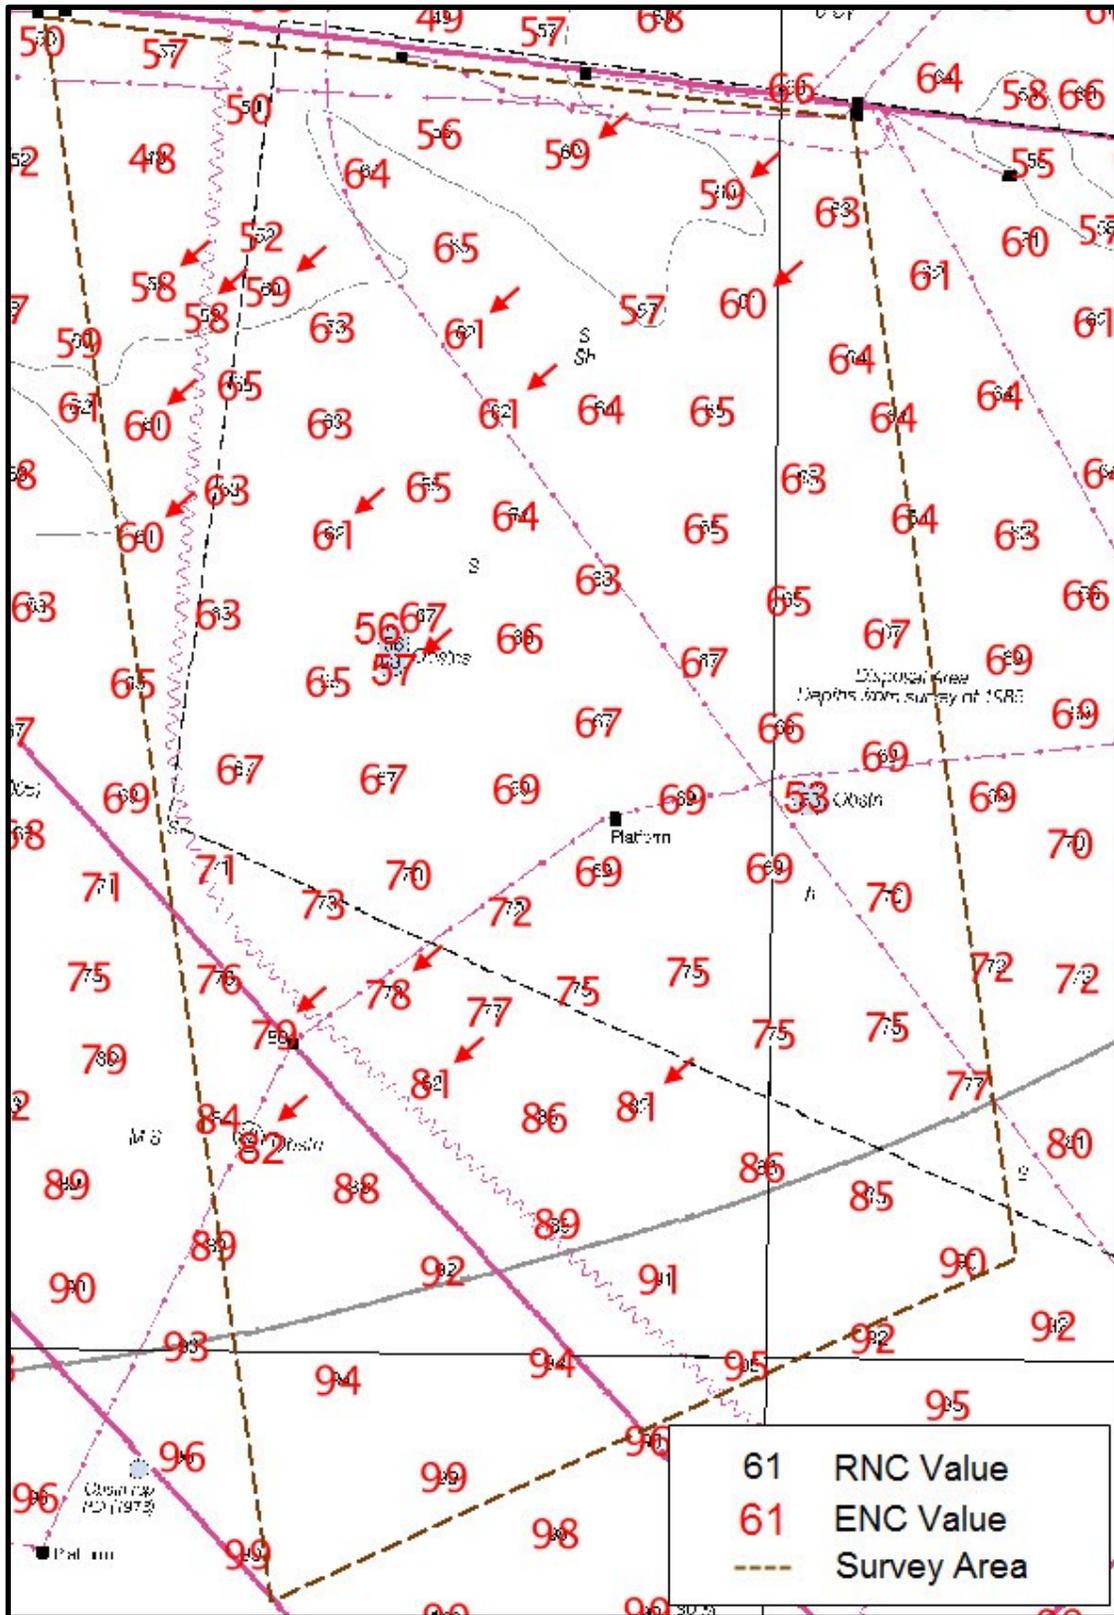
Figure 2. Sounding Discrepancies between 11373 and US4MS12M

Chart 11373 was compared to US4MS12M within the H12468 survey area. As depicted in Figure 2, multiple discrepancies were discovered during this comparison where ENC soundings were one foot shoaler than the corresponding RNC sounding. This appears to be an issue with implementation of NOAA sounding rounding rules (rounding at 0.75). When the ENC is set to display soundings in feet with default rounding (rounding at 0.5) the ENC and RNC soundings agree.

Charted differences determined by comparing surveyed depths to a digital surface of US4MS12M are discussed in Section D.1.2.

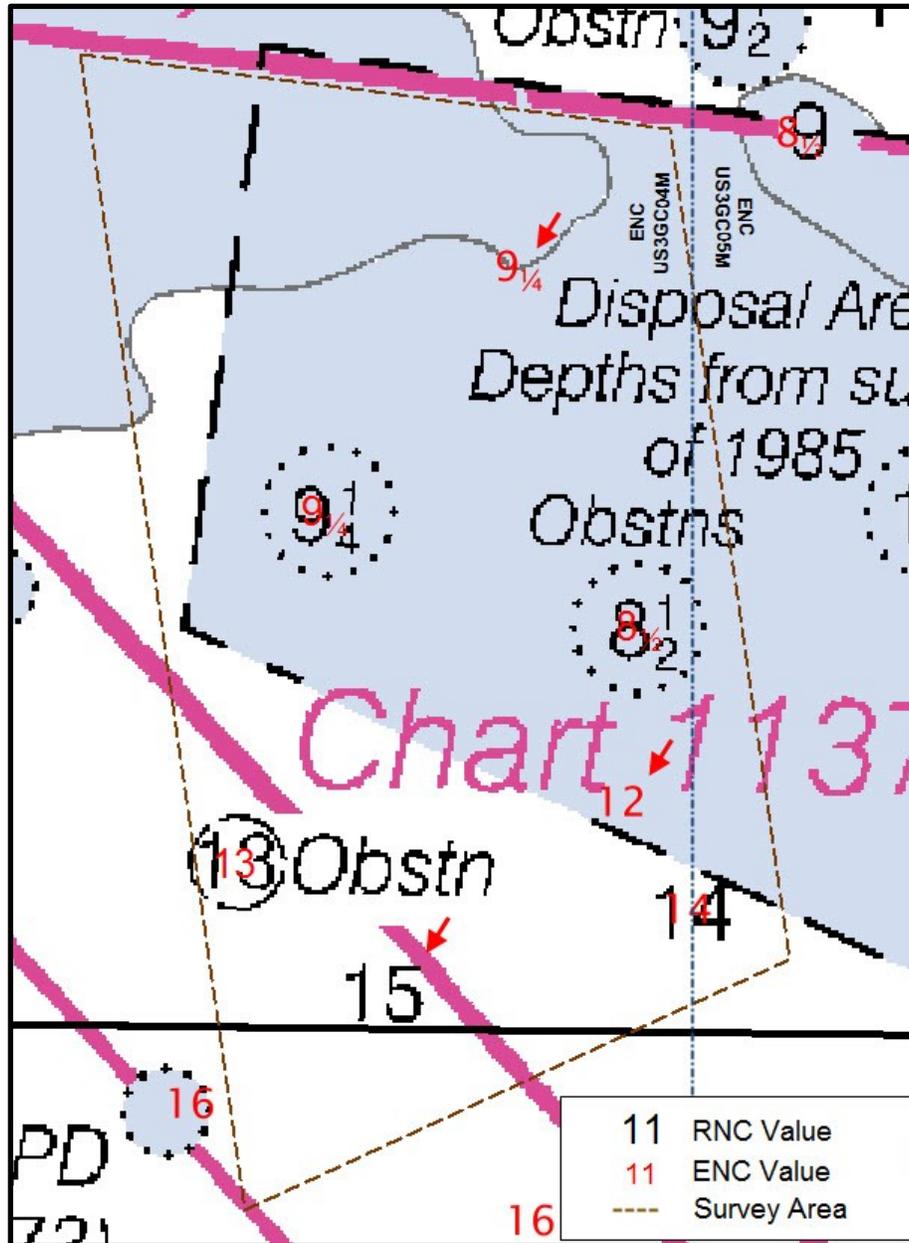
Figure 3. Sounding Discrepancies between 11360 and US3GC04M and US3GC05M

Chart 11360 corresponds to part of charts US3GC04M and US3GC05M within the H12468 survey area. As depicted in Figure 3, chart 11360 includes one sounding that is not portrayed on US3GC04M and is missing two soundings which are charted on US3GC04M. Chart 11360 agrees with US3GC05M within the survey area.

Charted differences in this area determined by comparing surveyed depths to a digital surface of US3GC04M and US3GC05M are discussed in Section D.1.2.

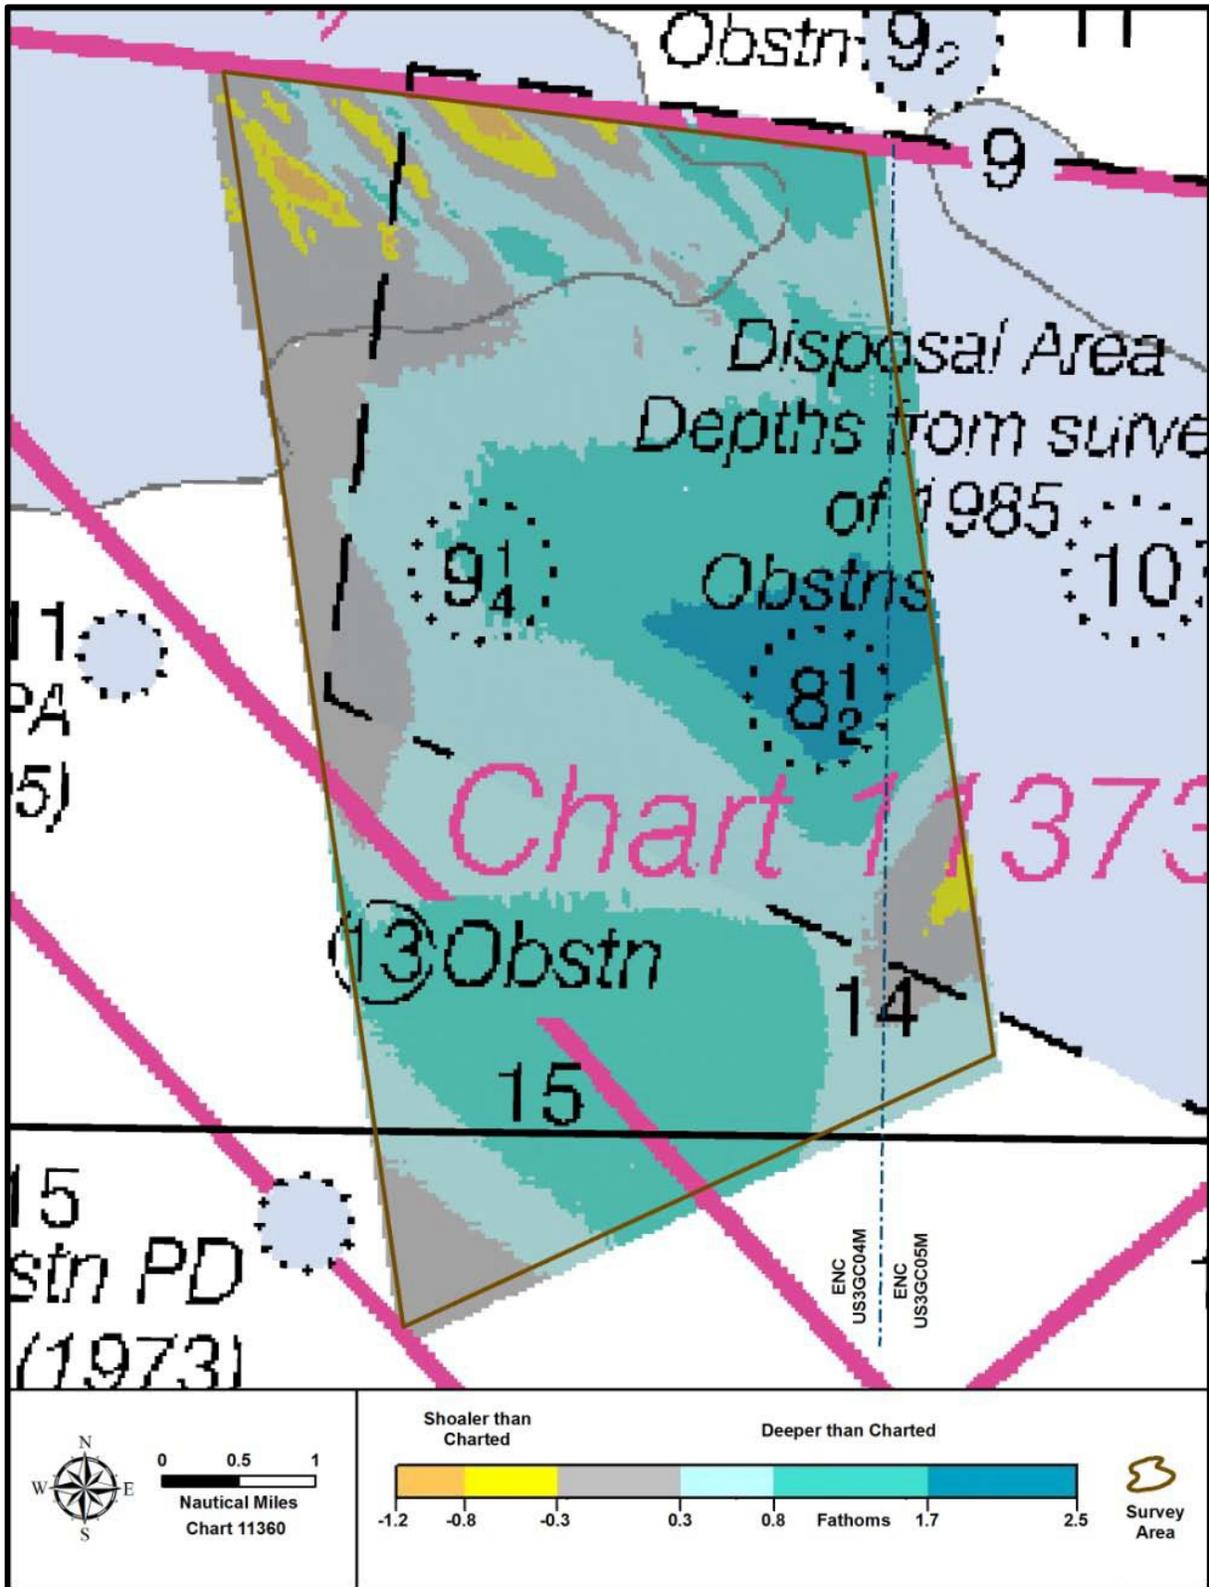
Figure 5. Depth Difference between H12468 and charts US3GC04M and US3GC05M

The difference surface created from these small scale charts shows surveyed depths are generally zero to three fathoms deeper than charted (Figure 5) with the largest discrepancy at the disproved charted 8 1/2-fathom obstruction (AWOIS item 7365).

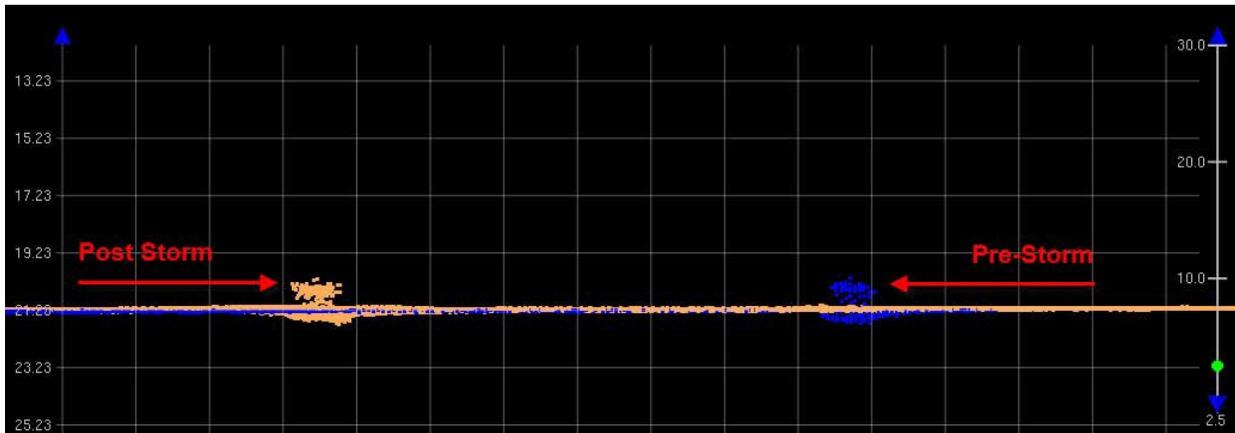
Figure 6. Pre (Blue) and Post (Salmon) Hurricane Isaac feature movement

There was no additional information of scientific or practical value observed during the survey. No anomalous tidal or environmental conditions were observed during the survey that impacted the quality of the survey. However, from August 25, 2012 (DN 238) through September 5, 2012 (DN249) Hurricane Isaac impacted the survey area. When comparing mainscheme data collected before the storm and investigation data collected after the storm, a feature was found to have moved 38 meters (Figure 6). The feature at its pre-storm location was disproved by the investigation data and therefore rejected. A designated sounding was used in order to properly portray the feature in the depth surface at its post storm location

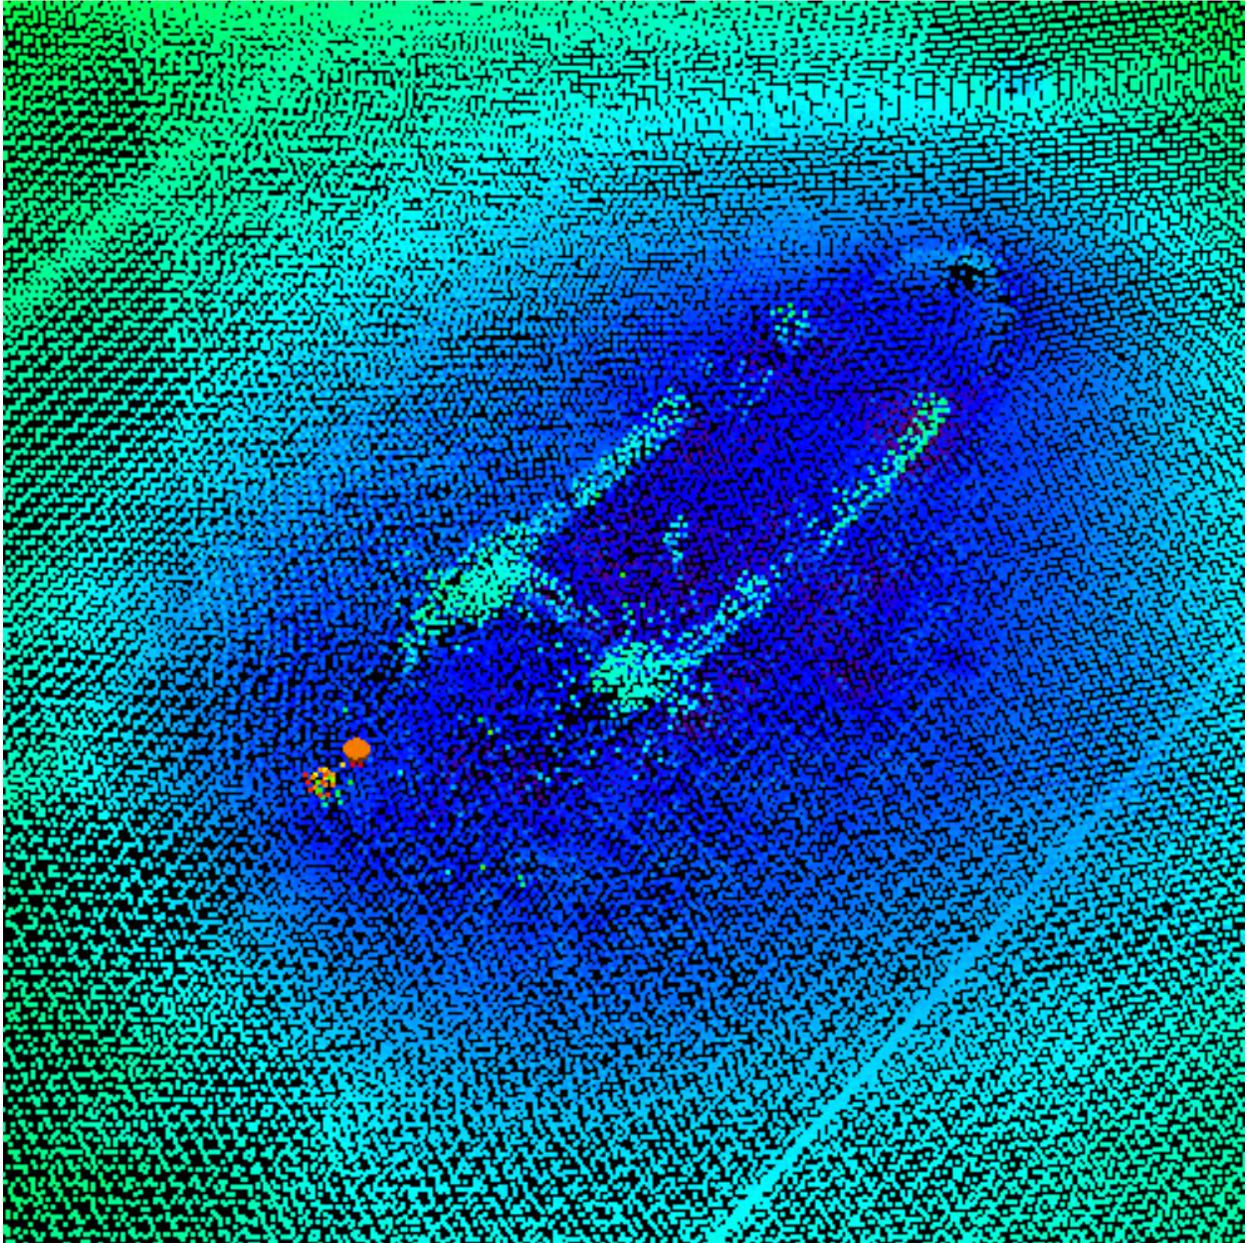
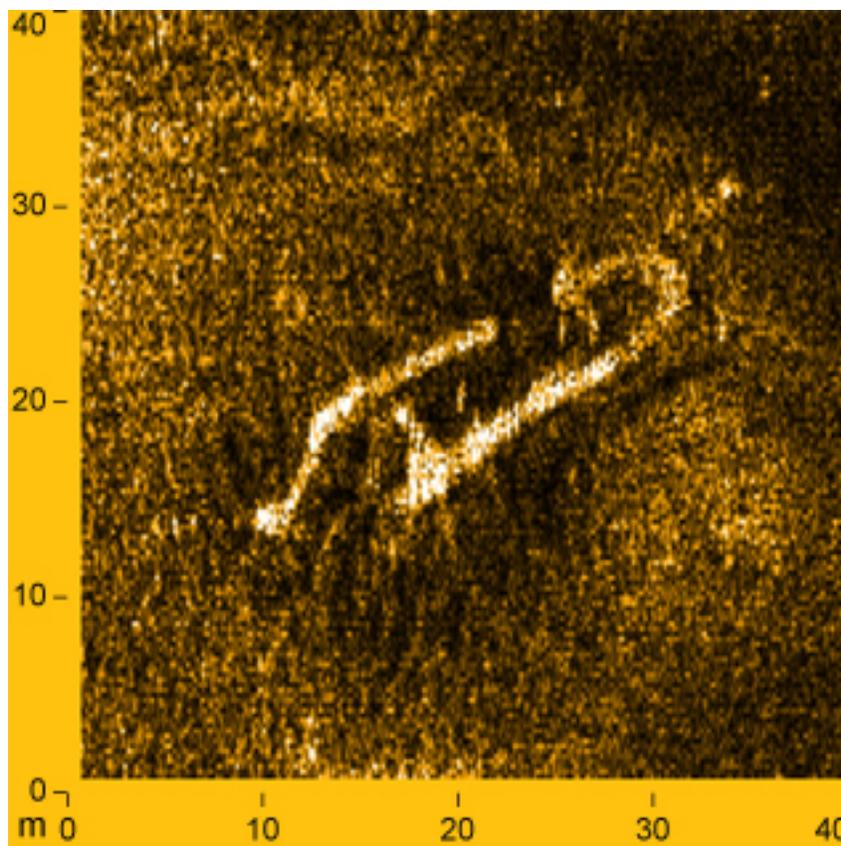
Figure 1.1.1

**SAR NOTE:** This feature was ensonified with set-line spacing MBES and 200% SSS. The feature was found in the surveyed location. The feature is located within a scour or depression in the sea floor. Data points interpreted as wreck like in appearance; feature shape confirmed and validated by the SS imagery. Defer final charting disposition to AHB Compiler.

**COMPILATION:** Concur. AWOIS #7365 feature observed in survey data appears to be a wreck with minimal relief. Recommend delete obstruction from chart. Add wreck with least depth of 64.659 ft. to chart.
