DESCRIPTIVE REPORT

Type of Survey: Navigable Area

Registry Number: H12508

Sub-locality: Saybrook Outer Bar to Salt Works Bay

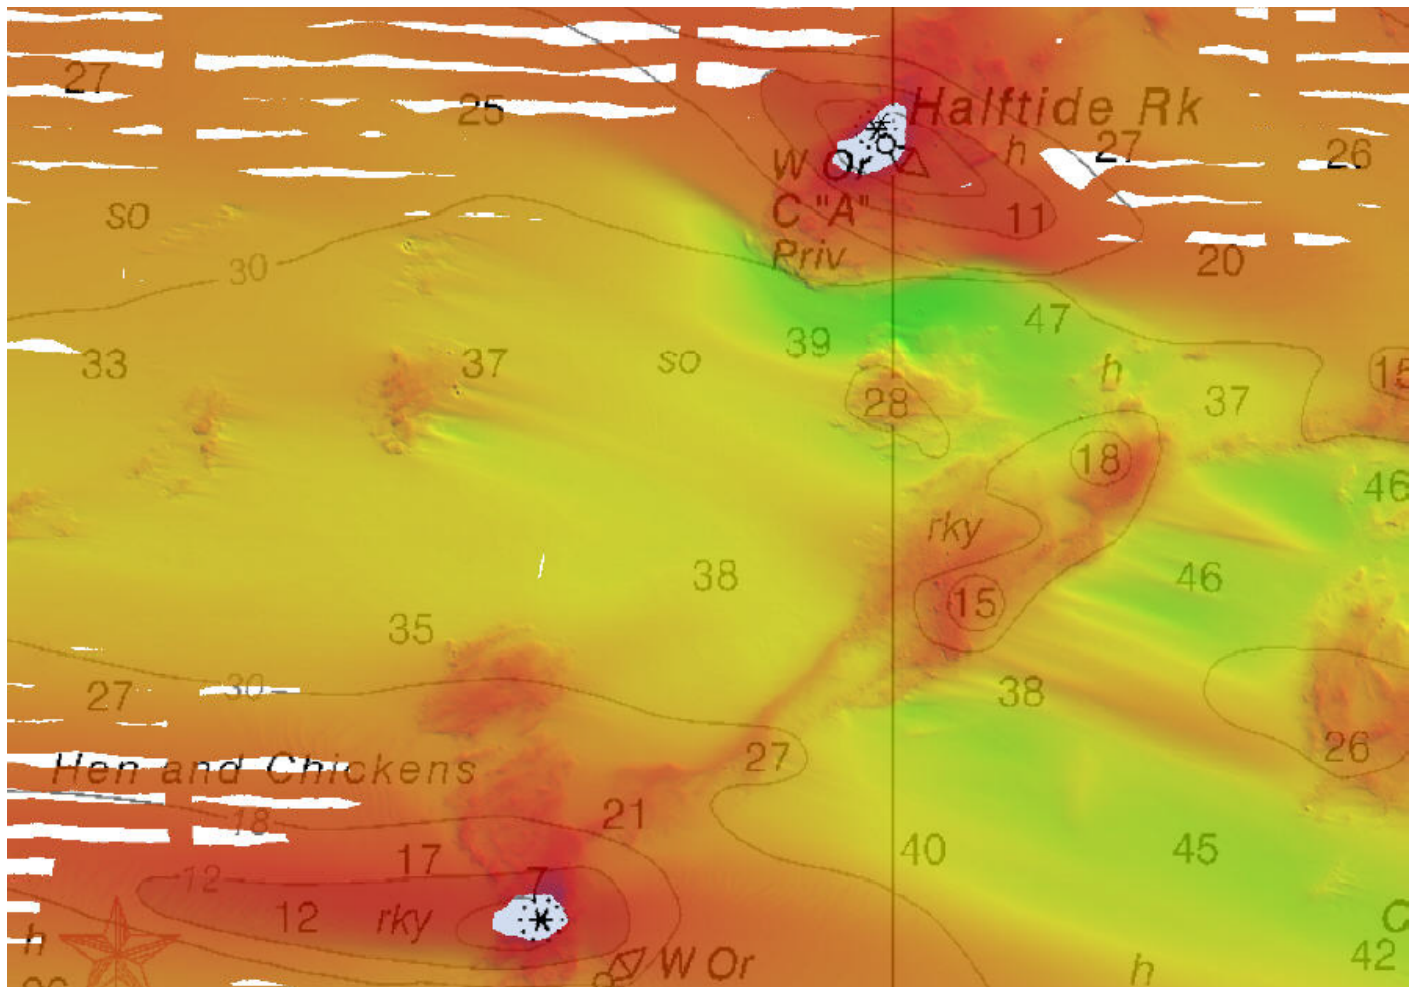
Figure 11: Shoreline Features

Two assigned shoreline features exist within the survey limits, Hen and Chickens Rock, and Halftide Rock. MBES was acquired around the exposed rocks as close as was considered safe. No Detached Positions were taken. The positions of both rocks are accurately charted.

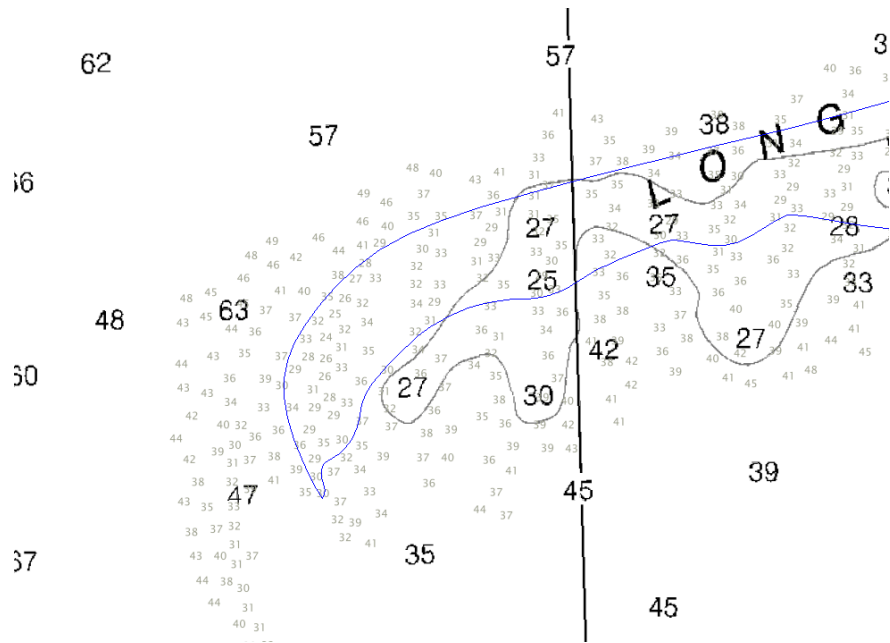
Figure 3: Western edge of 30 ft contour has migrated 150 meters to the west.

Update contour lines and soundings to reflect current survey data.

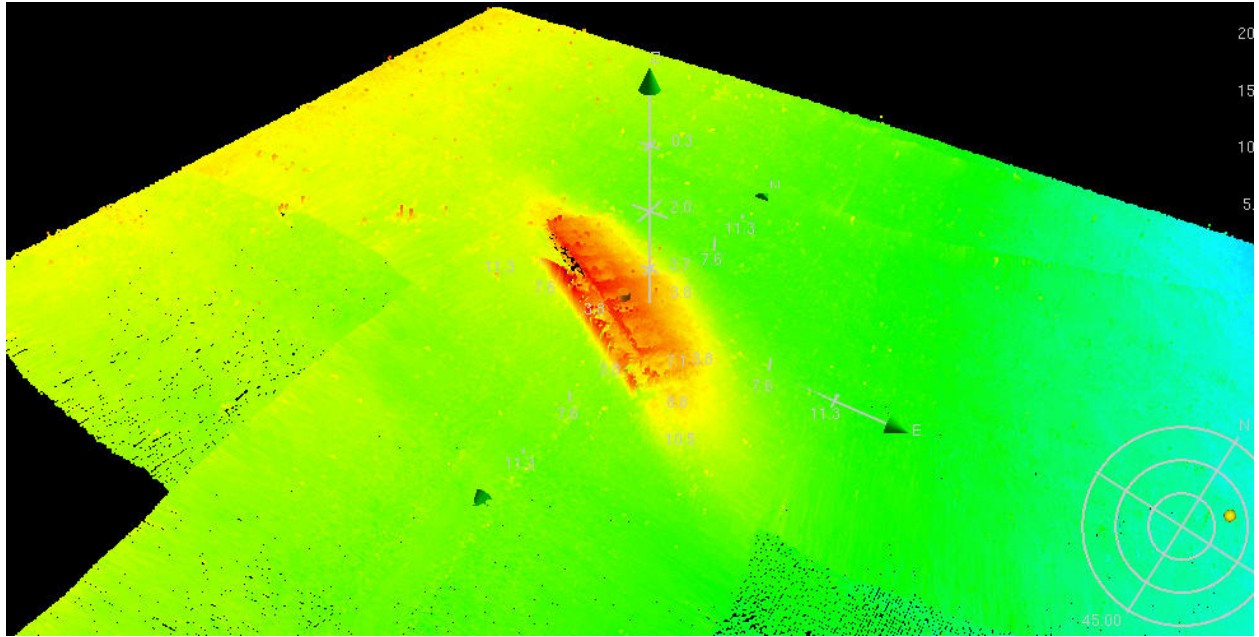
Figure 1.7.1

Geo object 1: Wreck (WRECKS)
Attributes: CATWRK - 2:dangerous wreck
 QUASOU - 6:least depth known
 SORDAT - 20140529
 SORIND - US,US,graph,H12508
 TECSOU - 3:found by multi-beam

Office Notes: Concur.
