DESCRIPTIVE REPORT

Type of Survey: Navigable Area

Registry Number: H12594

Sub-locality: Vicinity of Chernabura Island

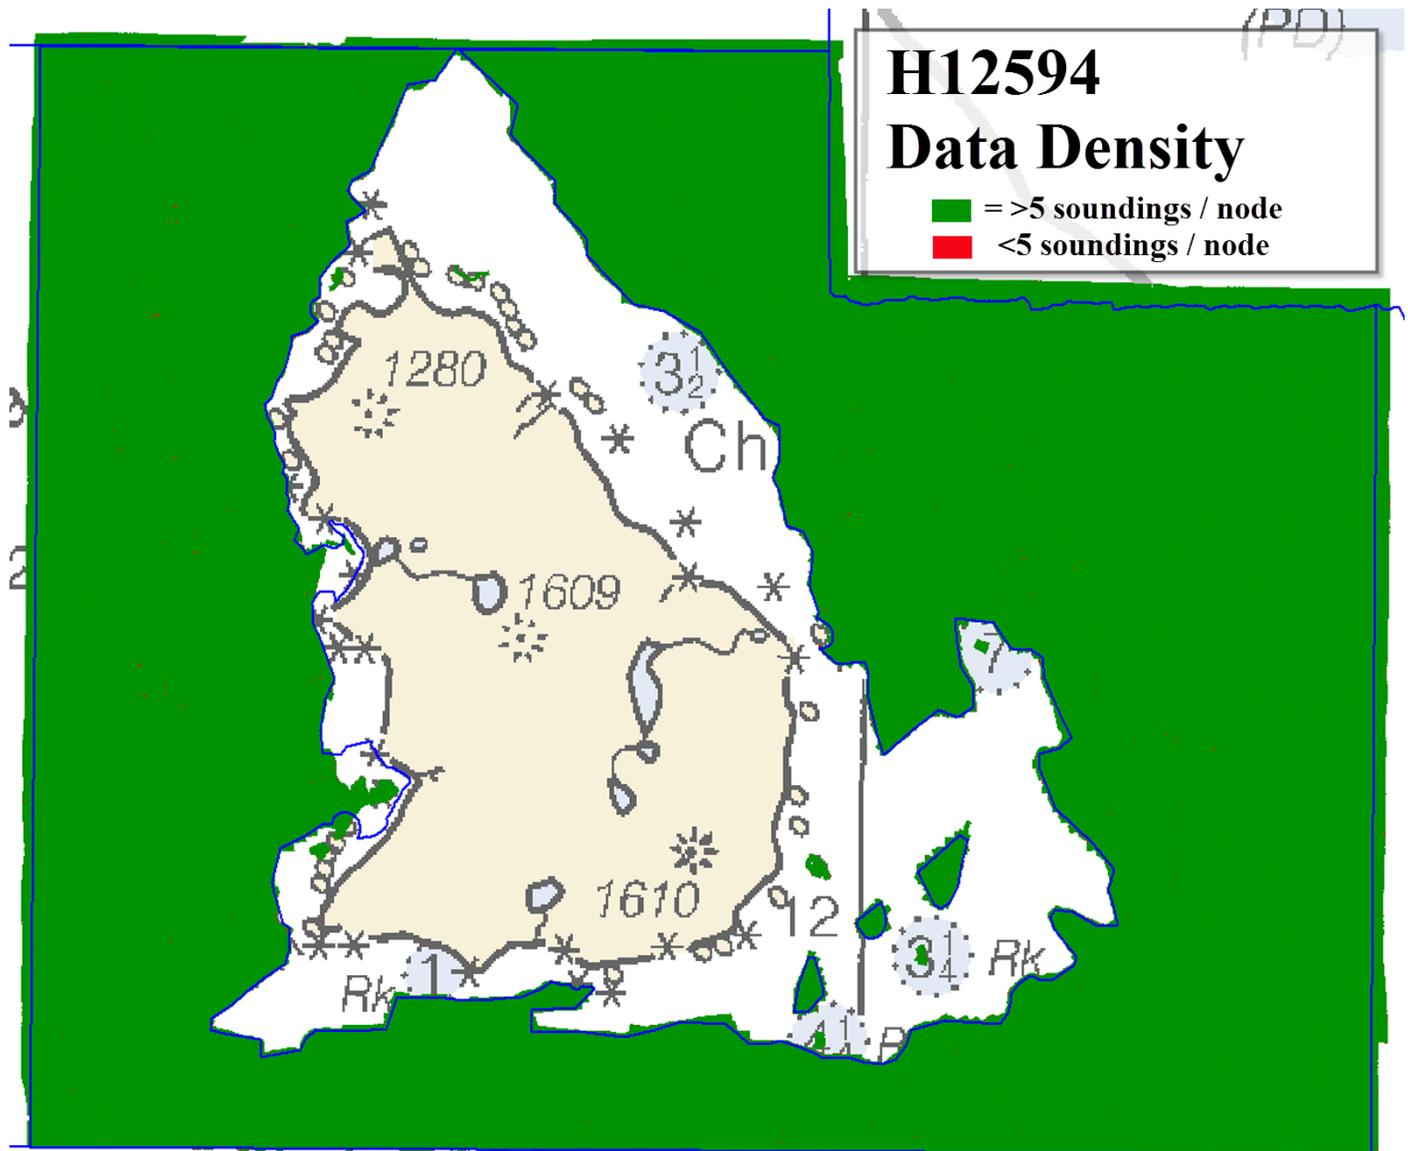
Figure 2: Data density. Areas in green meet the threshold of 5 soundings per node; red areas have a density of fewer than 5 soundings per node.

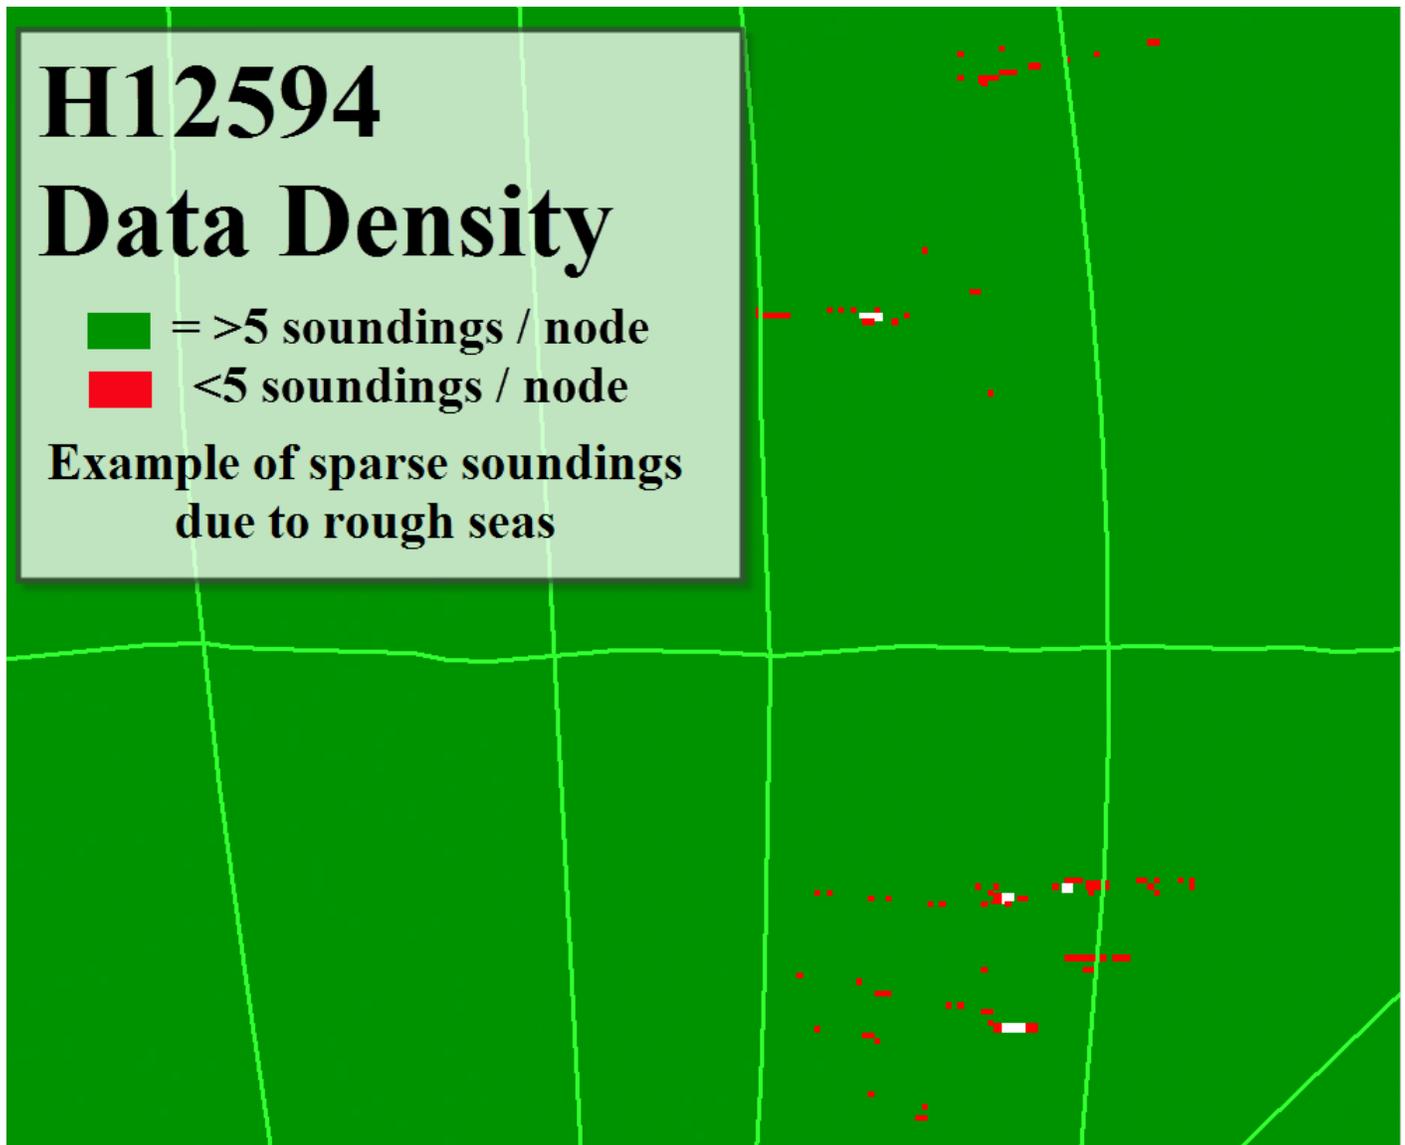
Figure 3: Examples of data density failures due to rough seas. Areas in green meet the threshold of 5 soundings per node; red areas have a density of fewer than 5 soundings per node.

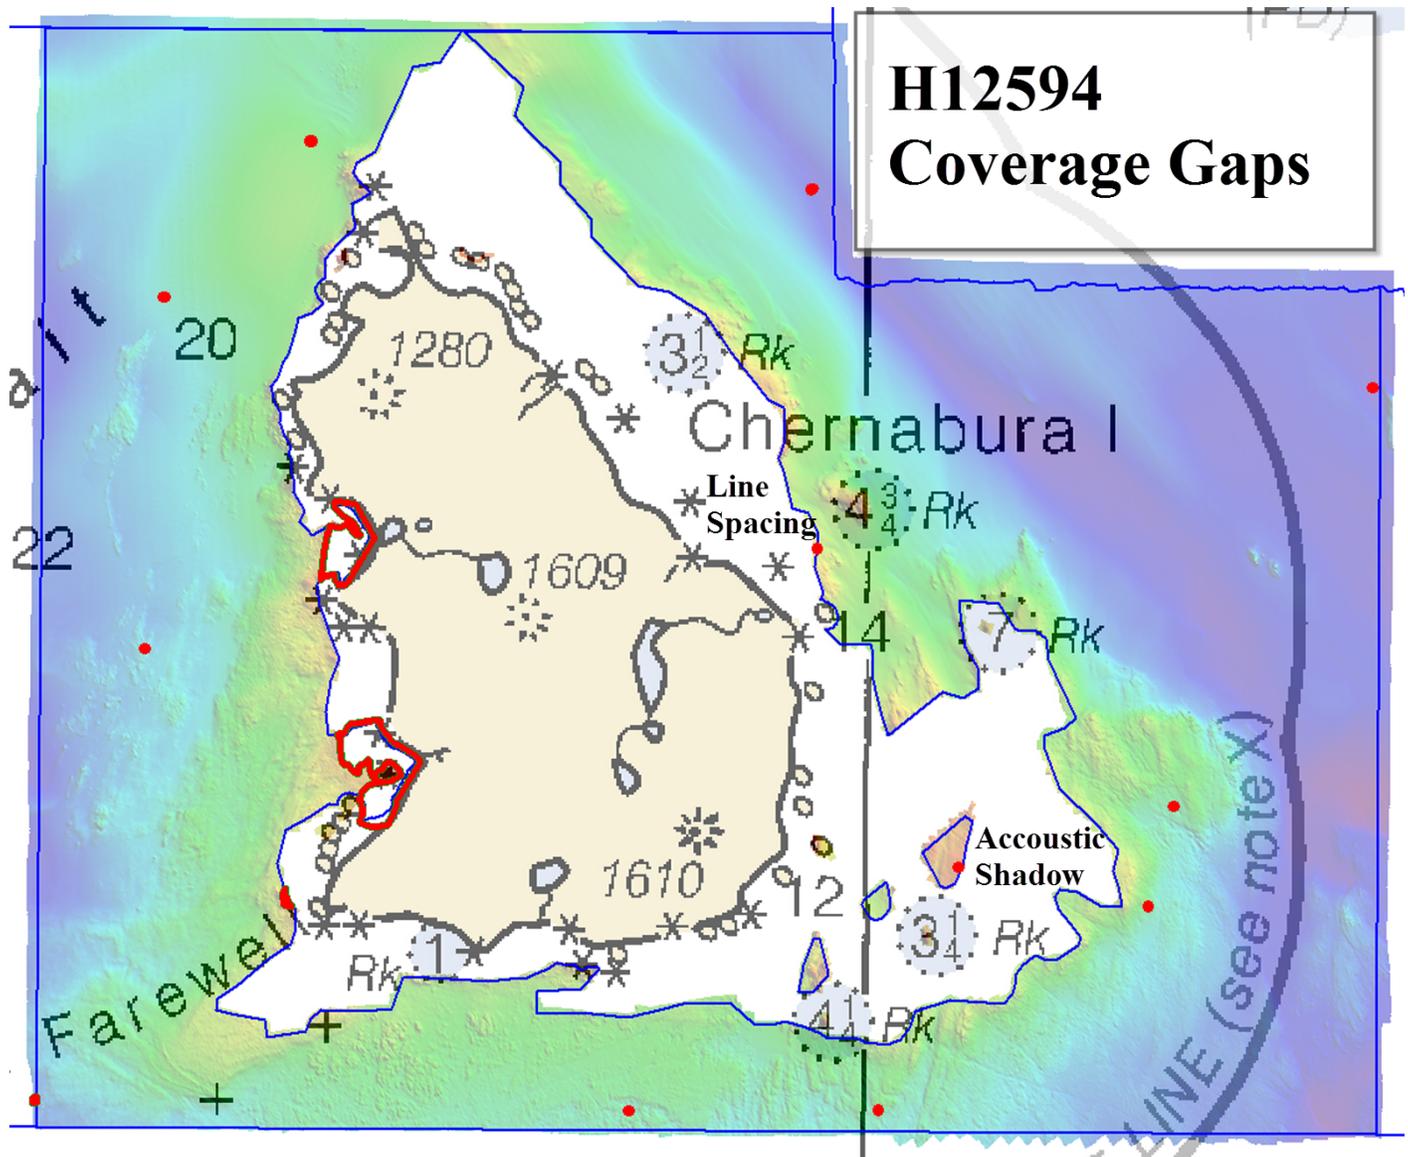
On the southwestern sheet limit there is a 14x2 node coverage gap that is completely covered by junction survey H12593 (Figure 7). Southeast of Chernabura Island, there is a 4-node holiday created by inadequate line spacing (Figure 8); this is fully covered by junction survey H12102. There is a 3-node acoustic shadow holiday located east of the island (Figure 9); this is fully covered by junction survey H12102.

There are 9 coverage gaps in depths greater than 30 meters, the largest of which is 16 by 1 grid nodes in size. In the opinion of the Hydrographer these coverage gaps are not navigationally significant.

Figure 6: H12594 coverage gaps and holiday overview.

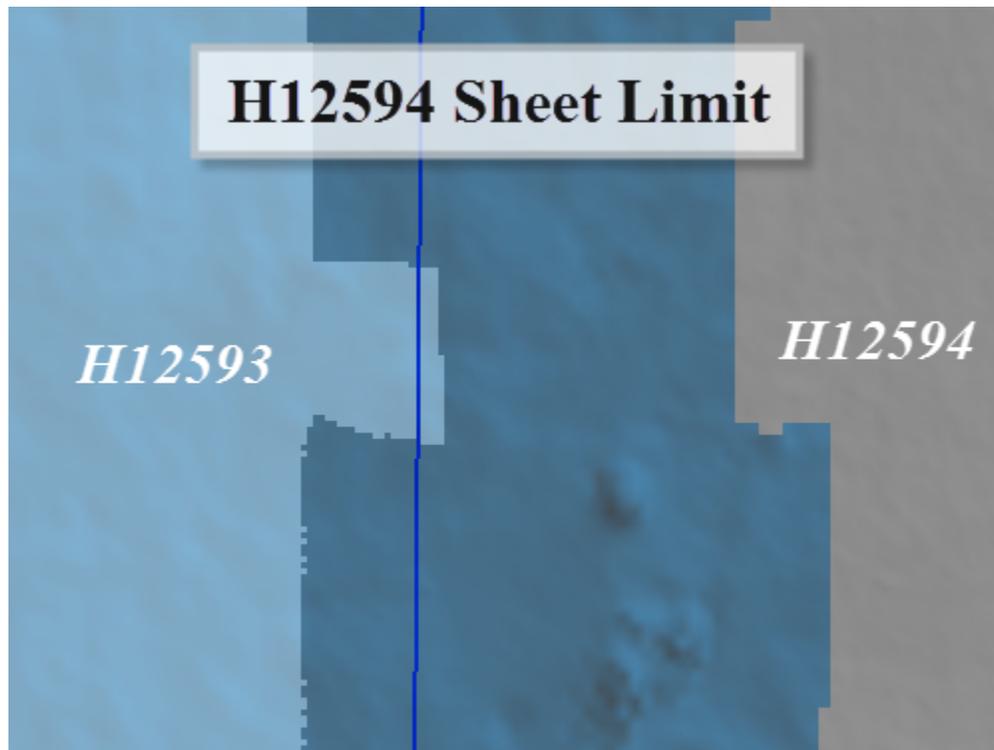
Figure 7: Holiday completely covered by junction H12593 overlap.

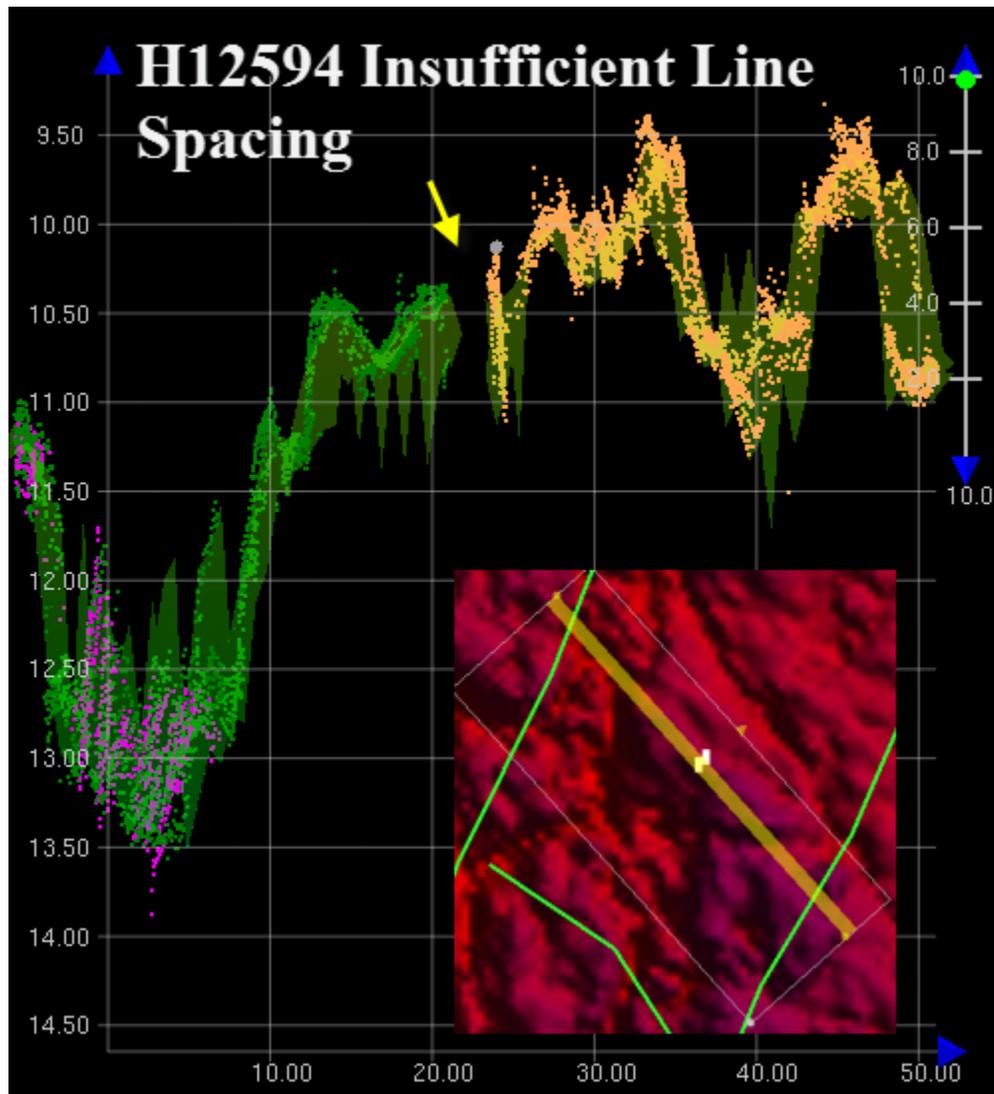
Figure 8: Holiday located southeast of Chernabura Island and north of the 3 1/4 fathom rock. This is covered by junction H12102.

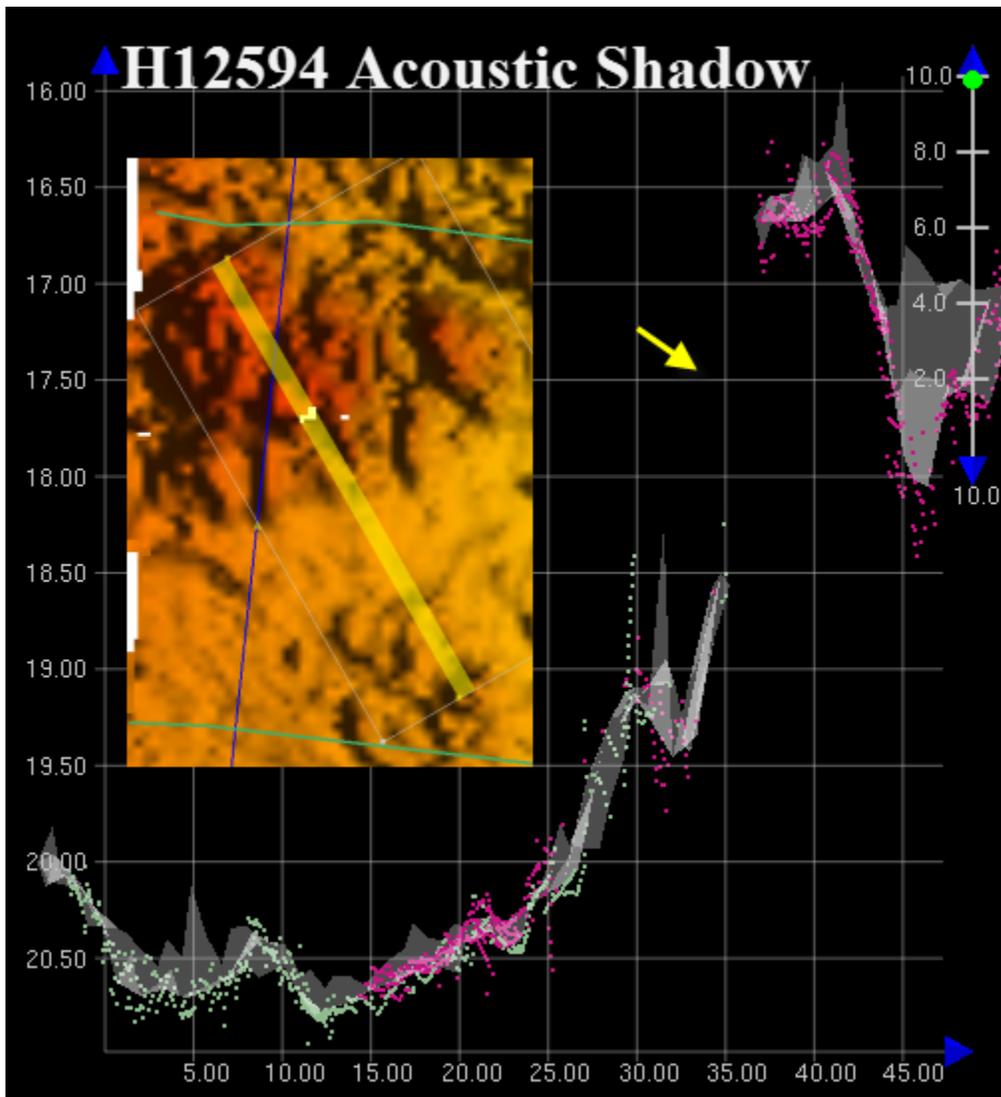
Figure 9: Acoustic shadow holiday located east of Chernabura Island and covered by junction H12102.

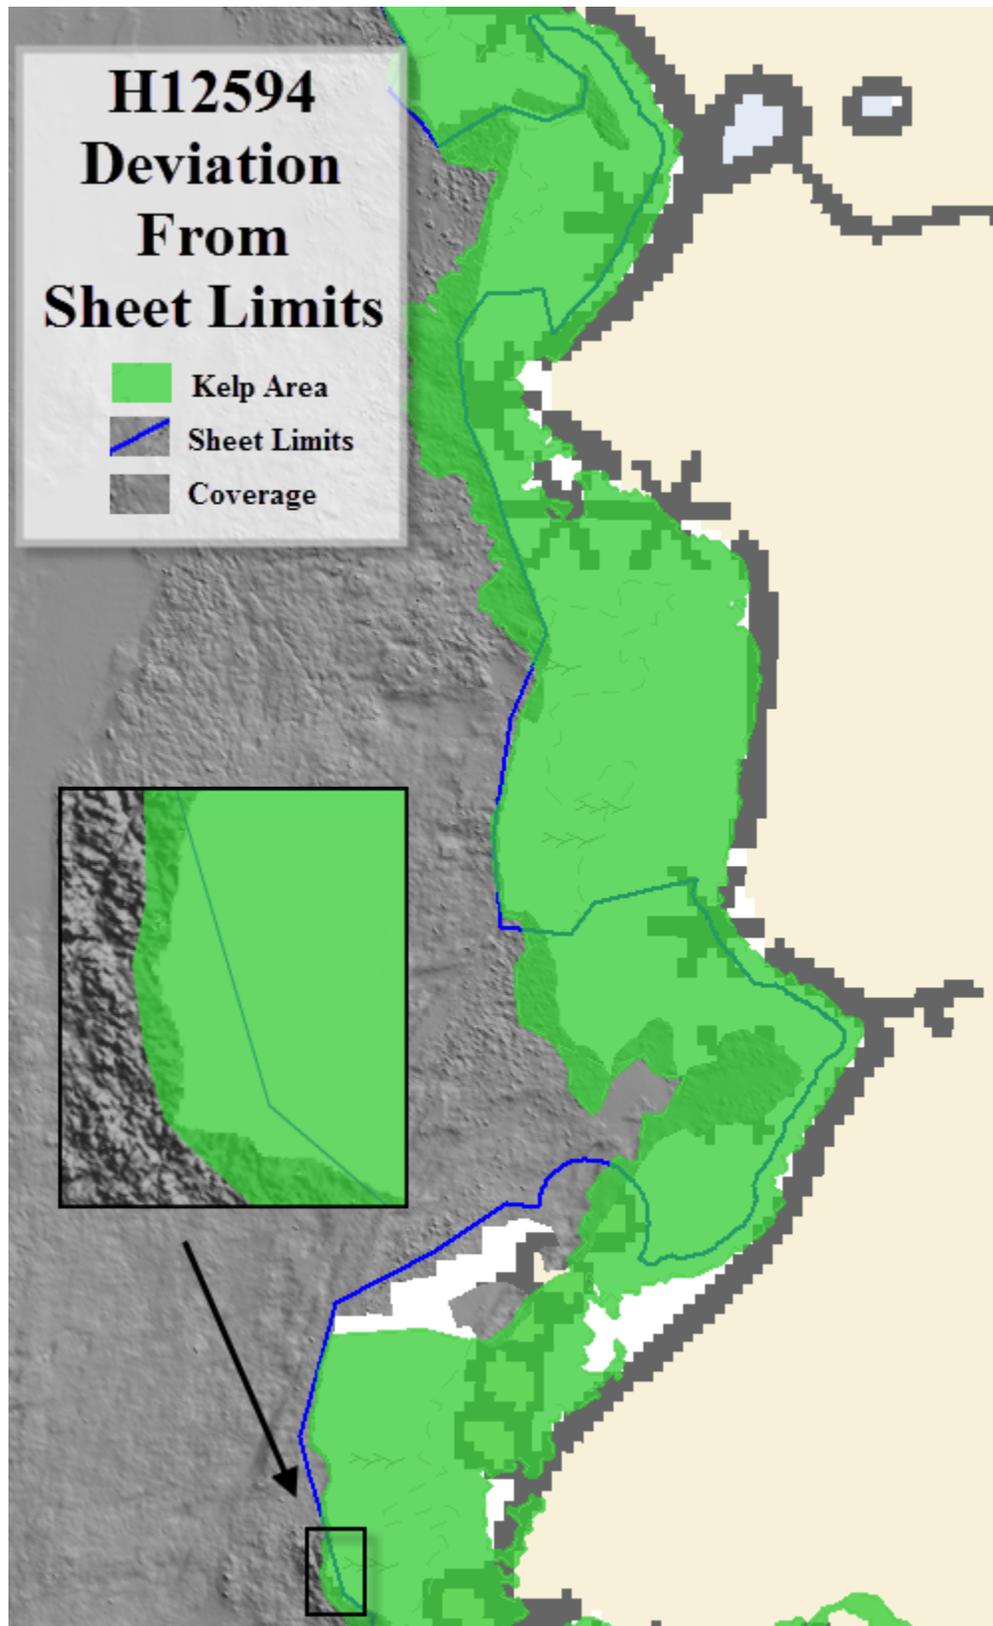
The sheet limits were not met in three areas due to kelp (Figure 10). These areas are delineated and attributed in the Final Feature File.

Figure 10: Areas where assigned sheet limits were not met due to kelp.

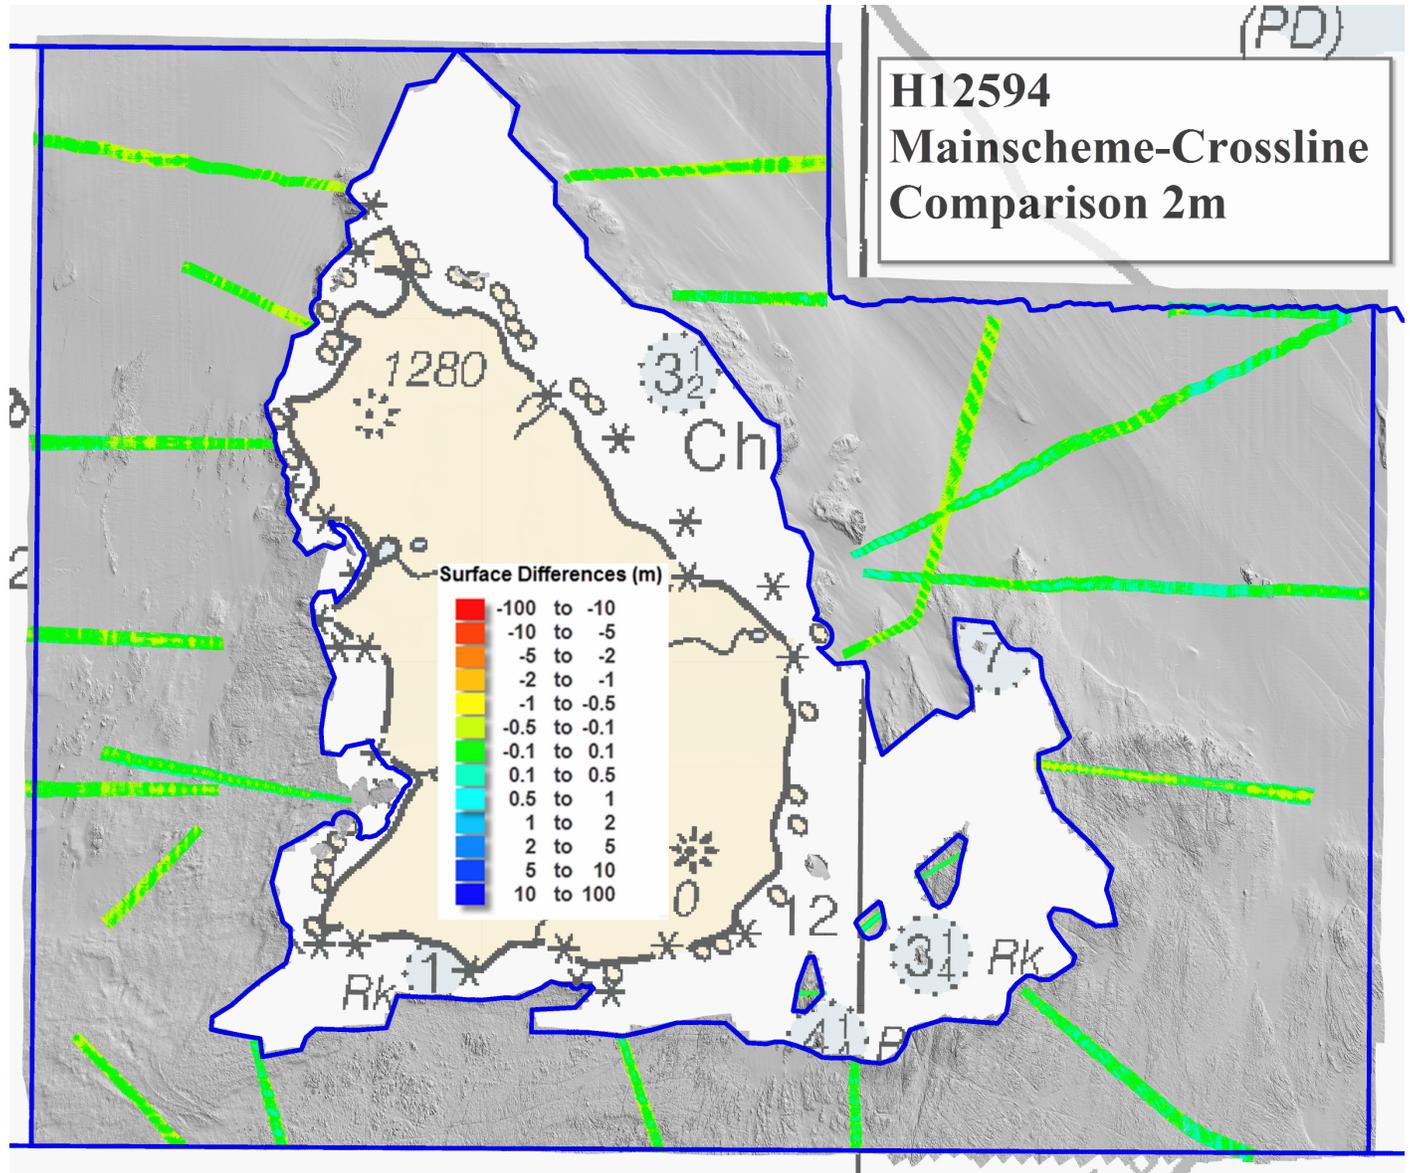
Multibeam crosslines were acquired using the Kongsberg EM710 on S221 (NOAA Ship RAINIER), and a Reson 7125 on vessels 2801 (RA-4), 2802 (RA-5), and 2803 (RA-3). A 2-meter CUBE surface was created using strictly the mainscheme lines, while a second 2-meter CUBE surface was created using only crosslines, from which a difference surface was generated in CARIS at a 2-meter resolution (Figure 11). Statistics were then derived from the difference surface and are shown in Figure 12. Mainscheme lines were on

average 0.02 meters shoaler than the crosslines, with a standard deviation of 0.13 meters. This is well within allowable IHO Order 1 accuracy at these depths.

Figure 11: Crossline comparison showing the difference in meters between the mainscheme and crossline soundings for the 2-meter surface. Values are positive where the crosslines are shoaler than the mainscheme.

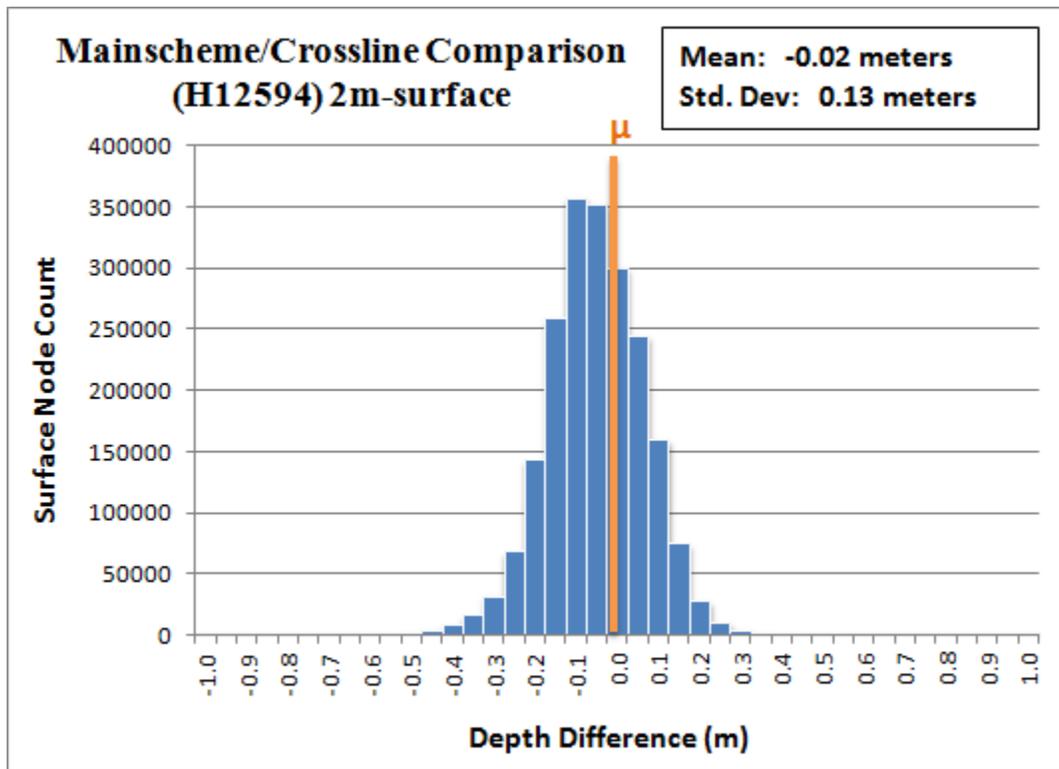
Figure 12: Difference surface statistics between mainscheme and crossline 2-meter surfaces. On average the mainscheme lines are 0.02 meters shoaler than the crosslines. **Crosslines accounted for 4.7% of mainscheme acquisition for this survey, which meets the requirements set forth in the HSSDM.**

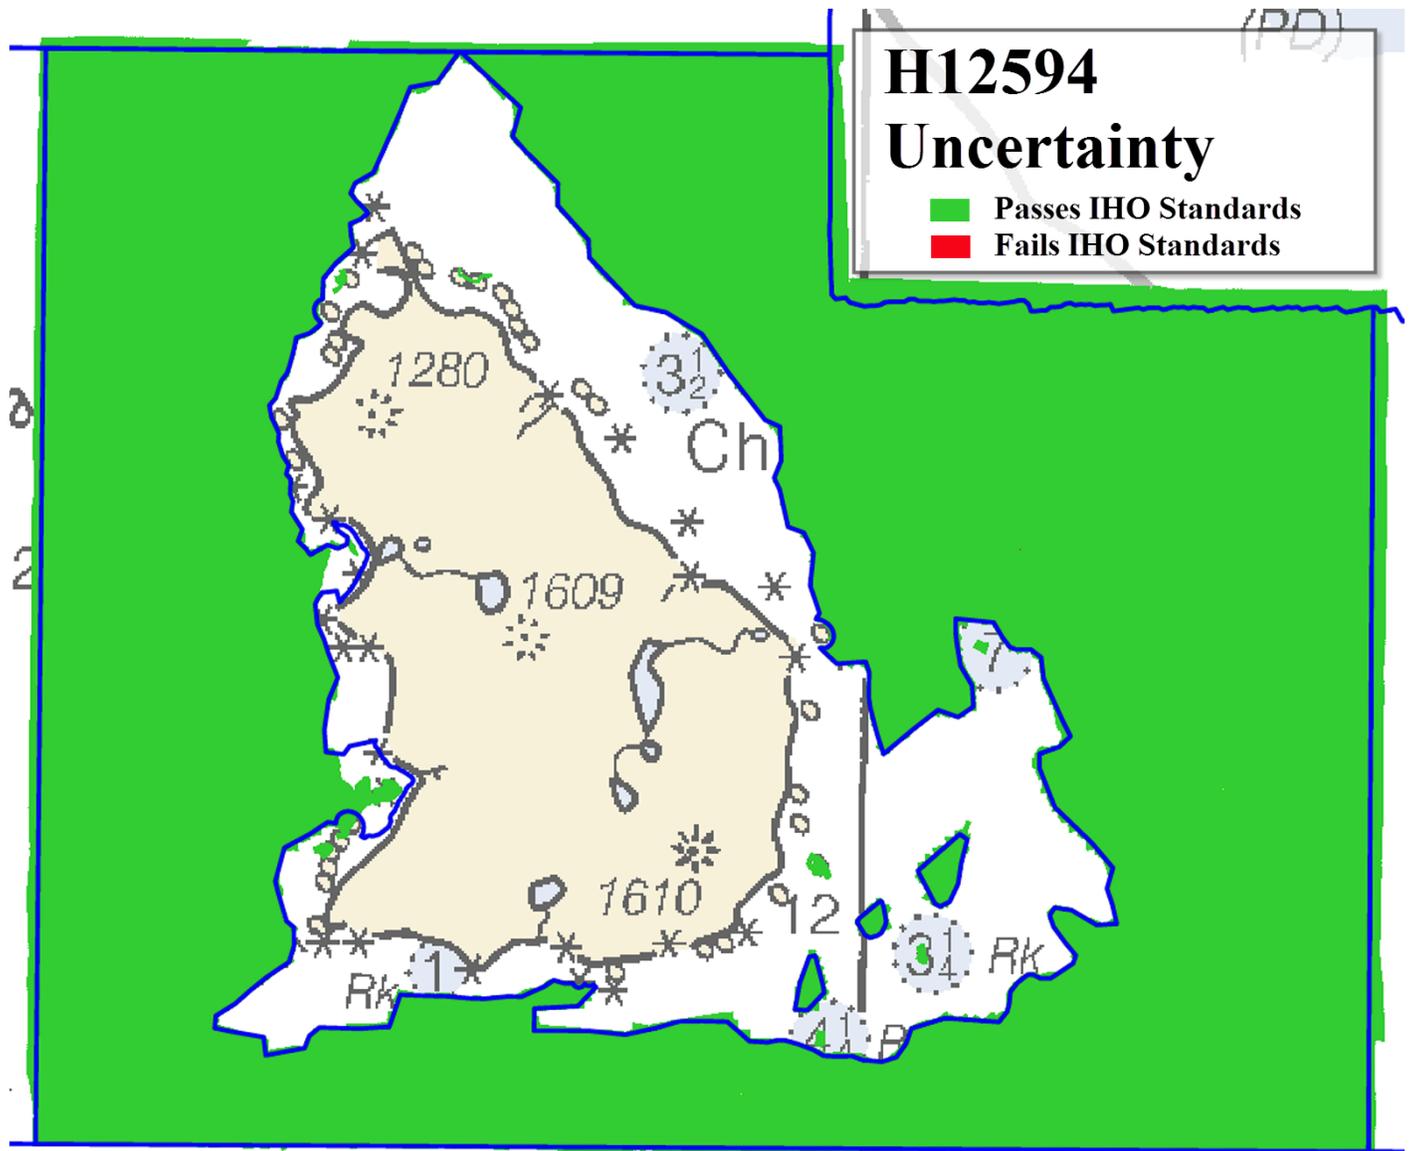
Uncertainty values of submitted finalized grids were calculated in CARIS using the "Greater of the Two" of uncertainty and standard deviation (scaled to 95%). To visualize the locations in which accuracy requirements were met for each finalized surface, a custom predicted IHO-compliance layer was created, based on the difference between calculated uncertainty of the nodes and the allowable IHO uncertainty (Figure 13). To quantify the extent to which accuracy requirements were met, the preceding predicted IHO compliance layers were queried within CARIS and then examined in Excel (Figure 14). Overall, 100.0% by node and 100.0% by area of survey H12594 met the accuracy requirements stated in the HSSD.

Figure 13: H12594 met IHO accuracy standards for 100.0% of the survey area.

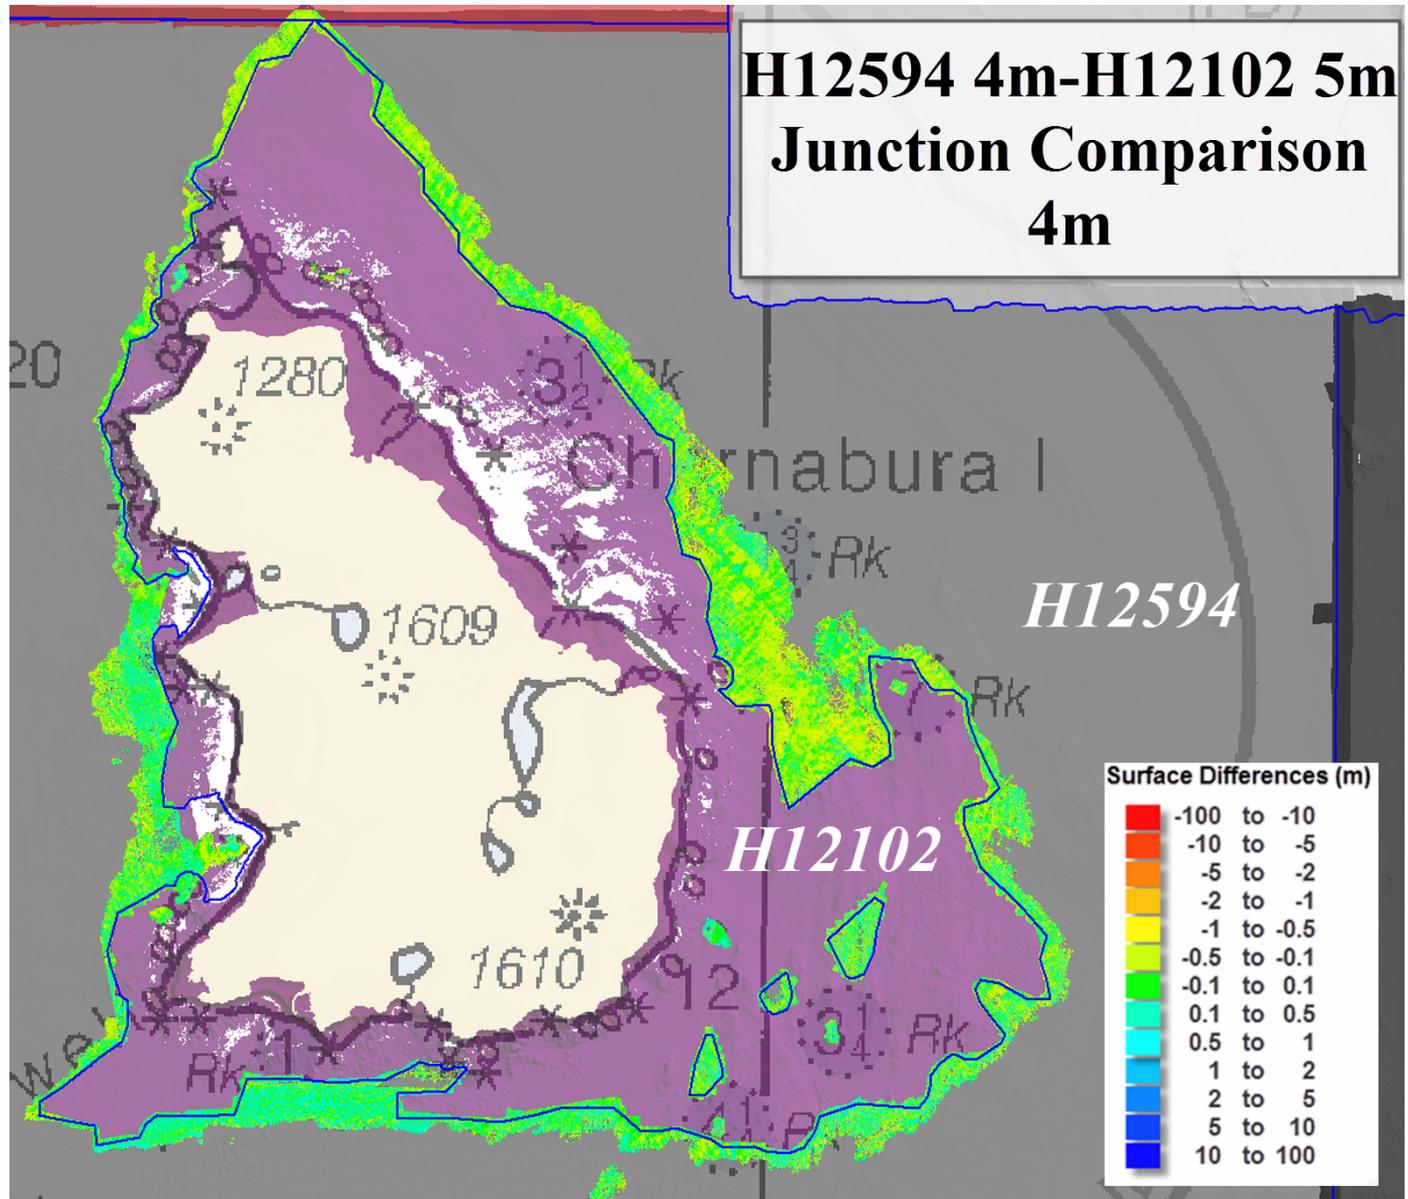
Survey H12102 is in the center of survey H12594, with overlap ranging from 30 to 900 meters and depths from 2 to 35 meters (Figure 16). Difference surface analysis between the H12594 4-meter and the H12102

Figure 16: Difference surface (5-meter grid) of the junction of H12594 and H12102 in meters. Values are positive where H12102 is shoaler than H12594.

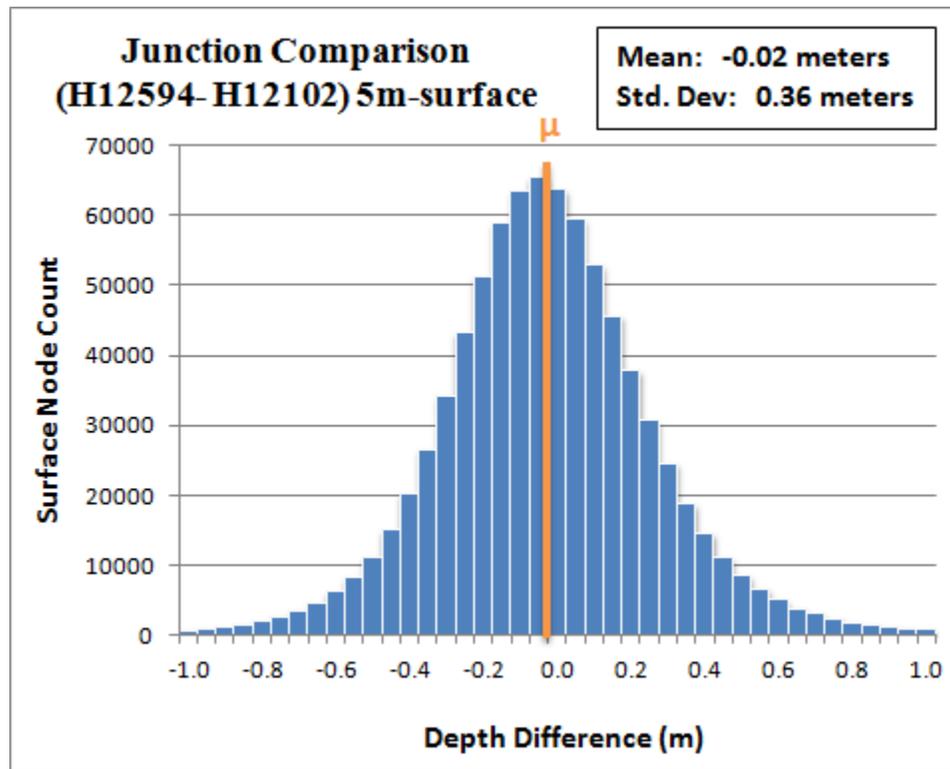
5-meter depth layers showed H12594 to be an average of 0.02 meters shoaler than H12102, with a standard deviation of 0.36 meters (Figure 17). This is well within allowable IHO Order 1 accuracy at these depths.

Figure 17: Difference surface statistics between H12594 4-meter and H12102 5-meter depth surfaces. H12102 is on average 0.02 meters deeper than H12594.

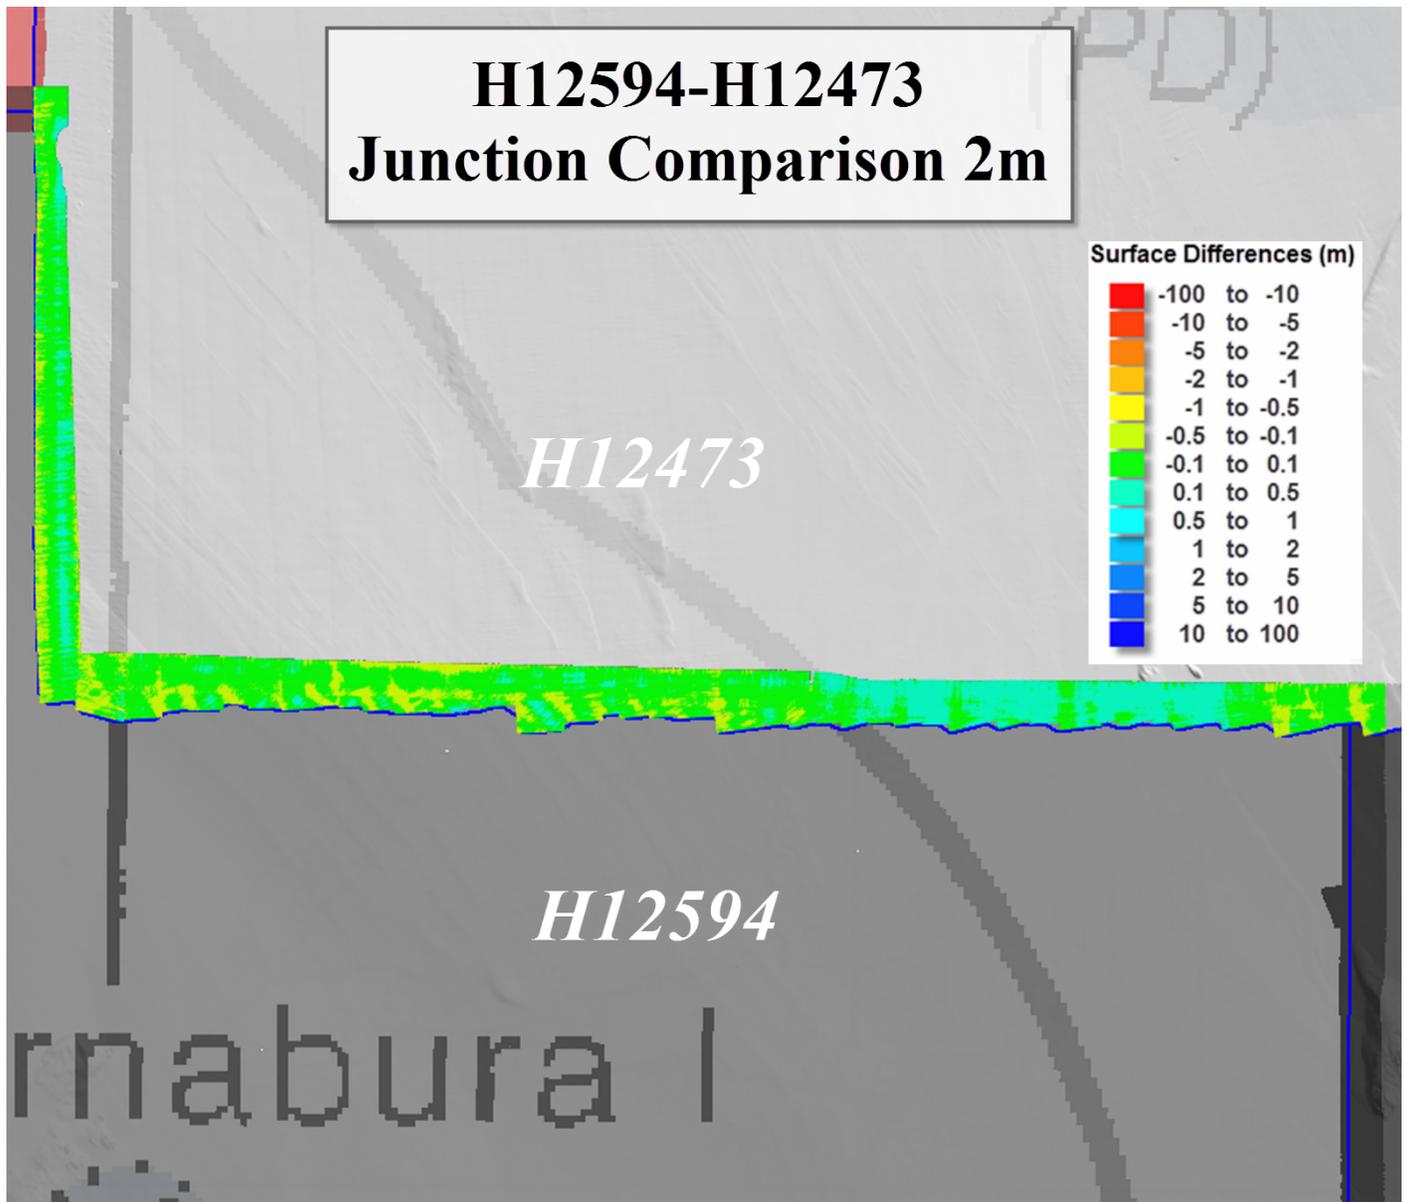
The overlap with survey H12473 was approximately 210 meters wide along the northeastern boundary of H12594, with depths from 45 to 50 meters (Figure 18). Difference surface analysis between the 2-meter CUBE depth layers showed H12594 to be an average of 0.01 meters deeper than H12473, with a standard deviation of 0.12 meters (Figure 19). This is well within allowable IHO Order 1 accuracy at these depths.

Figure 18: Difference surface (2-meter grid) of the junction of H12594 and H12473 in meters. Values are positive where H12473 is shallower than H12594.

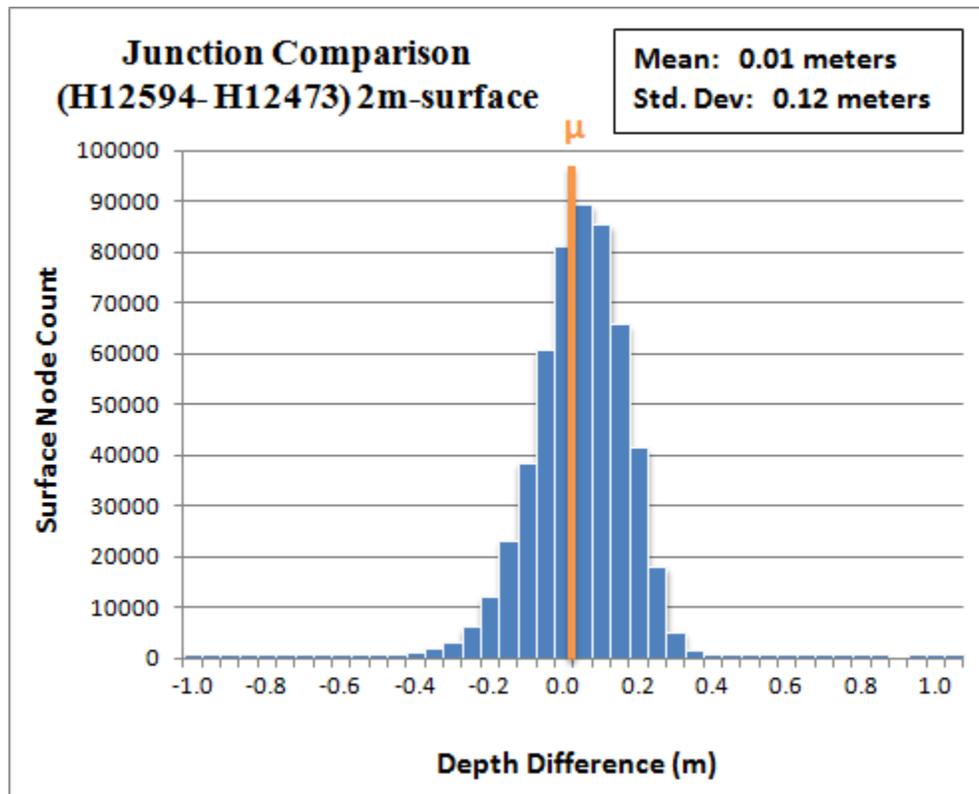
Figure 19: Difference surface statistics between H12594 and H12473 2-meter depth surfaces. H12473 is on average 0.01 meters shoaler than H12594.

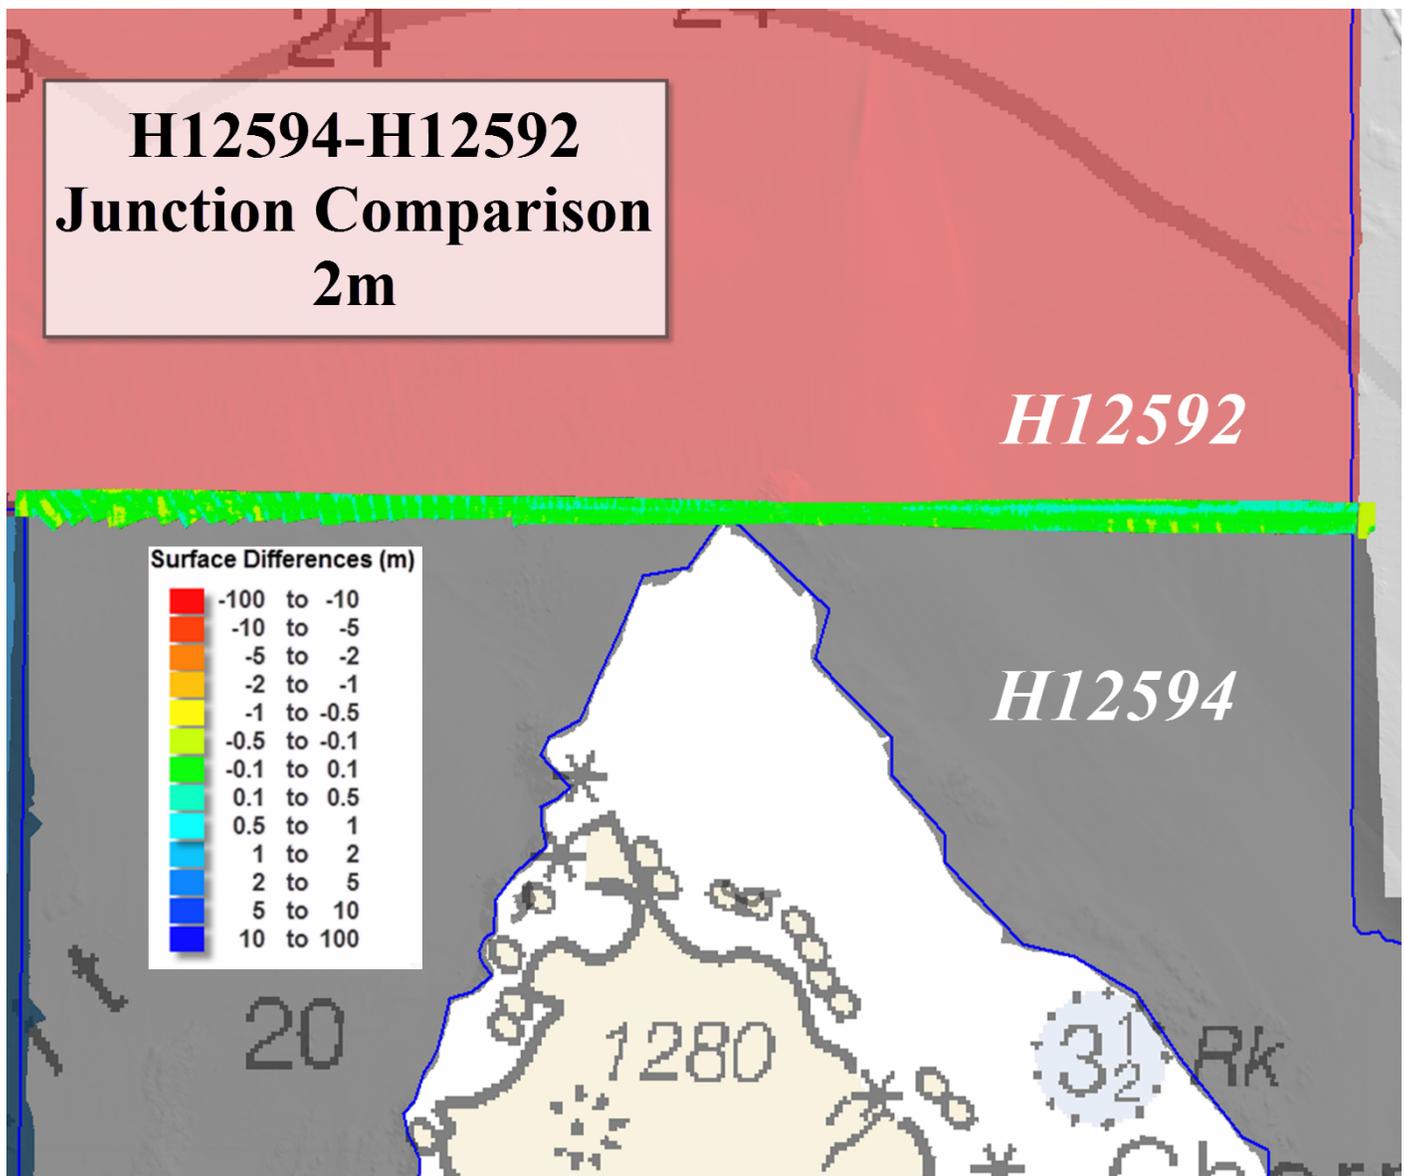
The overlap with survey H12592 was approximately 200 meters wide along the northern boundary of H12594, with depths from 20 to 45 meters (Figure 20). Difference surface analysis between the 2-meter CUBE depth layers showed H12594 to be an average of 0.03 meters deeper than H12592, with a standard deviation of 0.08 meters (Figure 21). This is well within allowable IHO Order 1 accuracy at these depths.

Figure 20: Difference surface (2-meter grid) of the junction of H12594 and H12592 in meters. Values are positive where H12592 is shallower than H12594.

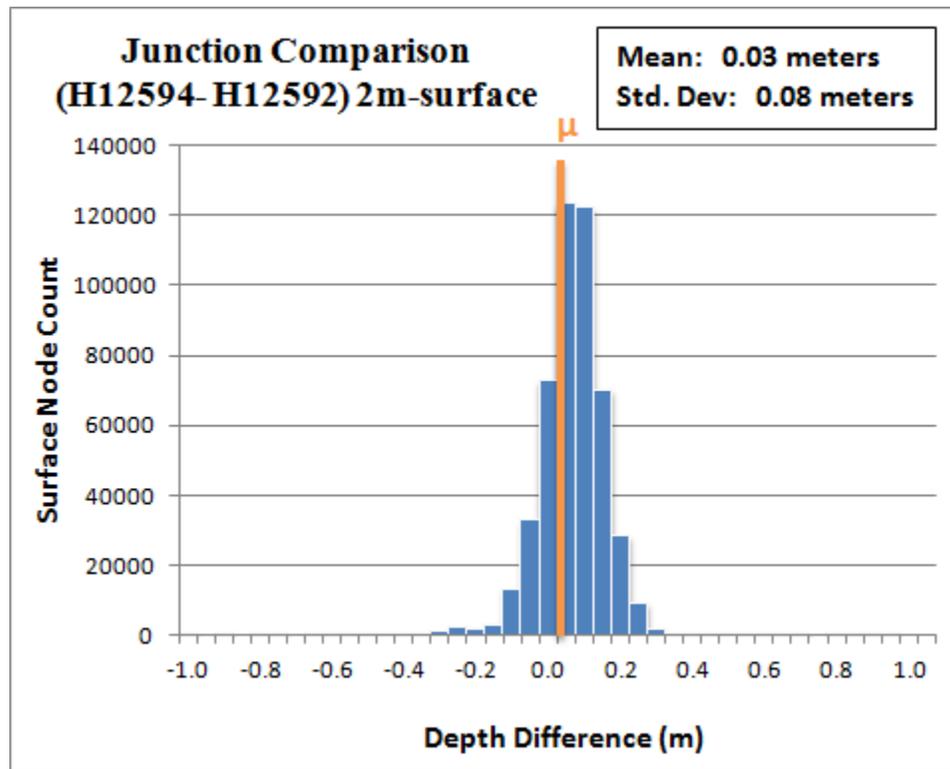
Figure 21: Difference surface statistics between H12594 and H12592 2-meter depth surfaces. H12592 is on average 0.03 meters shoaler than H12594.
