DESCRIPTIVE REPORT

Type of Survey: Navigable Area

Registry Number: H12594

Sub-locality: Vicinity of Chernabura Island

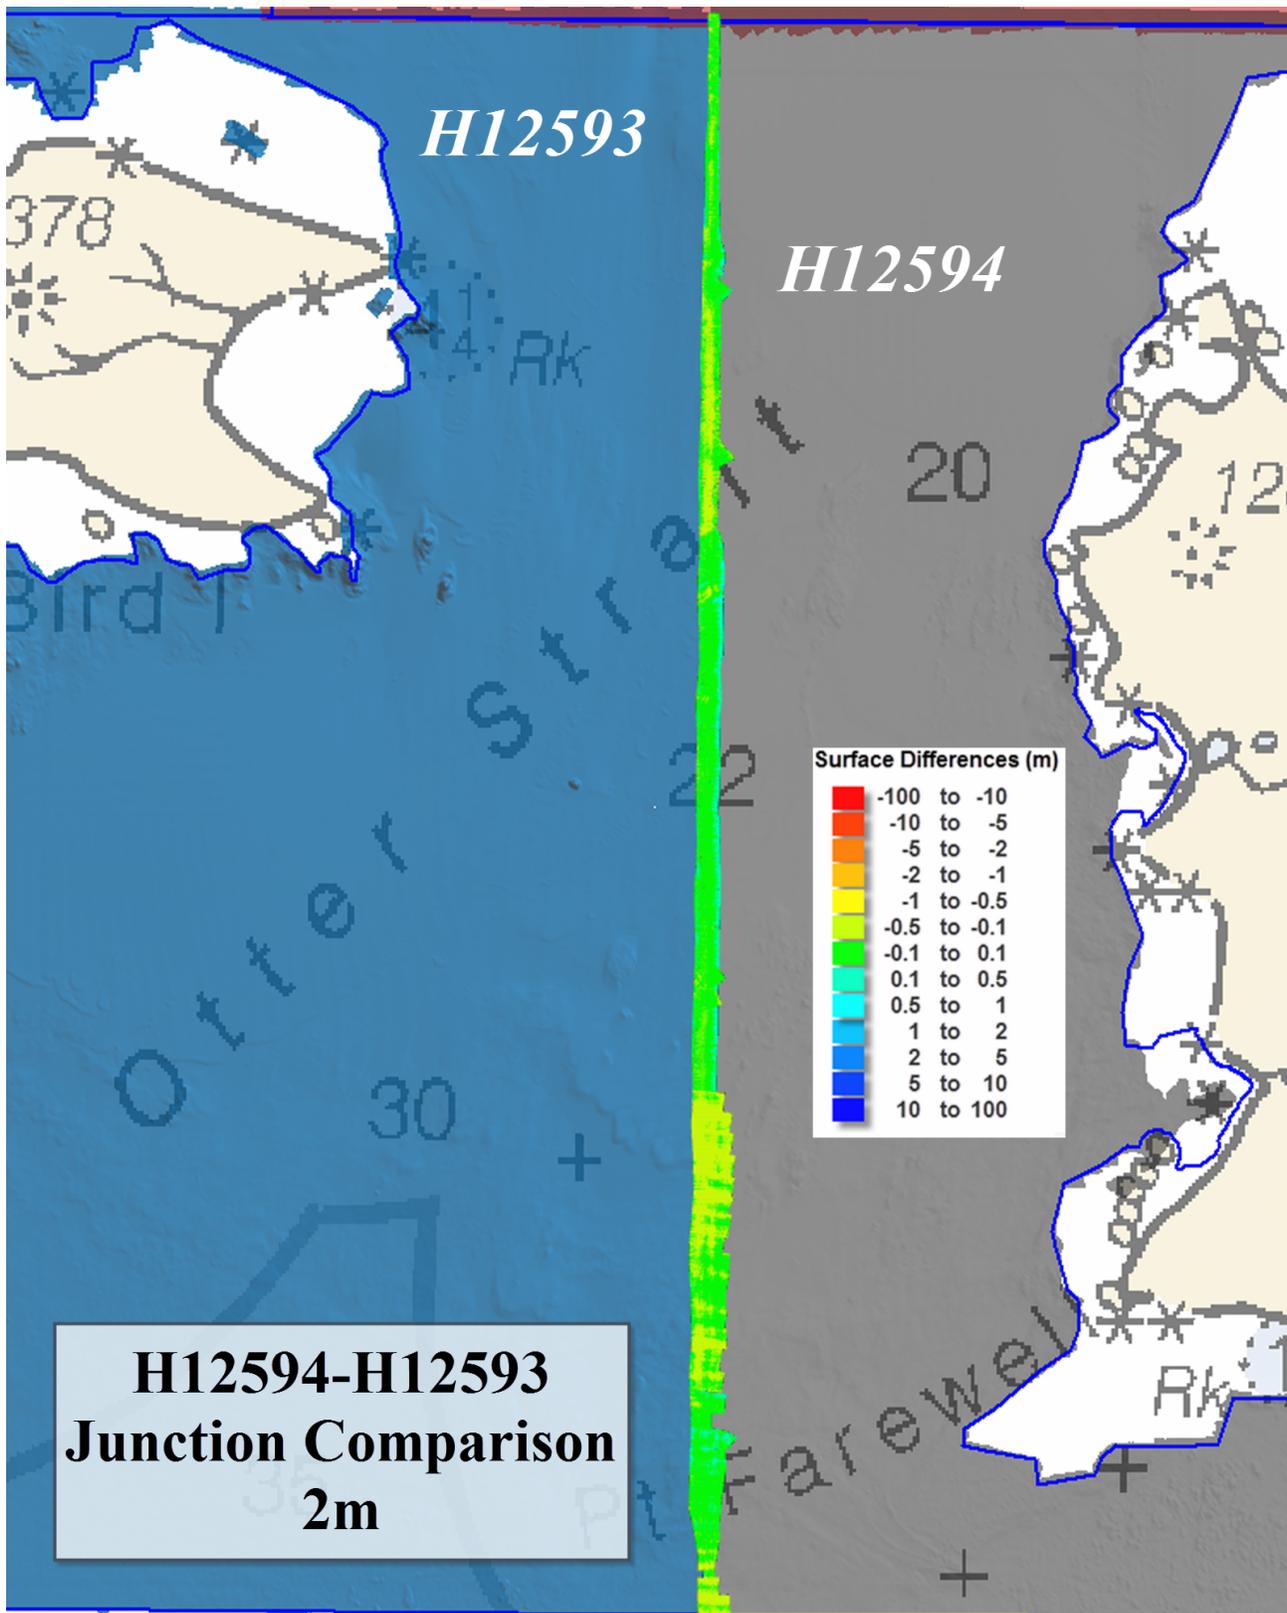
Survey H12593 had 90 to 300 meters of overlap along the western boundary of H12594, with depths from 35 to 40 meters (Figure 22). Difference surface analysis between the 2-meter CUBE depth layers showed H12594 to be an average of 0.04 meters shoaler than H12593, with a standard deviation of 0.11 meters (Figure 23). This is well within allowable IHO Order 1 accuracy at these depths.

Figure 22: Difference surface (2-meter grid) of the junction of H12594 and H12593 in meters. Values are positive where H12593 is shallower than H12594.

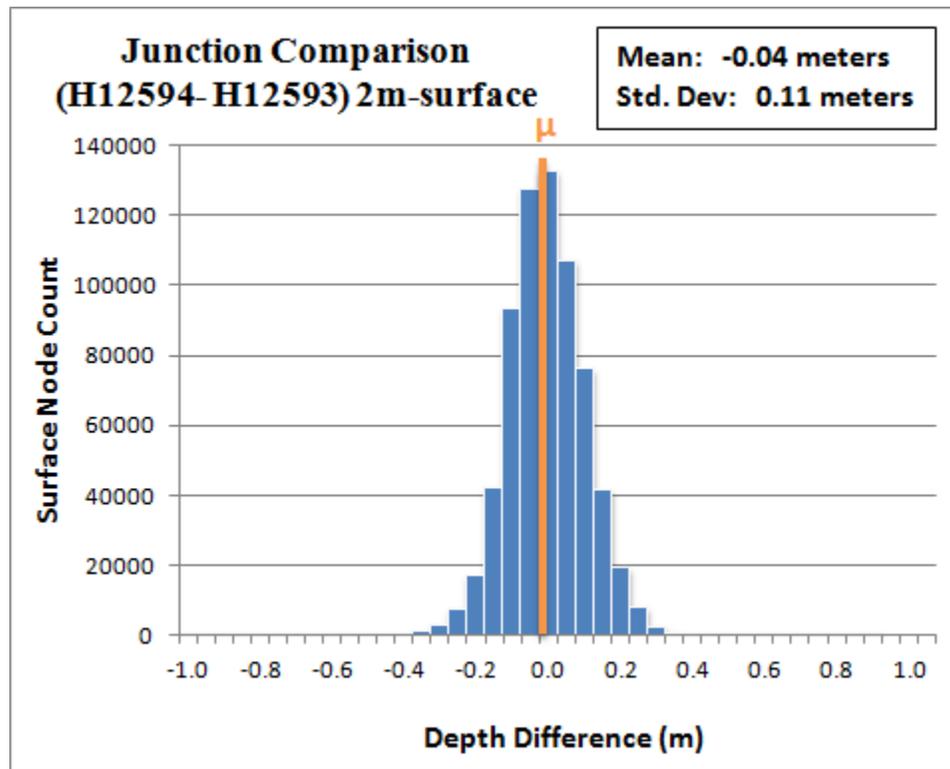
Figure 23: Difference surface statistics between H12594 and H12593 2-meter depth surfaces. H12593 is on average 0.04 meters deeper than H12594.

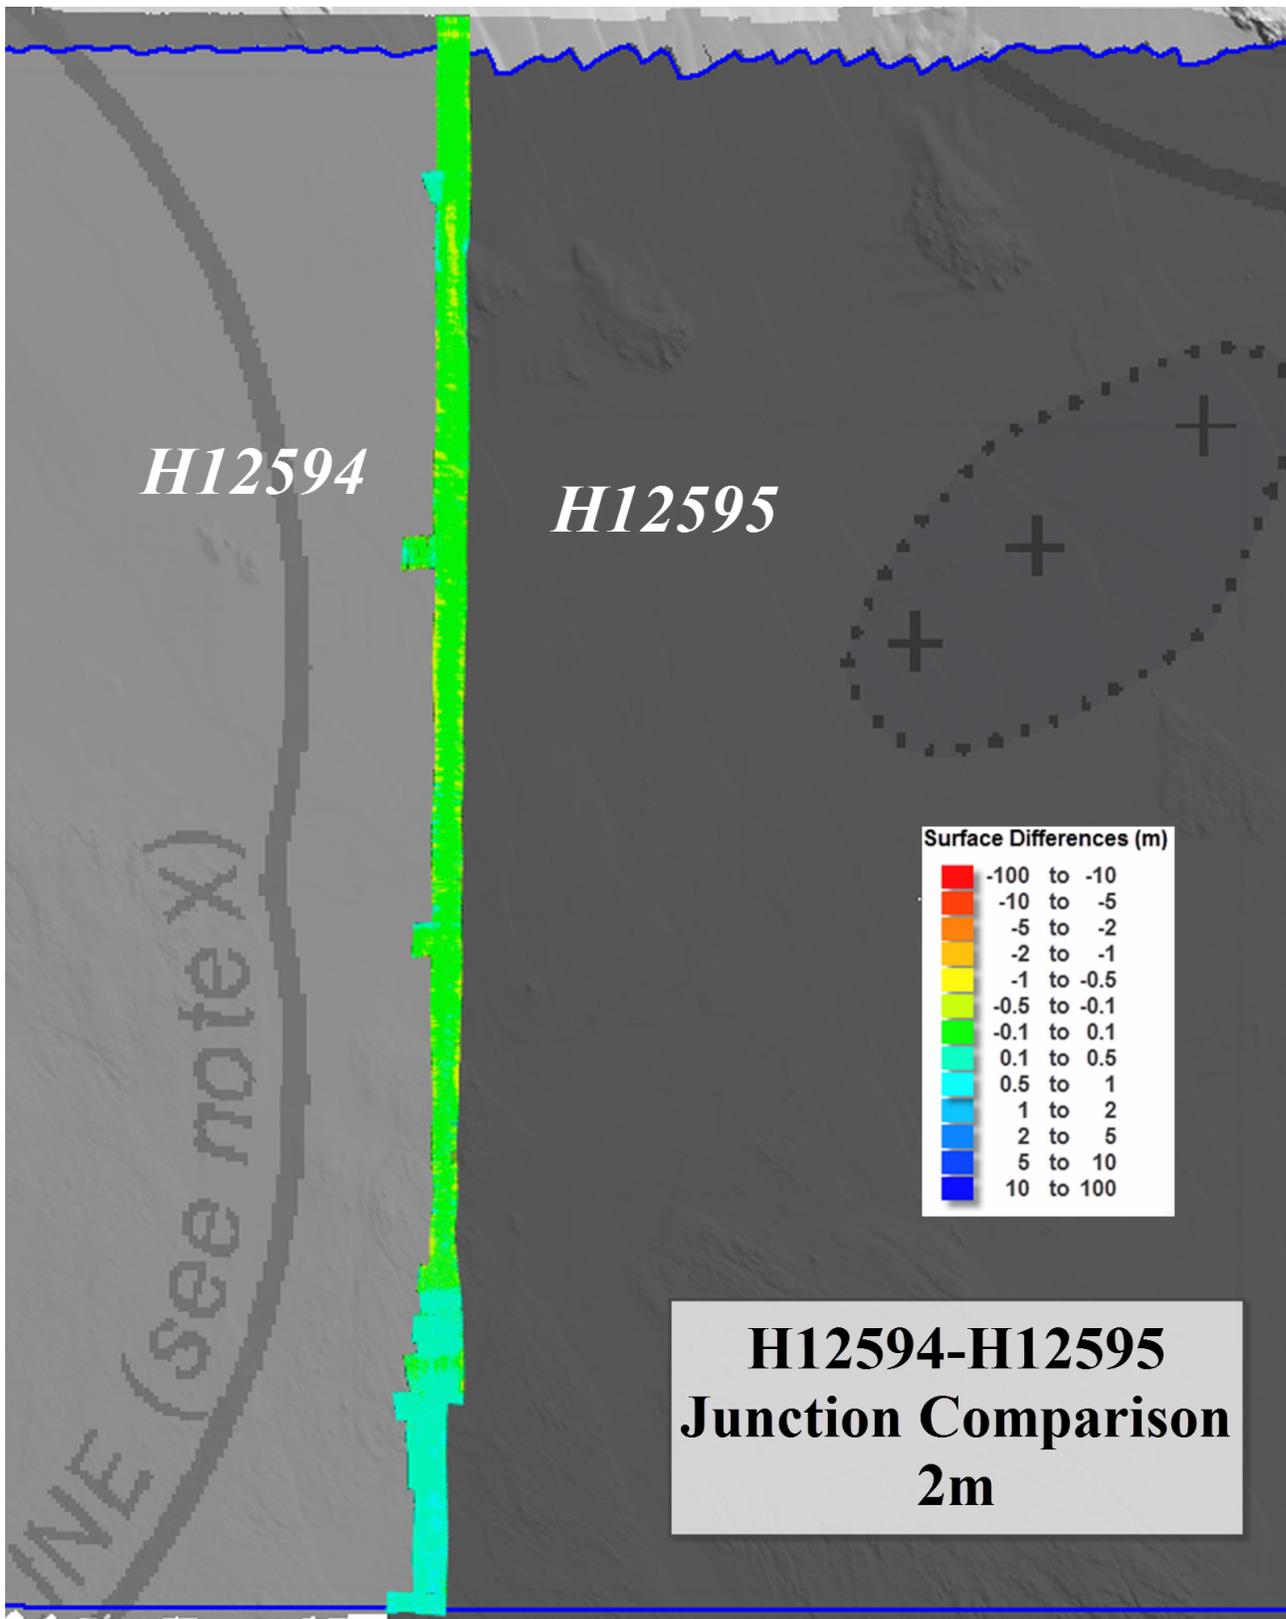
The overlap with survey H12595 was approximately 200 meters wide along the eastern boundary of H12594, with depths from 40 to 55 meters (Figure 24). Difference surface analysis between the 2-meter CUBE depth layers showed H12594 to be an average of 0.08 meters deeper than H12594, with a standard deviation of 0.19 meters (Figure 25). This is well within allowable IHO Order 1 accuracy at these depths.

Figure 24: Difference surface (2-meter grid) of the junction of H12594 and H12595 in meters. Values are positive where H12594 is shoaler than H12595.

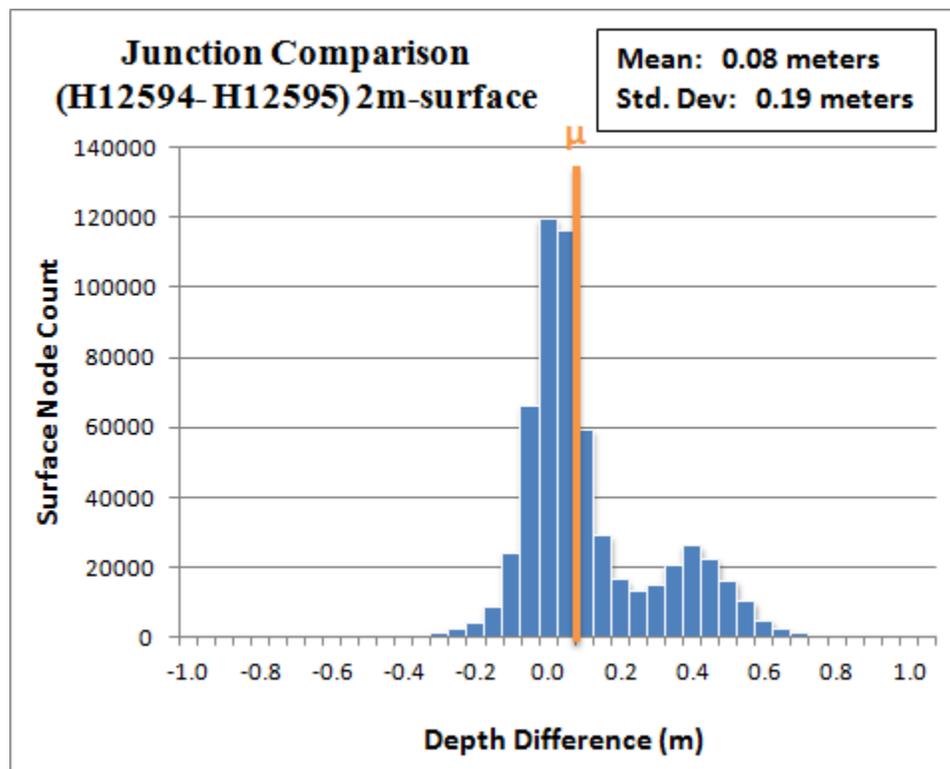
Figure 25: Difference surface statistics between H12594 and H12595 2-meter depth surfaces. H12595 is on average 0.08 meters shoaler than H12594.

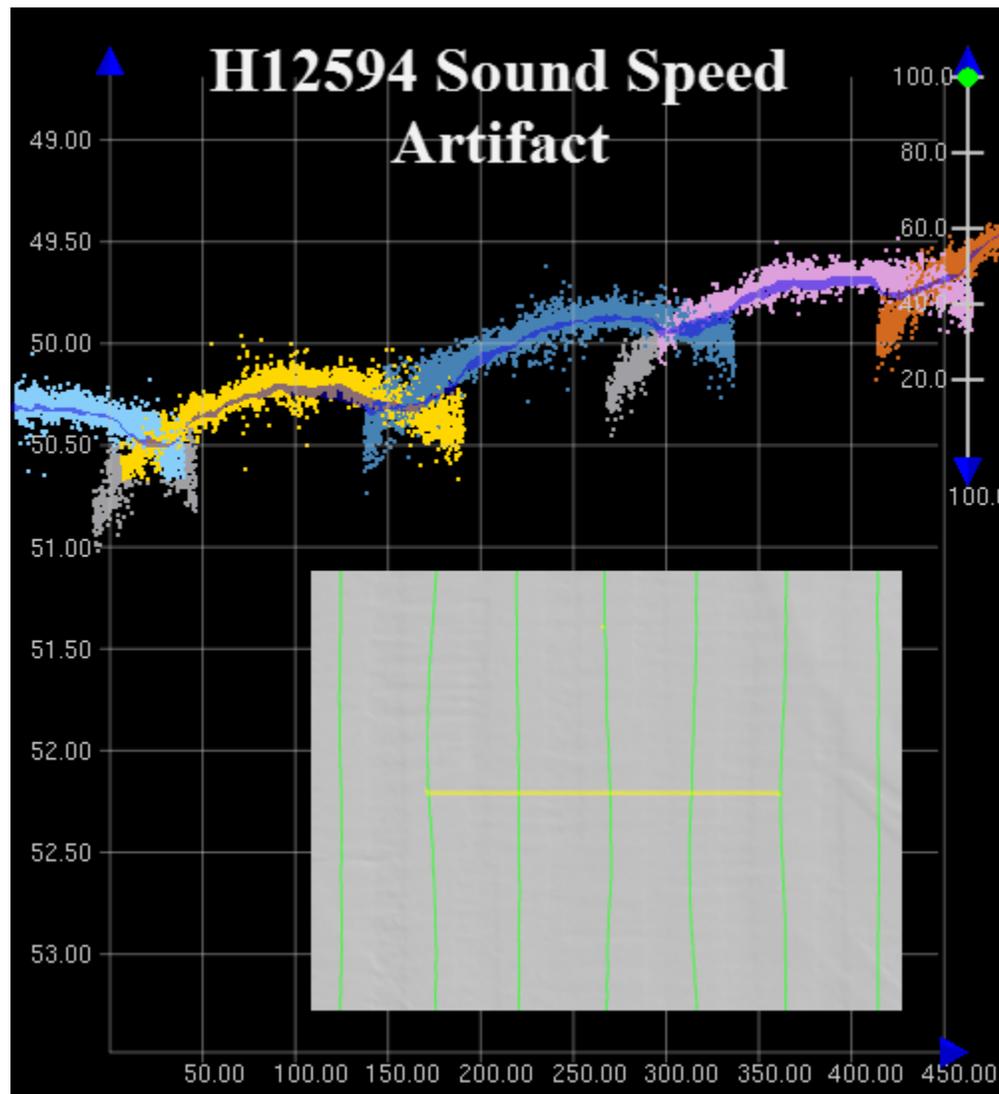
Despite casts being taken as frequently as every 15 minutes, with consideration to spatial distribution, sound speed artifacts were seen within the data. These artifacts occurred as "smiles" or "frowns" due to inadequately modeled refraction. In these areas, the outer beams were flagged as rejected to assist the gridding algorithm in bringing the surface back to better represent the true seafloor. Although this artifact exists within the data, it is within uncertainty standards specifications as stated within Section 5.1.3 of the HSSD. The Hydrographer finds that the data is adequate to supersede charted data (Figure 26).

Figure 26: Example of sound speed artifact. Areas were cleaned where it significantly affected the CUBE surface.

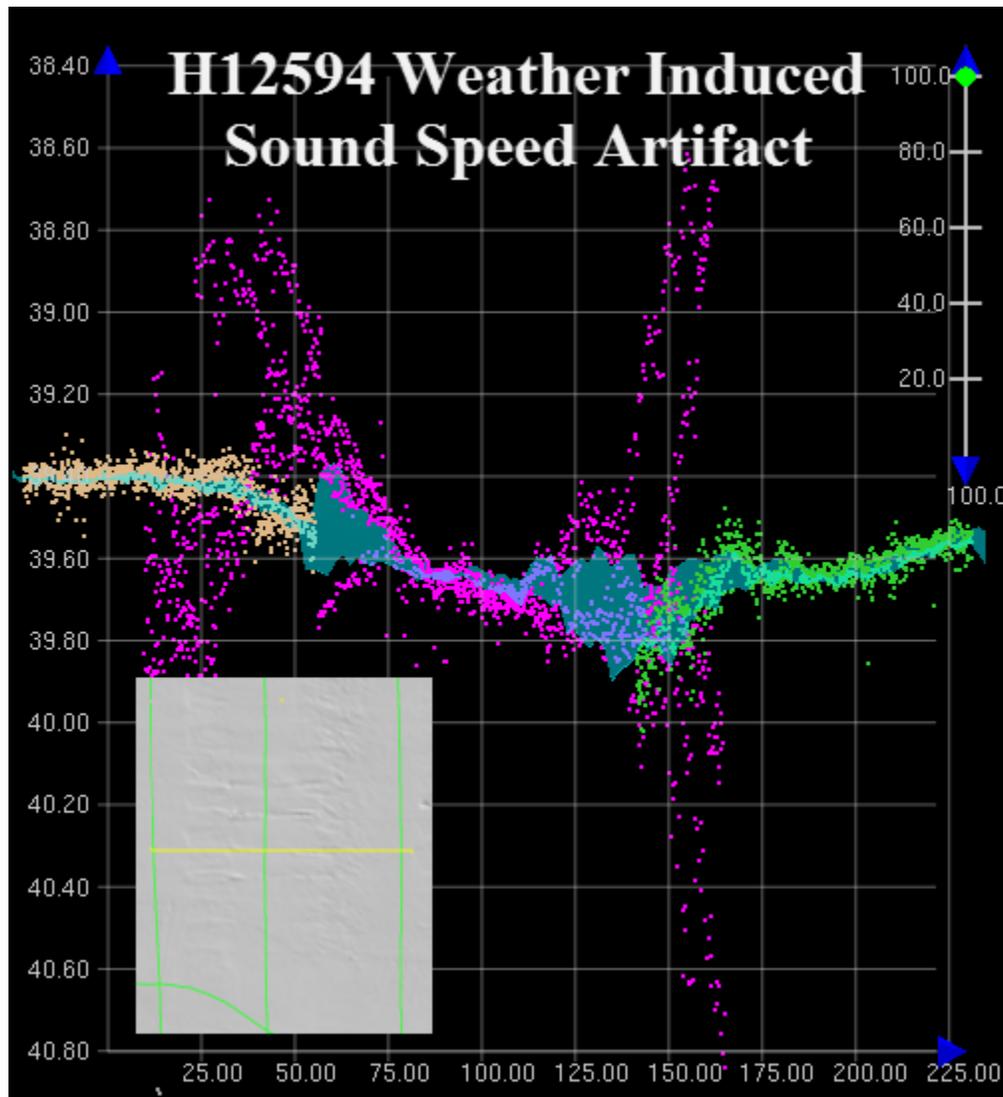
In heavy seas, bubble sweep across the SVP70 sound speed sensor resulted in occasional loss of accurate surface sound speed data, causing artifacts on DN198, 212, 214, and 244 (Figure 27). Artifacts are visible in the CUBE surfaces on southbound lines heading into the prevailing sea state. Artifacts were inspected in CARIS using Subset Editor and cleaned to within IHO standards of neighboring data. Although this artifact exists within the data, it is within specification as stated within the HSSD. It is in the opinion of the Hydrographer that the data is adequate to supersede the chart.

Figure 27: Typical weather induced 0.15 meter surface sound speed artifact in CUBE surface. Areas were cleaned where it significantly affected the CUBE surface, based on IHO standards.

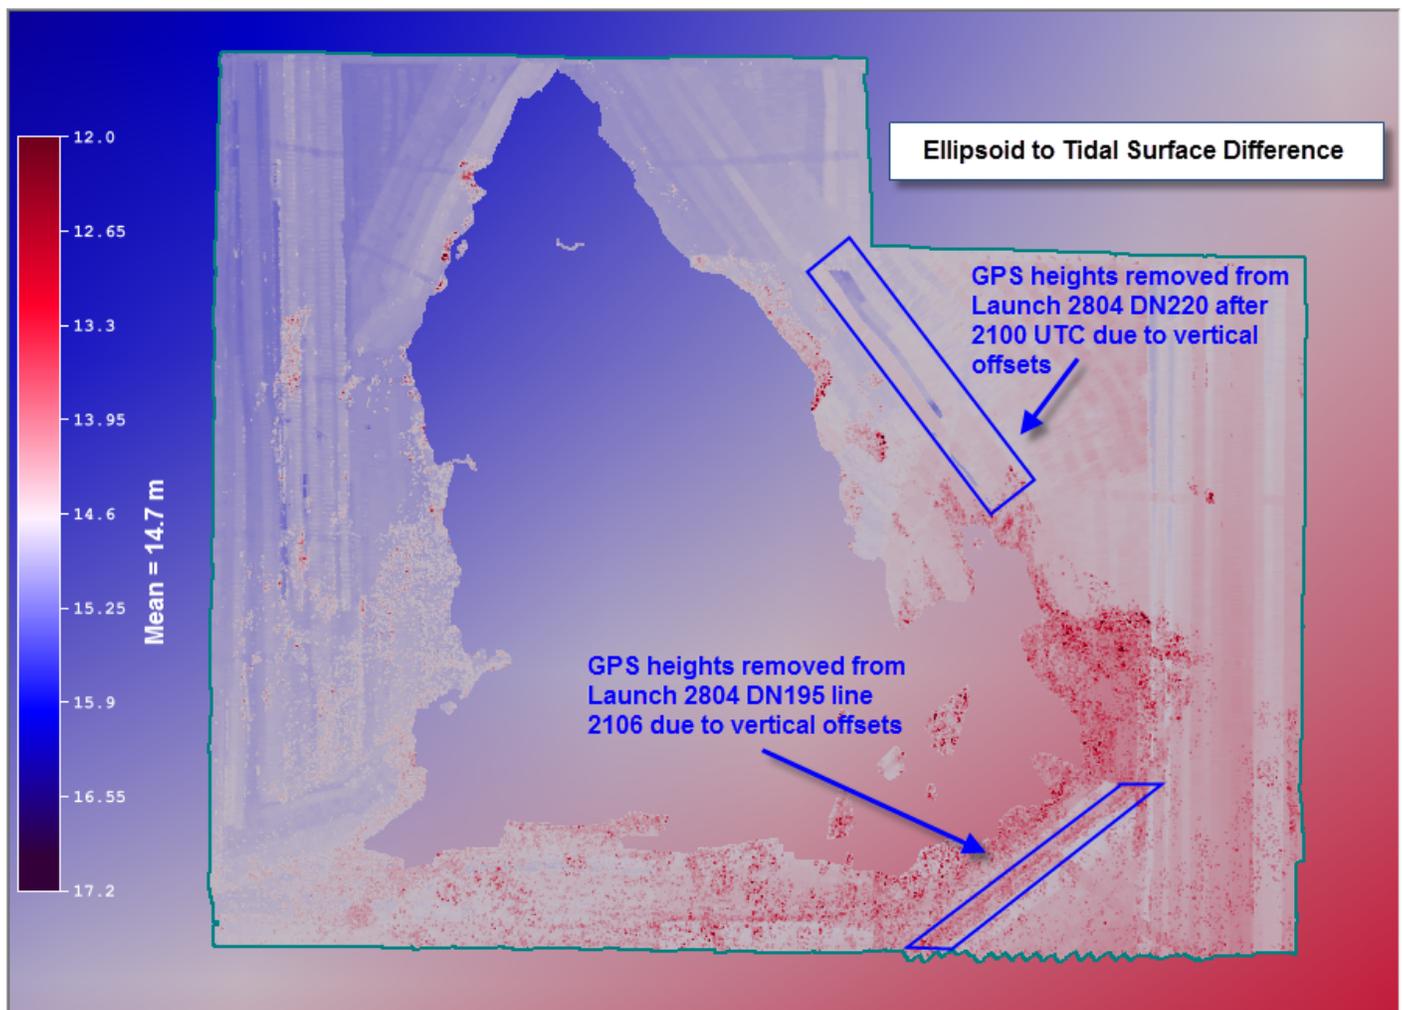
Upon review of this surface, vertical offsets were found in the data for Launch 2804 (RA-6) on DN220 after 2100 UTC, and for line 2804_2013RA1952106 from Launch 2804 on DN195, when referenced to the ellipse. These offsets at times exceeded one meter vertically when compared to surrounding data. Out

The depth gradient between the MLLW and the ERS surfaces is expected to be similar in magnitude and position as the EGM2008-WGS84 geoid-ellipsoid separation model published by the National Geospatial Intelligence Agency (NGA). In review it was found that the two models compare well - exhibiting a signature NW-to-SE gradient of depth differences across the survey area - particularly considering the 2.5' resolution of the NGA surface and the expected differences between the geoid and MLLW (Figure 28).

Figure 28: Difference surface between the ellipsoidally-referenced and tidally-referenced surfaces.

Difference surface is overlaid on the EGM2008-WGS84 geoid-ellipsoid separation model.

of an abundance of caution, GPS heights were removed from this data. Since no horizontal offsets were seen at MLLW or the ellipse, the rest of the correctors within the SBETs were retained (see C.3 Additional Horizontal or Vertical Control Issues).

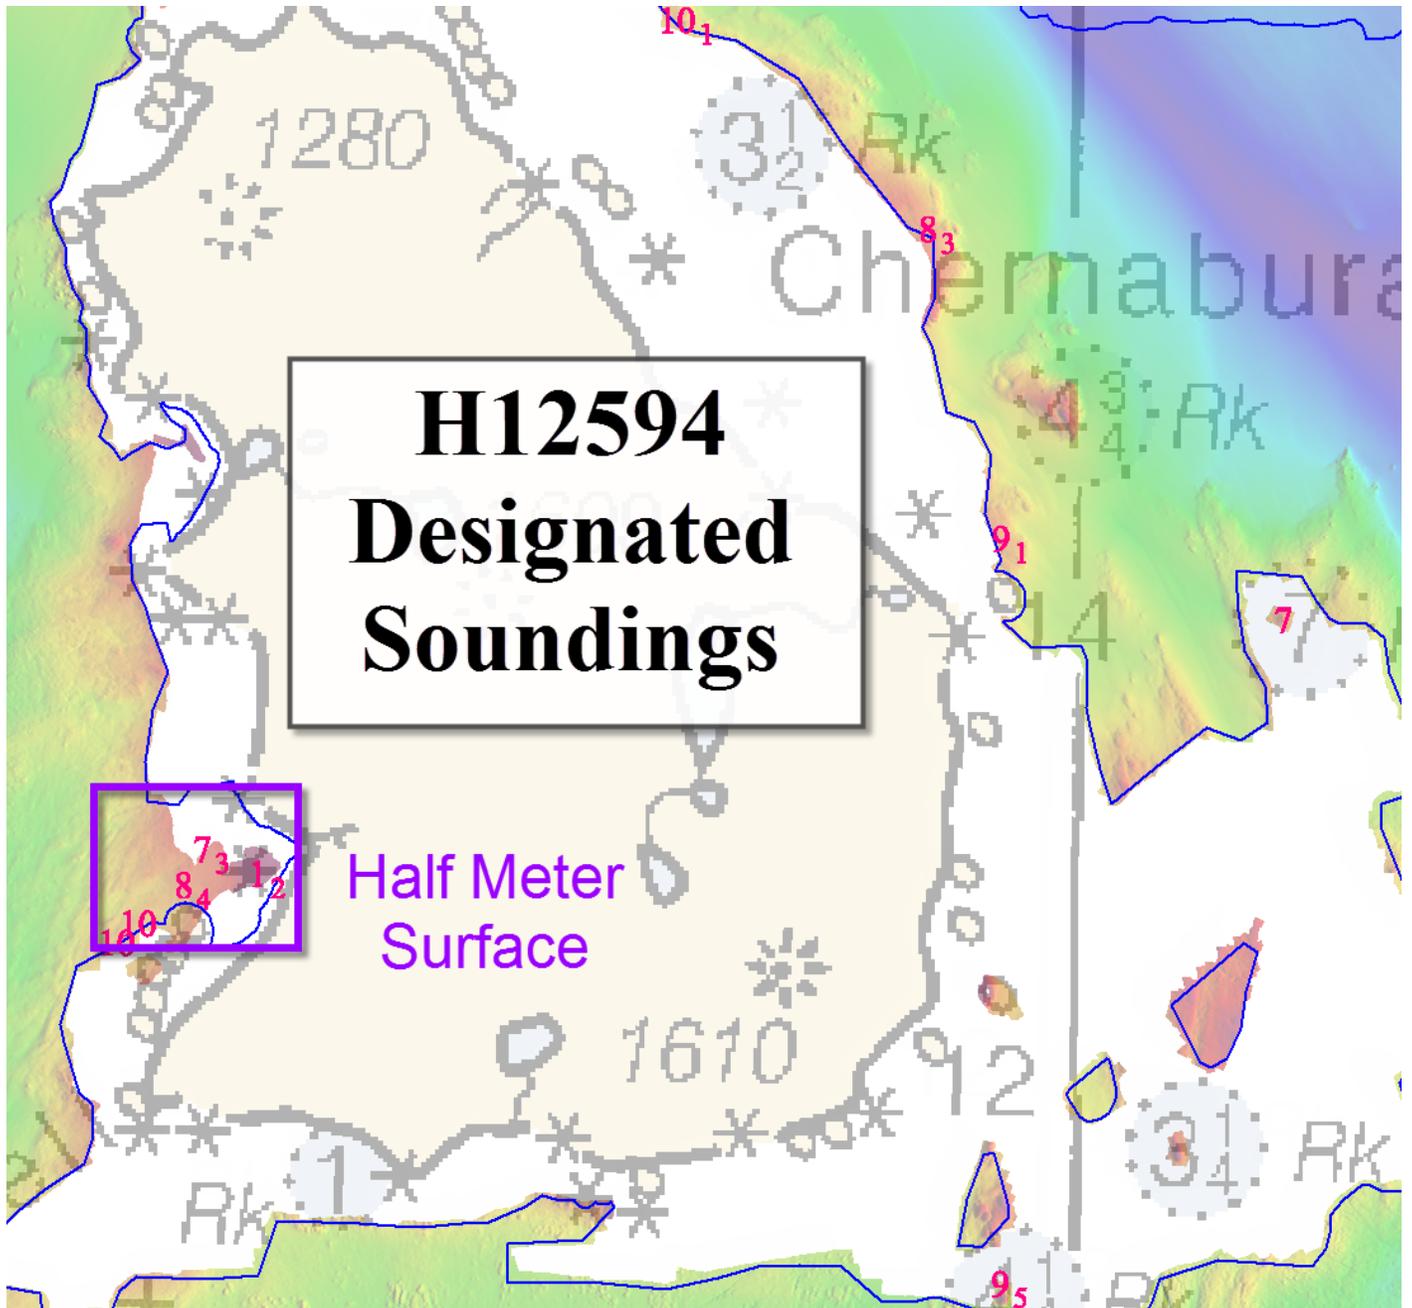
Ten designated soundings were selected in accordance with 5.2.1.2 of the HSSD to override the gridded CUBE surfaces in an area in which the model did not accurately reflect the shoalest sounding (Figure 30).

Figure 30: H12594 designated soundings in fathoms.

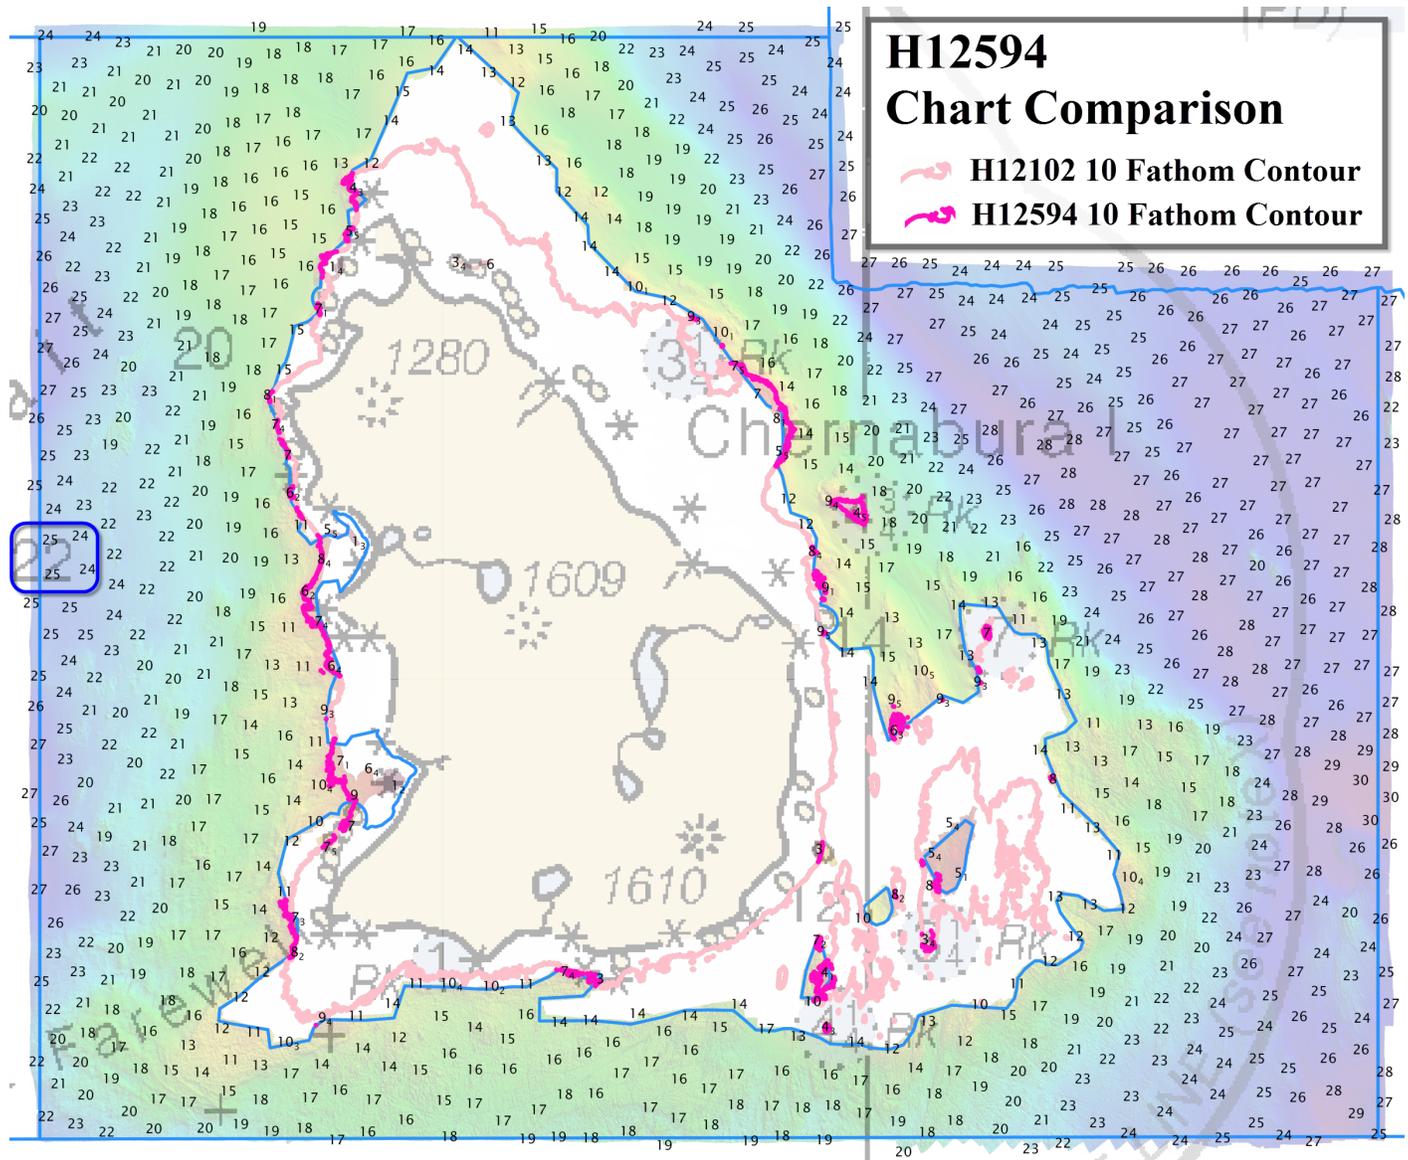
Contours and soundings were created from H12594 data and were visually compared to Chart 16540 (Figure 31). One of the seven soundings was found to be deeper than previously charted. The Hydrographer recommends that H12594 data supersede all charted depths on Chart 16540.

Figure 31: Comparison of Chart 16540 soundings to those derived from H12594. All soundings are in fathoms. Chart soundings are larger, survey soundings are smaller. One sounding was deeper than charted (marked in blue). All other soundings were found to be in general agreement.

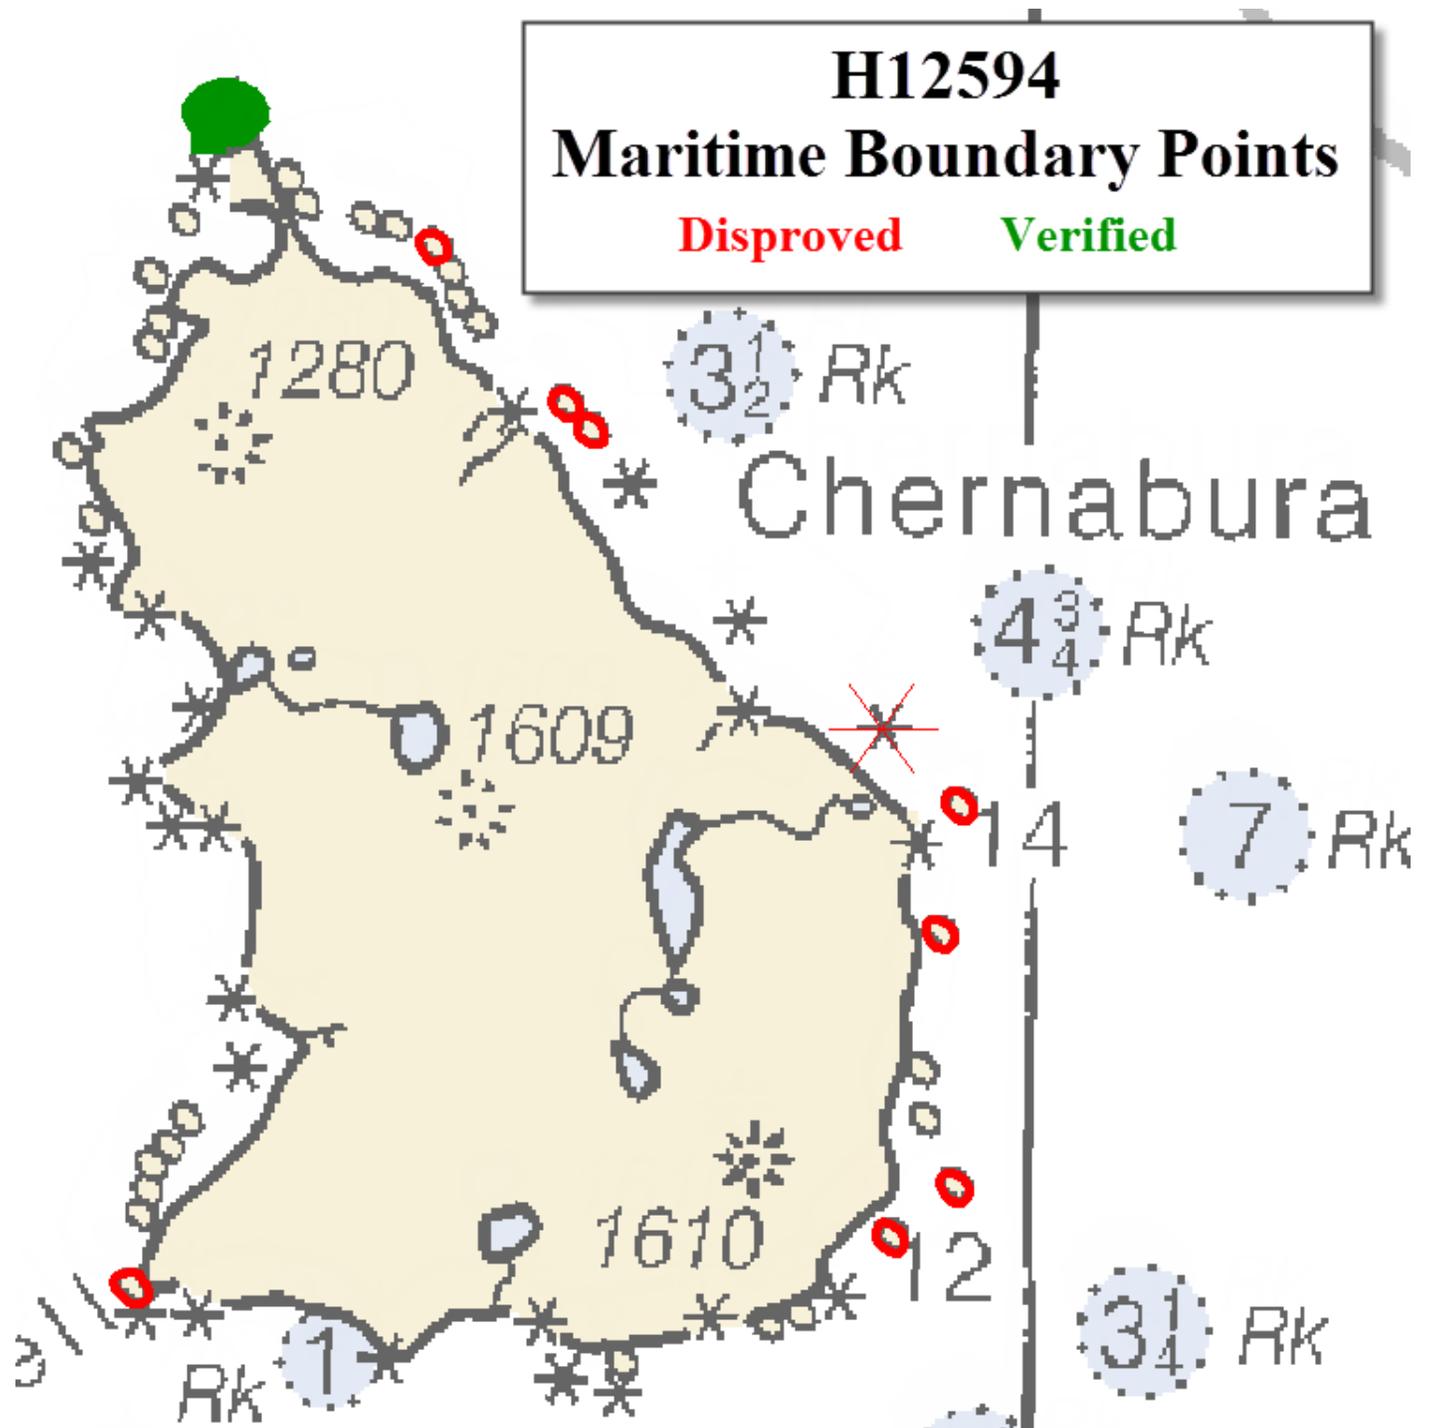
Two Maritime Boundary Points were assigned and investigated in accordance with section 3.5.6 of the FPM. Eight additional unassigned MBPs were disproved during shoreline investigation (Figure 31). The MBP features were addressed as required with S-57 attribution and recorded in the H12594 Final Features File.

Figure 32: H12594 disproved and verified Maritime Boundary Points.

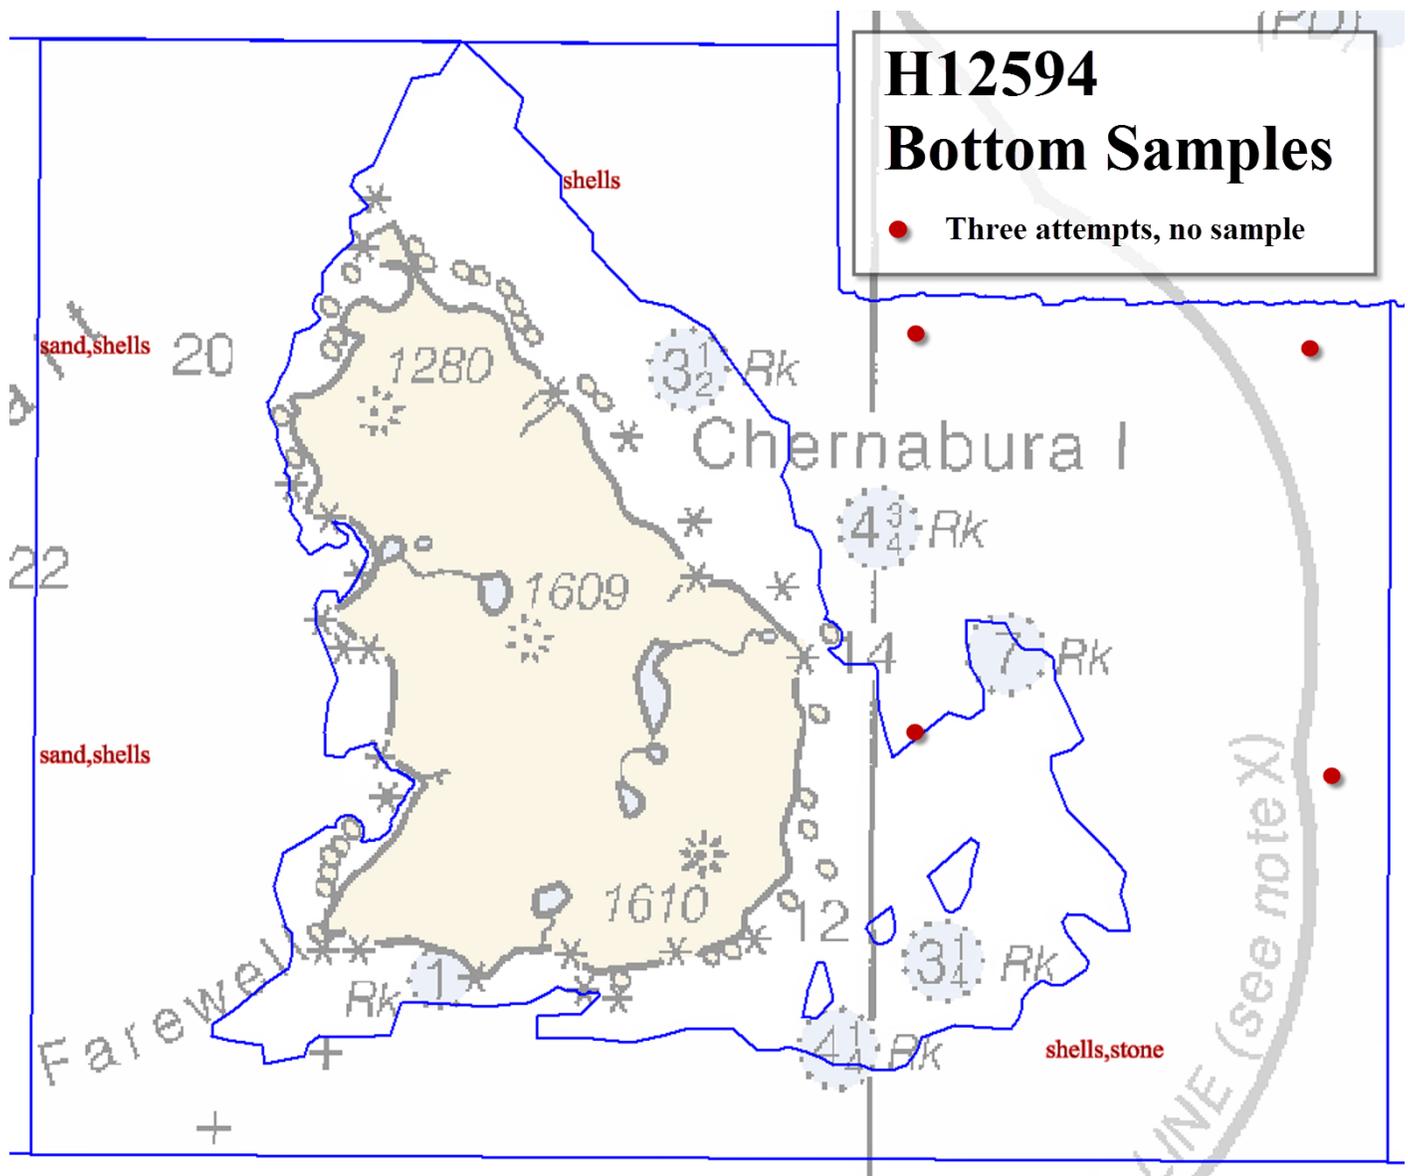
Bottom samples were acquired in accordance with the Project Instructions and the HSSD and are attributed in the Final Features File. A total of 8 bottom samples were collected, 4 of which had conclusive samples (Figure 33).

Figure 33: Locations of H12594 bottom samples.

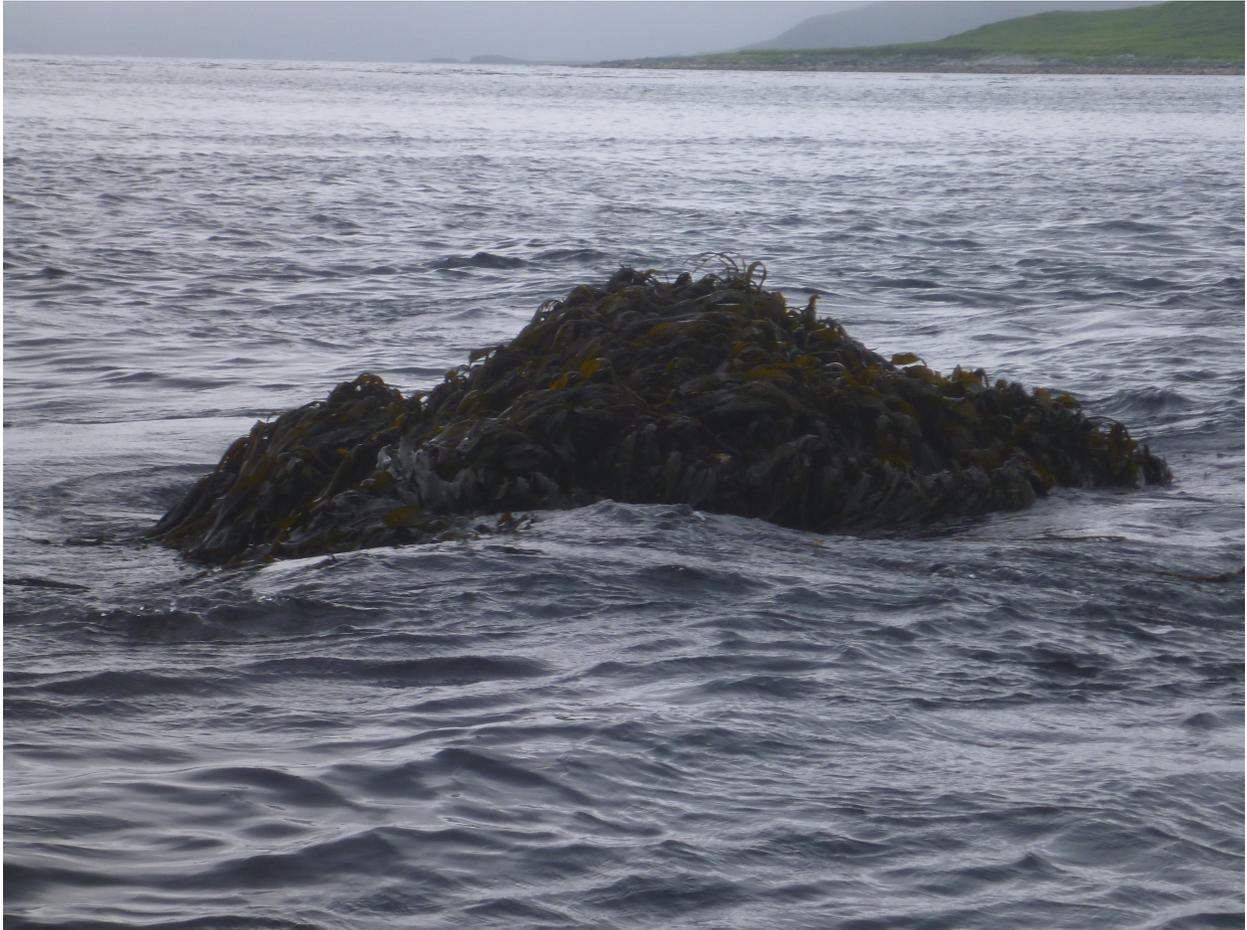
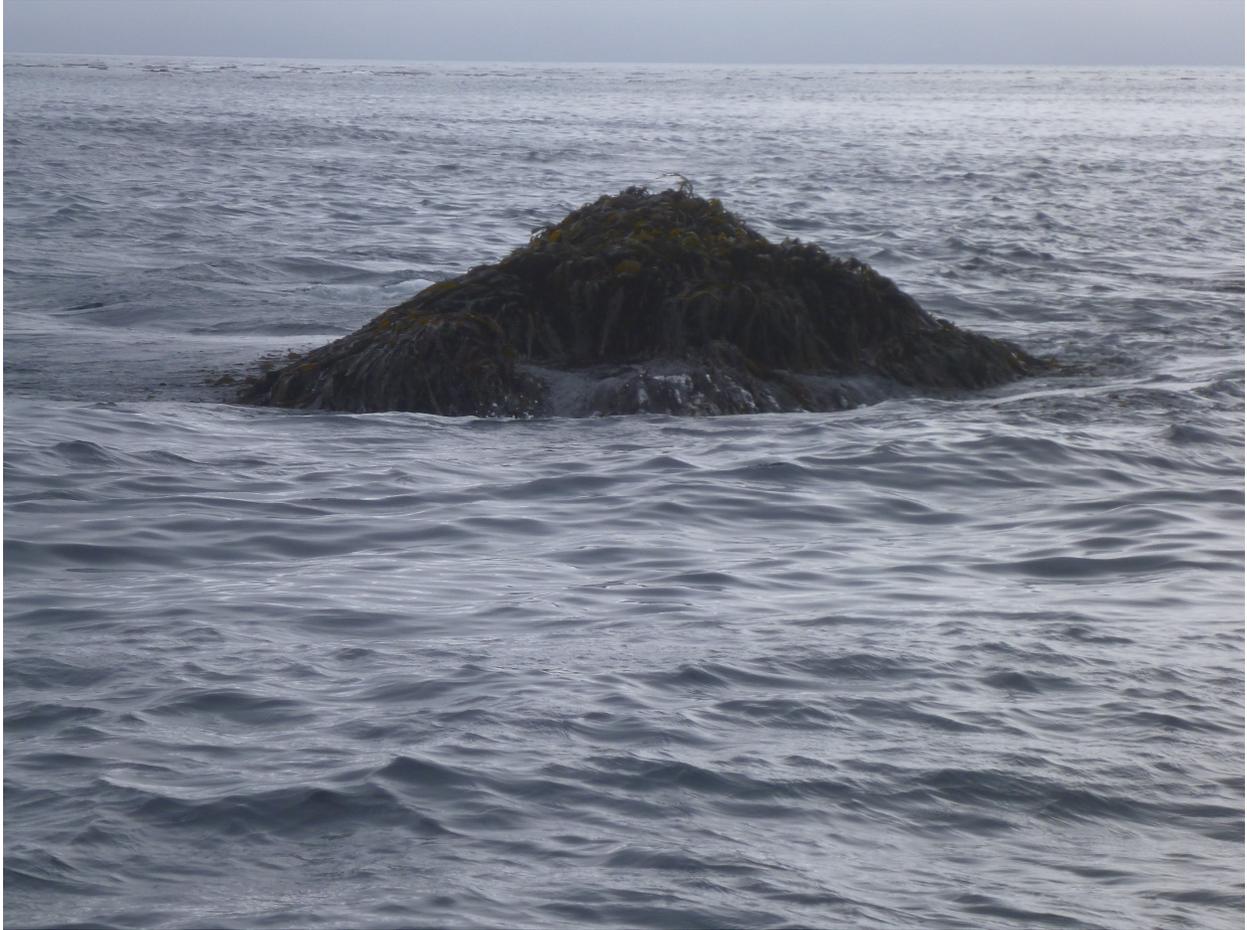
Figure 1.4.1

Attributes: NATSUR - 9:rock
 QUASOU - 6:least depth known
 SORDAT - 20130901
 SORIND - US,US,graph,H12594
 TECSOU - 12:found by levelling
 VALSOU - -0.978 m

Concur with clarification. Chart rock with updated depth.
