DESCRIPTIVE REPORT

Type of Survey: Navigable Area

Registry Number: H12594

Sub-locality: Vicinity of Chernabura Island

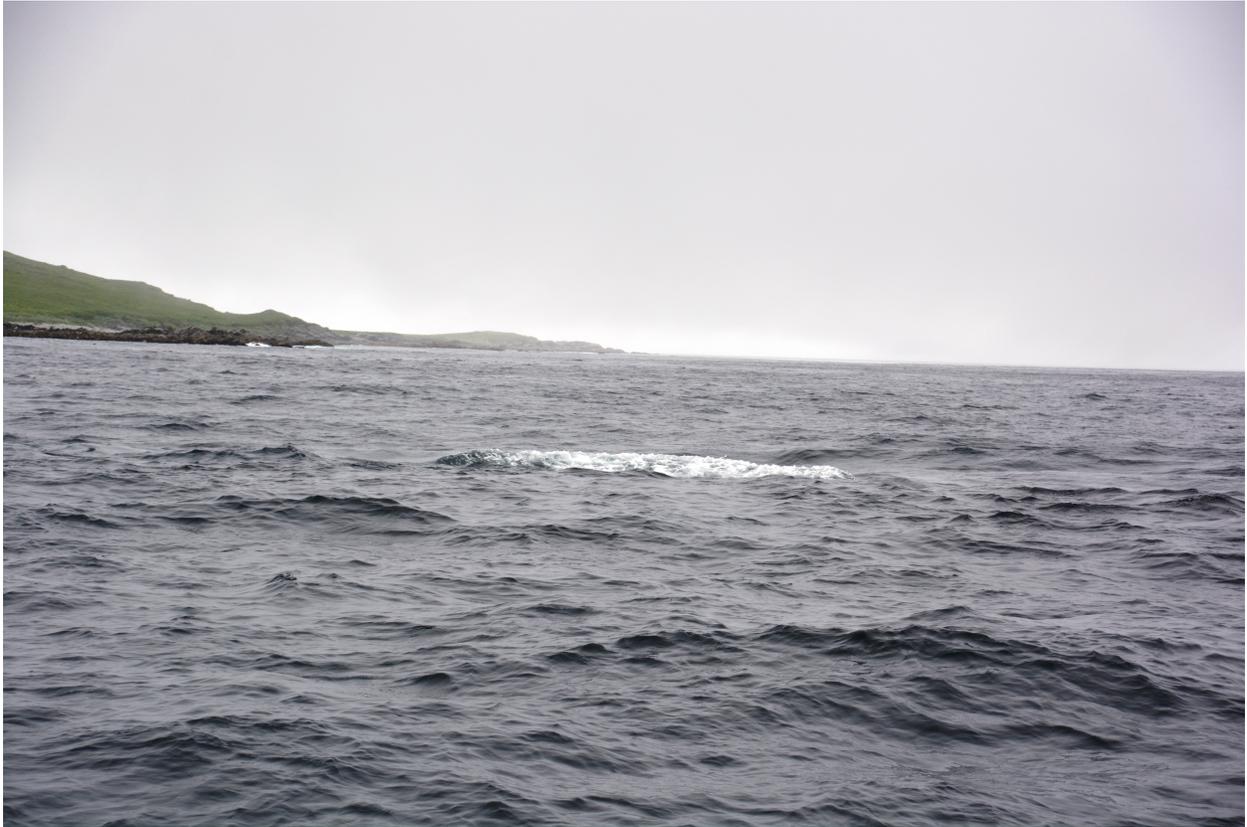
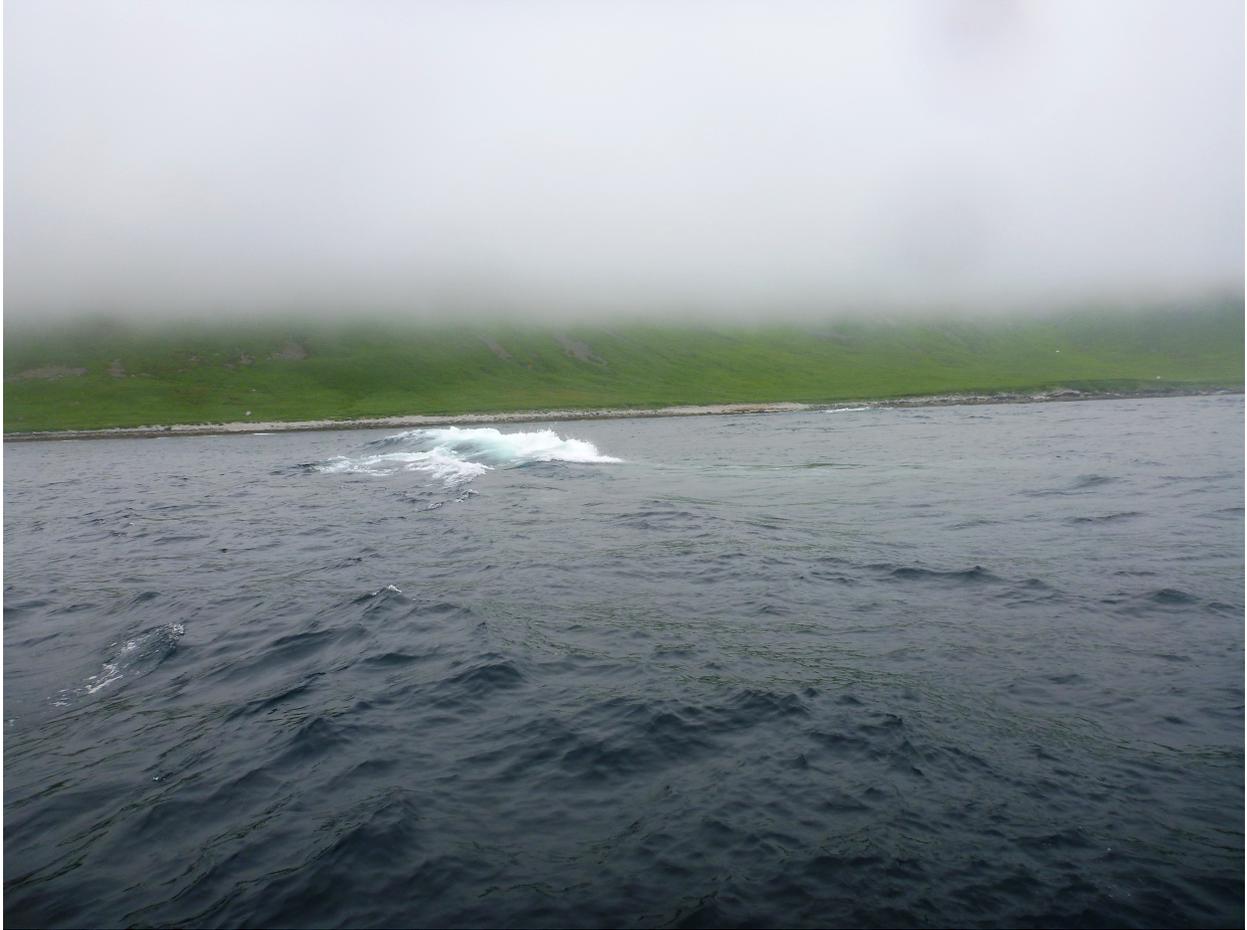
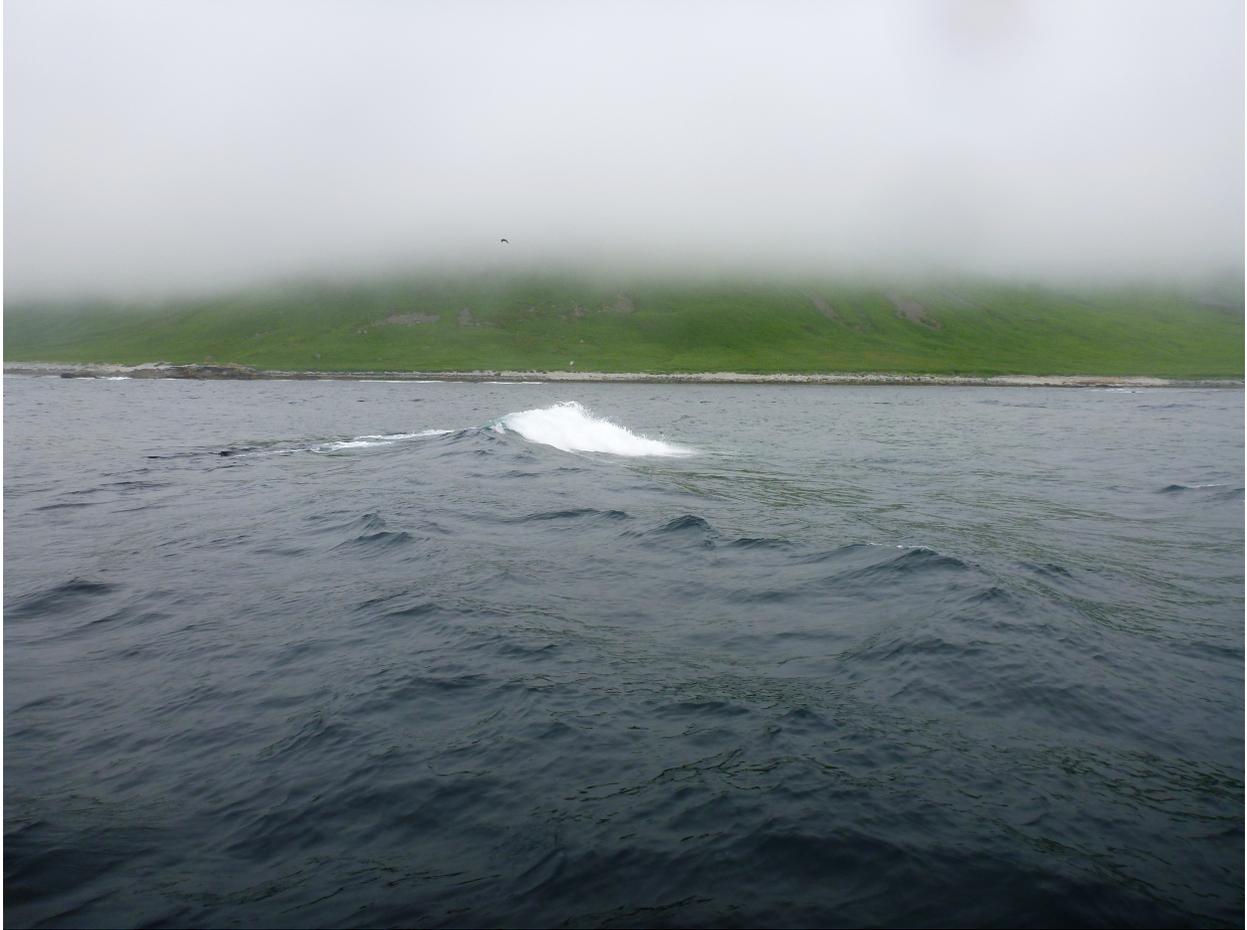
Figure 2.1.1

Attributes: NATSUR - 9:rock
 QUASOU - 6:least depth known
 SORDAT - 20130902
 SORIND - US,US,graph,H12594
 TECSOU - 12:found by levelling
 VALSOU - 0.322 m
 WATLEV - 5:awash

Concur with clarification. Chart rock in place of islet with depth found by levelling (shoaler than LIDAR depth).
