**DESCRIPTIVE REPORT**

Type of Survey: Navigable Area

Registry Number: H12600

General Locality: Vicinity of Southern Long Island

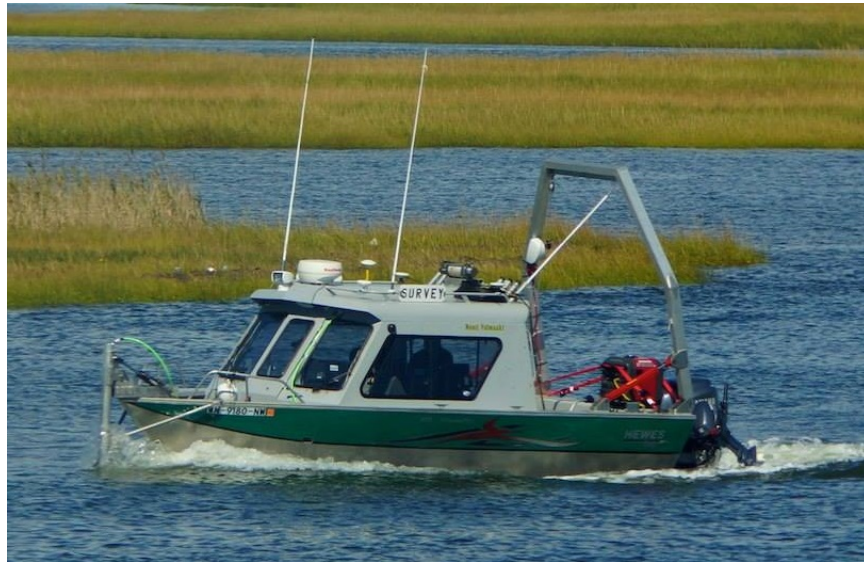
*Figure 7: M/V Nooit Volmaakt from the port side. The pole mount on the bow for the Edge Tech SSS can be seen.*

The M/V Nooit Volmaakt acquired all multibeam data with a pole mounted R2Sonic 2024 at 400kHz and a pole mounted EdgeTech 4600 at 540 kHz using a POSMV for position, orientation and motion corrections. For more detailed information on equipment and vessel please refer to OPR-C331-KR-13 DAPR submitted under a different cover.

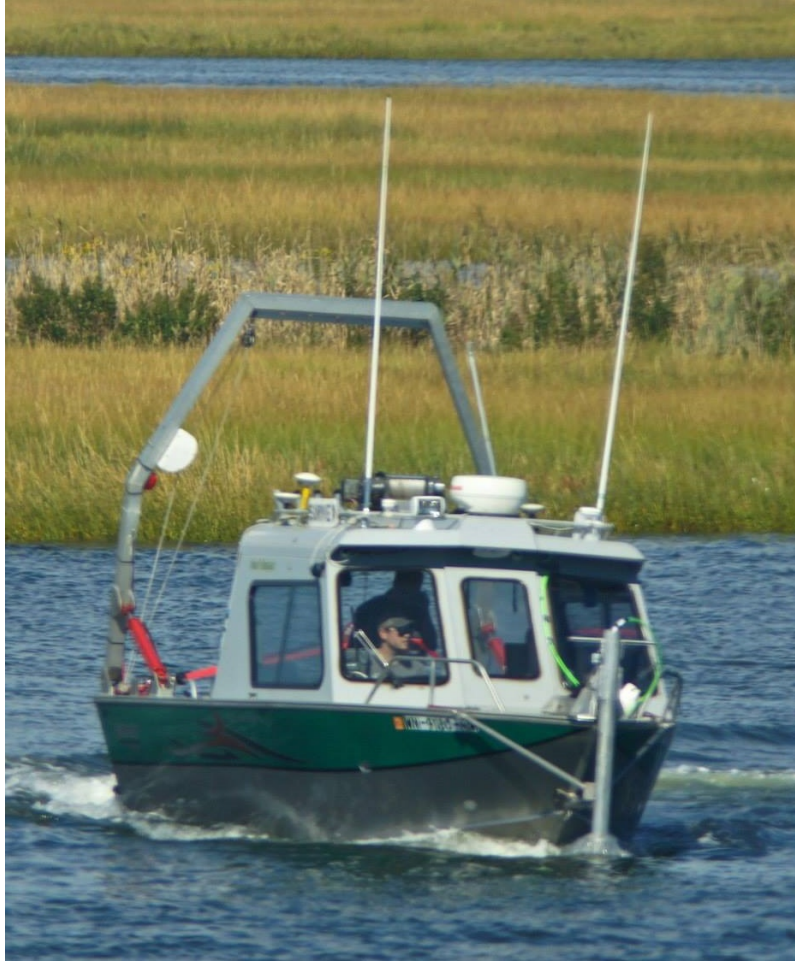
*Figure 8: M/V Nooit Volmaakt from the starboard bow. The pole mount on the bow for the Edge Tech SSS can be seen.*

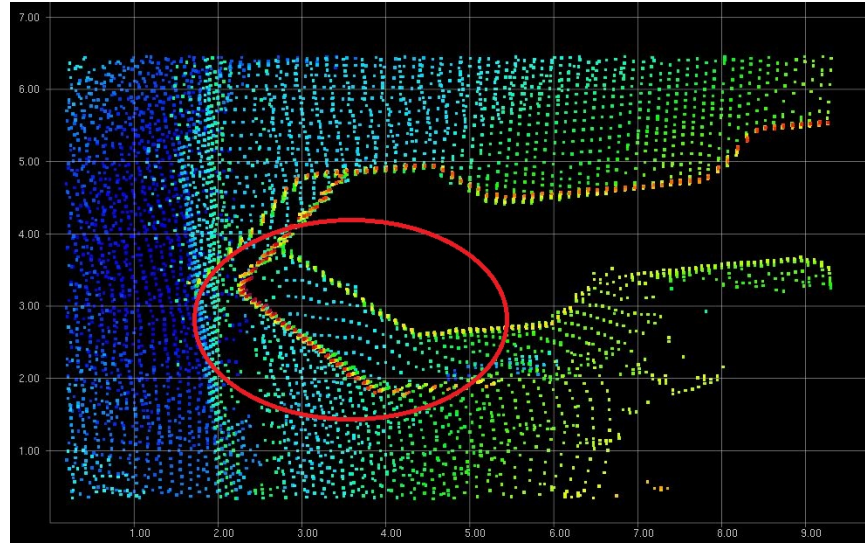
DGPS position suffered slightly under the Robert Moses Bridge. Small positional discrepancies are focused around the bridge supports where satellite coverage is partially blocked. Many passes were made in this area, however horizontal matchup of the data directly under the bridge could not be resolved to the positional standard as the rest of the data set. The positions are however still within the allowable DGPS horizontal uncertainty. The largest horizontal offset measured beneath the bridge was 80cm.

Figure 20: This overhead image shows the soundings in CARIS from 3 separate passes by a bridge support. The positional discrepancy can be seen within the red circle. Red soundings are shoal while blue soundings are deeper.

*The data is adequate for charting despite positional offsets under the Robert Moses Bridge.*

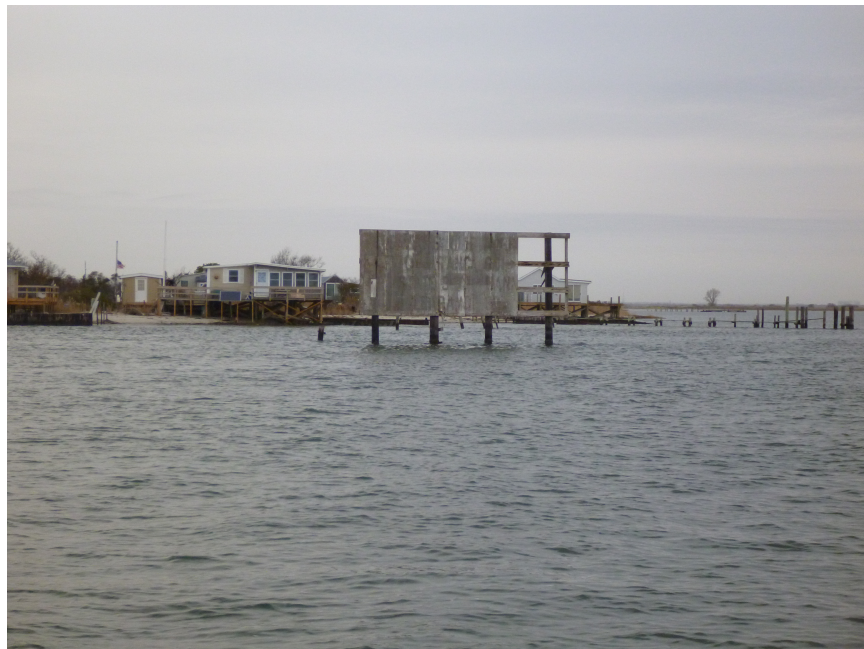
*Figure 25: Picture taken on site of the abandoned advertisement sign near Captree Island, this feature was assigned to verify.*

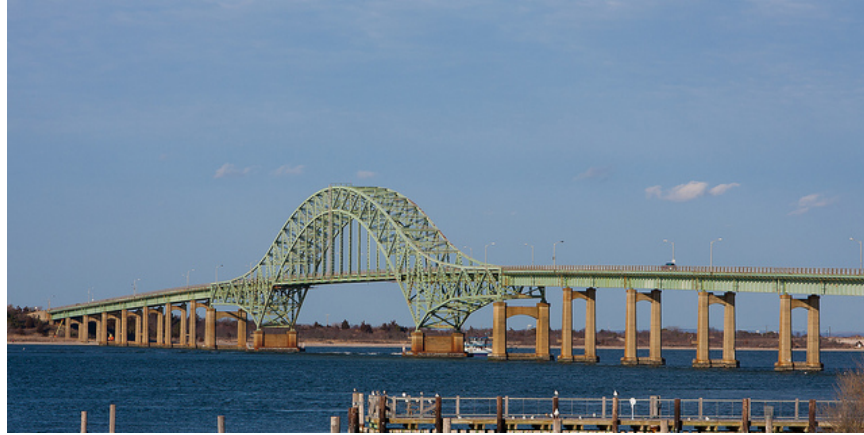
*Figure 33: Picture showing central span of Robert Moses Bridge.*

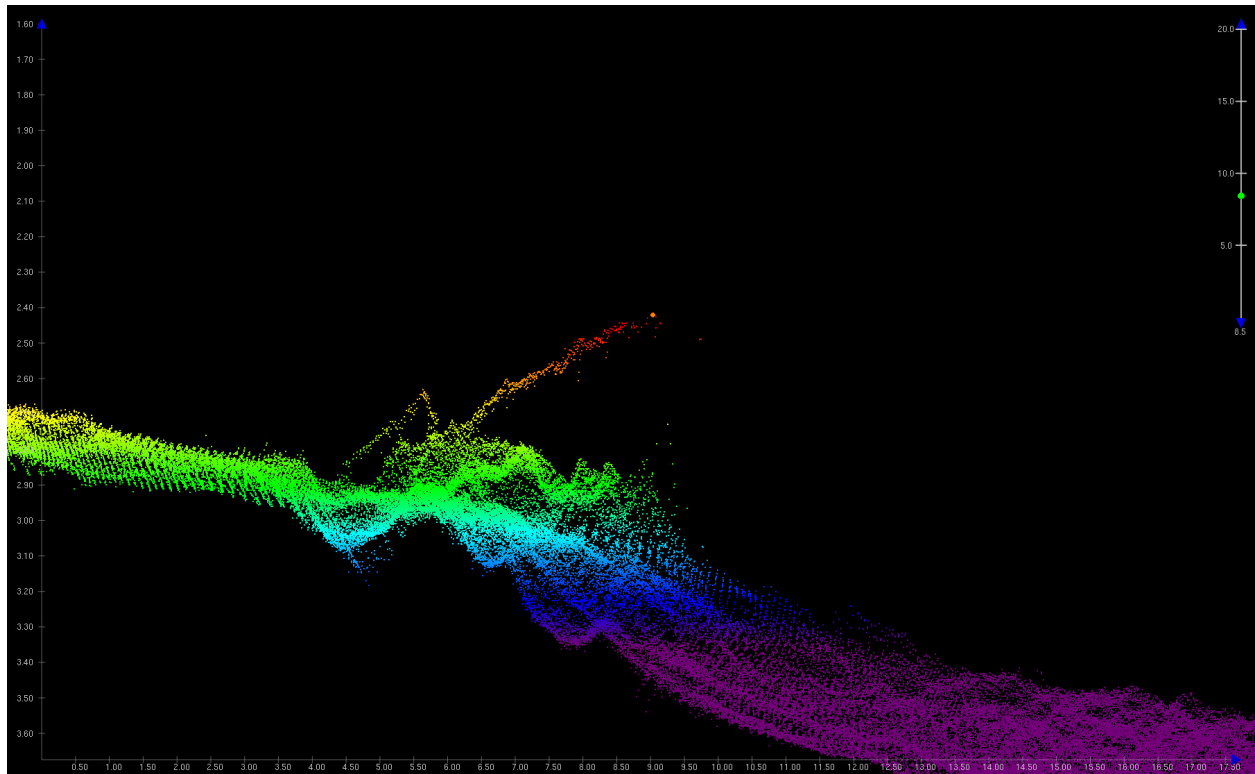
Figure 2.5.1

**Geo object 1:** Wreck (WRECKS)  
**Attributes:** CATWRK - 4:wreck showing mast/masts  
 EXPSOU - 1:within the range of depth of the surrounding depth area  
 INFORM - Uncharted Dangerous Wreck/Debris, Mast sticking off bottom, Within Charted Foul Area, 5 x 0.7m, 0.95m off bottom  
 OBJNAM - H12600\_293\_011  
 QUASOU - 6:least depth known  
 SORDAT - 20140113  
 SORIND - US,US,graph,H12600  
 TECSOU - 3:found by multi-beam  
 VALSOU - 2.416 m  
 WATLEV - 3:always under water/submerged

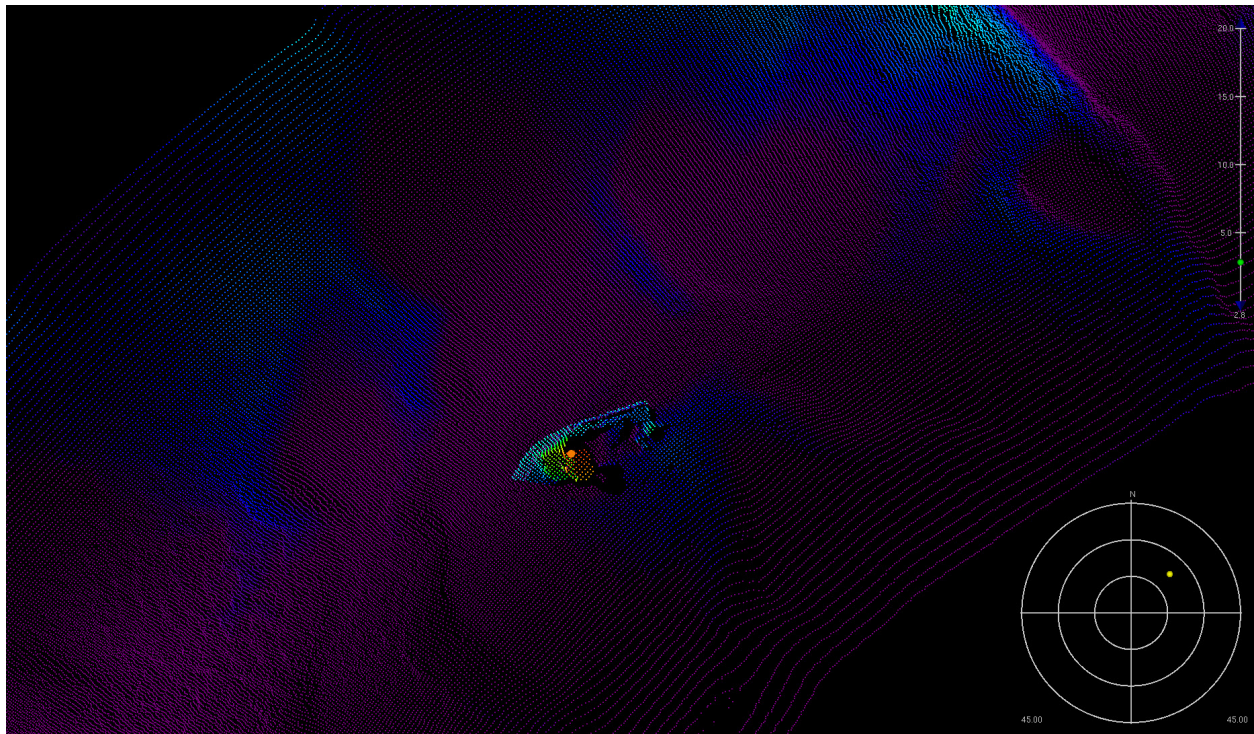
Figure 2.6.1

**Geo object 1:** Wreck (WRECKS)  
**Attributes:** CATWRK - 2:dangerous wreck  
 EXPSOU - 1:within the range of depth of the surrounding depth area  
 INFORM - Significant Feature, Wreck. Near charted 20ft / 6m, 2.80 x 2.5m, 1.83m off bottom  
 OBJNAM - H12600\_308\_035  
 QUASOU - 6:least depth known  
 SORDAT - 20140113  
 SORIND - US,US,graph,H12600  
 TECSOU - 3:found by multi-beam  
 VALSOU - 5.639 m  
 WATLEV - 3:always under water/submerged
