DESCRIPTIVE REPORT

Type of Survey: Navigable Area

Registry Number: H12603

Sub-locality: Vicinity South of Jones Beach

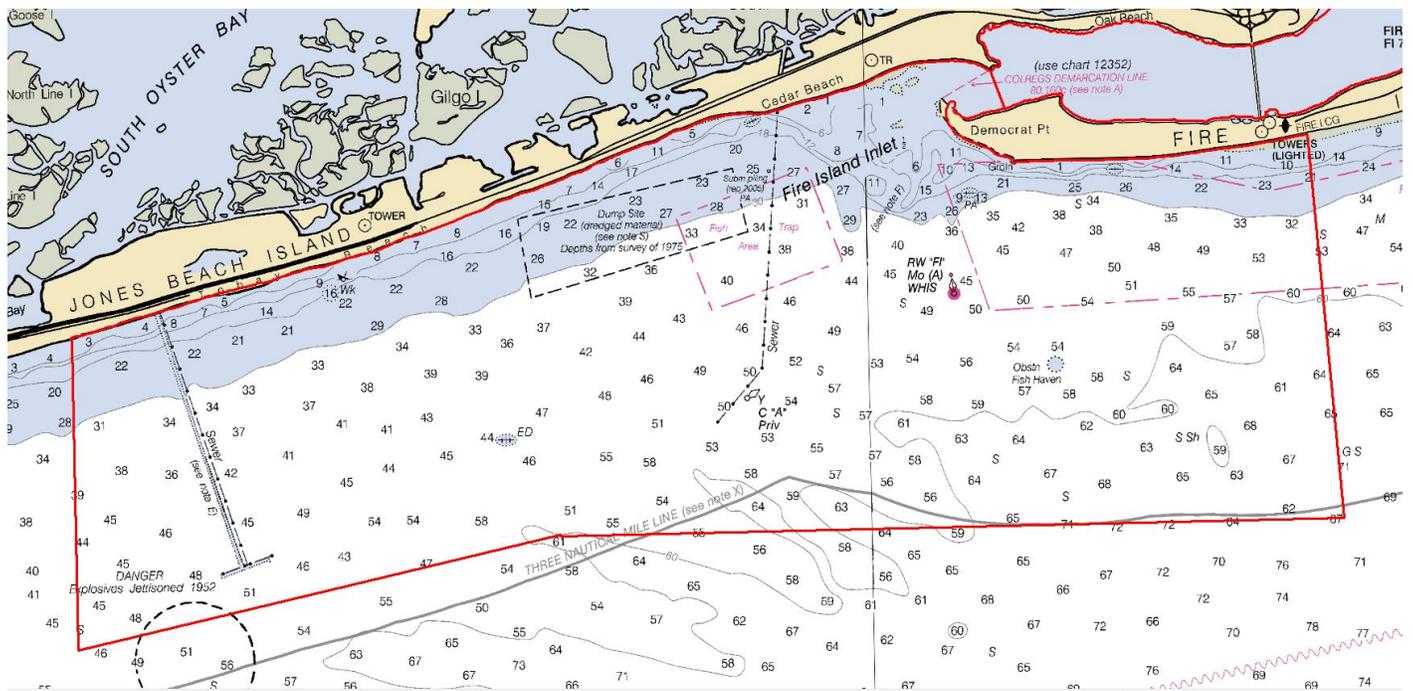
Figure 1: H12603 Sheet Boundaries Overlaid on Chart 12326

As per the field crews email confirmation (review correspondence folder) with the COTR on Oct 28th, sheet H12603 was surveyed to the 2m contour inshore of the inlet, and to the 4m contour offshore of the inlet within the bounds of vessel safety. The 2m navigable area limit line (NALL) was frequently unachievable due to shoal waters, breaking seas and inshore man made obstructions. Vessel and crew safety was a priority concern.

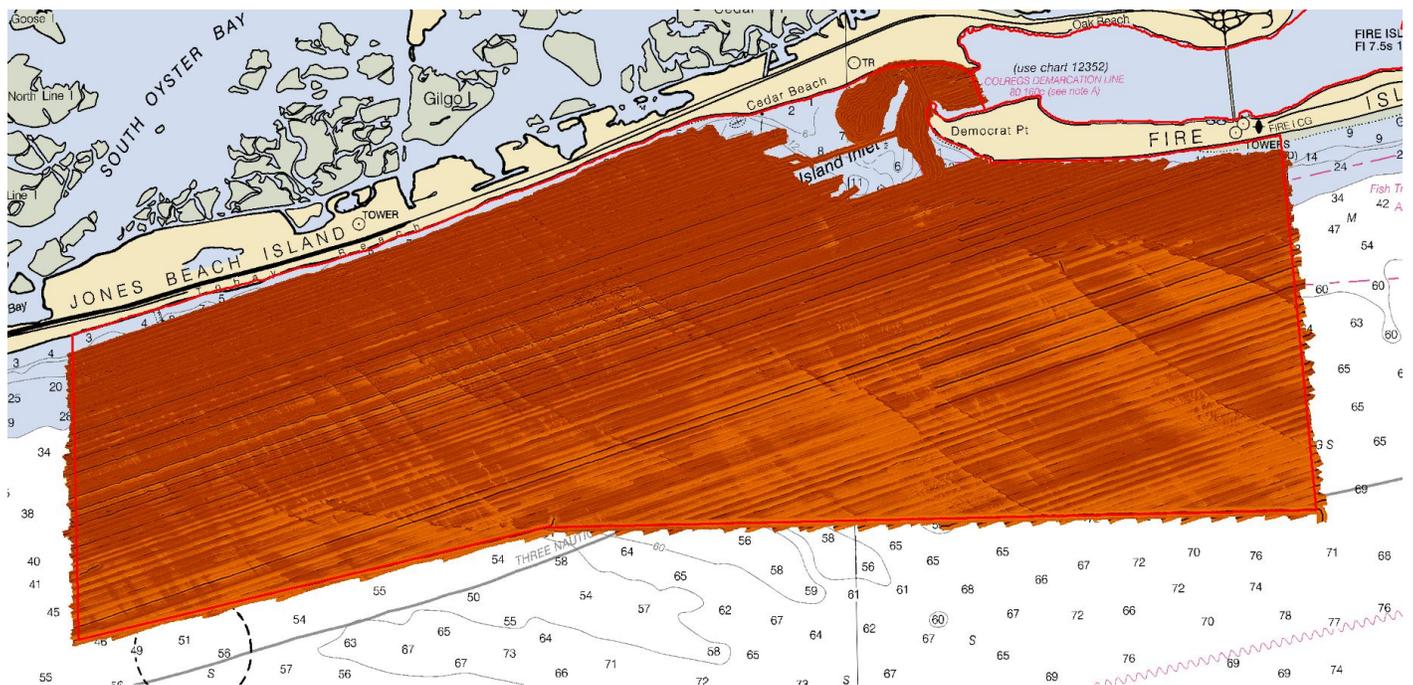
Figure 2: H12603 SSS Mosaic of all Data Acquired Overlaid on Chart 12326

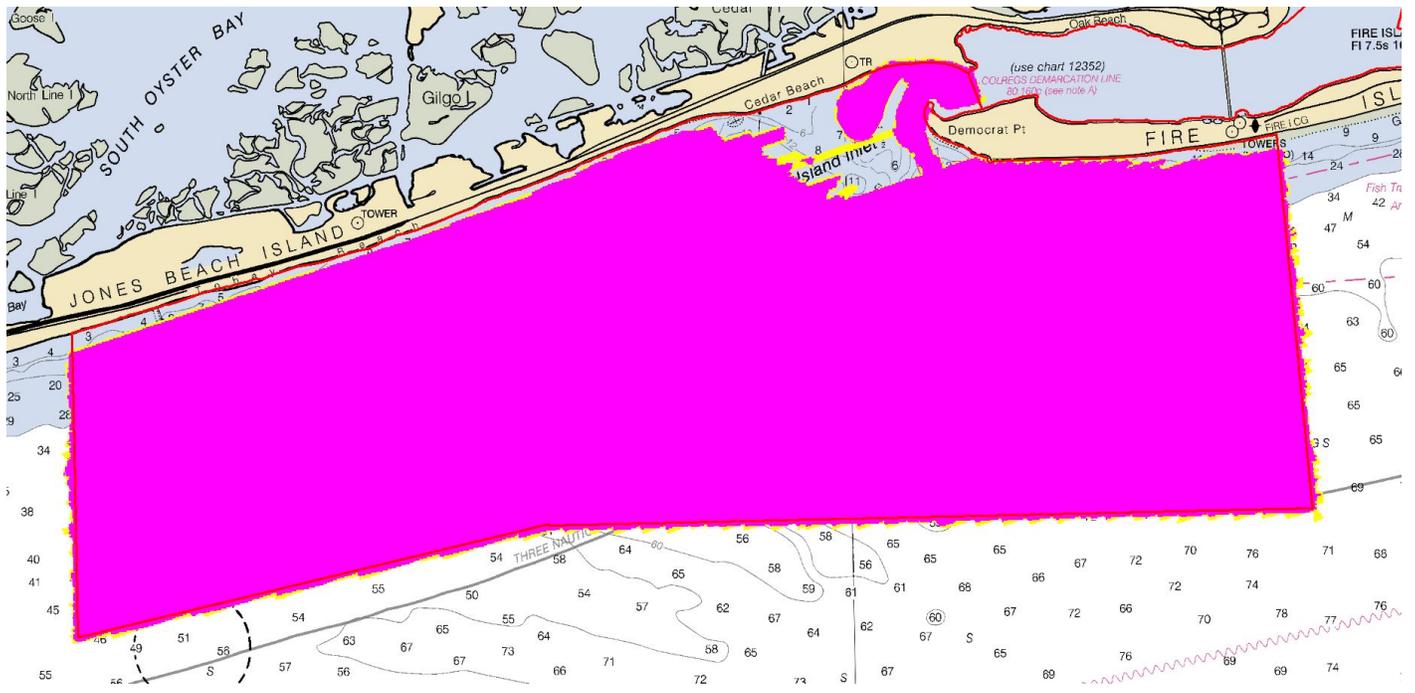
Figure 3: H12603 SSS Coverage Depicting percent of coverage: Yellow = 100%, Purple = 200%

Due to changing morphology and a combination of shoal and swell conditions, coverage gaps are present in SSS data. Vessel and crew safety was a priority concern and was always taken into consideration. There are four coverage gaps located in this sheet. A gap in survey coverage can be found immediately south of Jones Beach Island due to shallow water and shoal conditions. Several coverage gaps are located west of the Fire Island Inlet near Democrat Point, all caused from shoal conditions.

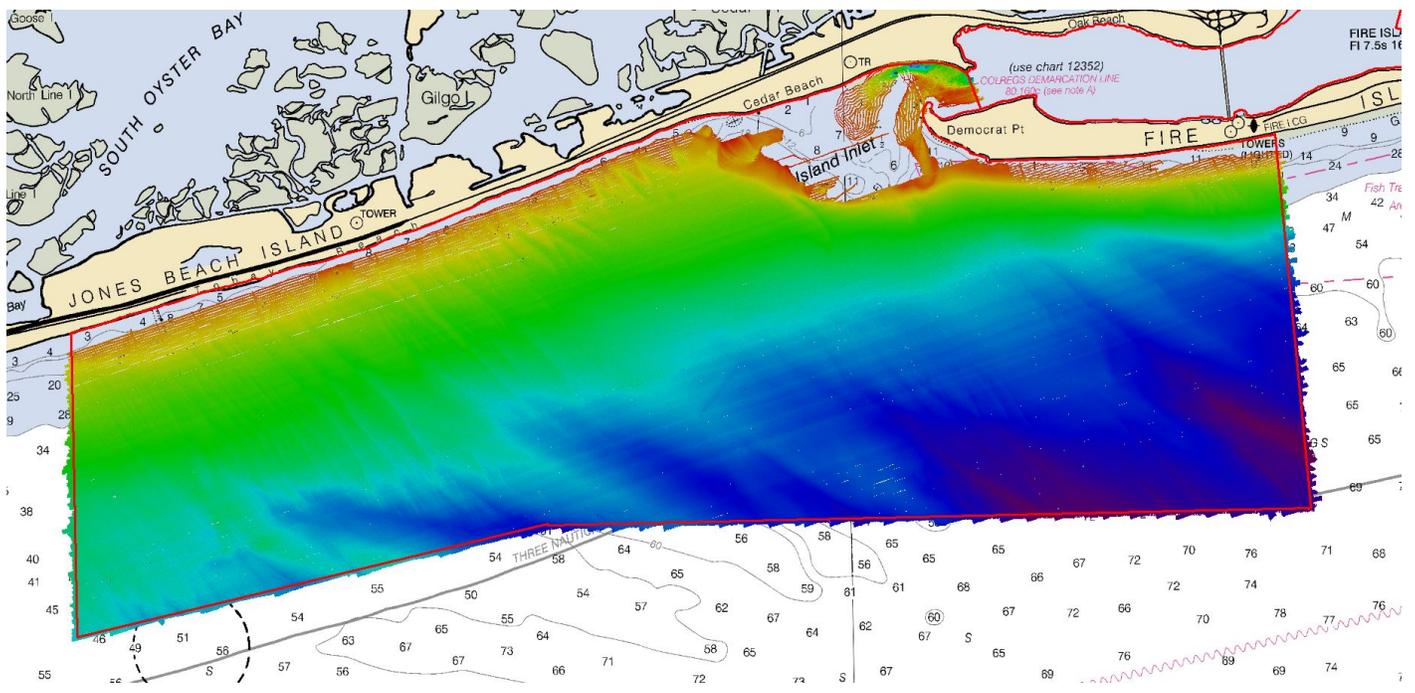
Figure 4: H12603 MBES Coverage Overlaid on Chart 12326

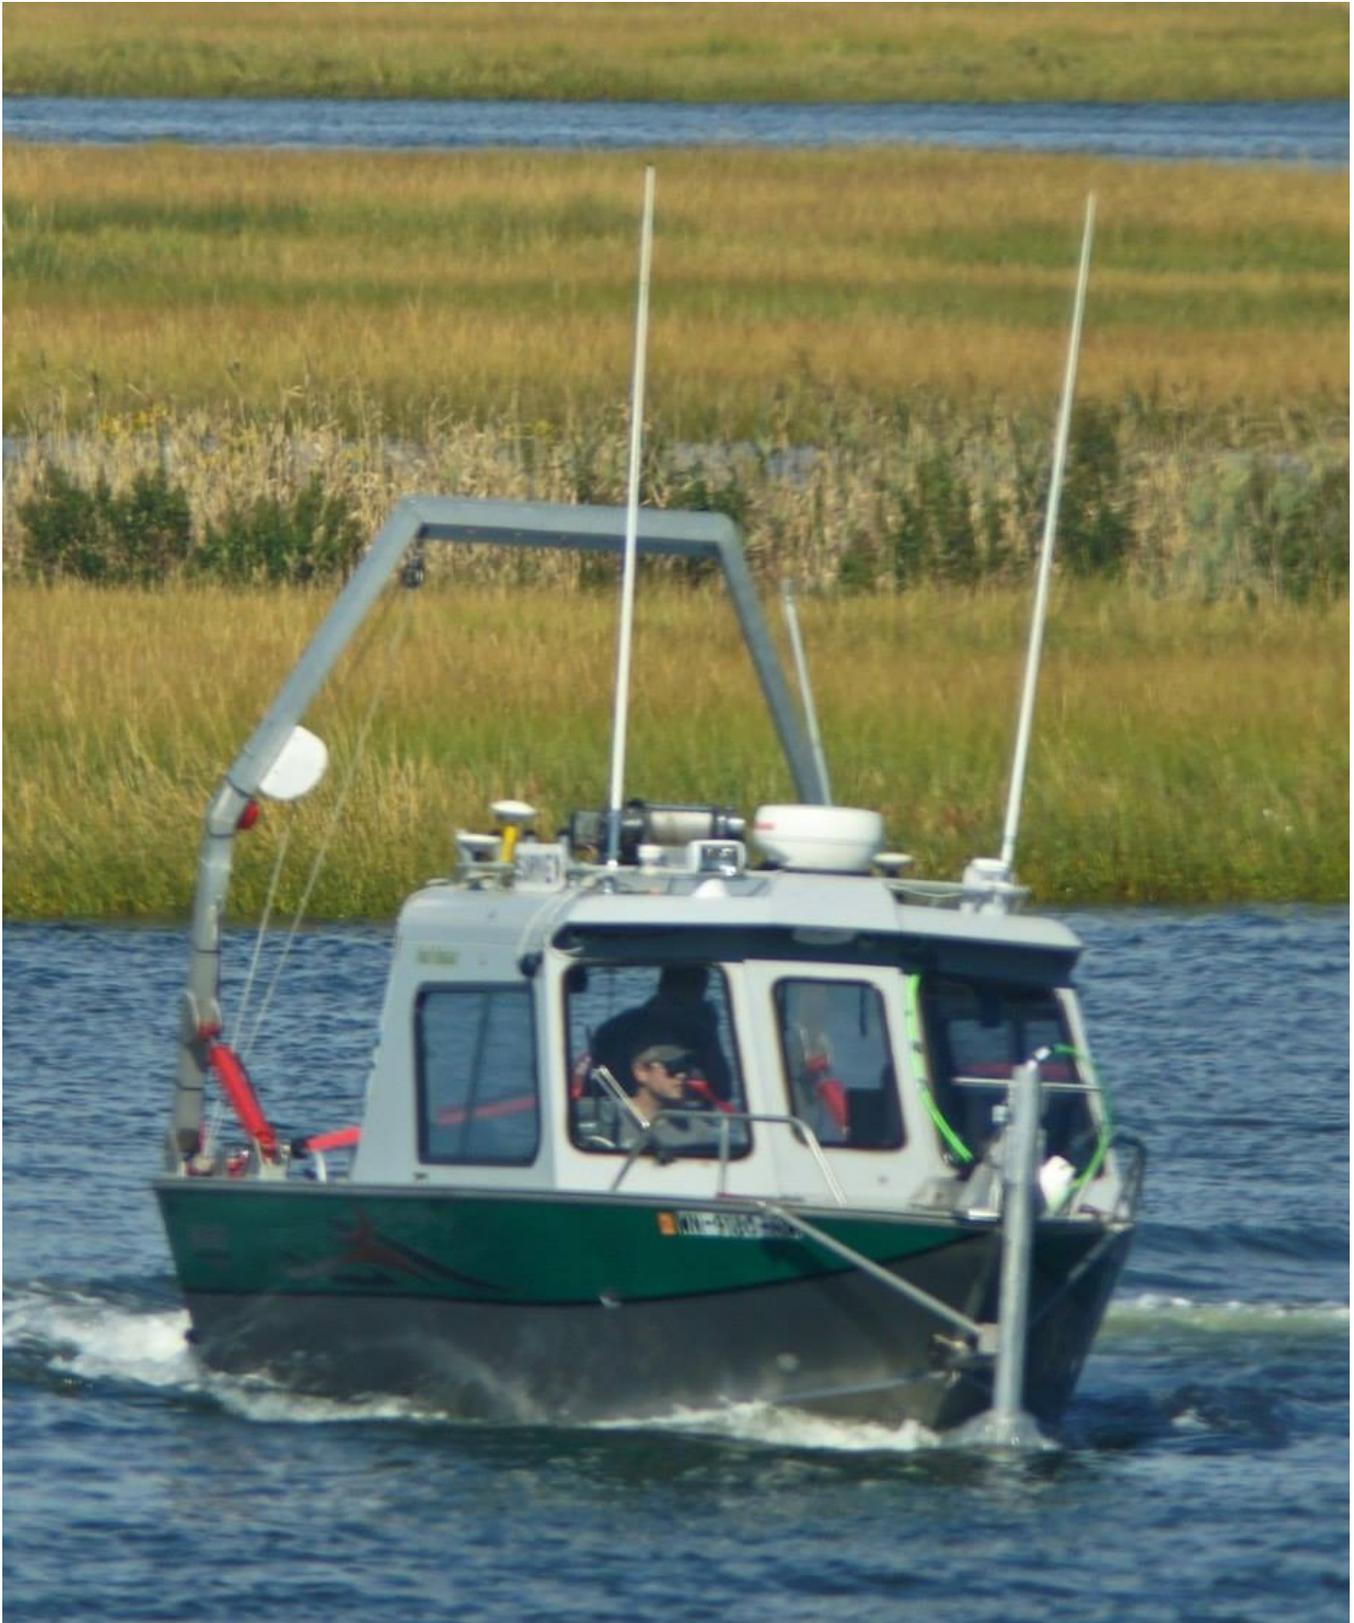
Figure 6: M/V Nooit Volmaakt from the starboard bow. The pole mount on the bow for the Edge Tech SSS can be seen.

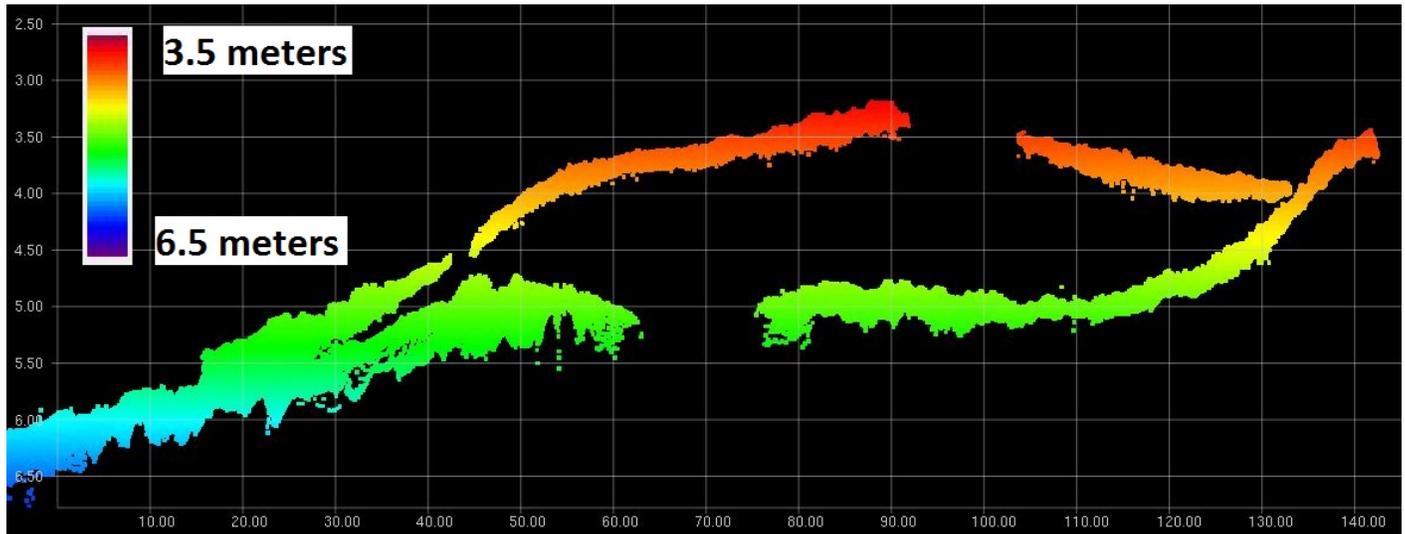
Sand features in waters shallower than 10 meters are constantly shifting, as much as 25cm per day in some areas. Areas concentrated around the inlet are subject to the strongest and most rapid tidal current. As a result these areas experience the most morphological shifting, resulting in poor data alignment, especially if

overlapping acquisition was separated by as much as 5-10 days. Due to this effect on the data overlapping, the timing of acquisition was strongly considered in planning. A dredge also worked the inlet during the course of the survey. Efforts were made to minimize data matchup issues by waiting for the dredge to finish before surveying the dredged area.

Figure 7: MBES soundings showing depths for 5 lines, three acquired on JD 330, 2013 and two on JD 170, 2014. You can see the separation in seabed morphologies well here as the sand has shifted due to currents and other environmental factors.

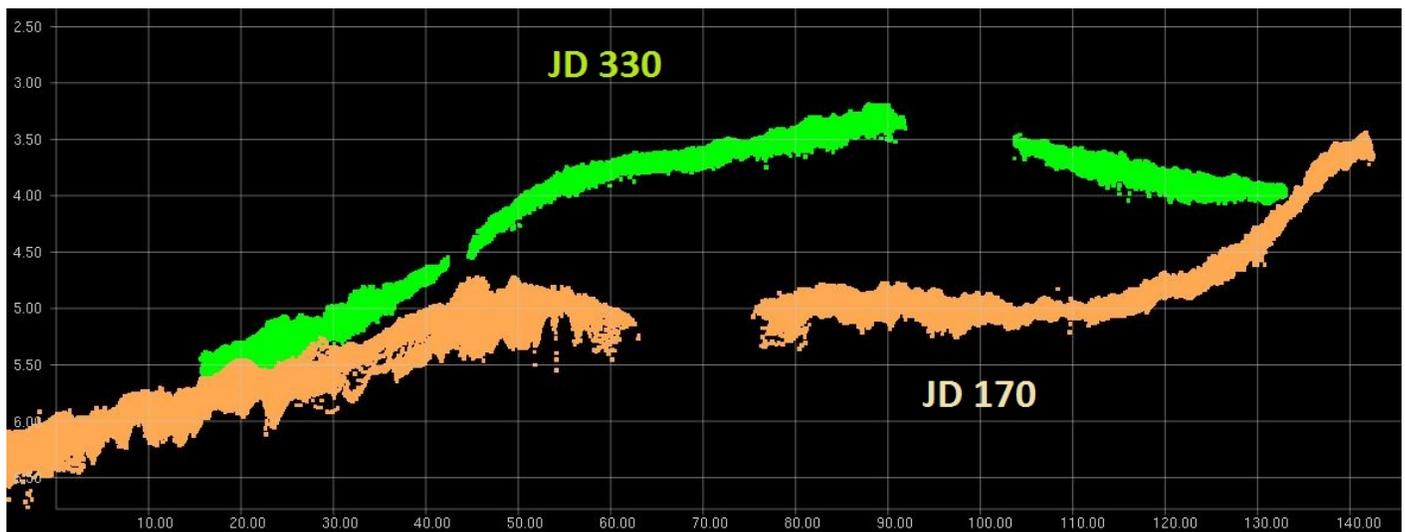
Figure 8: Image to be associated with the previous figure. The colors signify days of acquisition. Light green for JD 330, 2013 and custard for JD 170, 2014.

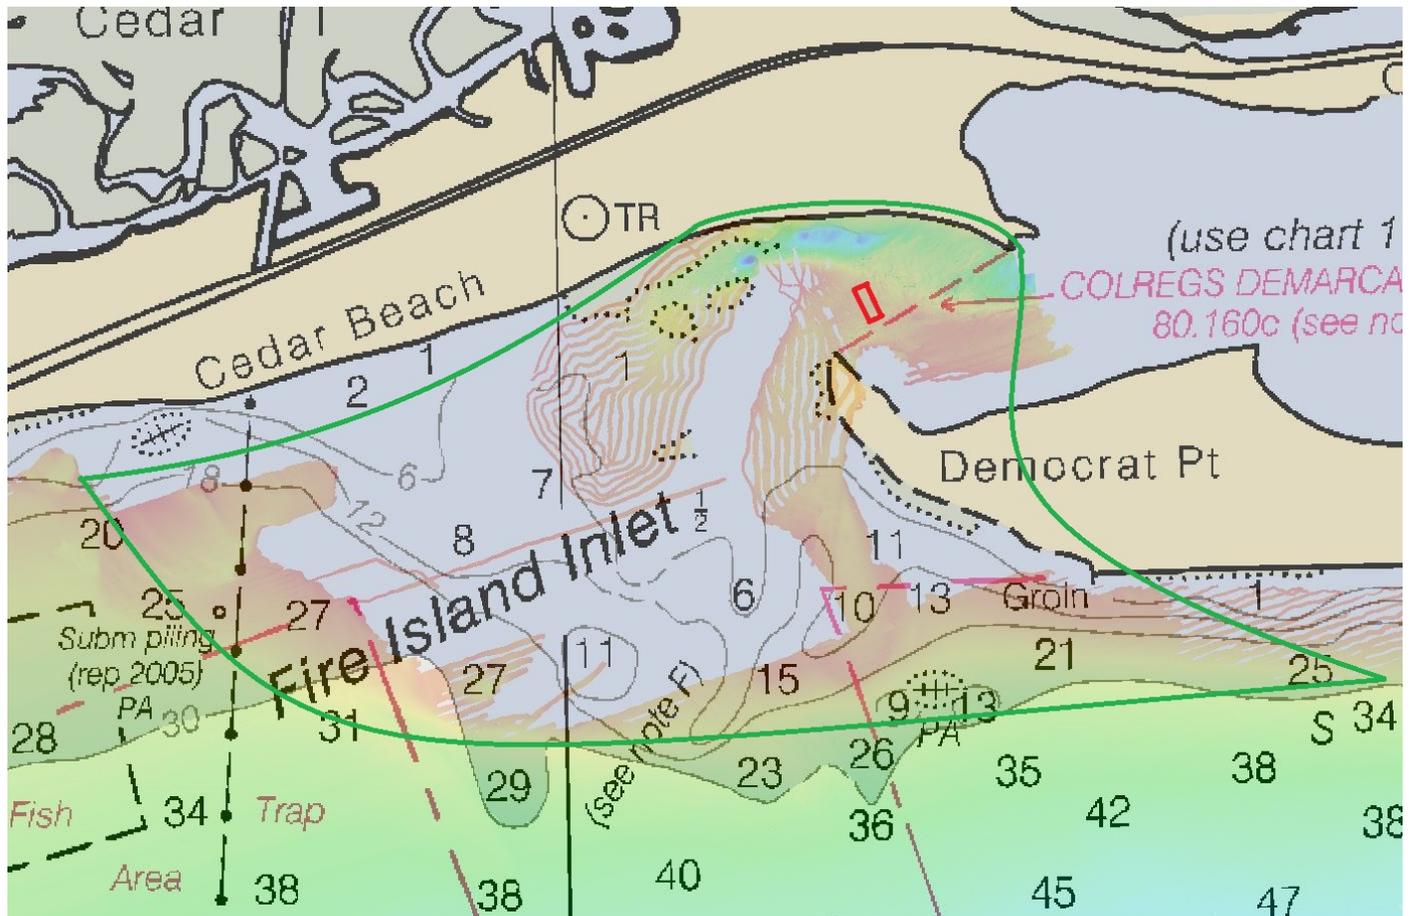
Figure 9: Chart 12326 overlain with bathy and a red box highlighting the area of shifting seabed shown in the previous two figures. The area enclosed in the green shape encompasses the inlet area where the shifts in sand features will be most evident in the data.

The area in the vicinity of Fire Island Inlet is known to be dynamic and is addressed with a chart note. The data acquired during this survey is adequate for charting as it is an accurate snapshot of the seafloor at the time of survey.

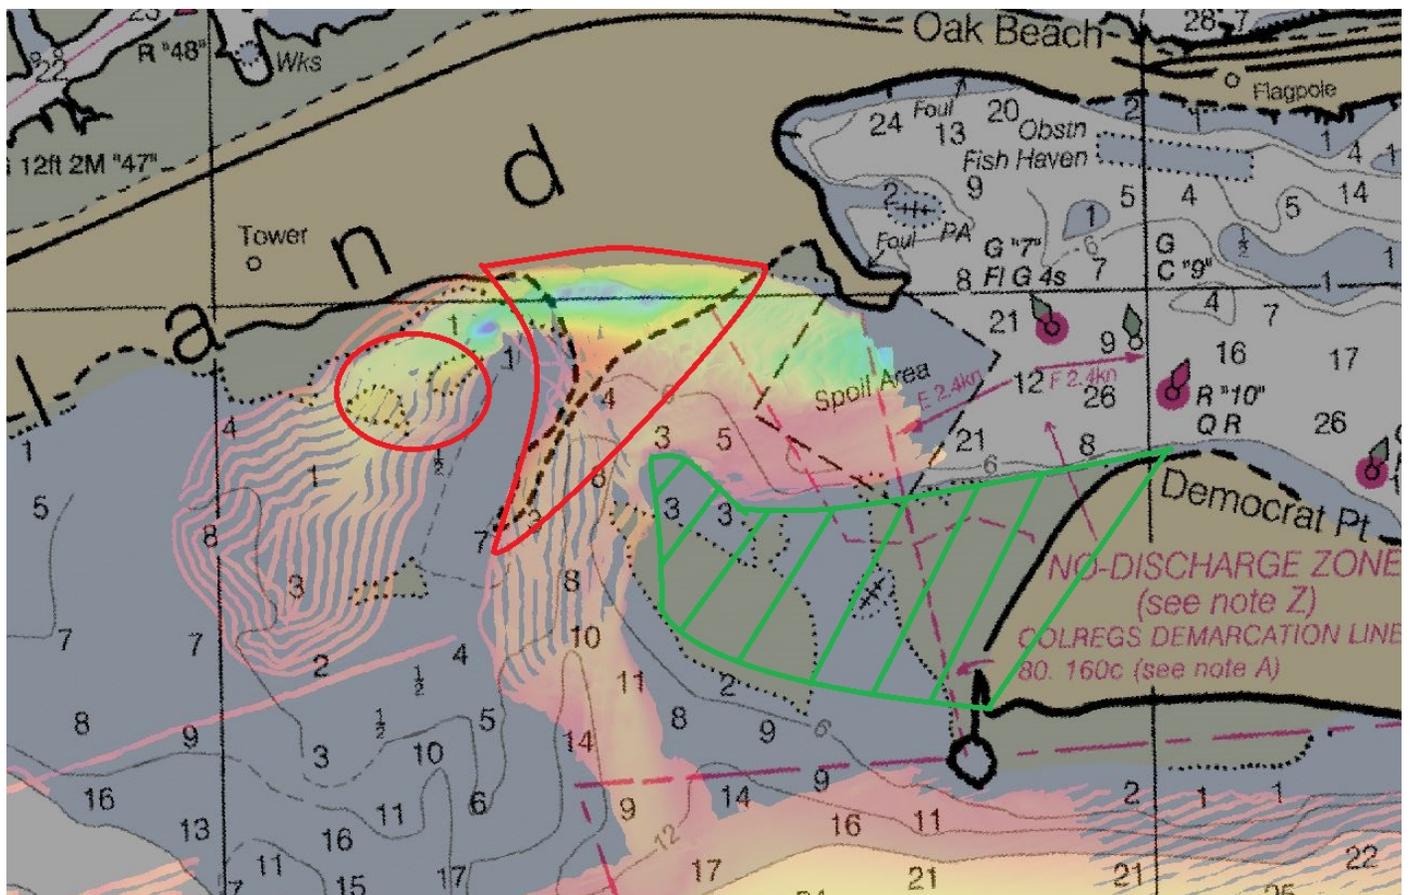
Refer to the discussion for chart 12326.

Figure 10: MBES data overlaid on Chart 12352. Areas in Red highlight shore/foul areas that are no longer present. Areas in Green portray current land mass.

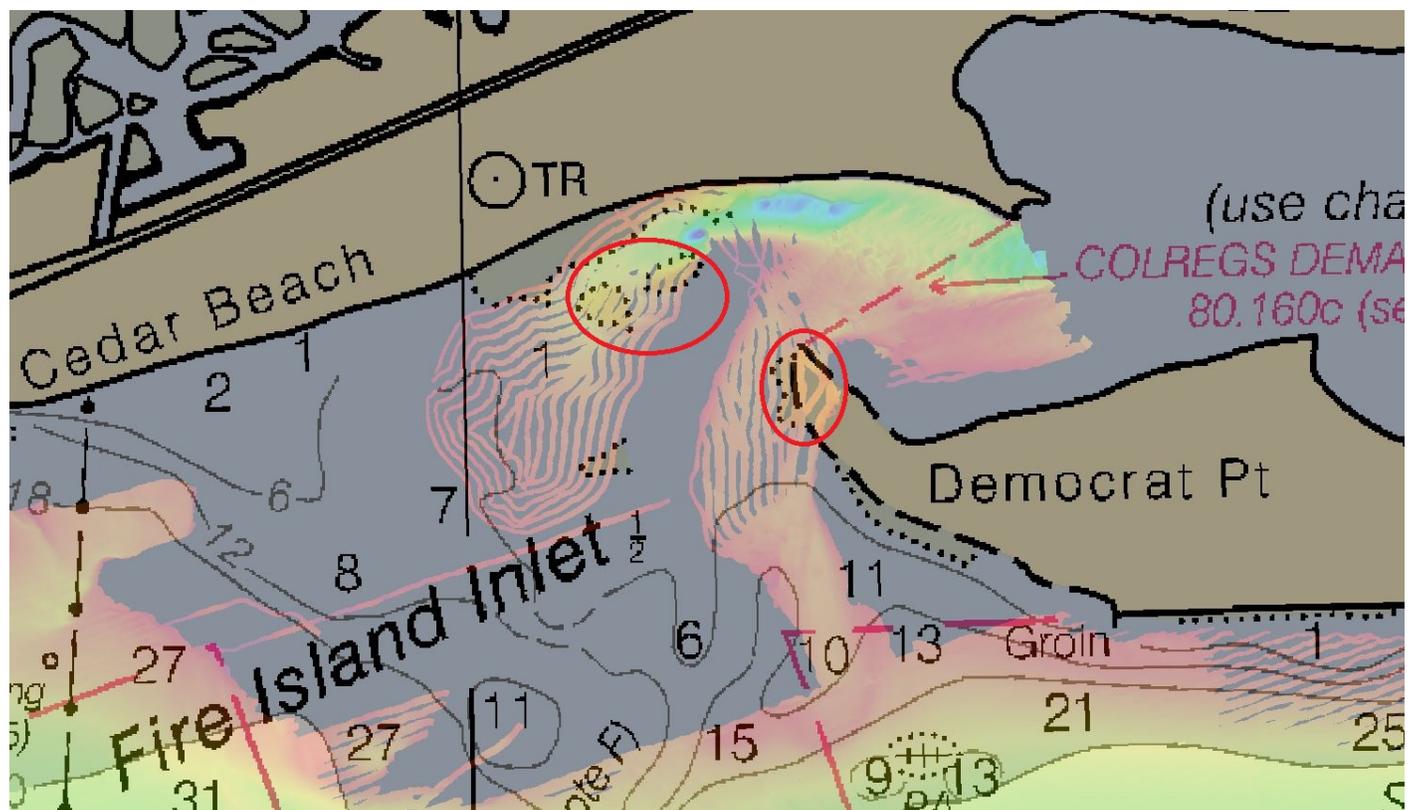
H12603 survey data was compared to Raster Chart 12352 and 12326. In general, the chart and survey depths match well. The areas that have shoaled or are constantly shifting are discussed in the section labeled Shoal and Hazardous Features. An Army Corps of Engineers dredge worked the inlet during the fall and winter months of 2013-2014. A new inlet channel was dredged and marked with uncharted buoys, refer to section D.1.8 for more information on the new Fire Island inlet channel. Refer to section D.2.3 for additional information on the uncharted ATONs. There were drastic shifts in the shoreline west of the inlet if compared to chart 12352 however the shoreline is accurately represented in chart 12326. A few foul areas charted in the inlet on RNC 12326 now have surveyed depths up to 20m.

Figure 11: MBES data overlaid on Chart 12326. Areas in Red highlight shore/foul areas that are no longer present.

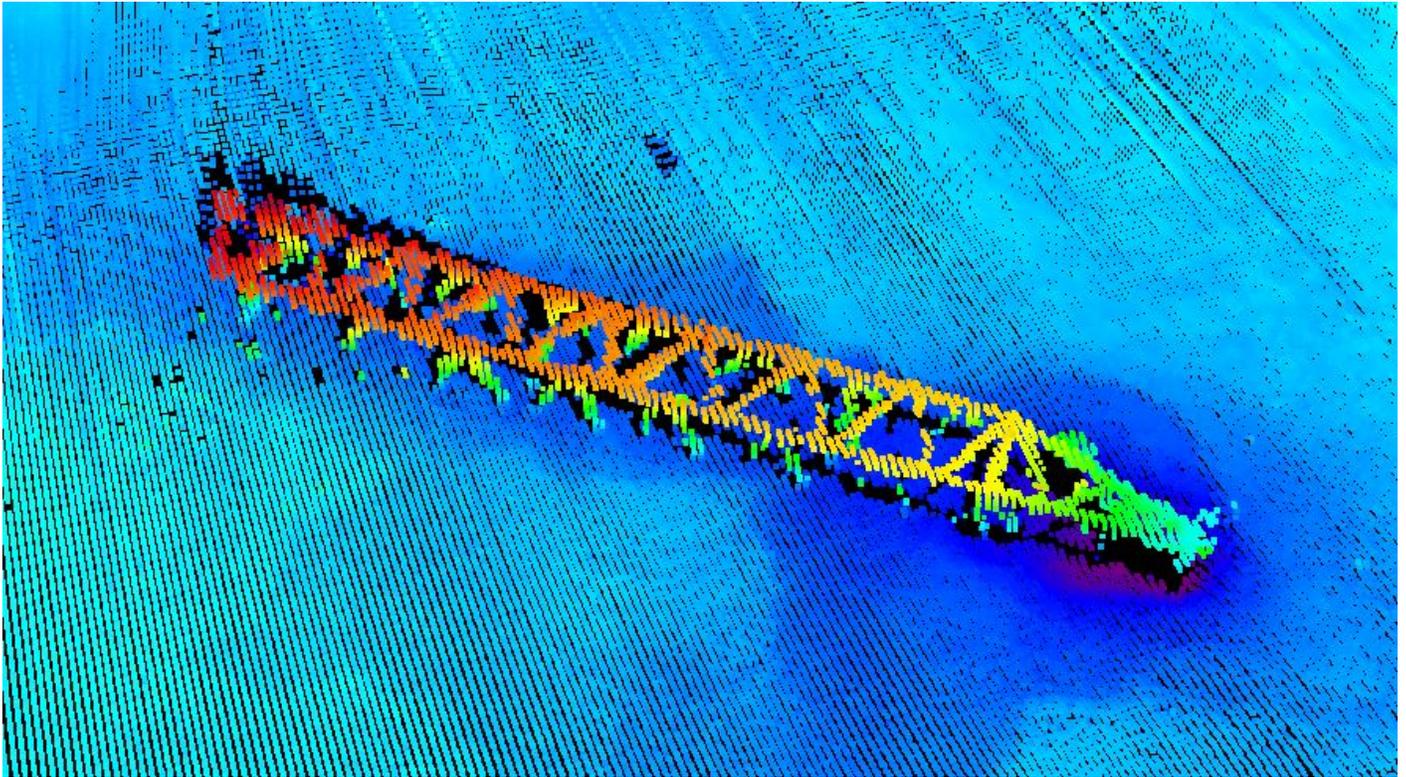
H12603 did not contain a large number of uncharted features. Only seven significant features were found that were not associated with either an AWOIS radius, charted feature or a fish haven. One feature appeared to be the hull of a sailboat and was submitted as a DTON. Two obstructions appeared to be portions of a crane boom and were also submitted as DTONS. Two wrecks were located near to shore and not far from AWOIS item 1685 however were not a danger to navigation. The remaining 2 features appeared to be debris and posed no navigational threat either.

Figure 12: MBES image showing the obstructions that appeared to be portions of a crane boom.

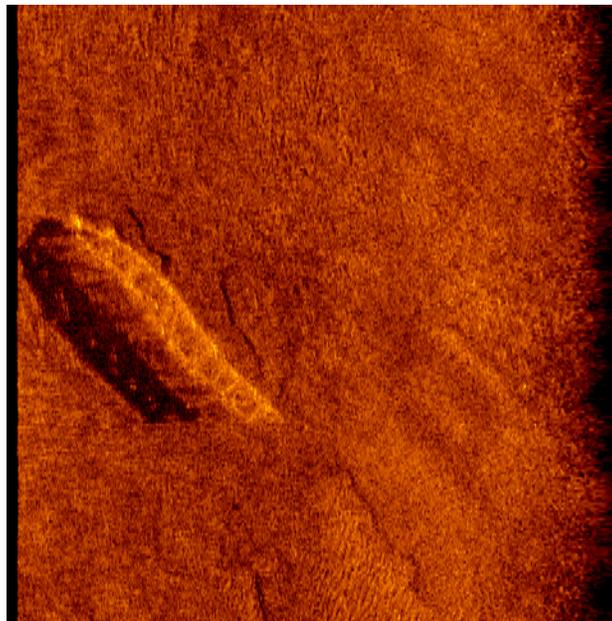
Figure 13: SSS image showing the obstructions that appeared to be portions of a crane boom.
The discussion refers to AWOIS 1685, which does not exist within the limits of this survey.

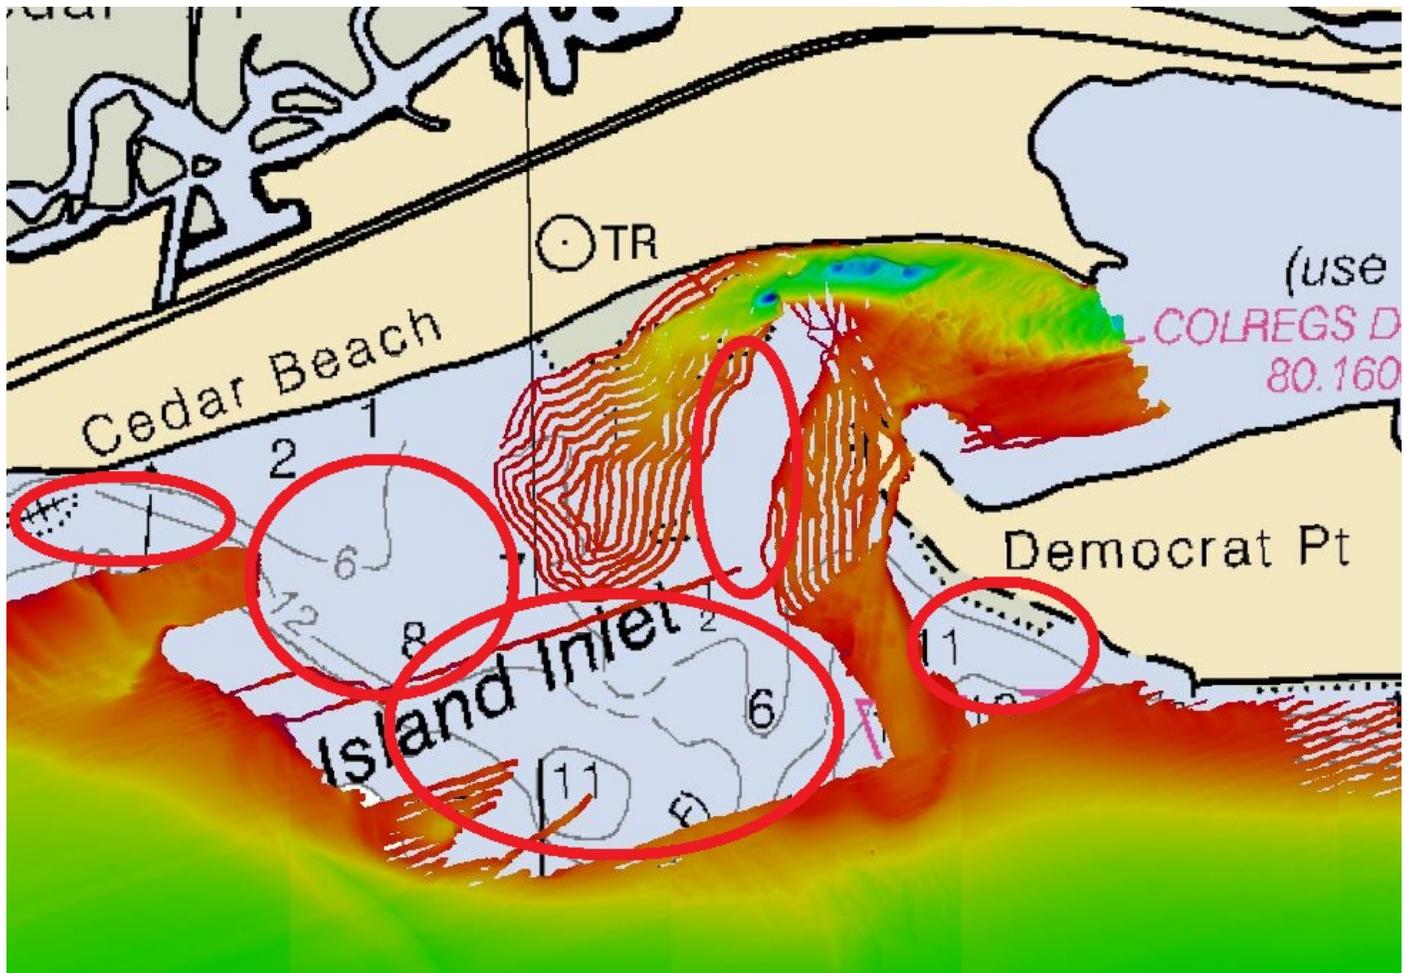
In order to investigate shoaling areas and compare to charted depths a grid was overlaid on raster charts 12352 and 12326. This allowed the area to be compared visually and easily obtain depth value differences with a high level of accuracy. Since chart 12352 differed vastly in the shoreline/inlet area (refer to D.1 Chart Comparison) this discussion will be using RNC 12326. The area surrounding the inlet contains shifting sand bars where breaking seas and shoal depths cause navigational hazards. Much of this area was unsurveyable due to these hazards.

Figure 14: Overhead image of the Fire Island Inlet in sheet H12603. The areas circled in red highlights the locations of dangerous shoals and breaking seas offshore of the inlet.

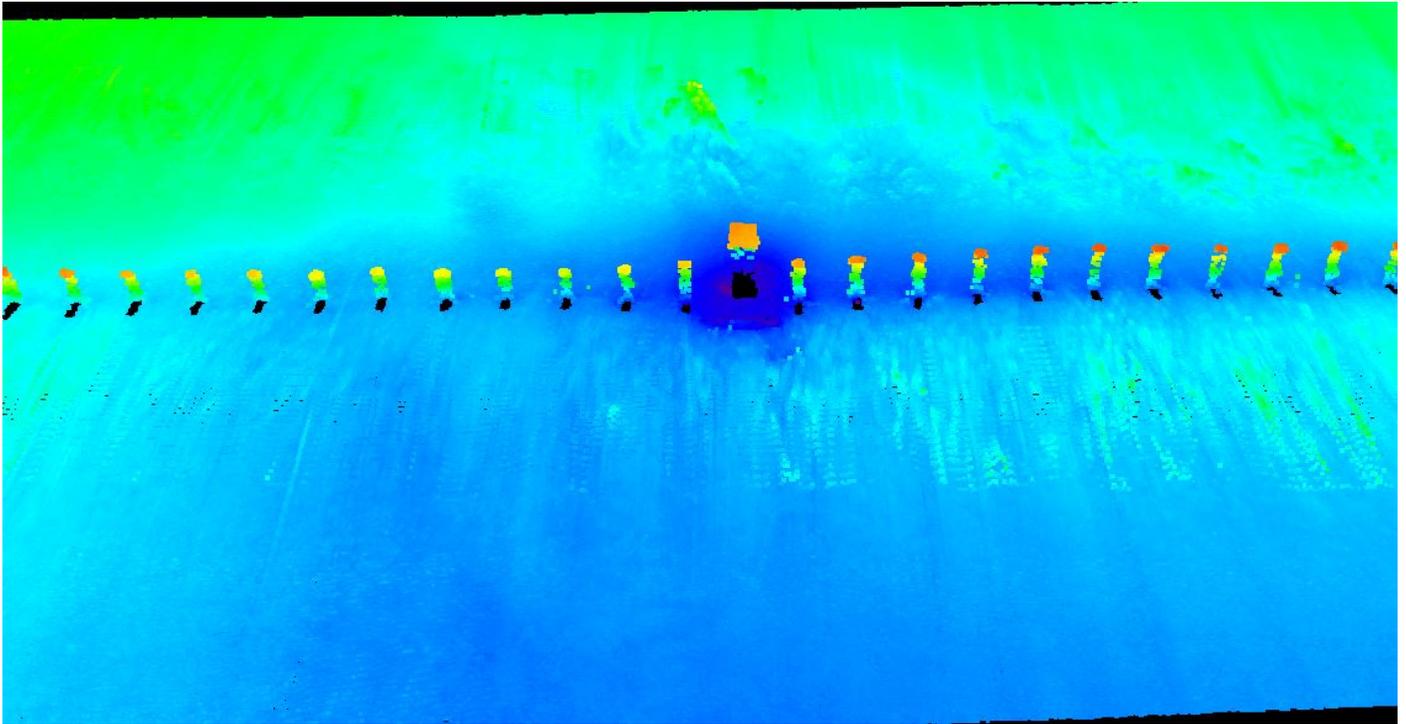
Figure 15: MBES Image showing the southern end of the western most charted outfall.

Only remnants at the southern end of the westernmost sewer outfall were identified in the survey. The other pipelines were not seen in the multibeam or sidescan data. The final feature file is not included with this report.

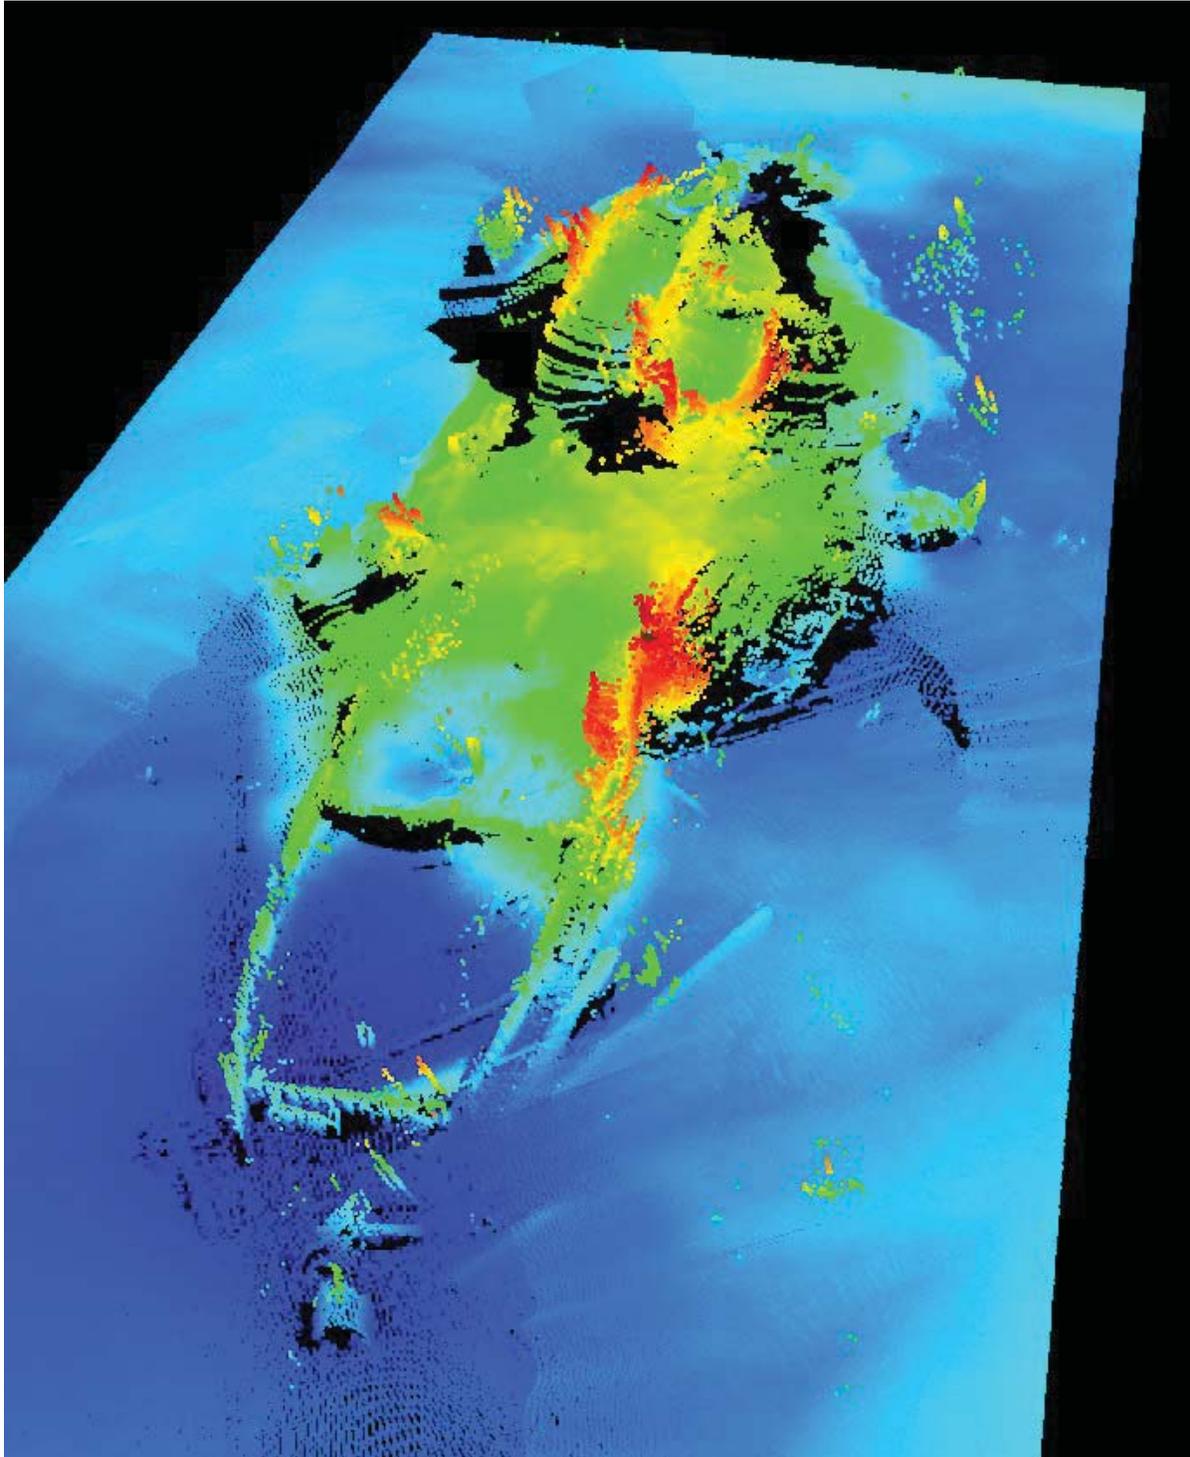
Figure 2.1.1

Geo object 1: Wreck (WRECKS)
Attributes: CATWRK - 2:dangerous wreck
 EXPSOU - 2:shoaler than range of depth of the surrounding depth area
 INFORM - Significant Featured, AWOIS item# 1660. Large Wreck Near Shore, Concrete Pile sticking up above waterline mid wreck, 91 x 16m, 4.35m off bottom
 QUASOU - 2:depth unknown
 SORDAT - 20140623
 SORIND - US,US,graph,H12603
 TECSOU - 3:found by multi-beam
 VALSOU - 0.945 m
 WATLEV - 4:covers and uncovers

Concur with clarification. Chart wreck as visible, depth unknown. AWOIS 1660.

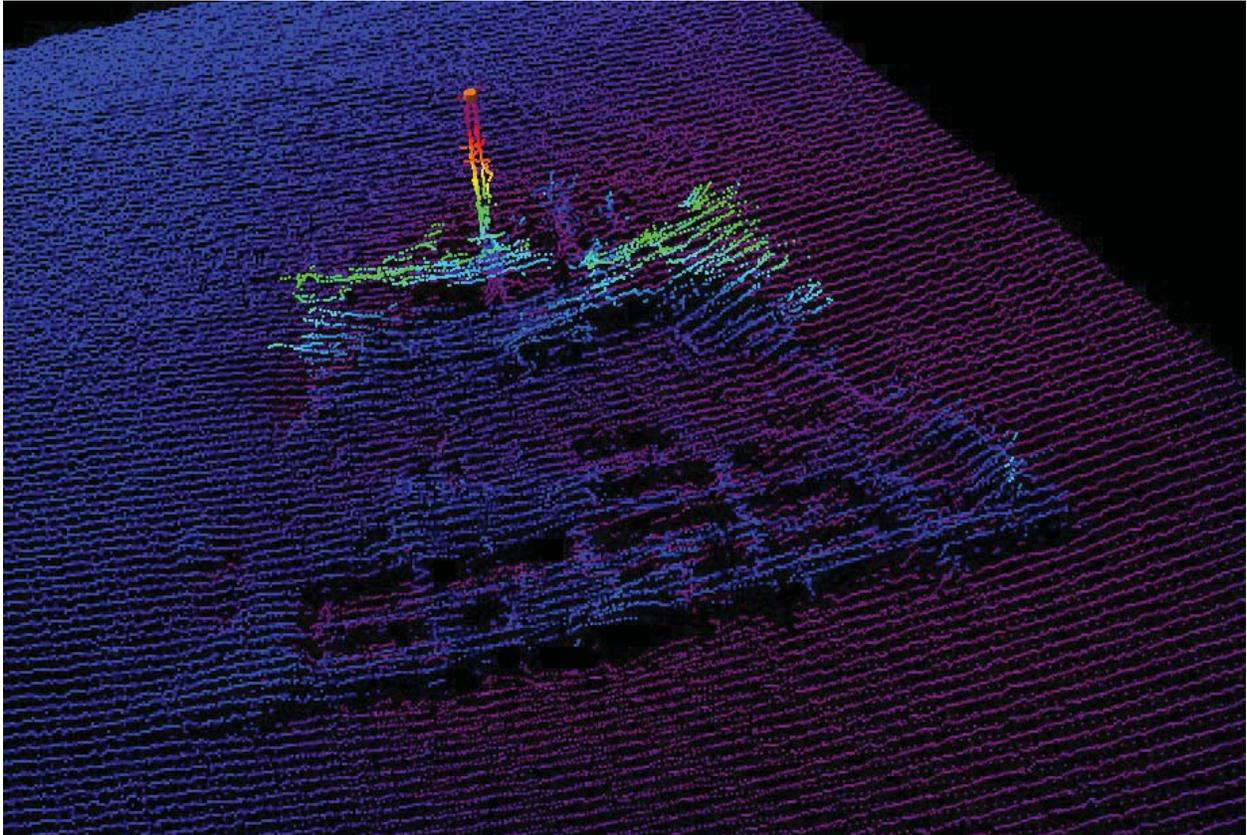
Figure 2.2.1

Geo object 1: Wreck (WRECKS)
Attributes: CATWRK - 2:dangerous wreck
 EXPSOU - 1:within the range of depth of the surrounding depth area
 INFORM - Significant Feature, Wreckage near charted wreck, portion of a hull with a significant vertical protrusion, 5.9 x 7.4m, 2.13m off bottom
 OBJNAM - H12603_128_014
 QUASOU - 2:depth unknown
 SORDAT - 20140623
 SORIND - US,US,graph,H12603
 TECSOU - 2:found by side scan sonar
 VALSOU - 1.579 m

Concur with clarification. Chart as least depth known.

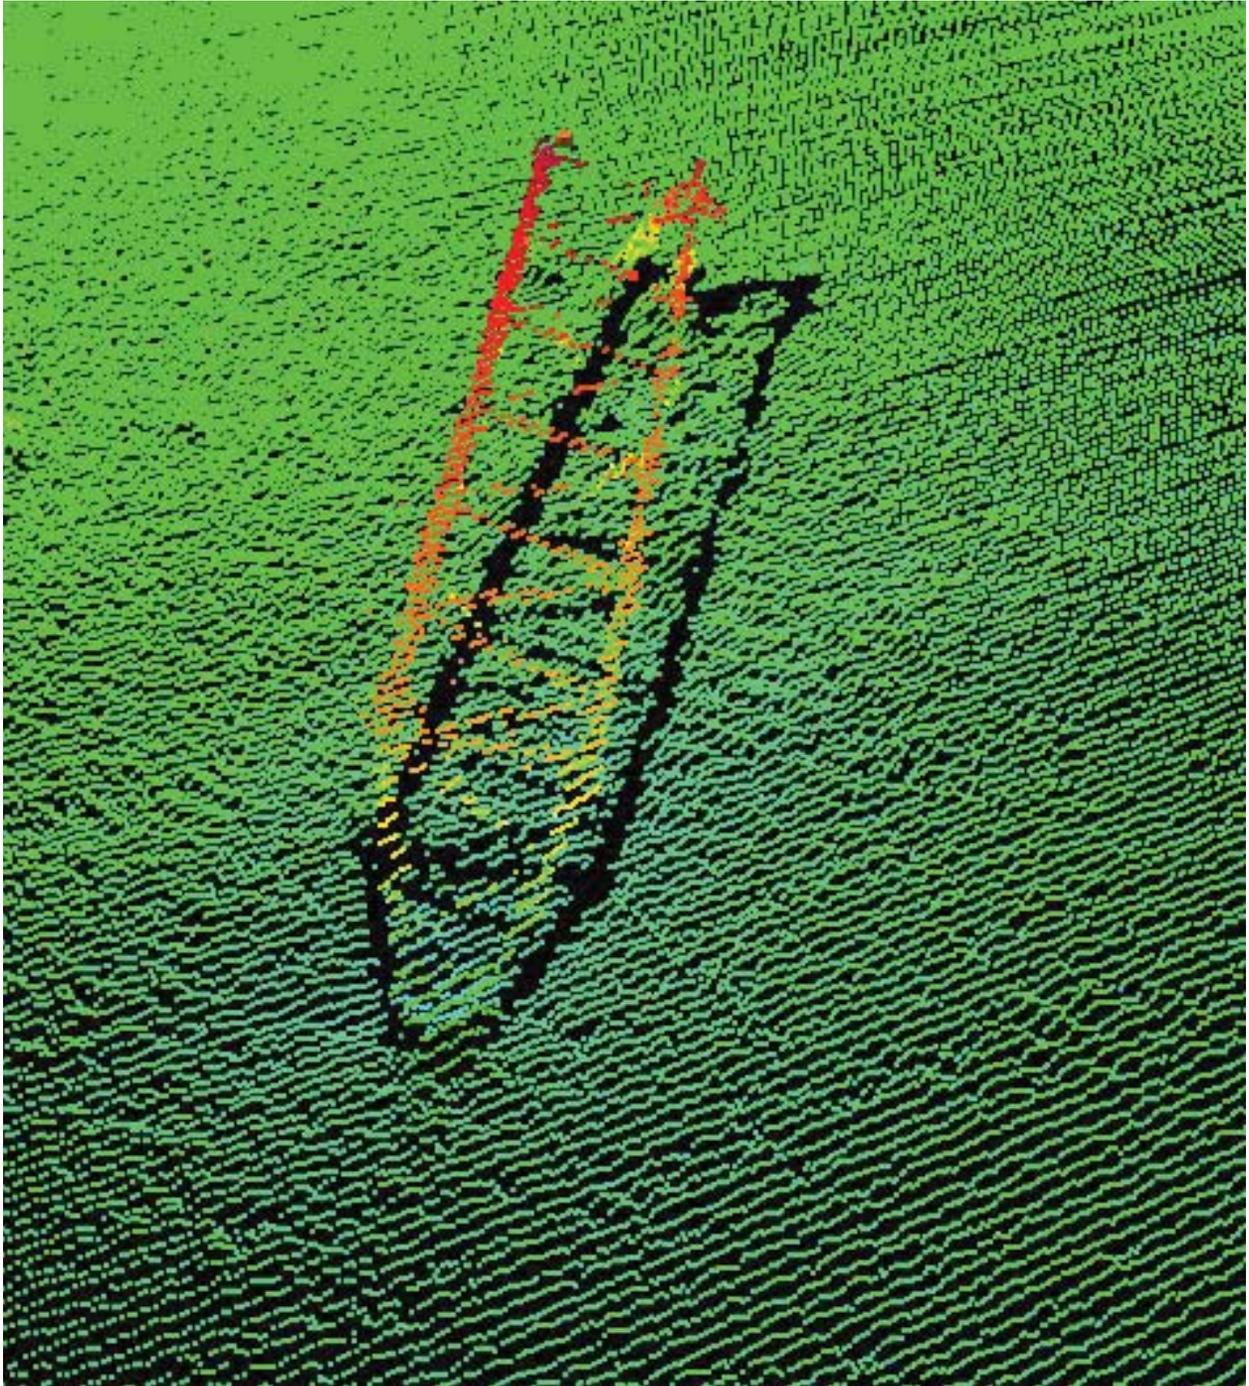
Figure 3.1.1

Geo object 1: Obstruction (OBSTRN)
Attributes: QUASOU - 6:least depth known
 SORDAT - 20140623
 SORIND - US,US,graph,H12603
 TECSOU - 3:found by multi-beam
 VALSOU - 7.474 m
 WATLEV - 3:always under water/submerged

Concur with clarification. Combine with adjacent DTON into an obstruction area.
