DESCRIPTIVE REPORT

Type of Survey: Navigable Area

Registry Number: H12603

Sub-locality: Vicinity South of Jones Beach

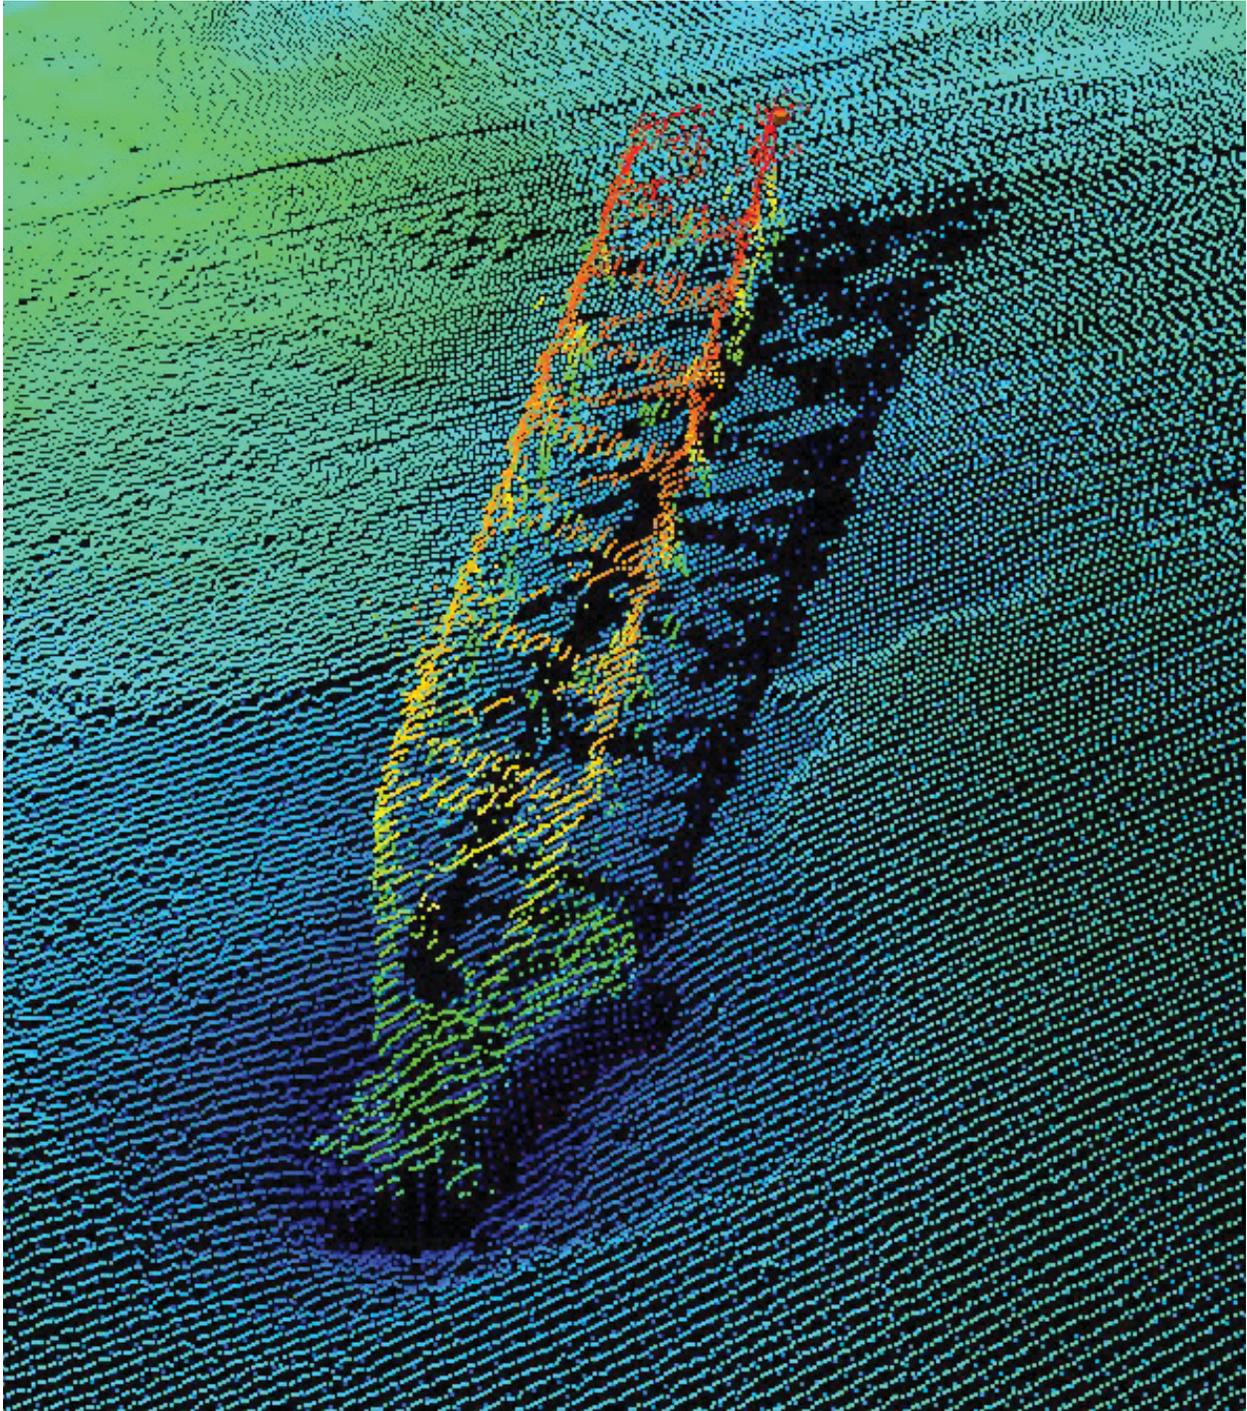
Figure 3.2.1

Geo object 1: Obstruction (OBSTRN)
Attributes: QUASOU - 6:least depth known
 SORDAT - 20140623
 SORIND - US,US,graph,H12603
 TECSOU - 3:found by multi-beam
 VALSOU - 7.523 m
 WATLEV - 3:always under water/submerged

Concur with clarification. Combine with adjacent DTON into an obstruction area.

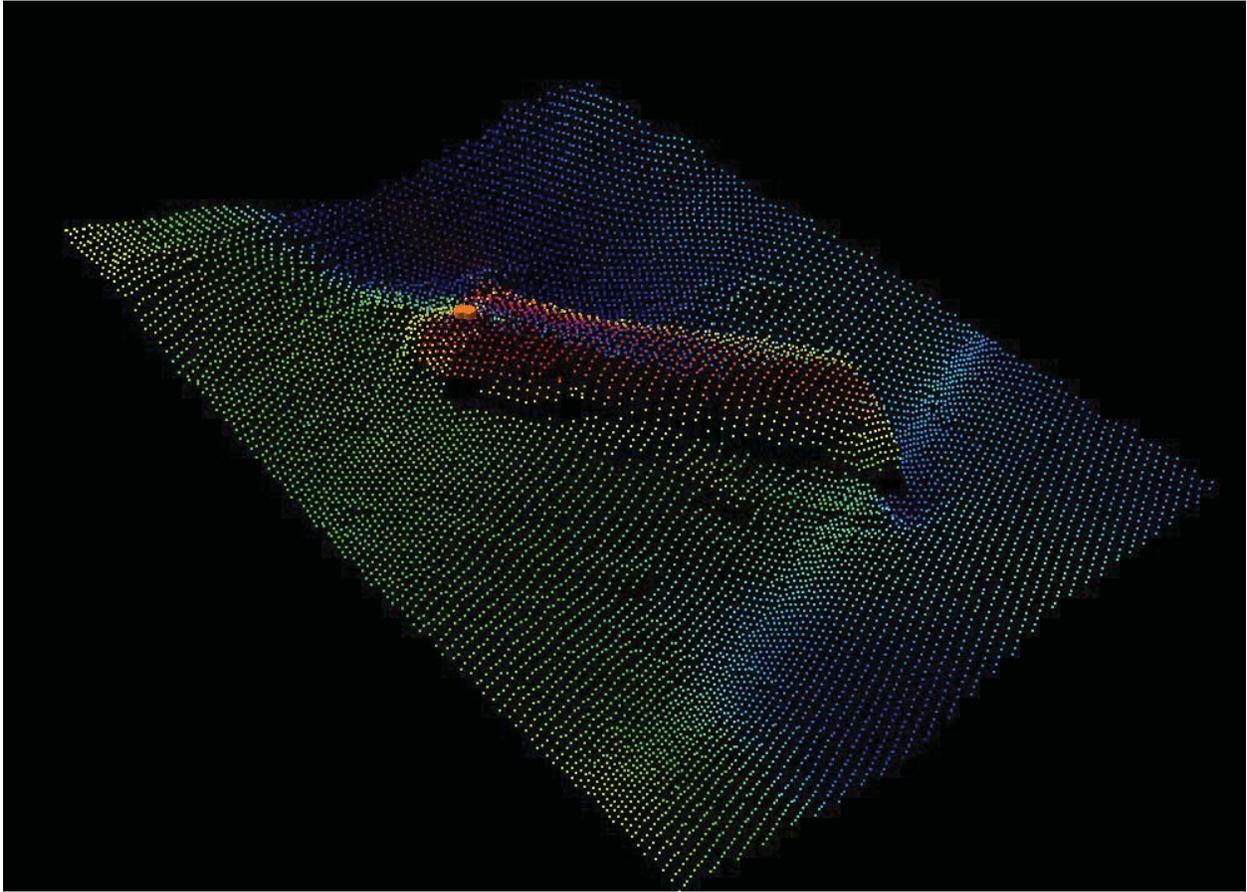
Figure 3.3.1

Geo object 1: Obstruction (OBSTRN)
Attributes: INFORM - Significant Feature, Wreck, possible sailboat, 7 x 2.1m, 2m off bottom
 QUASOU - 6:least depth known
 SORDAT - 20140623
 SORIND - US,US,graph,H12603
 TECSOU - 3:found by multi-beam
 VALSOU - 9.198 m
 WATLEV - 3:always under water/submerged

SAR: Recommend update as OBSTRN, include least depth

Concur. Located within search radius for AWOIS 15113.
