# H12607

NOAA FORM 76-35A	
U.S. Department of Commerce National Oceanic and Atmospheric Administration National Ocean Service	
DESCRIPTIVE REPORT	
Type of Survey:	Navigable Area
Project Number:	OPR-C301-KR-13
Registry Number:	H12607
LOCALITY	
State(s):	New York
General Locality:	North Atlantic, East Rockaway Inlet, NY
Sub-locality:	East Rockaway Inlet to Zachs Bay
2014	
CHIEF OF PARTY George G. Reynolds	
LIBRARY & ARCHIVES	
Date:

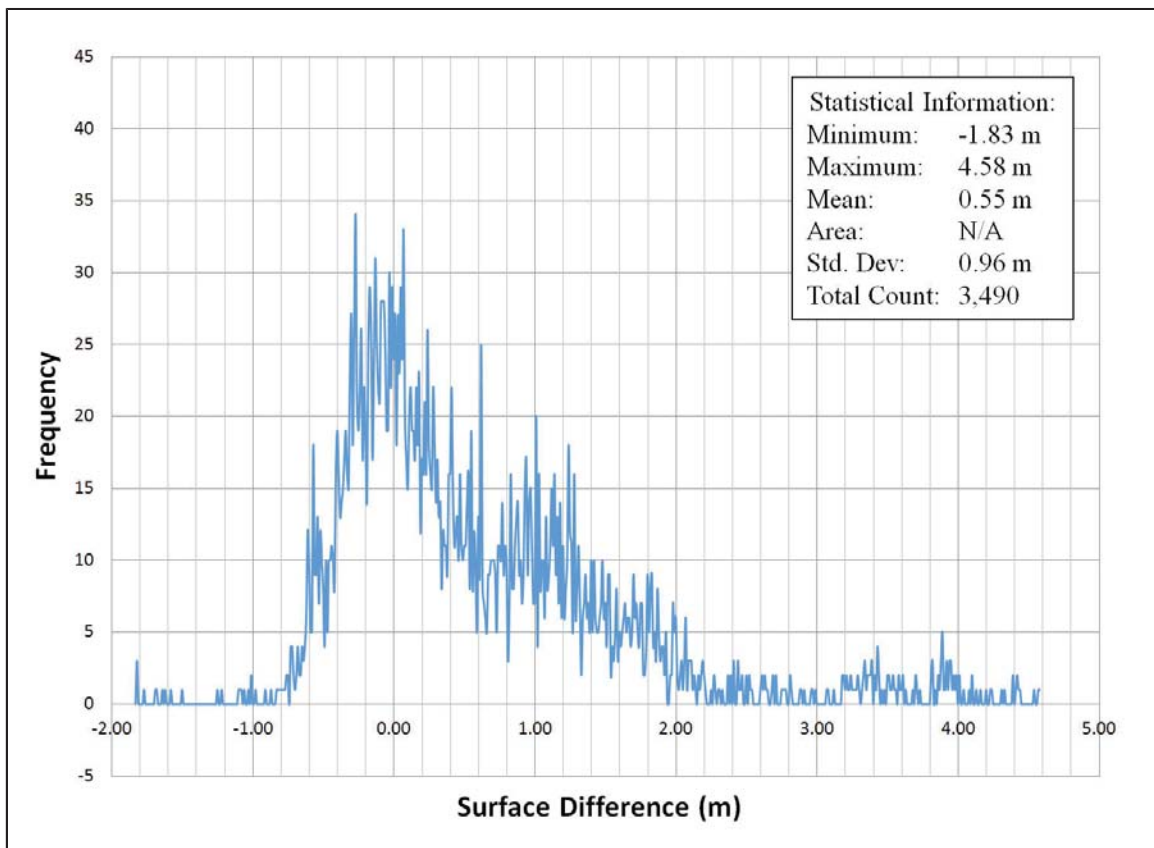
Figure 8: The graph shows a frequency distribution of the resultant depth differences from the subtraction of an H12138 2-m depth surface from an H12607 2-m depth surface. Statistics from the depth difference sample set are displayed in the inset.

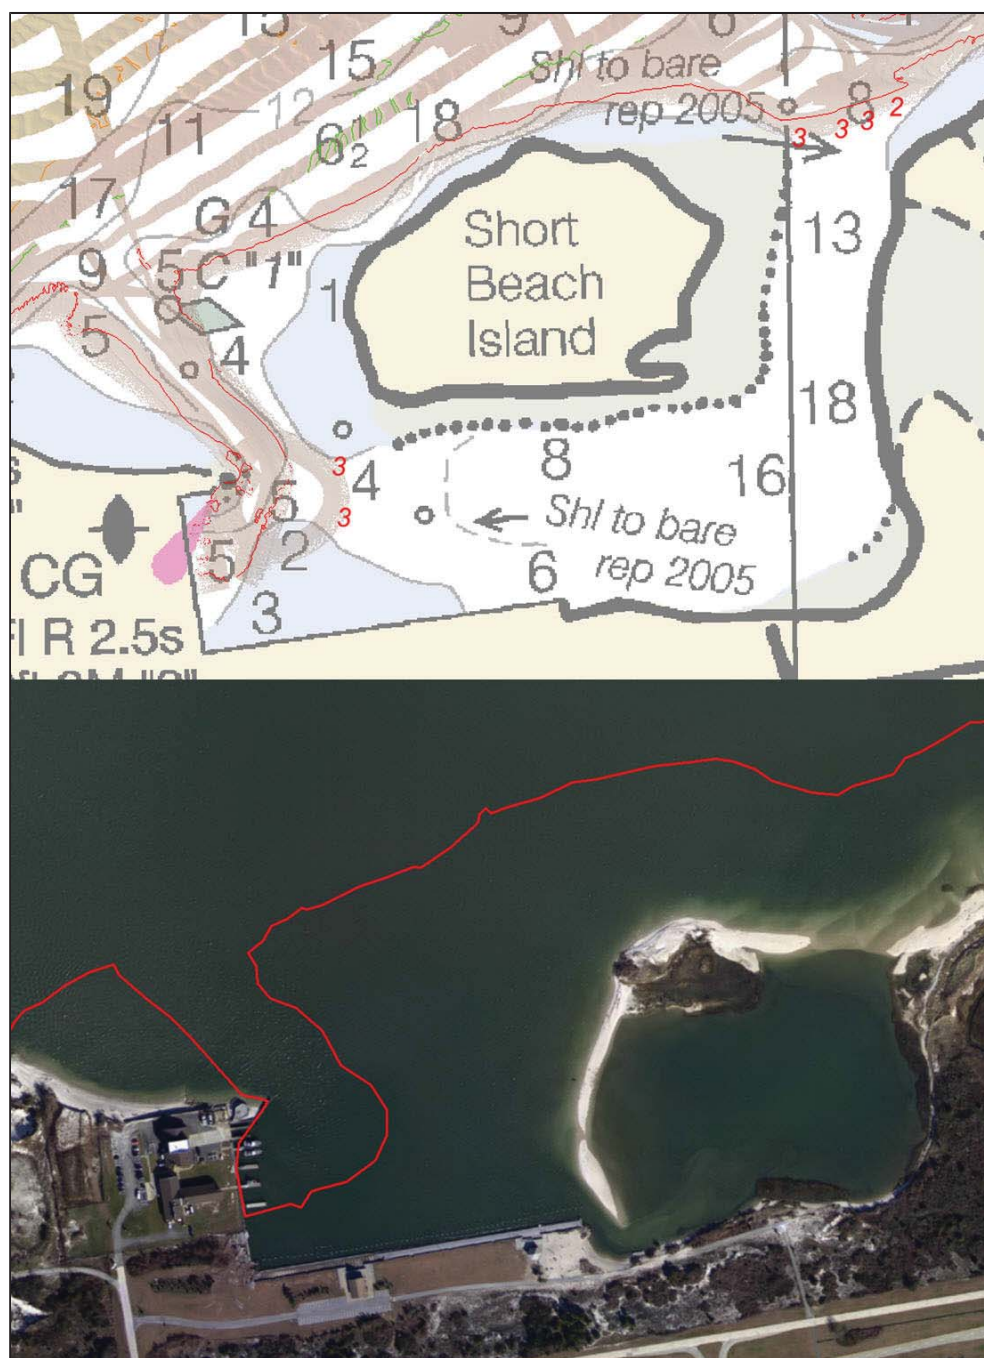
Figure 39: In the top image, contours generated from the H12607 MBES data (6' in red, 12' in green, and 18' in orange) are shown in reference to Short Beach Island. Representative soundings of the shoaling surrounding the island are highlighted in red with a CUBE surface overlaid on RNC 12352 in the background. In the image on the bottom, NGS post-Sandy imagery of Short Beach Island is shown with the H12607 survey outline highlighted in red.

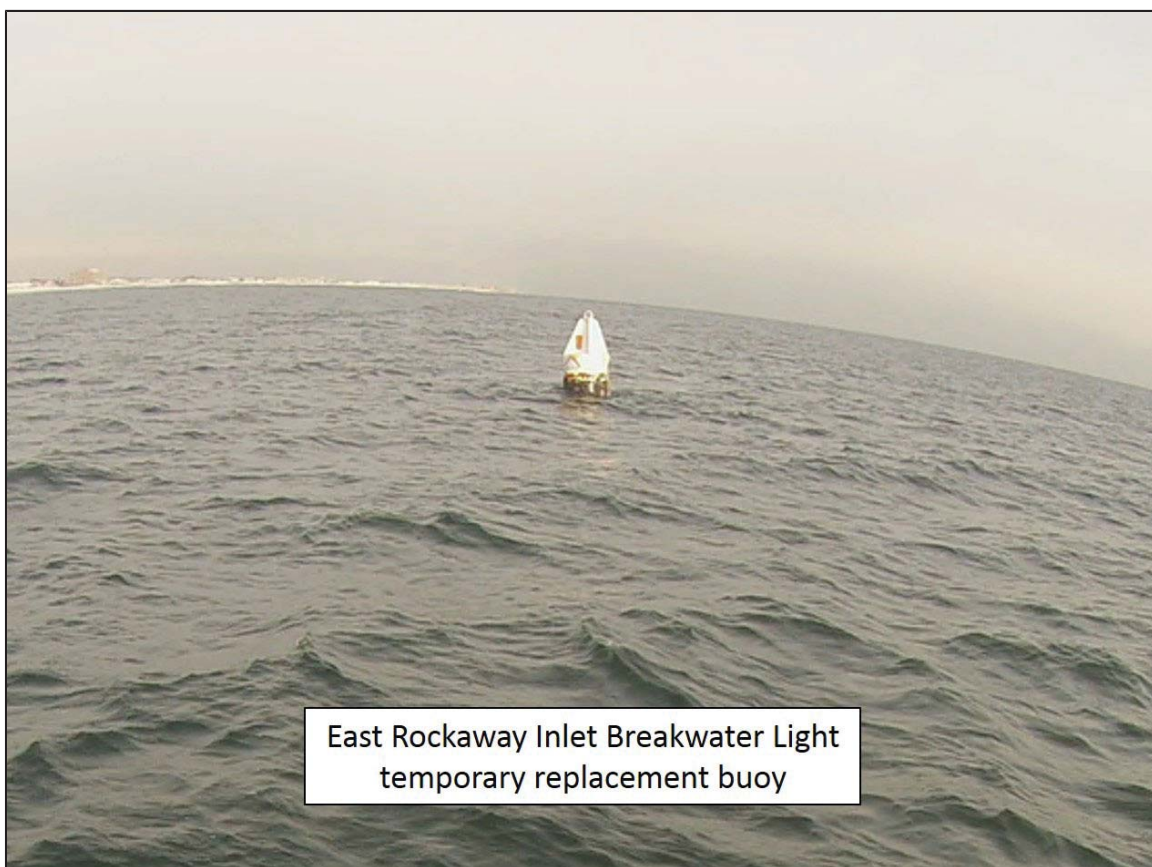
*Figure 41: A photo of the East Rockaway Inlet Breakwater Light TRUB, temporary replacement buoy.*

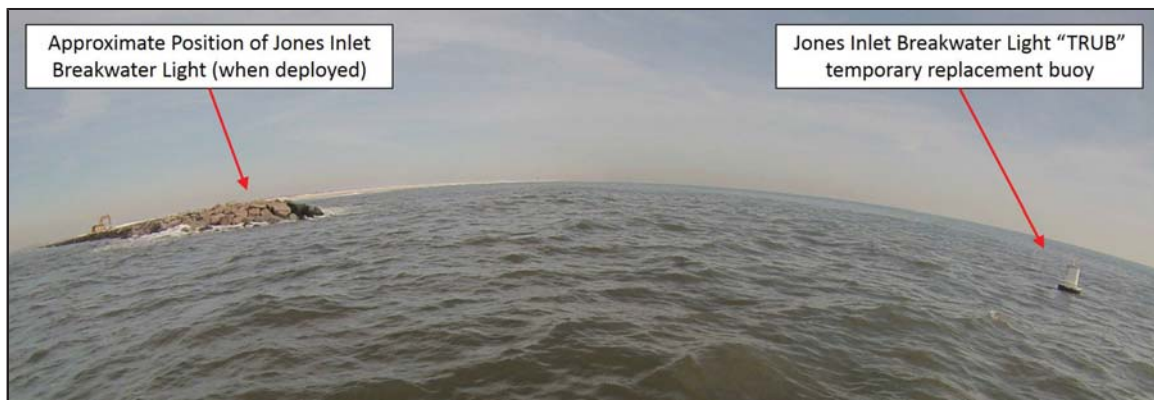
*Figure 44: A photo of the Jones Inlet Breakwater Light TRUB, temporary replacement buoy.*

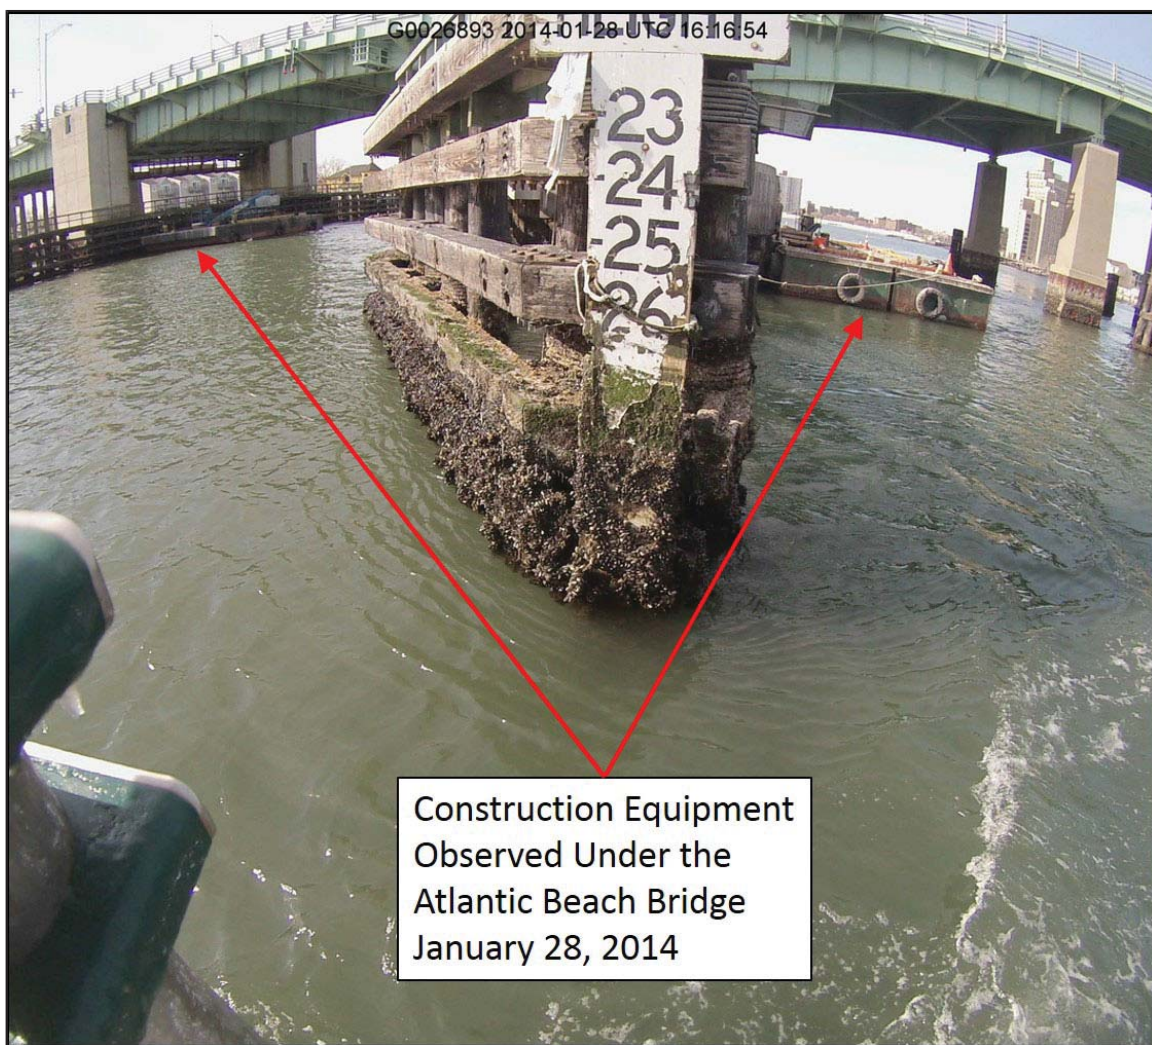
*Figure 45: A photo of construction equipment observed under the Atlantic Beach Bridge during Survey H12607.*

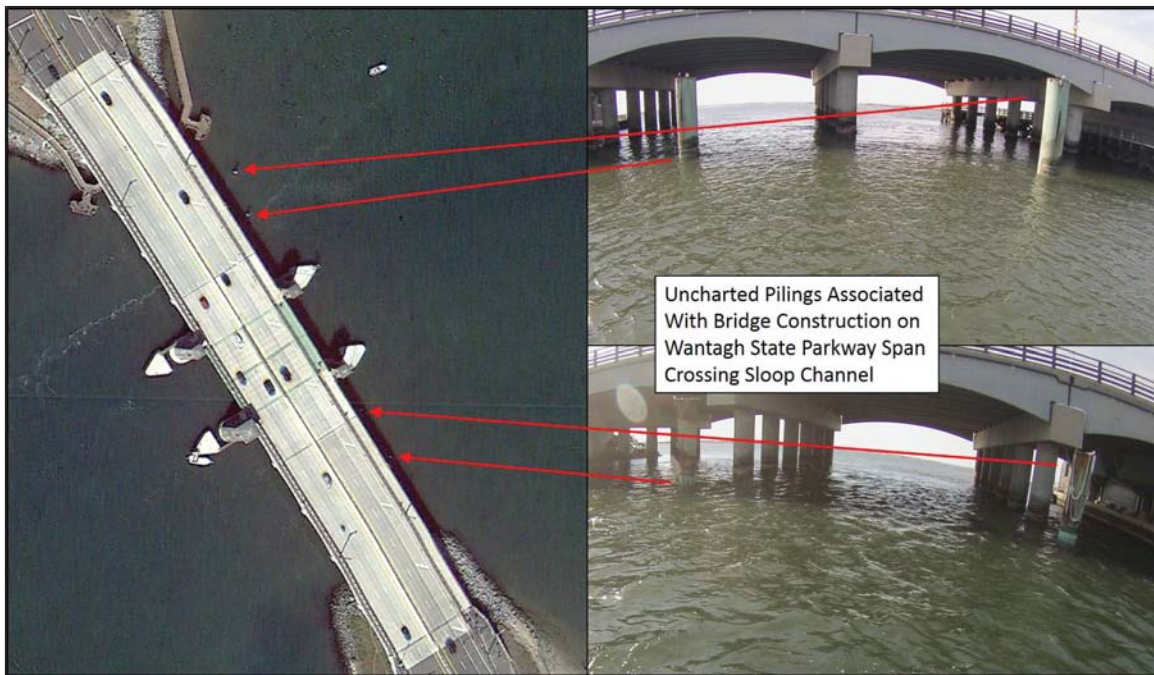
*Figure 46: Aerial imagery and photographs acquired during survey acquisition show the uncharted pilings associated with bridge construction of the Wantagh State Parkway span crossing Sloop Channel.*

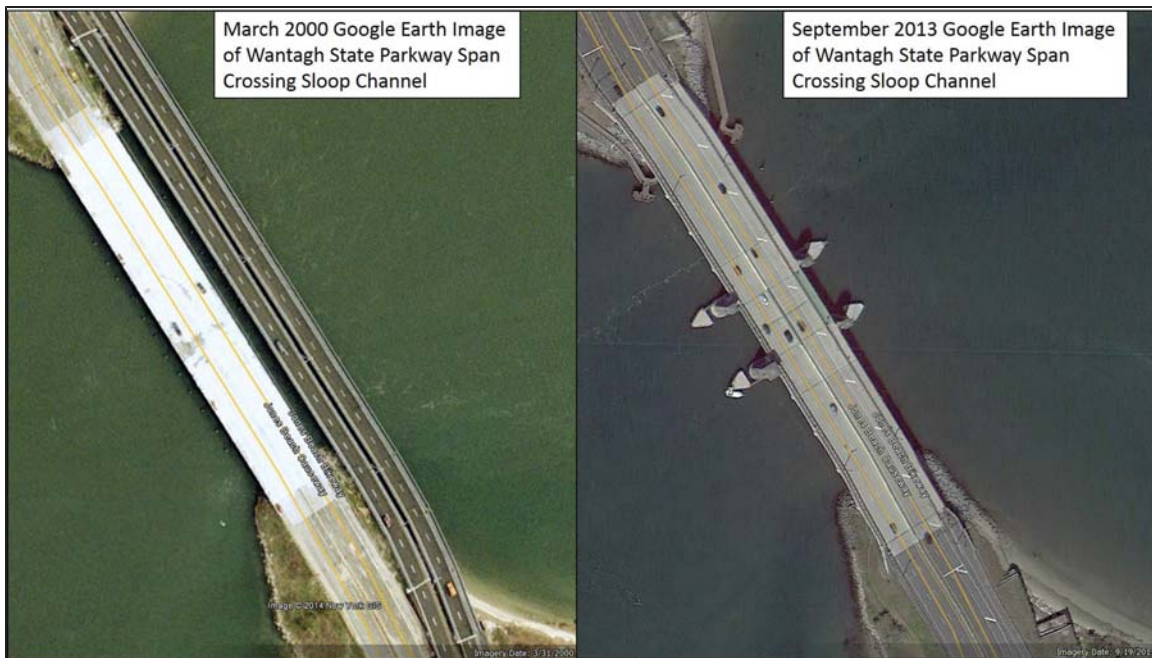
*Figure 47: Google Earth imagery from 2000 (left panel) and 2013 (right panel) show the changes to the Wantagh State Parkway span crossing Sloop Channel.*

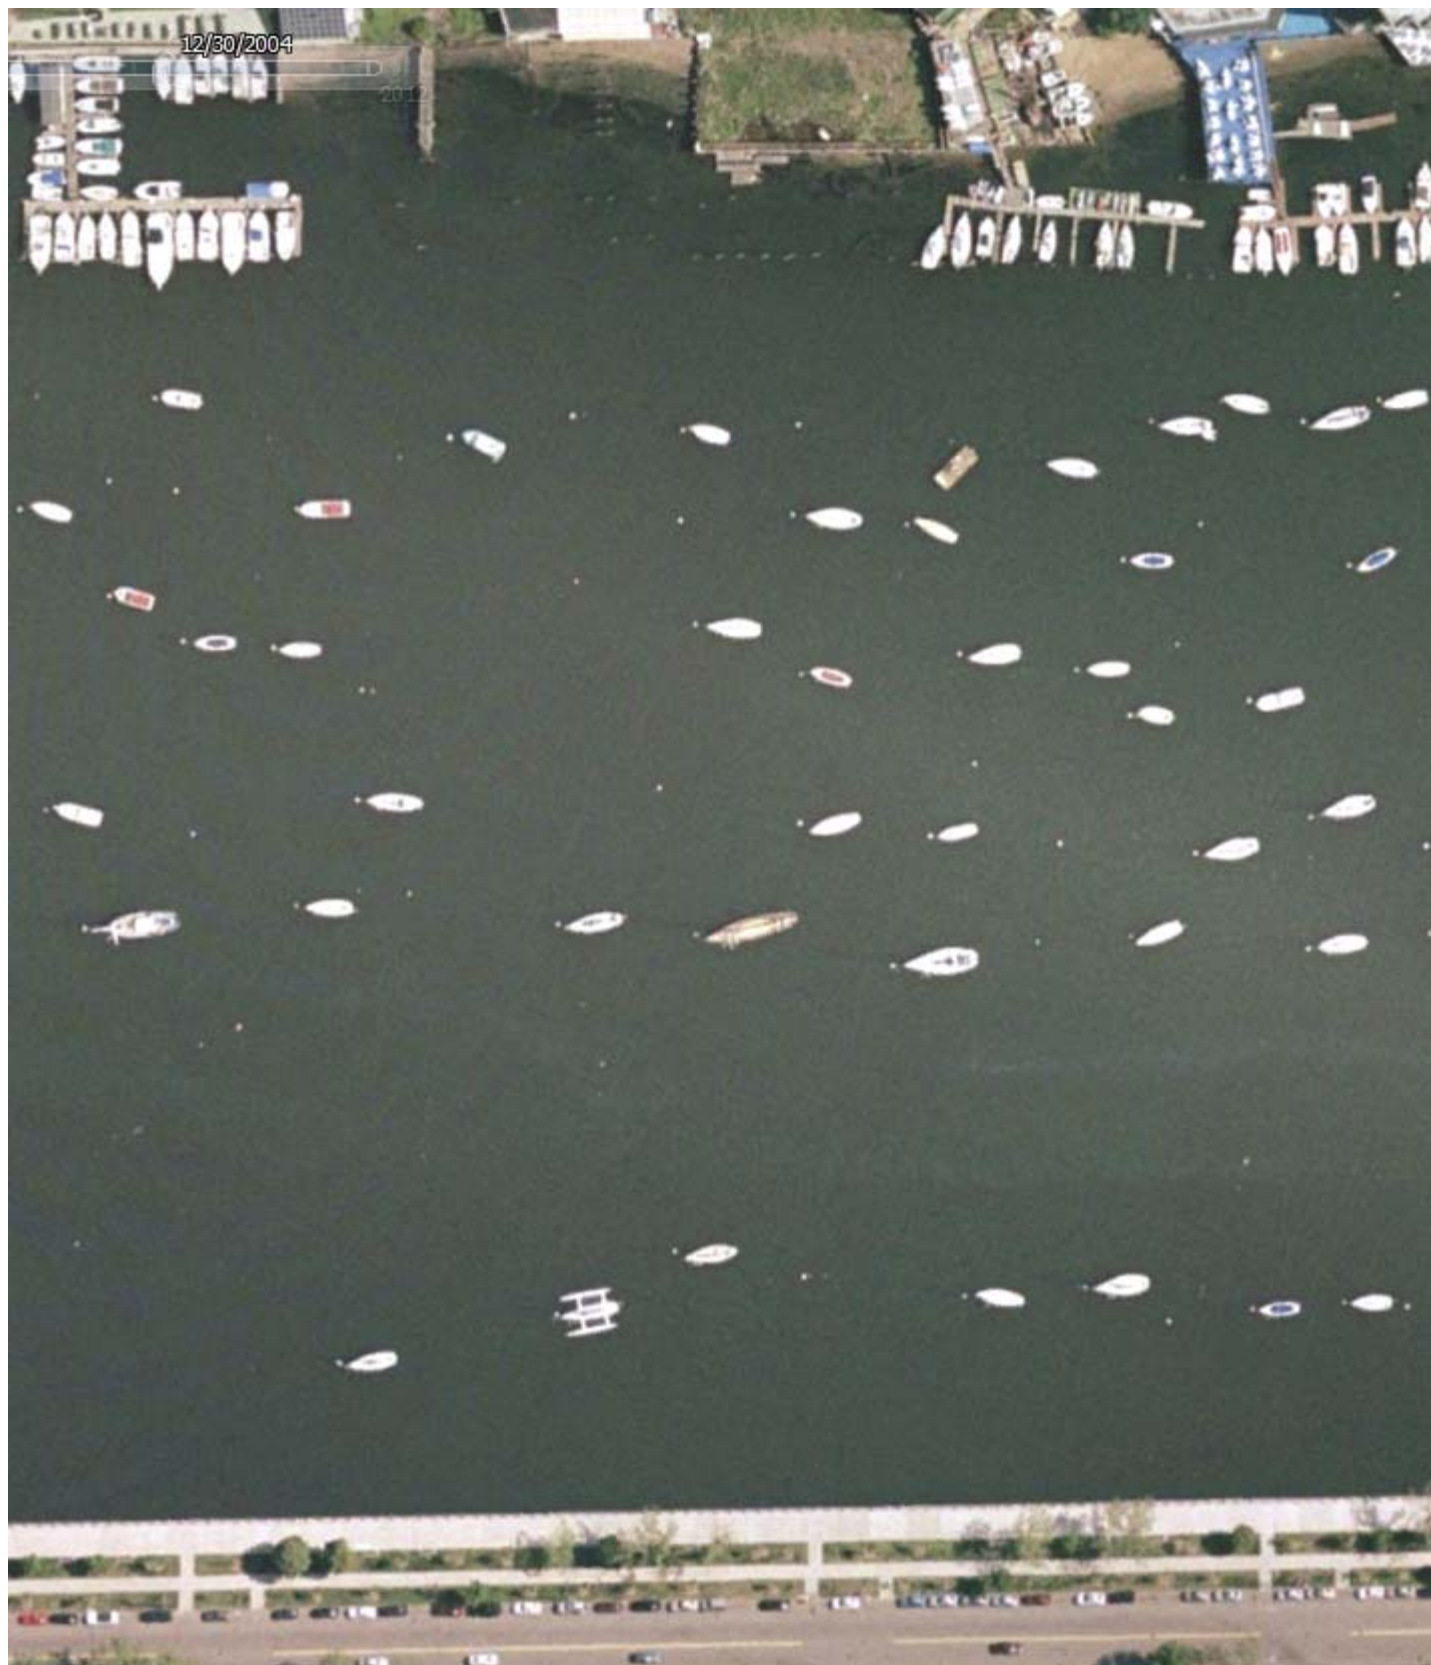
Moorings and Docks

3) There are also docks that appear to be located in less than 2 meters of water. Is there a requirement to locate these structures?

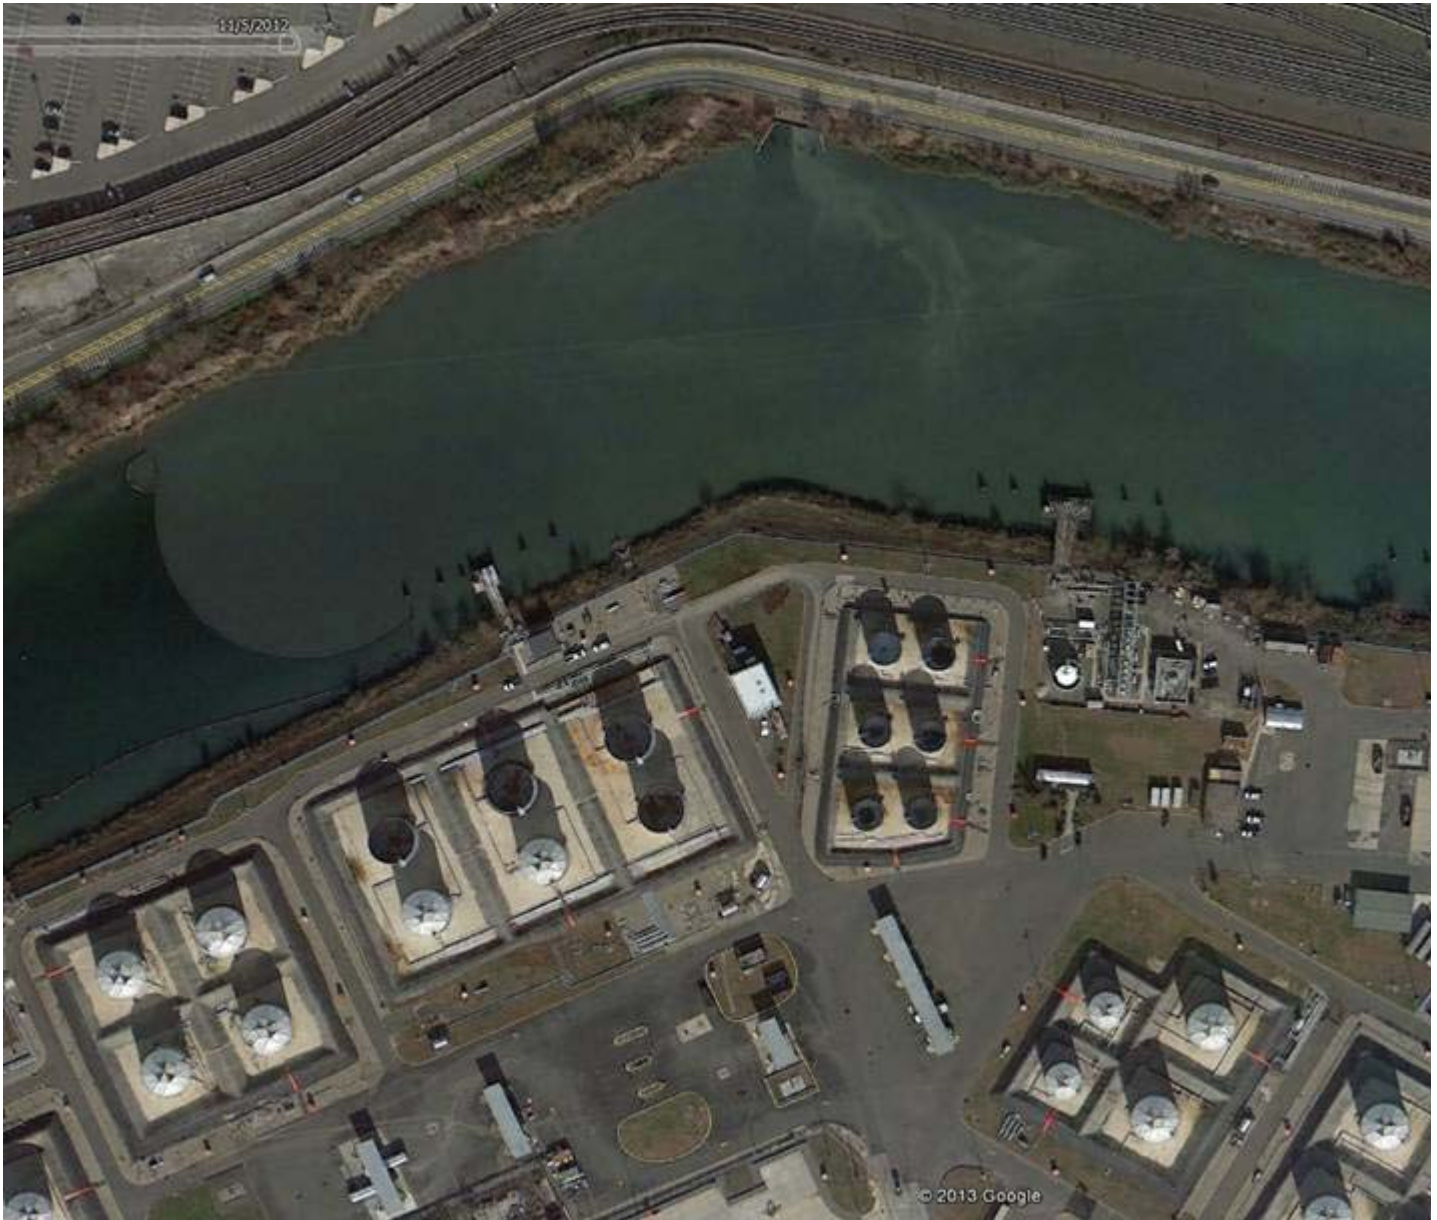
### Booms and Containment Areas

4) There are cases where containment booms cross the waterway. We assume that the survey will extend into these blocked areas. If so, will NOAA be able to provide a letter of introduction that we can transmit to State and City Departments along with interested private property owners as needed in attempt to gain access to these restricted reaches?

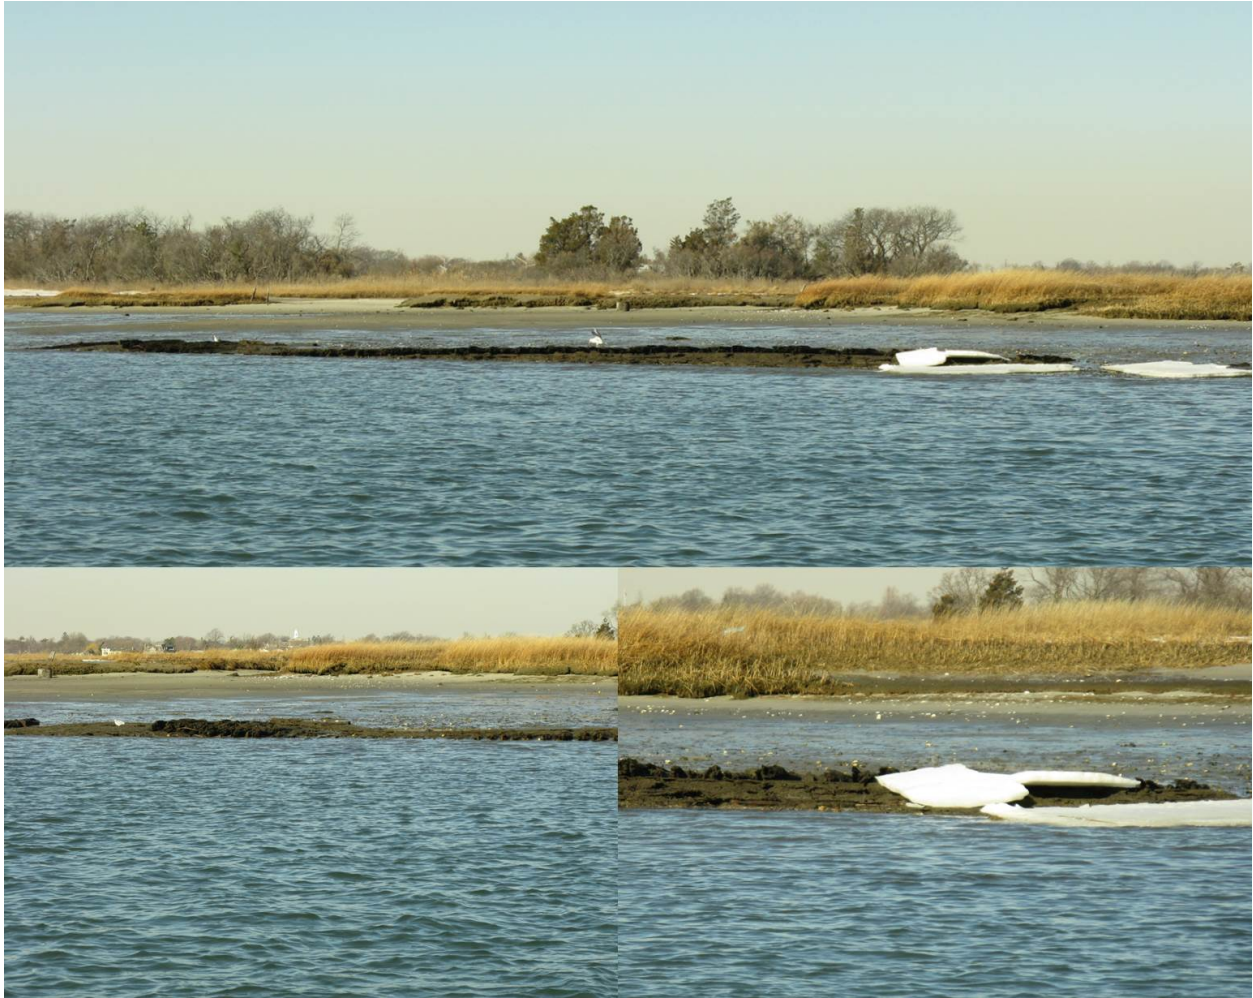
*Figure 1.2.1*

WRECKS/remrks: The search radius of the charted wreck ED was partially developed with MBES coverage and SSS coverage. Most of the 50 meter search radius is located inshore of the 2 meter contour. The remnants of a large wreck were observed visually and positioned with partial 100% SSS coverage. The AWOIS History is as follows: L-1356(77)--Wreck PA, currently charted as an ED in approx position LAT 40-35-38.67N / 073-43-48.79. (ENT, 6/11/2013 PTT).

Concur with clarification with field recommendation. AWOIS Item #15137 detected visually by the field unit. The search radius was only partially ensonified with the requisite 100% SSS coverage. The side scan imagery includes an object with wreck like appearance that correlates to the photograph. Update the position of the charted wreck, and the associated "ED" annotation is considered disproved and recommended for deletion.

It is recommended that the wreck's position be updated and the ED annotation removed.
