DESCRIPTIVE REPORT

Type of Survey: Navigable Area

Registry Number: H12613

Sub-locality: Vicinity of Isles of Shoals

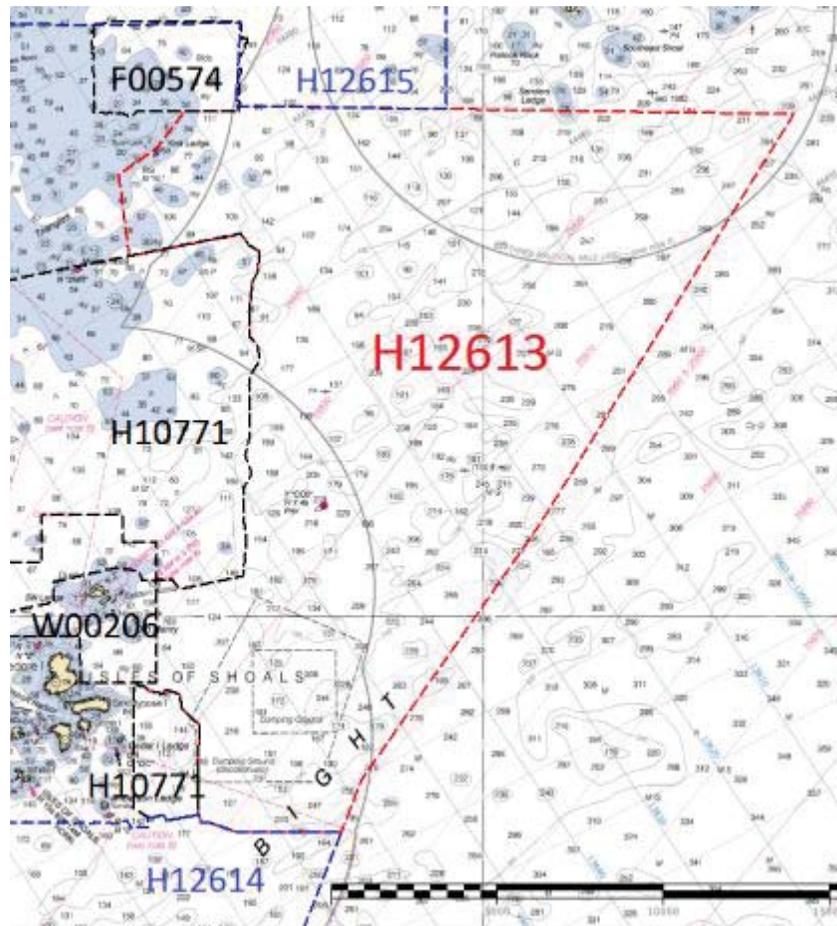
Figure 5: Surveys junctioning H12613. Surveys in blue are a part of OPR-A321-FH-13. Surveys in black were provided with project instructions.

The areas of overlap between sheet H12613 and its junction sheets, shown in Figure 5, were reviewed in CARIS Subset Editor for sounding consistency. Each junctioning surface was subtracted from the corresponding resolution surface of H12613 to assess sounding consistency.
