DESCRIPTIVE REPORT

Type of Survey: Navigable Area

Registry Number: H12618

General Locality: Long Beach, CA

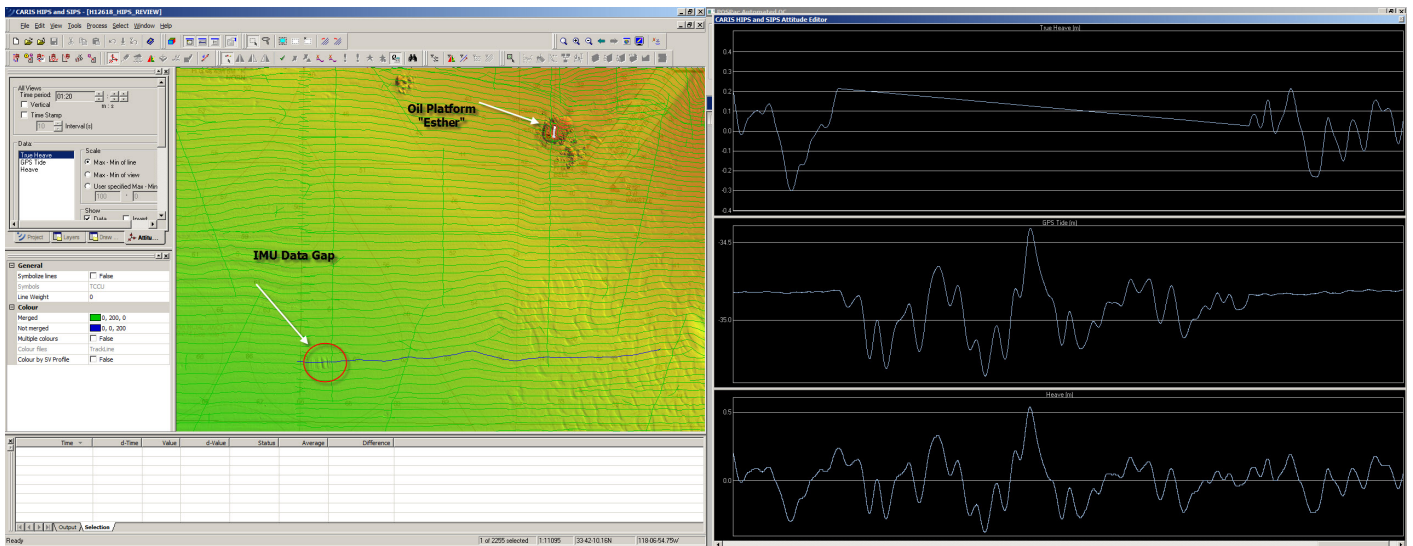
Figure 16: H12618 IMU Data Gap

An artifact due to a small period of IMU data gap was found at 33-42-13.83N, 118-07-53.73W, approximately 1 NM south-west of the oil platform "Esther" figure 16. The IMU data gap caused a rippling in survey line 28072013M_2722058. The MBES data was reviewed in CARIS Subset Mode with appropriate reference surfaces. The reference surface accurately depicts the seafloor.

The IMU data gap only affected TrueHeave data, all other IMU data was left intact. The gap, which is approximately 170 meters in length, is represented in the gridded data. A portion of this errant data does not meet HSSD Specification for heave error but does meet IHO standards.

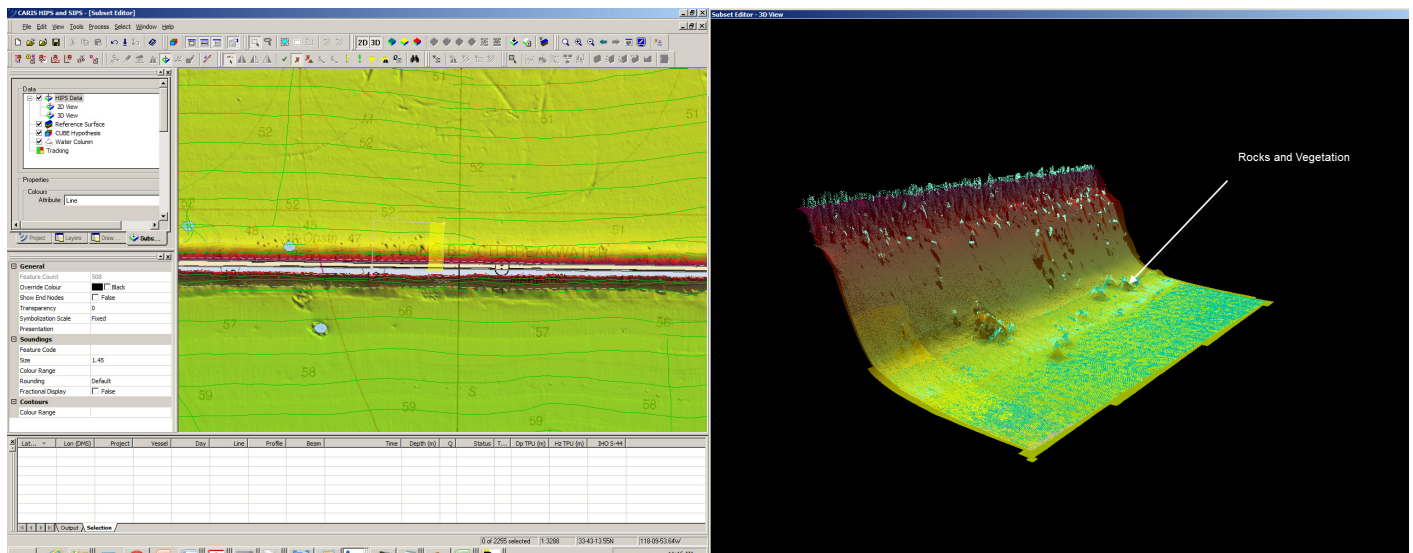
Figure 17: H12618 Breakwater rock and vegetation

During the cleaning and review processes for sheet H12618, the areas outside and inside the LA/LB breakwater containing many rocks with vegetation. A foul area with kelp was added to the final feature file to depict the extension of this rock and vegetation. The MBES data was reviewed in CARIS Subset Mode with appropriate reference surfaces. The spikes were removed and the gaps were interpolated across. The reference surface accurately depicts the seafloor. See figure 17.

During office processing a rocky seabed area was also added here, to complete the depiction of the area as foul with rocks and kelp.

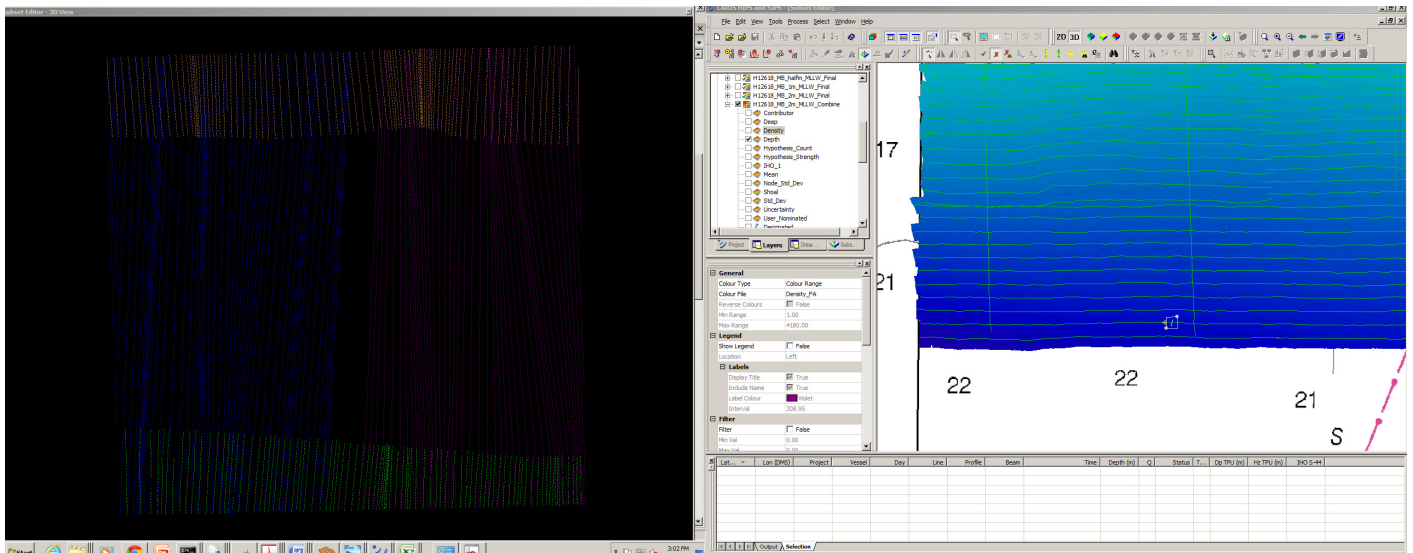
Figure 21: South West corner of H12618.

The holiday located south west corner of H12618, $33^{\circ} 37' 37.62''\text{N}$, least depth is represented. The holiday is depicted below in Figure 21.

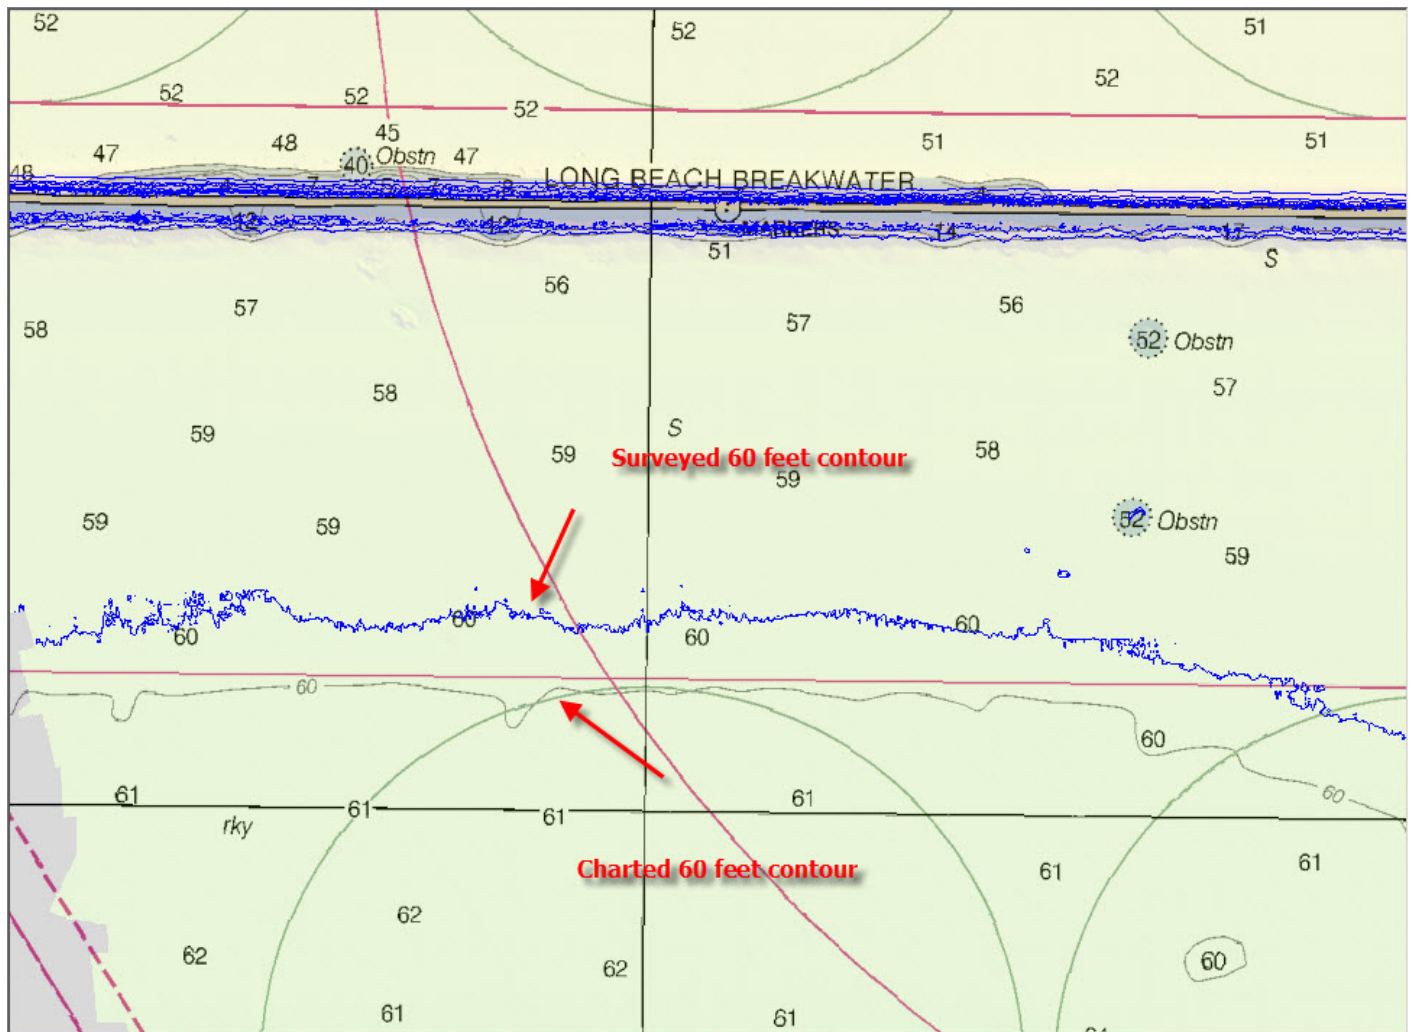
Figure 24: Disagreement between charted contour (18751) and surveyed contour south of Long Beach Breakwater.

South of breakwater: The 60 feet contour was surveyed 100m North of the general charted location. See figure 24.

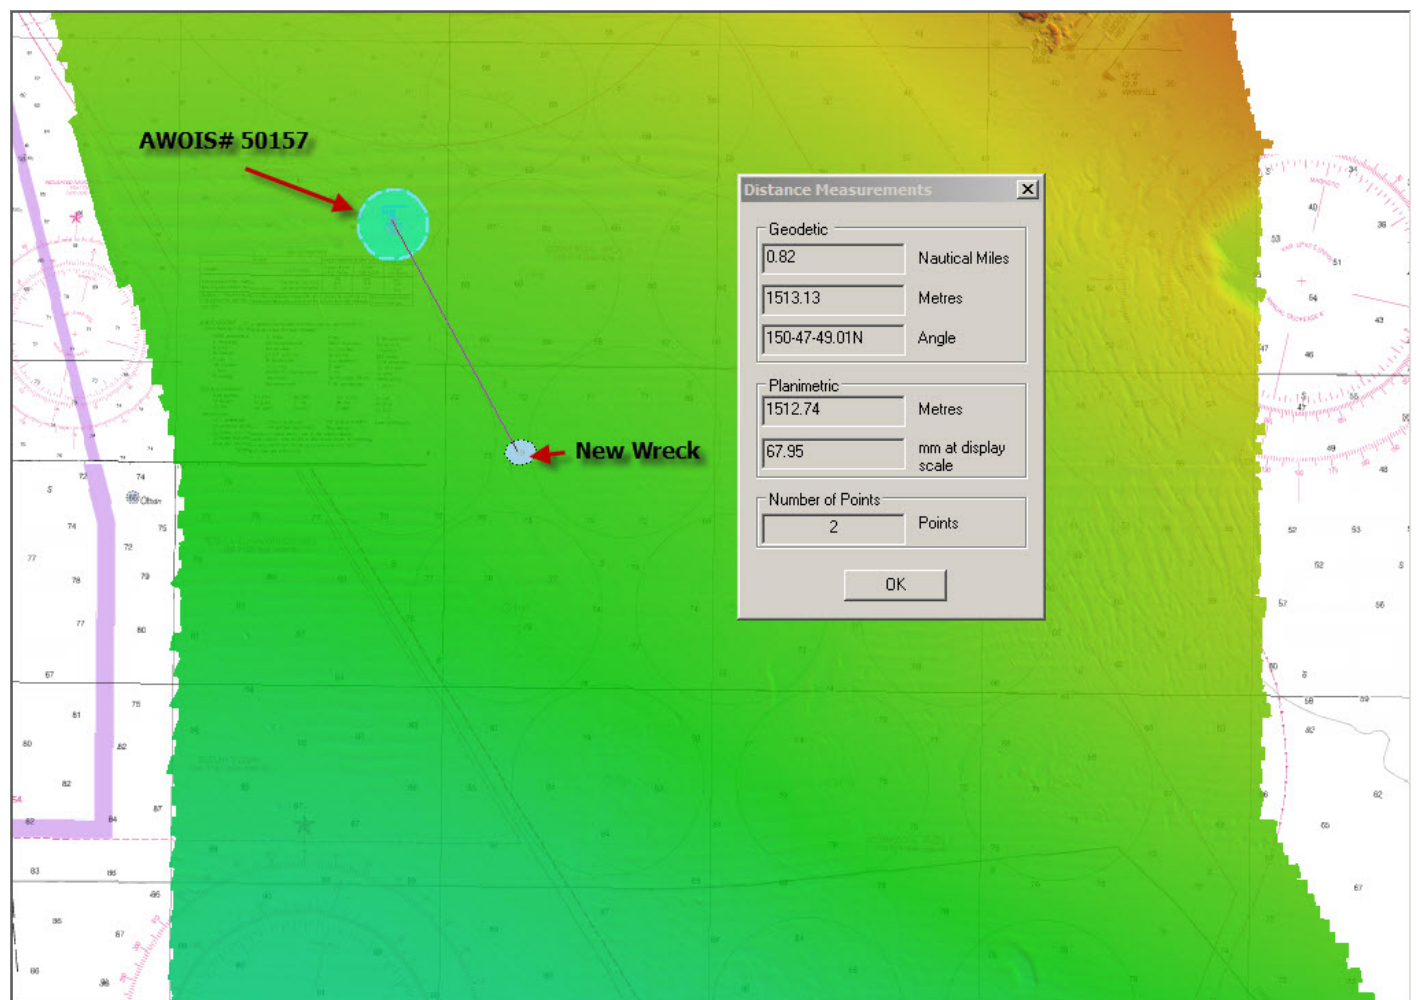
Figure 27: AWOIS# 50157 possible new location.

AWOIS# 50157 was not found within the 200 m radius provided in the Project Reference File (OPR-L318-FA-13_PRF). The textual description depicts a 1 NM accuracy. A wreck was found within 1 NM radius fitting the description of the AWOIS# 50157. This wreck was reported removed from an unknown authority. See figure 27.

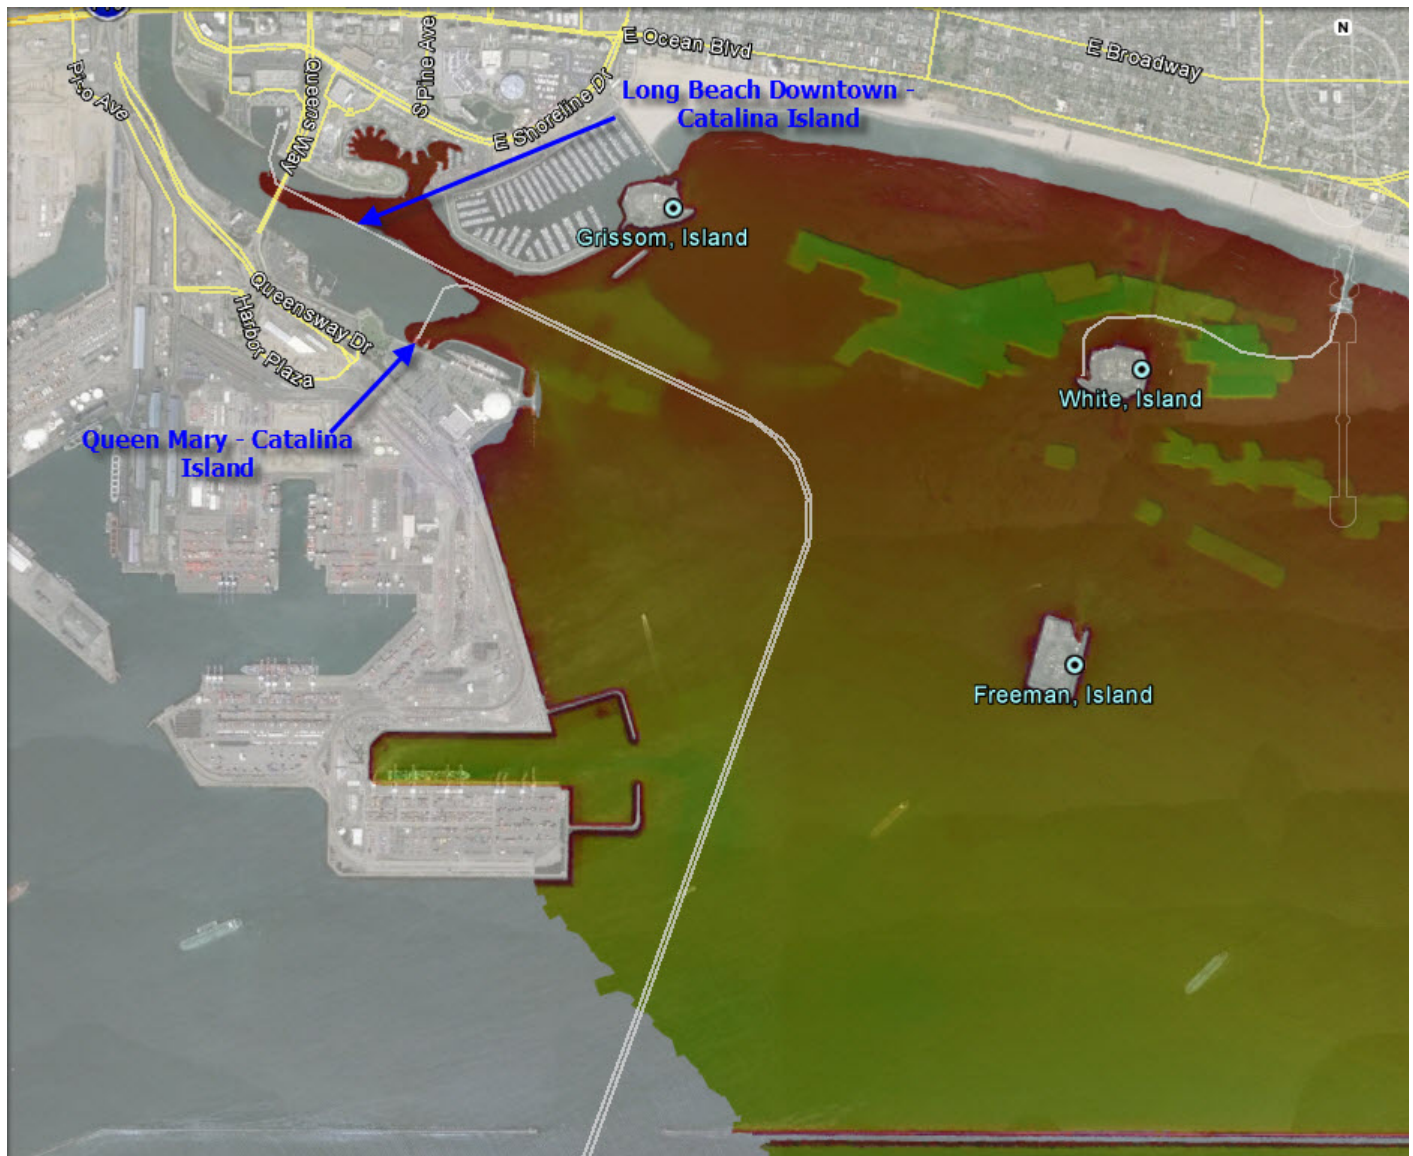
Figure 39: H12618 Ferry Routes.

Although not depicted on navigational charts of the area, different ferry routes pass through the boundaries of survey H12618. These ferry routes run from Queensway Bay to Catalina Island using the Long Beach Channel. See figure 39.
