**DESCRIPTIVE REPORT**

Type of Survey: Navigable Area

Registry Number: H12620

Sub-locality: Approaches to Long Beach

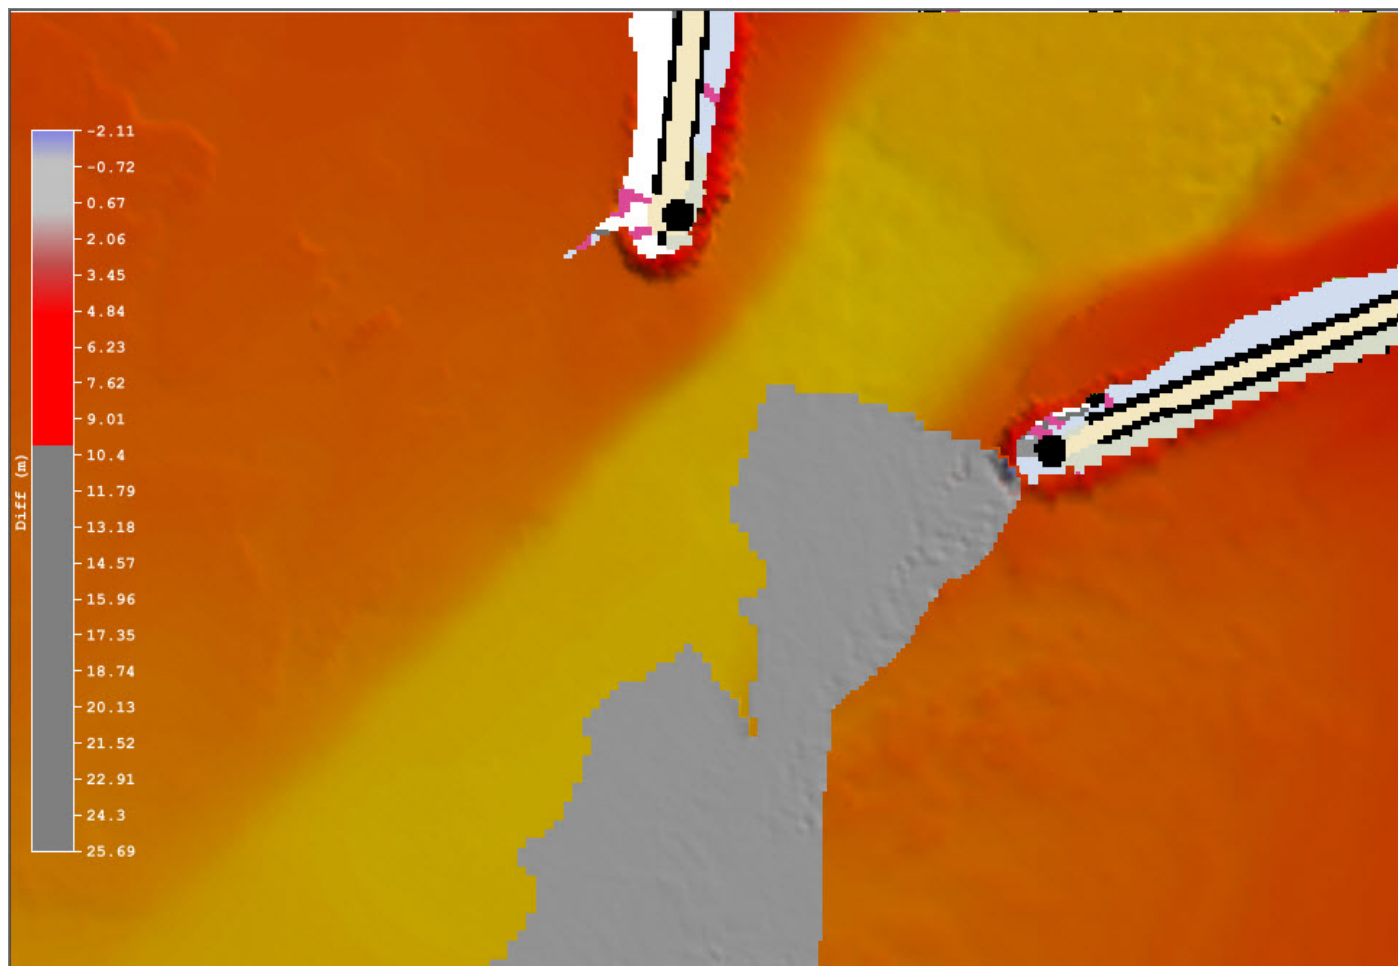
Surface differencing in CARIS HIPS and SIPS was used to assess junction agreement between H12618\_MB\_2m\_MLLW\_Combined surface and H12620\_MB\_2m\_MLLW\_Combined. The difference between surfaces were generally less than 0.5m and the few areas of larger differences are believed to be

caused by rapid changes in slope. See Figure 6 for a graphical representation and figure 7 for statistical information of the surface differencing.

*Figure 6: Graphical representation of differences between junction H12618 and H12620.*

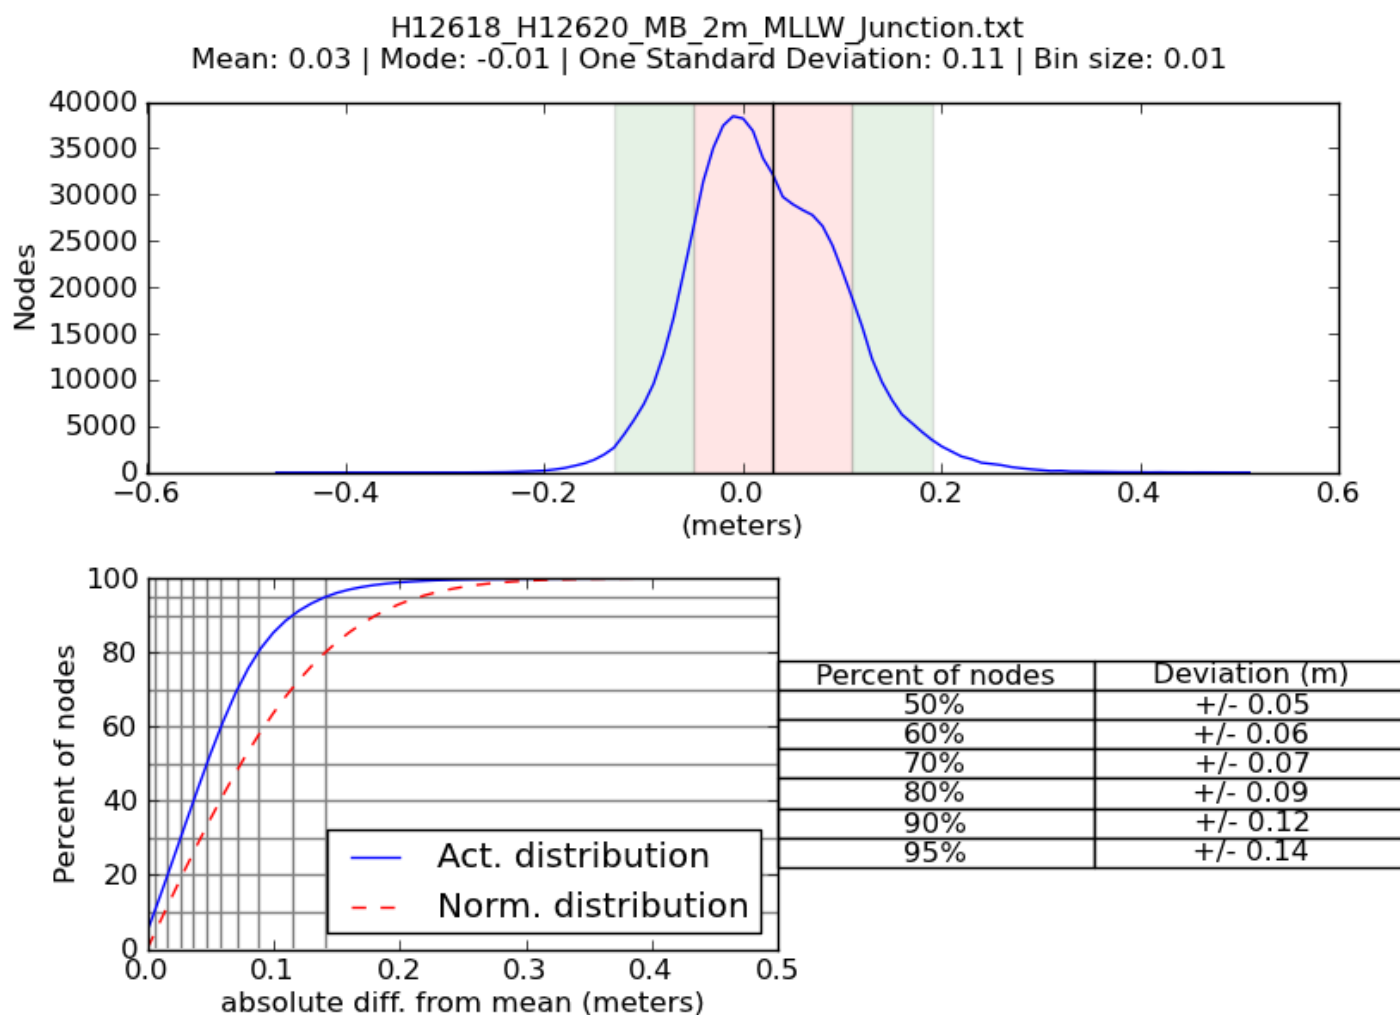
Figure 7: Statistical information for junction comparison between sheet H12618 and H12620.

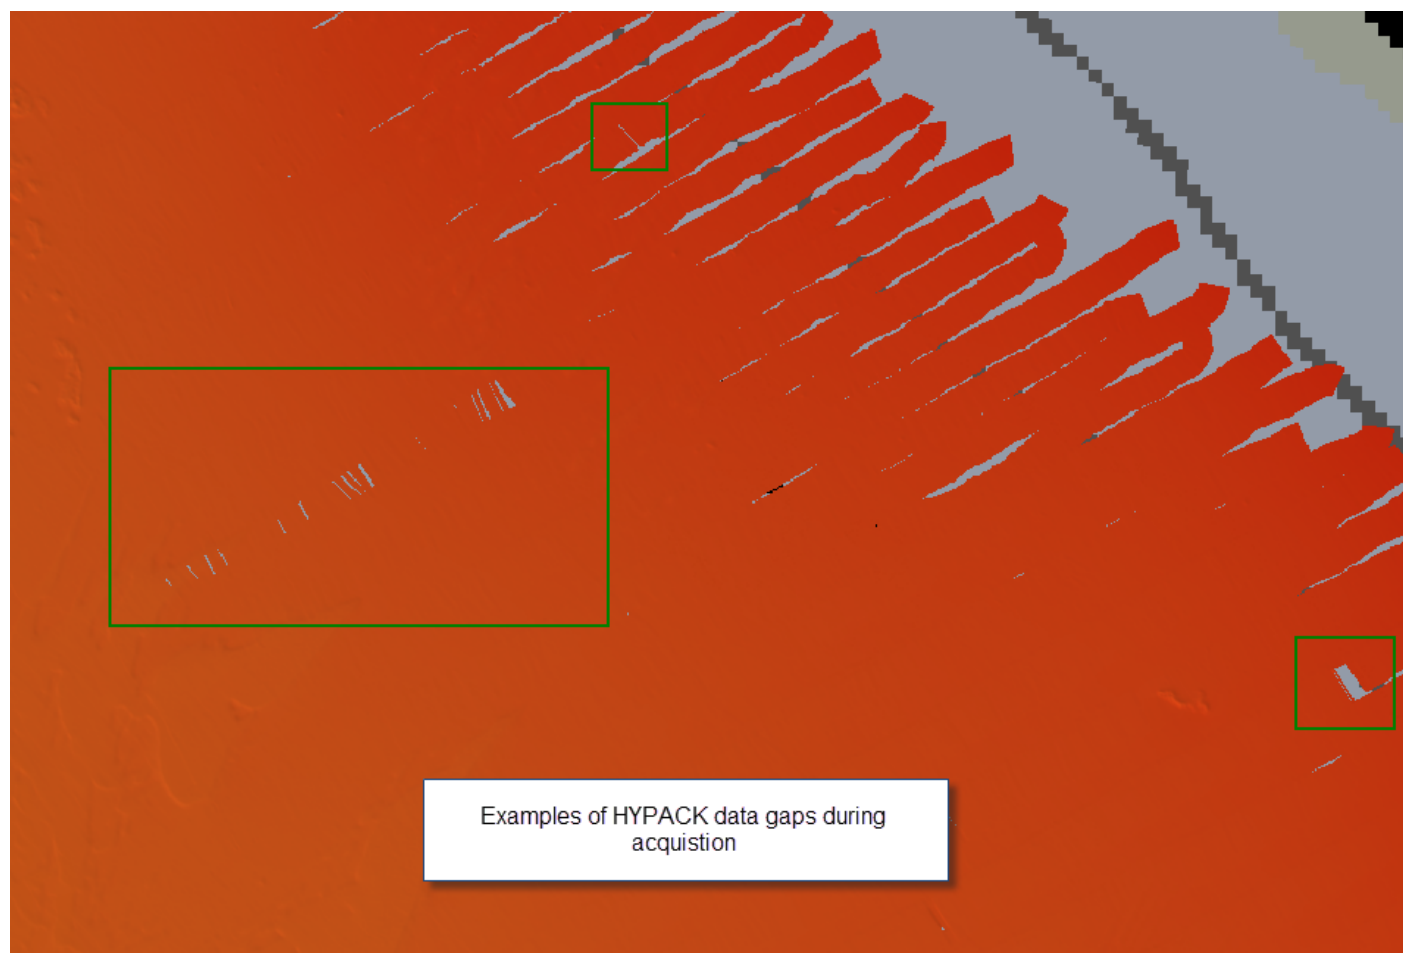
During acquisition, data gaps occurred in the HYPACK/HYSWEEP software that lead to holidays in the raw data. Figure 8 shows examples of these data gaps.

*Figure 8: Example of HYPACK/HYSWEEP data gaps.*

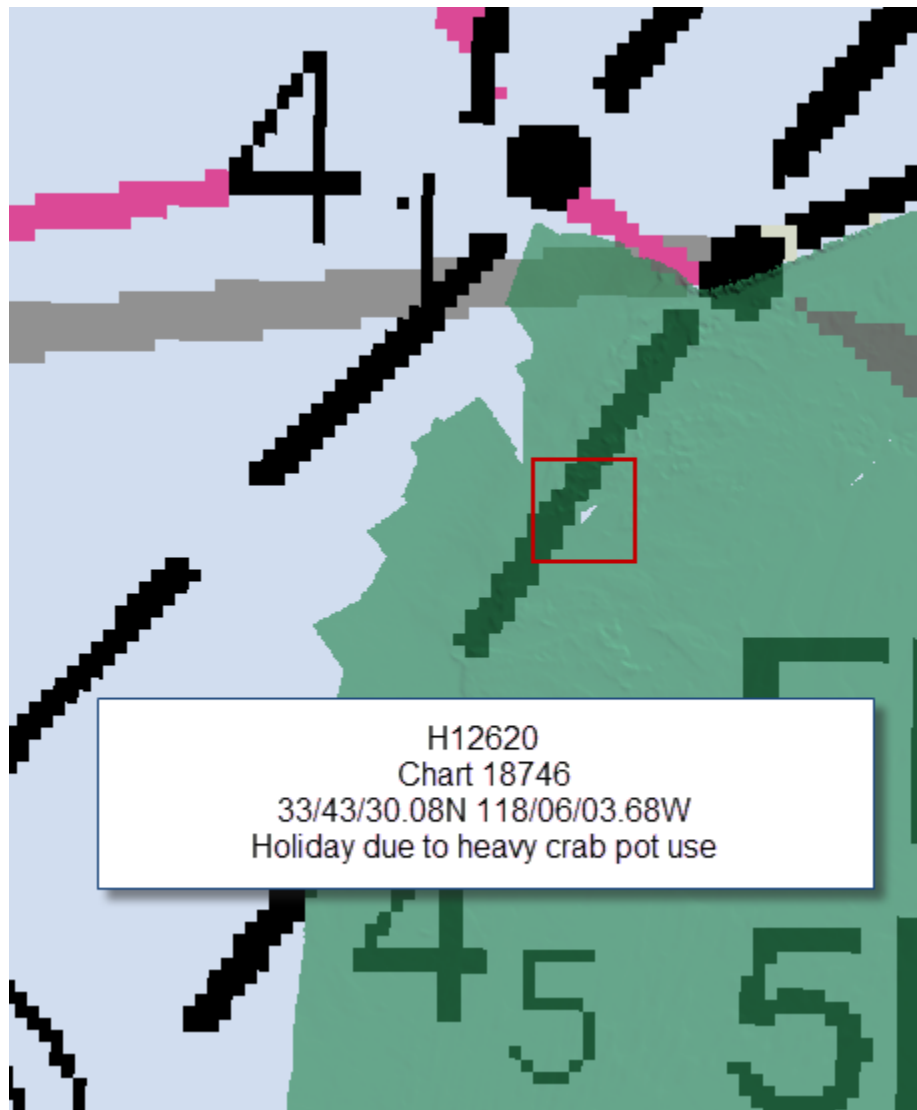
erroneous Surface Sound Speed measurements. The holiday located at the entrance to Anaheim Bay has the least depth represented and is shown in Figure 12. Figure 13 shows the holidays resulting from the cleaning out of pilings that are part of Platform EMMY (chart 18746).

*Figure 12: H12620 Holiday due to heavy crab pots in the area of Anaheim Bay.*

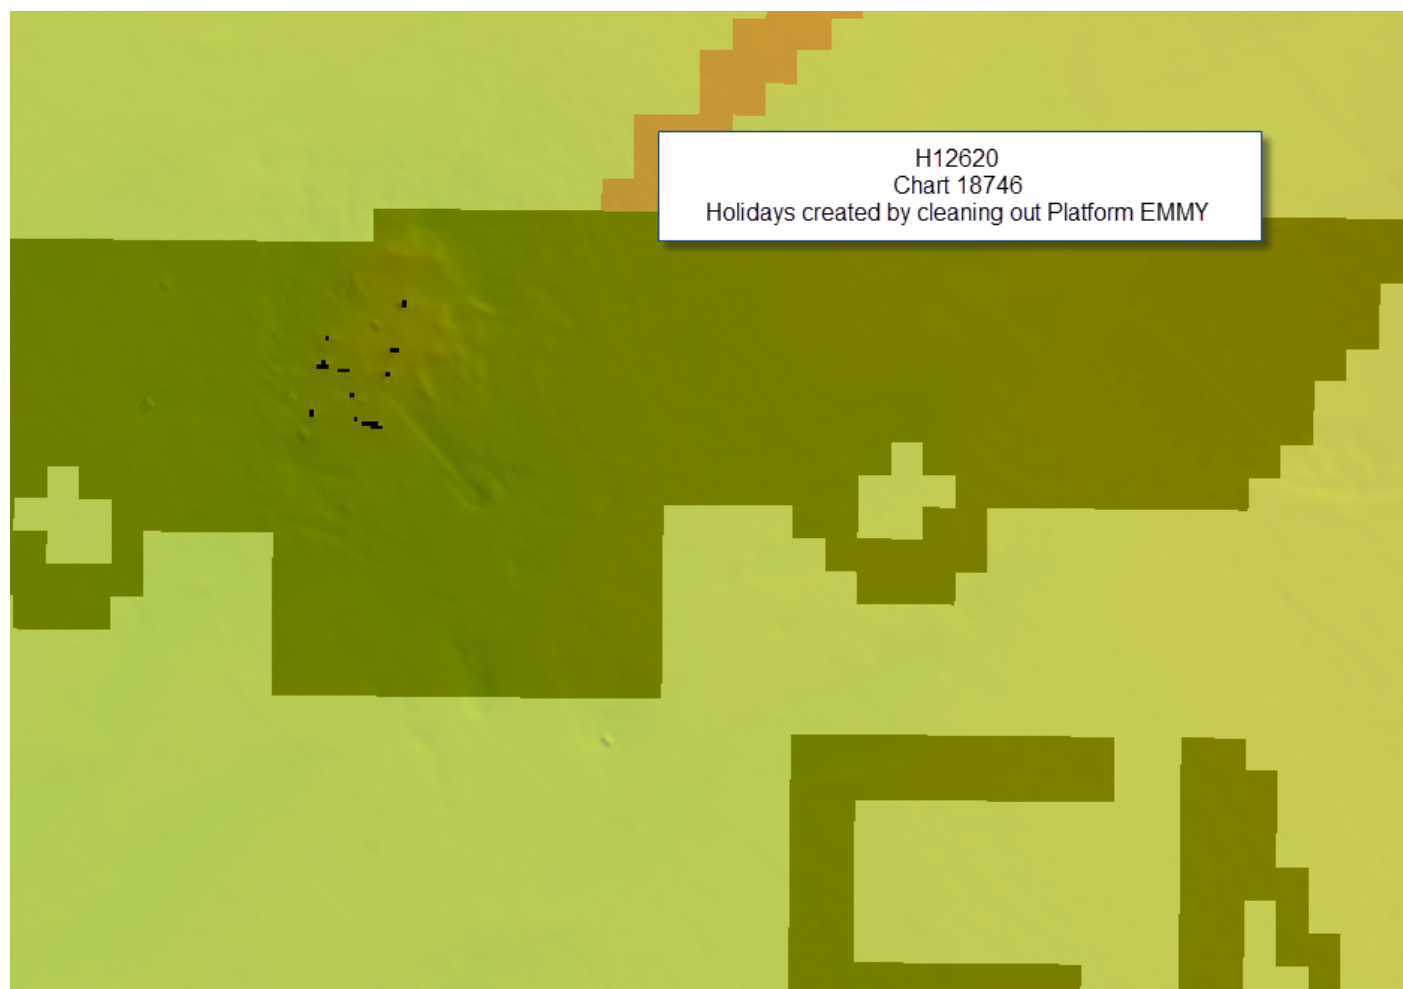
*Figure 13: H12620 Holidays due to cleaning of Platform EMMY (chart 18746) from the HIPS Surface.*

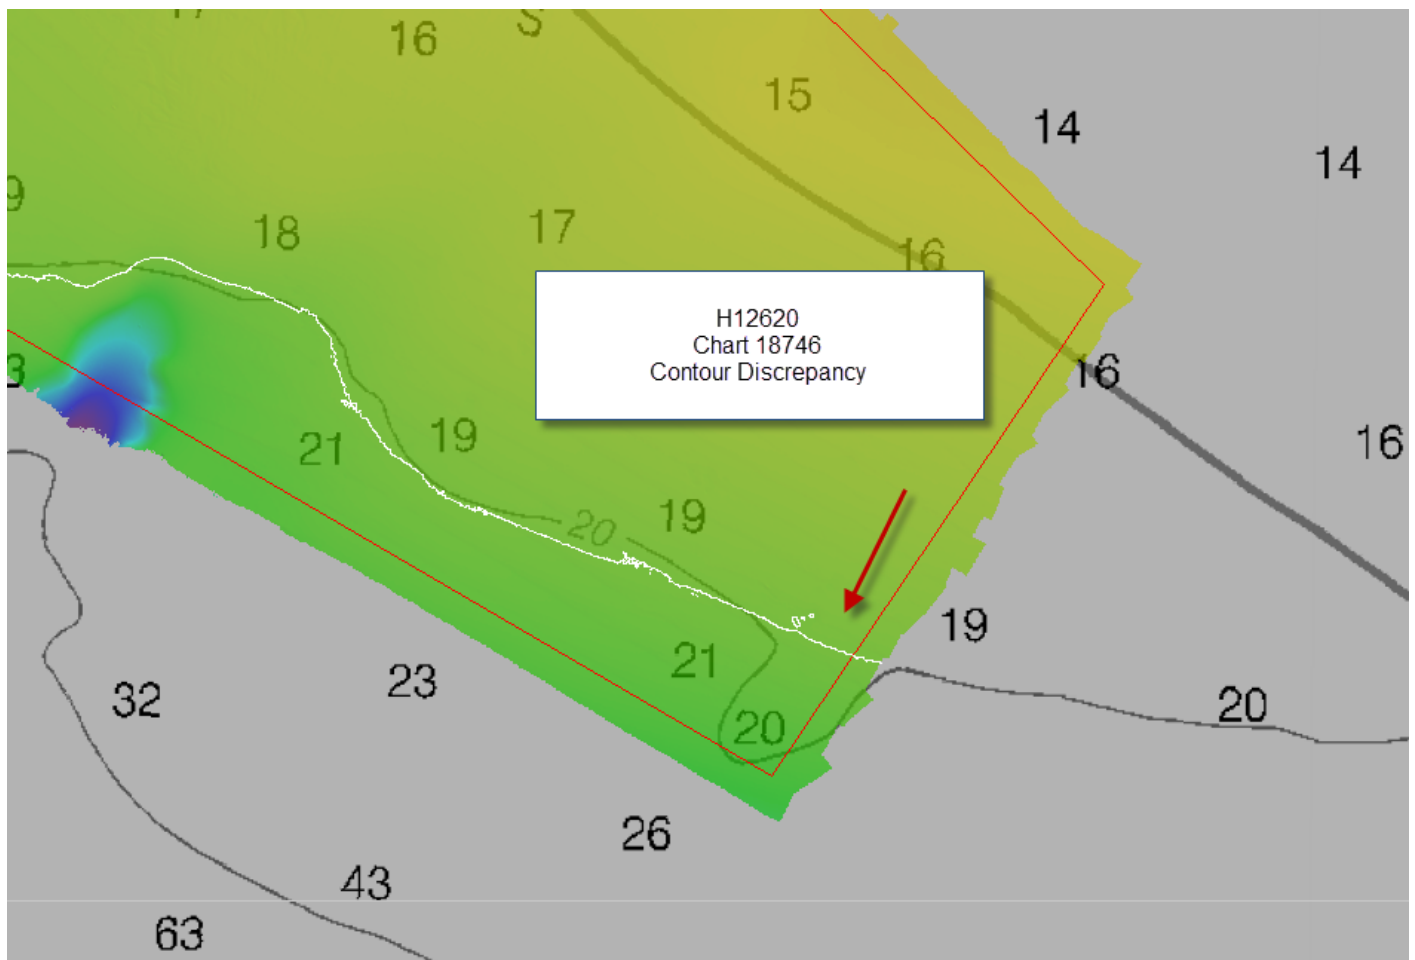
Soundings from survey H12620 generally agree within one to two fathoms of the charted depth. Contours generally agree with the chart except near the SW corner of the survey as noted in Figure 14 and West of Bolsa Bay as noted in Figure 15.

*Figure 14: Disagreement between charted contours (18746) and surveyed soundings SW of Huntington Beach.*

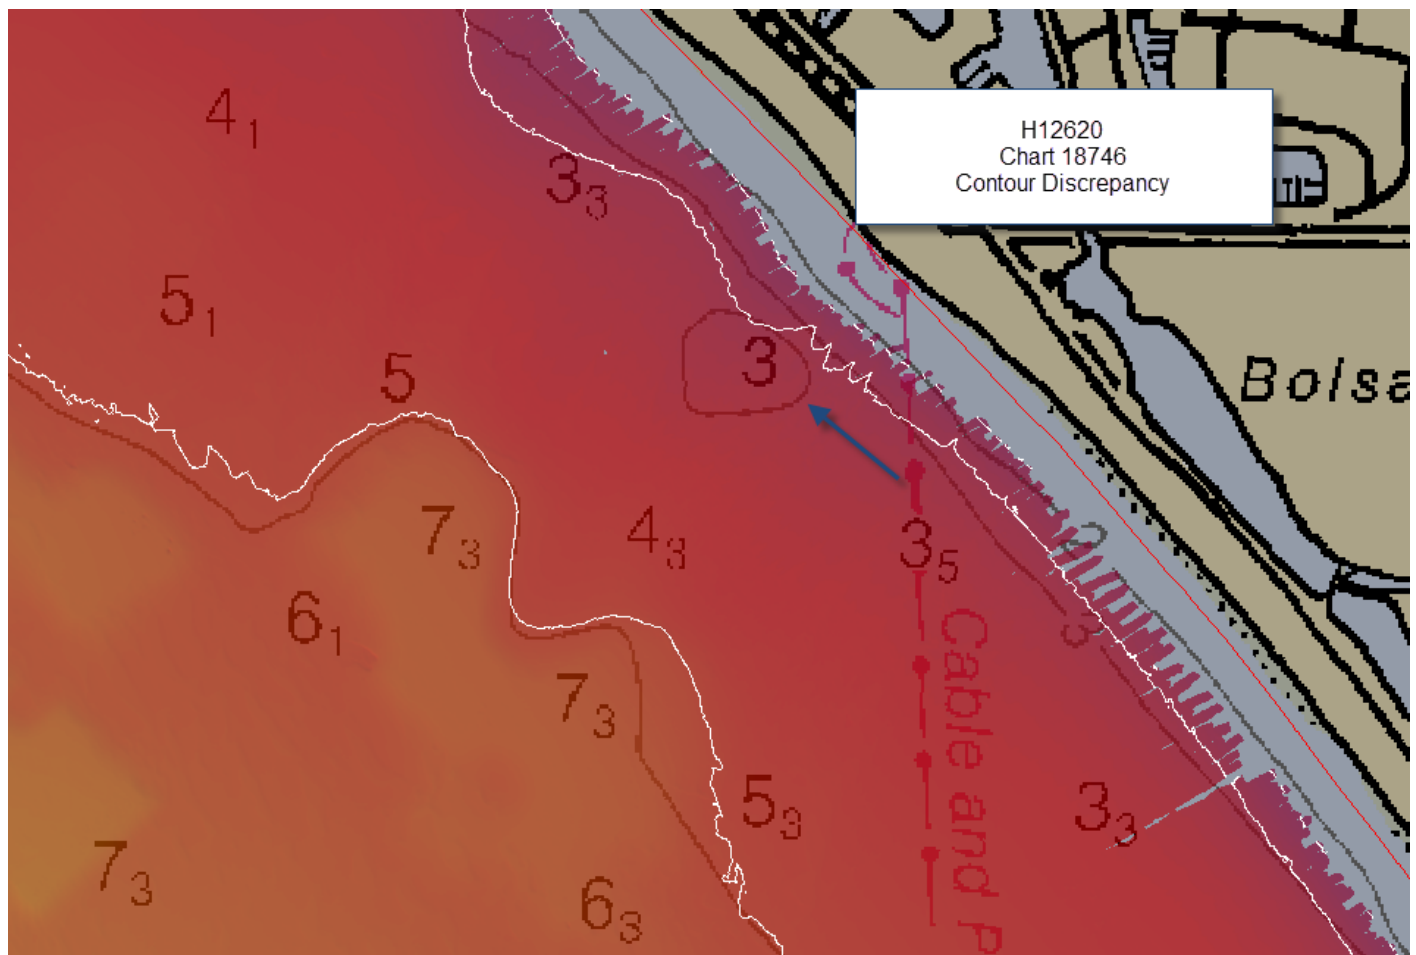
*Figure 15: Disagreement between charted contours (18746) and surveyed soundings West of Bolsa Bay. Charted 3fm contour no longer present.*

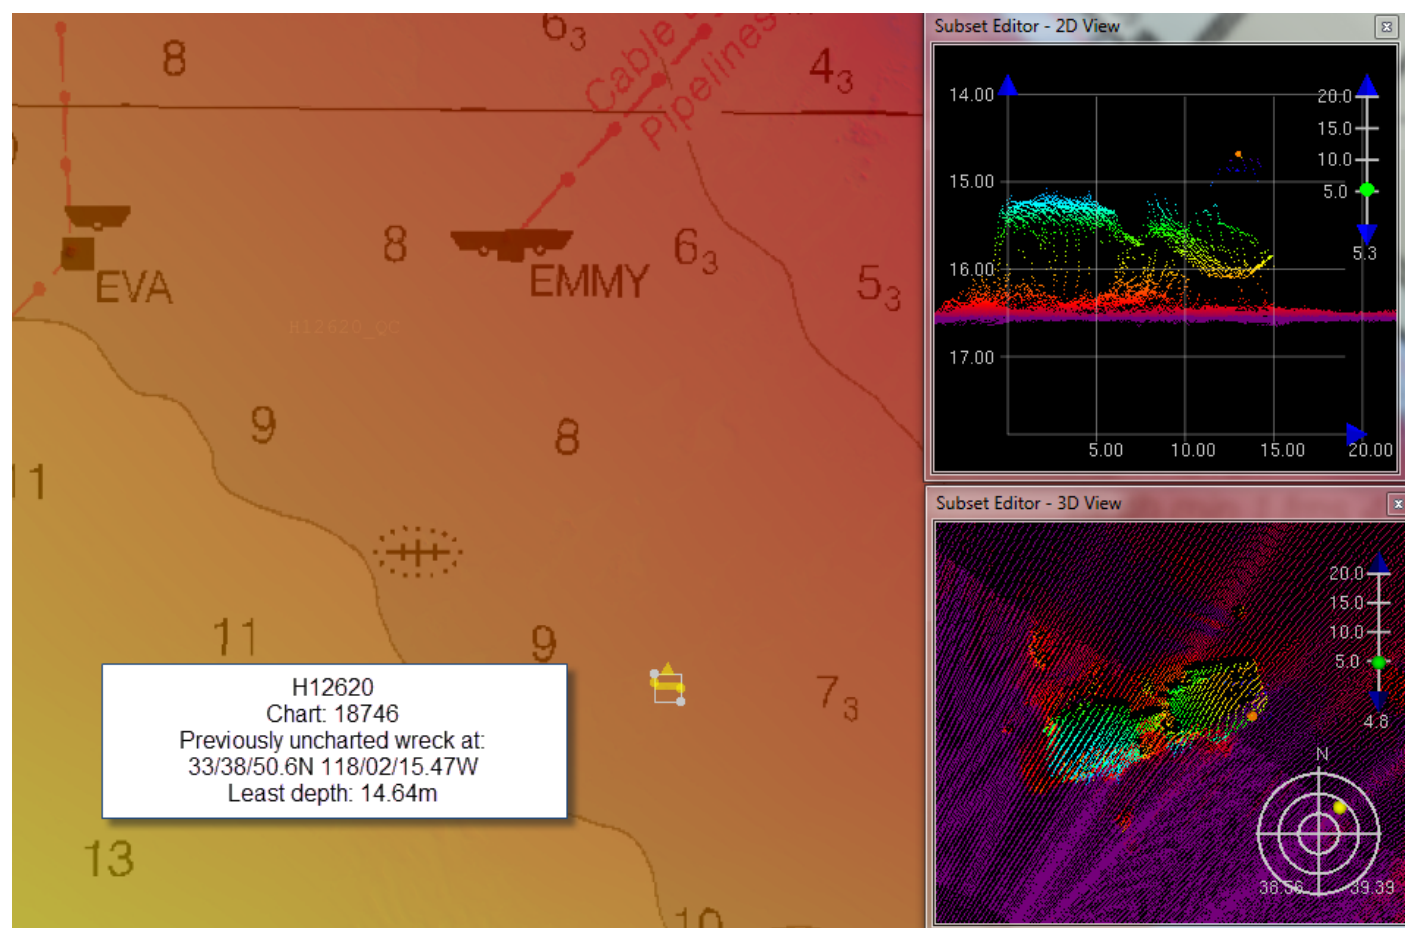
Survey H12620 has two previously uncharted wrecks. The wreck West of Sunset Beach at 33/42/51.4N 118/05/02.33W is approximately 4m long and 1m high with a least depth of 7.6m (25ft) as shown in Figure 17. The wreck South of platform Emmy on chart 18746 at 33/38.50N 118/02/15.48W is approximately 17.5m long and 1.8m high with a least depth of 14.64m as shown in Figure 18. Figure 19 shows an area at the entrance to Anaheim Bay that was inundated with crab pots. A holiday resulting from this is shown in Figure 12 under Additional Quality Control: Holiday Assessment.

Figure 18: H12620 Previously uncharted wreck South of platform Emmy on chart 18746

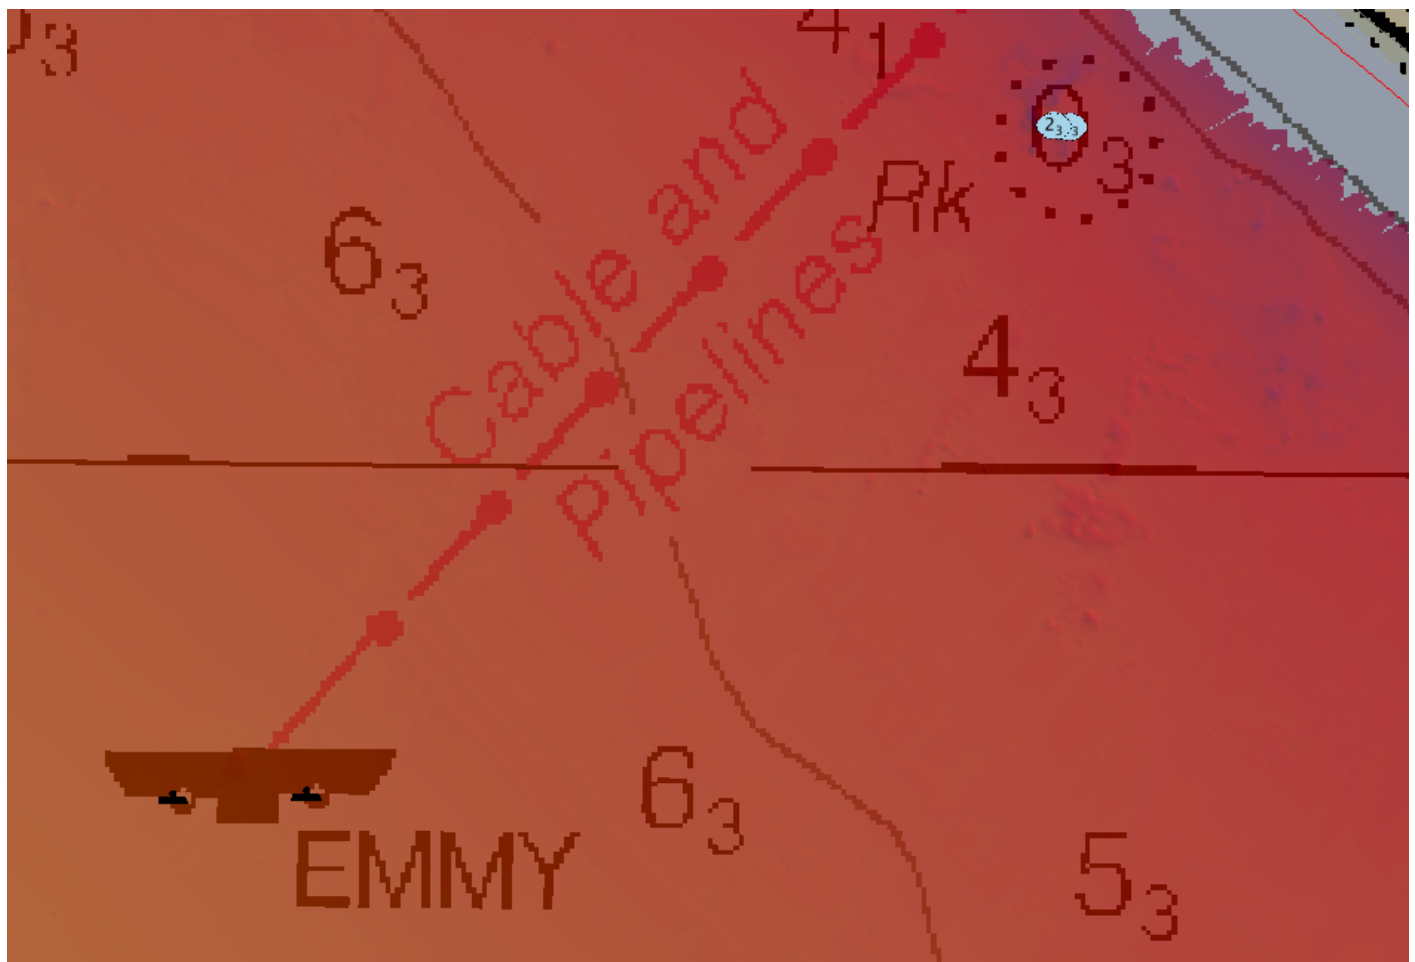
Survey H12620 includes one hazardous feature. A charted rock northeast of platform Emmy on chart 18746 has a new least depth of 2.3m and has a new position as shown in Figures 20 and 21. Recommendations are included in the Final Feature File for H12620.

*Figure 20: H12620 Charted rock Northeast of platform Emmy*

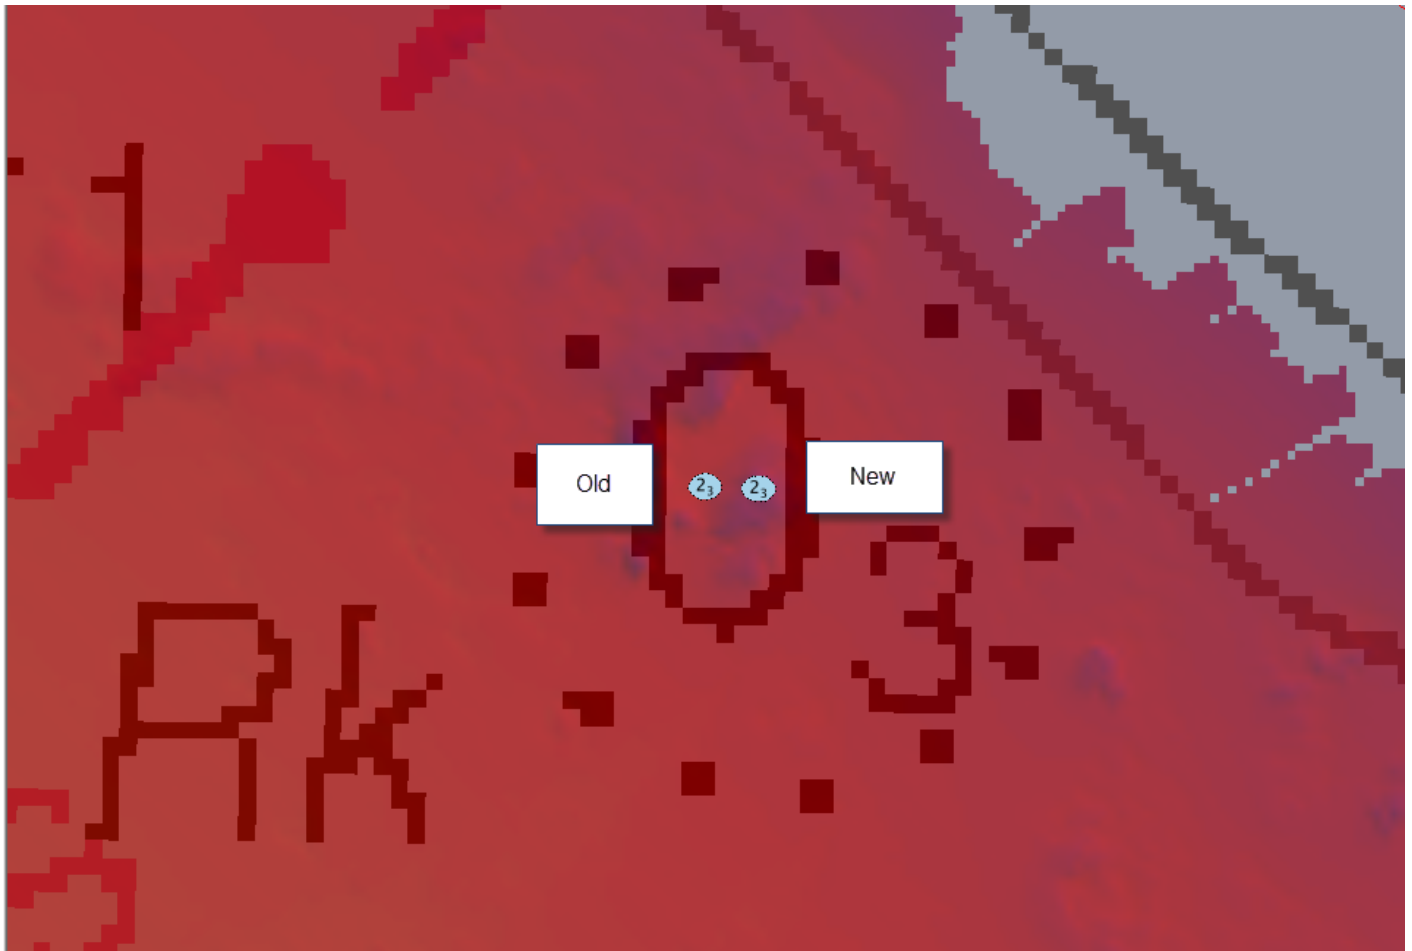
*Figure 21: H12620 Charted rock East of platform Emmy new position*

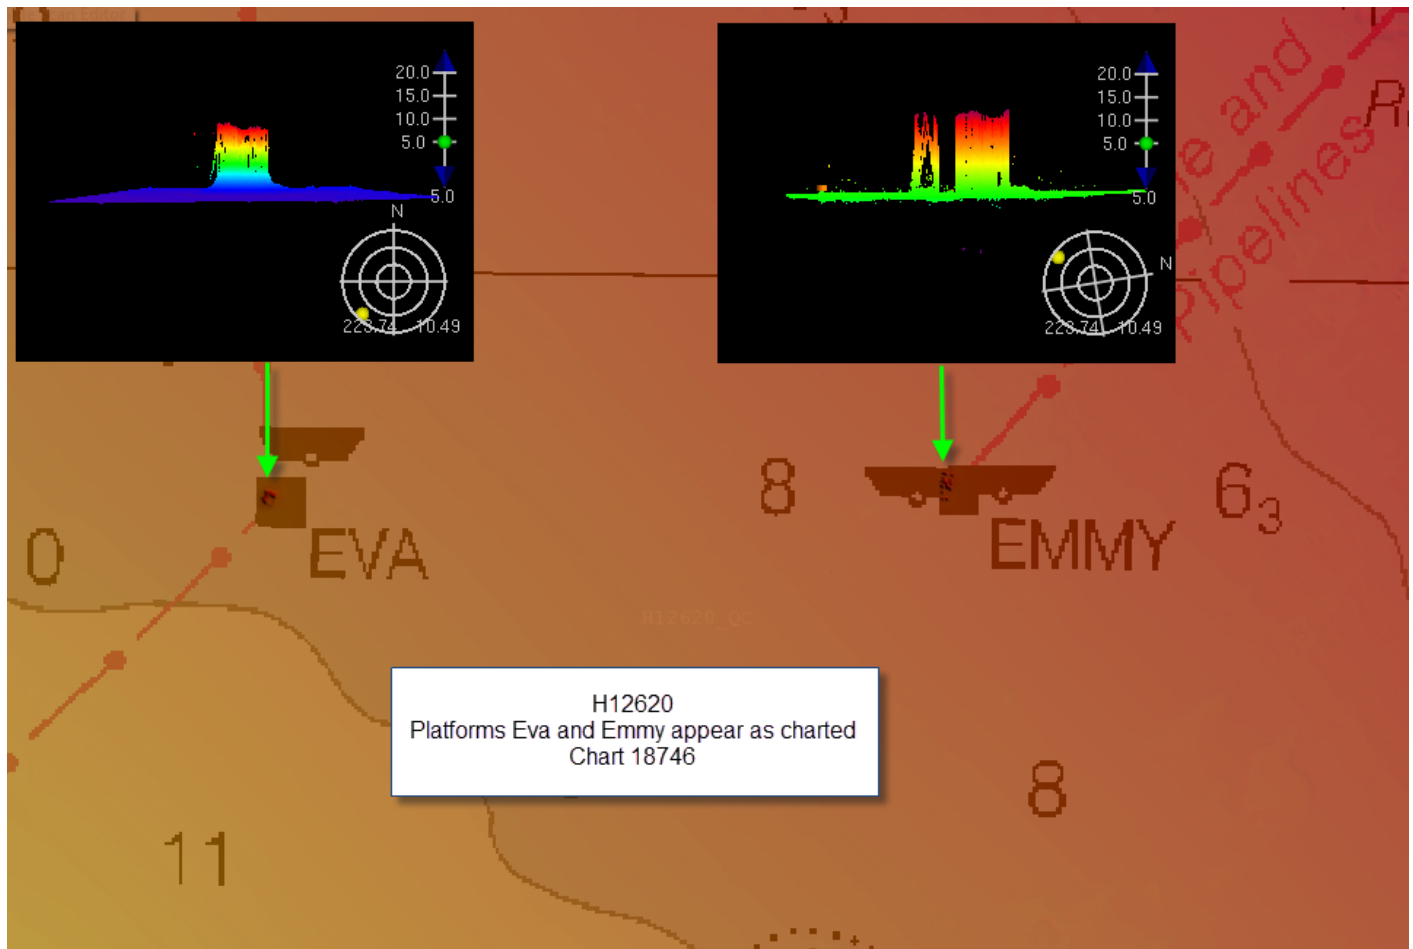
Survey H12620 contains two permanent platforms on chart 18746. Figure 24 shows these platforms as being charted correctly. After verification, the platform data was removed from HIPS surfaces. Figure 13 under Holiday Assessment shows the resulting holidays around Platform Emmy.

Figure 24: H12620 Platforms Eva and Emmy on chart 18746.

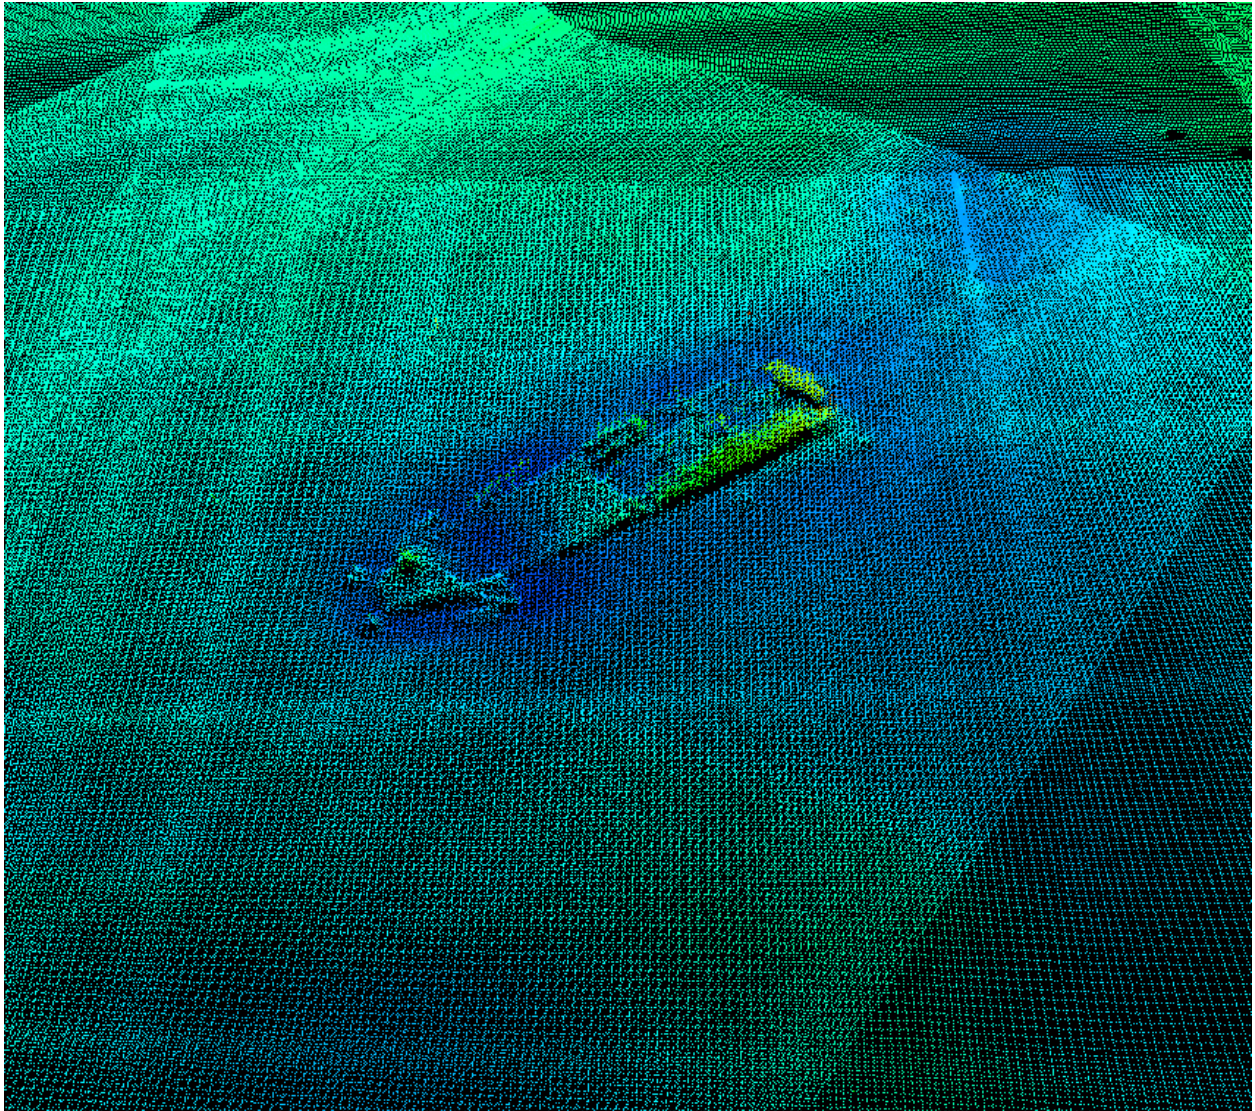
*Figure 1.1.1*

AWOIS item #53262 found by MBES. New least depth and position of charted wreck acquired.

**Geo object 1:** Wreck (WRECKS)  
**Attributes:** CATWRK - 1:non-dangerous wreck **Office Note: CATWRK is dangerous**  
QUASOU - 6:least depth known  
SORDAT - 20131111  
SORIND - us,us,graph,H12620  
TECSOU - 3:found by multi-beam  
VALSOU - 15.580 m  
WATLEV - 3:always under water/submerged

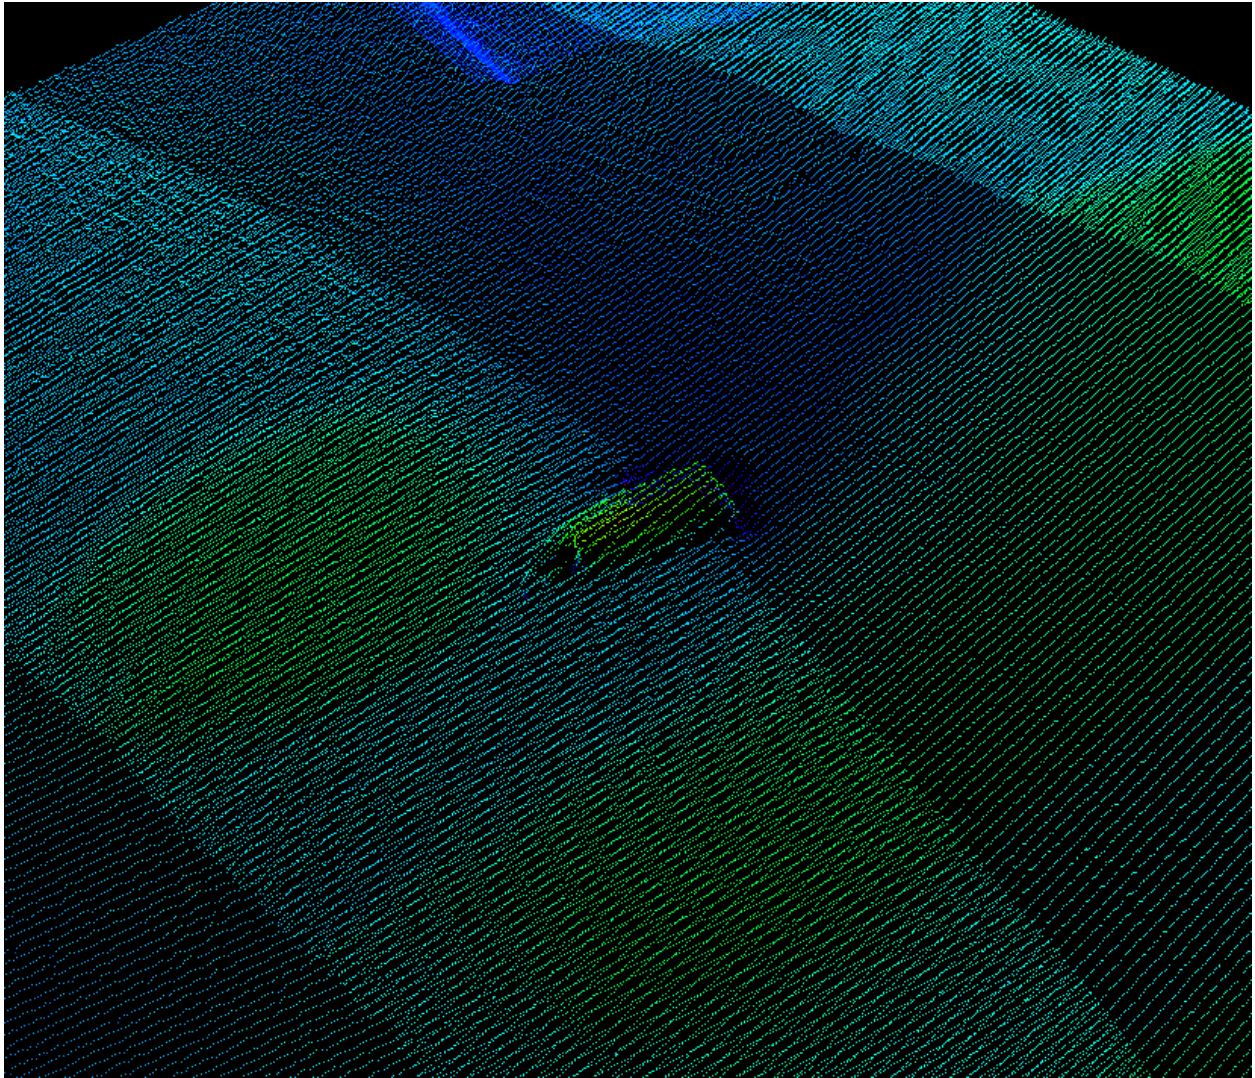
*Figure 2.1.1*

WRECKS/remrks: New wreck observed by full coverage MBES.

**Geo object 1:** Wreck (WRECKS)  
**Attributes:** CATWRK - 1:non-dangerous wreck Office Note: CATWRK is dangerous  
 QUASOU - 6:least depth known  
 SORDAT - 20131111  
 SORIND - US,US,graph,H12620  
 TECSOU - 3:found by multi-beam  
 VALSOU - 7.620 m  
 WATLEV - 3:always under water/submerged

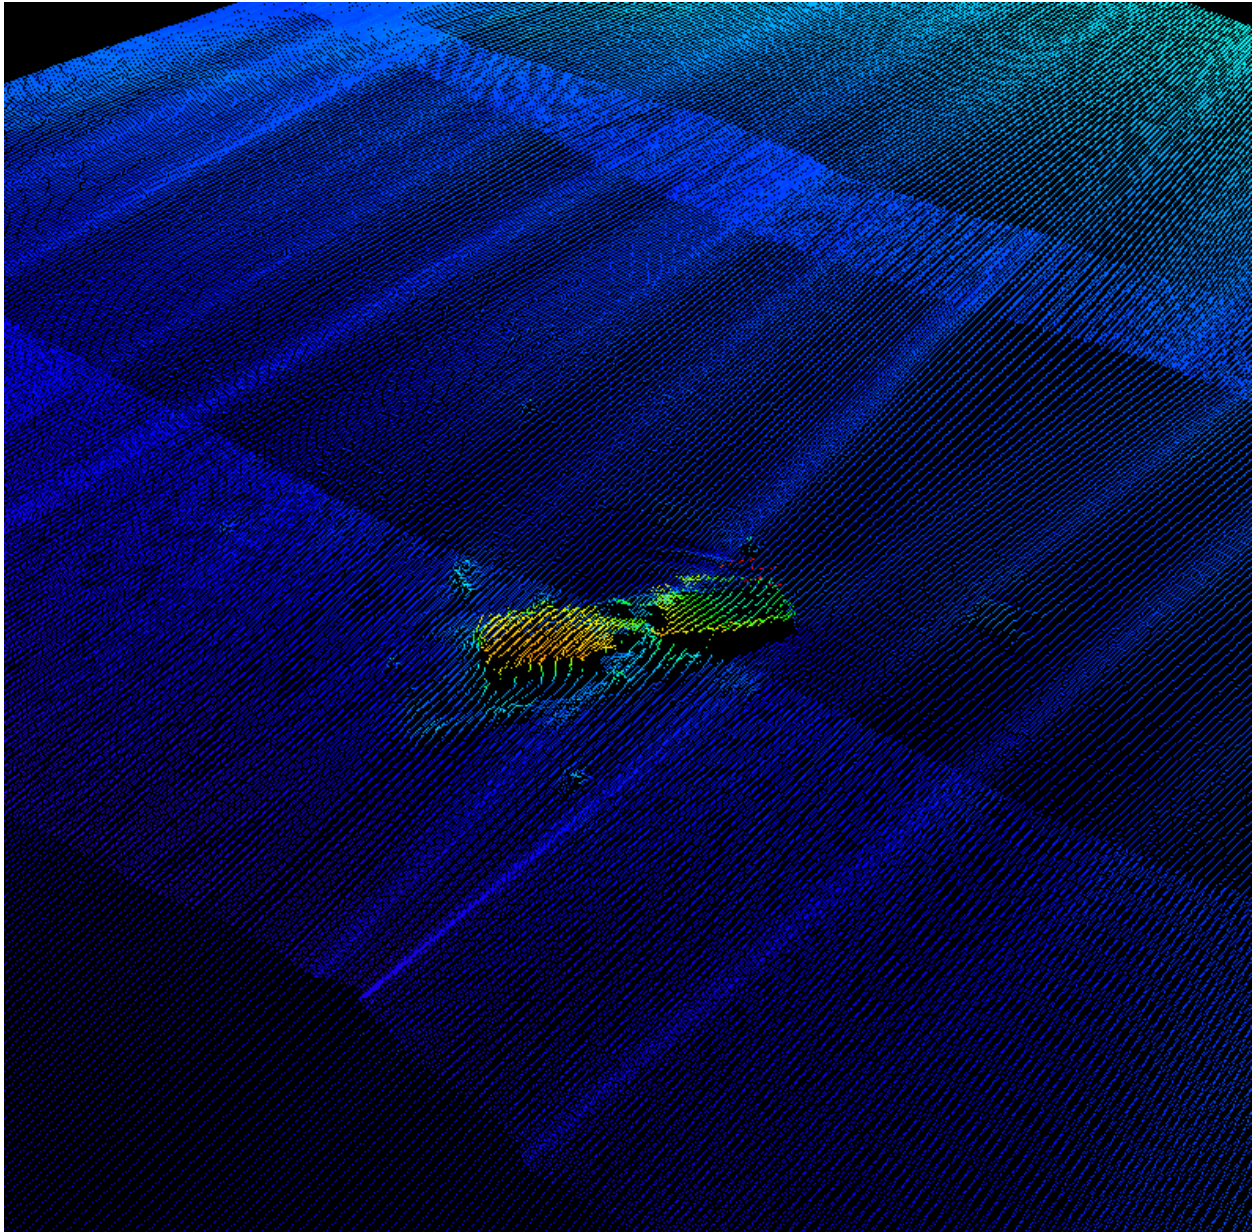
*Figure 2.2.1*

WRECKS/remrks: New wreck observed by full coverage MBES.

**Geo object 1:** Wreck (WRECKS)  
**Attributes:** CATWRK - 1:non-dangerous wreck **Office note: CATWRK is dangerous**  
 QUASOU - 6:least depth known  
 SORDAT - 20131111  
 SORIND - US,US,graph,H12620  
 TECSOU - 3:found by multi-beam  
 VALSOU - 14.600 m  
 WATLEV - 3:always under water/submerged
