**DESCRIPTIVE REPORT**

Type of Survey: Navigable Area

Registry Number: H12886

Project: OPR-A366-KR-16

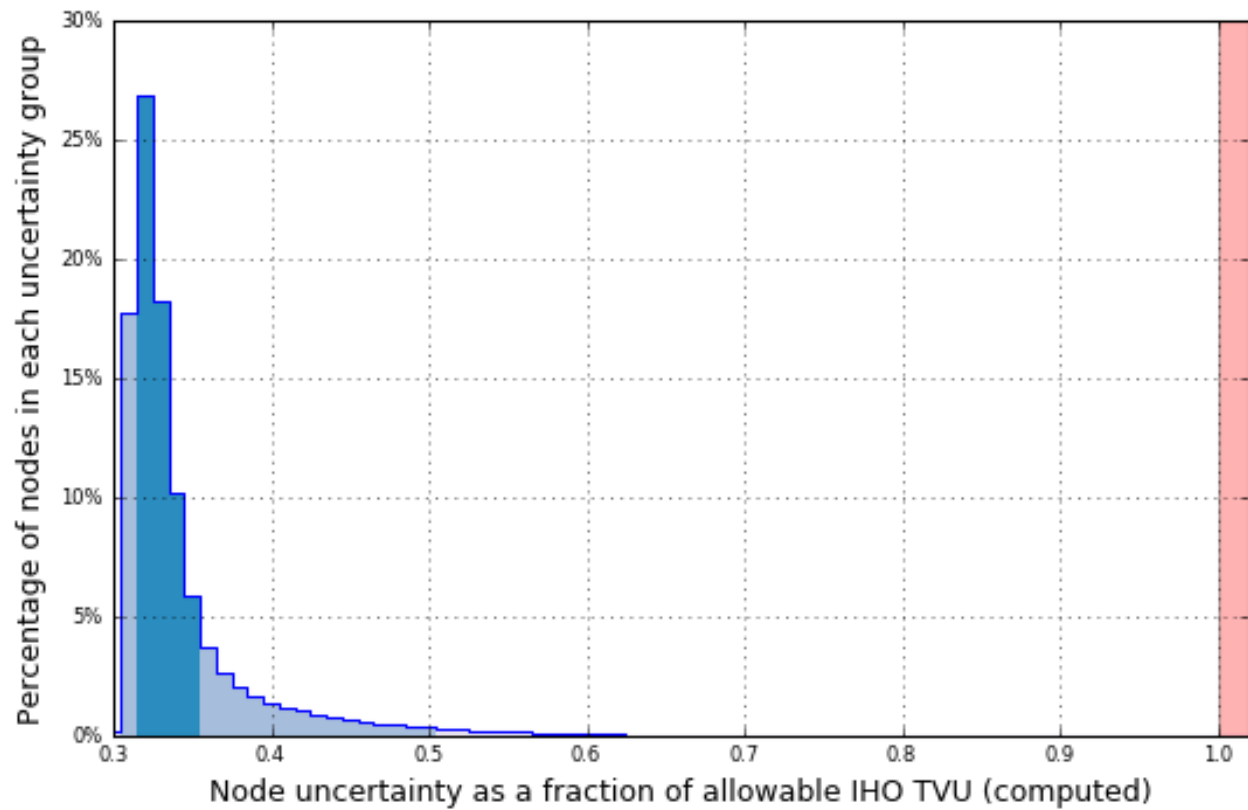
Figure 15: Hydroffice Surface Report H12886 (Priority 4) 1m Final

99.5+% pass (30,009,341 of all nodes), min=0.30, mode=0.32, max=2.60

Percentiles: 2.5%=0.31, Q1=0.32, median=0.33, Q3=0.35, 97.5%=0.50

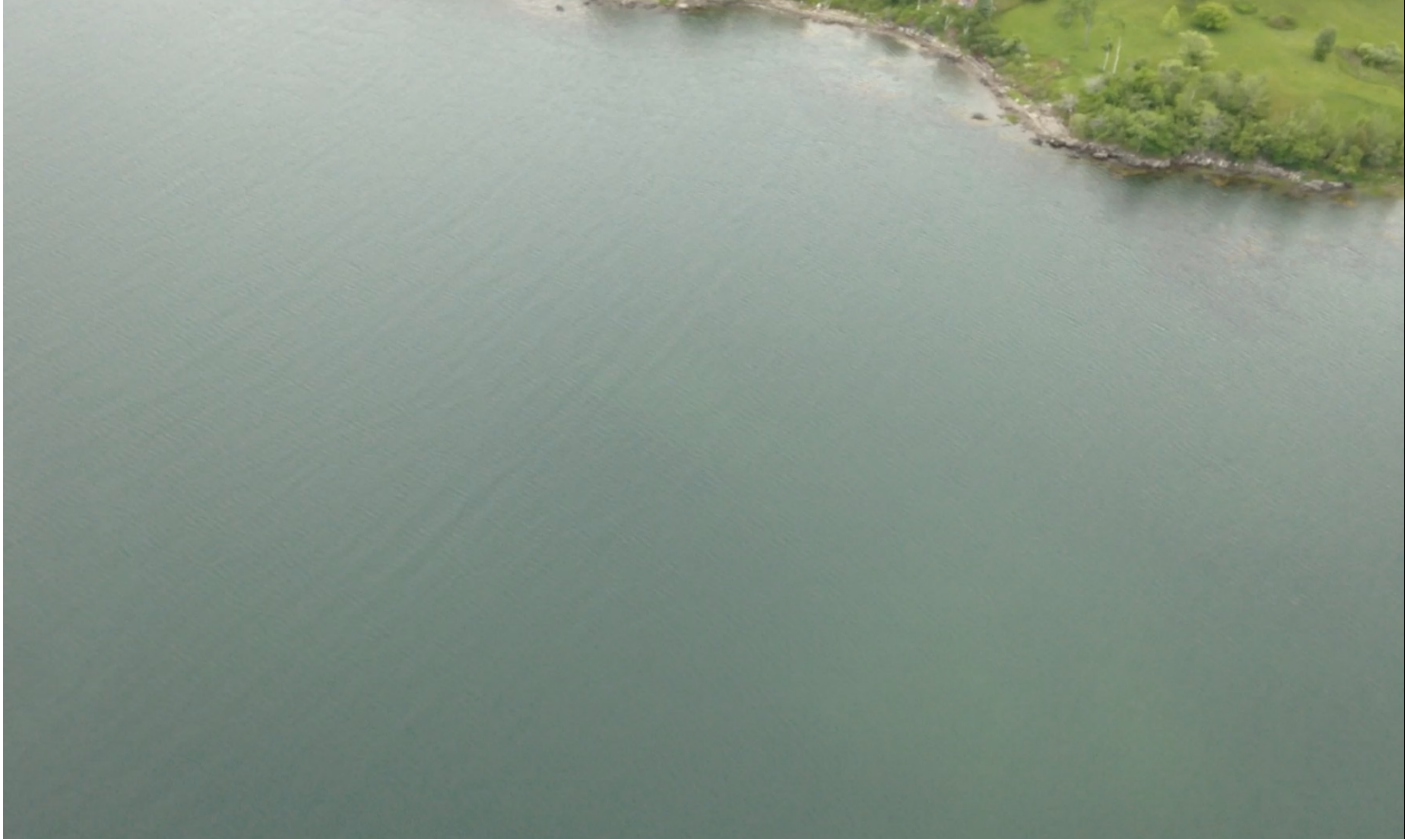
*Figure 32: Water Clarity*

On 13 June 2016, Fugro staff undertook an aerial reconnaissance mission in the vicinity of Penobscot Bay. Conditions of the water clarity were documented in photos and overall, found to be relatively poor. Water was seen to be clear in the very shallow depths (likely, under four meters) and murky in deeper depths.

Conditions were similar in the survey area around Vinalhaven Island and North Haven Island as well, with shallow depths being clearer than the depth range of interest (four to eight meters). The bathymetry in the area tends toward a steep descent into depths outside the range of ALB.

The water clarity had a negative impact on coverage within the four to eight meter depth range, a range of particular interest to this survey. A test flight was conducted during high tide in order to eliminate the low tide timing as the issue with water clarity, due to tidal flushing. Water conditions on this test flight were

consistent with those seen on the flights timed around low tide so it was concluded that the tide level was not the cause of the poor water clarity.

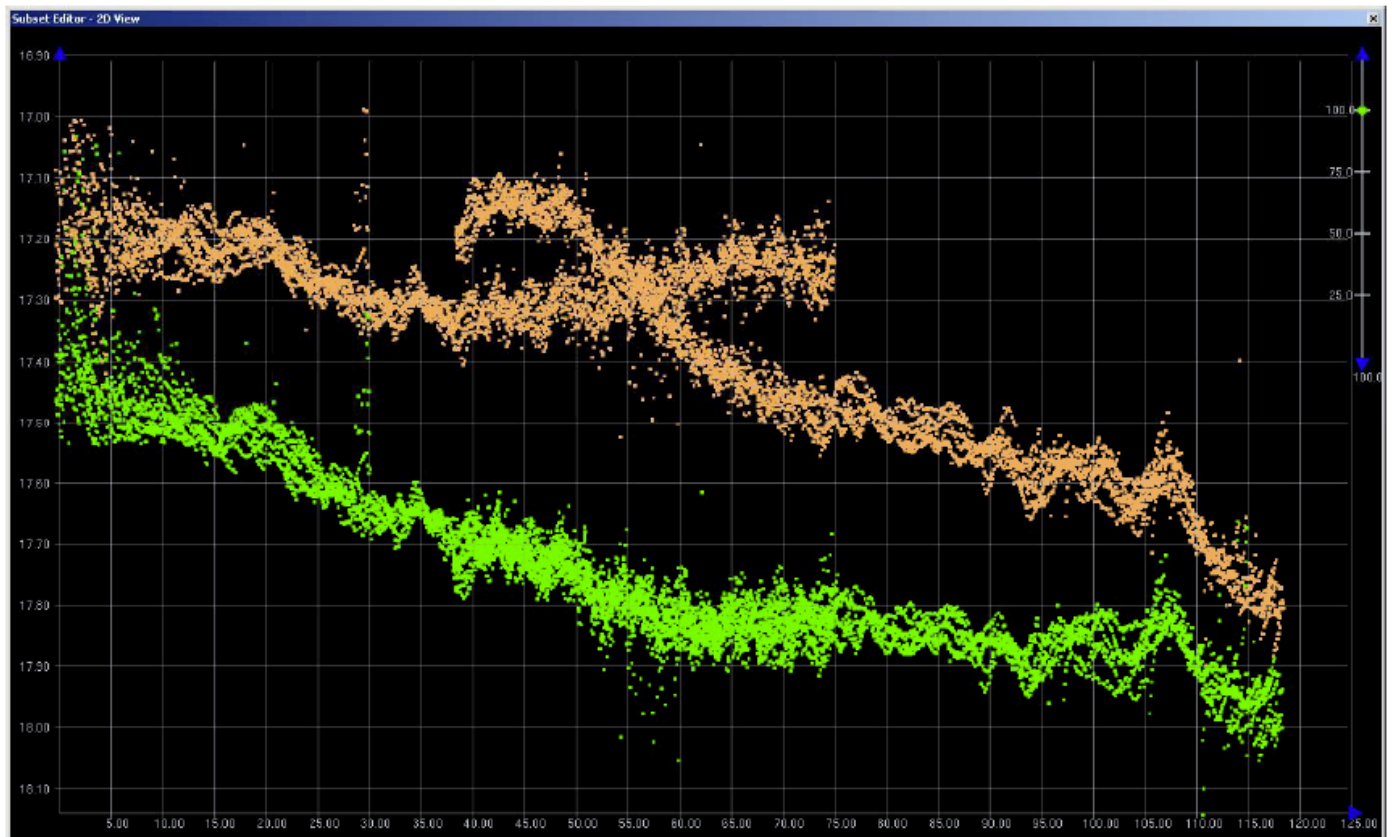
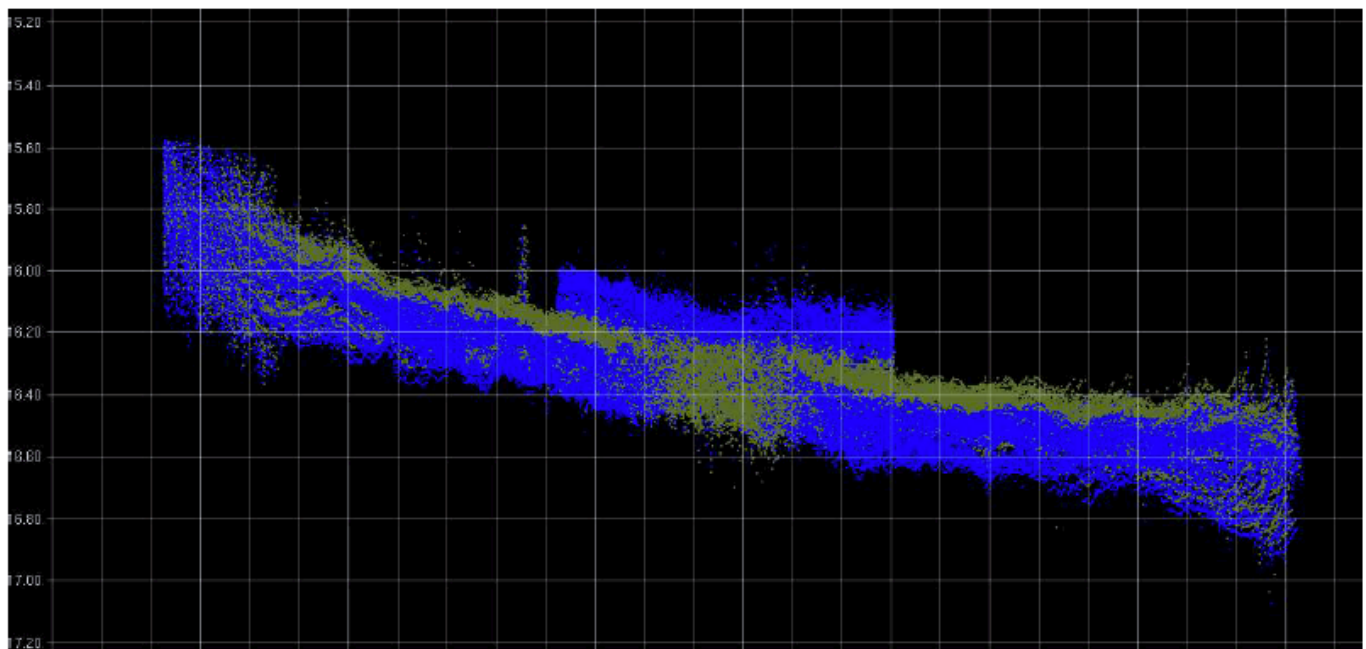
For the first several weeks on the R/V JAB, the transmitter and receiver were inadvertently mismatched, with the port receiver using the starboard system's transmitter, and vice versa. Proper reduction of soundings measured in this configuration requires that the sonar be treated as a bi-static system, and that the absolute locations of the transmitter and receiver be accounted for. CARIS HIPS is designed to handle such a situation, and offset information in the form of a 7030 record, which was added to each dual head s7k file to enable proper processing without an adjustment to the processing pipeline used by Fugro. The methodology was validated using a postage stamp survey over a flat seafloor. Adjusted 7030 records were inserted into all applicable previously collected data and reprocessed in CARIS using Fugro's standard methodology for the processing of 7027 dual head records.

*Figure 33: Uncorrected (orange) and corrected (green) with artificial vertical separation*

*Figure 34: Uncorrected (blue) and corrected (gray) with artificial waterline removed*

*Figure 35: Gridded Surface using uncorrected data*

*Figure 36: Gridded Surface using corrected data*

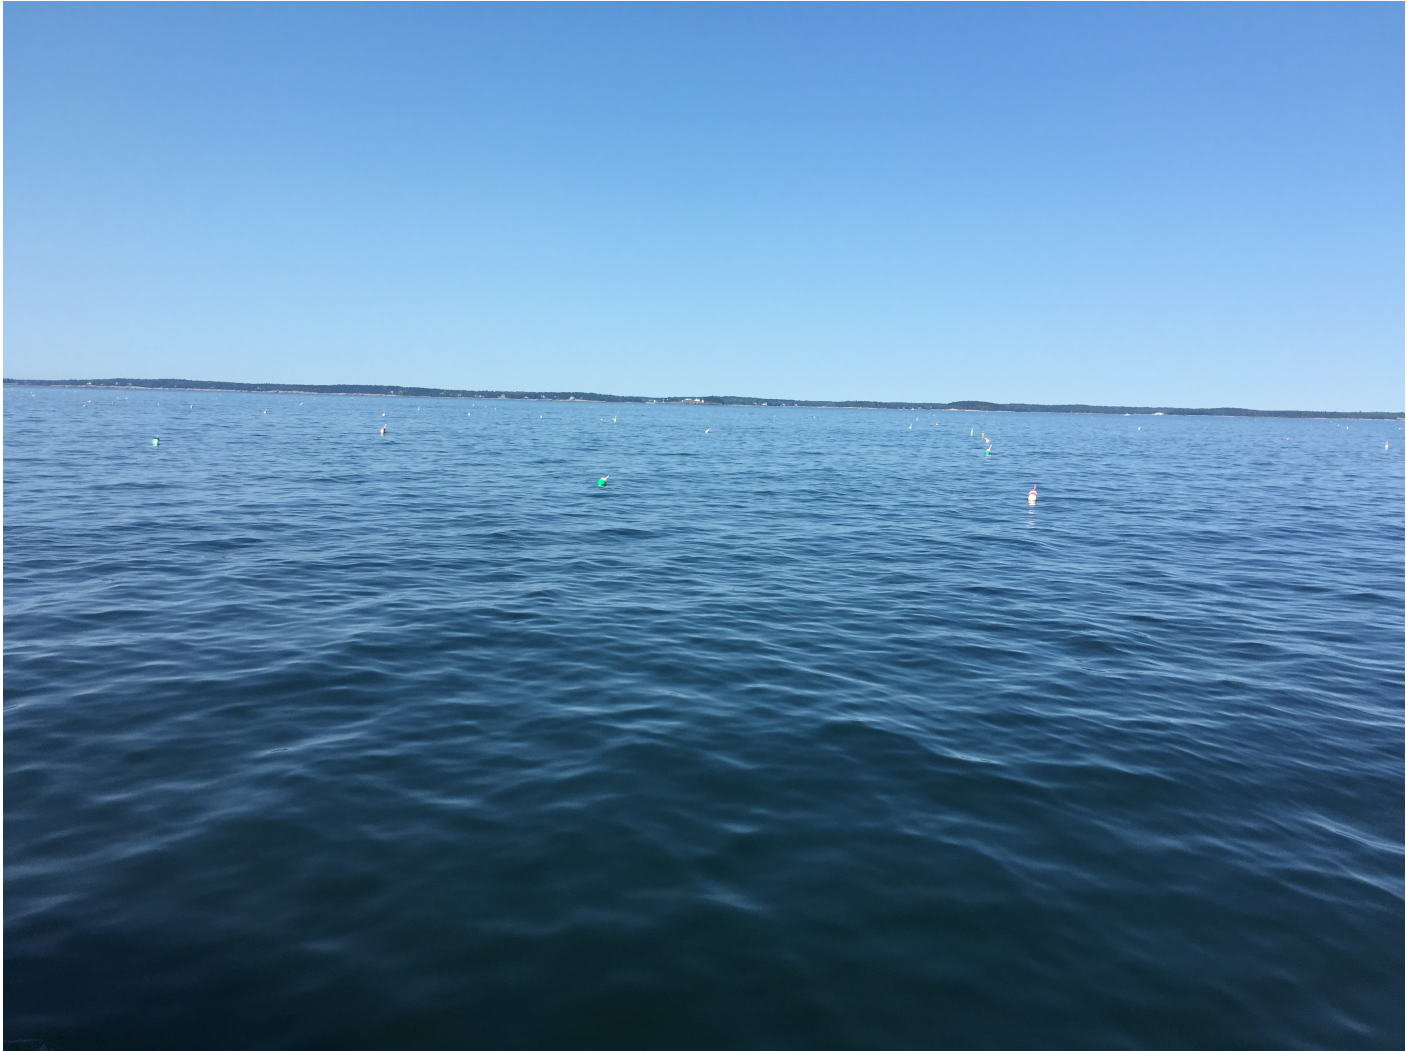
*Figure 39: Fishing Gear*

The survey was awarded and conducted during the peak of lobster season, resulting in an extremely high presence of fishing gear (and fishing vessels) in the survey area. This resulted in having to maneuver in and around the surface buoys and fishing vessels causing not only numerous in-fills and re-runs, but increased time spent on manually rejecting erroneous data (fishing gear in the water column) in CARIS HIPS.

Because of the density of fishing gear in the area, vessel speed was at times reduced to near idle. Entanglements between the survey vessel's deployed sonar equipment and fishing gear happened quite often, resulting in a loss of survey time. The risk of entanglement also increased before and after the high tide peaks due to submerged buoys in some areas.

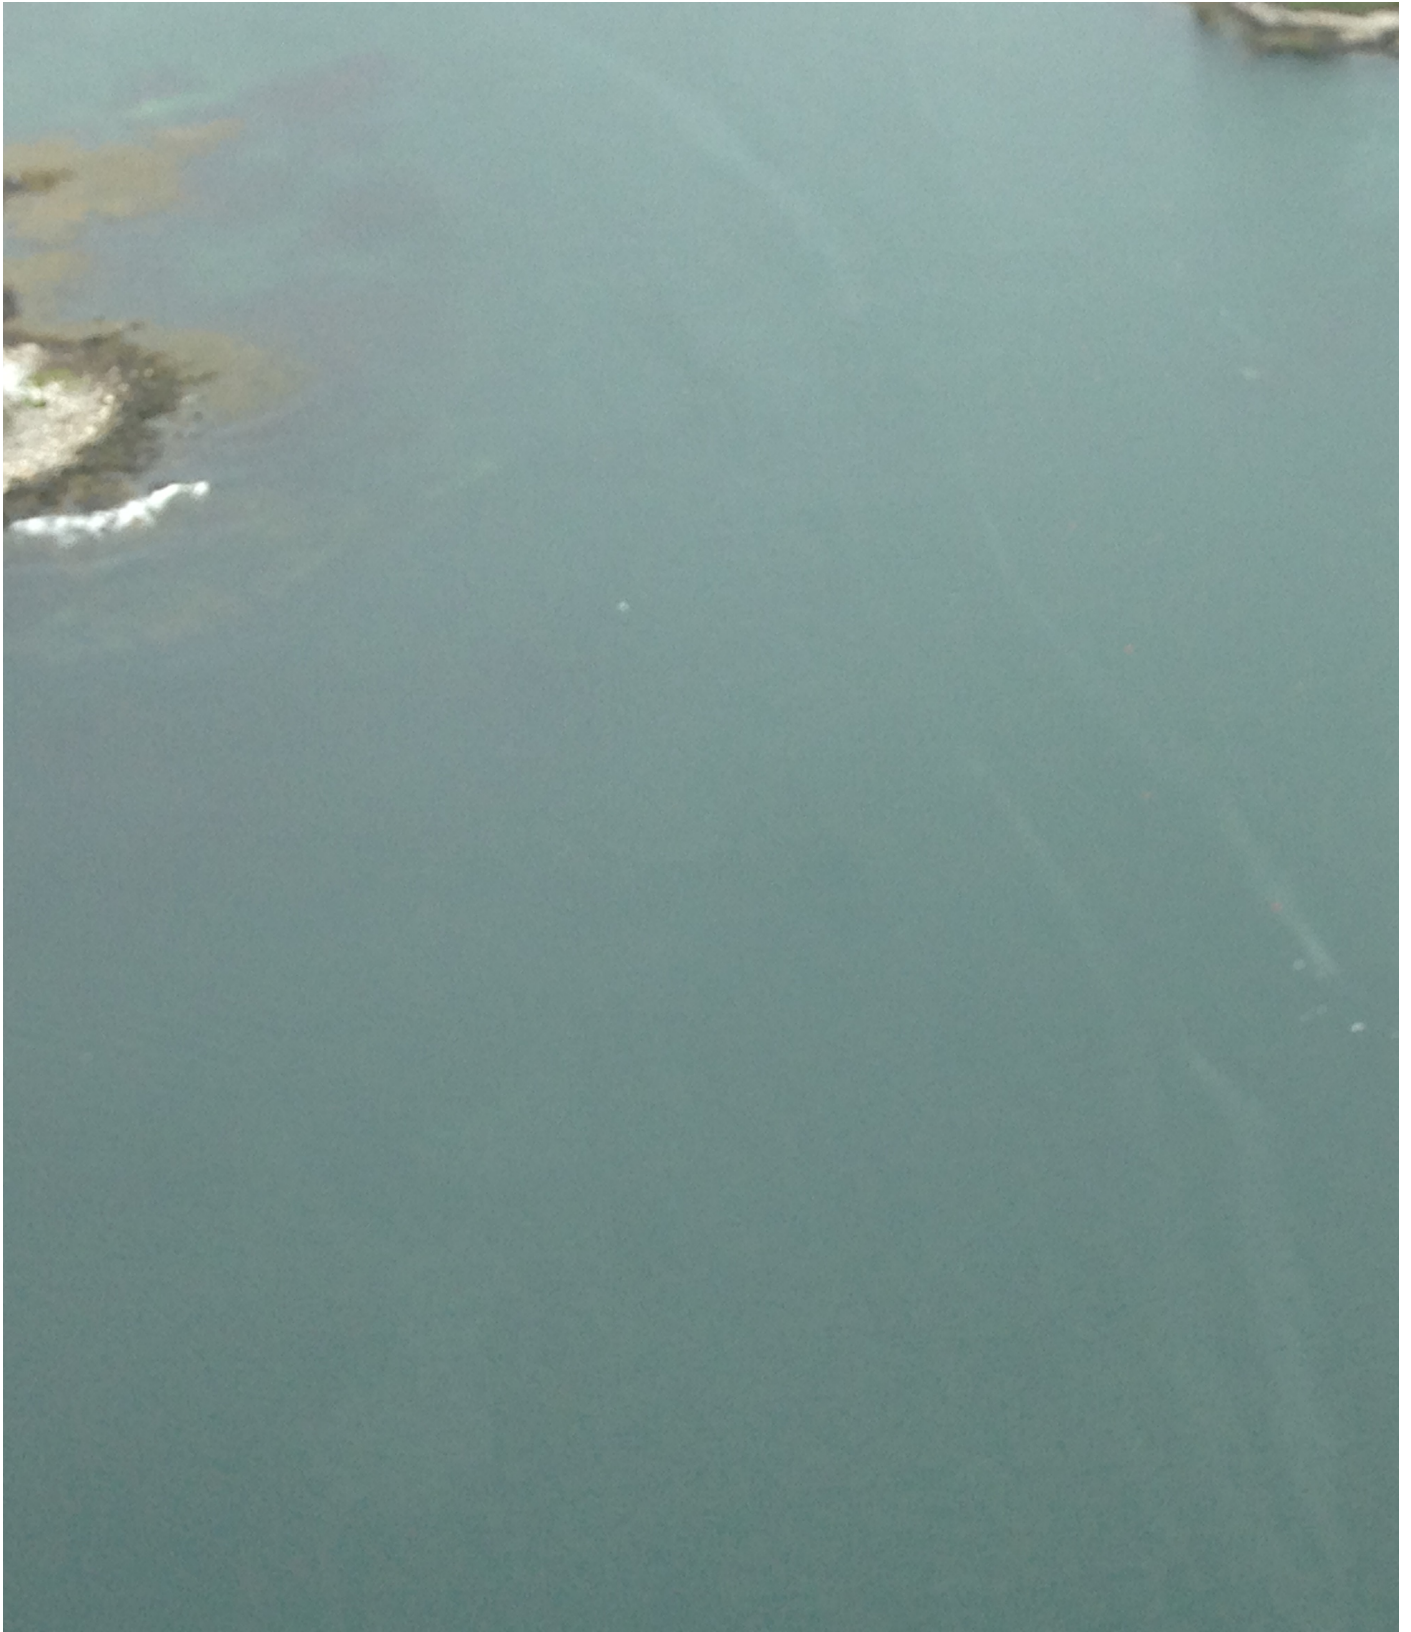
*Figure 40: Water Clarity*

In addition to being an issue in equipment effectiveness, water clarity was a factor affecting soundings. Refer to section B.2.5 for the explanation on water clarity.

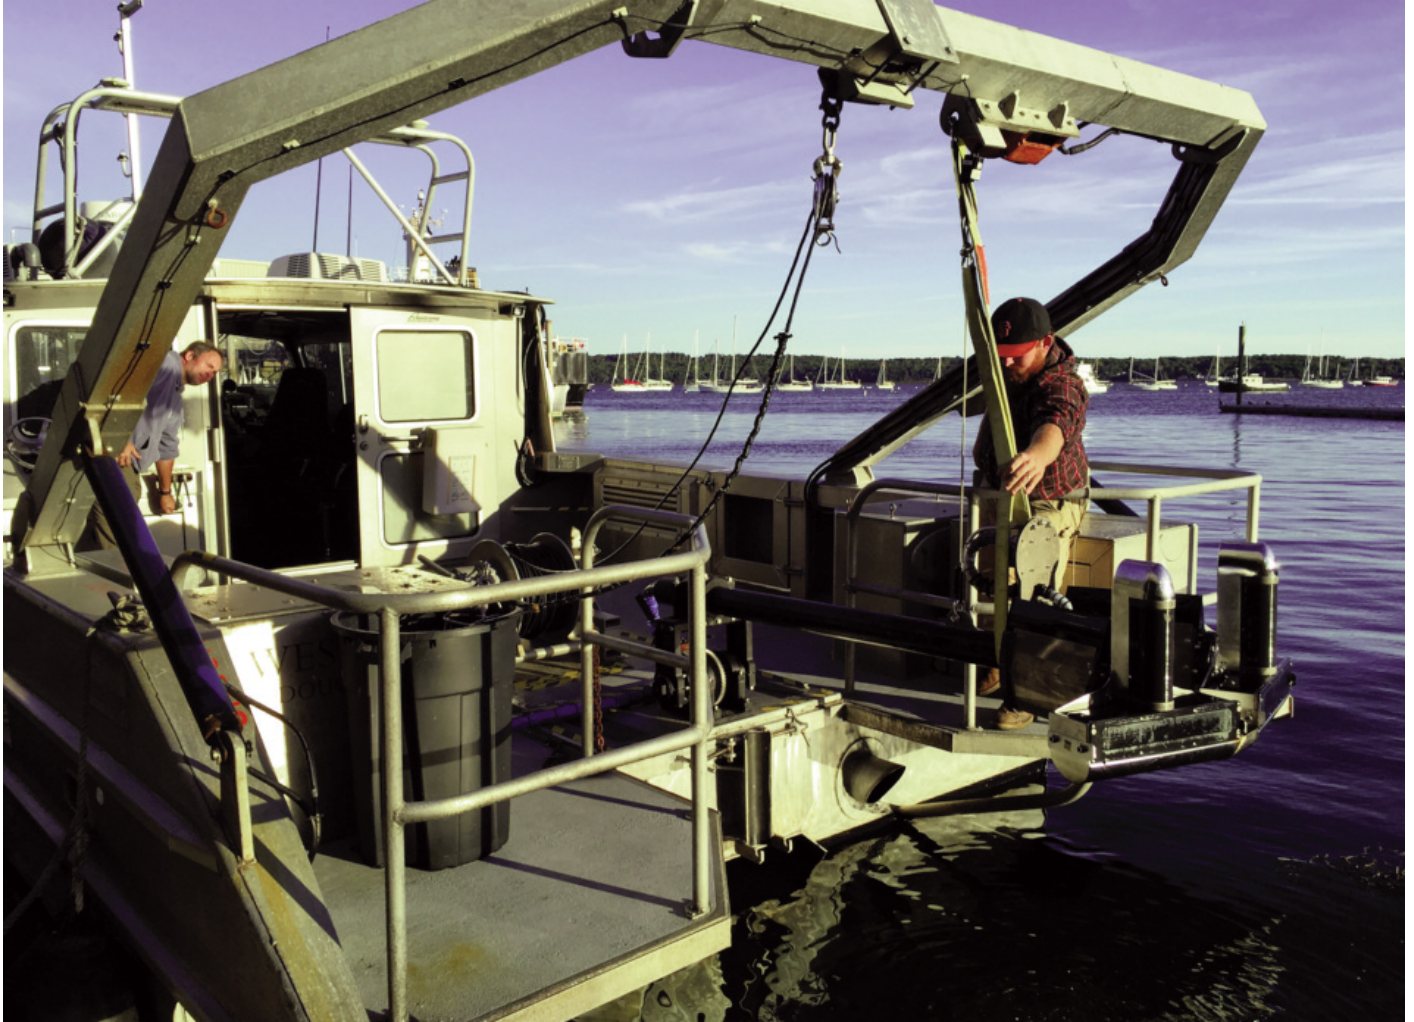
*Figure 41: AML SVP*

R/V Jab and R/V Westerly were equipped with two AML 1000 dbar Sound Velocity & Pressure (AML SV&P) Smart Sensors. The AML SV&P directly measures sound velocity through a time of flight calculation, and measures pressure with a temperature compensated semiconductor strain gauge at a 10Hz sample rate. The instrument has a 0.015 m/s resolution with a  $\pm 0.05$  m/s accuracy for sound velocity measurements and a 0.01 dbar resolution and a  $\pm 0.5$  m dbar accuracy for pressure.
