H12887

## DESCRIPTIVE REPORT

Type of Survey: Basic Hydrographic Survey

Sub-locality: Offshore Vinalhaven Island

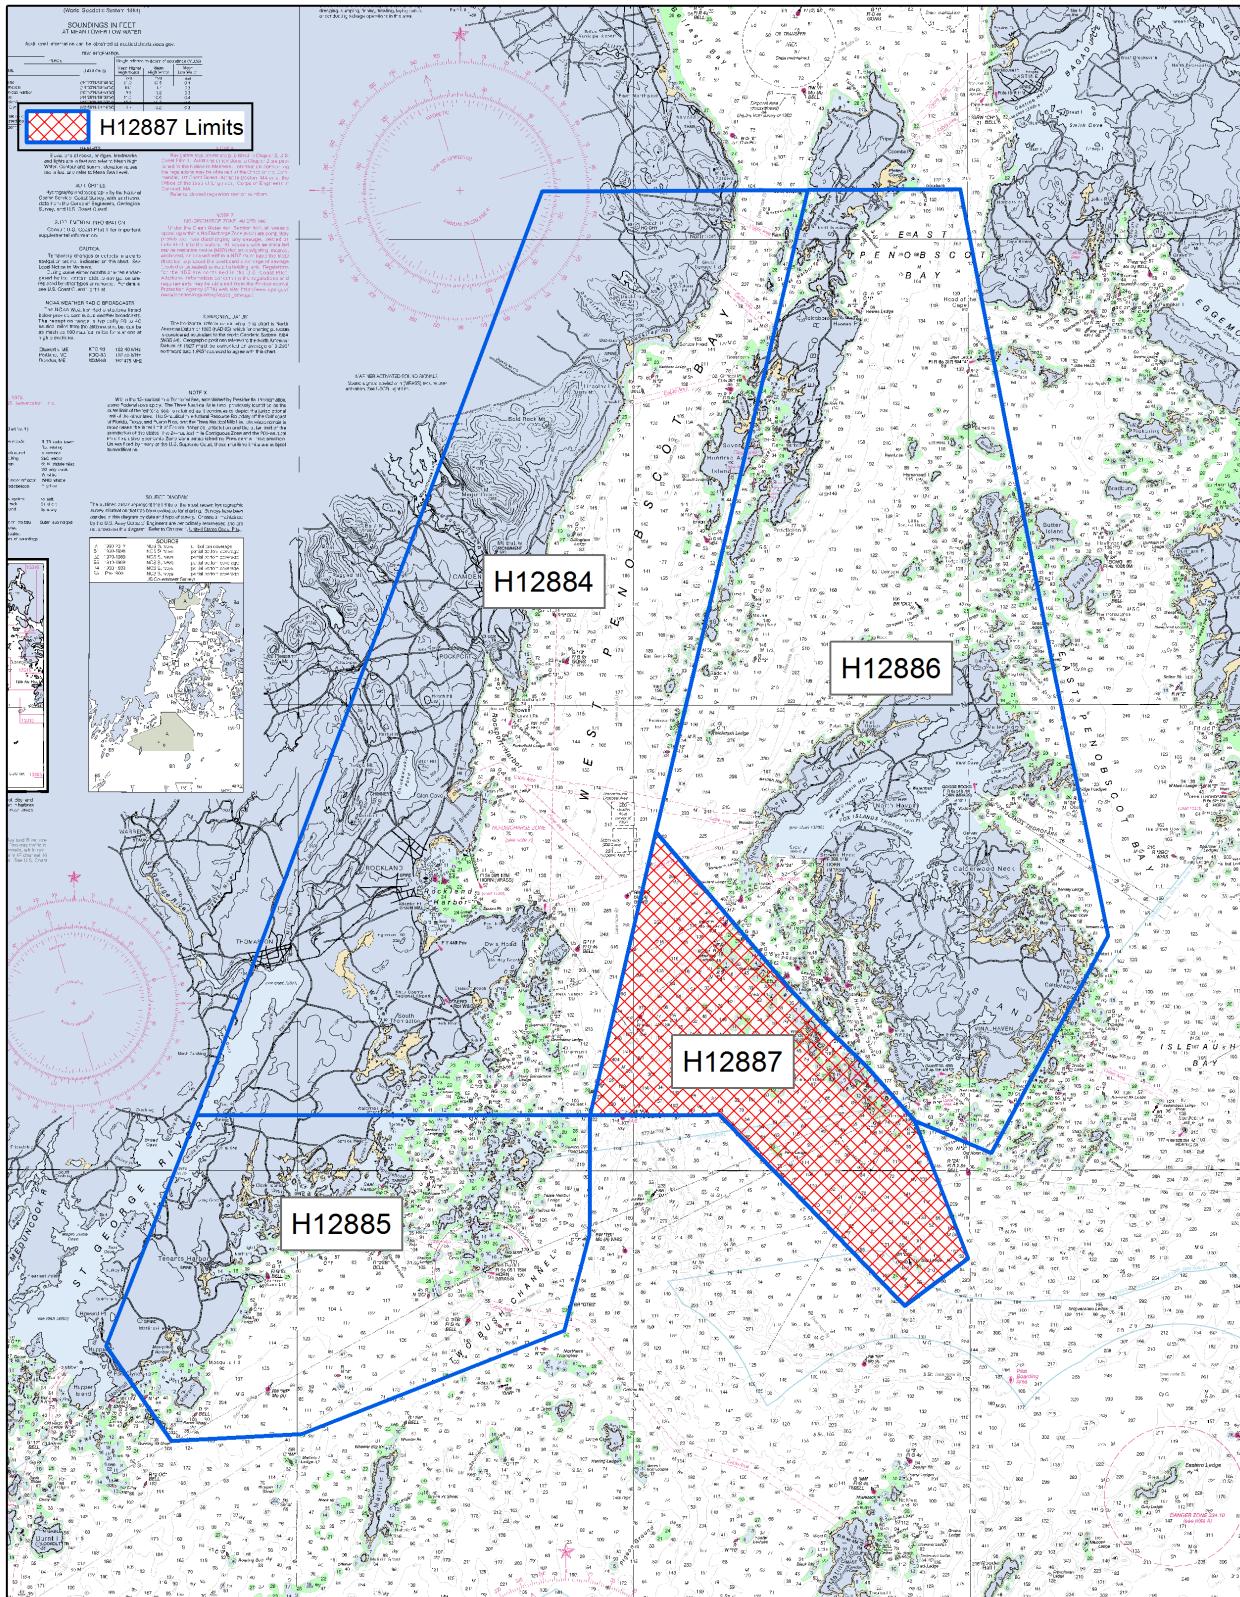
Figure 1: H12887 Sheet 3 Limits

The survey limits were revised to encompass the additional LiDAR data that was collected during field acquisition and were submitted as the final outlines following field operations. It should be noted that the limits were extended only to capture the extra LiDAR data and that the multibeam (MB) collection concluded at the survey limits as outlined in the project instructions.

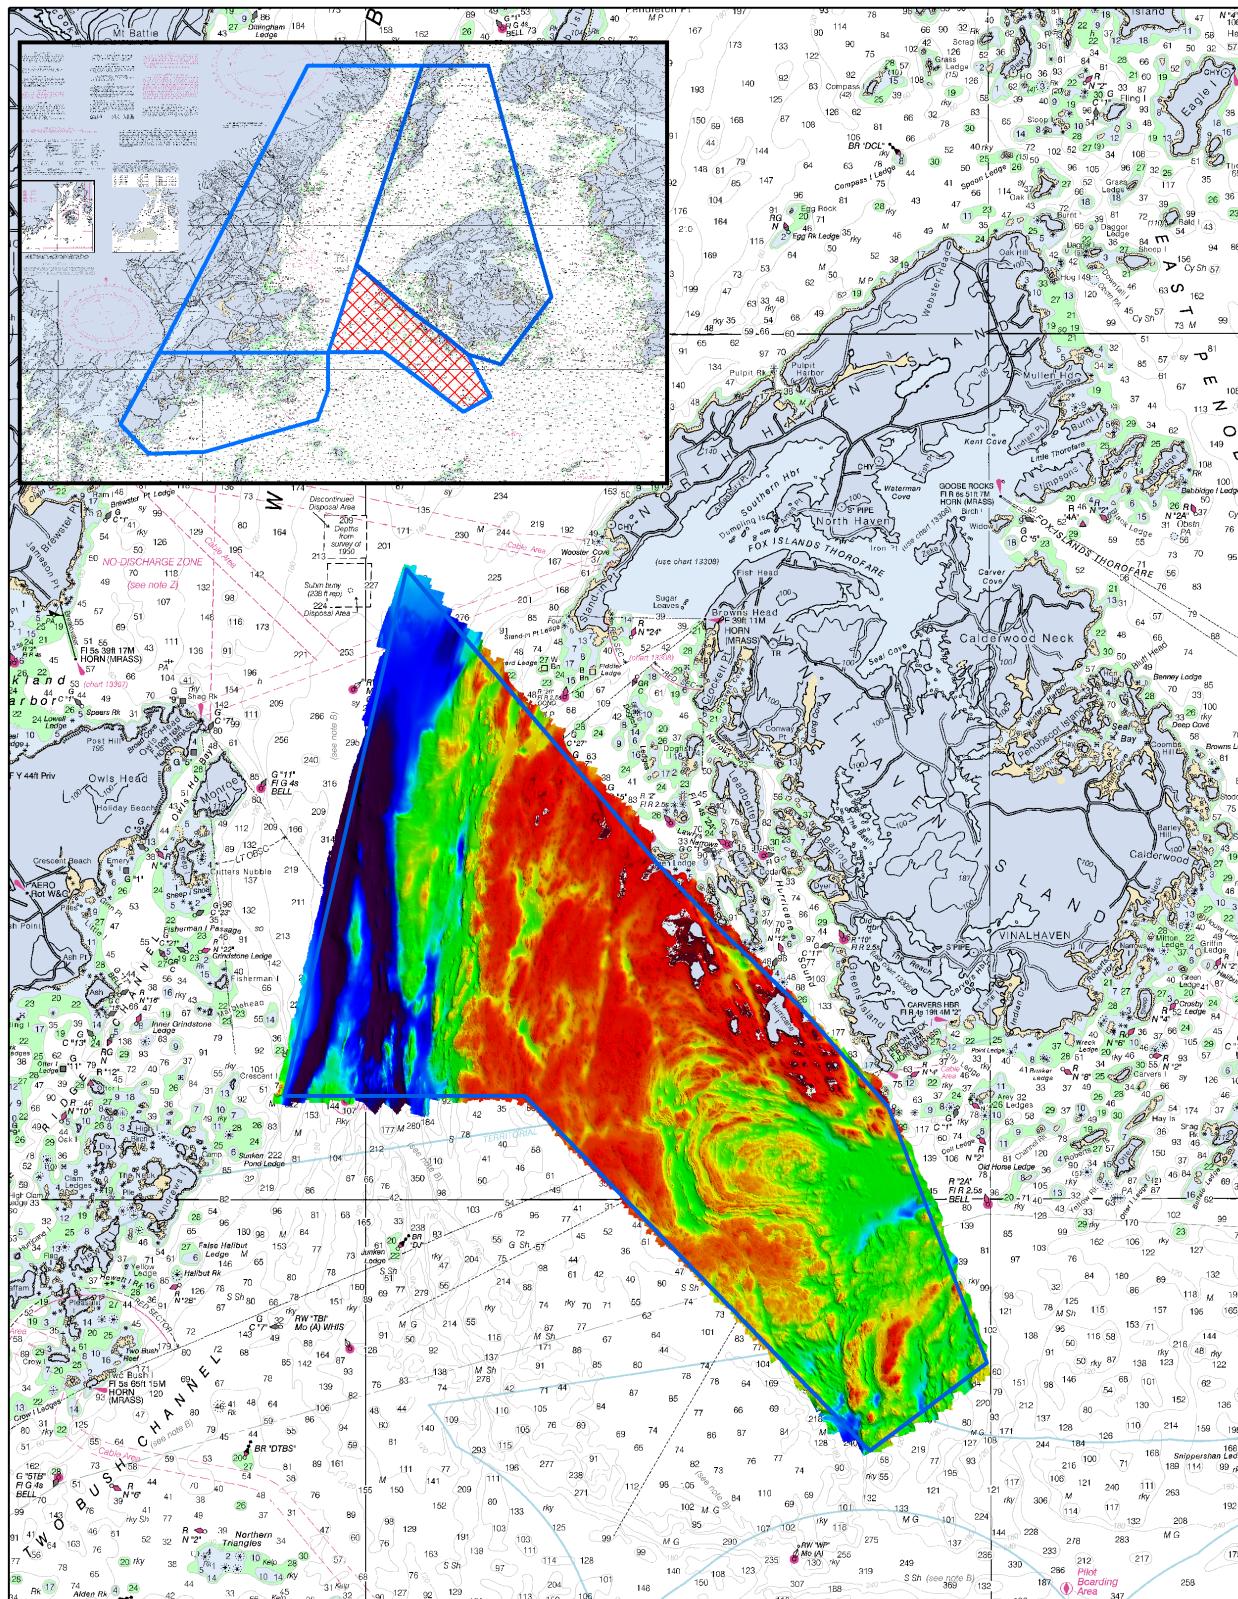
Figure 2: H12887 Survey Coverage  
4

Data holidays are present in the LiDAR data due to the removal of vessels and other surface structures. A gap between the LiDAR and MB data sets exists and is due to water clarity in the area. The water clarity had a negative impact on coverage within the four to eight-meter depth range, which varied significantly both spatially and temporally across the project area. A test flight was conducted during high tide in order to eliminate the low tide timing as the issue with water clarity, due to tidal flushing. Water conditions on this test flight were consistent with those seen on the flights timed around low tide, so it was concluded that the tide level was not the cause of the poor water clarity. Though not required, since the limit for the MB was greater than an 8-meter water depth, to bridge this gap, additional nearshore lines were conducted during field operations.

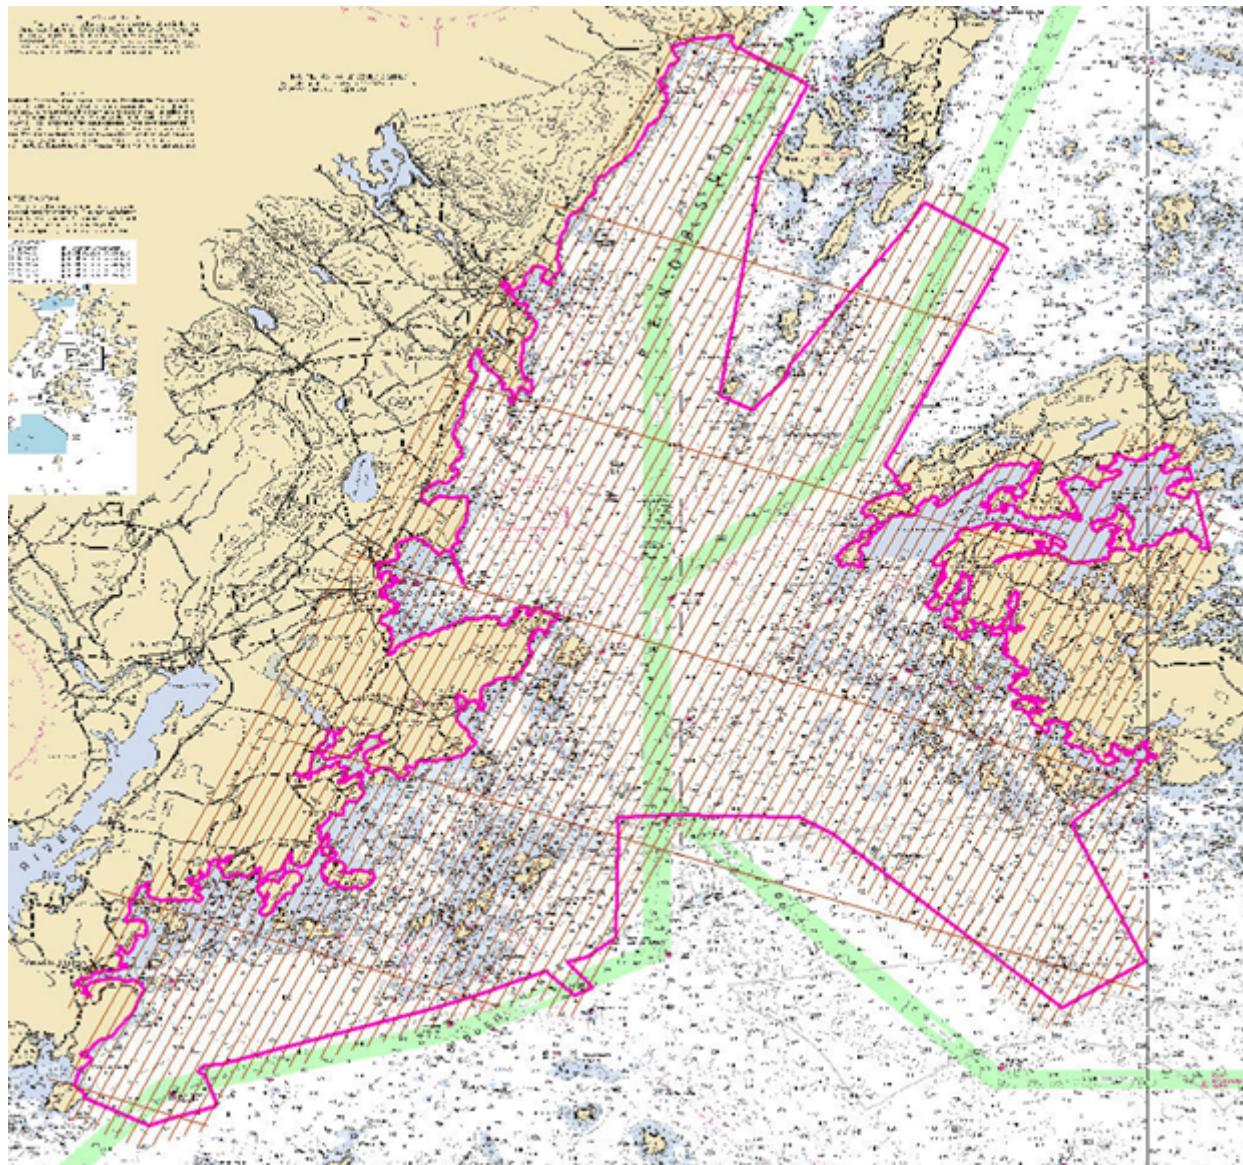
Figure 3: Proposed LiDAR Plan

The LiDAR program was proposed and planned for 100% of the area to be flown with a five by five (or better) spot spacing. A reconnaissance coverage survey would be used from the inshore limit (4-meter) to the 8-meter water depth. The actual line spacing was based on 200% coverage to try to provide maximum coverage and data density; this resulted in doubling the anticipated mainscheme linear nautical miles. In addition to this, the LiDAR area extends to the original survey limits and not to the revised survey limits as outlined in the project instructions (the area was reduced due to the allocated and available budget). For these reasons, the percentage of LiDAR mainscheme lines to LiDAR crosslines are not within the HSSD 2016 specification.

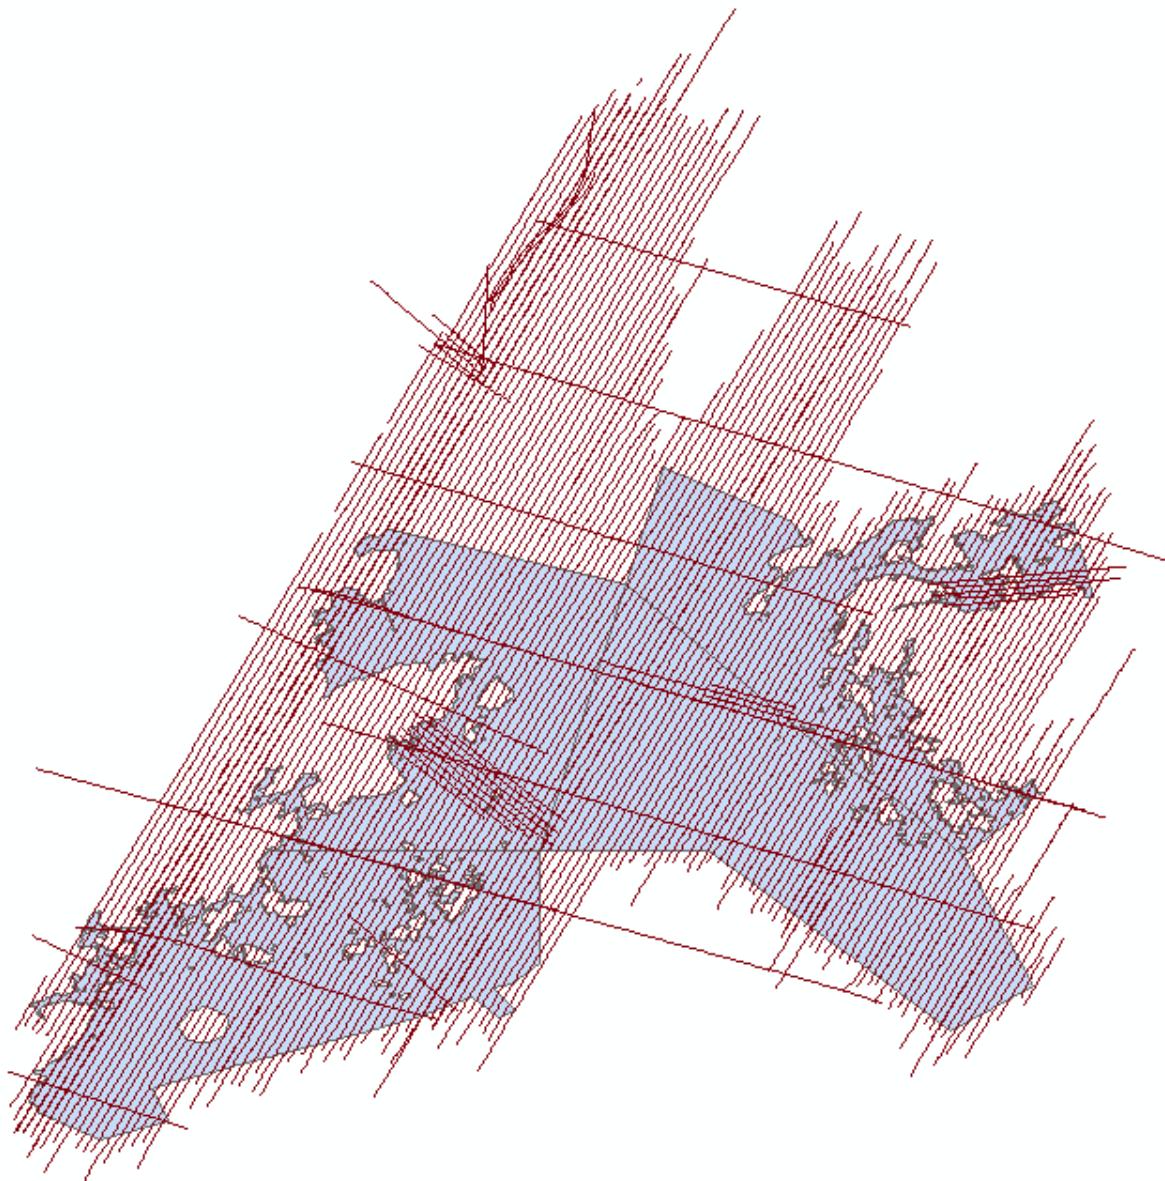
*Figure 4: Actual LiDAR Plan*

**The following statistics were computed during office processing: Lidar MS =1045 miles, Lidar XL =94 miles (percent of XL to LIMS =9.0%).**

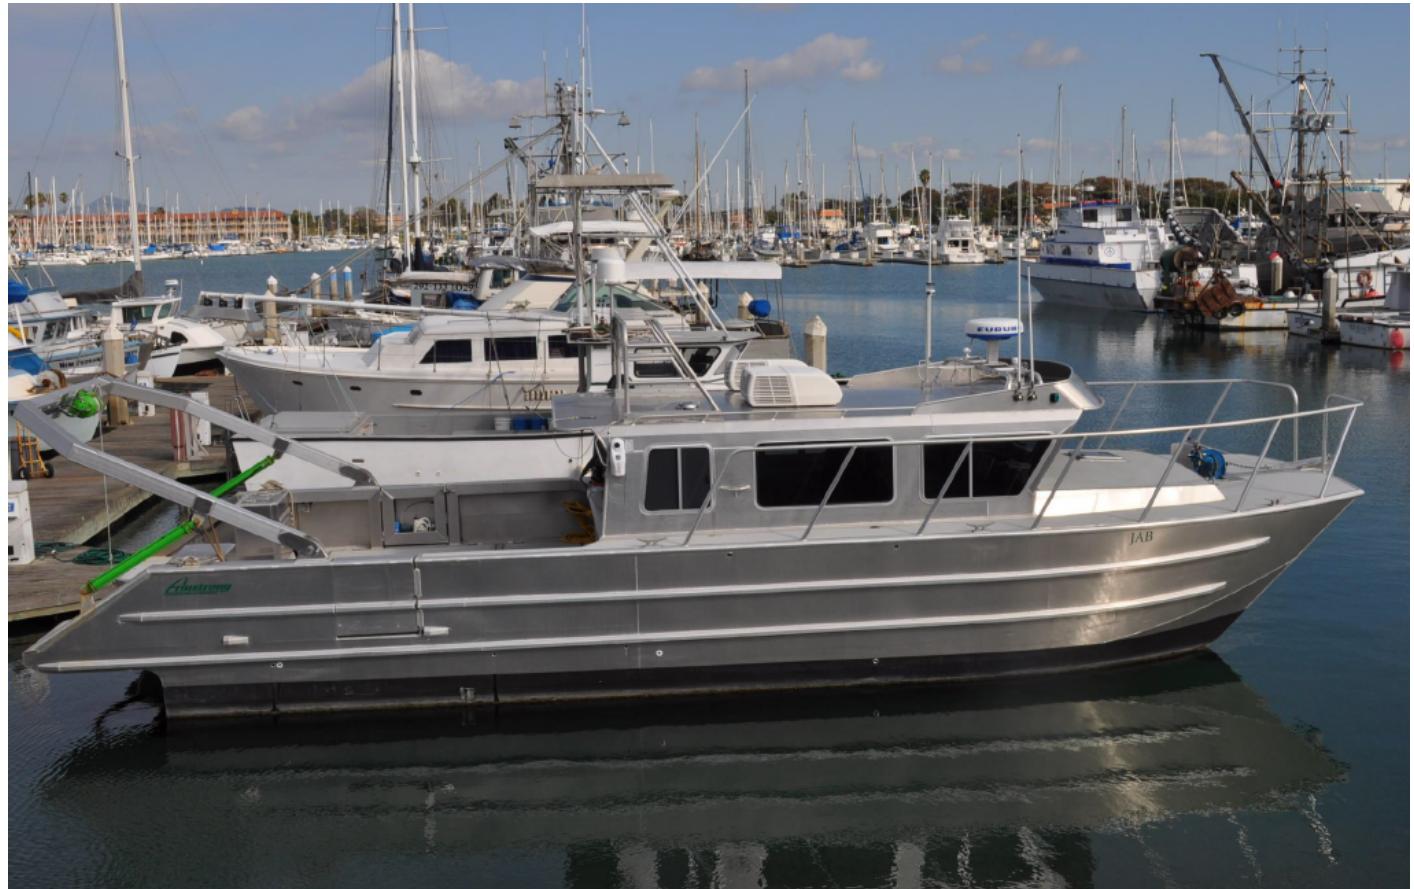
*Figure 5: R/V JAB (1229272)*

R/V JAB (1229272), R/V Westerly (1231991) and the Beechcraft King Air A90 (N87Q) systems acquired all sounding data for H12887.

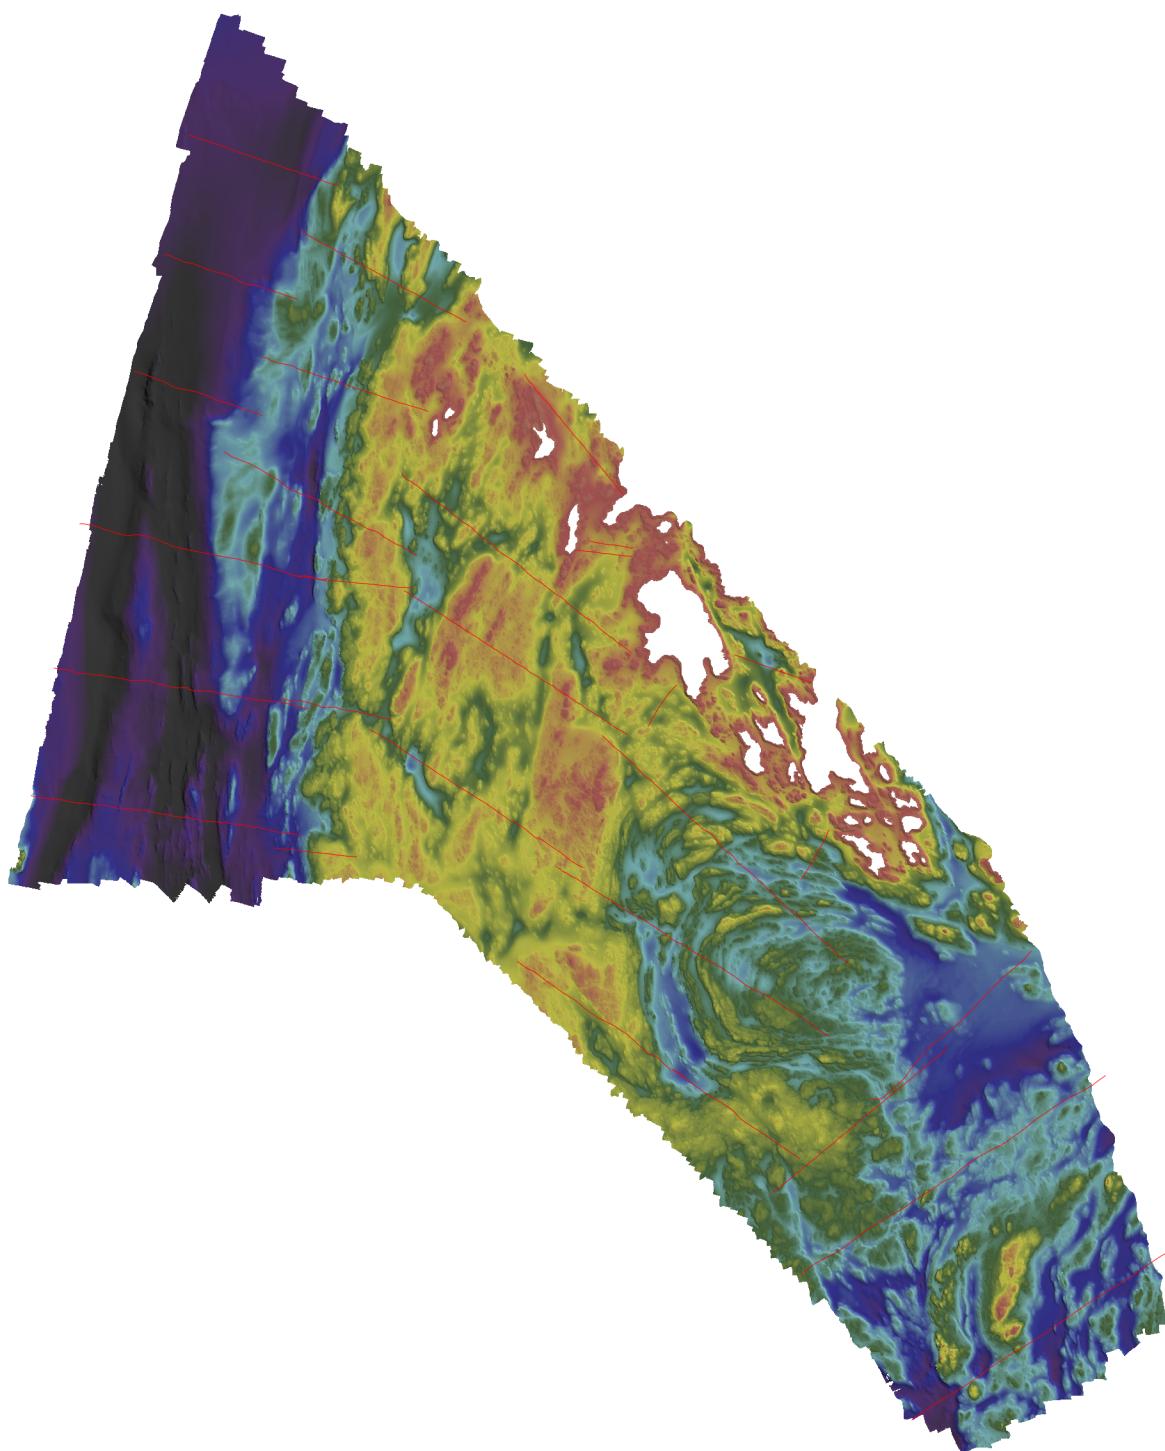
Figure 8: H12887 Crossline Overview

A difference analysis between the crosslines and the main survey lines was performed using the Crosscheck program within Fledermaus. A surface grid was created from the production lines at a bin size of approximately 3 meters. The crossline points were then compared to the surface, and point-to-surface statistics generated. The crossline comparison documents illustrate that elevated standard deviation of the differences occurs over rocky and high gradient seabed. In relatively featureless areas of seabed, the differences present a much lower variability.

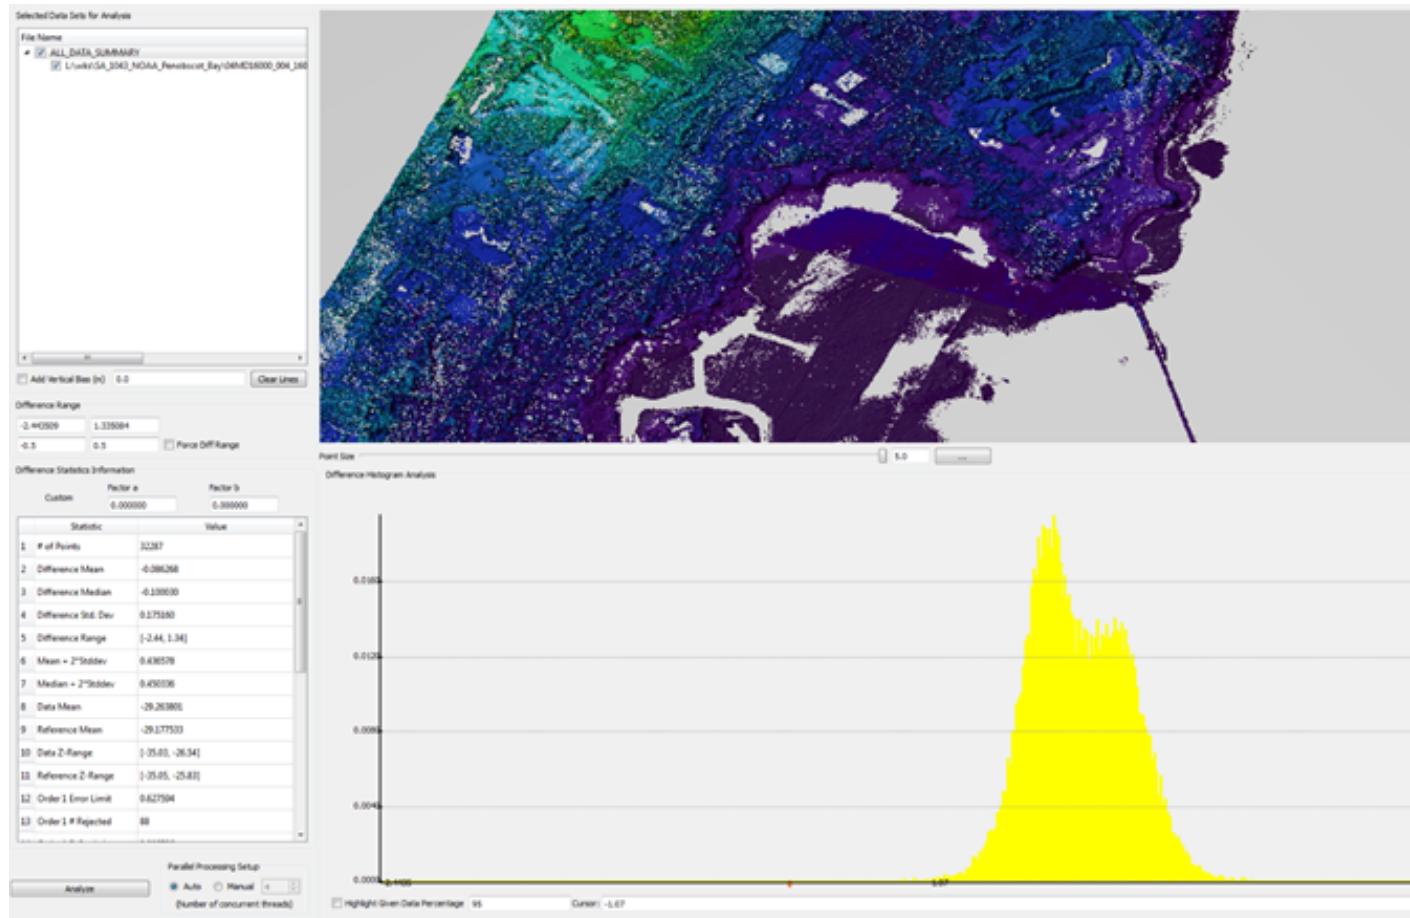
Figure 12: Flight Line 20160713 1713 01191 QC

Difference Statistics Information		
Custom	Factor a	Factor b
	0.000000	0.000000
	Statistic	Value
1	# of Points	32085
2	Difference Mean	-0.082842
3	Difference Median	-0.098863
4	Difference Std. Dev	0.162220
5	Difference Range	[-0.50, 0.49]
6	Mean + 2*Stddev	0.407285
7	Median + 2*Stddev	0.423306
8	Data Mean	-29.259207
9	Reference Mean	-29.176365
10	Data Z-Range	[-35.03, -26.54]
11	Reference Z-Range	[-35.05, -26.11]
12	Order 1 Error Limit	0.627585
13	Order 1 # Rejected	0

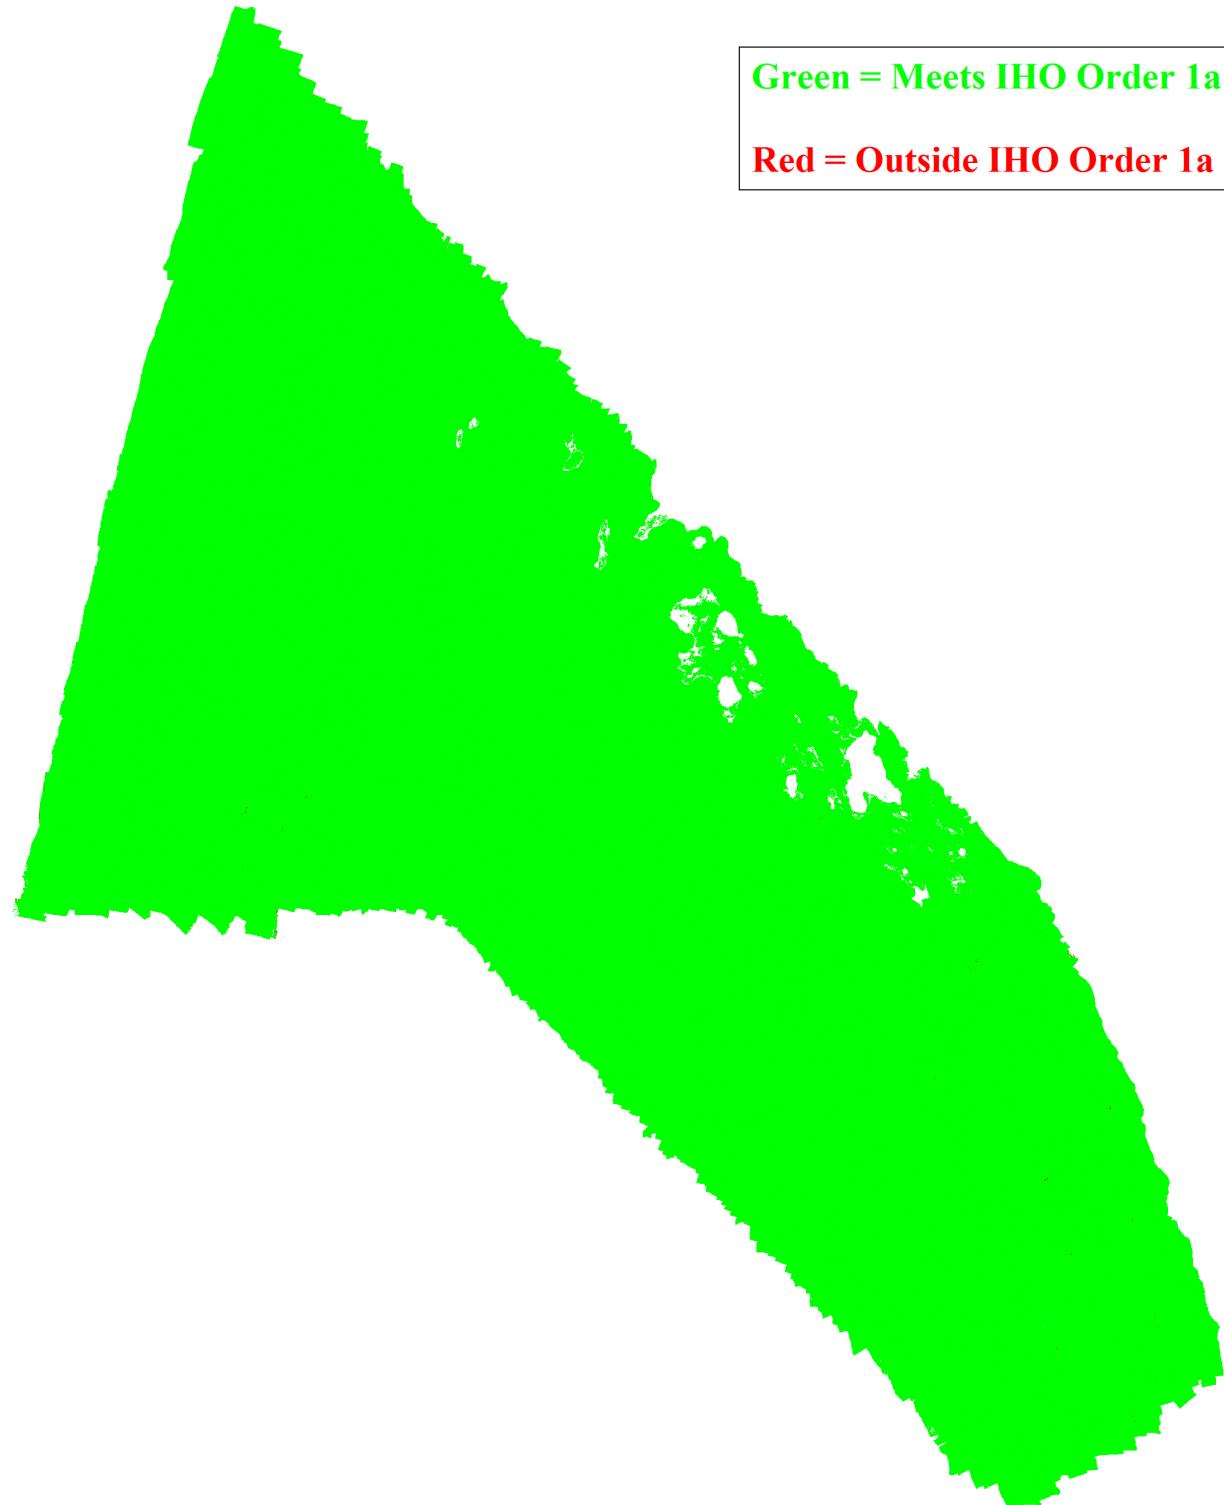
Figure 14: H12887 Uncertainty

In addition to using the surface QC report in CARIS to derive the TPU for H12887, HydroOffice QCTools were used to compute the total propagated vertical uncertainty (TVU). Both methods yielded similar results.

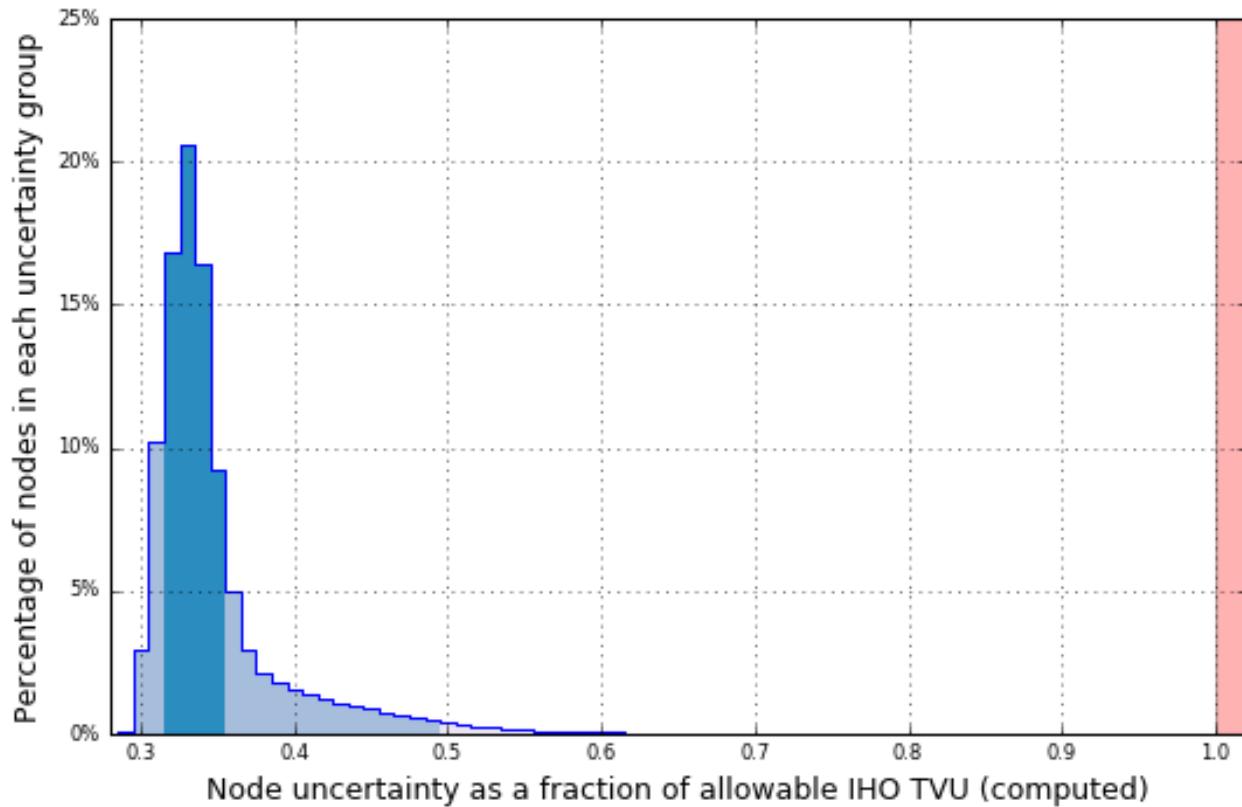
Figure 15: Hydrooffice Surface Report H12887 (Priority 3) 1m Final

99.5+% pass (24,219,490 of all nodes), min=0.28, mode=0.33, max=3.98

Percentiles: 2.5%=0.30, Q1=0.32, median=0.33, Q3=0.35, 97.5%=0.49

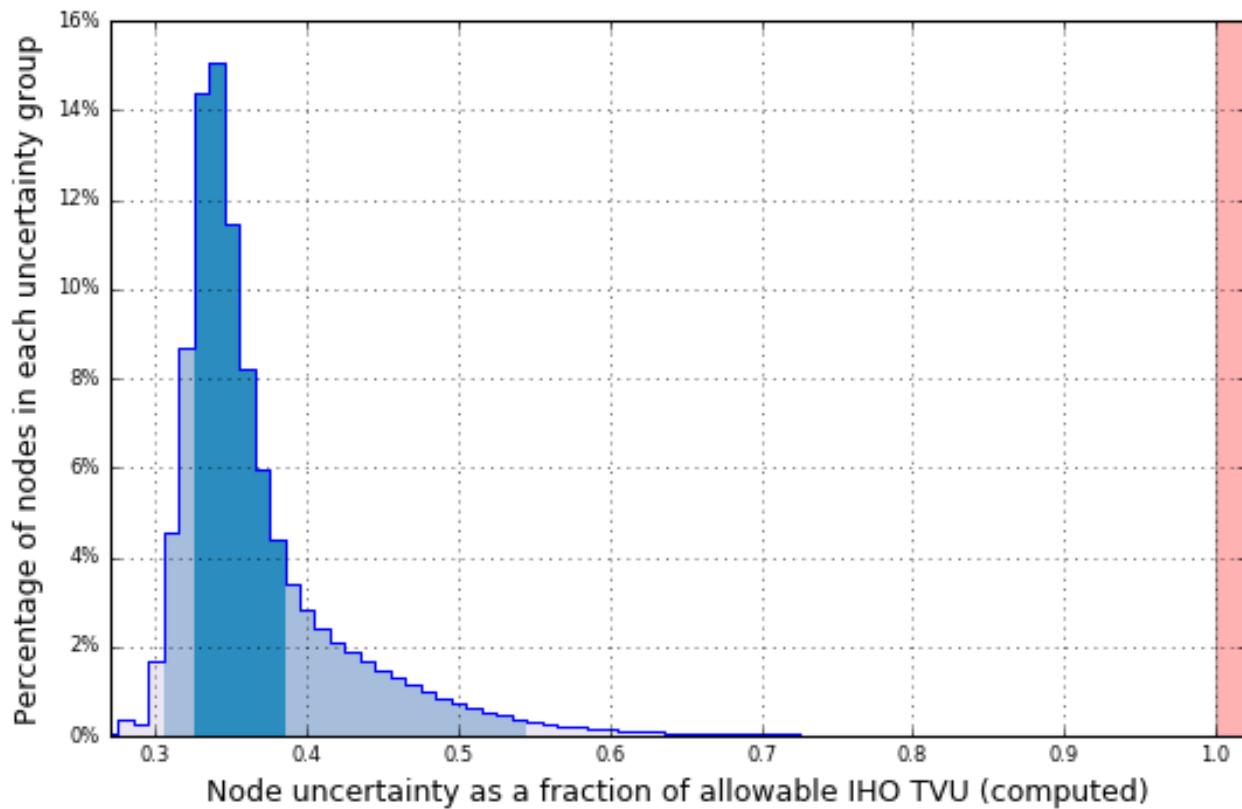
Figure 16: Hydrooffice Surface Report H12887 (Priority 3) 2m Final

99.5+% pass (11,738,152 of all nodes), min=0.27, mode=0.34, max=2.99

Percentiles: 2.5%=0.31, Q1=0.33, median=0.35, Q3=0.38, 97.5%=0.54

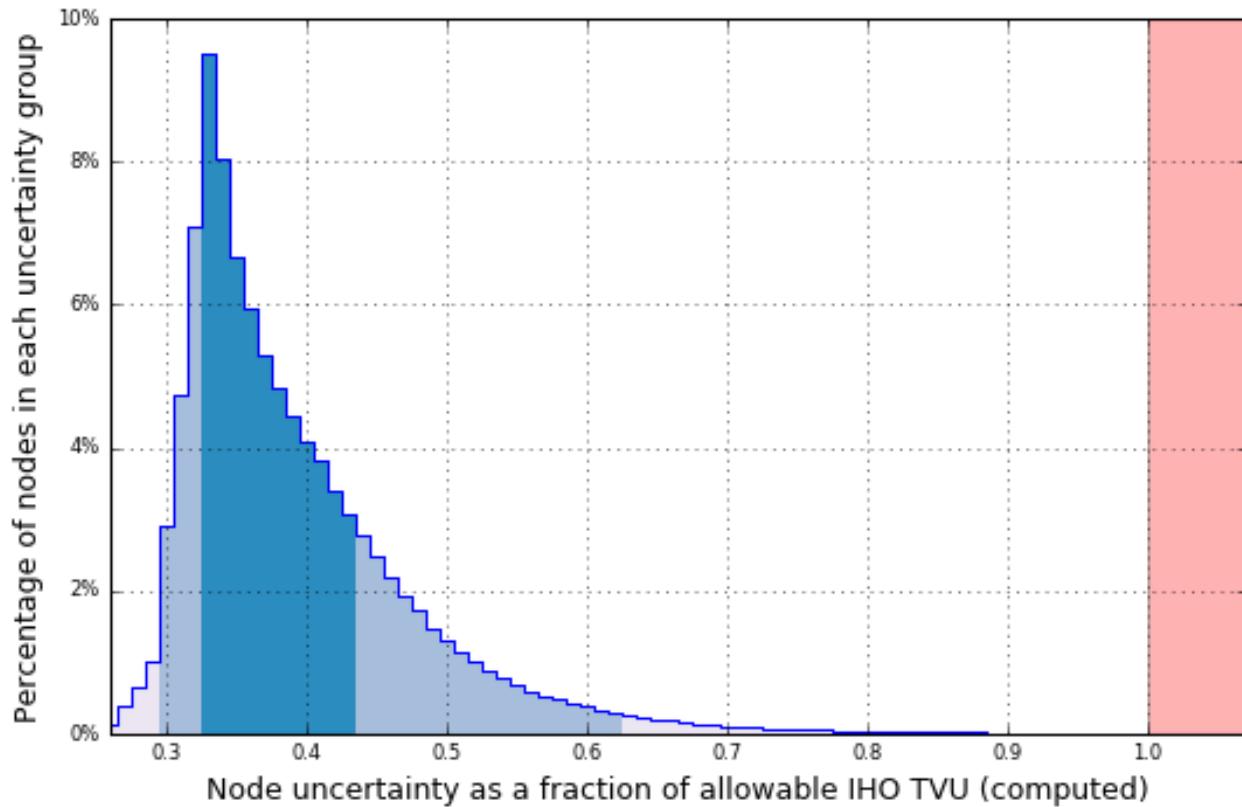
Figure 17: Hydrooffice Surface Report H12887 (Priority 3) 4m Final

99.5+% pass (2,565,563 of all nodes), min=0.26, mode=0.33, max=2.29

Percentiles: 2.5%=0.30, Q1=0.33, median=0.37, Q3=0.43, 97.5%=0.62

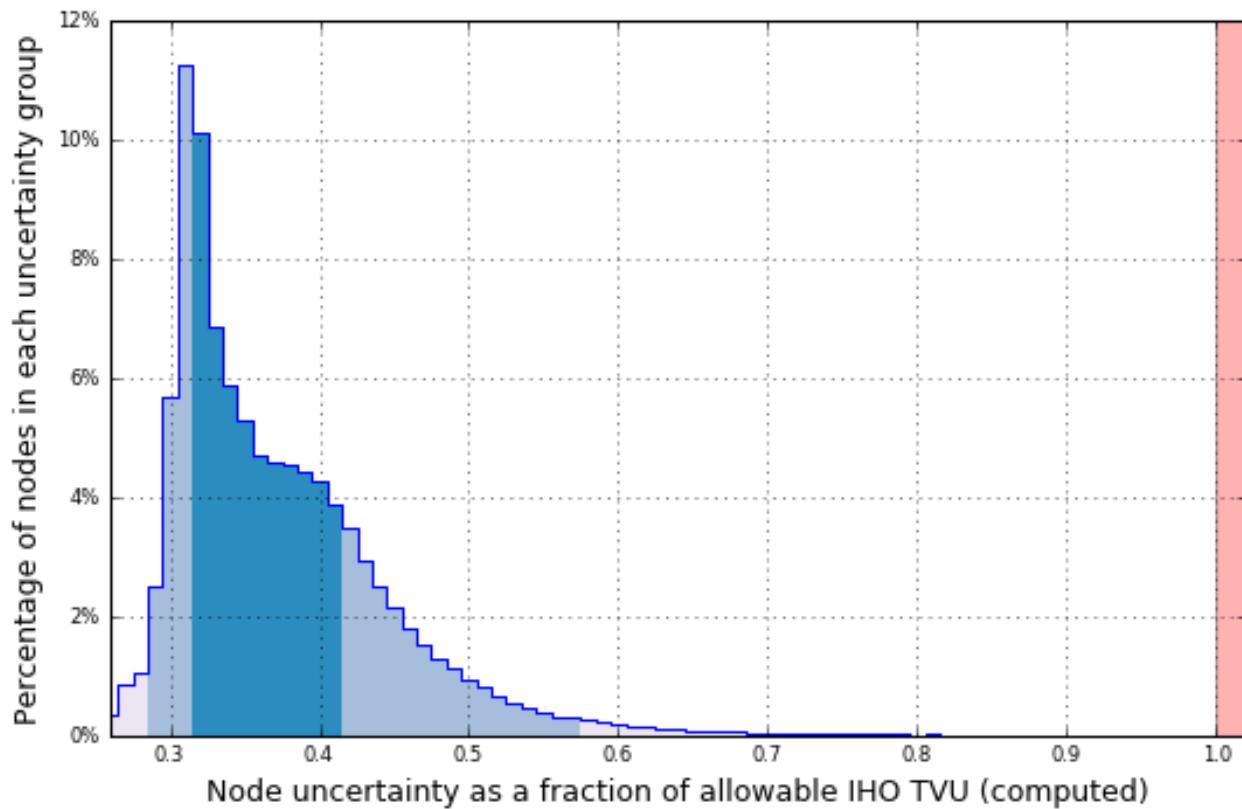
Figure 18: Hydrooffice Surface Report H12887 (Priority 3) 8m Final

99.5+% pass (288,383 of all nodes), min=0.26, mode=0.31, max=1.55

Percentiles: 2.5%=0.29, Q1=0.32, median=0.36, Q3=0.41, 97.5%=0.57

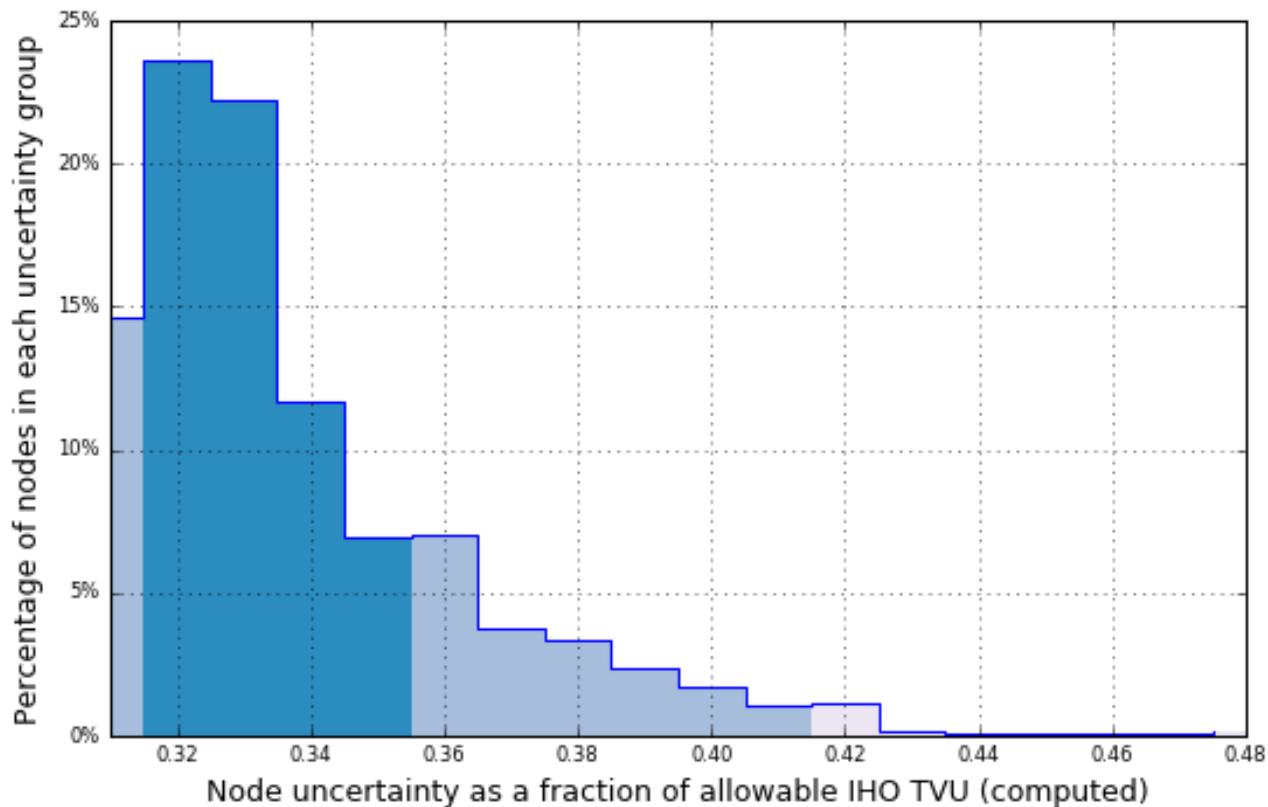
Figure 19: Hydroffice Surface Report H12887 (Priority 3) 16m Final

100% pass (1,260 of all nodes), min=0.31, mode=0.32, max=0.48

Percentiles: 2.5%=0.31, Q1=0.32, median=0.33, Q3=0.35, 97.5%=0.41

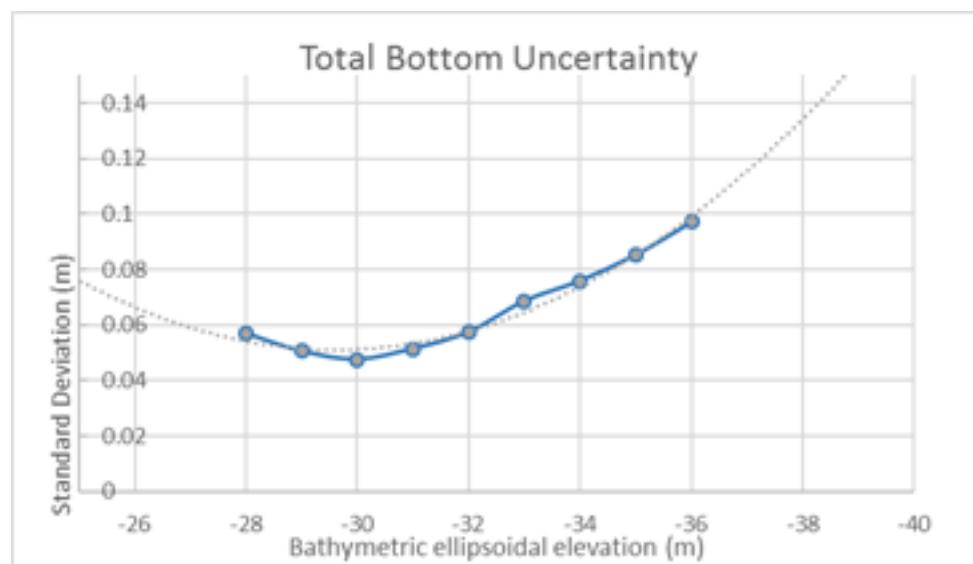
Figure 21: Total Bottom Uncertainty for SHOALS data sample

Regarding LiDAR, in order to accurately determine TVU for all depth data collected as part of the project, a 'TPU' line was designed and flown on eight separate occasions. One area of low gradient seabed was identified across the TPU line. Once all of the depth data had been processed, cleaned, and reduced to datum by a VDatum model, Fugro's LiDAR Total Error (LTE) tool (an extension in ArcGIS) was used to determine SHOALS uncertainty. LTE is a tool implemented in ArcGIS that uses spatial analysis of LiDAR point elevations to determine statistical variance of a significant data sample. The LTE tool application shows the common parameters for data sampling, as well as the water depth ranges being analyzed (or elevation on the ellipsoid). The inputs were the Hydrographic Output Files (HOF) files generated in the SHOALS-GCS processing software. The results of the analysis were tabulated and plotted to derive a depth-dependent model of Total Bottom Uncertainty (TBU). Refer to the Appendix II for the full report.

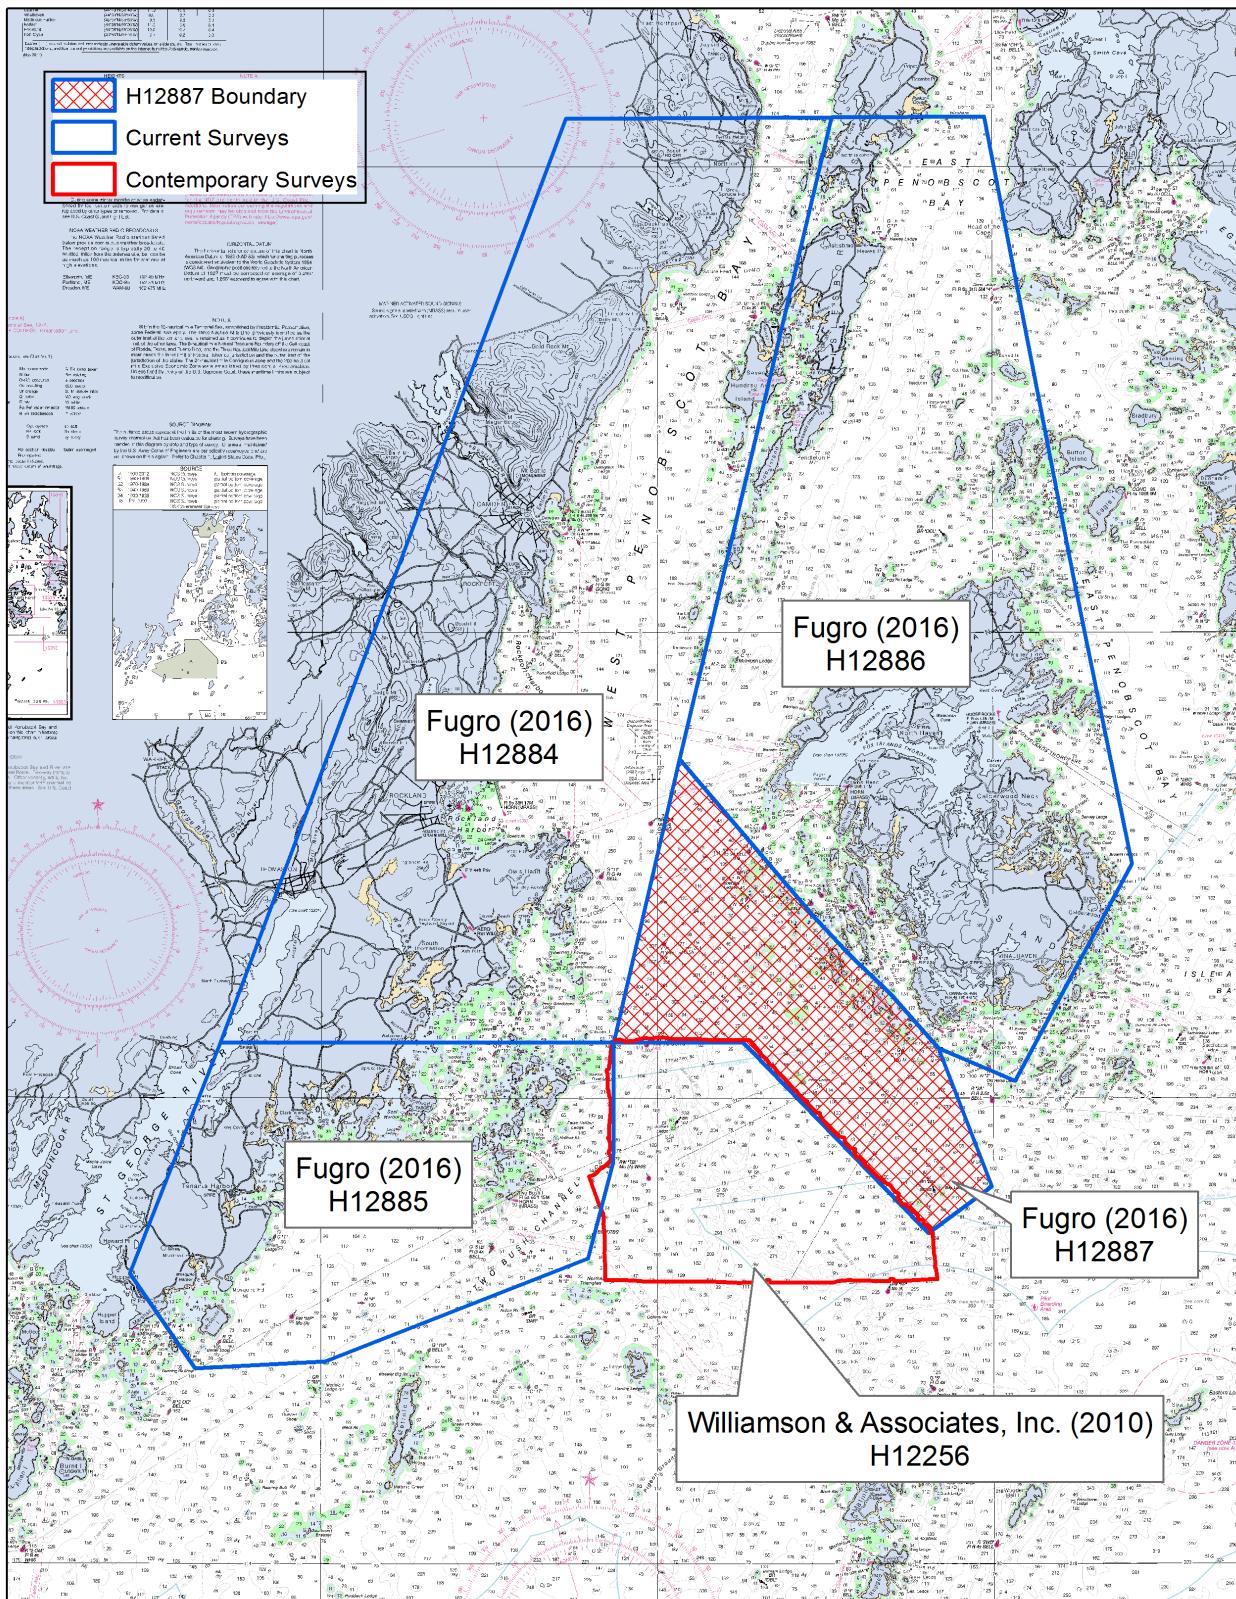
Figure 23: H12887 Junctions Overview

Comparisons between H12887 were made with contemporary survey H12256, and the current surveys H12884, H12885, and H12886. The results are as follows:
