H12887

## DESCRIPTIVE REPORT

Type of Survey: Basic Hydrographic Survey

Sub-locality: Offshore Vinalhaven Island

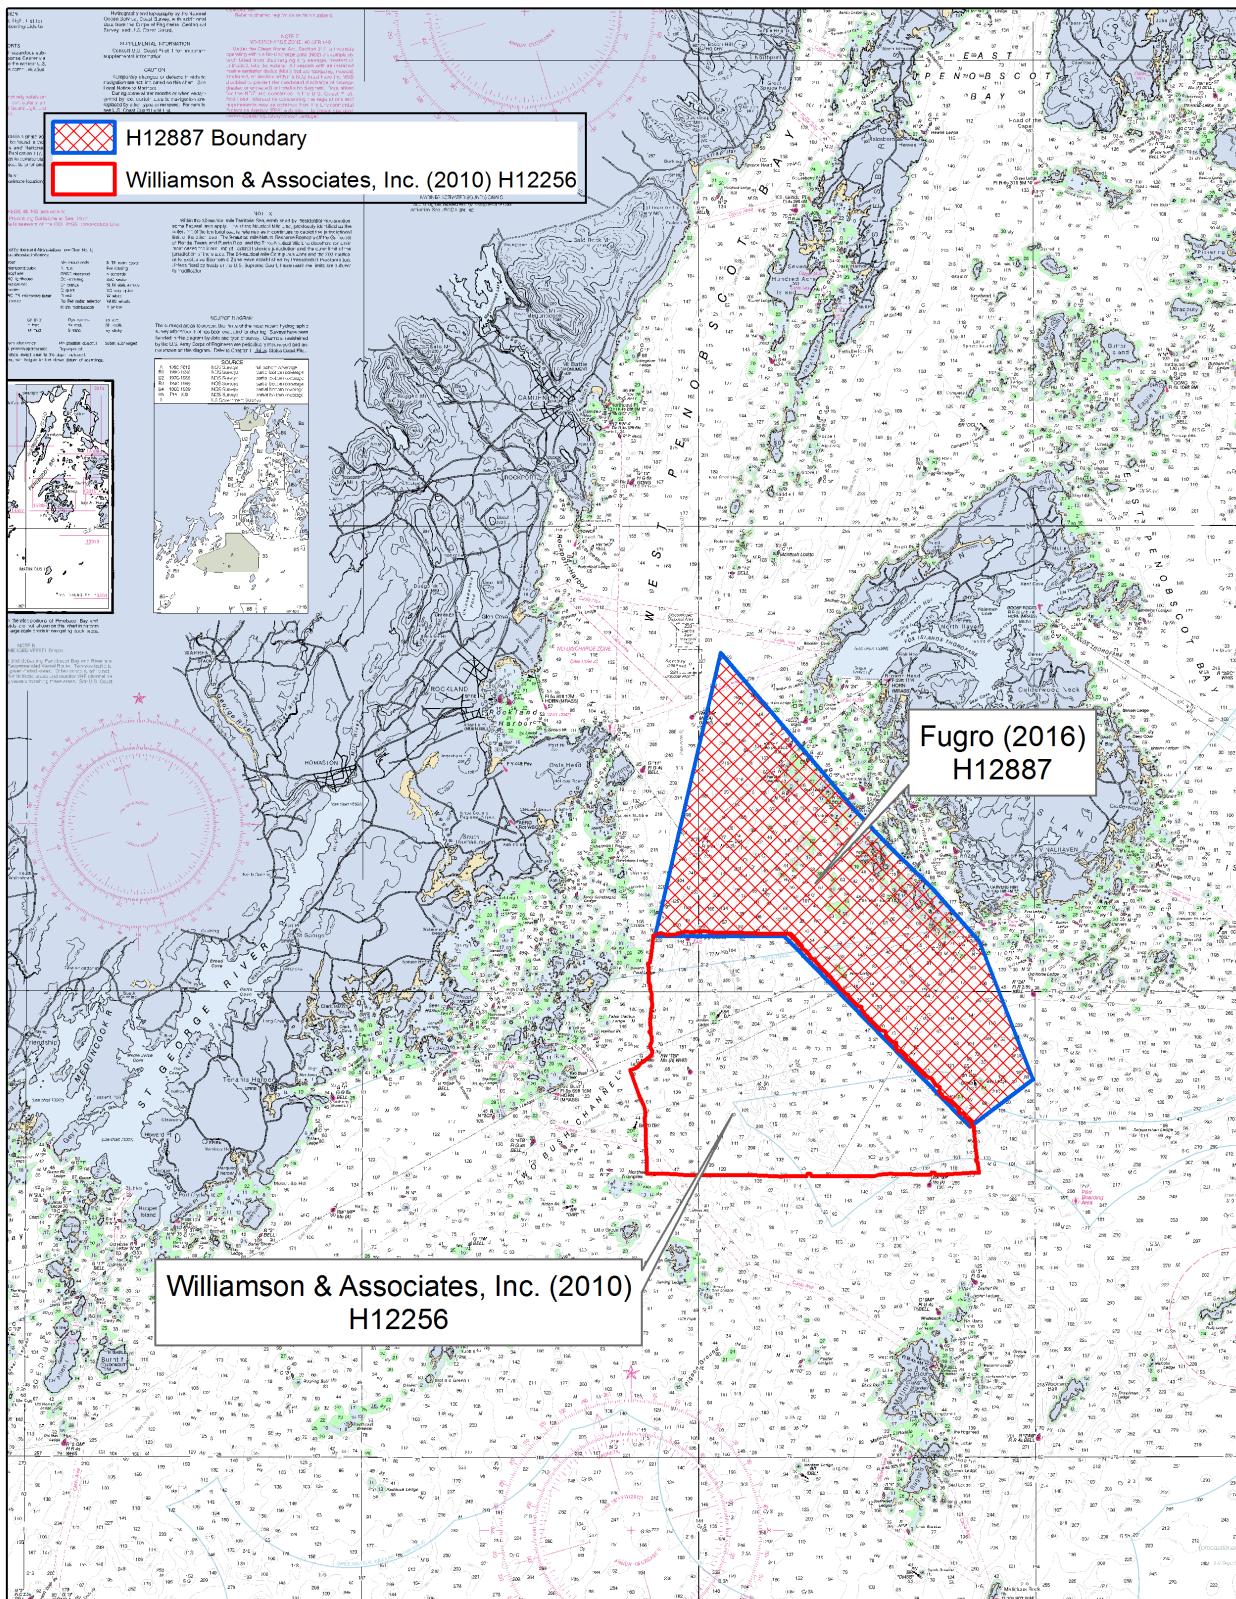
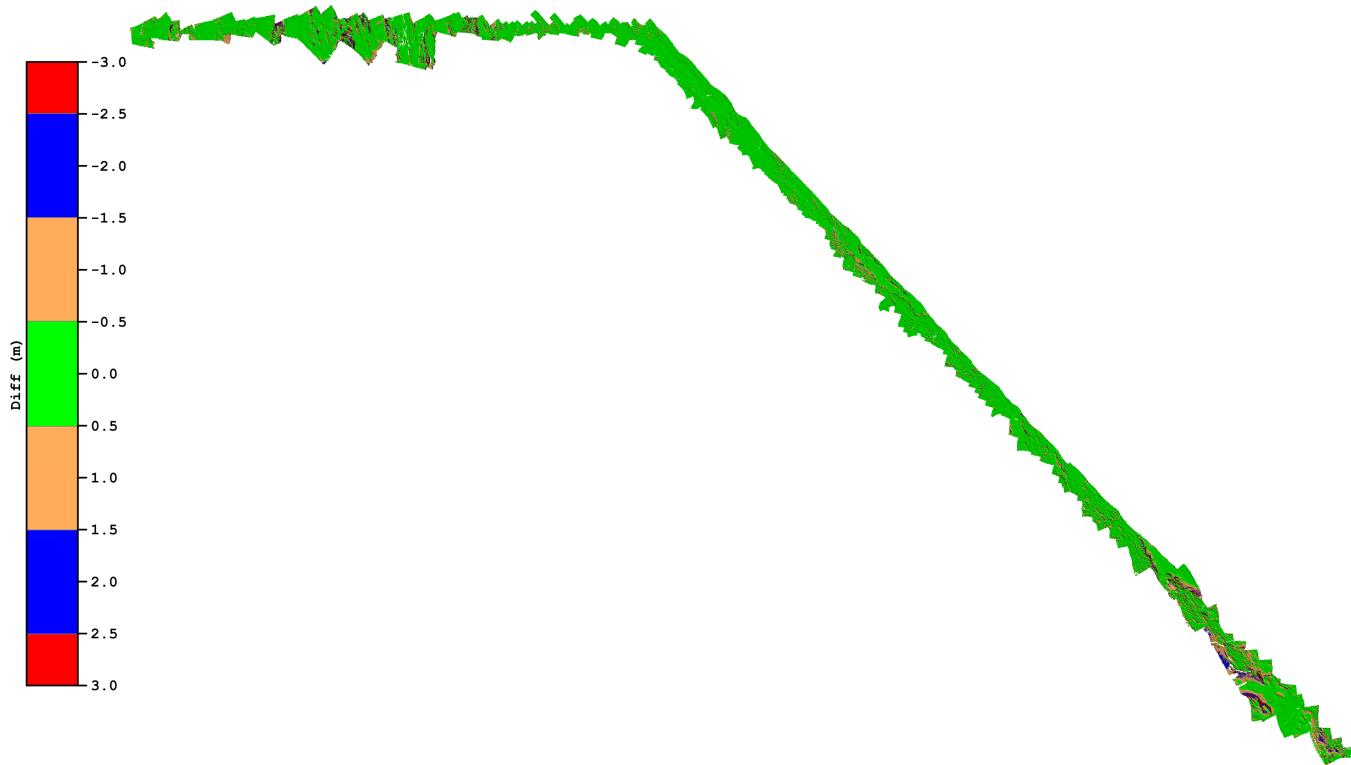
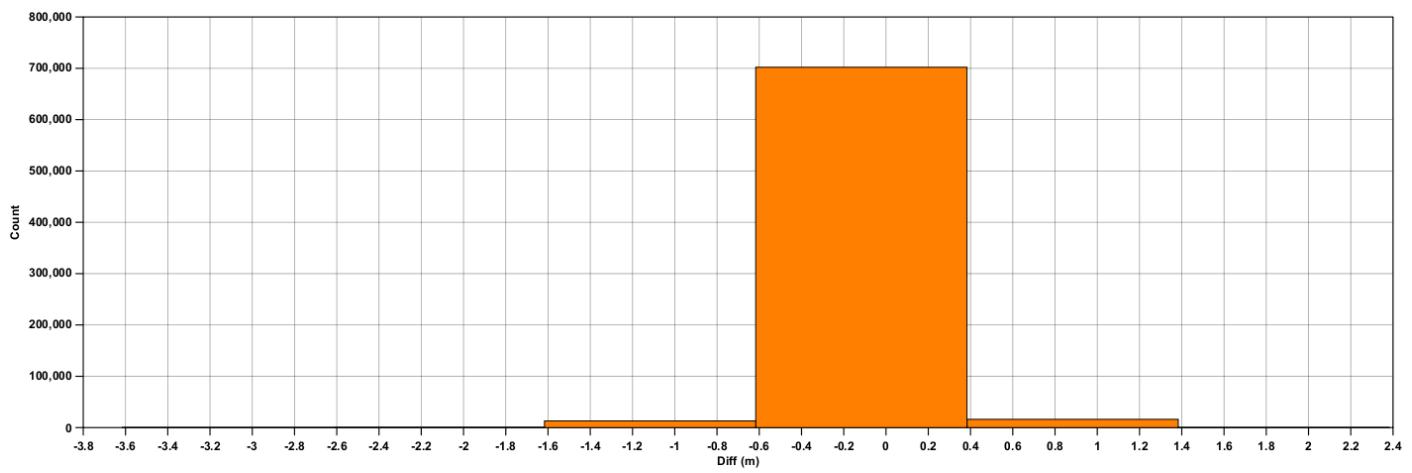
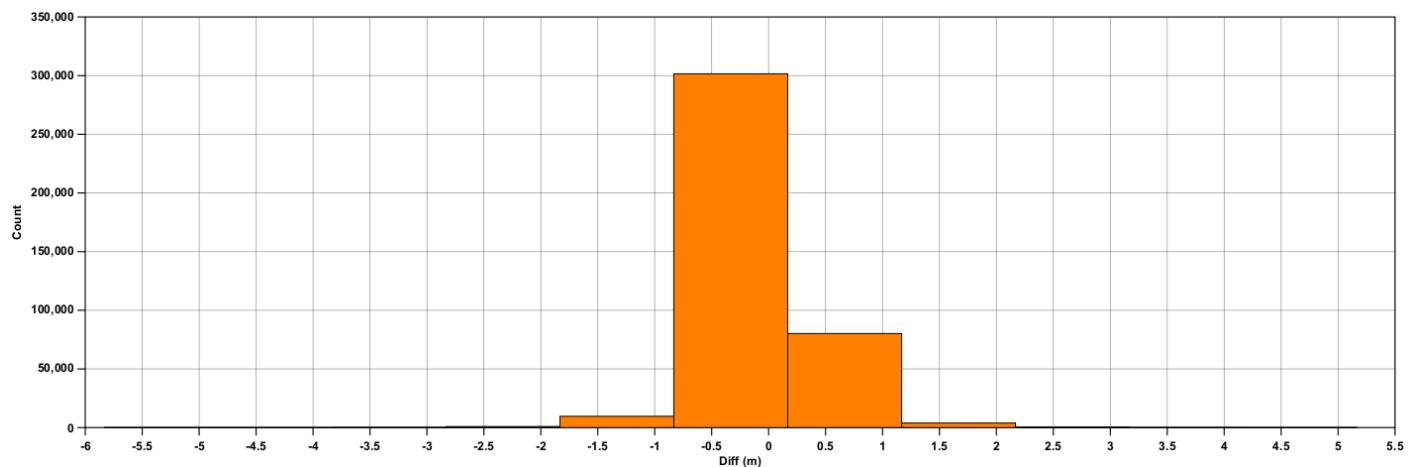
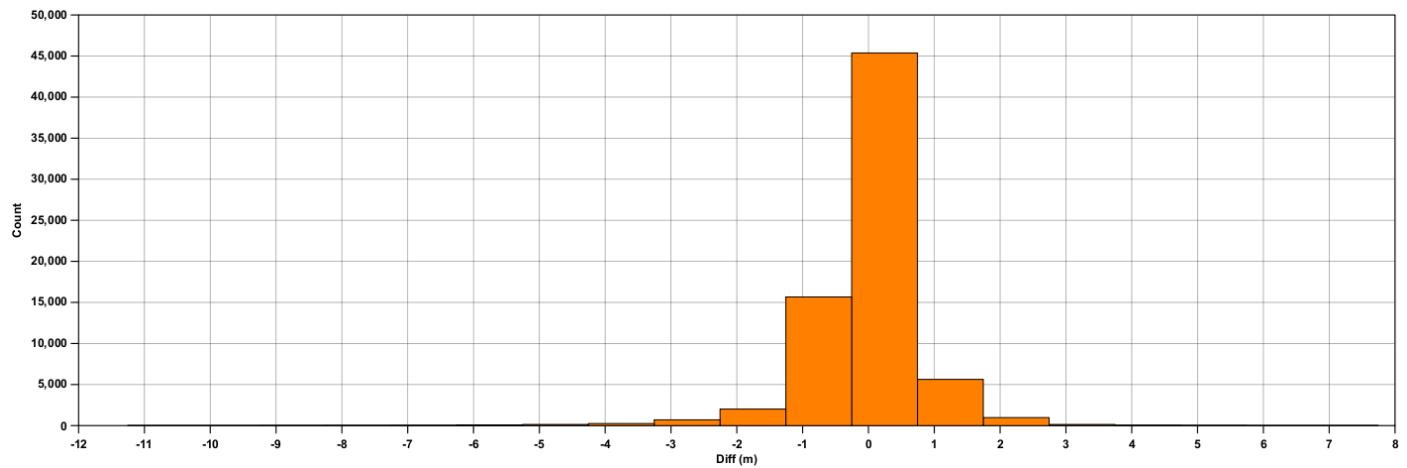
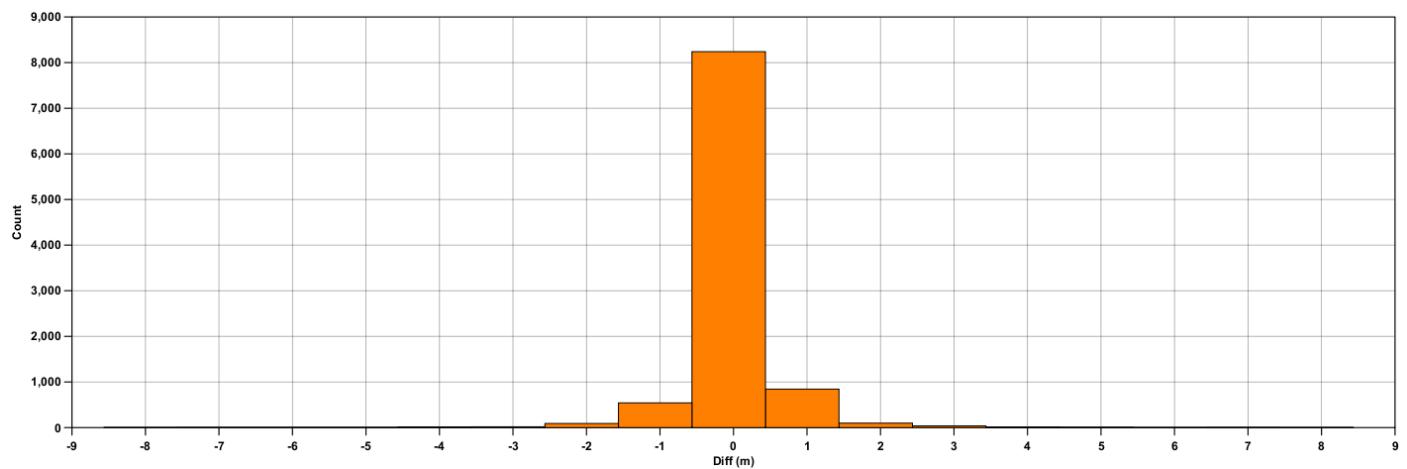
The conformity between H12887 and the junction with survey H12256 was inspected during processing using the CARIS HIPS Subset Editor routine and finalized as BASE Surfaces. A Difference Surface was generated using the CARIS HIPS Difference Surface function; comparing the depths from the H12887 survey (1, 2, 4, and 8-meter resolution) CUBE surfaces against the H12256 survey. Using the Compute Statistics function in CARIS, the difference surface yielded the following results: a standard deviation of 0.2 meters, and a mean difference of -0.1 meters for the one-meter surface, along with a standard deviation of 0.4 meters, and a mean difference of 0.0 meters for the two-meter surface, and a standard deviation of 0.8 meters, and a mean difference of 0.0 meters for the four-meter surface, and a standard deviation of 0.6 meters, and a mean difference of 0.0 meters for the eight-meter surface. The surveys are in agreement along their common borders and well within the total allowable IHO Order 1a vertical uncertainty. The majority of the difference between the two surveys can be attributed to motion artifacts in the H12256 data along with sound speed refraction and tide error accounting for a small portion of that difference.

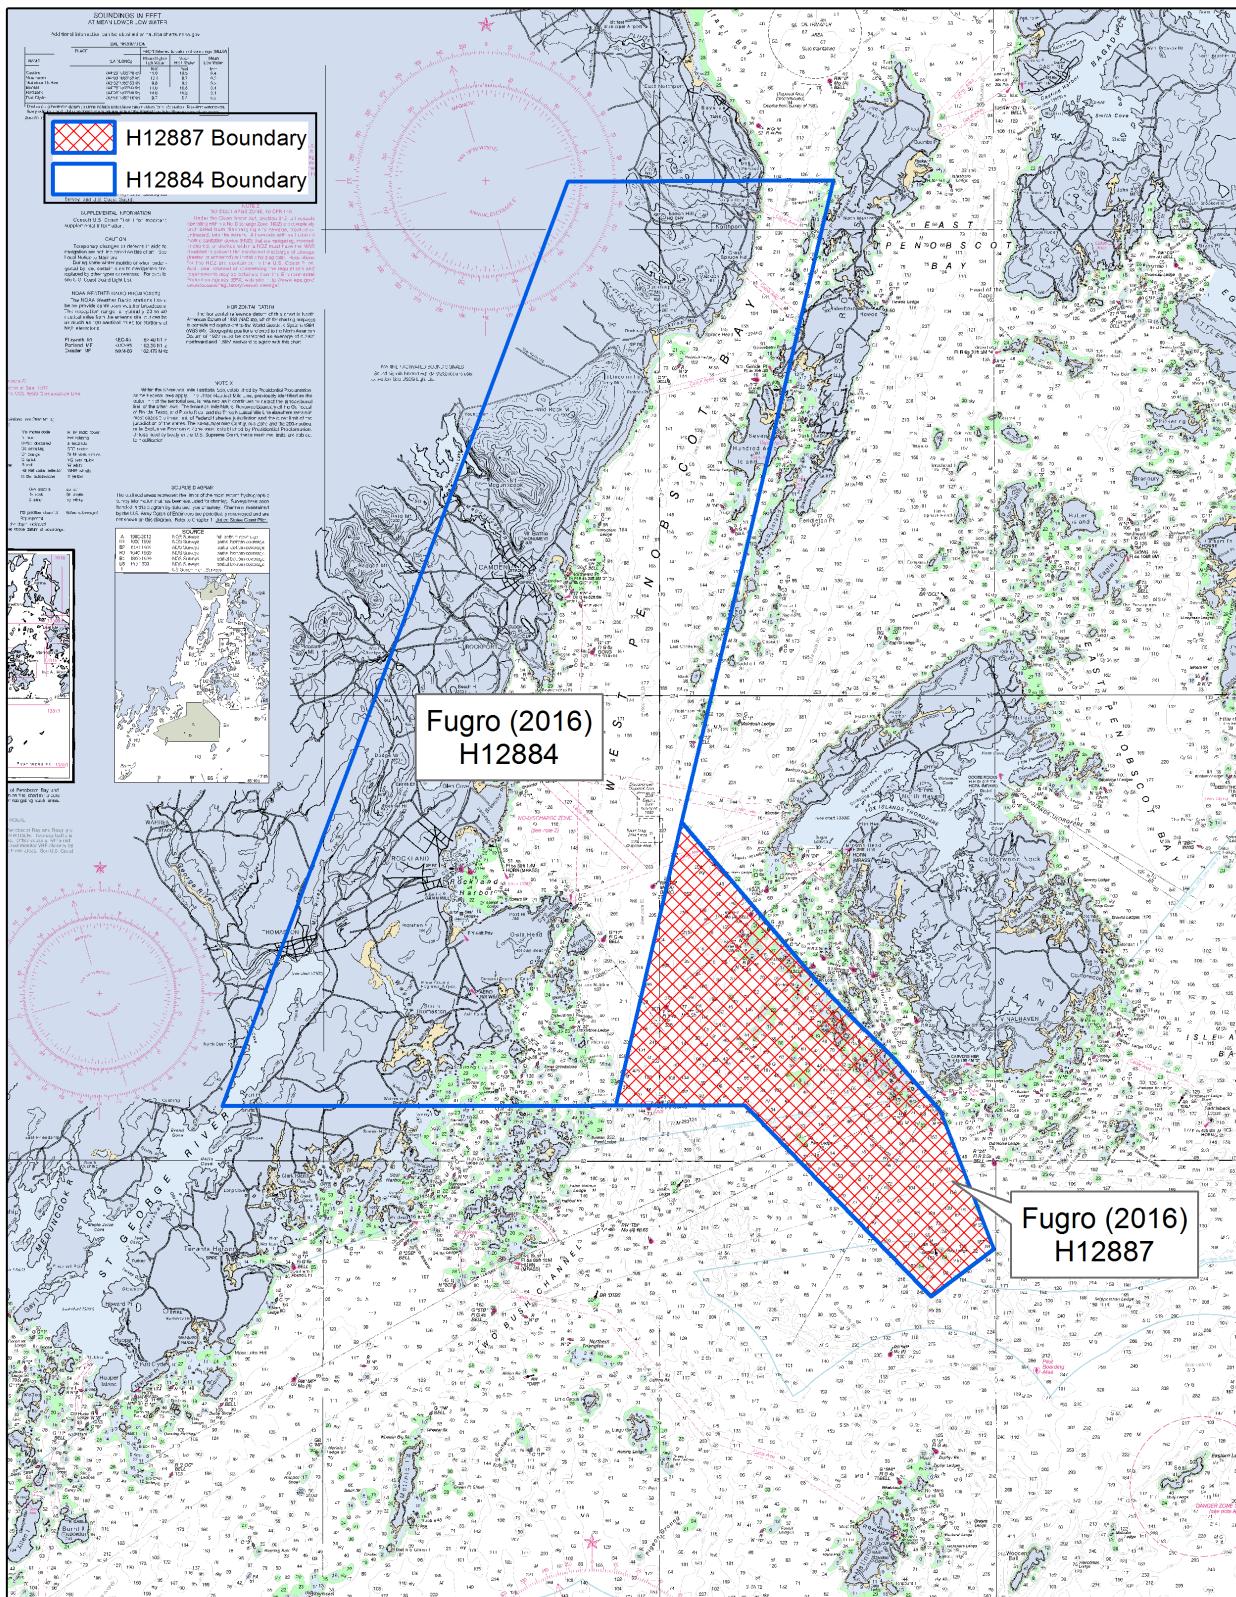
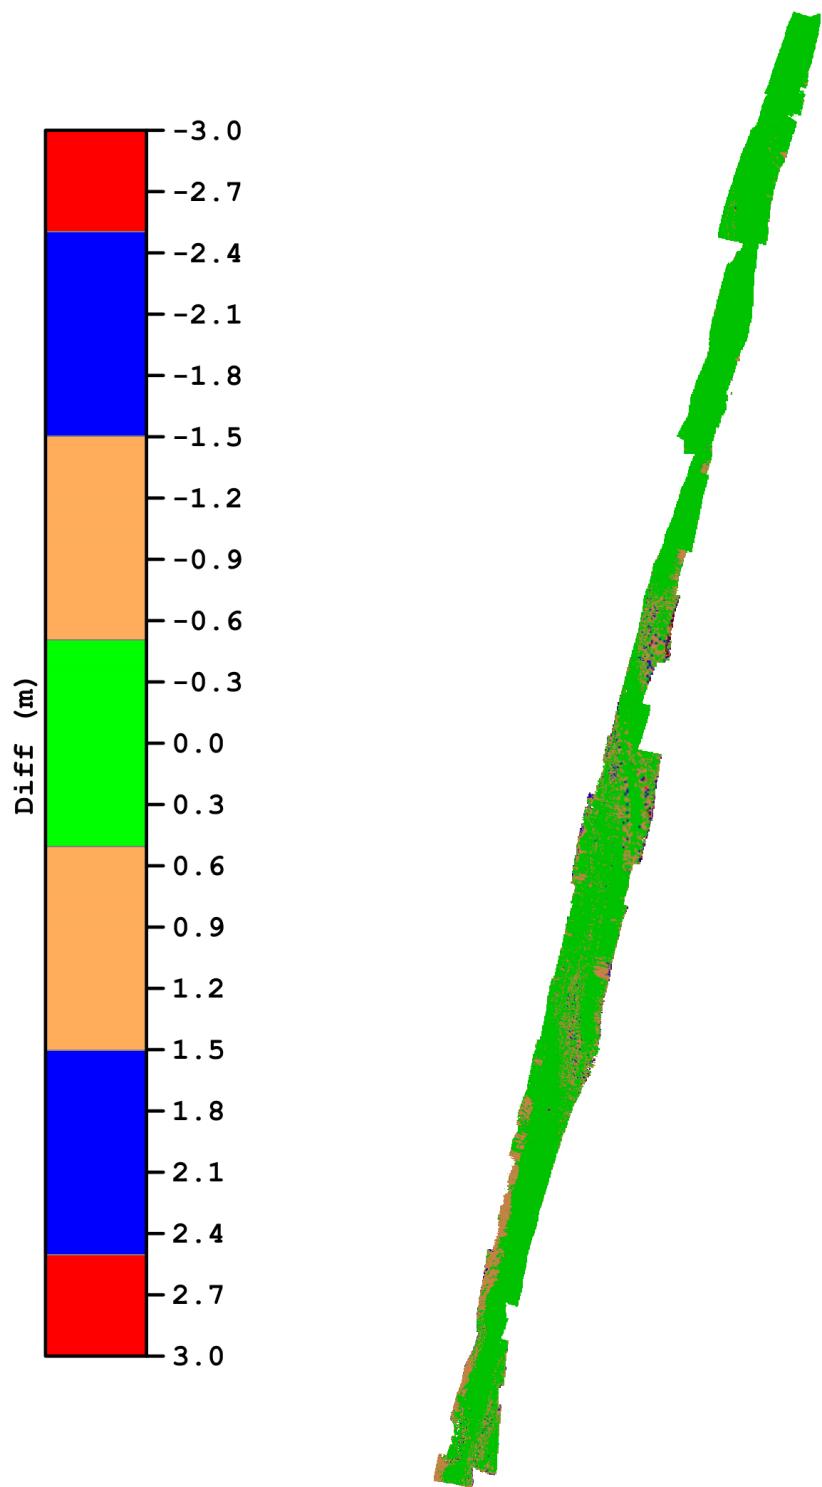
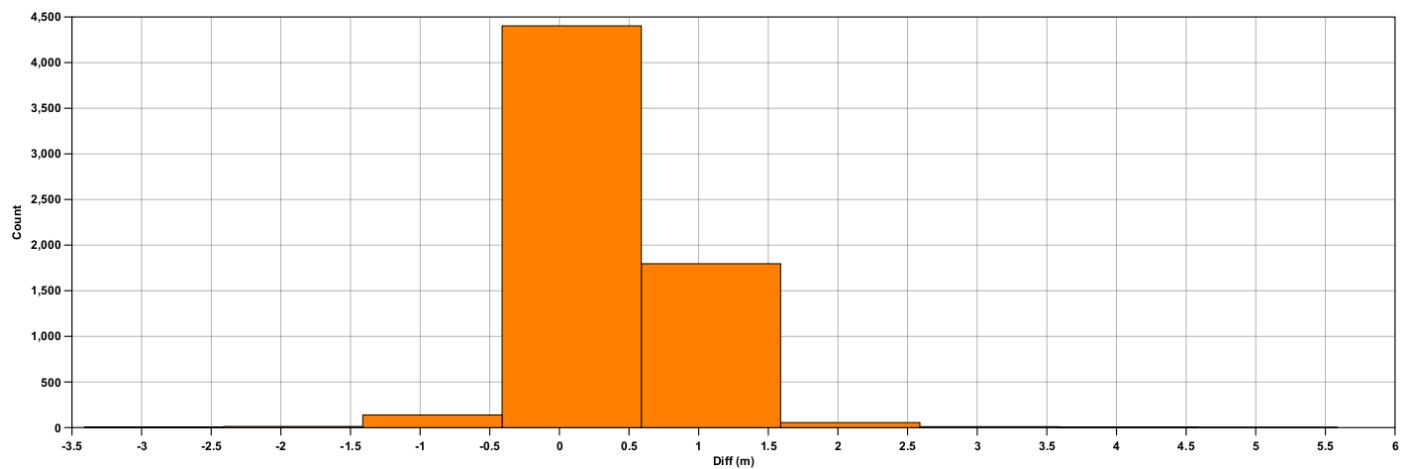
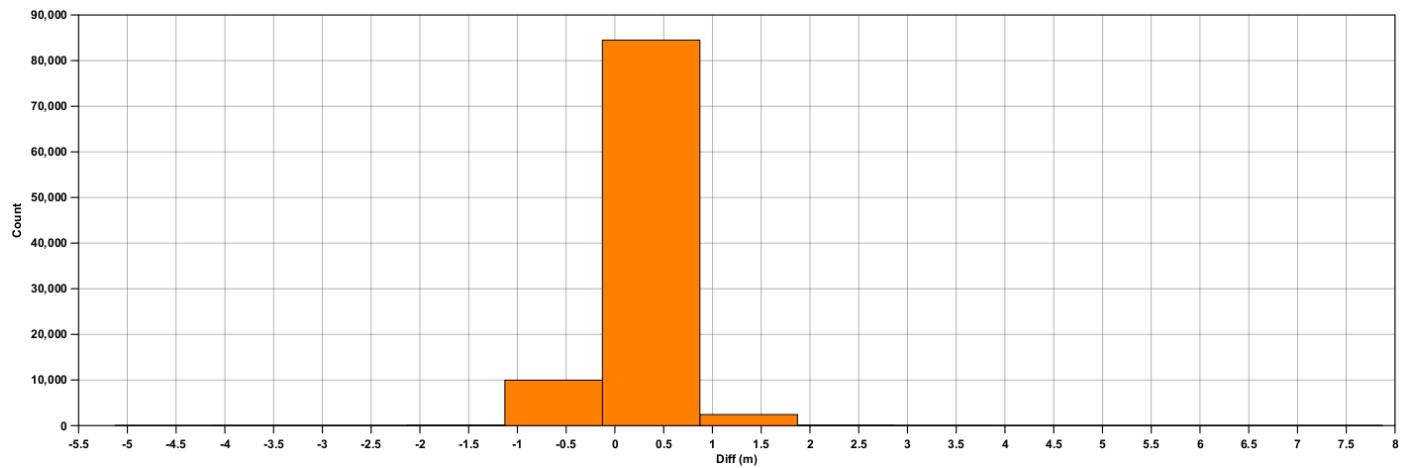
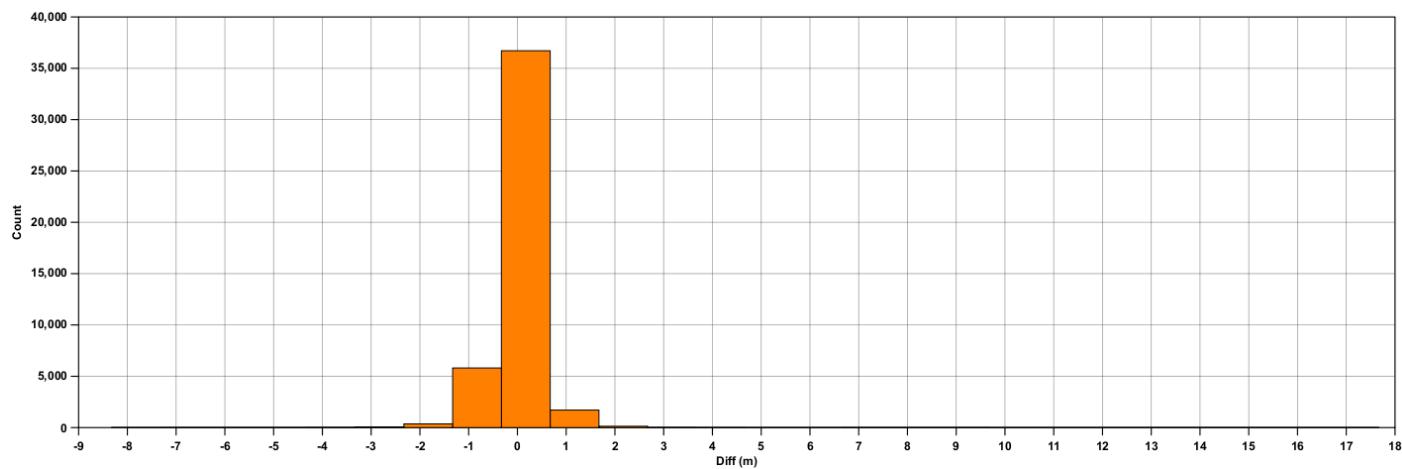
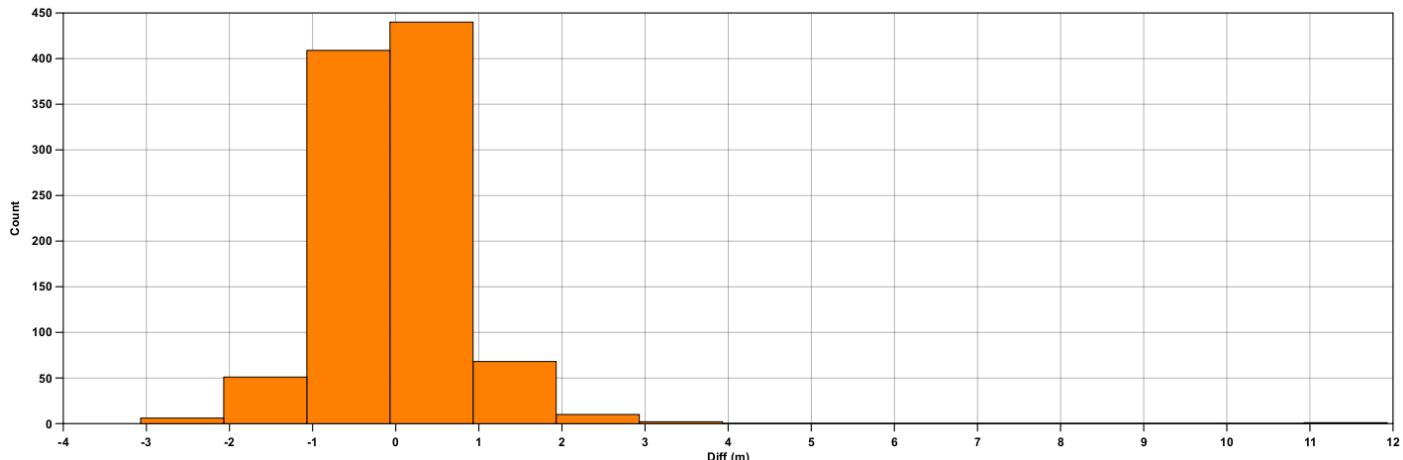
The conformity between H12887 and the junction with survey H12884 was inspected during processing using the CARIS HIPS Subset Editor routine and finalized as BASE Surfaces. A Difference Surface was generated using the CARIS HIPS Difference Surface function; comparing the depths from the H12887 survey (2, 4, 8, and 16-meter resolution) CUBE surfaces against the H12884 survey. Using the Compute Statistics function in CARIS, the difference surface yielded the following results: a standard deviation of 0.4 meters, and a mean difference of 0.4 meters for the two-meter surface, a standard deviation of 0.3 meters, and a mean difference of 0.1 meters for the four-meter surface, a standard deviation of 0.5 meters, and a mean difference of 0.0 meters for the eight-meter surface, and a standard deviation of 0.8 meters, and a mean difference of 0.0 meters for the sixteen-meter surface. The surveys are in agreement along their common borders and well within the total allowable IHO Order 1a vertical uncertainty. The majority of the difference between the two surveys can be attributed to sound speed refraction with tide error also accounting for a small portion of that difference. The increased standard deviation between the higher resolution grids can also be attributed to the grid, or node placement in the CUBE surface during creation. When CARIS creates the nodes for the H12887 8-meter surface, these will differ from the position of the nodes for H12884 8-meter surface. This small horizontal shift in the grid nodes can result in a depth difference, especially in areas with an irregular seafloor.

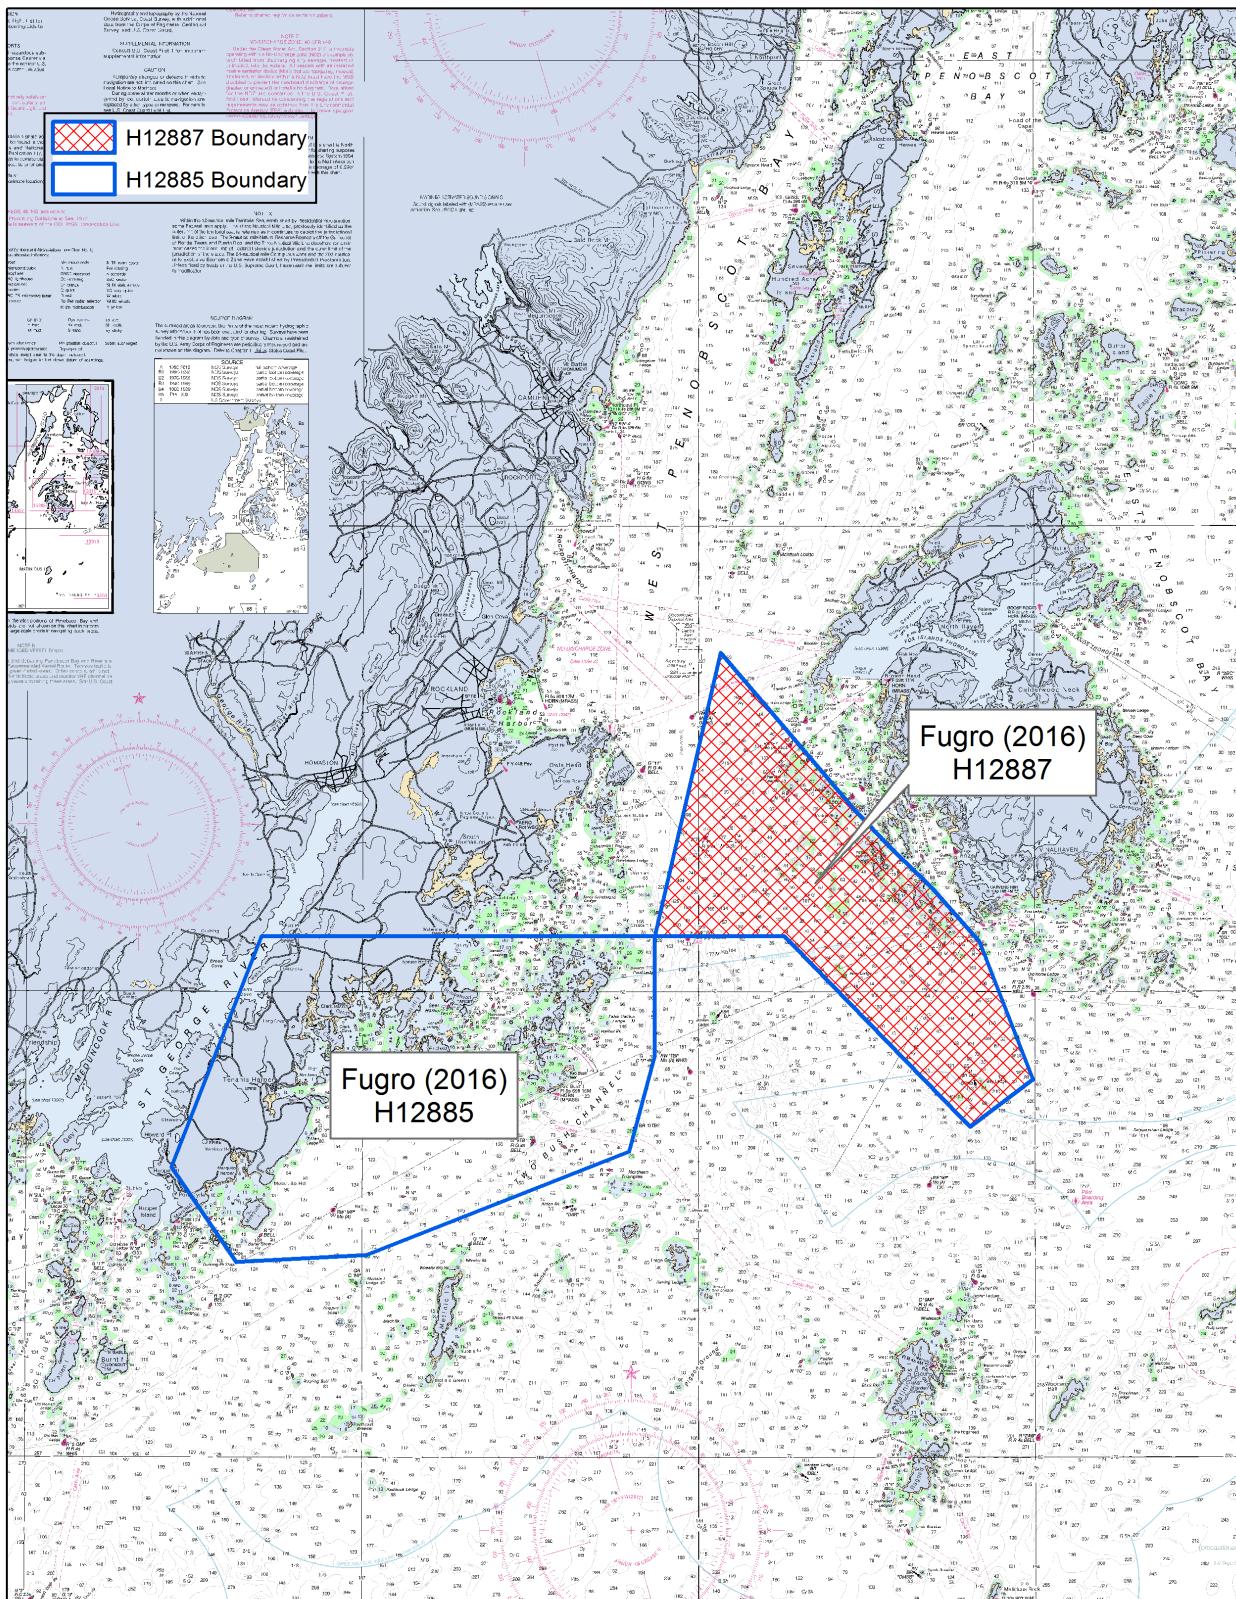
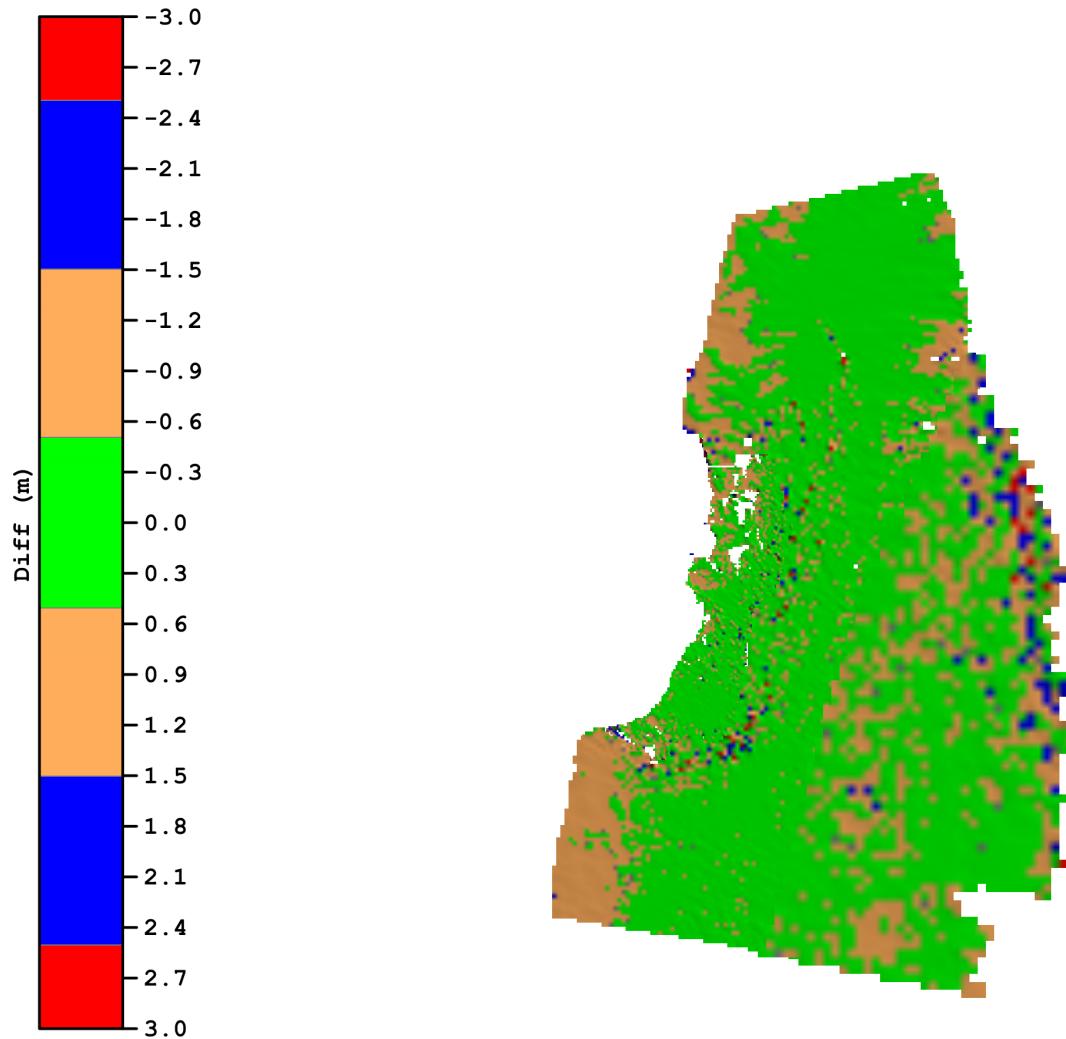
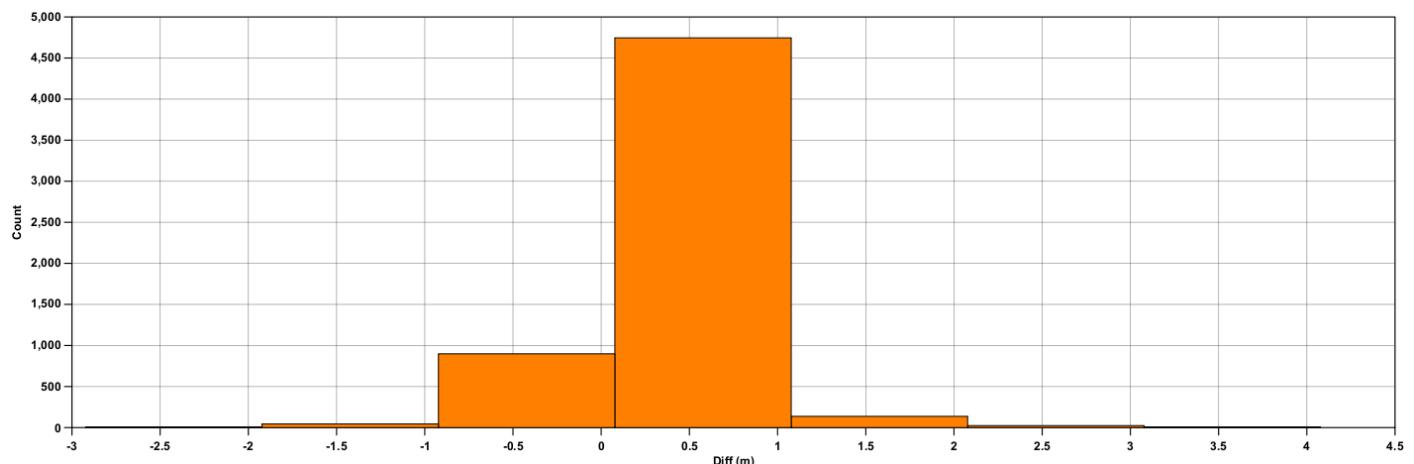
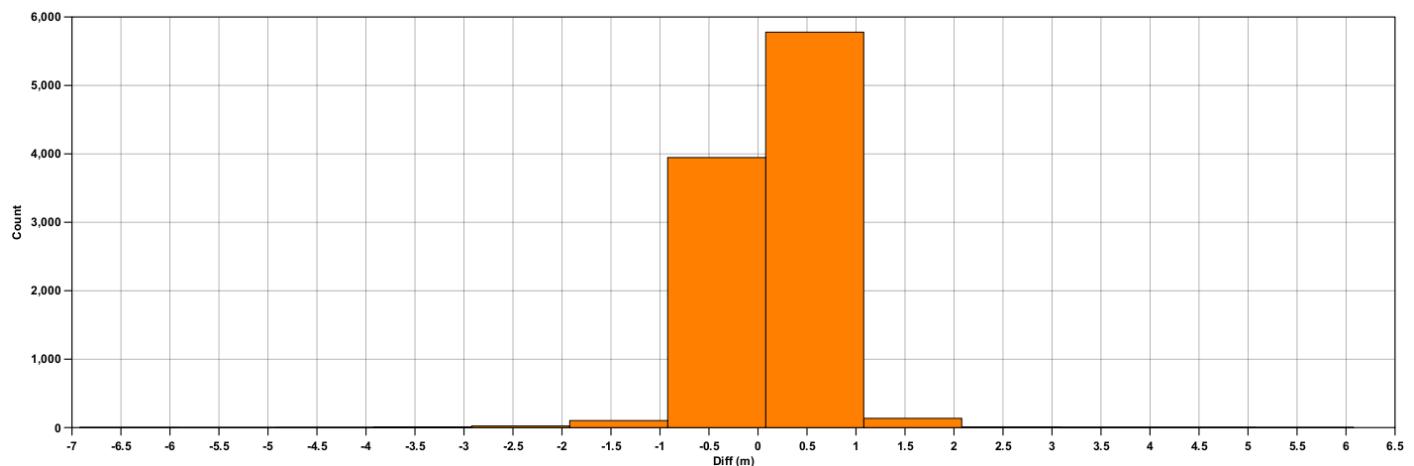
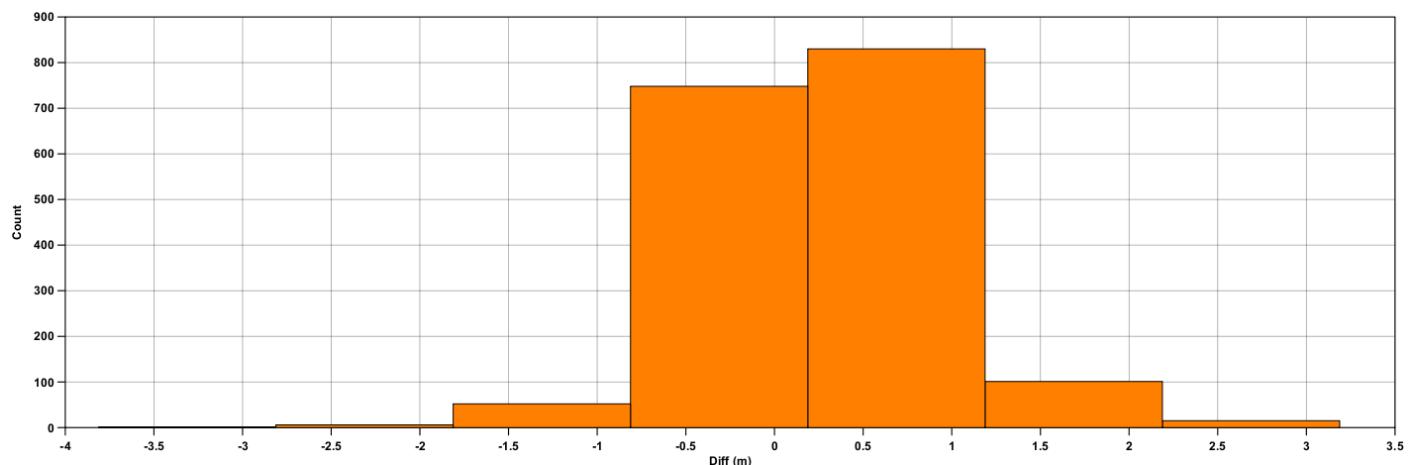
The conformity between H12887 and the junction with survey H12885 was inspected during processing using the CARIS HIPS Subset Editor routine and finalized as BASE Surfaces. A Difference Surface was generated using the CARIS HIPS Difference Surface function; comparing the depths from the H12887 survey (2, 4, and 8-meter resolution) CUBE surfaces against the H12885 survey. Using the Compute Statistics function in CARIS, the difference surface yielded the following results: a standard deviation of 0.4 meters, and a mean difference of 0.3 meters for the two-meter surface, a standard deviation of 0.5 meters, and a mean difference of 0.2 meters for the four-meter surface, and a standard deviation of 0.6 meters, and a mean difference of 0.3 meters for the eight-meter surface. The surveys are in agreement along their common borders and well within the total allowable IHO Order 1a vertical uncertainty. The majority of the difference between the two surveys can be attributed to sound speed refraction with tide error also accounting for a small portion of that difference. The increased standard deviation between the higher resolution grids can also be attributed to the grid, or node placement in the CUBE surface during creation. When CARIS creates the nodes for the H12887 8-meter surface, these will differ from the position of the nodes for H12885 8-meter surface. This small horizontal shift in the grid nodes can result in a depth difference, especially in areas with an irregular seafloor.
