H12887

## DESCRIPTIVE REPORT

Type of Survey: Basic Hydrographic Survey

Sub-locality: Offshore Vinalhaven Island

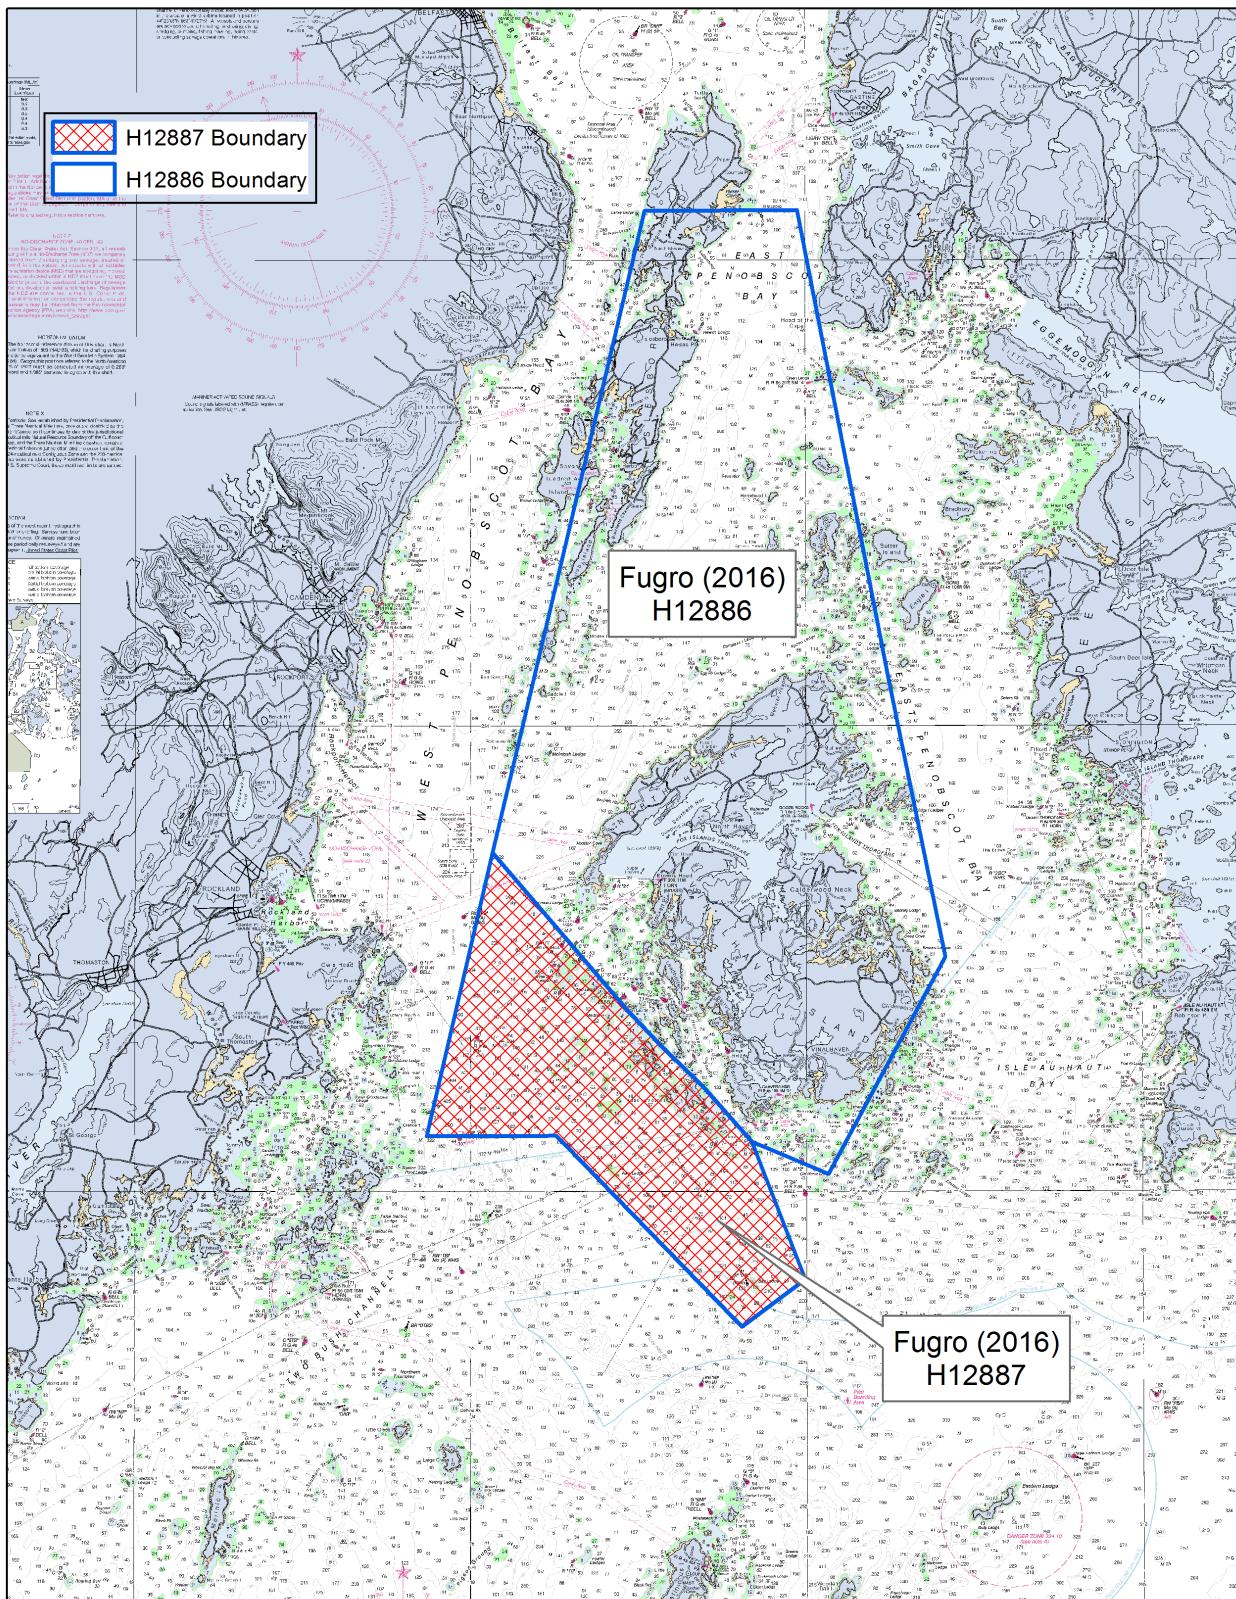
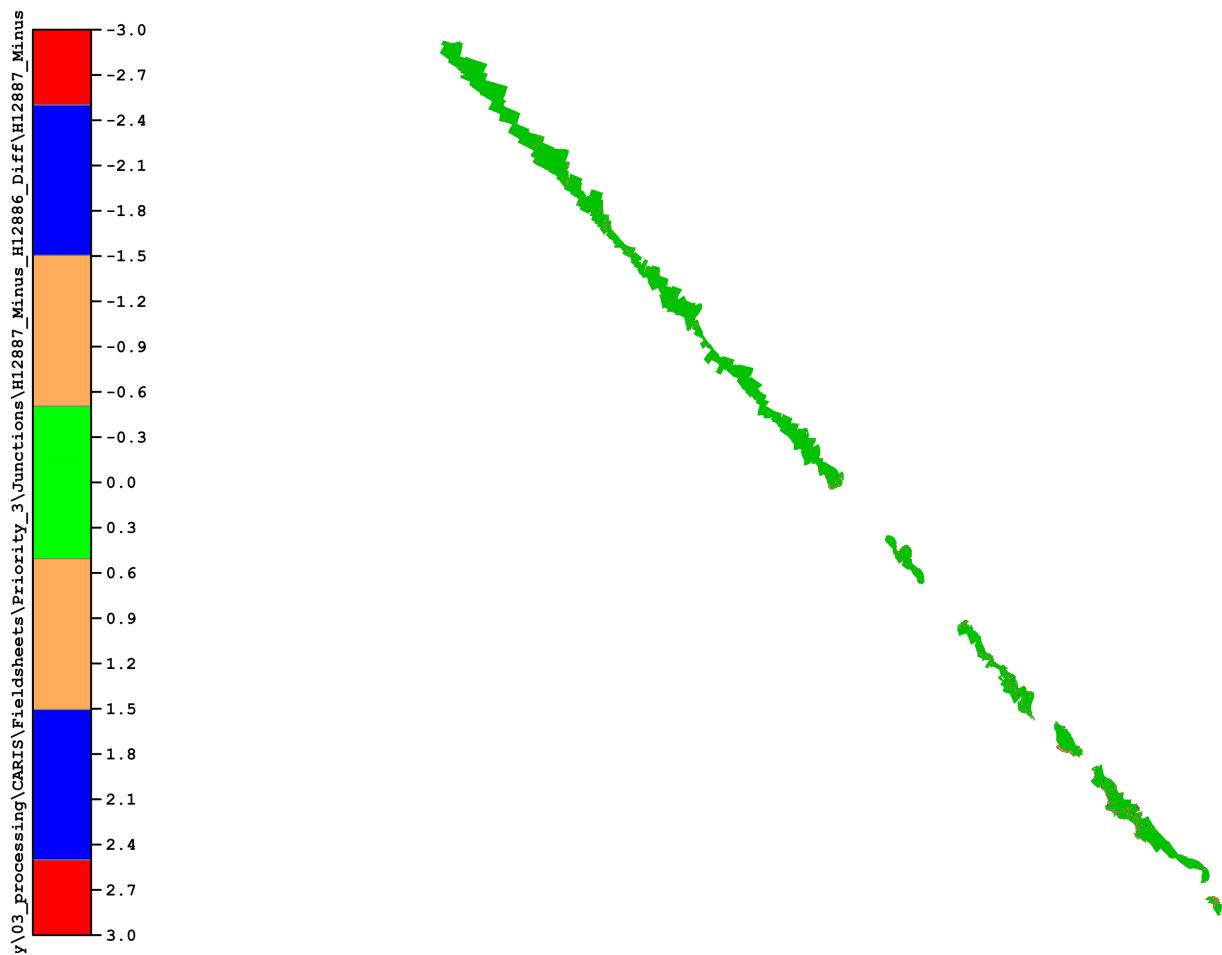
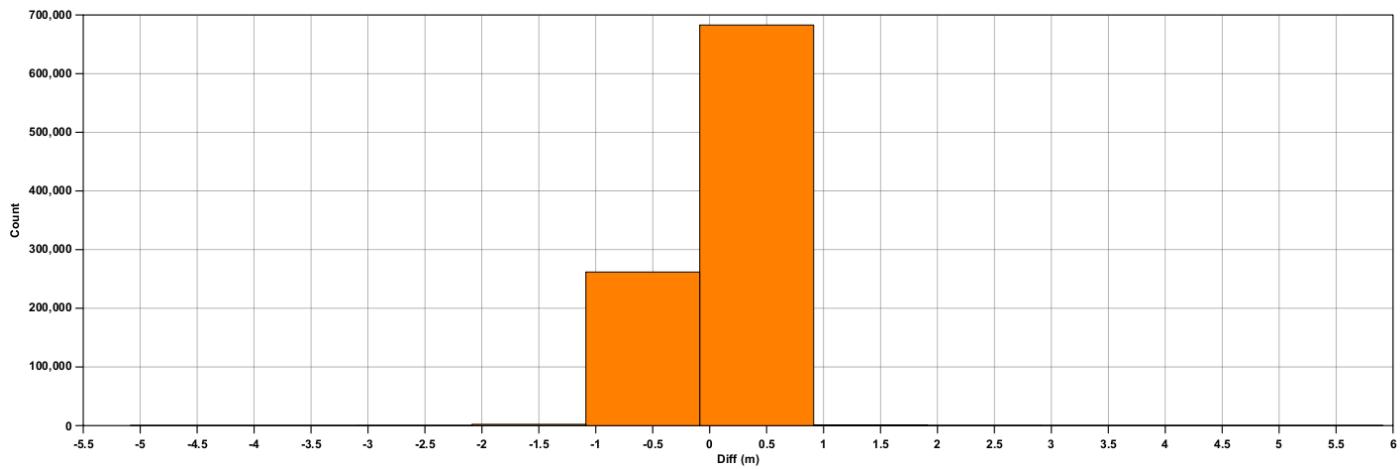
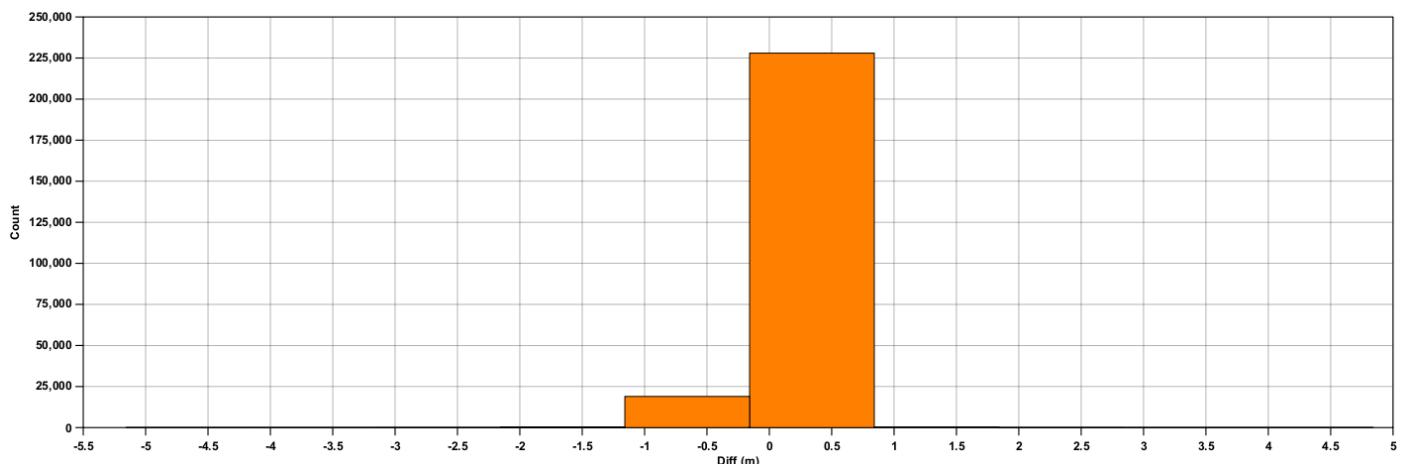
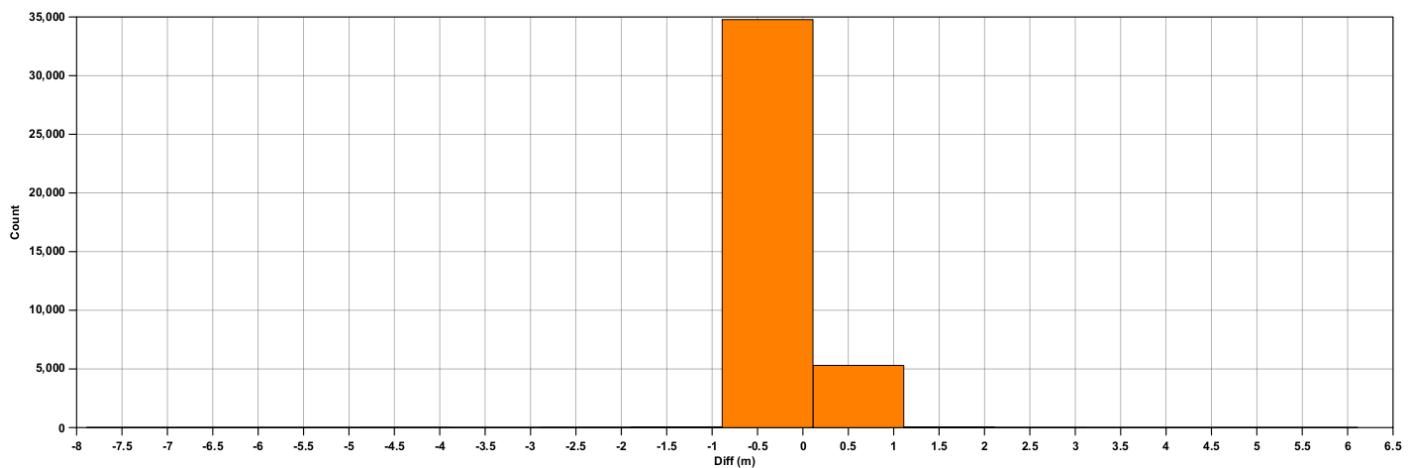
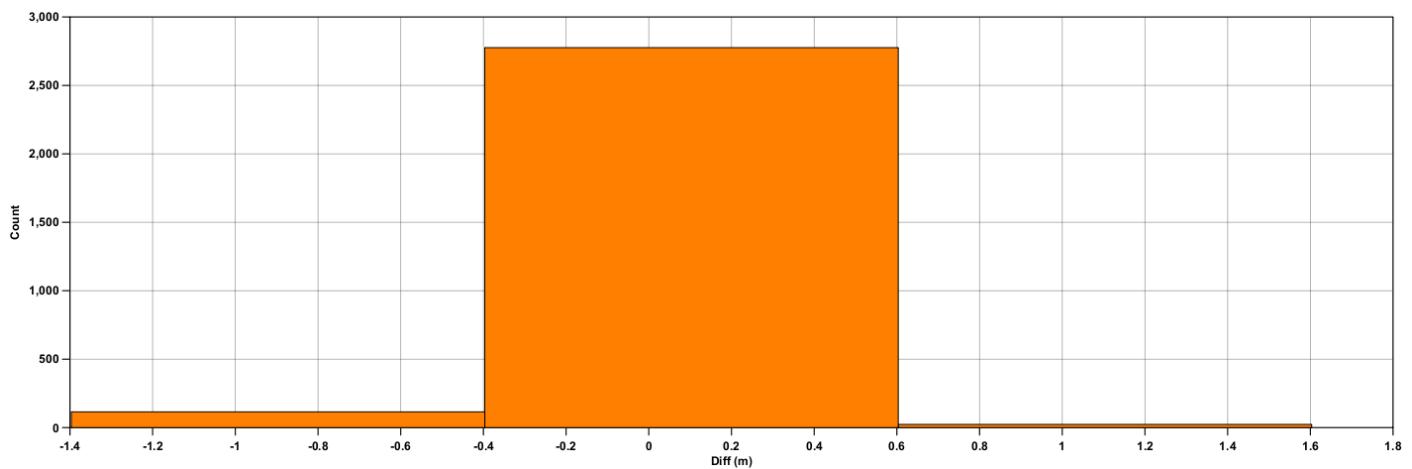
The conformity between H12887 and the junction with survey H12886 was inspected during processing using the CARIS HIPS Subset Editor routine and finalized as BASE Surfaces. A Difference Surface was generated using the CARIS HIPS Difference Surface function; comparing the depths from the H12887 survey (1, 2, 4, and 8-meter resolution) CUBE surface against the H12886 survey. Using the Compute Statistics function in CARIS, the difference surface yielded the following results: a standard deviation of 0.2 meters, and a mean difference of 0.0 meters for the one-meter surface, along with a standard deviation of 0.2 meters, and a mean difference of 0.0 meters for the two-meter surface, and a standard deviation of 0.2 meters, and a mean difference of 0.0 meters for the four-meter surface, and a standard deviation of 0.2 meters, and a mean difference of 0.0 meters for the eight-meter surface. The surveys are in agreement along their common borders and well within the total allowable IHO Order 1a vertical uncertainty. The majority of the difference between the two surveys can be attributed to sound speed refraction with tide error also accounting for a small portion of that difference. The increased standard deviation between the higher resolution grids can also be attributed to the grid, or node placement in the CUBE surface during creation. When CARIS creates the nodes for the H12887 8-meter surface, these will differ from the position of the nodes for H12886 8-meter surface. This small horizontal shift in the grid nodes can result in a depth difference, especially in areas with an irregular seafloor.

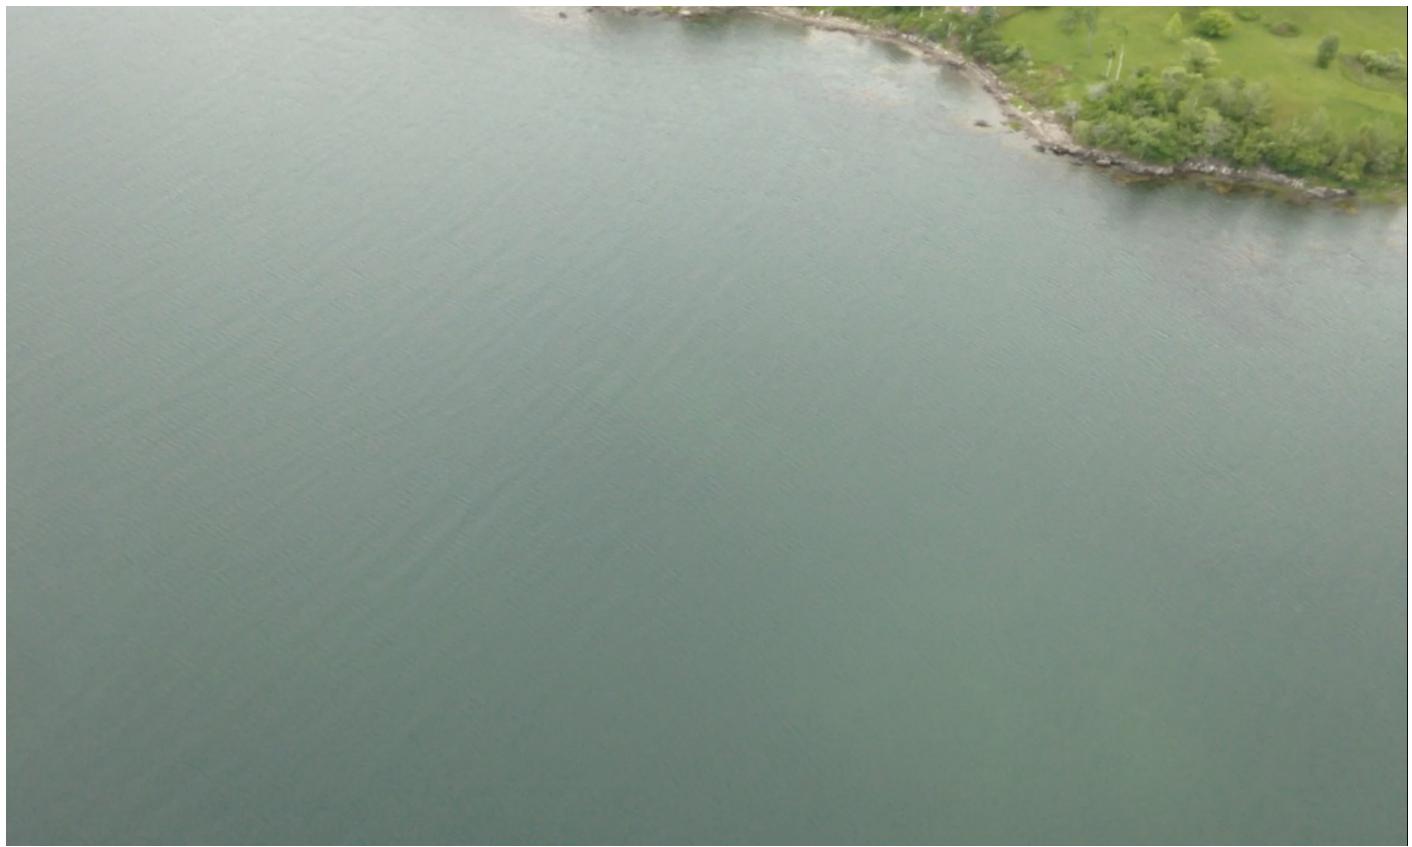
*Figure 47: Water Clarity*

On 13 June 2016, Fugro staff undertook an aerial reconnaissance mission in the vicinity of Penobscot Bay. Conditions of the water clarity were documented in photos and overall, found to be relatively poor. Water was seen to be clear in the very shallow depths (likely, under four meters) and murky in deeper depths.

Conditions were similar in the survey area around Vinalhaven Island and North Haven Island as well, with shallow depths being clearer than the depth range of interest (four to eight meters). The bathymetry in the area tends toward a steep descent into depths outside the range of ALB.

The water clarity had a negative impact on coverage within the four to eight meter depth range, a range of particular interest to this survey. A test flight was conducted during high tide in order to eliminate the low tide timing as the issue with water clarity, due to tidal flushing. Water conditions on this test flight were consistent with those seen on the flights timed around low tide so it was concluded that the tide level was not the cause of the poor water clarity.

In addition to being an issue in equipment effectiveness, water clarity was a factor affecting soundings. Refer to section B.2.5 for the explanation on water clarity.

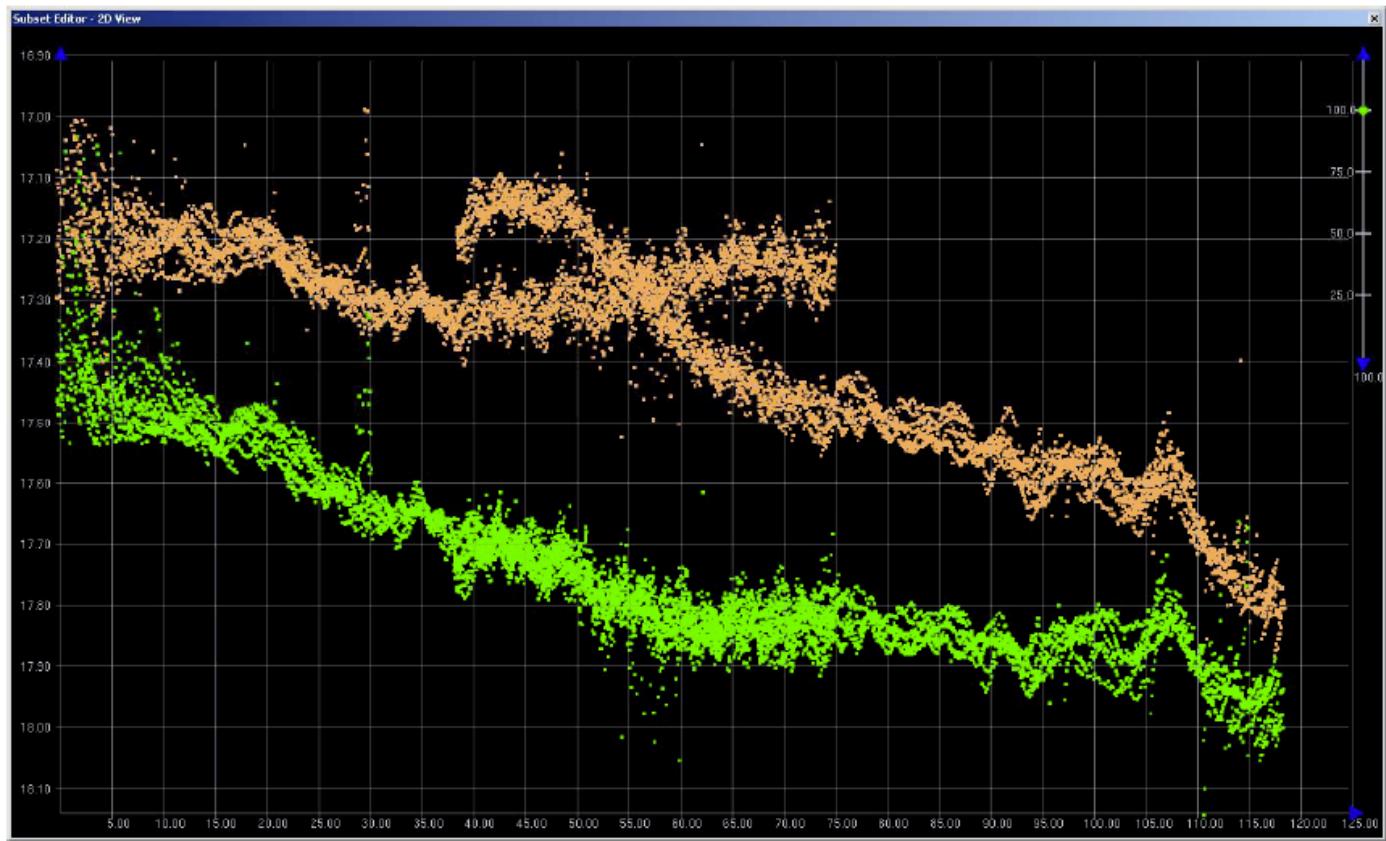
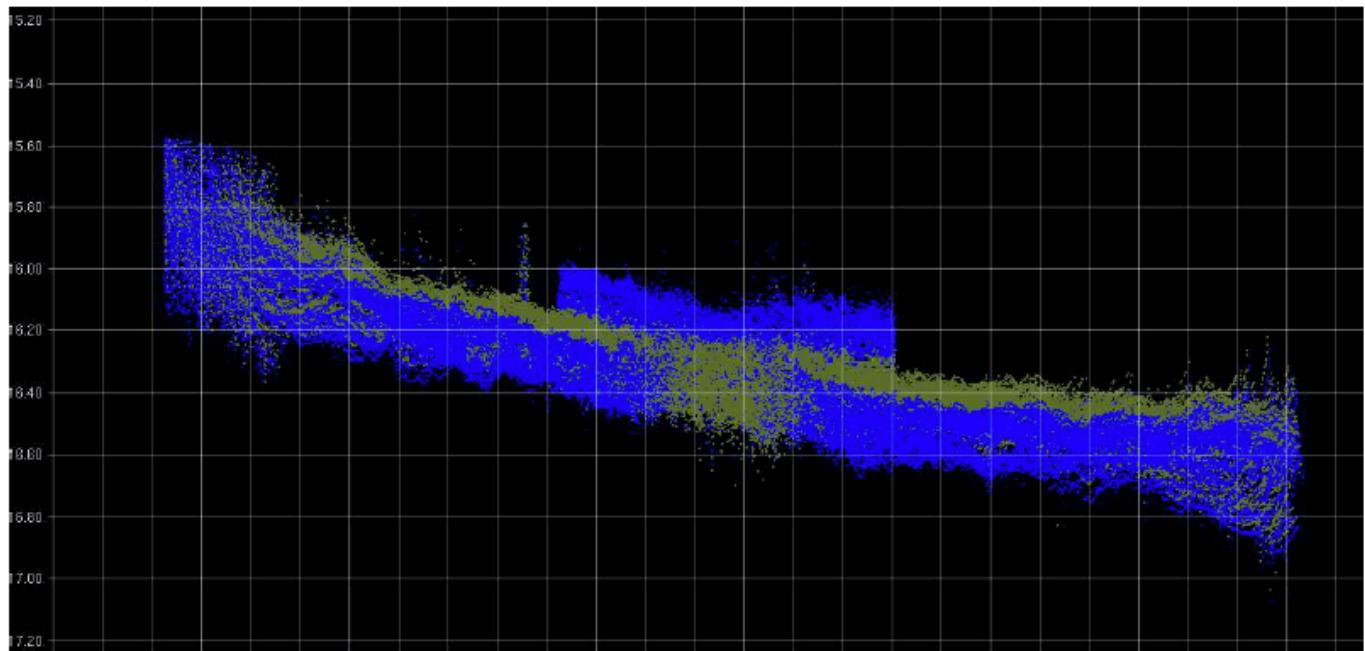
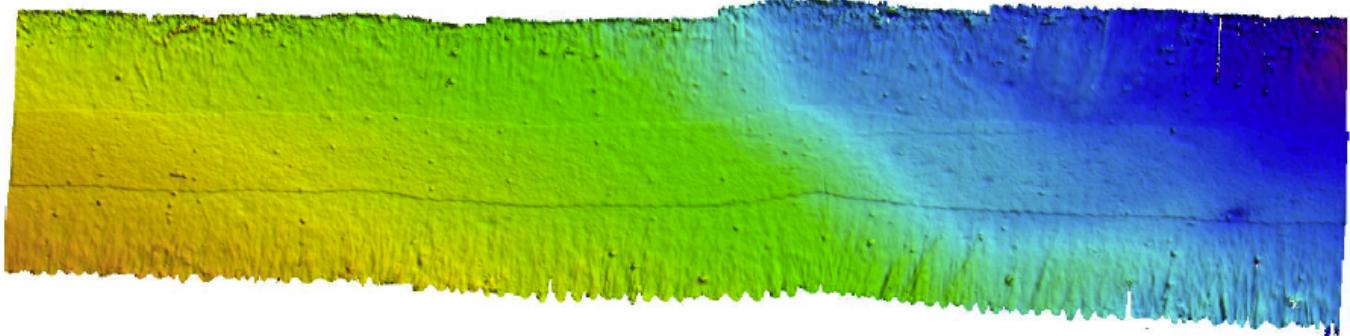
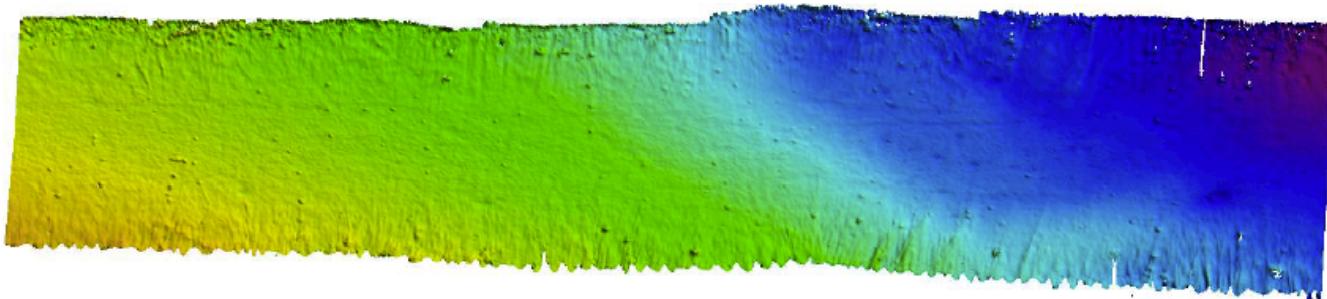
For the first several weeks on the R/V JAB, the transmitter and receiver were inadvertently mismatched, with the port receiver using the starboard system's transmitter, and vice versa. Proper reduction of soundings measured in this configuration requires that the sonar be treated as a bi-static system, and that the absolute locations of the transmitter and receiver be accounted for. CARIS HIPS is designed to handle such a situation, and offset information in the form of a 7030 record, which was added to each dual head s7k file to enable proper processing without an adjustment to the processing pipeline used by Fugro. The methodology was validated using a postage stamp survey over a flat seafloor. Adjusted 7030 records were inserted into all applicable previously collected data and reprocessed in CARIS using Fugro's standard methodology for the processing of 7027 dual head records.

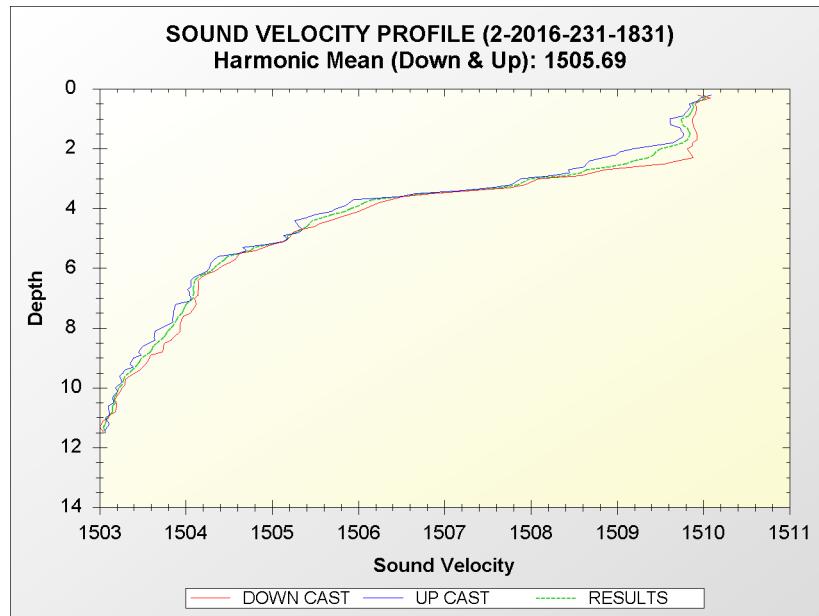
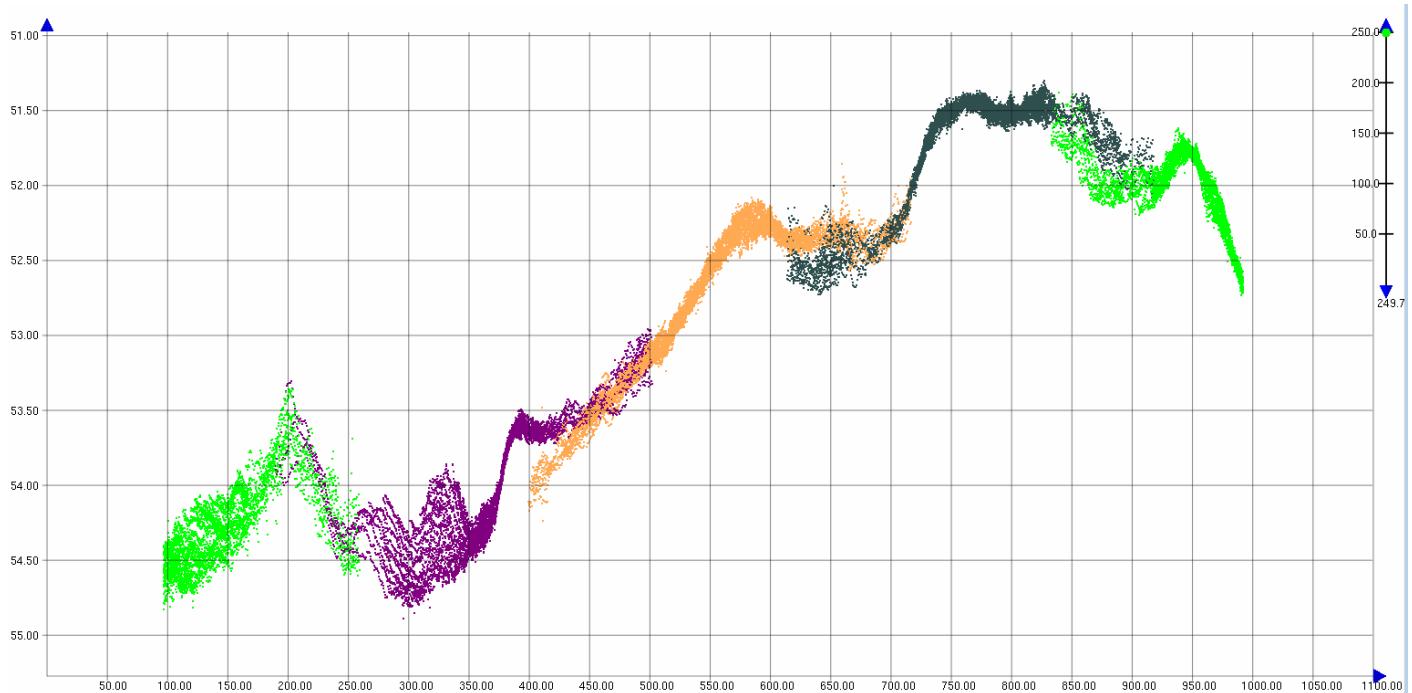
A general downward and/or upward cupping is noticeable in the across-track sounding profiles for certain areas. Sound speed refraction errors were seen in the outer beams on the majority of survey lines conducted and were on the order of 0.10 to 0.15 meters. These errors are a result of the strong tidal mixing in the area, which not only carries sediment, but also causes a change in water surface temperature and salinity.

The sound speed profiles conducted throughout the project had an increased inconsistency throughout the water column, much more evident at the surface or near the face of the sonars. In order to mitigate these sound speed errors, the frequency of sound speed casts was increased and the line spacing reduced. Data were examined (and filtered) in CARIS HIPS Subset Editor routine to ensure the data met IHO Order 1a specifications.

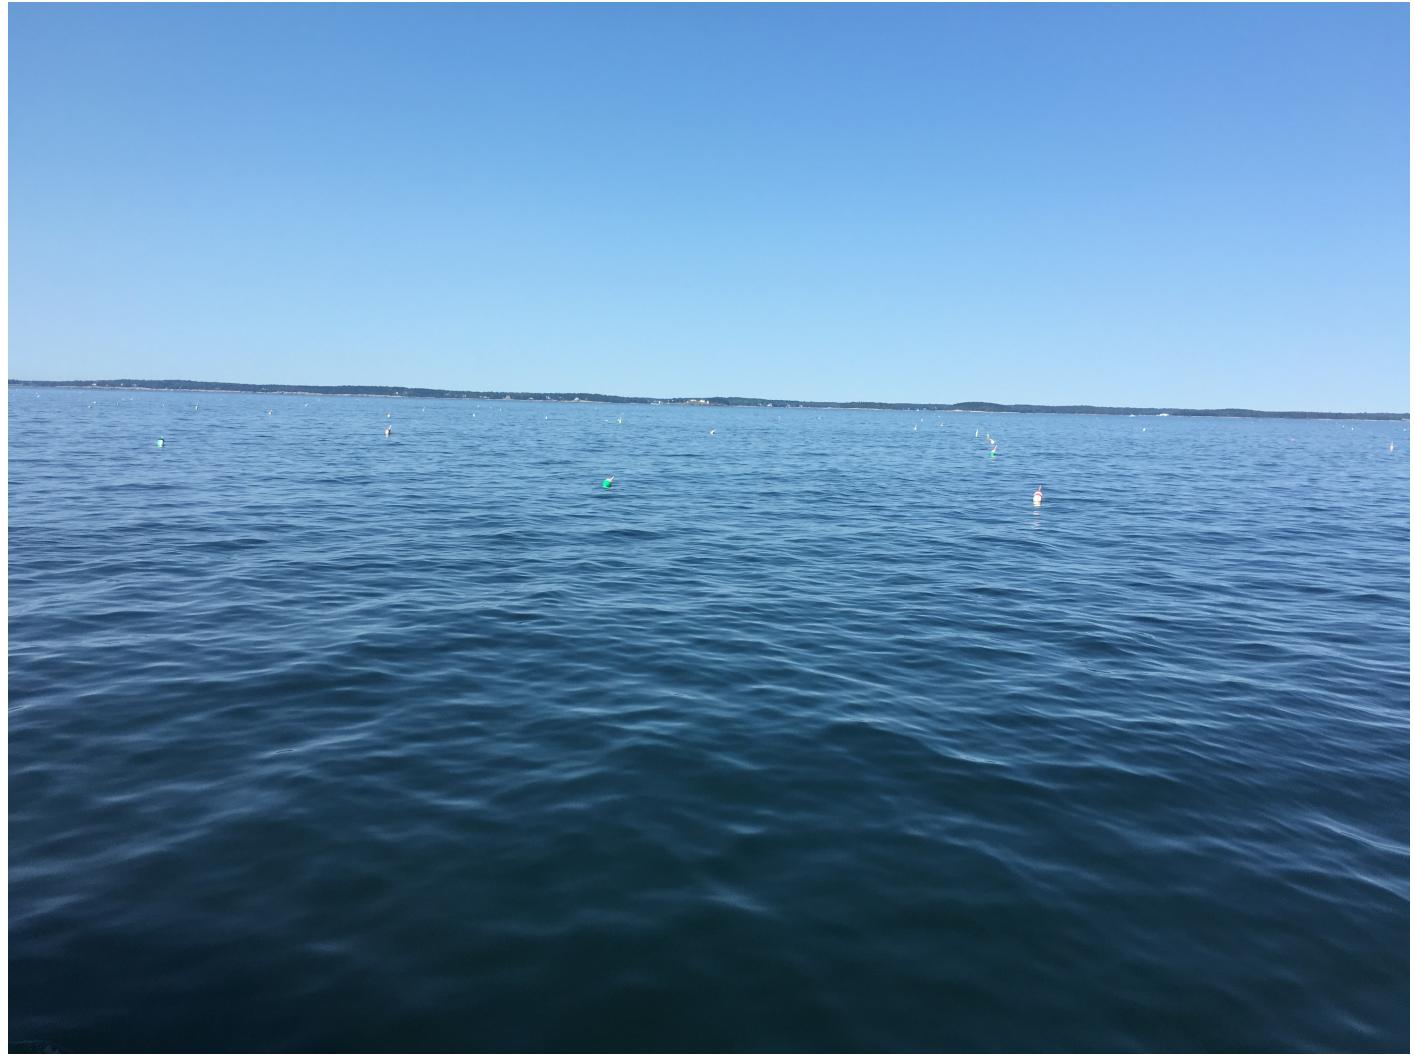
*Figure 54: Fishing Gear*

The survey was awarded and conducted during the peak of lobster season, resulting in an extremely high presence of fishing gear (and fishing vessels) in the survey area. This resulted in having to maneuver in and around the surface buoys and fishing vessels causing not only numerous in-fills and re-runs, but increased time spent on manually rejecting erroneous data (fishing gear in the water column) in CARIS HIPS.

Because of the density of fishing gear in the area, vessel speed was at times reduced to near idle. Entanglements between the survey vessel's deployed sonar equipment and fishing gear happened quite often, resulting in a loss of survey time. The risk of entanglement also increased before and after the high tide peaks due to submerged buoys in some areas.

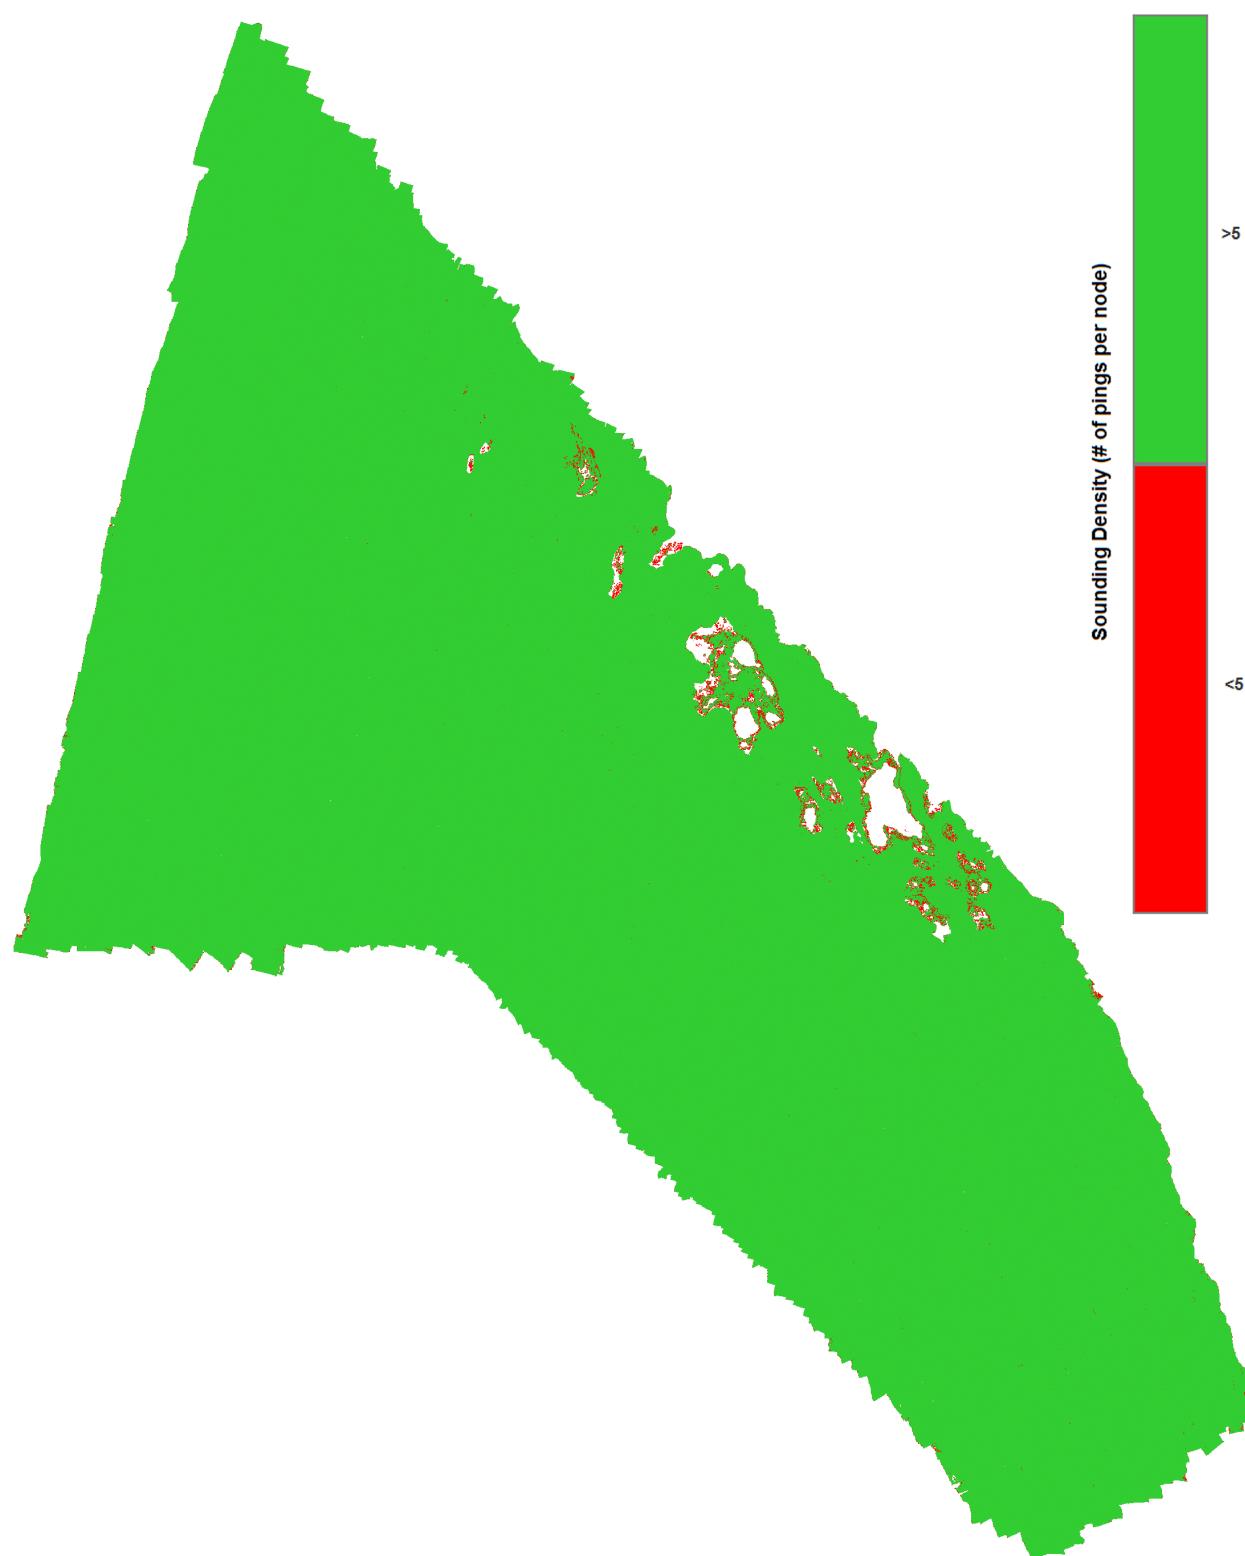
Figure 57: H12887 Final Density

The LiDAR program was proposed and planned for 100% of the area to be flown with a five by five (or better) spot spacing. In other words, a reconnaissance coverage survey would be used from the inshore limit (4 meters) to the 8-meter water depth. This explains the percentage of nodes that fall below the five sounding per bin threshold. It should be noted that per the project instructions, the final LiDAR surface was binned at five meters.

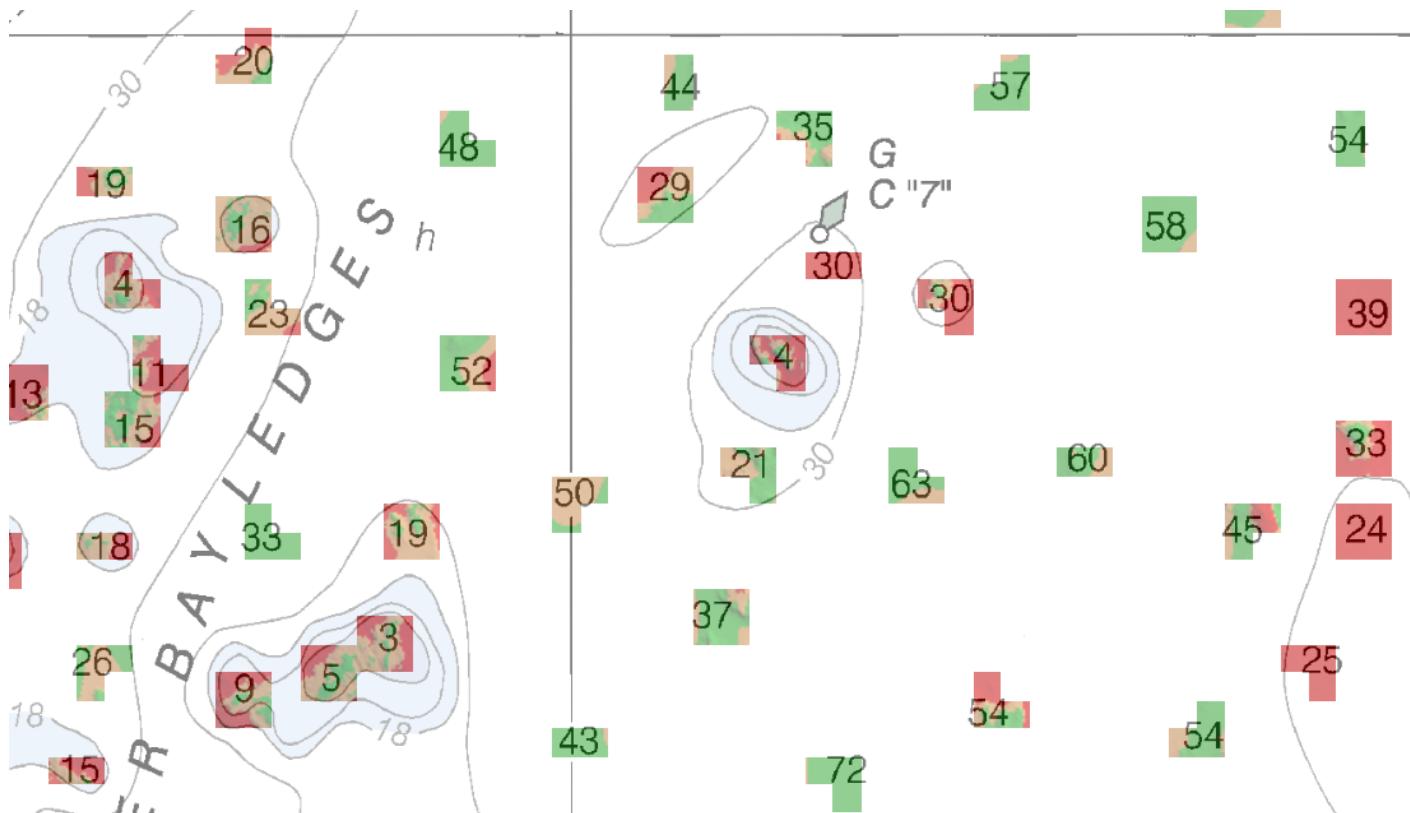
*Figure 58: Sample of difference surface of H12887 and ENC*

A comparison of soundings was accomplished by overlaying the latest edition of the largest scale NOS charts and ENCs onto the final BASE surfaces in CARIS HIPS and SIPS. An additional check was conducted by gridding the ENC sounding data and differencing the ENC \*.csar files against the H12887 \*.csar files. The general agreement between the charted soundings and H12887 soundings is noted in the Charts section. A more detailed comparison was undertaken for any charted shoals or other dangerous features and is discussed in the Shoals and Hazardous Features section.

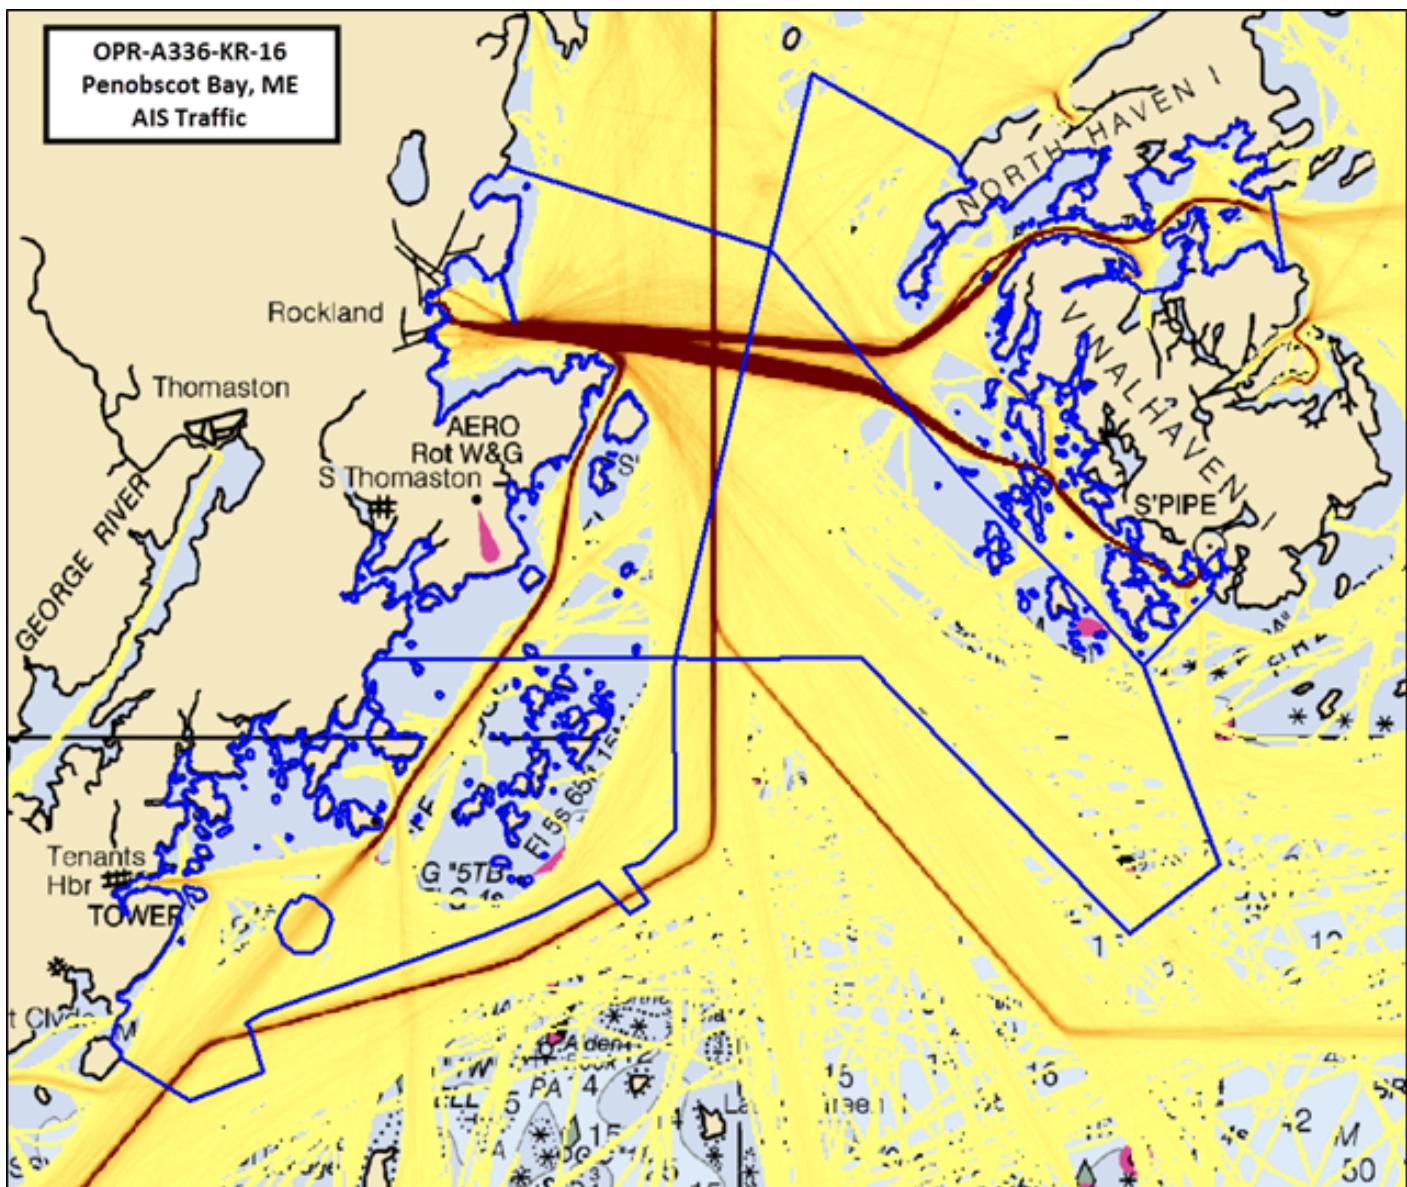
Figure 59: AIS Traffic Ferry Routes Running from Rockland to Vinalhaven

The Rockland Ferry Terminal services the islands of Matinicus, North Haven, and Vinalhaven. H12887 encompassed the main routes out of Rockland for these island ferry runs, and was surveyed with 100% MB coverage. H12887 had numerous dangers to navigation and shoal features, but none hinder the existing ferry routes.
