#### DESCRIPTIVE REPORT

Type of Survey: Navigable Area

Project Number: OPR-B310-KR2-13

Registry Number: H12604

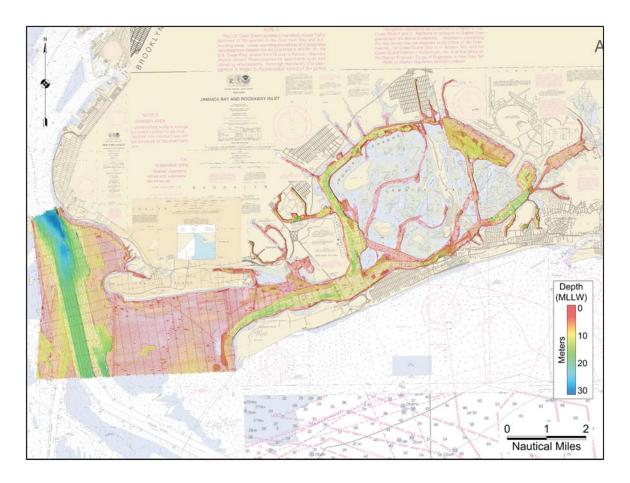
Figure 1: Survey H12604 MBES coverage colored by depth overlaid on RNC 12326.

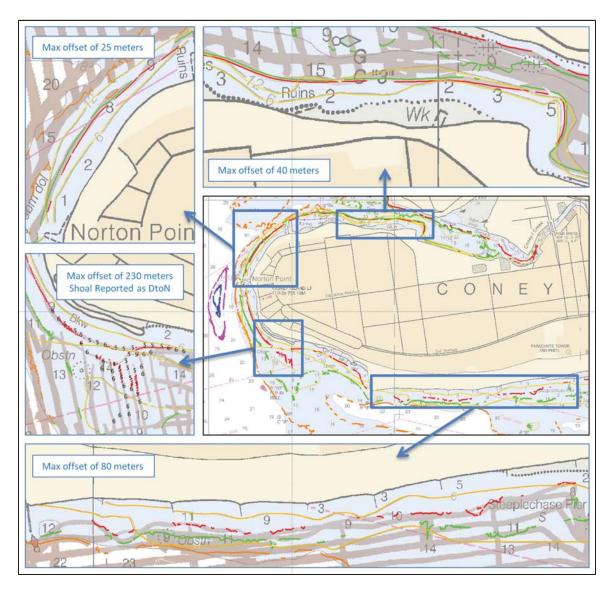
Figure 5: Contours generated from the H12604 MBES data (6' in red, 12' in green, and the 18' in orange) are shown in reference to the charted contours surrounding Coney Island from RNC 12402 (highlighted in yellow).

Discrepancies were noted between the locations of the charted contours and surveyed depth curves, with the largest changes noted along the coastal and shallow water contours. In several locations surrounding the Coney Island coastline the 6-foot contour was surveyed significantly offshore of its charted position (Figure 5), with the largest discrepancy noted off the southwest corner of Coney Island (40-34-17.21N, 074-00-35.14W) where the 6-foot contour has migrated over 200 meters offshore disproving a charted 14-foot depth and a 12-foot contour. Representative soundings over this shoal were submitted to AHB in S-57 format with H12604 DtoN #6.

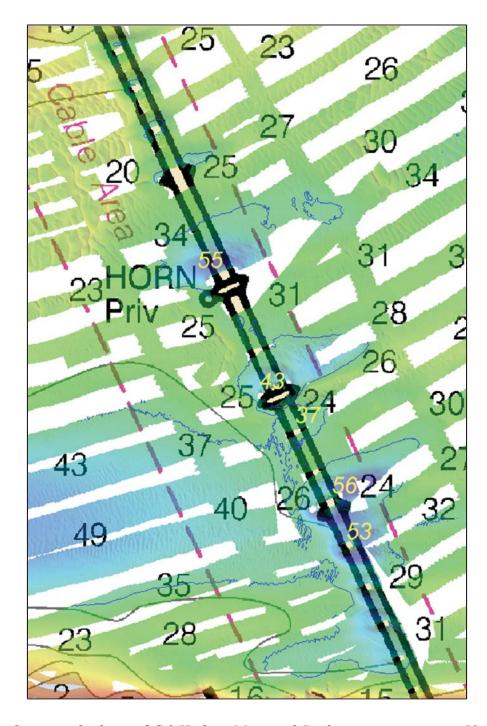
Figure 8: Scour at the base of Gil Hodges Memorial Bridge is apparent in a 50-cm CUBE surface overlaid on RNC 12350. Surveyed depths within the scour marks are colored in yellow and displayed in feet.

A new hole with a maximum surveyed depth of 51 feet (15.72 meters,  $\pm$  0.43 TPU) was centered at 40-34-04.5 N, 73-53-50.8 W near the shoreline of Rockaway Point seaward of a charted 18-foot contour and inshore of a charted 23-foot depth. A deepening trend was also observed around the bridge piers of the Gil Hodges Memorial Lift Bridge that spans Rockaway Inlet from 40-34-41.3 N, 073-53-16.0 W to 40-34-07.0 N, 073-52-55.0 W. Evidence of scour was apparent surrounding the bridge piers, with surveyed depths differing from charted depths by over 20 feet (Figure 8).

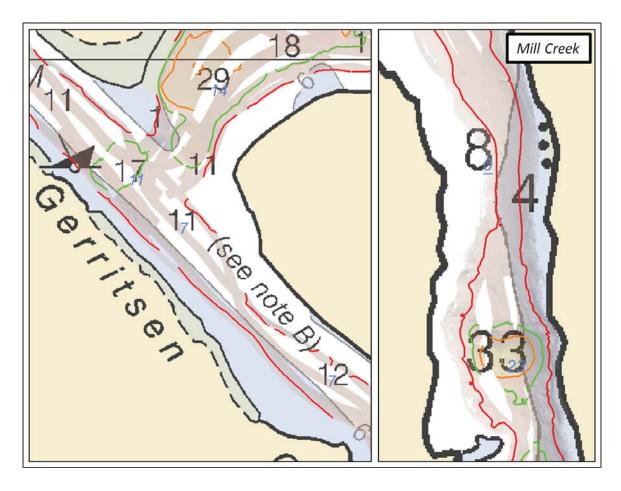
Figure 10: Contours generated from the H12604 MBES data (6' in red, 12' in green, and 18' in orange) are shown in reference to the charted contours within Mill and Gerritsen Creeks. Surveyed soundings that represent significant change from the charted depths are highlighted in blue with a 50-cm CUBE surface overlaid on RNC 12350 in the background.

On the eastern approach to Dead Horse Bay and Gerritsen Inlet, deepening was observed within the charted 0 to 6 foot depth area. The largest disparity between the surveyed and charted depths within this area was over a deep hole with a maximum surveyed depth of 33 feet (10.28 meters,  $\pm$  0.41 TPU) located at 40-34-42.5 N, 73-54-09.4 W between two charted depths of 4 feet.

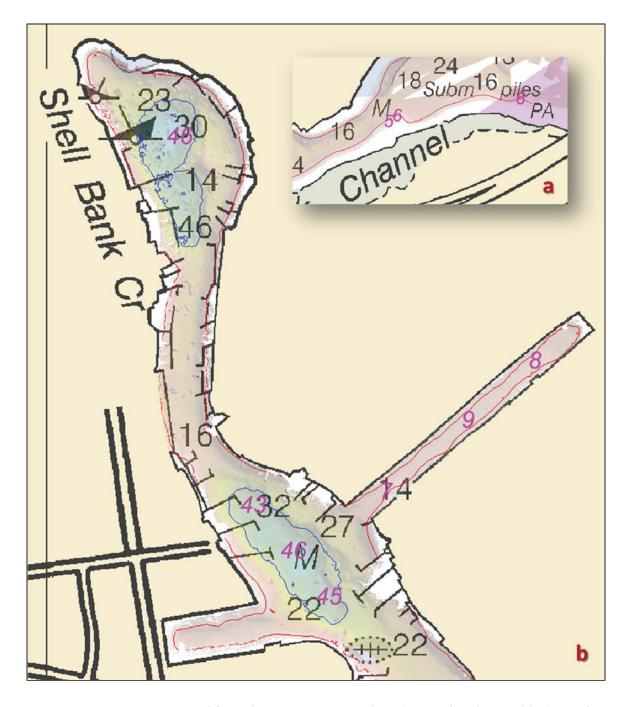
Figure 11: Contours generated from the H12604 MBES data (6' in red and 36' in blue) are shown in reference to Shell Bank Channel and Shell Bank Creek. Surveyed soundings that represent significant change from the charted depths are highlighted in pink with a 50-cm CUBE surface overlaid on RNC 12350 in the background.

Within Shell Bank Creek, soundings within a narrow channel off the eastern side of the creek were found to be shallower than the 14-foot controlling depth located at 40-35-20.6 N, 073-55-38.5 W and two deep holes were developed at the start and end of the creek. The holes contained a large amount of wreckage and were over 16 feet deeper than the charted soundings (Figure 11b).

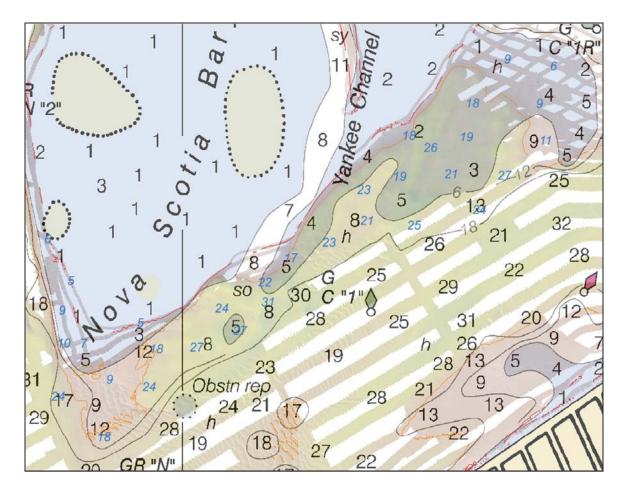
Figure 12: Contours generated from the H12604 MBES data (6' in red and 18' in orange) are shown in reference to northern Beach Channel. Representative soundings of the deepening trend over Nova Scotia Bar were highlighted in blue with a 50-cm CUBE surface overlaid on RNC 12350 in the background.

A significant amount of change was noted between charted and surveyed depths within Beach Channel. Most notably, there was expansive deepening along the northern limits of Beach Channel beneath Nova Scotia Bar and over Yankee Channel (Figure 12) and beneath Little Egg Marsh and Giant Bar Marsh (Figure 13).

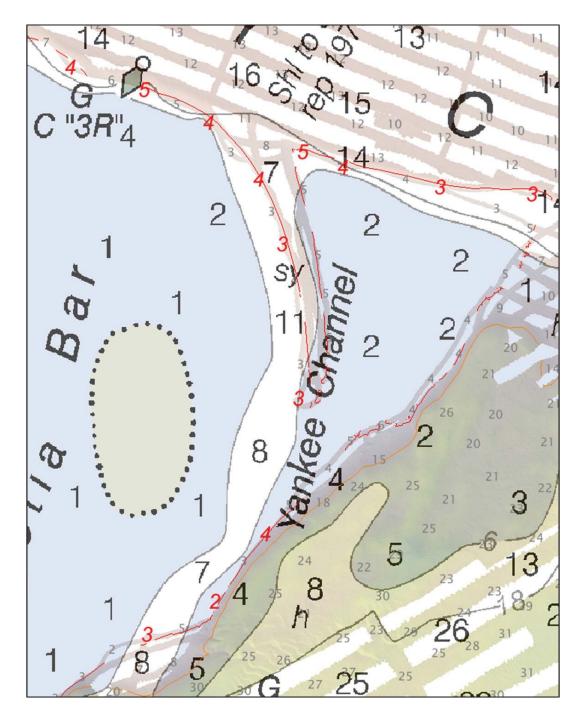
Figure 14: Contours generated from the H12604 MBES data (6' in red and 18' in orange) are shown in reference to Yankee Channel. Representative soundings of the shoaling trend over were highlighted in red with a 50-cm CUBE surface overlaid on RNC 12350 in the background.

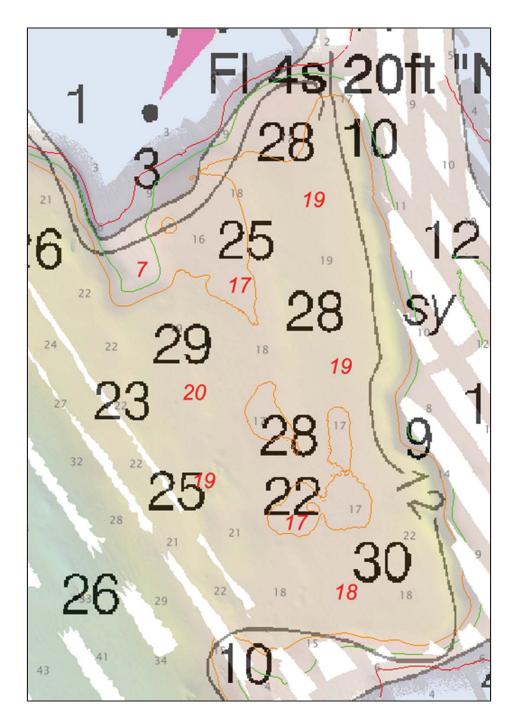
Figure 16: Contours generated from the H12604 MBES data (6' in red, 12' in green, and 18' in orange) are shown in reference to the east side of Island Channel north of Long Pol Bar. Representative soundings of the shoaling trend were highlighted in red with a 50-cm CUBE surface overlaid on RNC 12350 in the background.

Overall there was good agreement between charted and surveyed depths within Island Channel with shoaling noted north of Long Pol Bar on the east side of Island Channel (Figure 16). Representative soundings over the shoal were submitted to AHB with H12604 DtoN #3.

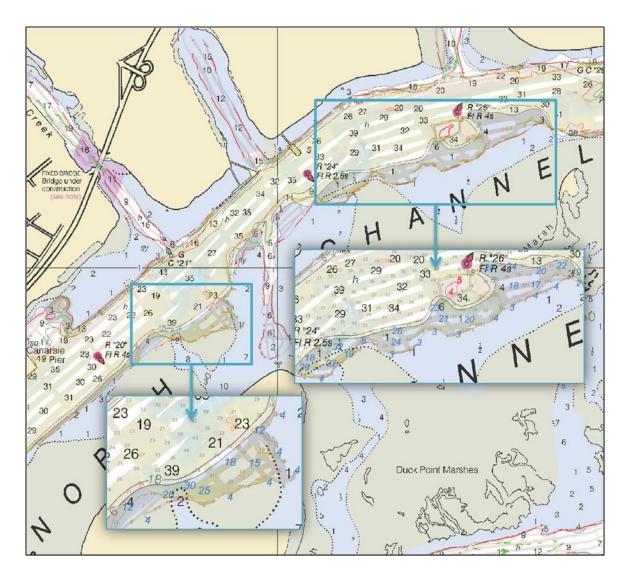
Figure 18: Contours generated from the H12604 MBES data (6' in red, 12' in green, and 18' in orange) are shown in reference to North Channel. Representative soundings of the shoaling and deepening trends were highlighted in red and blue with a 50-cm CUBE surface overlaid on RNC 12350 in the background.

Shoaling was observed within North Channel as well; soundings selected to represent the new shoals were submitted to AHB with H12604\_DtoN\_#17 and H12604\_DtoN\_#18. The shoaling included the migration toward the channel center of the charted 6-foot contour along the north shore of North Channel, new limiting depths at the entrance to Fresh Creek, and three new shoals: 1) the center of the channel south of Hendrix Creek (40-38-10 N, 073-52-00 W), 2) southwest of charted buoy R "26" (40-38-25 N, 073-51-19 W), and 3) south of charted buoy R N "30" (40-38-34 N, 073-50-32 W). Also included with DtoN #18 were soundings that delineated changes in the small bay at the entrance to Old Mill Creek (40-38-37 N, 073-51-19 W).

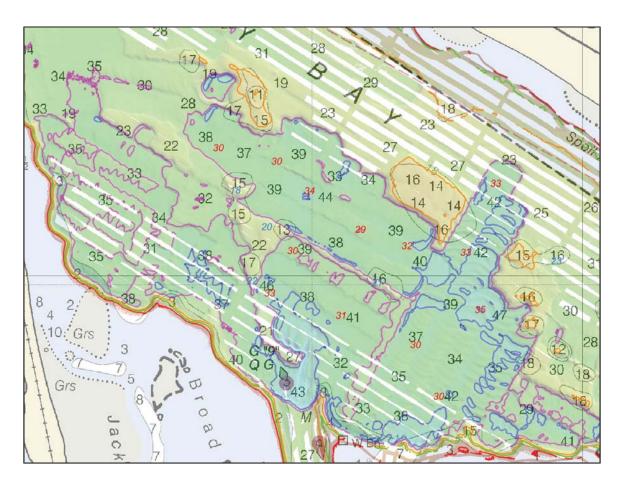
Figure 19: Evidence of past dredging was apparent in Grassy Bay as highlighted by contours generated from the H12604 MBES data (6' in red, 12' in green, 18' in orange, 30' in pink, and 36' in blue) overlaid on a 50-cm CUBE surface with RNC 12350 in the background. Representative soundings of the shoaling and deepening trends were highlighted in red and blue.

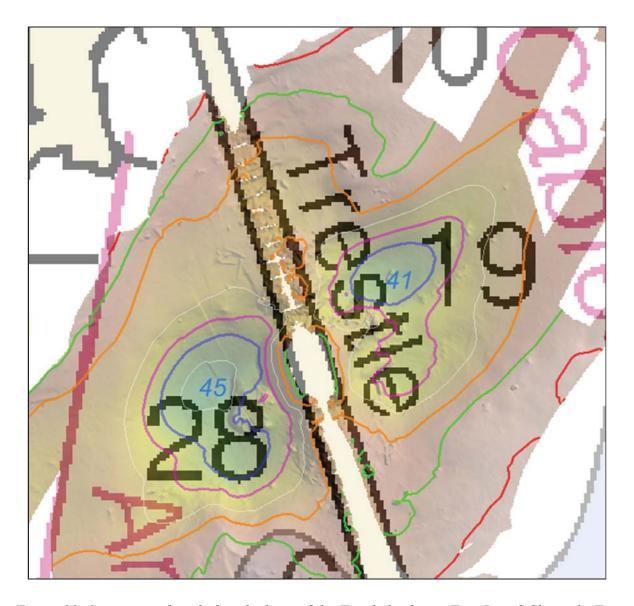
Figure 20: Scour was identified at the base of the Trestle bridge in East Broad Channel. Two deep holes were surveyed to the east and west of the bridge highlighted with contours generated from the H12604 MBES data (6' in red, 12' in green, 18' in orange, 30' in pink, and 36' in blue) and a 50-cm CUBE surface overlaid on RNC 12350. Soundings representing the maximum surveyed depth within the holes were colored in blue.

Evidence of scour was observed beneath the Trestle train bridge that spans East Broad Channel where a deepening trend was noted on both sides of the bridge (Figure 20). Surveyed depths were over 20 feet deeper than the charted depths.

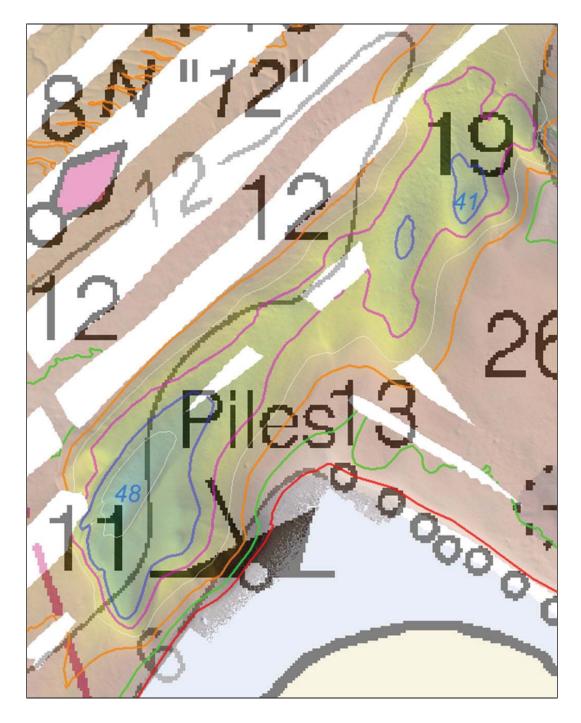
Figure 21: Two deep holes were surveyed near the entrance to Vernam Basin. The holes are highlighted by the contours generated from the H12604 MBES data (6' in red, 12' in green, 18' in orange, 30' in pink, and 36' in blue) and a 50-cm CUBE surface overlaid on RNC 12350. Soundings representing the maximum surveyed depth within the holes were colored in blue.

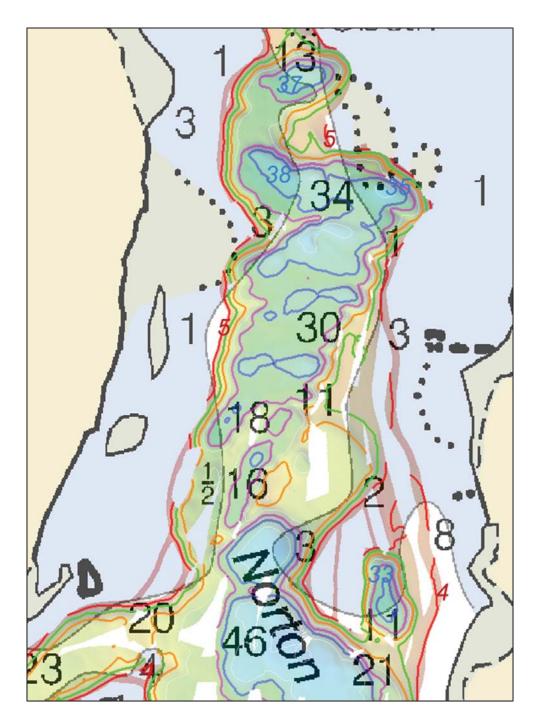
Figure 22: Contours generated from the H12604 MBES data (6' in red, 12' in green, 18' in orange, 30' in pink, and 36' in blue) are shown in reference to Norton Basin. Representative soundings of the shoaling and deepening trends are highlighted in red and blue with a 50-cm CUBE surface overlaid on RNC 12350 in the background.

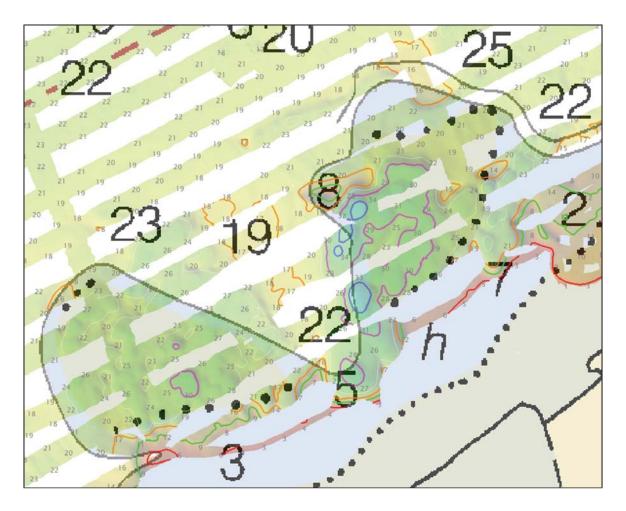
Figure 23: Contours generated from the H12604 MBES data (6' in red, 12' in green, 18' in orange, 30' in pink, and 36' in blue) are shown in reference to the southern side of Head of Bay. Significant deepening was surveyed over two charted shoals with a new 8-foot shoal reported as a DtoN.

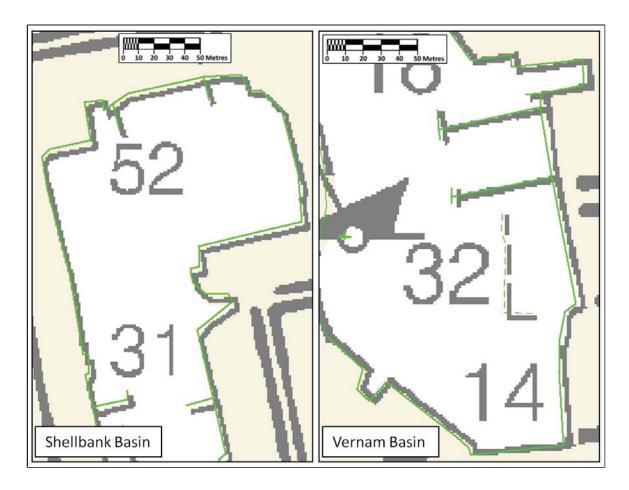
Figure 24: The figure highlights two examples from Jamaica Bay where a horizontal shift between the coastline and shoreline features in the CSF colored in green and the coastline as charted on RNC 12350 was apparent. The CSF was generated from ENC US5NY50M.

The results from the chart comparison between survey H12604 and ENC US5NY50M were identical to the comparison with RNC 12350 as the charted soundings, contours and features on the ENC and RNC matched. Therefore, see the chart comparison for RNC 12350 for information regarding discrepancies between charted and surveyed data. During chart comparisons and the generation of the FFF, a horizontal shift in position was noted between charted coastline and shoreline features on the ENC and the positions on the RNC. This position disparity was first identified in the CSF which was generated from the ENC. For the majority of Jamaica Bay, the ENC coastline and shoreline features were shifted approximately 5 meters northwest from the RNC position (Figure 24). Survey data, both MBES and SSS, confirm the RNC's coastline and shoreline feature positioning.

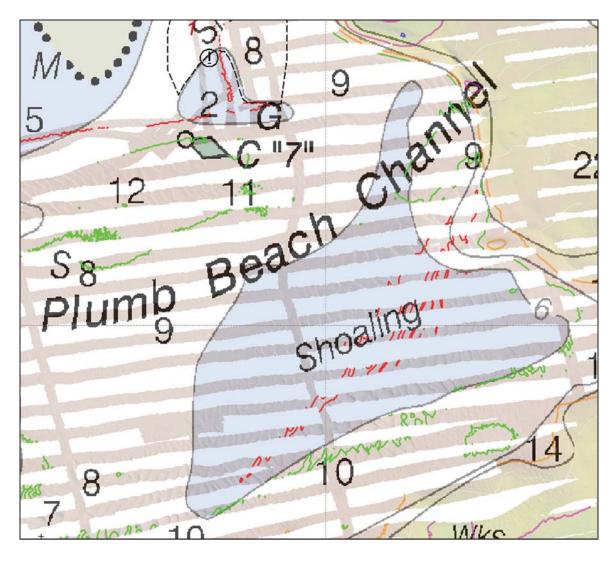
Figure 25: The extents of the Plumb Beach Channel shoal have changed significantly compared to the charted shoal as highlighted by contours derived from H12604 MBES data (6' in red, 12' in green, 18' in orange, and 30' in pink). In the background, a 50-cm CUBE surface is overlaid on RNC 12350.

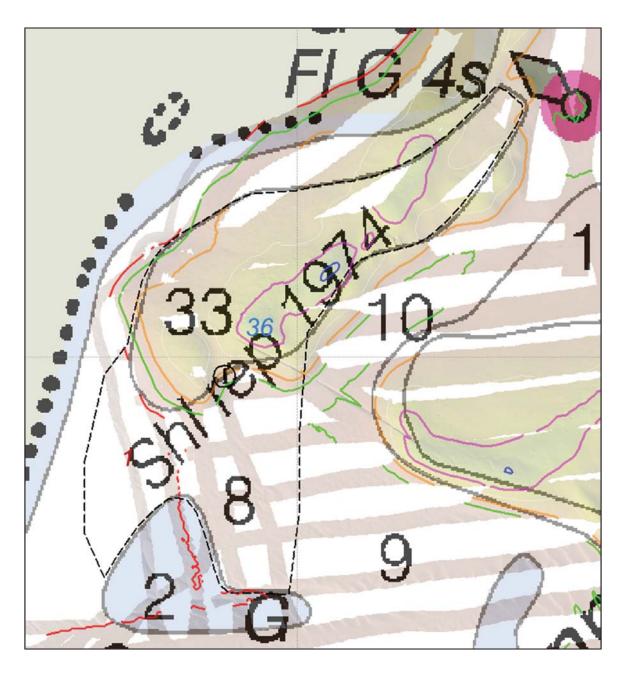
Figure 26: A charted shoal has changed significantly from the chart as highlighted by contours derived from H12604 MBES data (6' in red, 12' in green, 18' in orange, 30' in pink, and 36' in blue) compared with the charted caution area (black dashed line). In the background, a 50-cm CUBE surface is overlaid on RNC 12350.

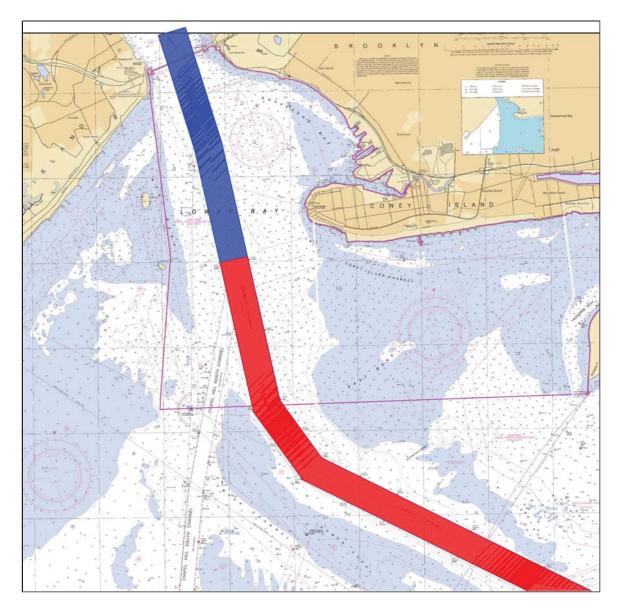
Figure 30: This figure highlights Ambrose Channel as currently charted (red hatch) and as defined by the NY Corps of Engineers (blue hatch) overlaid on RNC 12402. The assigned limits of Survey H12604 are shown as a magenta line.

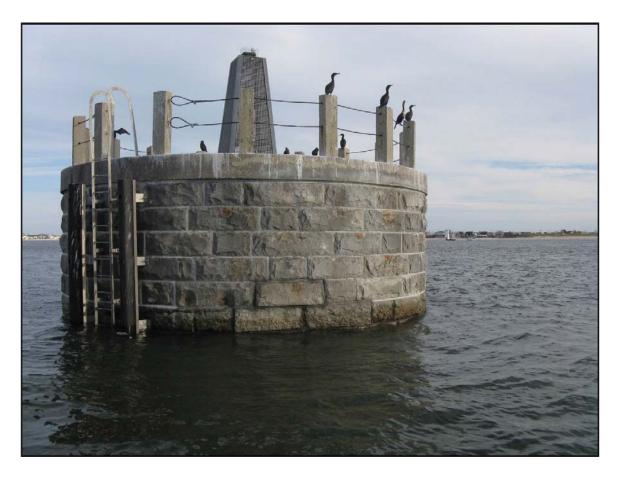
Figure 39: A photo of the Sewer Outfall Diffuser "Roundhous" e located within Rockaway Inlet. The charted light was not observed on the diffuser structure.

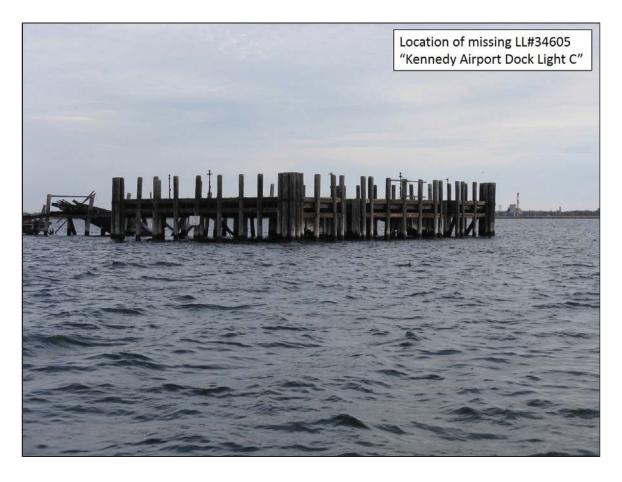
Figure 40: A photo of a damaged pier which was the supposed location of missing "Kennedy Airport Dock Light "C (LL#34605).

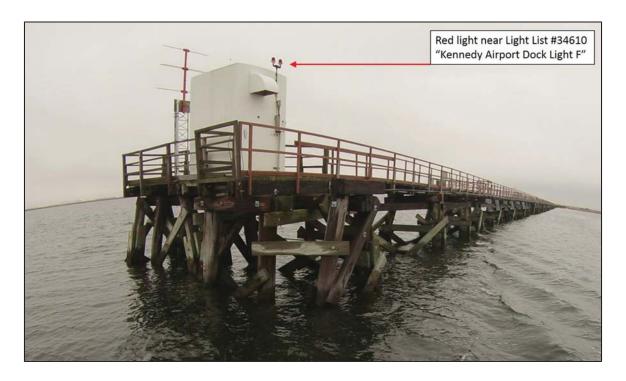
Figure 41: A photo of a red light on a dock house nearby the charted location of missing "Kennedy Airport Dock Light "F(LL#34610).

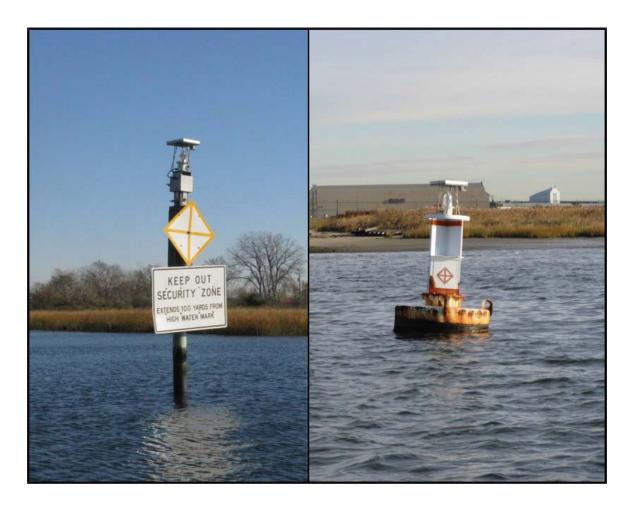
Figure 42: Photos of typical fixed and floating JFK security zone aids to navigation.

The security zone on the southern perimeter of JFK Airport is marked by a number of uncharted fixed and floating aids to navigation consisting of white security zone cans, white security zone lighted buoys, and pilings holding security zone signage. These aids are neither charted nor included in the USCG Light List. Neither their presence in the water nor their absence from the chart or Light List creates a Danger to Navigation, as such the aids are discussed herein. The fixed and floating JFK Airport security zone aids observed during the survey are included in the FFF. Typical fixed and floating security zone aids are depicted in Figure 42. The character of the lights on the lighted security buoys and/or piling security markers is not known.

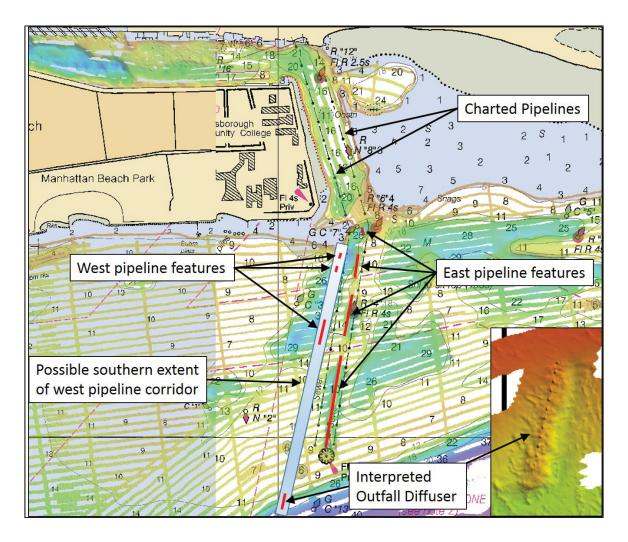
Figure 46: Rockaway Inlet Sewer Outfall pipelines overlaid by surveyed pipeline segments (in red) with RNC 12350 in the background.

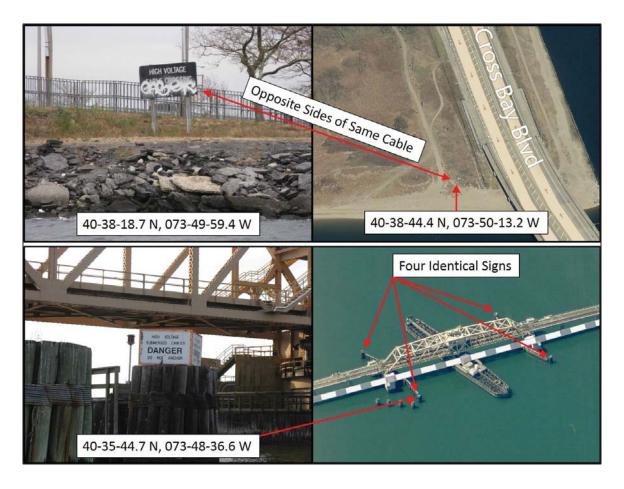
Figure 49: Cable signs alongside the Cross Bay Blvd Bridge within North Channel.

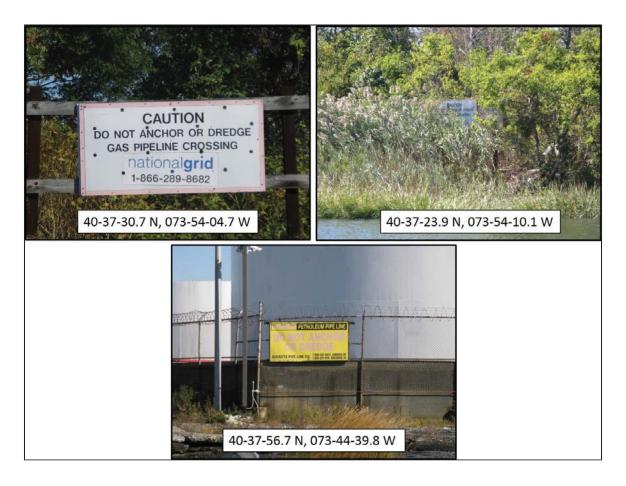
Figure 50: Pipeline crossing signs observed on the shoreline within Survey H12604.

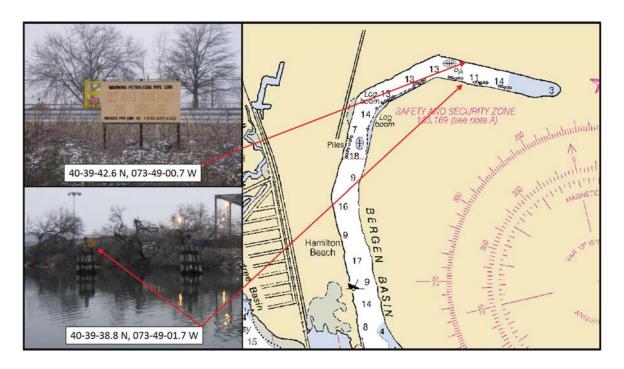
Figure 51: Pipeline signs indicate the presence of an uncharted pipeline in Bergen Basin.

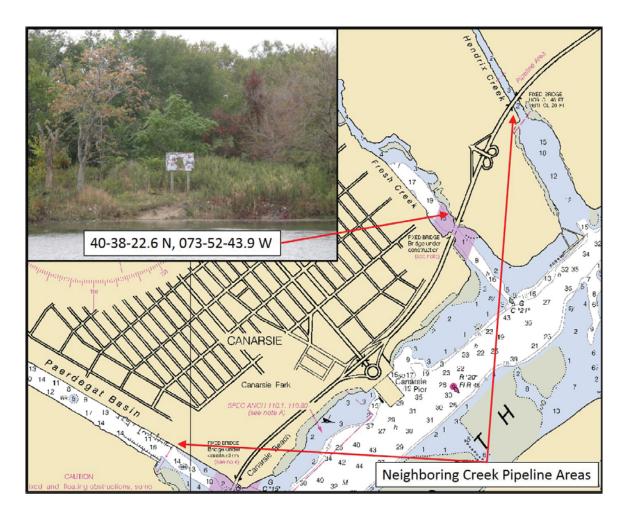
Figure 52: A vandalized sign indicates the possible presence of an uncharted pipeline within Fresh Creek.

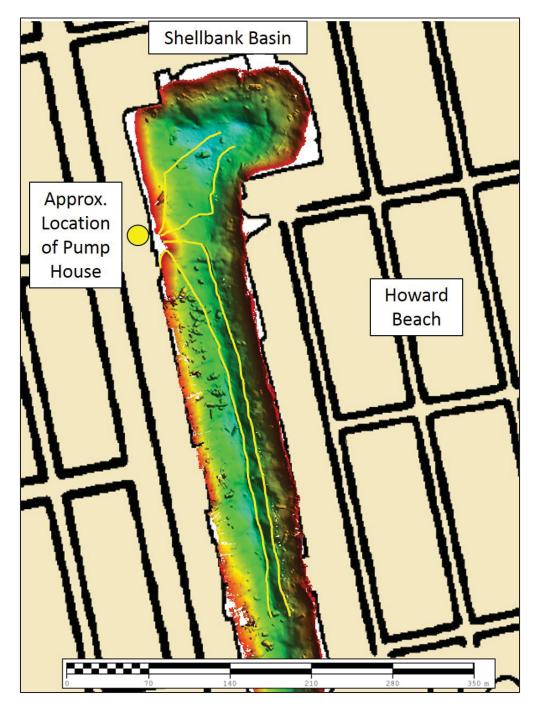
Figure 53: The location of the as-surveyed pipelines within Shellbank Basin were highlighted in yellow. In the background a 50-cm CUBE surface was overlaid on RNC 12350.

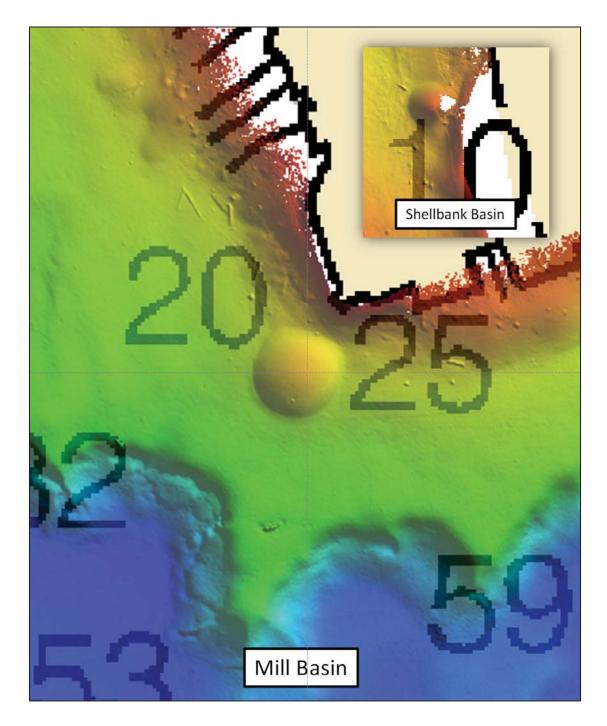
Figure 59: Two dome-like mounds were developed with MBES coverage within Survey H12604, shown in a 50-cm CUBE surface overlaid on RNC 12350.

Two dome-like, seafloor mounds were investigated within survey H12604. One mound was located within Mill Basin at 40-36-16.97 N, 73-54-19.39 W with a least depth of 13 feet (3.94 meters,  $\pm$  0.40 TPU) and the second mound was located within Shellbank Basin at 40-38-59.30 N, 73-50.11 W with a least depth of 4 feet (1.15 meters,  $\pm$  0.40 TPU) (Figure 59). The origin of the mounds is unknown, but the smooth dome-like shape is intriguing and could possibly be related to a natural geophysical phenomena.

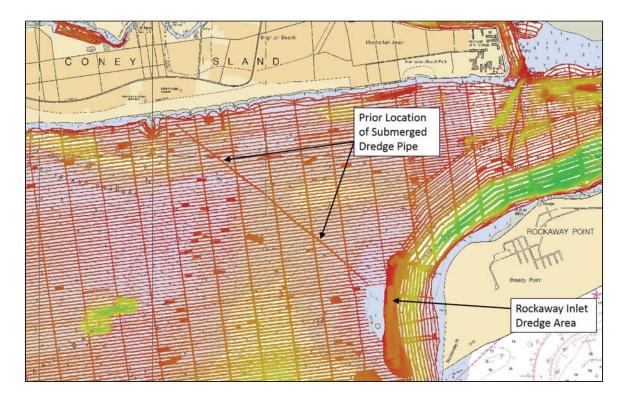
Figure 60: Rockaway Inlet dredge area and prior location of submerged pipeline highlighted represented in a 50-cm CUBE surface overlaid on RNC 12350.

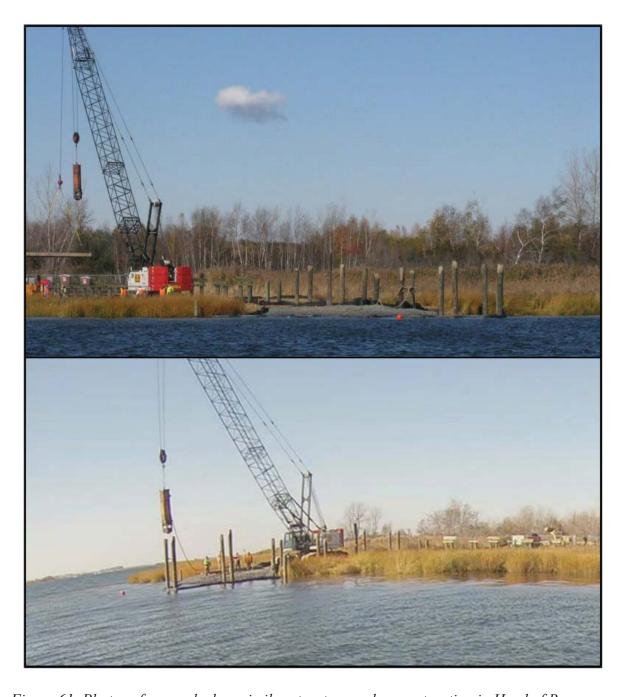
Figure 61: Photos of a new dock or similar structure under construction in Head of Bay.

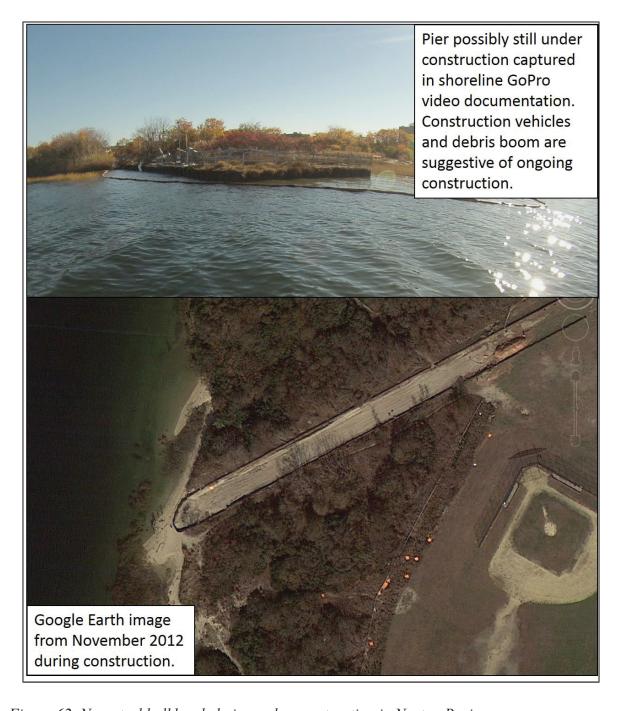
Figure 62: New steel bulkheaded pier under construction in Norton Basin.

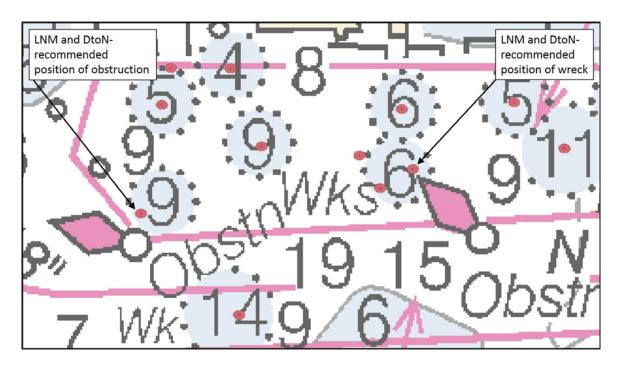
Figure 65: A chartlet displays the obstructions and wrecks submitted with OSI DtoN #15 highlighted in red and overlaid on the Sheepshead Bay Special Anchorage Area on RNC 12350 (downloaded June 13, 2014). There is a disparity between the submitted positions for two features, one wreck and one obstruction, and the charted positions.

Figure 65 depicts the disparity between charted symbol positions and the LNM and DtoN recommended positions of the obstruction and wreck discussed above.
