# DESCRIPTIVE REPORT

Registry Number: H12936

**Descriptive Report to Accompany Hydrographic Survey H12936**

Project M-I907-NF-16

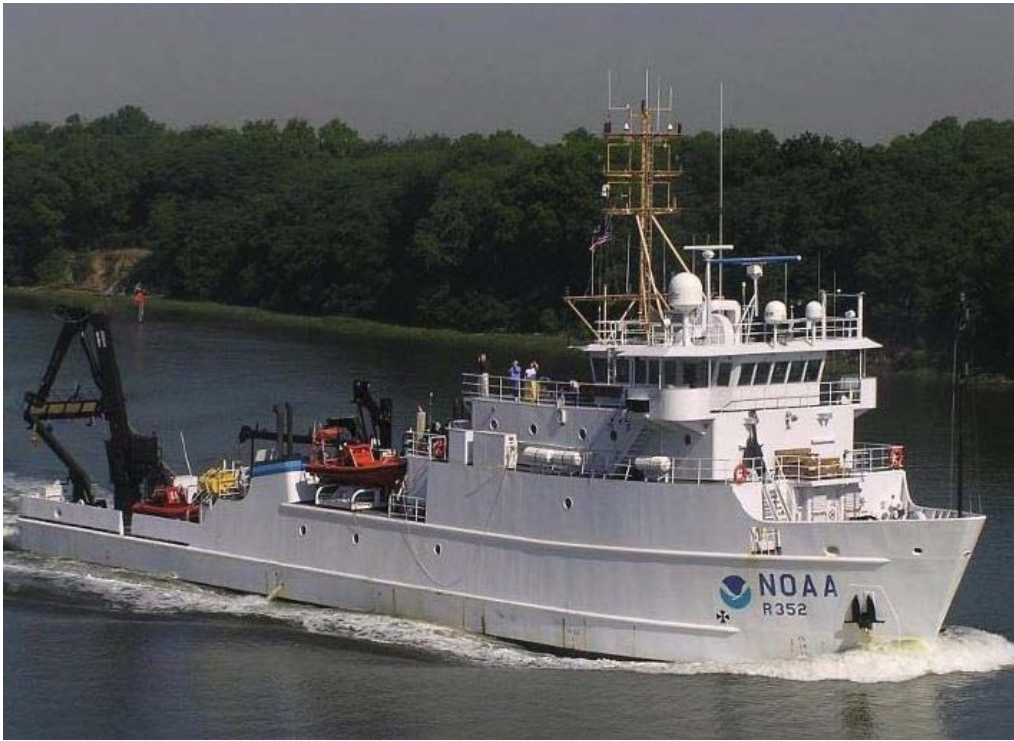
<b>NOAA Ship Nancy Foster</b>

Hull Number	R352
Builder	McDermott, Inc
Year Built	1990
Weight	1190 long tons
Length Overall	187'
Beam	40'
Draft, Maximum	11.2'
Cruising Speed	10.5 knots
Max Survey Speed	7 knots

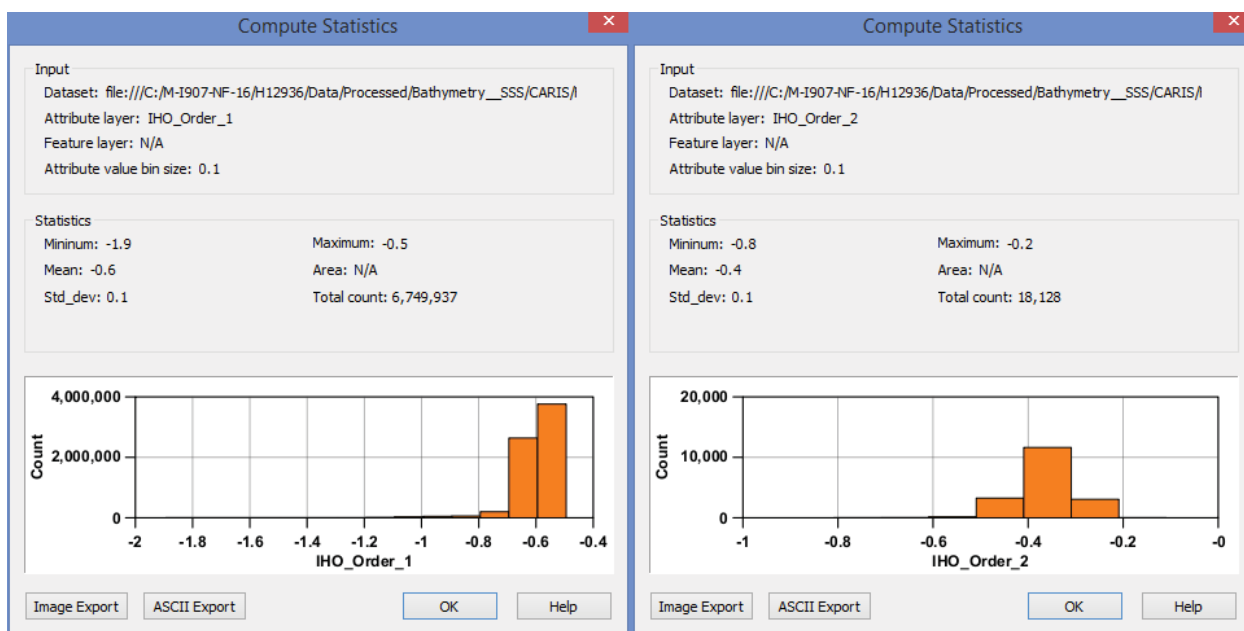
Figure 4 TVU QC Histograms for Both 4m and 16m CUBE Surfaces

As shown in Figure 4, the statistics from the TVU QC layers indicate that both the 16m and 4m areas have low mean values (-0.4, and -0.6 respectively). The 16 m surface also has no nodes which eclipse the IHO Order 2 error budget (its minimum value is -0.8), while the 4 m surface has very few nodes beyond -1 (and its minimum value is only -1.9). Therefore both these representative surfaces meet their relevant IHO Order specifications (as do the 2 m and 8 m surfaces).
