DESCRIPTIVE REPORT

Registry Number: H13003

General Locality: Kodiak Island

Sub-locality: William's Reef

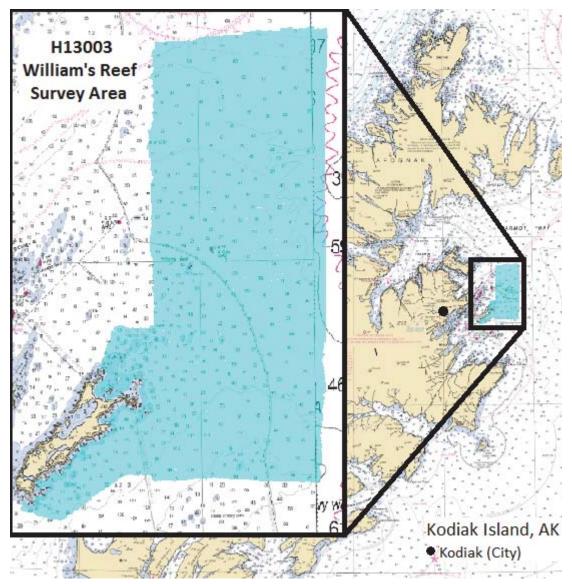
Figure 1: H13003 survey area as assigned in Project Instructions. Cyan tint shows the coverage area of H13003 relative to Kodiak Island.

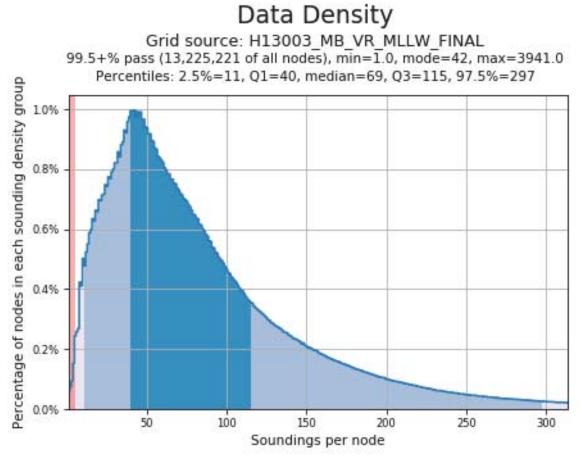
Pydro QC Tools 2 Grid QA was used to analyze H13003 multibeam echosounder (MBES) data density. The submitted H13003 variable-resolution (VR) surface met HSSD density requirements.

Figure 2: Pydro derived histogram plot showing HSSD density compliance of H13003 finalized variable-resolution MBES data.

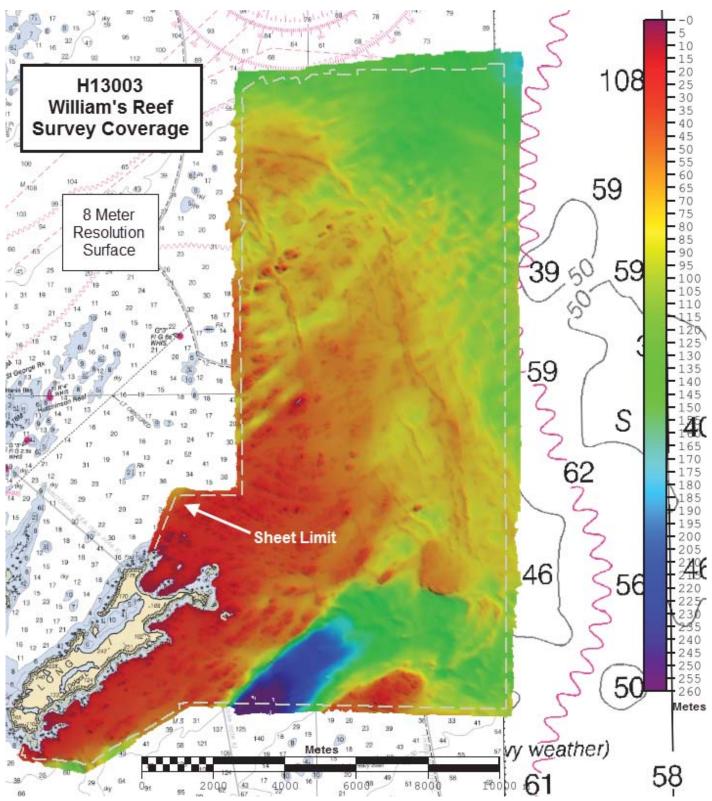
Complete multibeam echosounder (MBES) coverage was acquired to the inshore limit of hydrography, the Navigable Area Limit Line (NALL). In areas where survey coverage did not reach the 4-meter depth contour nor the assigned sheet limits, it was due to the survey vessel reaching the inshore extent of safe navigation as shown in the figure below. These areas were generally located near shore and were subject to dangerous wave action and other hazards.

Figure 4: H13003 MBES coverage and assigned survey limits.

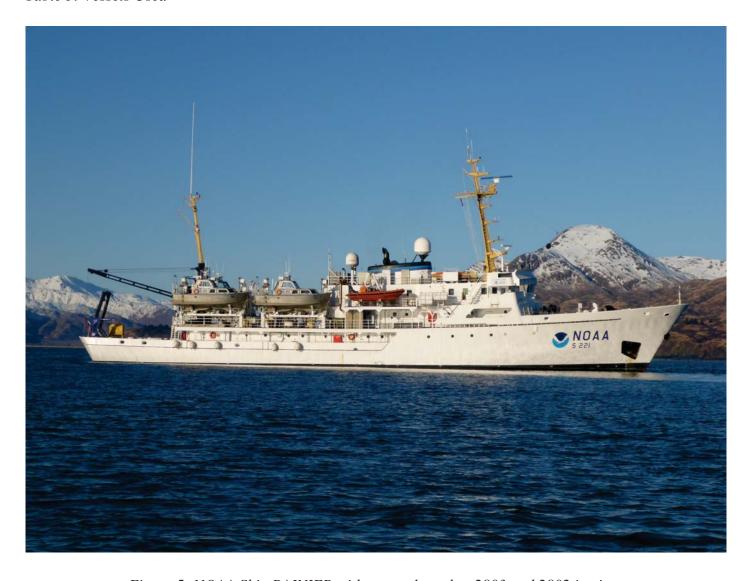
Figure 5: NOAA Ship RAINIER with survey launches 2803 and 2802 in view.

All the survey data for H13003 was acquired by survey launches 2801 RA-4, 2802 RA-5, 2803 RA-3, RA-6 2804, and the NOAA Ship RAINIER S221. The launches and ship acquired the MBES soundings, sound velocity profiles and bottom samples. The skiffs (1907, 1905) conducted all shoreline verification.

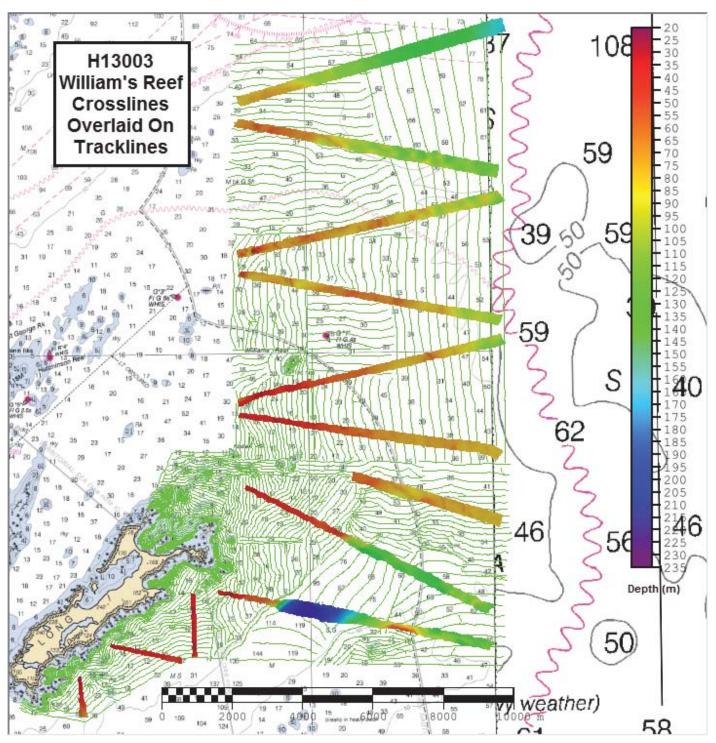
Multibeam crosslines were acquired using RAINIER launches 2802 and 2804 across all depth ranges, water masses and boat days that were practical; they are adequate for verifying and evaluating the internal consistency of survey data. Some crosslines were acquired prior to mainscheme acquisition, on headings roughly orthonormal to the assumed orientation of the mainscheme lines. However, the actual azimuth of mainscheme lines was often dictated by the sea conditions encountered at the time of acquisition. Thus, some crosslines were not collected at least 45° to mainscheme. The minimum 4% crossline requirement was still met by collecting a total of 6.64% overlapping coverage lines most of which fall within the defined specifications of crosslines. A VR CUBE surface was created using only H13003 mainscheme, and a second VR CUBE surface was created using only crosslines. Analysis was performed using the Compare Grids function in Pydro Explorer using these two surfaces. For its respective depths, the difference surface was compared to IHO allowable Total Vertical Uncertainty (TVU) standards. 99.5+% of nodes met allowable uncertainties, for additional results, see plots below.

Figure 6: H13003 crosslines surface overlaid on mainscheme track lines.

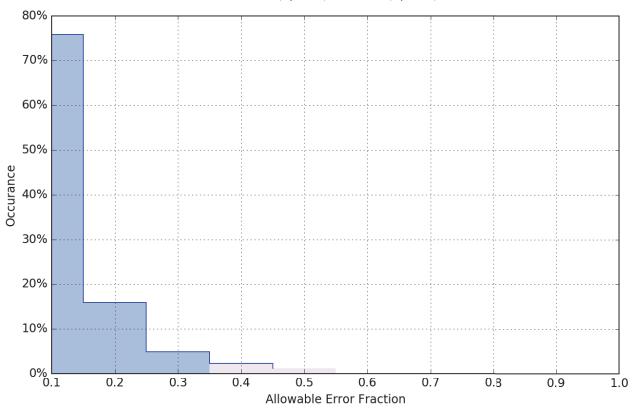
Percentiles: 2.5%=0.0, Q1=0.0, median=0.1, Q3=0.1, 97.5%=0.4

Figure 7: Pydro derived plot showing percentage-pass value of H13003 mainscheme to crossline data.

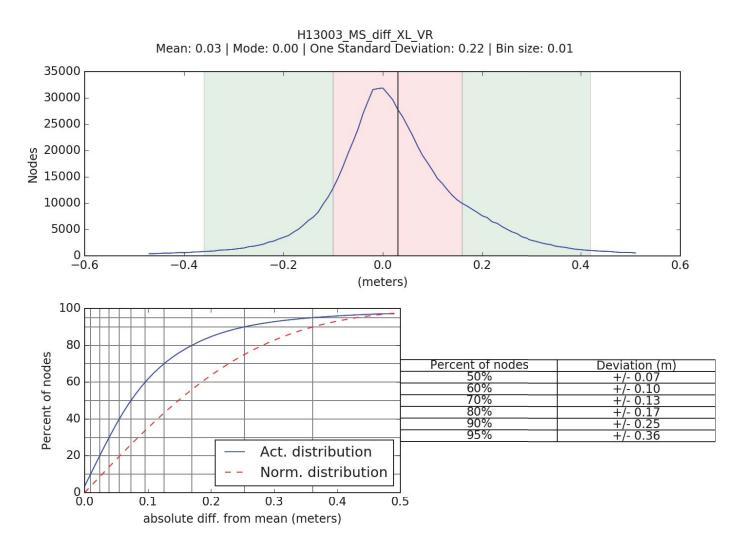
Figure 8: Pydro derived plot showing the statistical results of a comparison between H13003 mainscheme to crossline data.

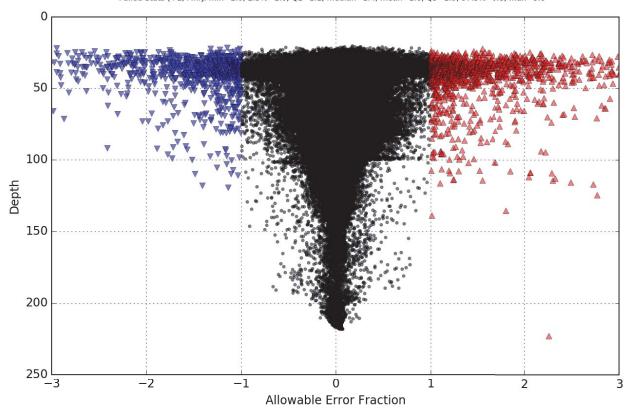
Failed Stats [-inf,-1): min=-7.0, 2.5%=-3.8, Q1=-1.8, mean=-1.6, median=-1.3, Q3=-1.1, 97.5%=-1.0, max=-1.0

Failed Stats (+1,+inf]: min=1.0, 2.5%=1.0, Q1=1.1, median=1.4, mean=1.6, Q3=1.9, 97.5%=3.8, max=8.6

Figure 9: Pydro derived plot showing node depth vs. allowable error fraction of H13003 mainscheme to crossline data.

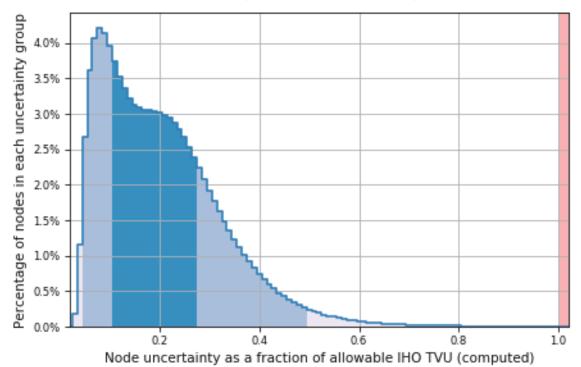
Grid source: H13003_MB_VR_MLLW_FINAL 99.5+% pass (13,273,357 of all nodes), min=0.02, mode=0.08, max=2.98 Percentiles: 2.5%=0.05, Q1=0.11, median=0.18, Q3=0.27, 97.5%=0.49

Figure 10: Pydro derived histogram plot showing TVU compliance of H13003 finalized multi-resolution MBES data.

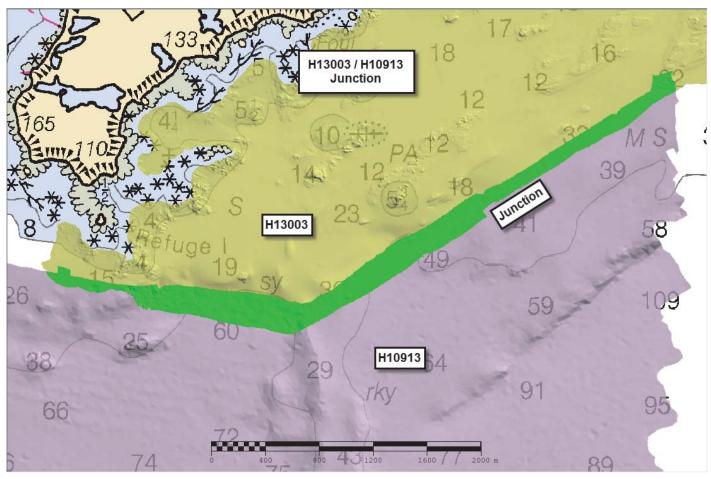
The junction with survey H10913 encompassed 0.24 square nautical miles along the southwestern boundary of H13003. The comparison was made using the Pydro tool "Compare Grids" application. The surfaces used for this comparison were 4-meter CUBE surfaces. Analysis of the difference surface indicate a standard deviation of 0.62 meters. For the respective depths, the difference surface was compared to the allowable TVU standards specified in the HSSD. In total, 97% of the depth differences between H13003 and junction survey H10913 were within allowable uncertainties. H13003 is shoaler by 0.58 meters on average in the junction area with H10913.

Figure 11: Junction survey area between H13003 and H10913.

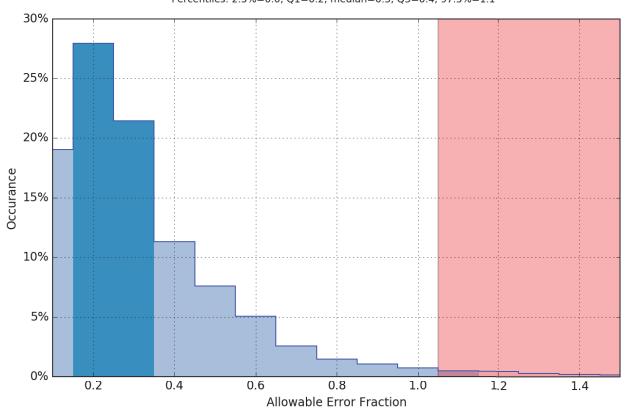
Per Grid: H13003_diff_H10913_4M_fracAllowErr.csar 97% nodes pass (48995), min=0.0, mode=0.2 mean=0.3 max=6.6 Percentiles: 2.5%=0.0, Q1=0.2, median=0.3, Q3=0.4, 97.5%=1.1

Figure 12: Pydro derived plot showing percentage-pass value of H13003 MBES data to H10913 MBES data.

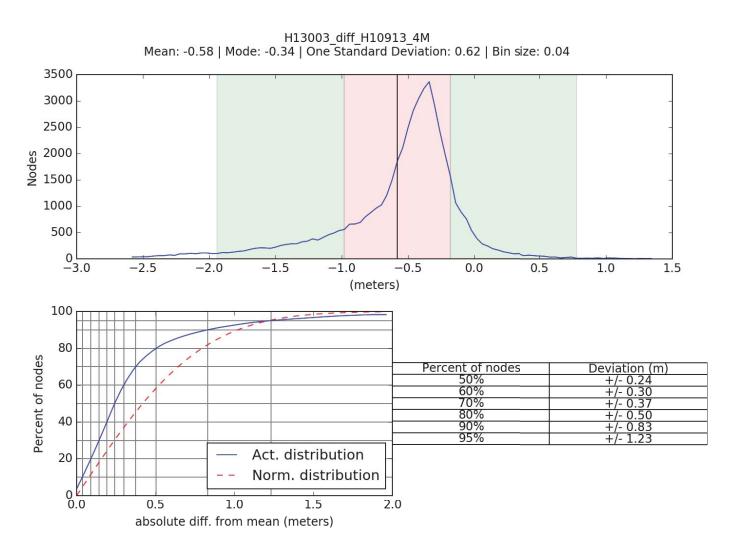
Figure 13: Pydro derived plot showing the statistical results of a comparison between H13003 MBES data to H10913 MBES data.

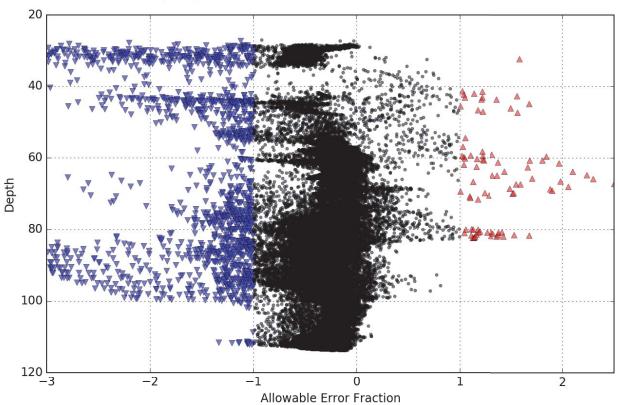
Failed Stats [-inf,-1): min=-6.6, 2.5%=-4.4, Q1=-2.2, mean=-1.8, median=-1.4, Q3=-1.2, 97.5%=-1.0, max=-1.0

Failed Stats (+1,+inf]: min=1.0, 2.5%=1.0, Q1=1.1, median=1.3, mean=1.4, Q3=1.5, 97.5%=2.2, max=2.5

Figure 14: Pydro derived plot showing node depth vs. allowable error fraction of H13003 MBES data to H10913 MBES data.

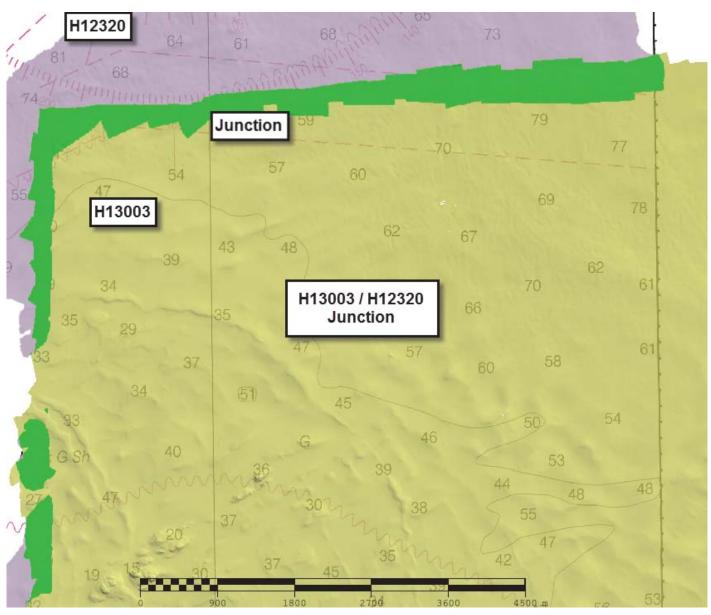
The junction with survey H12320 encompassed 1.08 square nautical miles along the northern boundary of H13003. The comparison was made using the Pydro tool "Compare Grids" application. The surfaces used for this comparison were 8-meter CUBE surfaces. The 8-meter surface provided for H12320 only contained depths below 72 meters. This is the reason for the gaps in the junction area on the western side. Analysis of the difference surface indicate a standard deviation of 0.45 meters. For the respective depths, the difference surface was compared to the allowable TVU standards specified in the HSSD. In total, 99.5+% of the depth differences between H13003 and junction survey H12320 were within allowable uncertainties. H13003 is deeper by 0.40 meters on average in the junction area with H12320.

Figure 15: Junction survey area between H13003 and H12320.

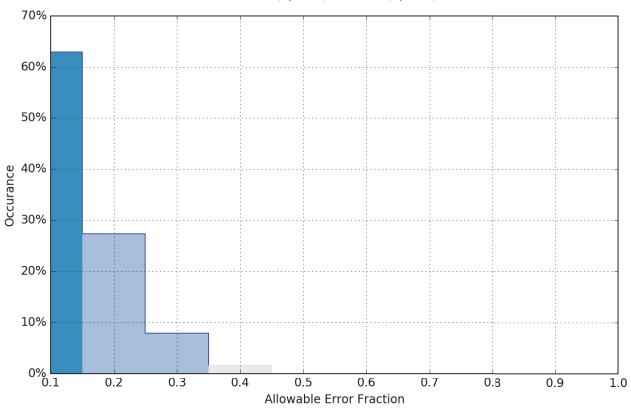
Percentiles: 2.5%=0.0, Q1=0.1, median=0.1, Q3=0.2, 97.5%=0.3

Figure 16: Pydro derived plot showing percentage-pass value of H13003 MBES data to H12320 MBES data.

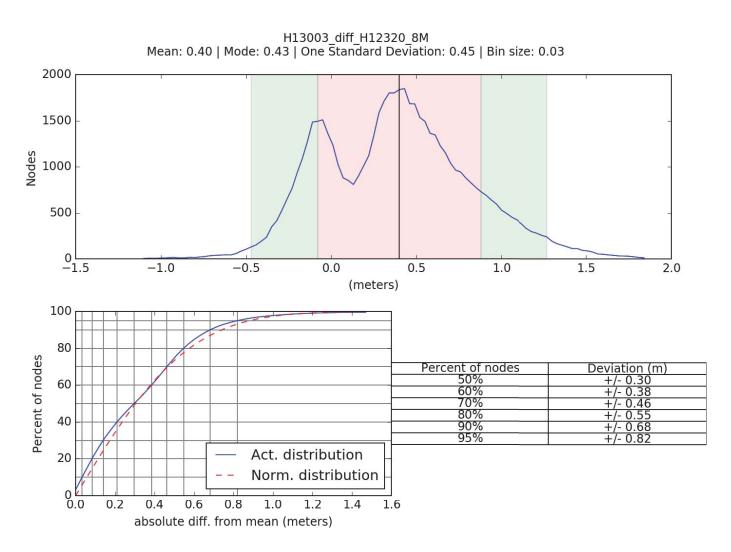
Figure 17: Pydro derived plot showing the statistical results of a comparison between H13003 MBES data to H12320 MBES data.

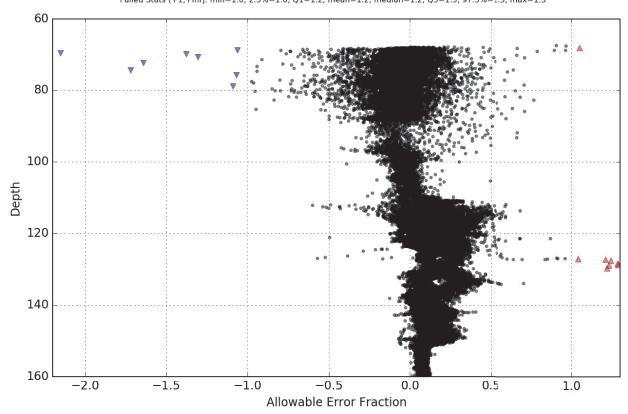
Failed Stats [-inf,-1): min=-2.2, 2.5%=-2.1, Q1=-1.7, mean=-1.4, median=-1.3, Q3=-1.1, 97.5%=-1.1, max=-1.1

Failed Stats (+1,+inf): min=1.0, 2.5%=1.0, Q1=1.2, mean=1.2, median=1.2, Q3=1.3, 97.5%=1.3, max=1.3

Figure 18: Pydro derived plot showing node depth vs. allowable error fraction of H13003 MBES data to H12320 MBES data.

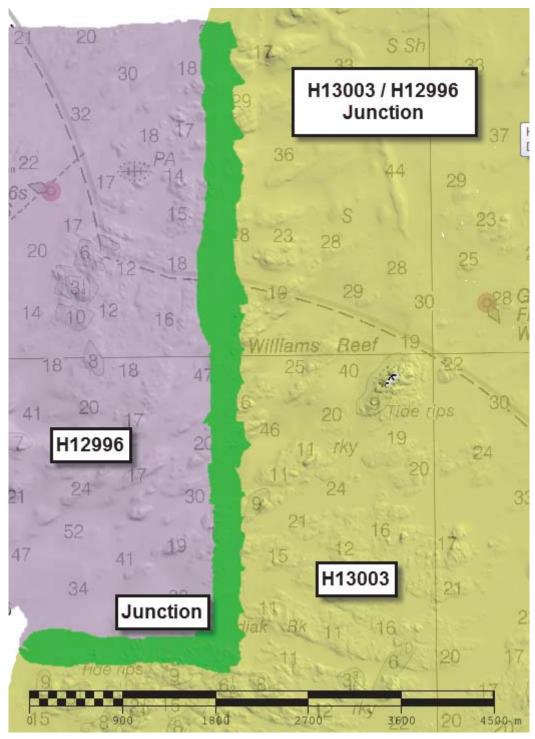
The junction with survey H12996 encompassed 0.73 square nautical miles along the western boundary of H13003. The comparison was made using the Pydro tool "Compare Grids" application. The surfaces used for this comparison were 2-meter CUBE surfaces. Analysis of the difference surface indicate a standard deviation of 0.29 meters. For the respective depths, the difference surface was compared to the allowable TVU standards specified in the HSSD. In total, 98% of the depth differences between H13003 and junction survey H1996 were within allowable uncertainties. H13003 is shoaler by 0.20 meters on average in the junction area with H12996.

Figure 19: Junction survey area between H13003 and H12996.

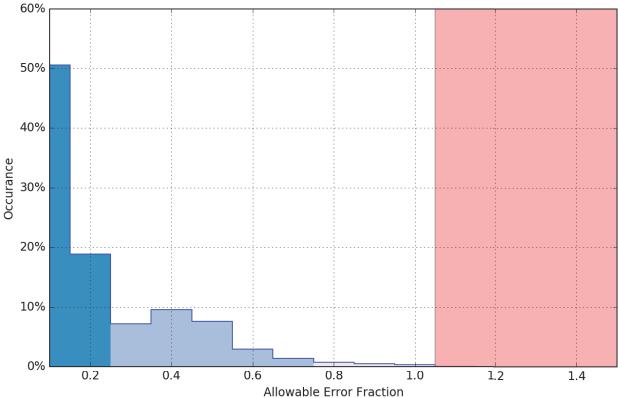
Percentiles: 2.5%=0.0, Q1=0.1, median=0.1, Q3=0.3, 97.5%=0.8

Figure 20: Pydro derived plot showing percentage-pass value of H13003 MBES data to H12996 MBES data.

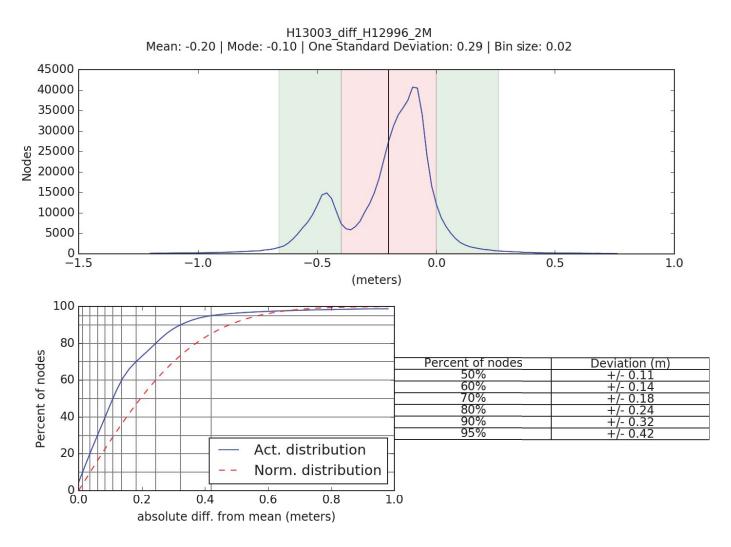
Figure 21: Pydro derived plot showing the statistical results of a comparison between H13003 MBES data to H12996 MBES data.

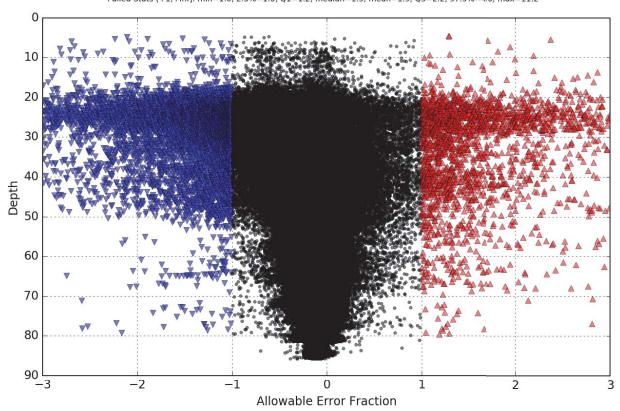
Failed Stats [-inf,-1): min=-13.7, 2.5%=-4.5, Q1=-1.9, mean=-1.7, median=-1.4, Q3=-1.2, 97.5%=-1.0, max=-1.0 Failed Stats (+1,+inf]: min=1.0, 2.5%=1.0, Q1=1.2, median=1.5, mean=1.9, Q3=2.2, 97.5%=4.6, max=11.2

Figure 22: Pydro derived plot showing node depth vs. allowable error fraction of H13003 MBES data to H12996 MBES data.

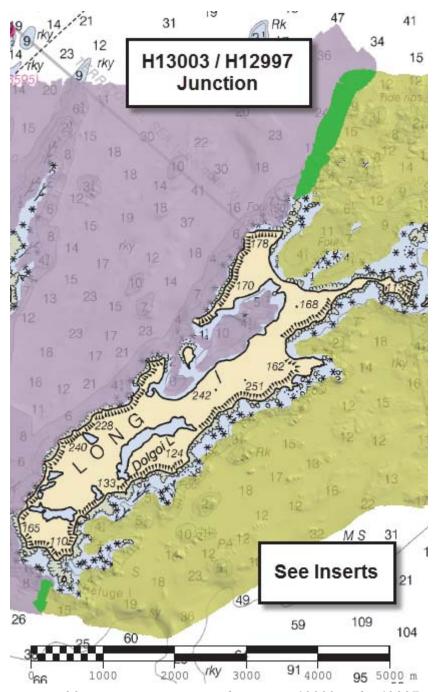
The junction with survey H12997 encompassed 0.17 square nautical miles along the boundary of H13003 north and south of Long Island. The comparison was made using the Pydro tool "Compare Grids" application. The surfaces used for this comparison were 4-meter CUBE surfaces. Analysis of the difference surface indicate a standard deviation of 0.31 meters. For the respective depths, the difference surface was compared to the allowable TVU standards specified in the HSSD. In total, 95% of the depth differences between H13003 and junction survey H12997 were within allowable uncertainties. H13003 is shoaler by 0.68 meters on average in the junction area with H12997.

Figure 23: Junction survey area between H13003 and H12997.

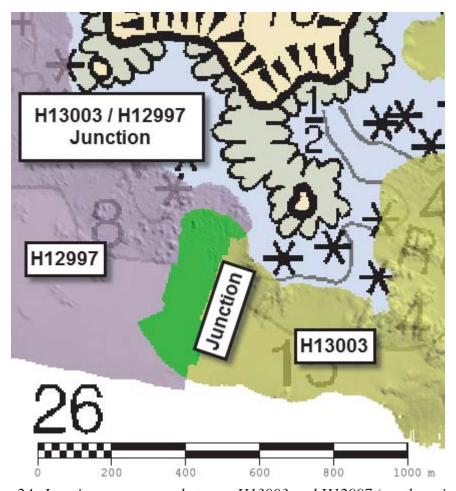
Figure 24: Junction survey area between H13003 and H12997 (southern insert).

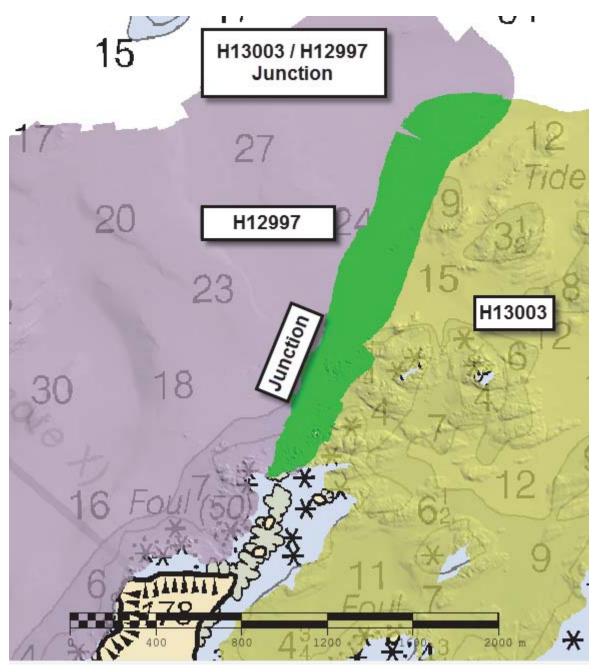
Figure 25: Junction survey area between H13003 and H12997 (northern insert).

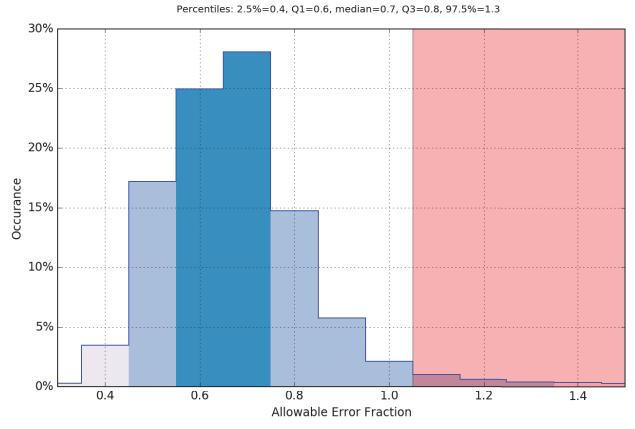
Per Grid: H13003_diif_H12997_4M_fracAllowErr.csar 95% nodes pass (34148), min=0.0, mode=0.7 mean=0.7 max=16.5

Figure 26: Pydro derived plot showing percentage-pass value of H13003 MBES data to H12997 MBES data.

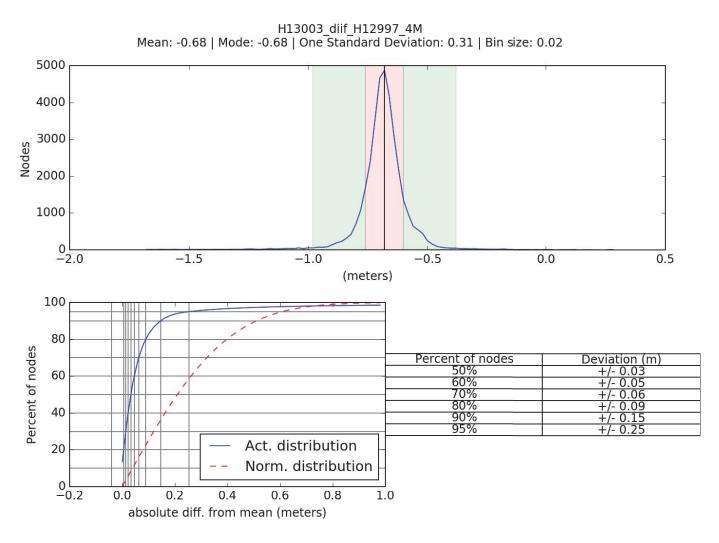
Figure 27: Pydro derived plot showing the statistical results of a comparison between H13003 MBES data to H12997 MBES data.

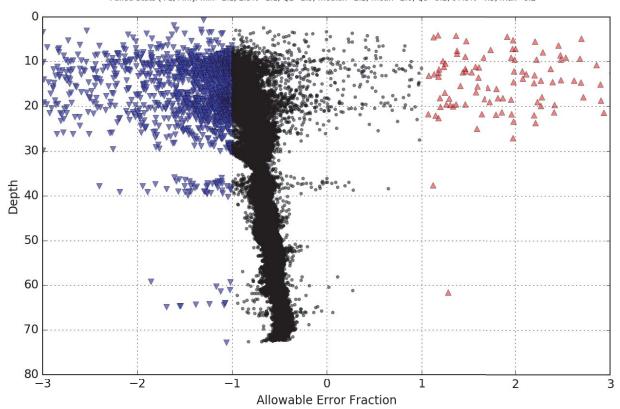
Failed Stats [-inf,-1): min=-16.5, 2.5%=-5.1, Q1=-1.8, mean=-1.7, median=-1.3, Q3=-1.1, 97.5%=-1.0, max=-1.0 Failed Stats (+1,+inf]: min=1.1, 2.5%=1.1, Q1=1.5, median=2.2, mean=2.6, Q3=3.2, 97.5%=6.3, max=8.2

Figure 28: Pydro derived plot showing node depth vs. allowable error fraction of H13003 MBES data to H12997 MBES data.

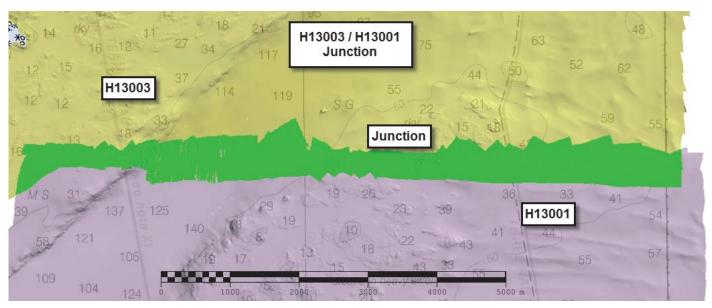
The junction with survey H13001 encompassed 1.48 square nautical miles along the southern boundary of H13003. The comparison was made using the Pydro tool "Compare Grids" application. The surfaces used for this comparison were 8-meter CUBE surfaces. Analysis of the difference surface indicate a standard deviation of 0.60 meters. For the respective depths, the difference surface was compared to the allowable TVU standards specified in the HSSD. In total, 98% of the depth differences between H13003 and junction survey H13001 were within allowable uncertainties. H13003 is shoaler by 0.48 meters on average in the junction area with H10913.

Figure 29: Junction survey area between H13003 and H13001.

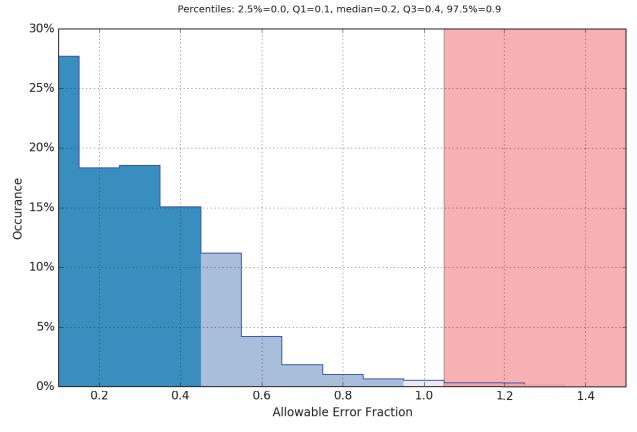
Per Grid: H13003_diff_H13001_8M_fracAllowErr.csar 98% nodes pass (76350), min=0.0, mode=0.1 mean=0.3 max=19.1

Figure 30: Pydro derived plot showing percentage-pass value of H13003 MBES data to H13001 MBES data.

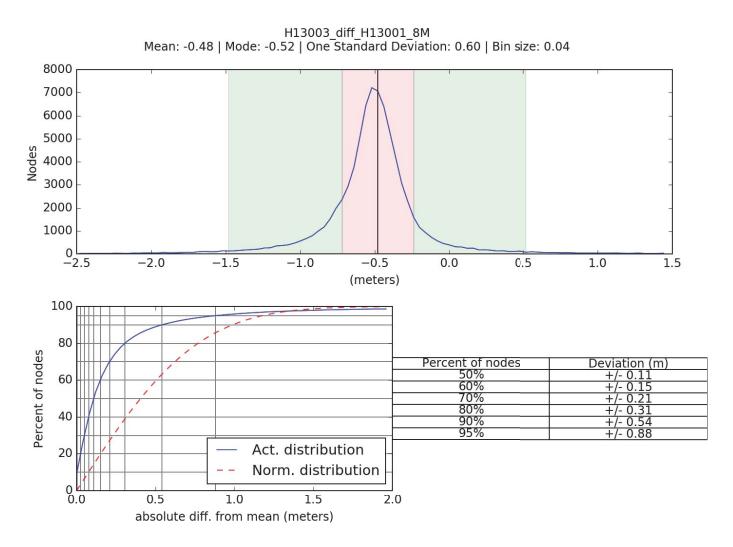
Figure 31: Pydro derived plot showing the statistical results of a comparison between H13003 MBES data to H13001 MBES data.

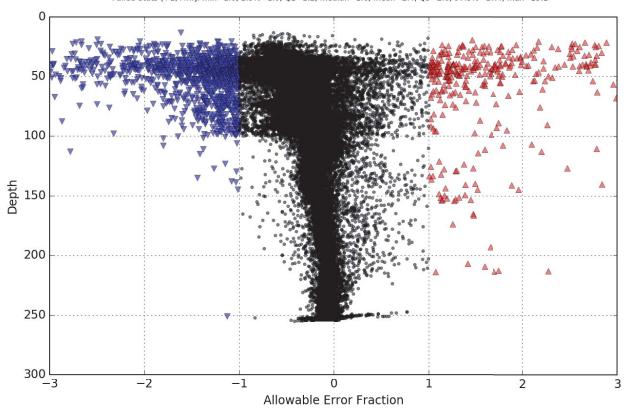
Failed Stats [-inf,-1): min=-12.3, 2.5%=-4.9, Q1=-1.9, mean=-1.8, median=-1.4, Q3=-1.2, 97.5%=-1.0, max=-1.0 Failed Stats (+1,+inf]: min=1.0, 2.5%=1.0, Q1=1.2, median=1.6, mean=2.4, Q3=2.6, 97.5%=10.4, max=19.1

Figure 32: Pydro derived plot showing node depth vs. allowable error fraction of H13003 MBES data to H13001 MBES data.

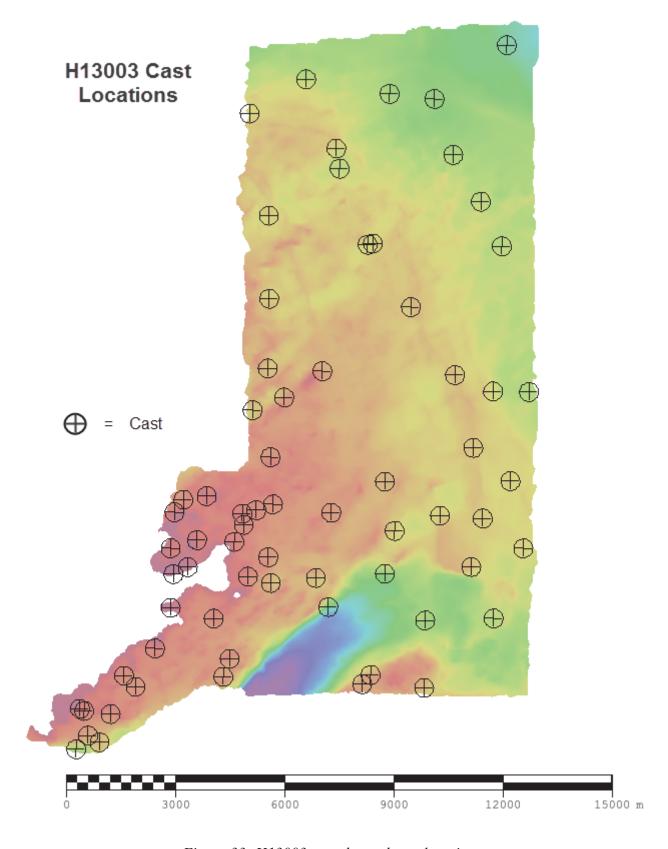
Sound Speed Cast Frequency: Seventy four sound speed profiles were acquired for this survey at discrete locations within the survey area at least once every four hours, when significant changes in surface sound speed were observed, or when operating in a new area. Sound speed profiles were acquired using Sea-Bird 19plus SEACAT Profilers and the Odim Brooke Ocean MVP 200 Moving Vessel Profiler. All casts were concatenated into a master file and applied to MBES data using the "Nearest distance within time" (4 hours) profile selection method.

Figure 33: H13003 sound speed cast locations.

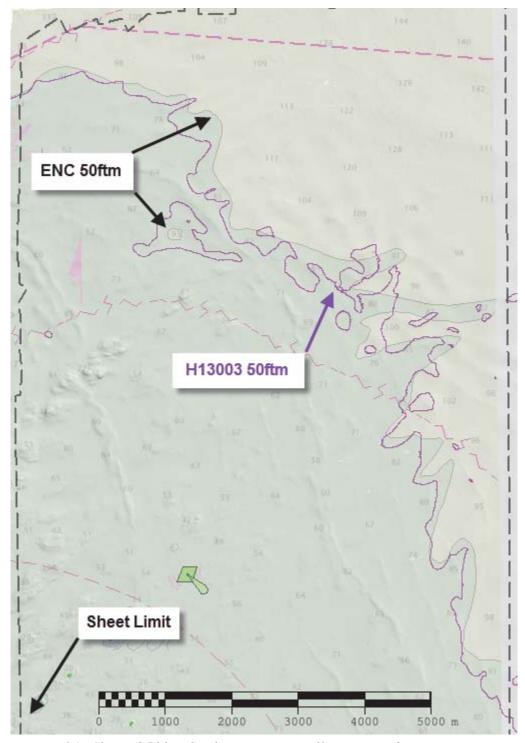
Figure 34: Charted 50ftm depth curves generally agree with survey contours.

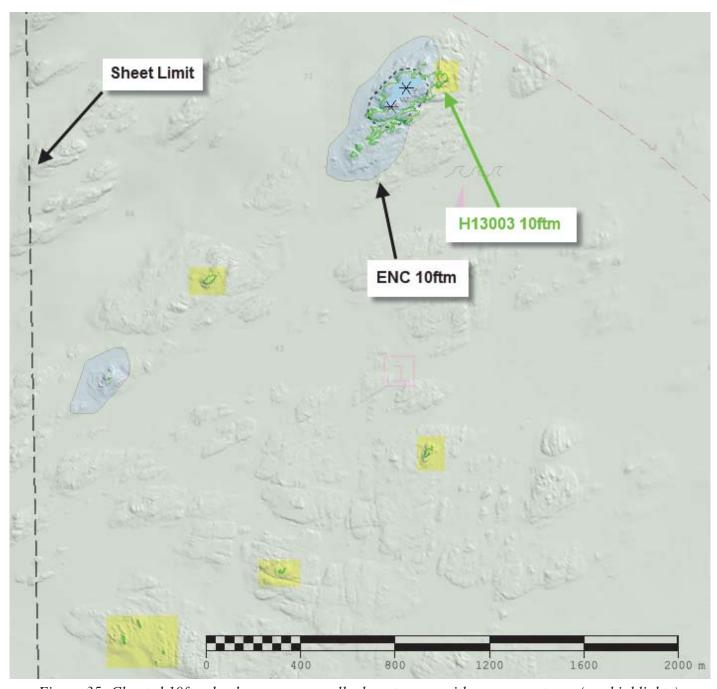
Figure 35: Charted 10ftm depth curves generally do not agree with survey contours (see highlights).

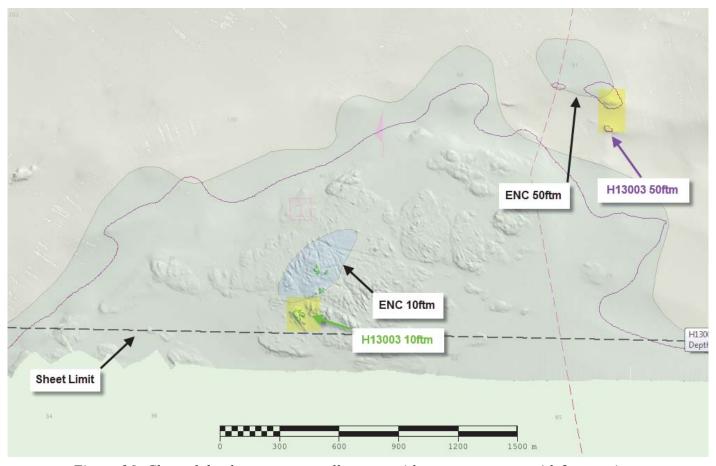
Figure 36: Charted depth curves generally agree with survey contours with 2 exceptions.

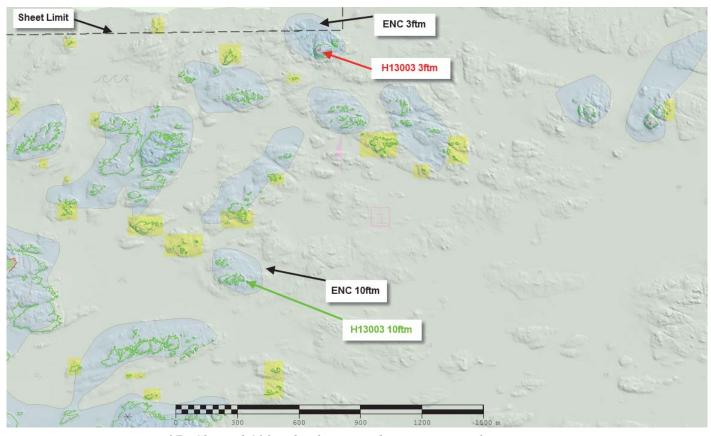
Figure 37: Charted 10ftm depth curves do not agree with survey contours.

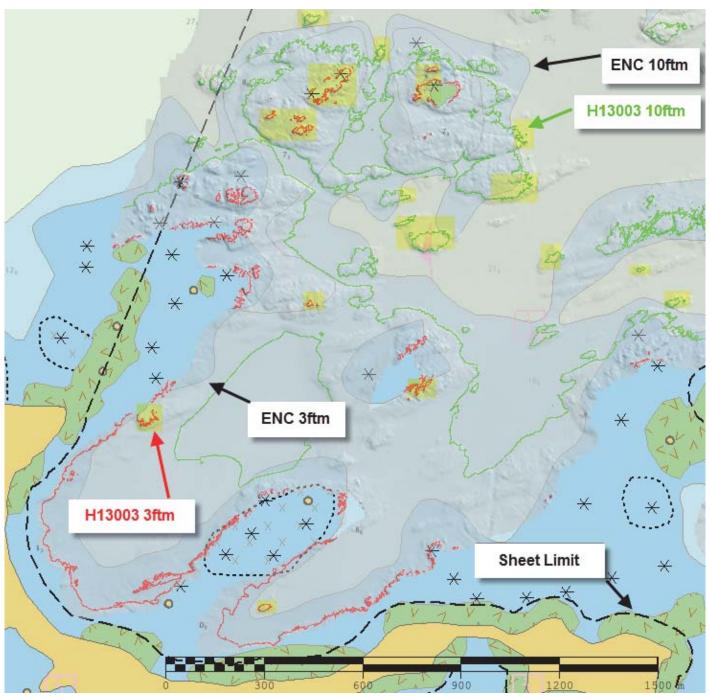
Figure 38: Charted 10ftm depth curves generally agree or are deeper than survey contours. Charted 3ftm depth curves generally agree with survey contours (dangerous exceptions highlighted).

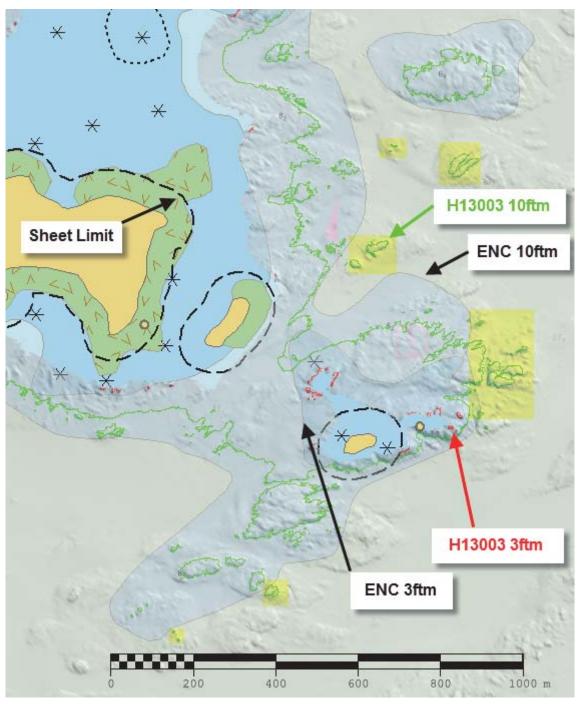
Figure 39: Charted 10ftm depth contours generally agree with survey contours (exceptions highlighted). Charted 3ftm depth curves generally agree with survey contours.

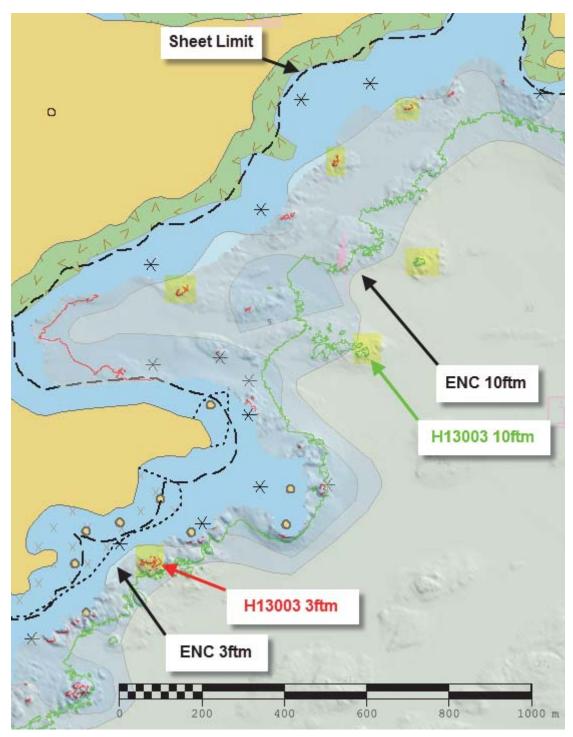
Figure 40: Charted 3 and 10 ftm depth curves generally agree with survey contours (exceptions highlighted). Charted 3ftm depth curve in center of bay poorly represents depth.

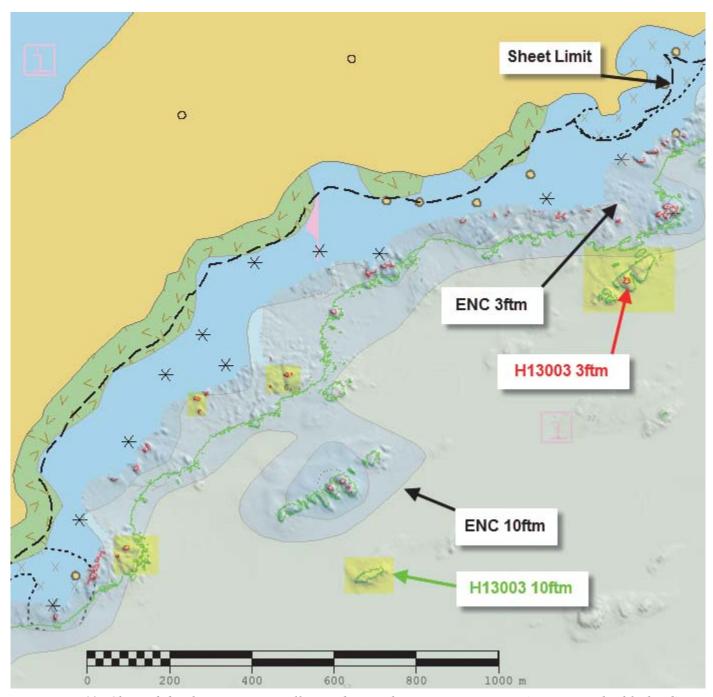
Figure 41: Charted depth curves generally are deeper than survey contours (exceptions highlighted).

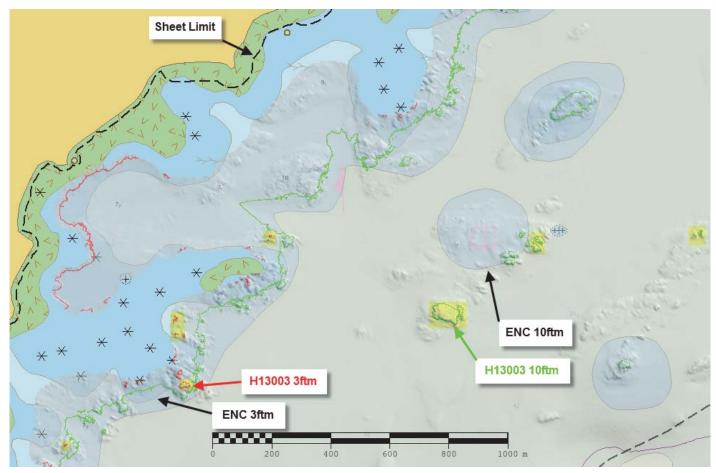
Figure 42: Charted depth curves generally are deeper than survey contours (exceptions highlighted). Charted 10ftm depth curve in center right of image does not accurately represent data.

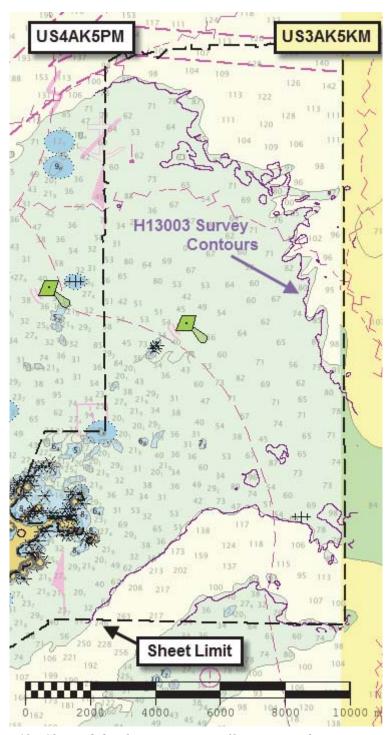
The very small section that lies on the eastern portion of H13003 generally agrees with abutting ENC with insignificant offsets considering the small scale of US3AK5KM.

Figure 43: Charted depth curves generally agree with survey contours.

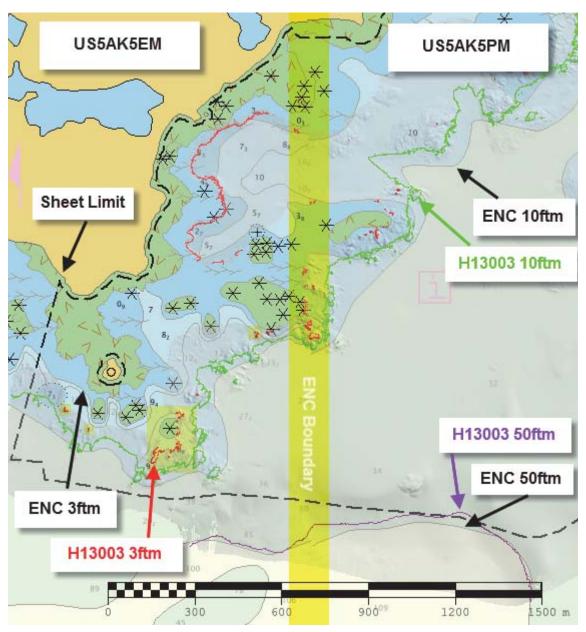
Charted three and ten fathom depth curves generally agree with survey contours with several exceptions of the charted three fathom depth curve.

Figure 44: Charted depth curves generally agree with survey contours (exceptions highlighted).

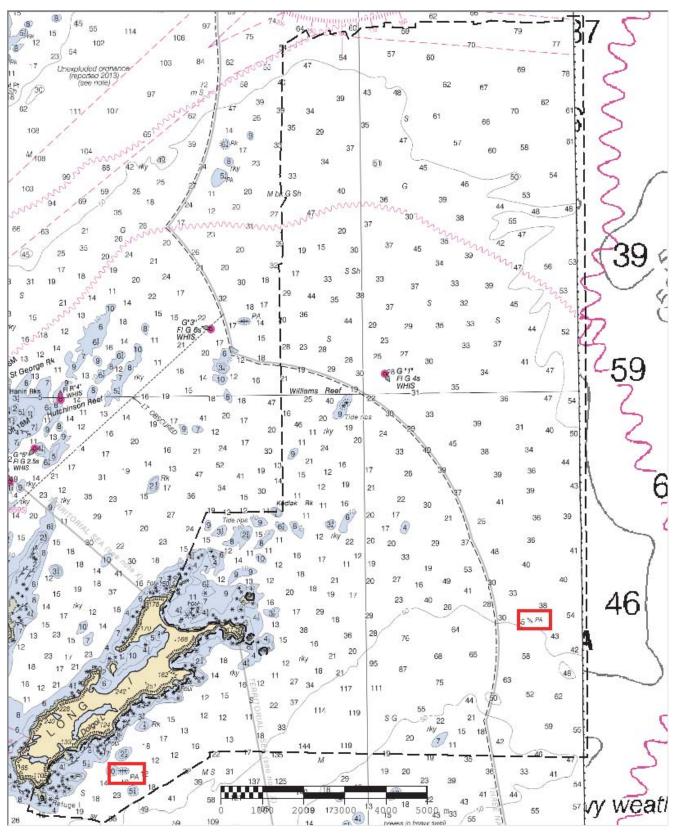
Figure 45: Overview of two PA wrecks for sheet H13003.

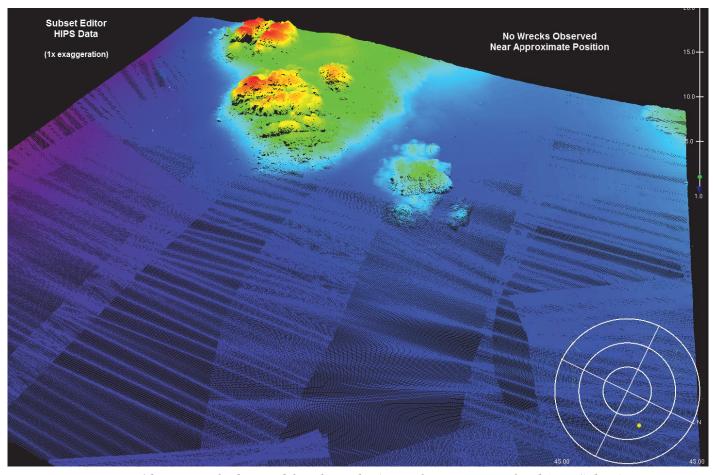
Figure 46: No wreck observed for charted PA wreck near Long Island (HIPS data).

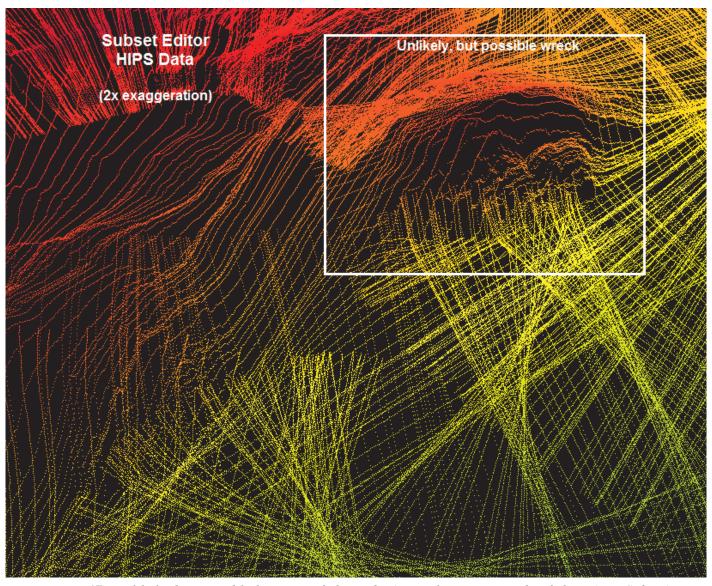
H13003 MBES data do not support a strong hypothesis for the charted PA wreck towards the east side of sheet, but cannot positively disprove the wreck location. The highly unlikely, but possible location is the same as the charted location. See Figures 47 and 48

Figure 47: Unlikely, but possible location of charted PA wreck near east side of sheet (HIPS data).

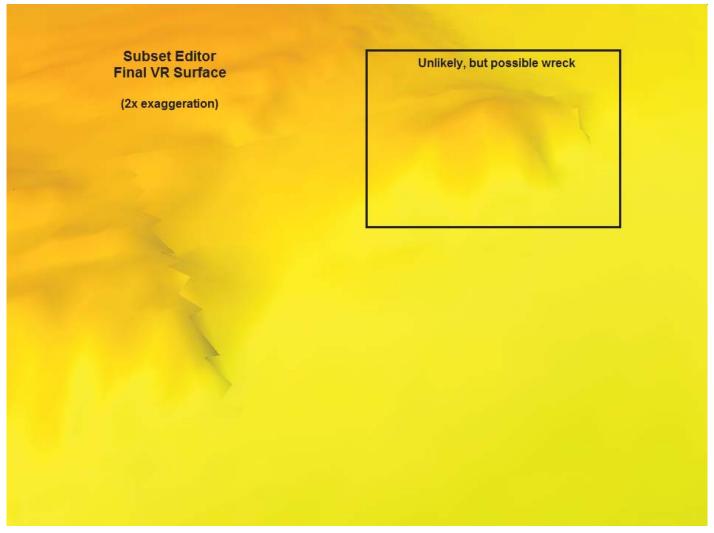
Figure 48: Unlikely, but possible location of charted PA wreck near east side of sheet (Surface view).

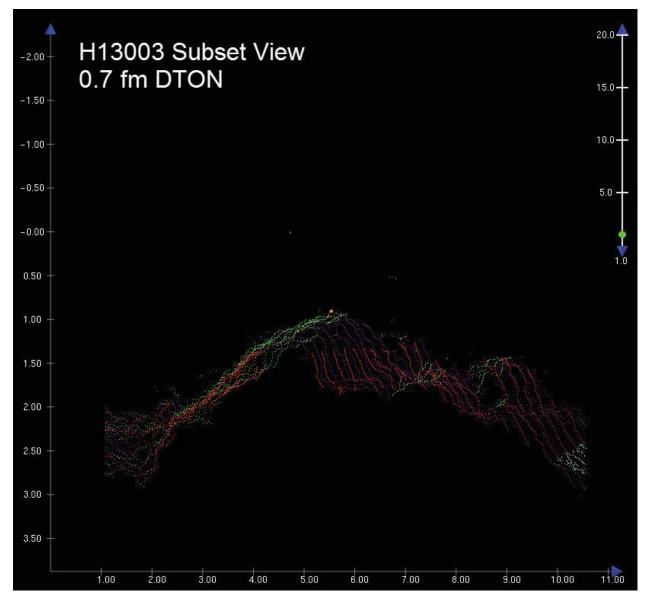
Figure 1.1.1

1.1) Profile/Beam 90/393 / 2802_2017__2192225

The Hydrographer Recommendations section for Feature 1.1 in the PDF and XML file states, "Update chart with 0.83 fathom depth at 57°44'49.6082"N, 152°17'16.4045"W".

The Hydrographer Recommendations section of the PDF report and the XML file should state the following for Feature 1.1: "Update chart with 0.88 fathom depth at 57°44'49.6082"N, 152°17'16.4045"W"
