DESCRIPTIVE REPORT

Type of Survey: Navigable Area

Registry Number: H13023

Project: OPR-B396-NRT5BH2-17

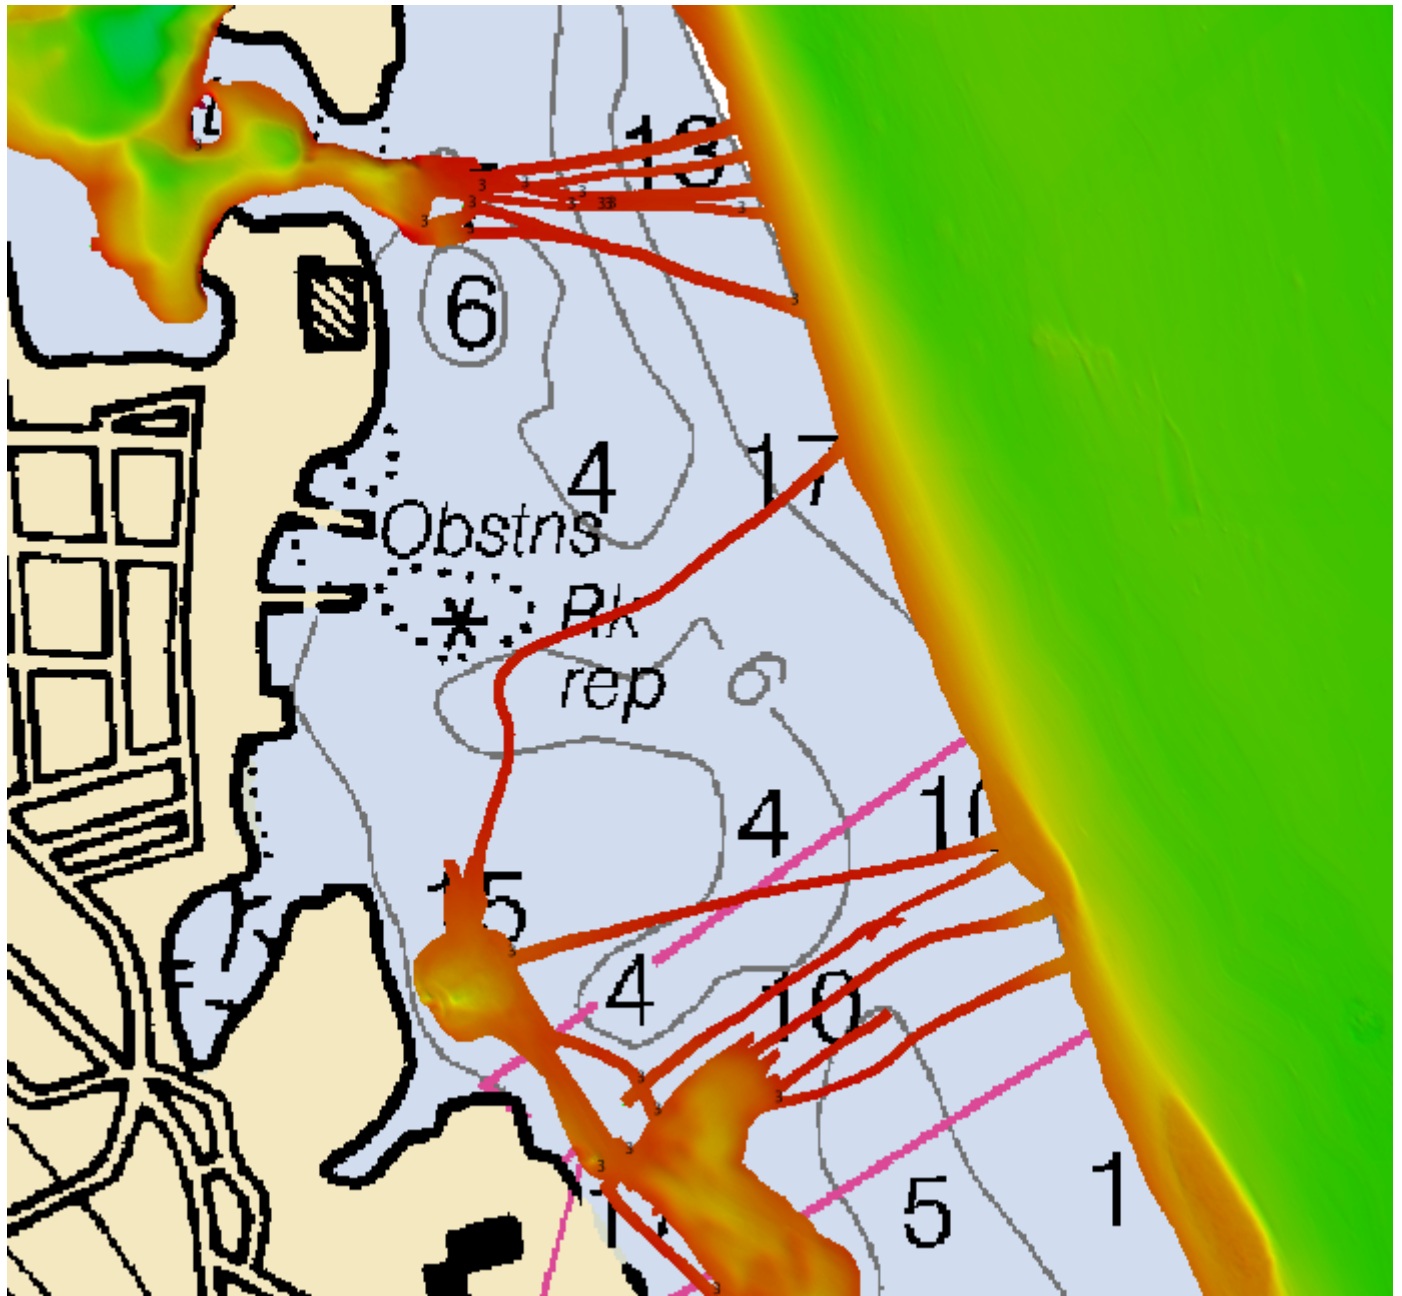
Figure 5: Holidays created from lines exploring transit paths to deeper areas.

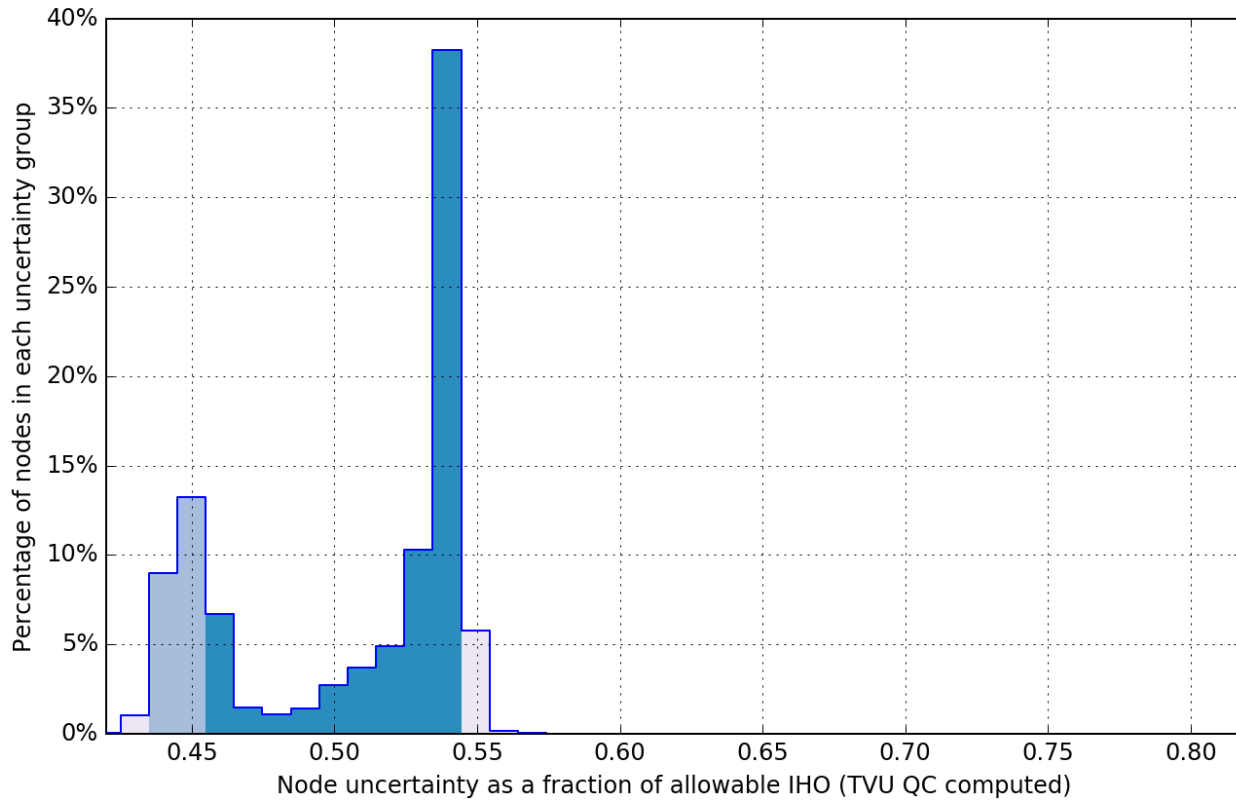
The uncertainty statistics (Figure 9) were calculated using Pydro Explorer's Finalized CSAR QA tool.

99.5+% nodes pass (76396403), min=0.42, mode=0.54 mean=0.51 max=2.34

Percentiles: 2.5%=0.44, Q1=0.46, median=0.53, Q3=0.54, 97.5%=0.55

Figure 9: Pydro derived histogram plot showing HSSD uncertainty standards compliance of H13023 0.5m finalized surface.

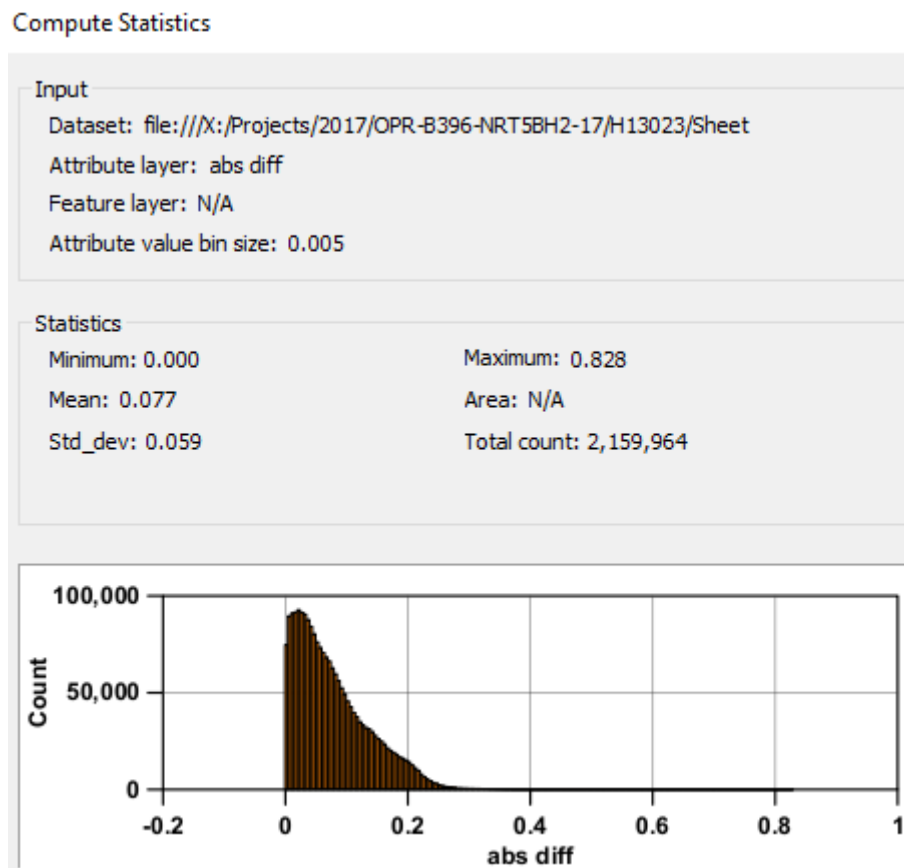
Overlap between H13022 and H13023 was approximately 200 meters. In CARIS HIPS a difference surface was made using 50cm surfaces and statistics computed (Figure 10). The mean difference was 0.077, with a standard deviation of 0.059. An area of greater disagreement was present on the east side of the river (Figure 11)

Figure 10: Absolute difference statistics between H13023 and H13022.

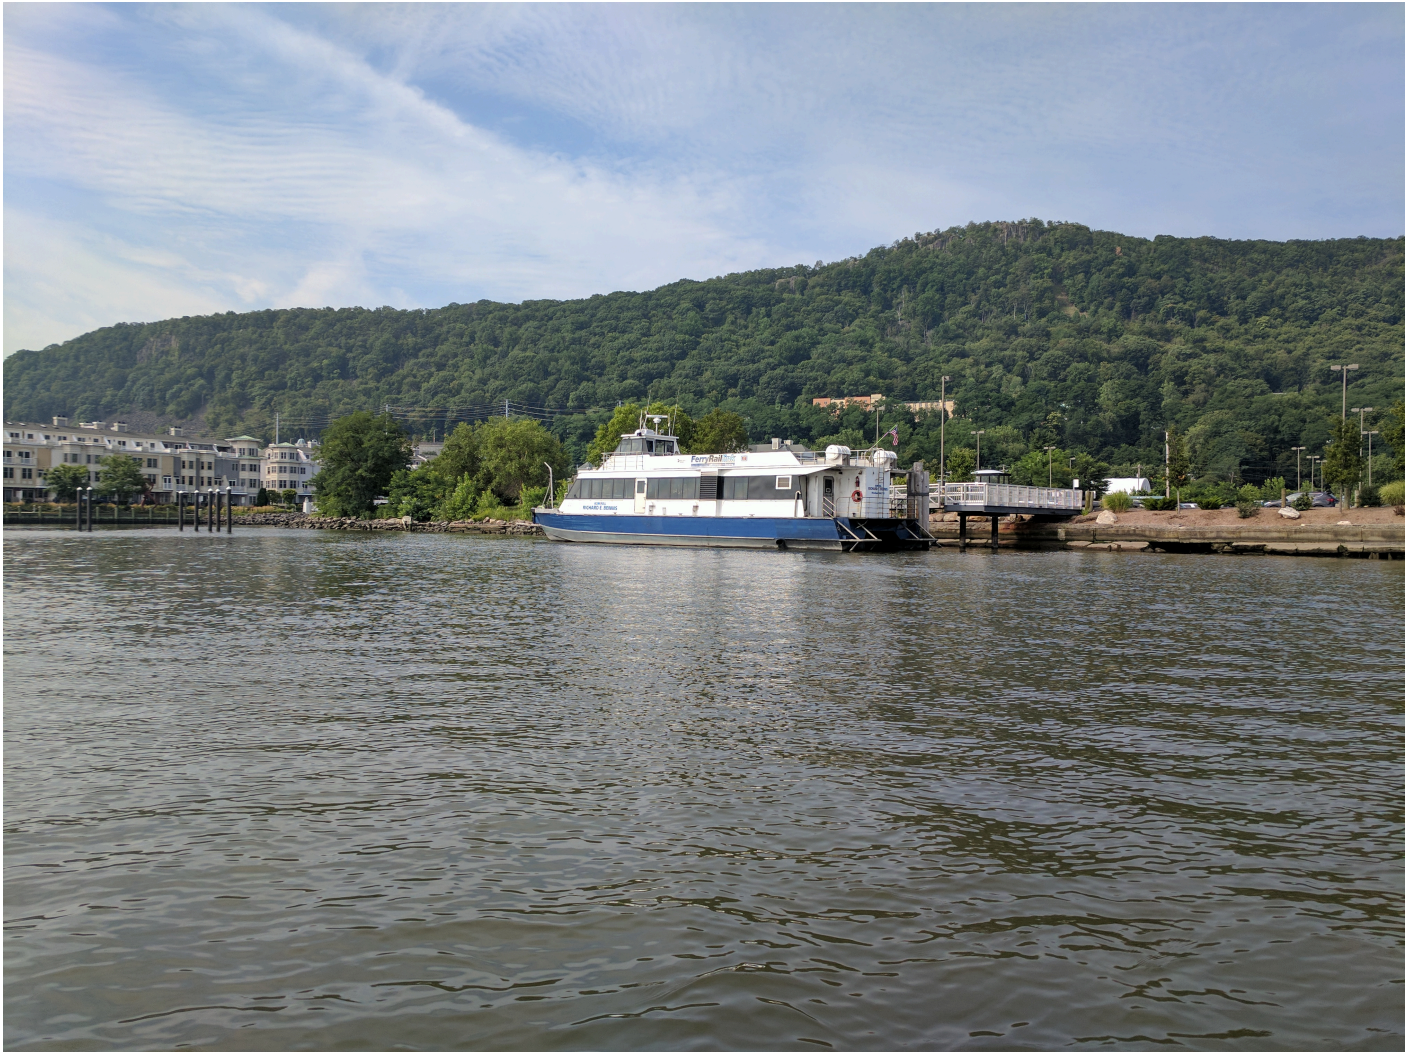
A ferry exists that goes from Haverstraw, NY to Ossining, NY. The route the ferry takes was observed visually in the field and found online, see http://web.mta.info/mnr/html/raillink/schedules/haverstraw_start.htm. The route has been attributed in the final feature file.

Figure 19: Ferry at Haverstraw, NY.
