DESCRIPTIVE REPORT

Type of Survey: Navigable Area

Registry Number: H13088

Sub-locality: Johnson's Lee and vicinity

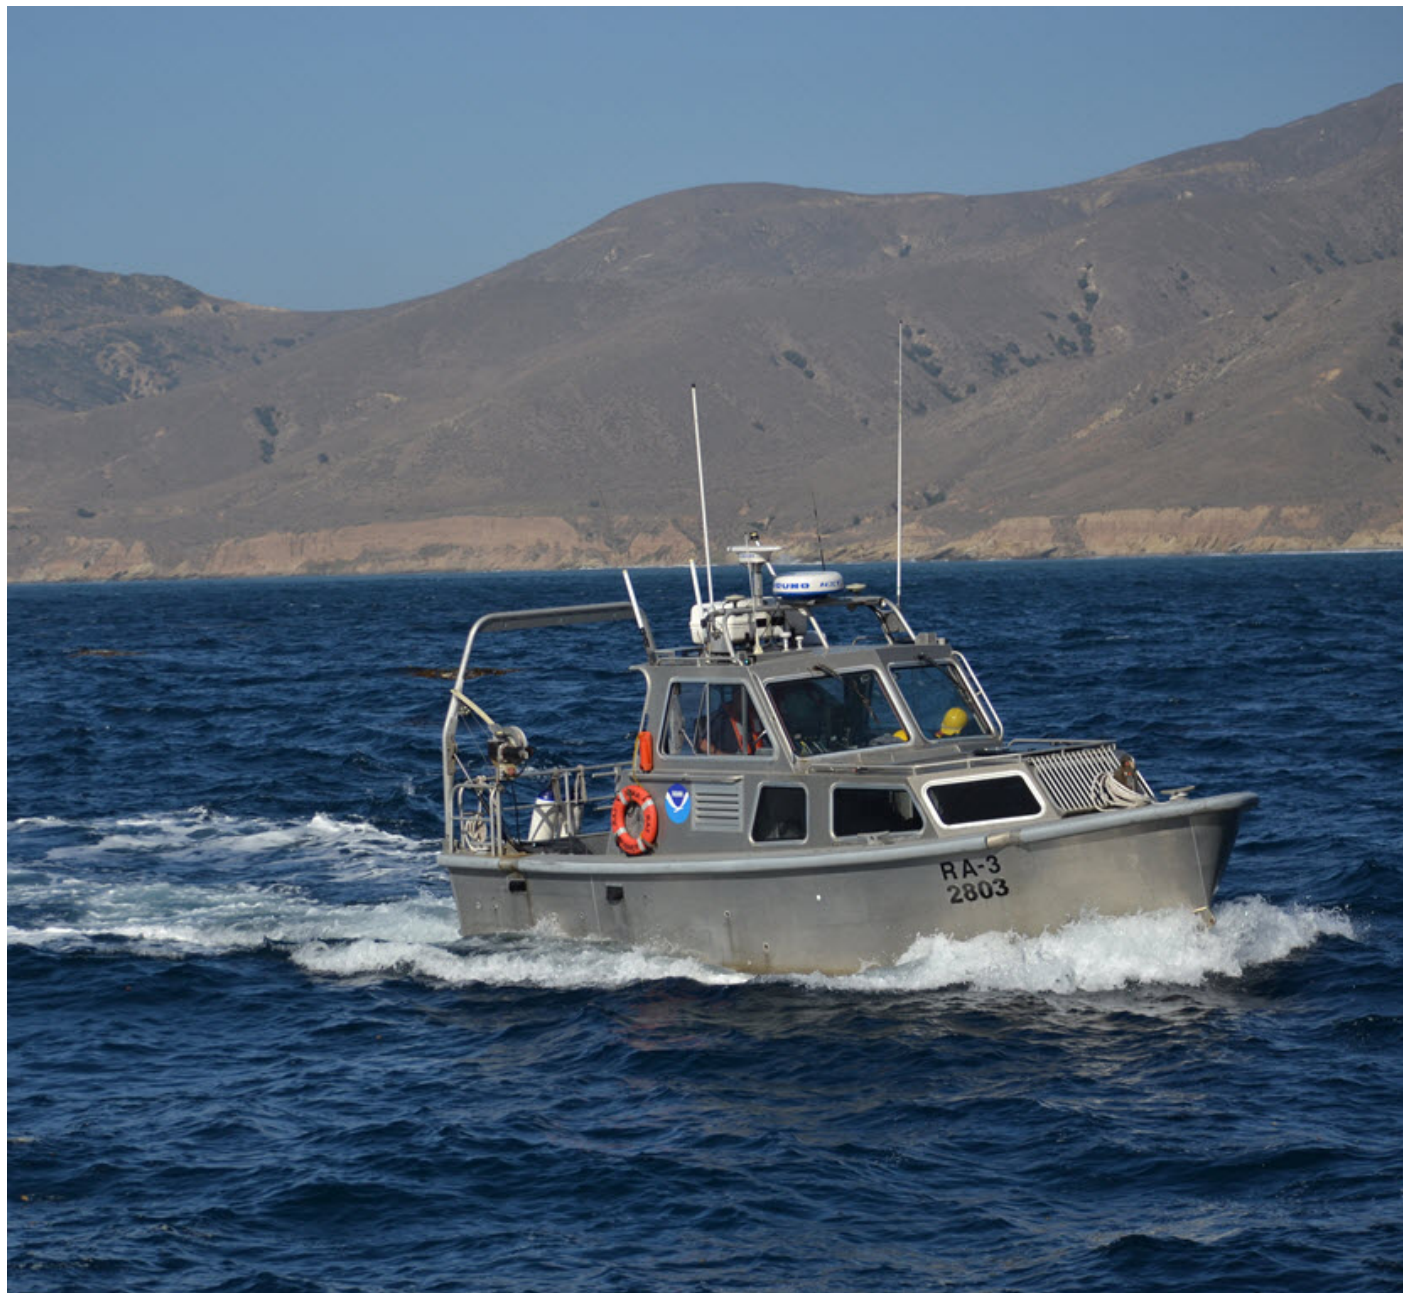
Figure 6: NOAA Survey Launch 2803 near Santa Cruz Island

All data for H13088 were acquired by NOAA Ship RAINIER and survey launches 2801, 2802, 2803, and 2804. The vessels acquired depth soundings, backscatter imagery and sound speed profiles. Shoreline feature verification was conducted from RAINIER skiffs 1905 and 1907.

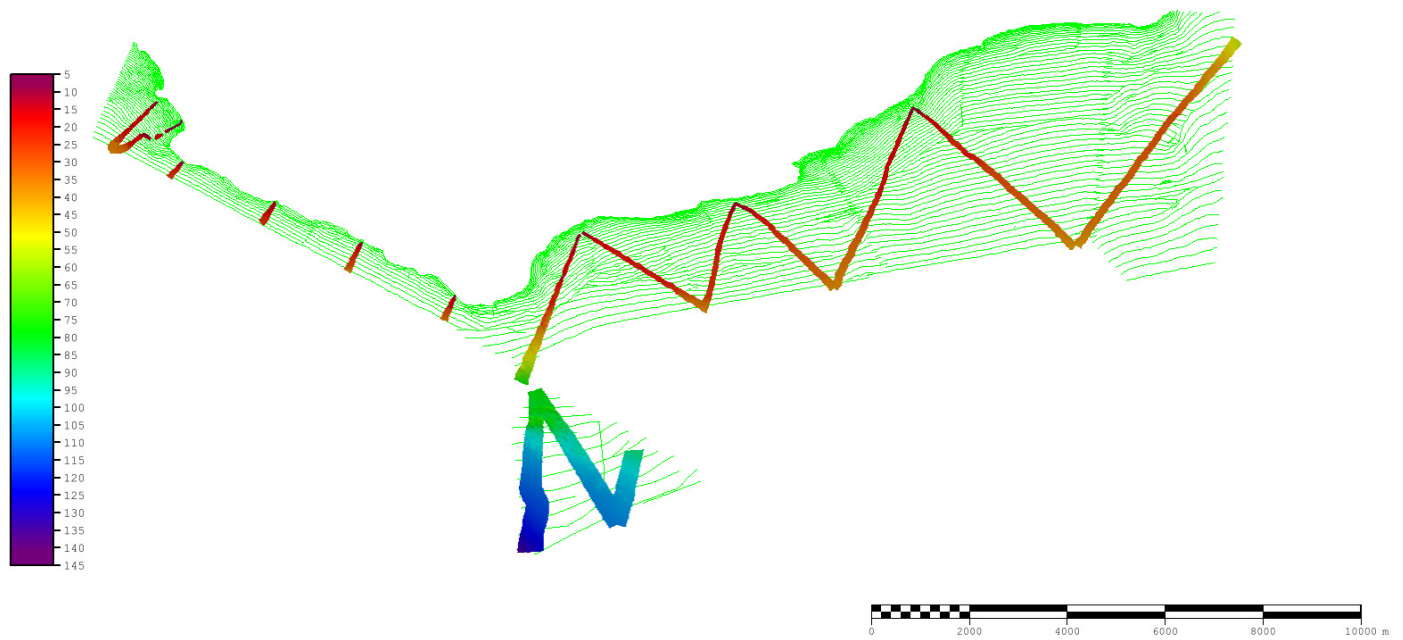
Figure 7: H13088 crossline surface overlaid on mainscheme tracklines.

21.33 nautical miles of multibeam crosslines were acquired by RAINIER S221 and launches 2801, 2802, and 2803 across most depth ranges and 3 boat days. The Hydrographer deems them adequate for verifying and evaluating the internal consistency of H13088 survey data. Analysis was performed using the Compare Grids function in Pydro Explorer on 2-meter resolution finalized surfaces of H13088 mainscheme only and crossline only data. 99.5+% of nodes met allowable uncertainties. For additional results, see figures below.

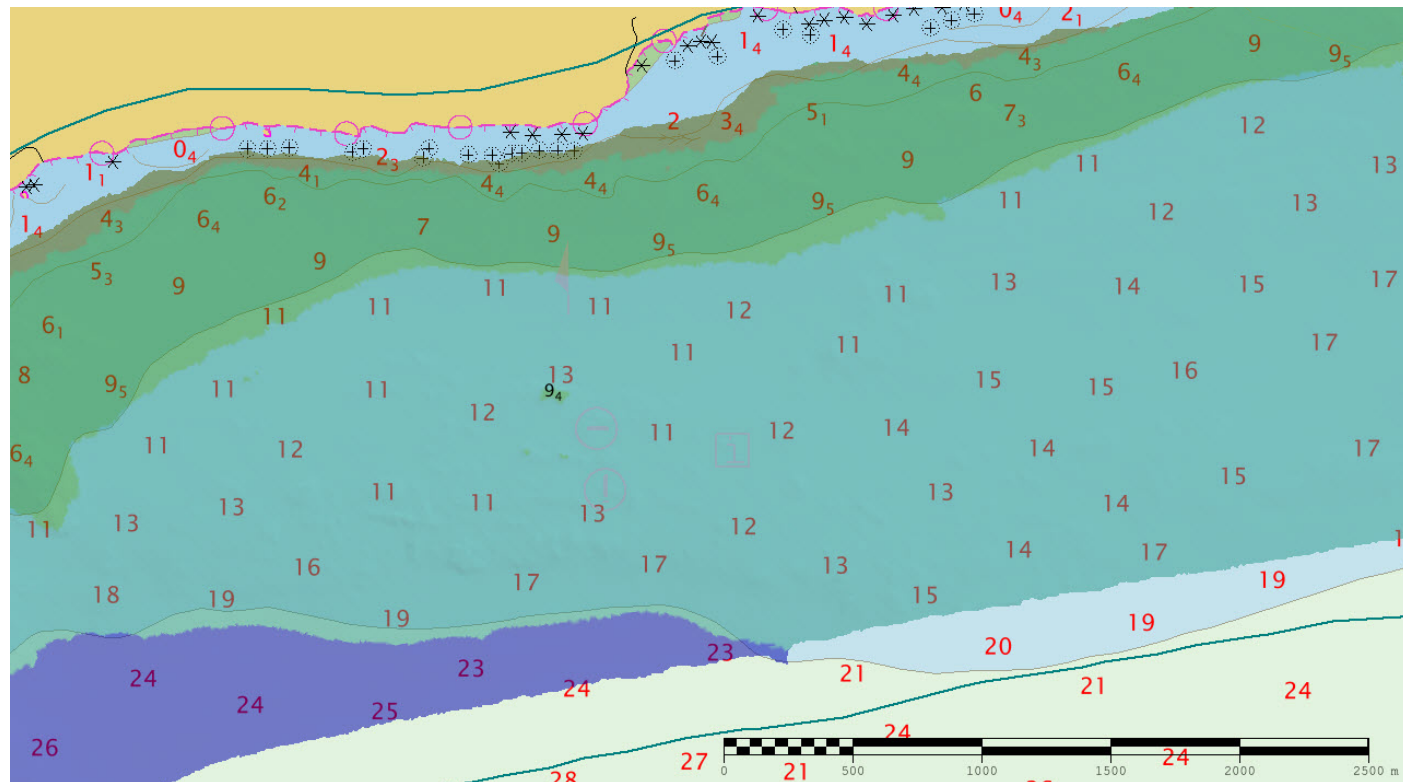
Figure 21: 9.4 fathom sounding below 13 fathom depth on US3CA66M.

Comparison between the soundings on H13088 and depth curves US5CA66M revealed the following: a sounding of 9.4 fathoms was found outside the 10 fathom depth curve and directly under a 13 fathom depth on the ENC (Figure 21). A 13 fathom sounding was found between 21 fathom and 19 fathom depths, on the 20 fathom depth curve of the ENC (Figure 22).

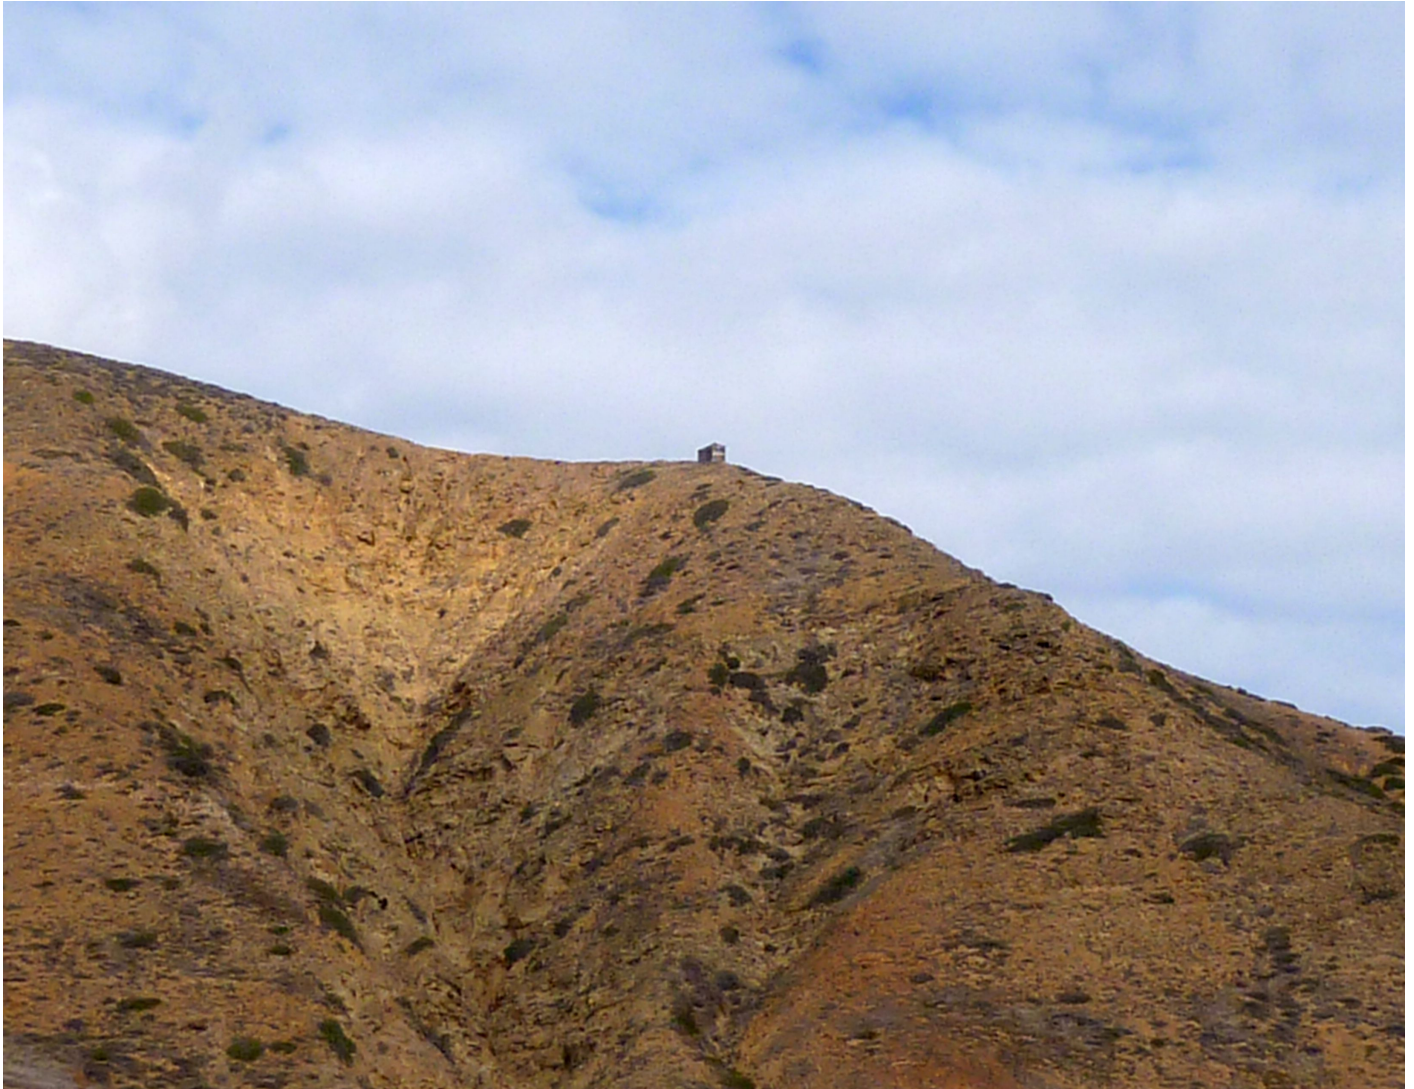
Figure 26: The South Point Light, located in the small white house on the ridge.

One ATON, the South Point Light (Light List # 2755) was observed in the field and appears to be serving its intended purpose.
