DESCRIPTIVE REPORT

Type of Survey: Navigable Area

Registry Number: H13092

Sub-locality: Piermont Pier to South of Ossining

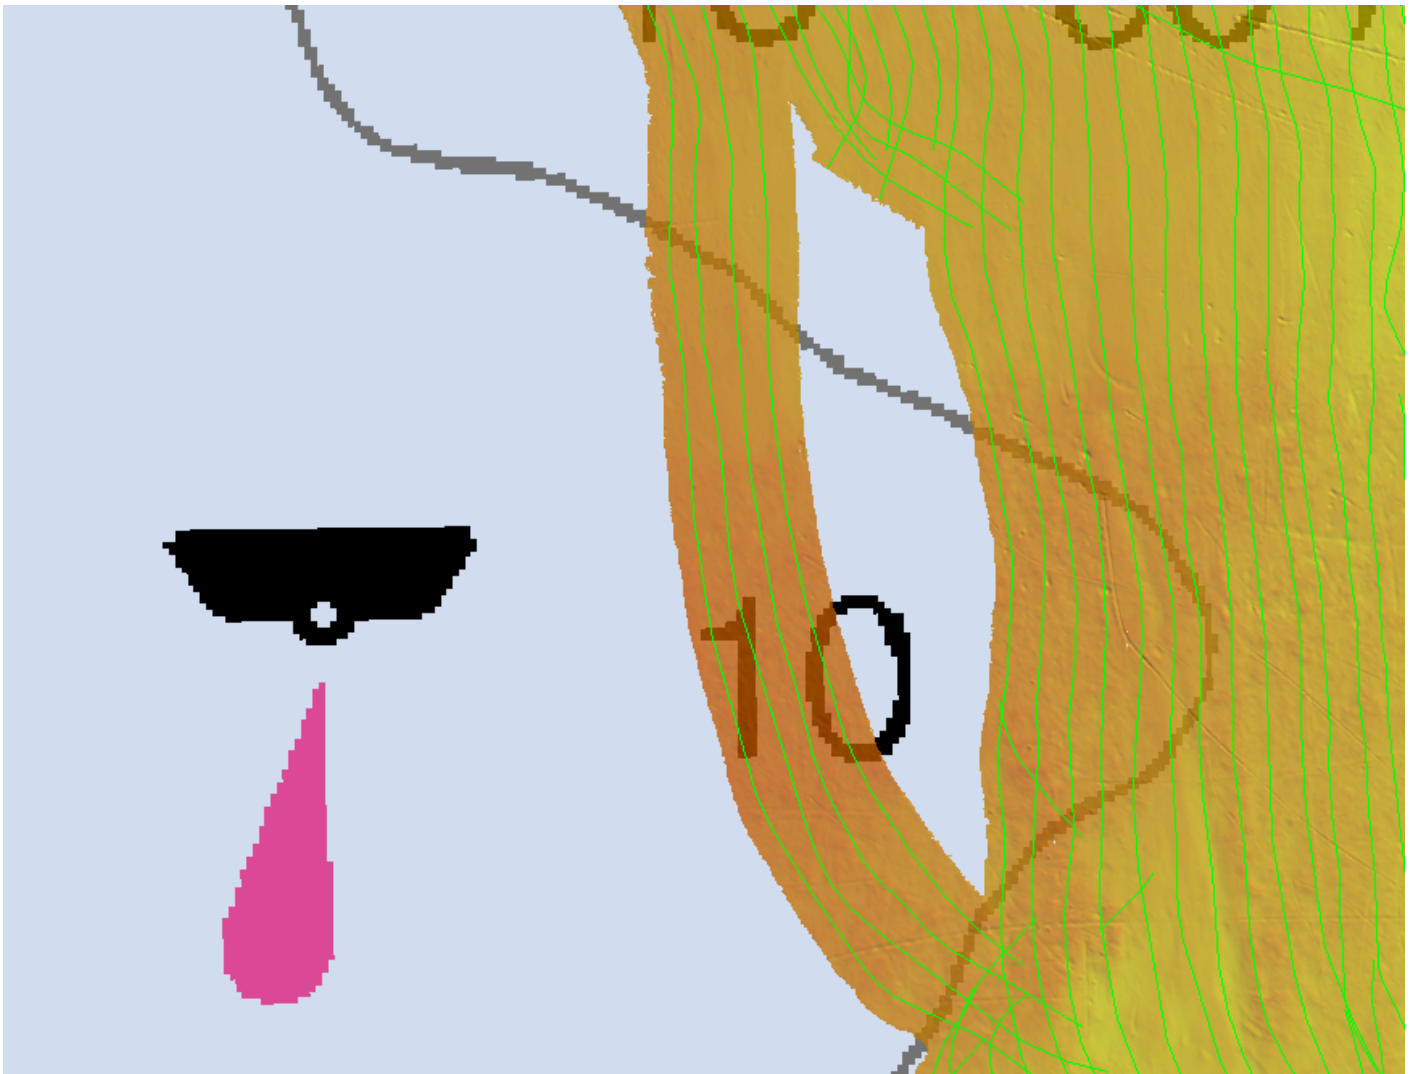
Figure 6: Holiday from surveying around a moored barge

- 3) An approximately 300 meter long by 70 meter wide holiday exists at the south west corner of the survey area where data was acquired around a barge moored to a buoy (Figure 6).

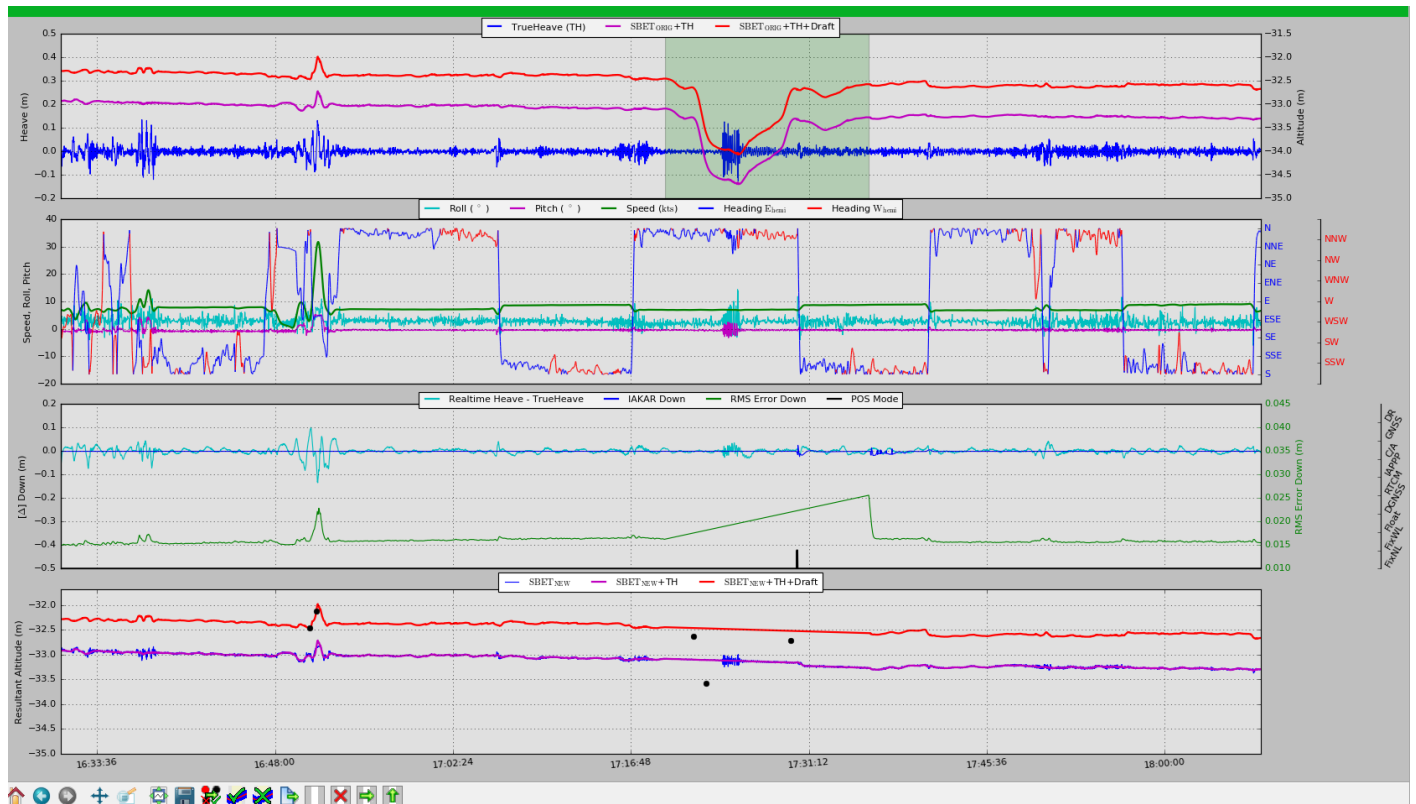
Figure 20: Exampe of an interpolated altitude spike in POSpac Auto QC

Altitude spikes occurred throughout survey H13092 and were cleaned out through interpolation in post processing in Pydro's POSpac Automated QC tool (Figure 20). Subsequently, new SBETs were exported and applied to the bathymetry data in CARIS.

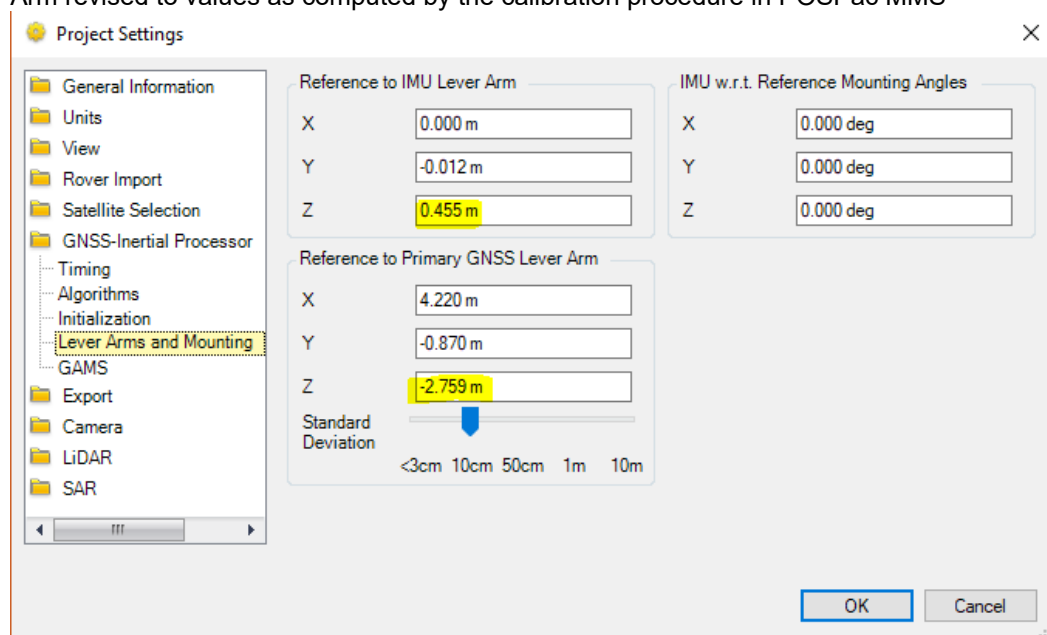
It turned out to be a problem with the lever arm offsets in the POS MV setup. Fortunately those can be adjusted in POSpac MMS processing -- see below for a screenshot of your current "bad" values vs. the revised values:

Existing "bad" values; Note: Ref. to IMU Z has wrong sign (should be - rather than positive), and Ref. to Pri. GNSS Lever Arm revised to values as computed by the calibration procedure in POSpac MMS

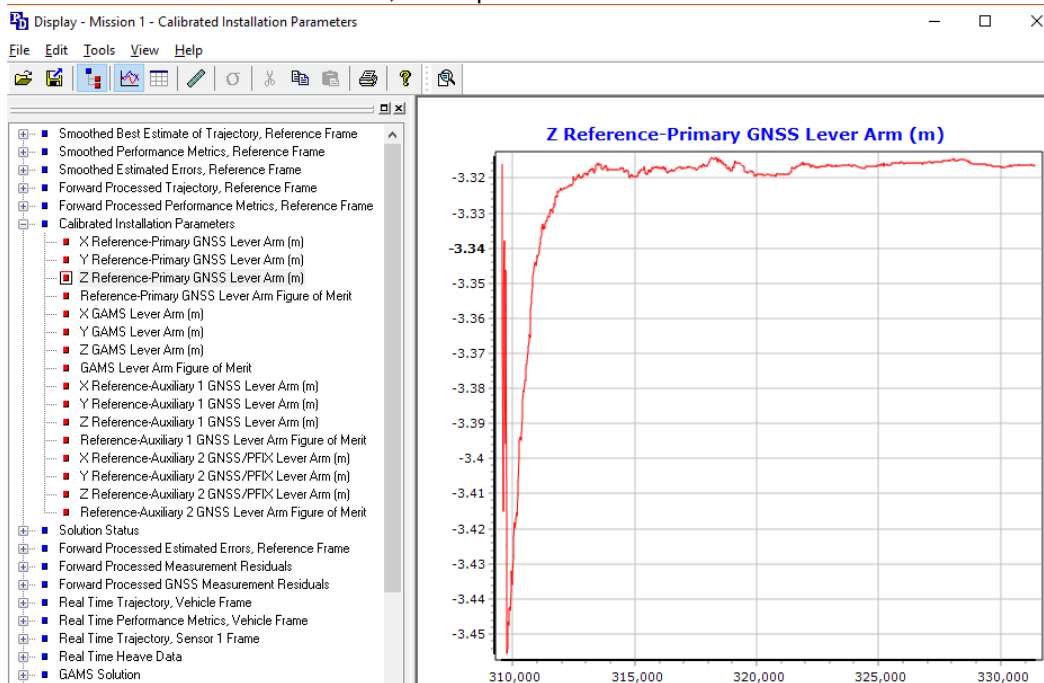
MMS Ref to Pri GNSS Lever arm, Z-component = -3.316 m

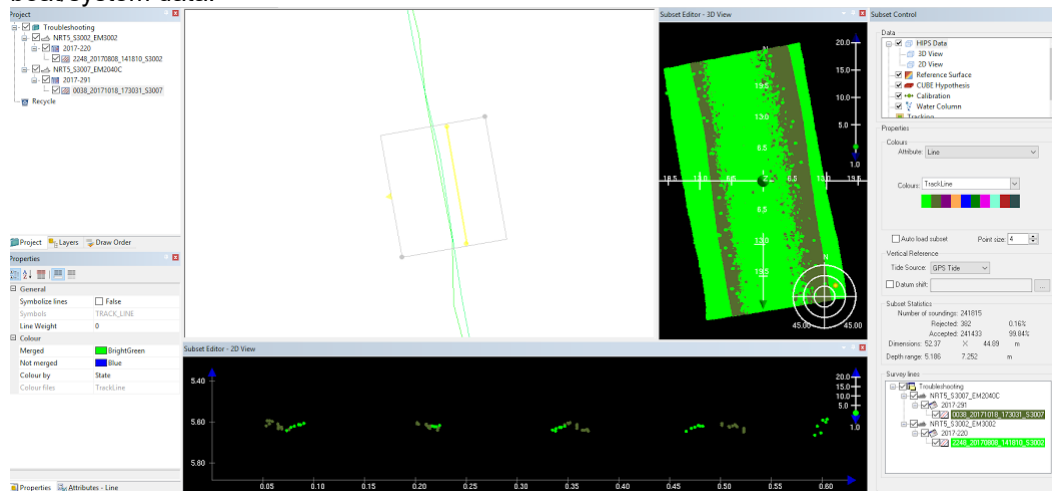
Loading the revised SBET Navigation & GPS Height into the NRT5_S3007_EM2040C/2017-291/0038_20171018_173031_S3007 line you sent, followed by (re)Compute GPS Tide & (re)Merge makes it align with the old boat/system data:
