**DESCRIPTIVE REPORT**

Type of Survey: Navigable Area

Registry Number: H13116

Sub-locality: Ikatan Bay

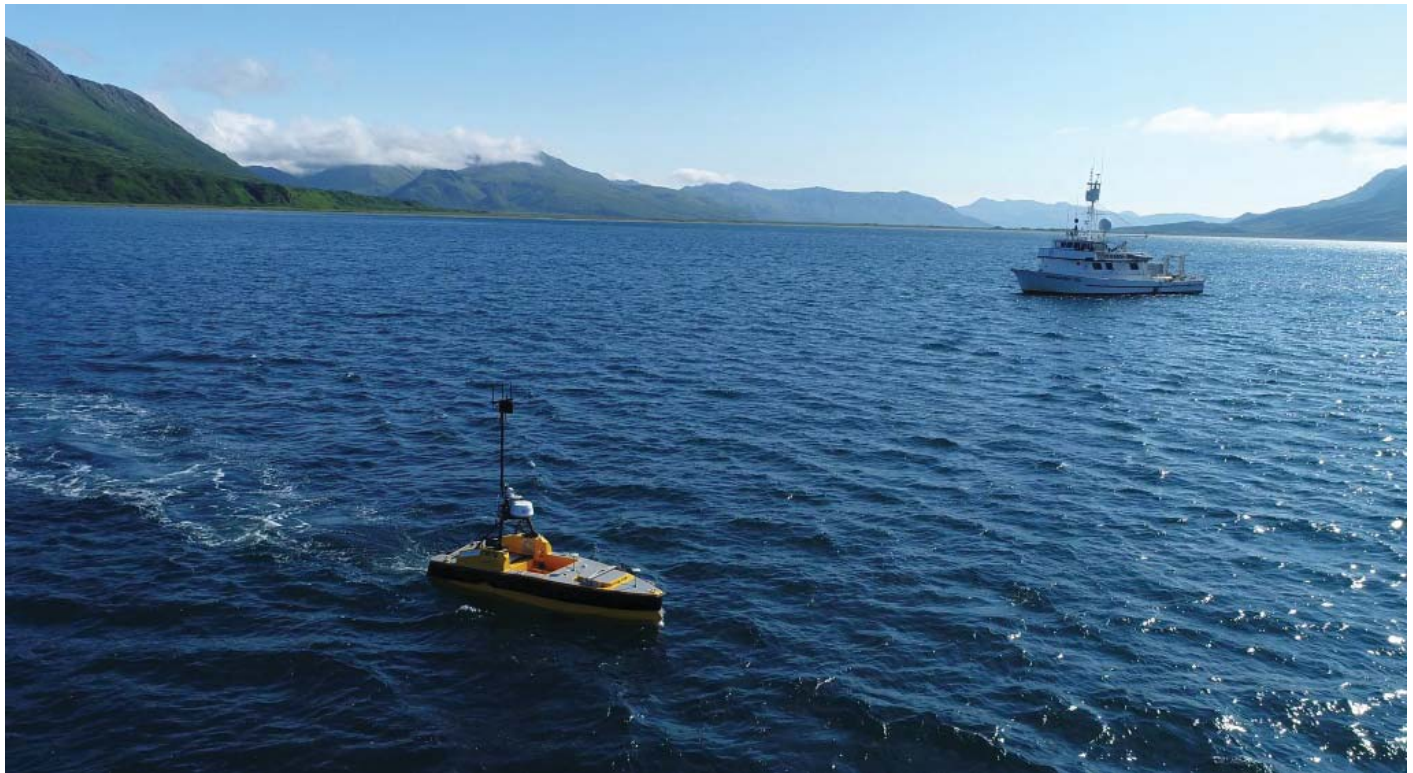
*Figure 4: Survey vessels used on this project - ASV-CW5 (foreground), Q105 (background)*

The Qualifier 105 (Q105) is a 32 m aluminum-hull vessel owned and operated by Support Vessels of Alaska. The Q105 acquired multibeam data and provided housing and facilities for on-site data processing. The vessel was also used to collect bottom samples, deploy/recover BMPG tide gauges, conduct sound speed casts, and deploy/recover the ASV-CW5 vessel.

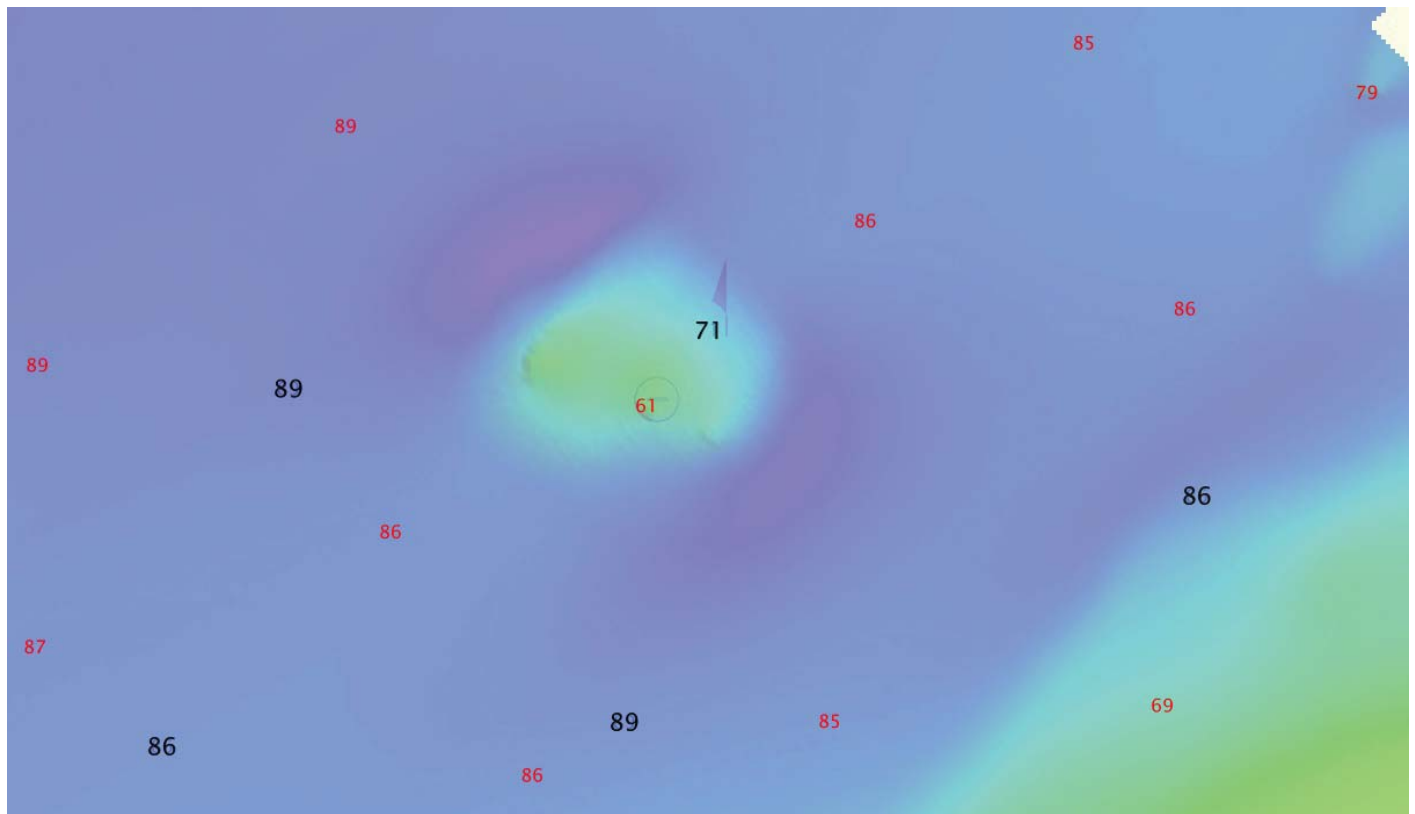
Significant discrepancies appear to be largely due to misrepresented seafloor topology on steep slopes where a small amount of horizontal positioning variance can cause a large discrepancy in depth, or in areas where the survey technology used to produce the soundings on the chart did not fully capture the least depths of the area. An example is included in the images below.

*Figure 10: A common example of a discrepancy on this survey. Soundings from this survey (red) shown on chart US4AK5CM (black). The charted 71 m sounding is relatively accurate but does not capture the nearby 61 m rise in the seafloor found on this survey.*

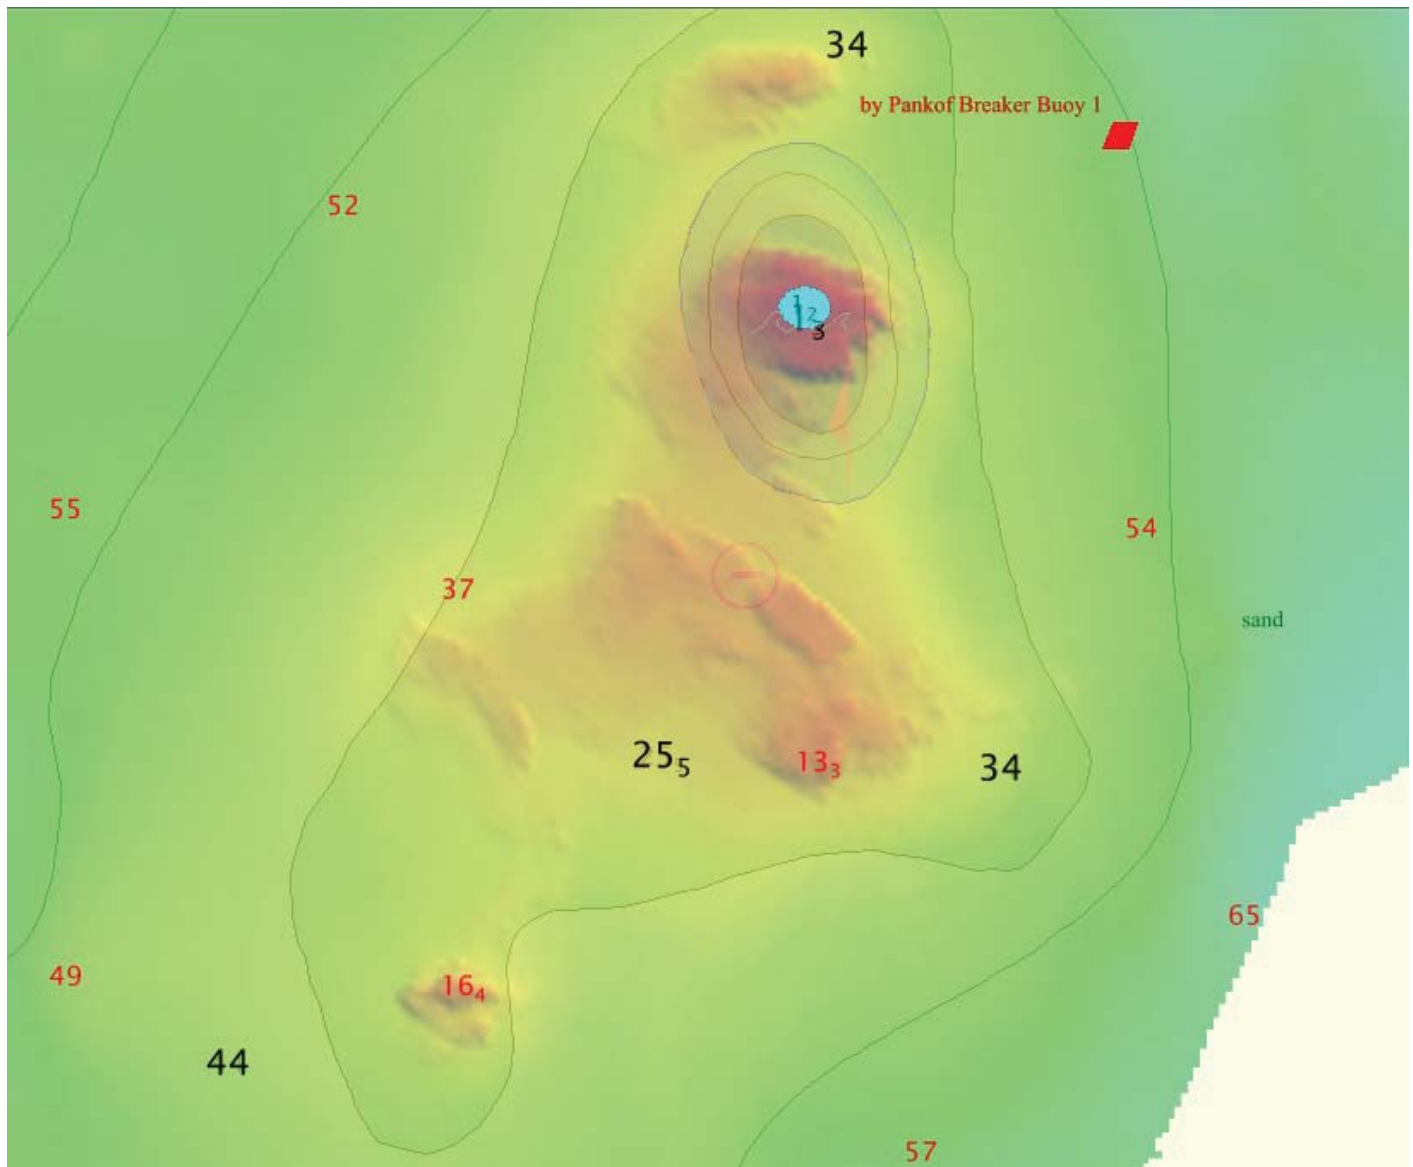
Potentially hazardous soundings were found on seafloor rises south of Pankof Breaker. These were not issued as DTONs considering the proximity to the charted Pankof Breaker danger and draft of vessels commonly transiting this area. This included a 16.4 m sounding at 54-42-19.471 N, 163-00-44.035 W which is between charted 43.8 and 25.6 m soundings, as well as a 13.3 m sounding at 54-52-28.117 N, 163-00-18.8 W which is between charted 25.6 and 34.7 m soundings.

The rock forming Pankof Breaker is adequately charted for both position and depth, though a slightly updated position and least depth are provided for this rock in the FFF.

Figure 14: Shoaler than charted soundings on seafloor features south of Pankof Breaker. Soundings from this survey (red) overlaid on soundings from US4AK5CM (black). Note 16.4 m and 13.3 m survey soundings. Also note updated depth (1.2 m) and position of the rock forming Pankof Breaker (blue).

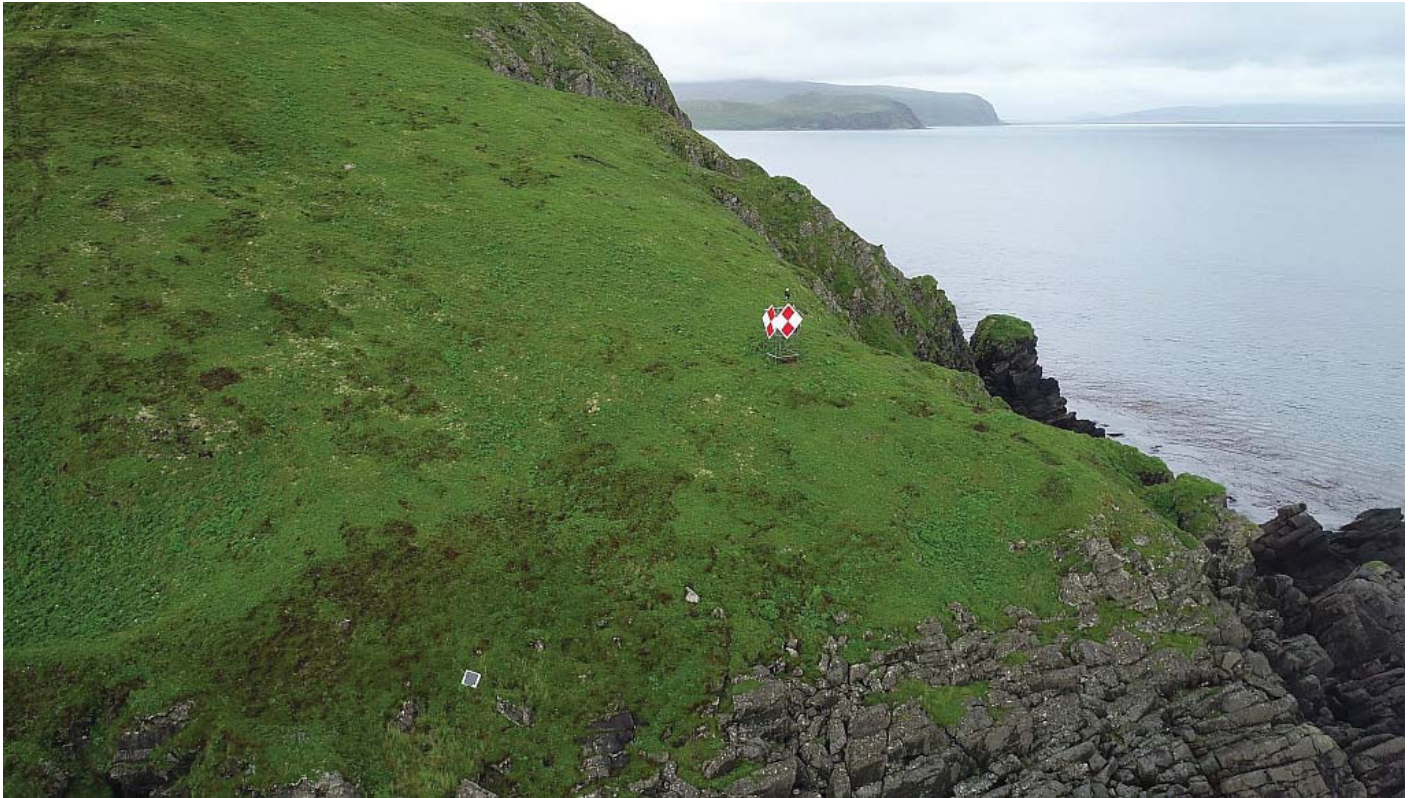
At the time of this survey, Ikatan Point Light was found to be on station, functional, and serving its intended purpose. The position was checked by UAS inspection and found to agree to within 5 m of the charted and USCG Light List position.

*Figure 16: Ikatan Point Light ATON during this survey*
