DESCRIPTIVE REPORT

Type of Survey: Navigable Area

Registry Number: H13196

Sub-locality: Mississippi River, Vicinity of Mile 26 to 0

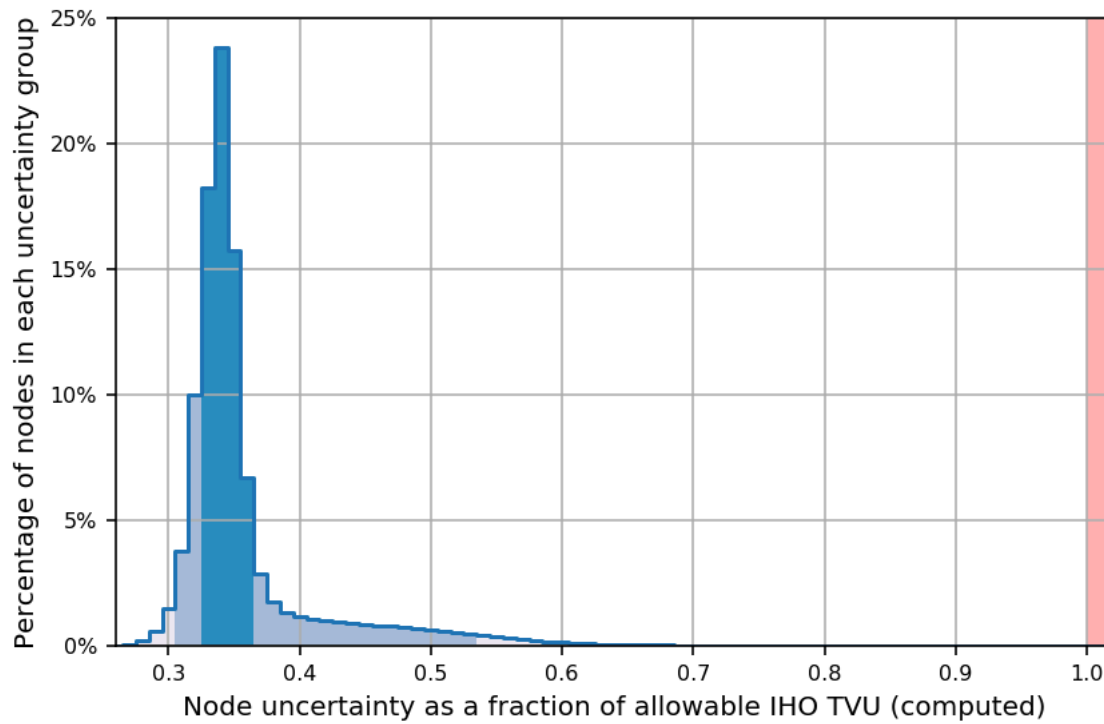
Figure 8: Node TVU statistics - 1m finalized

99.5+% pass (11,485,073 of 11,485,090 nodes), min=0.26, mode=0.34, max=1.15

Percentiles: 2.5%=0.31, Q1=0.33, median=0.34, Q3=0.36, 97.5%=0.53

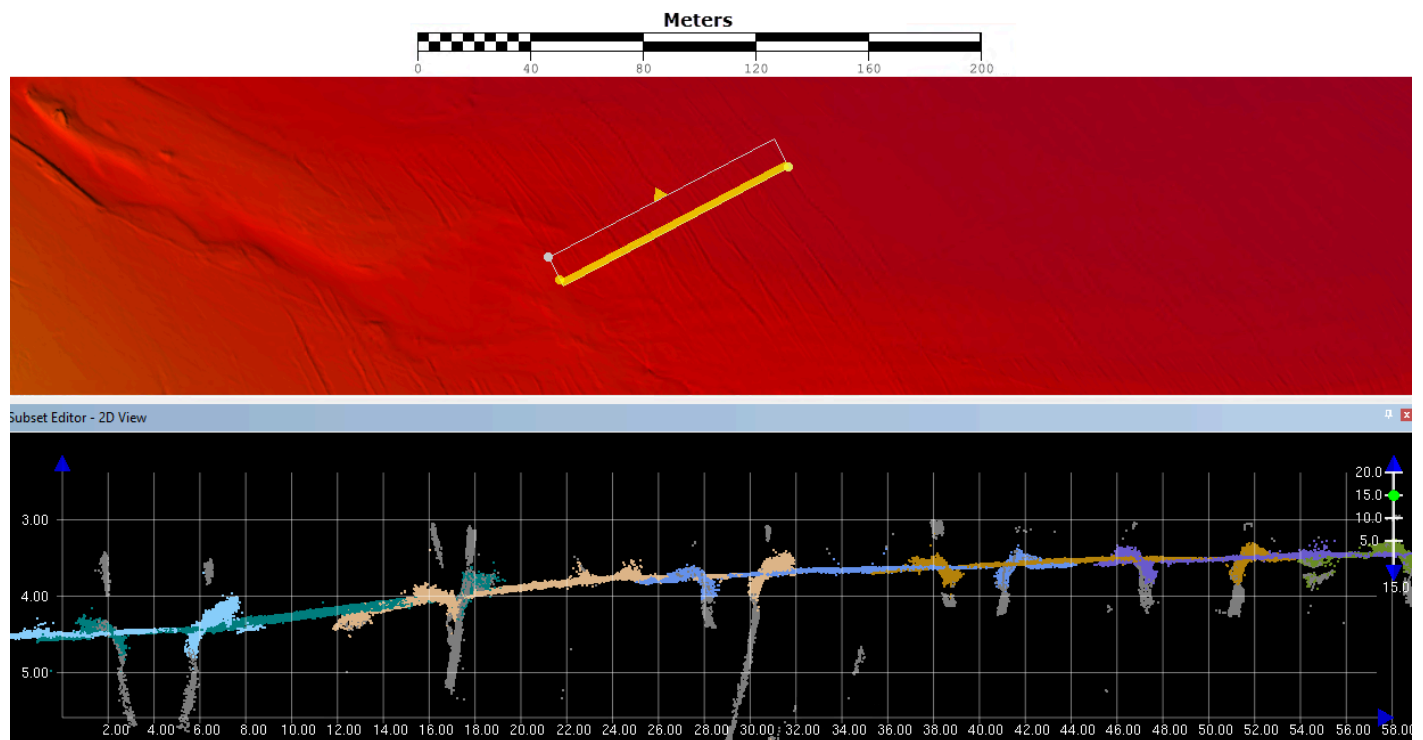
Figure 16: Example of erroneous bottom tracking of flat shoal areas in HDCS data and resultant surface artifact (gray soundings rejected manually by hydrographer to limit effects to the surface)

During survey acquisition, it was apparent that the combination of shallow water and the river bottom type (an assumption of soft silty mud) made it difficult to get a clean bottom track return from the MBES system. This most frequently was displayed in shallow, flat areas out of the main channel current. To try to mitigate the effect, sonar settings were changed by the hydrographer during acquisition, including changing power, gain, time variable gain (TVG) settings, and pulse length. In the end no clear solution fixed the issue and the hydrographer continuously tuned the sonar for the best return at the time. This is likely a limitation of the instrument and the acoustic properties of the sediments in the depths being surveyed. The HDCS dataset was well cleaned to mitigate the effects to the final surfaces. However, artifacts within IHO specifications, will be apparent in the final delivered surface as shown in Figure 16, with units represented in meters.

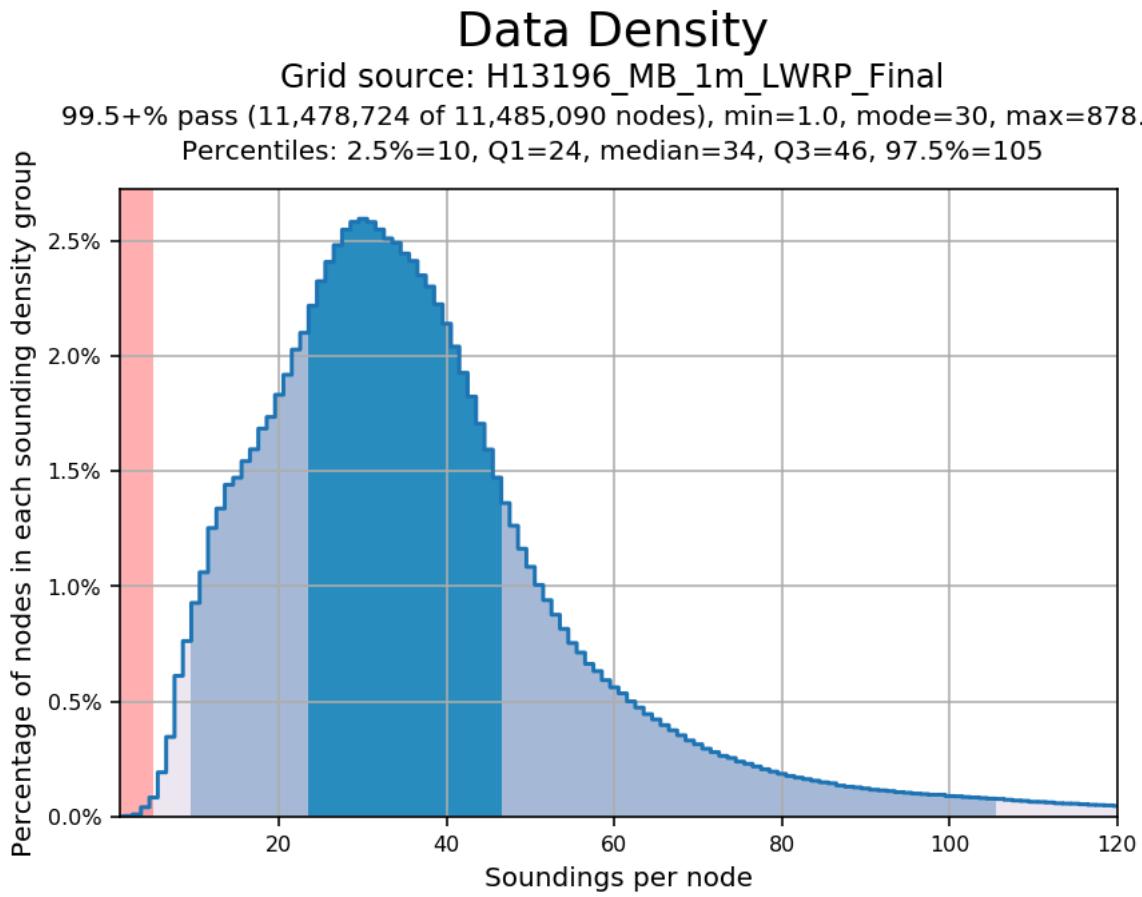
The sounding density requirement of 95% of all nodes, populated with at least five soundings per node, was verified by analyzing the density layer of each finalized surface. Individual surface results are stated in Figures 20 through 22.
