**DESCRIPTIVE REPORT**

Type of Survey: Navigable Area

Registry Number: H13248

General Locality: Kuskokwim Bay, AK

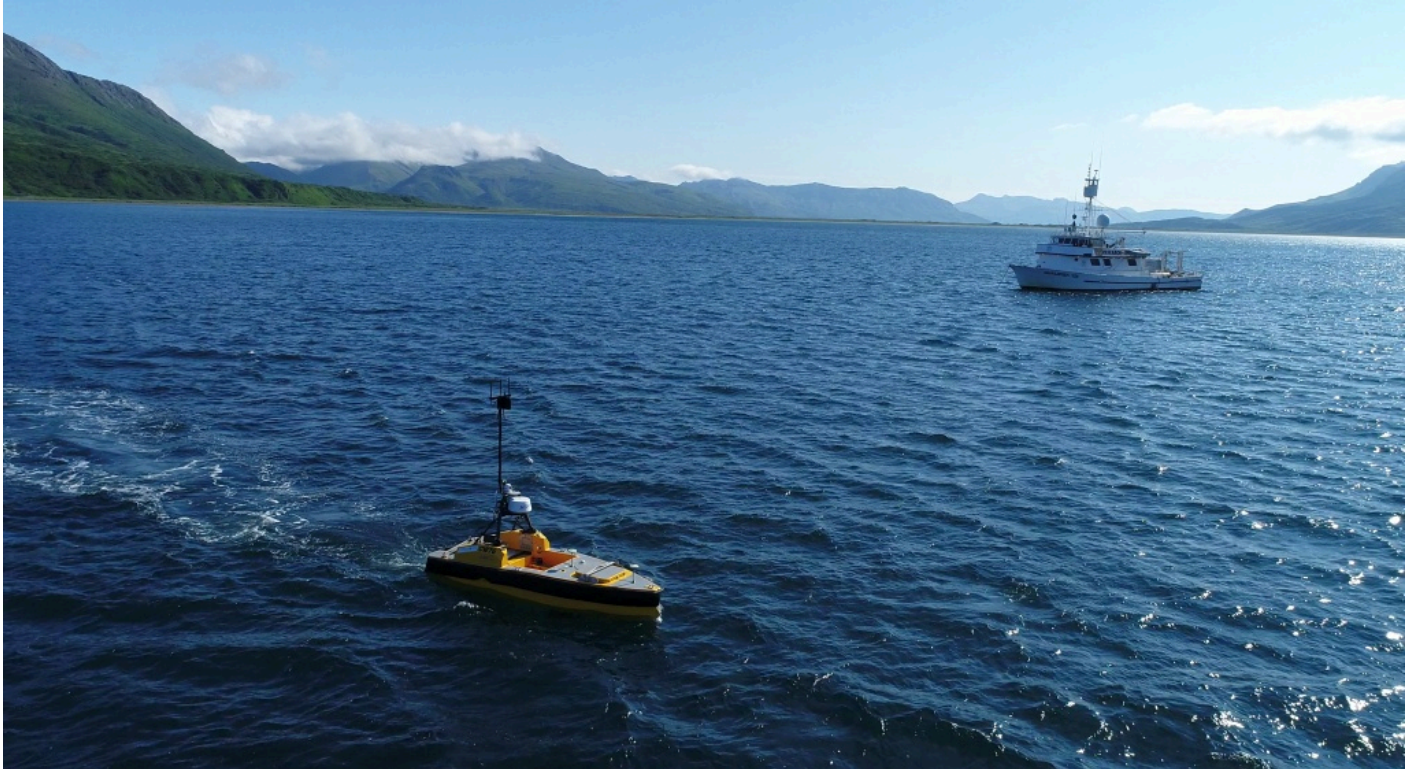
*Figure 3: ASV-CW5 (foreground), and Q105 (background).*

The Qualifier 105 (Q105) is a 32 m aluminum-hull vessel owned and operated by Support Vessels of Alaska. The Q105 acquired multibeam data and provided housing and facilities for on-site data processing. The vessel was also used to collect bottom samples, deploy/recover BMPG tide gauges, conduct sound speed casts, and deploy/recover the ASV-CW5 vessel.

The ASV-CW5 (C-Worker 5) is a 5.5 m aluminum-hull Autonomous Surface Vessel (ASV) owned and operated by L3-Harris ASV. The ASV was operated in an unmanned but monitored mode, collecting multibeam data in close proximity to the Q105.

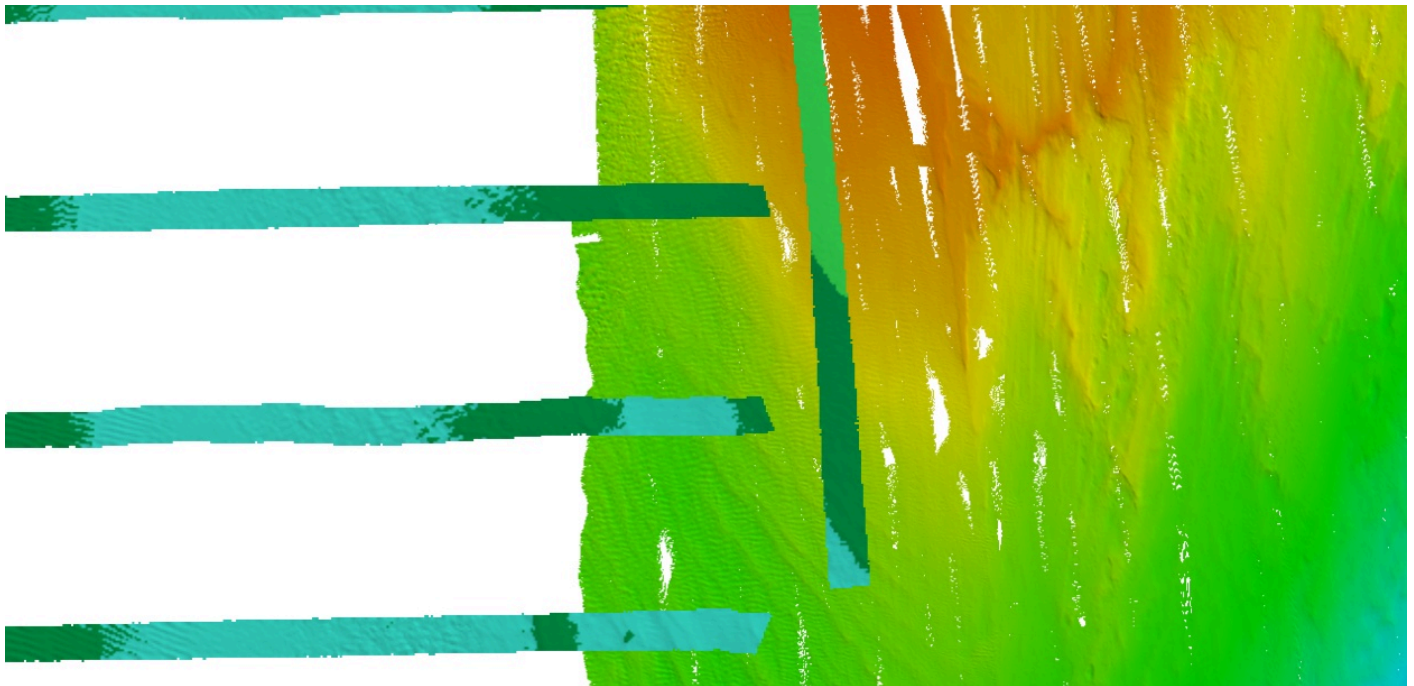
Agreement between the surveys is poor. The mean difference is 0.25 m with a standard deviation of 0.70 m. 76% of grid cells compare within allowable TVU for the depth.

Differences are attributable to bottom change in this very dynamic area. Much of the area appears surprisingly stable given the 8 years separation between the two surveys. However, the most variability exists in areas where both data sets show sandwaves on the seafloor.

*Figure 6: Image showing an area of up to 1 m of disagreement between the 2011 (right side of image) and 2019 (left side of image) surveys. Sandwaves are readily apparent in both data sets.*
