DESCRIPTIVE REPORT

Type of Survey:	Basic Hydrographic Survey
Registry Number:	H13292
	LOCALITY
State(s):	Washington
General Locality:	Bellingham, WA
Sub-locality:	Approach to Bellingham
	2019
	CHIEF OF PARTY
Michelle	e M. Levano, LTJG/NOAA
LIB	RARY & ARCHIVES
Date:

Descriptive Report to Accompany Survey H13292

Project: S-N905-NRT3-19

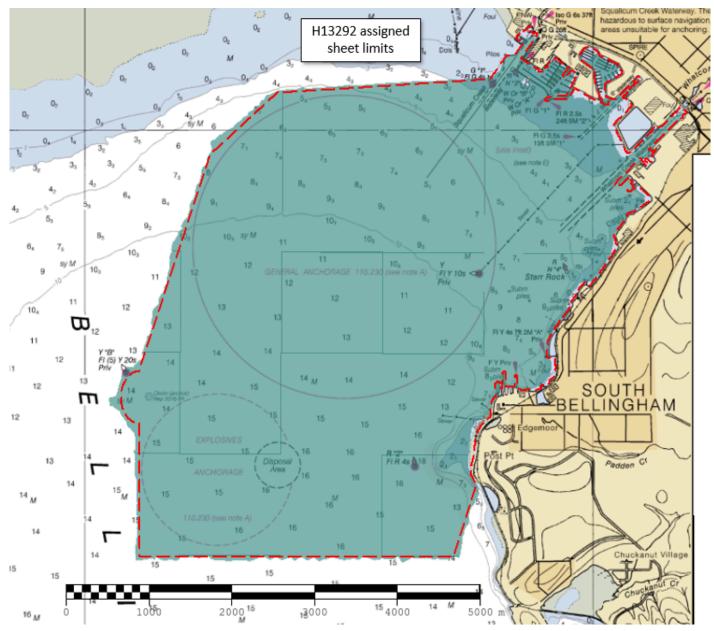
Figure 1: H13292 assigned sheet limits (in red) and survey coverage overlaid onto NOAA chart 18424_1.

This hydrographic survey was acquired in accordance with the requirements defined in the Project Instruction S-N905-NRT3-19. H13292 survey area includes Bellingham Bay along with a general anchorage and an explosives anchorage which are both large ship anchorages (Figure 1).

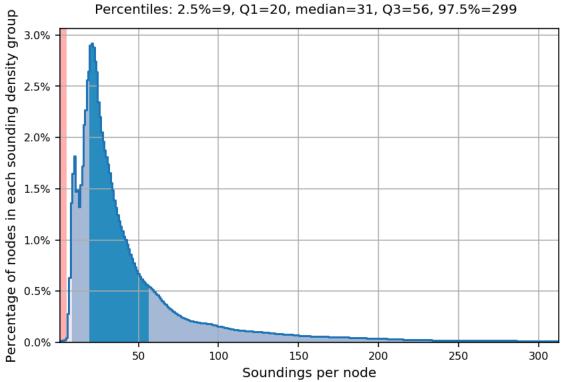
99.5+% pass (65,158,954 of 65,207,118 nodes), min=1.0, mode=21, max=20295.0

Figure 2: Pydro derived histogram plot showing HSSD object detection compliance of H13292 MBES within the finalized CUBE surface.

The surface was analyzed using the HydrOffice QC Tools Grid QA feature (Figure 2). Density requirements for H13292 were achieved with at least 99.5% of surface nodes containing five or more soundings as required by HSSD Section 5.2.2.3. The H13292 survey area shows that the depths less then 30 meters has a largest number of grid nodes (Figure 3).

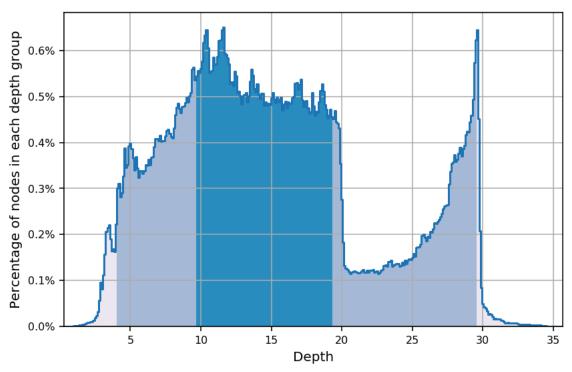
Total nodes: 65,207,129, min=0.30, mode=11.6, max=36.12 Percentiles: 2.5%=4.1, Q1=9.7, median=14.2, Q3=19.3, 97.5%=29.5

Figure 3: Pydro QC tools derived plot showing the percentage of nodes per the depth distribution for H13292 MBES within the finalized CUBE surface.

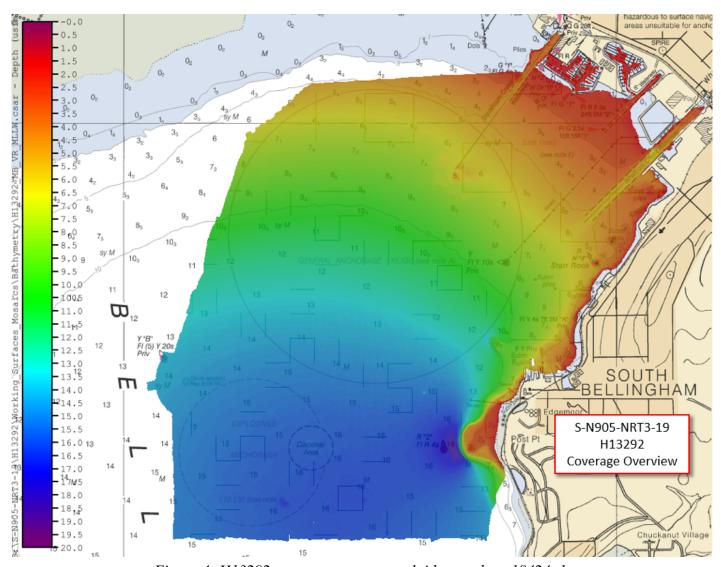
Figure 4: H13292 survey coverage overlaid onto chart 18424_1.

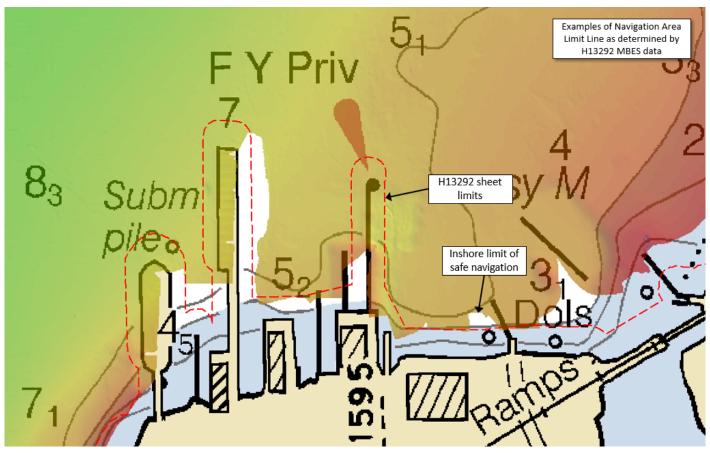
Figure 5: Examples of NALL determination due to piers and boat moorages.

In all areas where the 3.5 meter depth contour or the sheet limits were not met, the Navigable Area Limit Line (NALL) was defined as the inshore limit of bathymetry due to the risks of maneuvering the survey vessel in close proximity to the shoreline and obstructions (Figures 4,5) Hydrographer oversight also lead to two small gaps in the survey coverage (Figures 6-8).

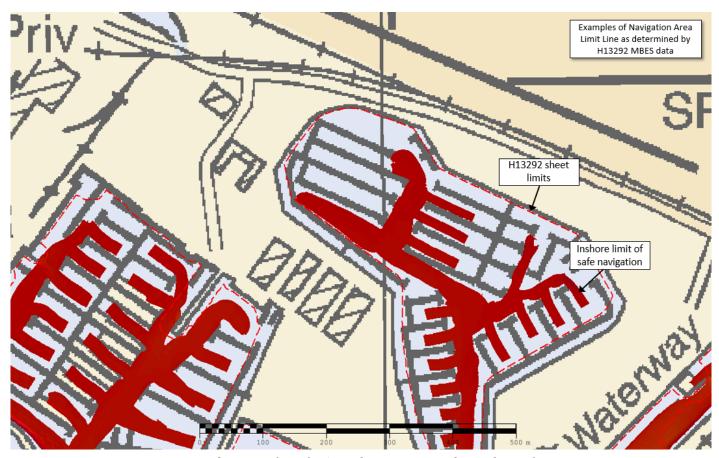
Figure 6: Examples of NALL determination due to boat slips.

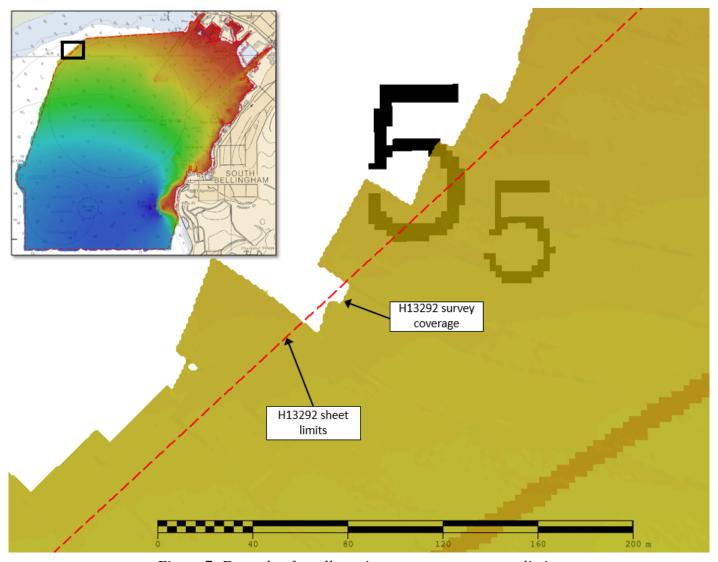
Figure 7: Example of small gap in coverage near survey limits.

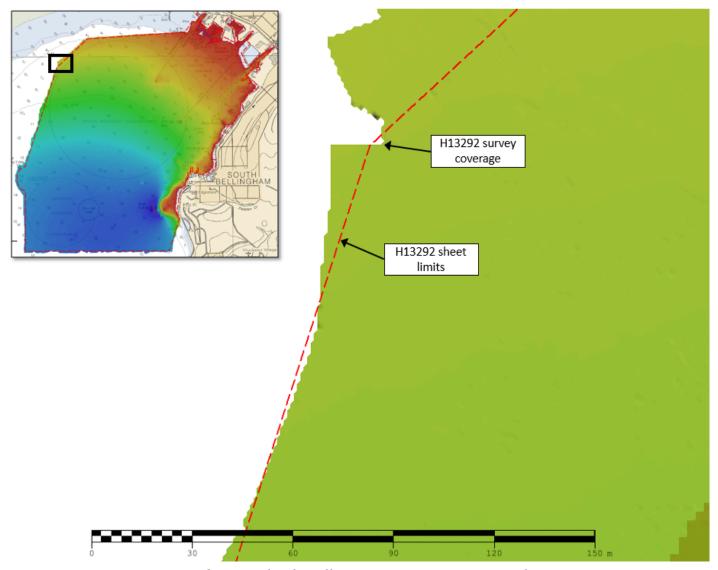
Figure 8: Example of small gap in coverage near survey limits.

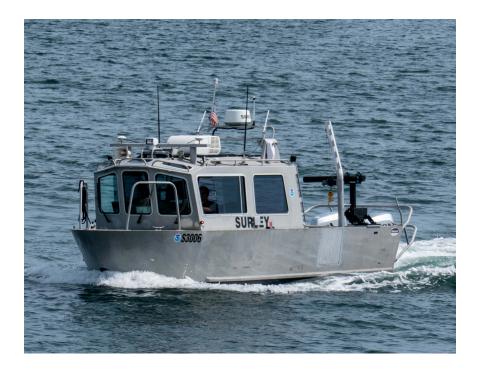
Figure 9: NRT S3006

All data was collected by S3006 (Figure 9). The vessel acquired multibeam depth soundings, sound speed profiles, and bottom samples.

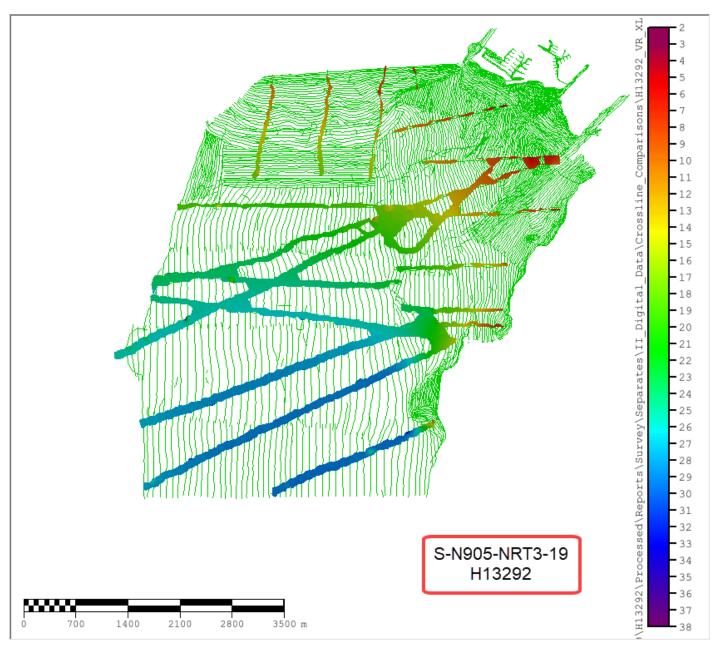
Figure 10: H13292 crossline surface overlaid on mainscheme tracklines showing good temporal and geographic distribution.

Crosslines were collected, processed and compared in accordance with Section 5.2.4.2 of the HSSD (Figure 10). A Variable Resolution (VR) surface was created of only mainscheme lines, and a second VR surface was created of only crosslines. A difference surface was generated in Pydro Explorers Compare Grids tool by subtracting the crossline only surface from the mainscheme surface (mainscheme- crosslines= difference surface). From the difference surface, the following statistics were derived. The mainscheme only, crossline only, and difference surface are included in the submission of this survey as Digital Data.

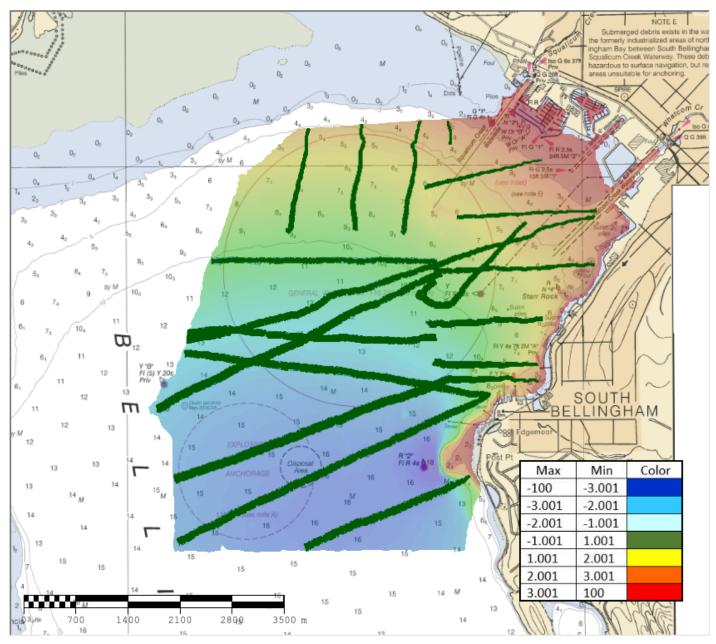
Figure 11: Depth differences between H13292 mainscheme and crossline data as compared to NOAA allowable uncertainty standards for associated depths.

The coloring represents areas where the TVUmax error tolerance in exceeded; red, orange and yellow colors represent areas where mainscheme data is deeper than crossline data; the blue shades represent crossline data is deeper than mainscheme data (Figure 11). In total, 99.5% of the total number of nodes pass the TVUmax test between H13292 mainscheme and crossline data (Figure 12). For H13292 respective depths, the difference surface was compared to the allowable NOAA uncertainty standards (Figure 13,14). Statistics show the mean difference between the depths derived from mainscheme H13292 data and crossline data was 0.11 meters, with mainscheme data being deeper.

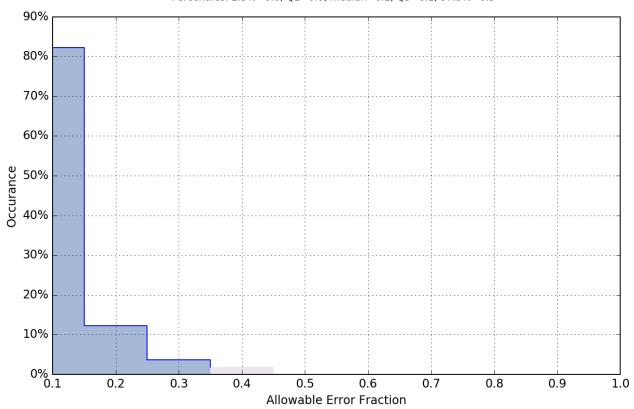
99.5+% nodes pass (1817560), min=0.0, mode=0.1 mean=0.1 max=12.5

Percentiles: 2.5%=0.0, Q1=0.0, median=0.1, Q3=0.1, 97.5%=0.3

Figure 12: Histogram plot utilizing the magnitude (absolute value) of the Allowable Error Fraction to show the indication of what percentage of the total number of the comparisons pass the TVUmax test.

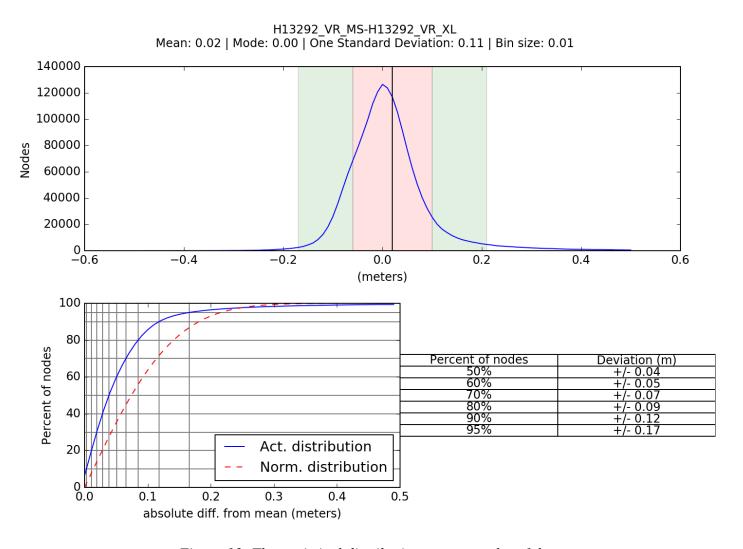
Figure 13: The statistical distribution summary plot of the difference between H13292 mainscheme and crossline data

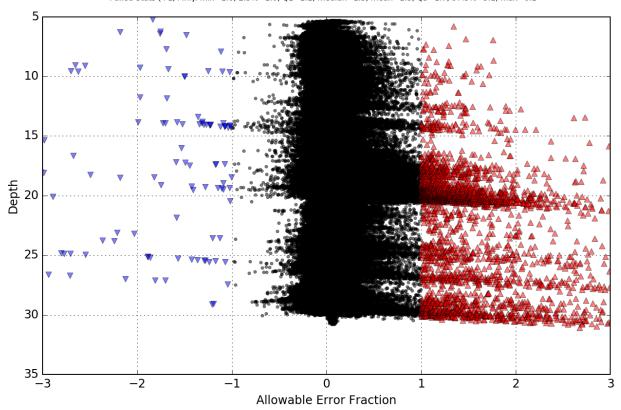
Failed Stats [-inf,-1): min=-12.5, 2.5%=-9.0, Q1=-3.3, mean=-2.7, median=-1.9, Q3=-1.3, 97.5%=-1.0, max=-1.0 Failed Stats (+1,+inf]: min=1.0, 2.5%=1.0, Q1=1.1, median=1.3, mean=1.5, Q3=1.7, 97.5%=3.1, max=6.1

Figure 14: The depth dependent plot of the Allowable Error Fraction, with values between and including +/-1 representing comparisons.

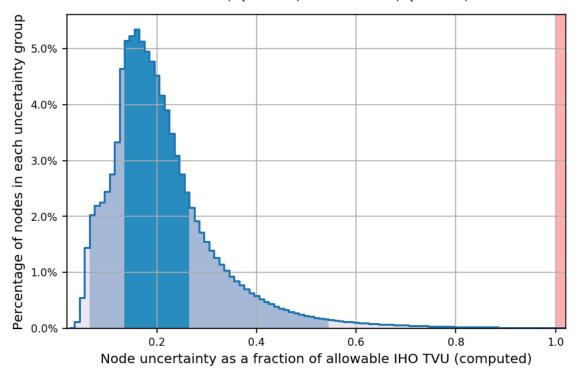
99.5+% pass (65,104,476 of 65,207,118 nodes), min=0.02, mode=0.16, max=6.30 Percentiles: 2.5%=0.07, Q1=0.14, median=0.19, Q3=0.26, 97.5%=0.54

Figure 15: Pydro derived histogram plot showing HSSD uncertainty standards compliance of H13292 finalized VR surface

The surface was analyzed using the HydrOffice QC Tools Grid QA feature to determine compliance with specifications. Overall, 99.5+% of nodes within the surface meet NOAA Allowable Uncertainty specifications outlined in Section 5.1.3 of the 2019 HSSD for H13292 (Figure 15).

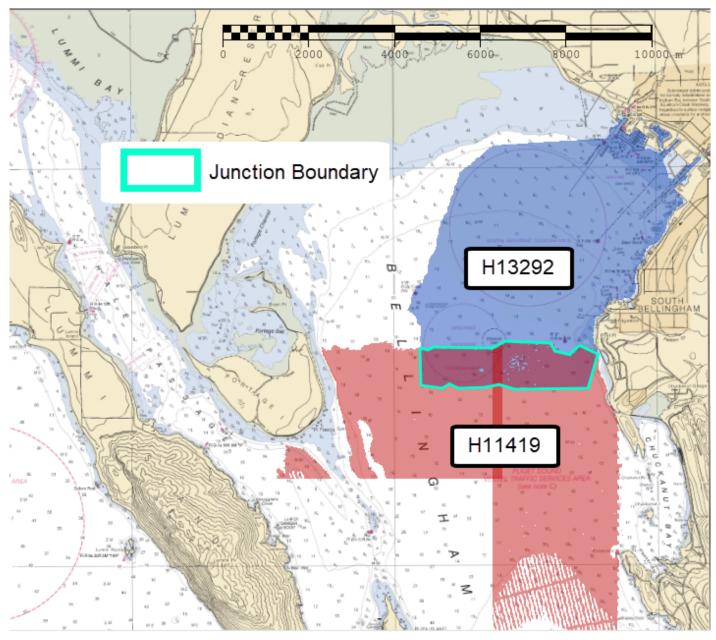
Figure 16: Overview of the survey junction with H11419

Overlap with survey H11419 was approximately 4080 meters wide and 960 meters long along the southern boundary of the survey (Figure 16). Depth within this junction area range from 25 to 30 meters. Contemporary H13292 data at a variable resolution CARIS .csar surface was compared to H11419 1 meter surface, section 14 (H11419_1m_MLLW_14of20) and 16 (H11419_MLLW_16of20).

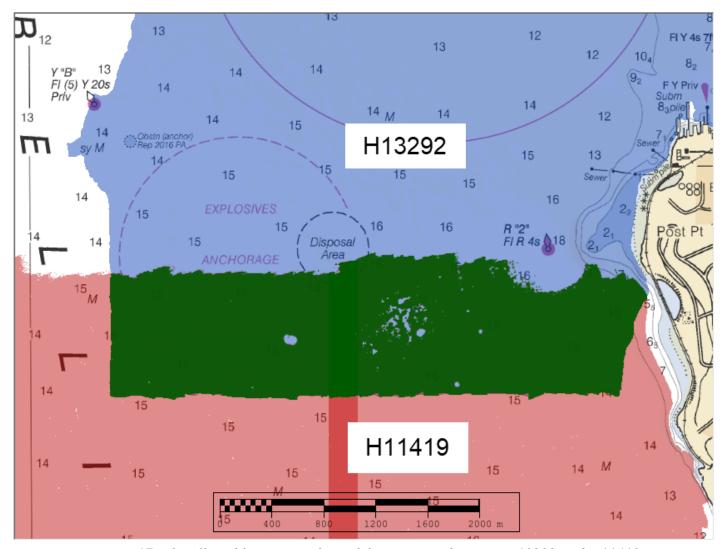
Figure 17: The allowable error surface of the junctions between H13292 and H11419

A comparison was made with Pydro Explorer's Compare Grids tool to create a difference surface between a For the respective depths, the difference surface was compared to the allowable TVU standards specified in the 2019 HSSD (Figure 17). In total 99.5% of the depth difference between H11419 and H13292 are within allowable uncertainties (Figure 18,19). Analysis of the absolute difference surface indicated a mean difference of 0.12 meters above H13292 data, with a standard deviation of 0.11 meters (Figure 20-23). The biggest differences (greater than 1 meter) occurred in areas >20 meters that were not accurately represented by the 1 meter .csar surfaces.

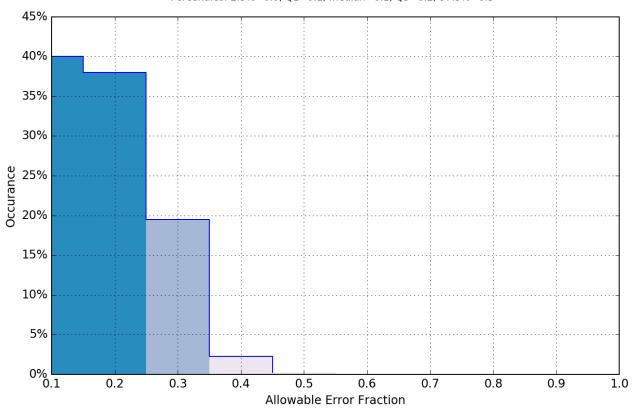
99.5+% nodes pass (2319415), min=0.0, mode=0.1 mean=0.2 max=5.1

Percentiles: 2.5%=0.0, Q1=0.1, median=0.1, Q3=0.2, 97.5%=0.3

Figure 18: Junction between H13292 and the surface H13419_1m_MLLW_14of20

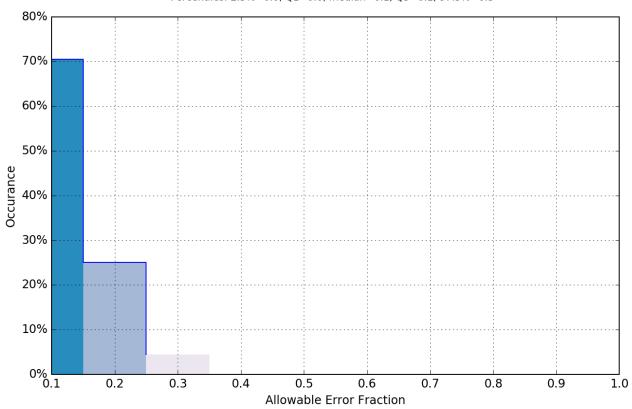
99.5+% nodes pass (1784382), min=0.0, mode=0.1 mean=0.1 max=3.5

Percentiles: 2.5%=0.0, Q1=0.0, median=0.1, Q3=0.1, 97.5%=0.3

Figure 19: Junction between H13292 and the surface H13419_1m_MLLW_16of20

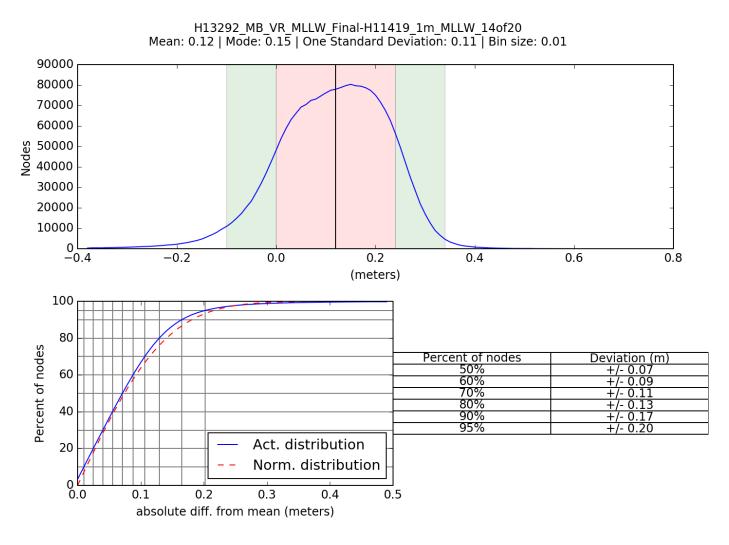
Figure 20: Junction between H13292 and the surface H13419_1m_MLLW_14of20

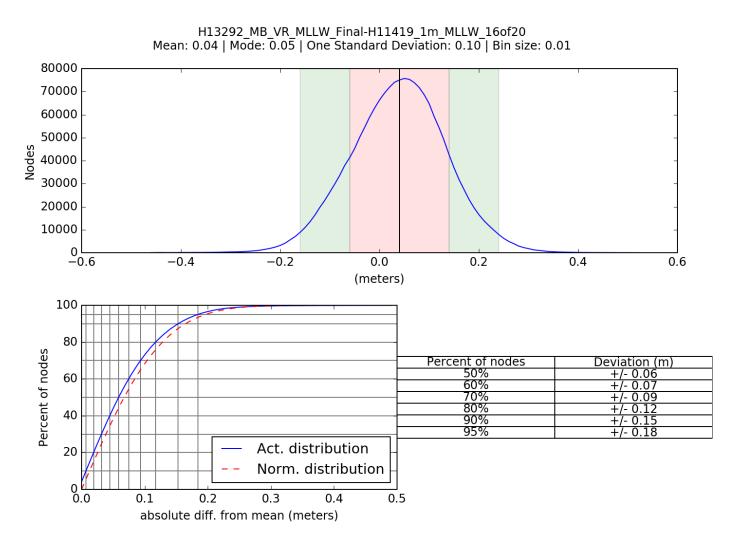
Figure 21: Junction between H13292 and the surface H13419_1m_MLLW_16of20

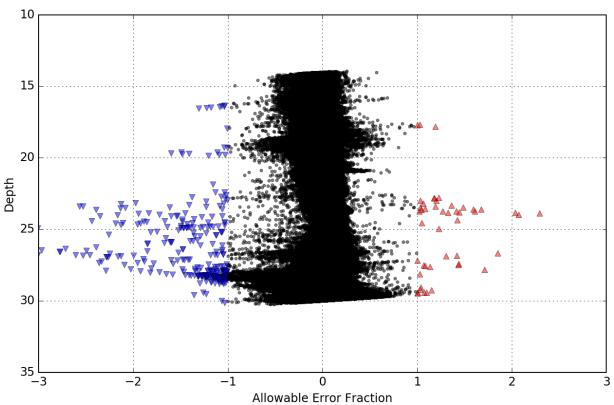
Failed Stats [-inf,-1): min=-5.1, 2.5%=-3.9, Q1=-1.7, mean=-1.6, median=-1.3, Q3=-1.1, 97.5%=-1.0, max=-1.0

Failed Stats (+1,+inf]: min=1.0, 2.5%=1.0, Q1=1.0, median=1.2, mean=1.3, Q3=1.4, 97.5%=2.3, max=3.3

Figure 22: Junction between H13292 and the surface H13419_1m_MLLW_14of20

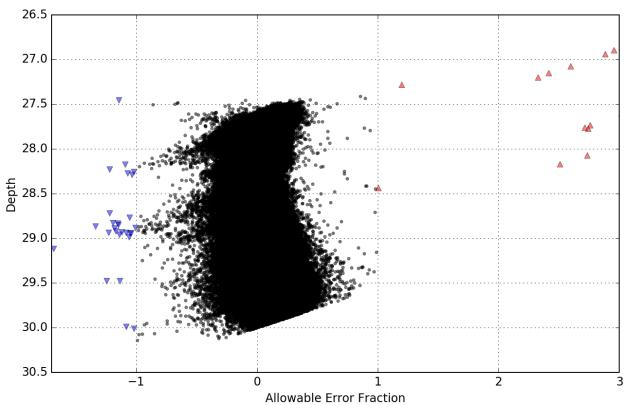
Failed Stats [-inf,-1): min=-1.7, 2.5%=-1.5, Q1=-1.2, mean=-1.1, median=-1.1, Q3=-1.1, 97.5%=-1.0, max=-1.0

Failed Stats (+1,+inf]: min=1.0, 2.5%=1.1, Q1=2.5, mean=2.7, median=2.7, Q3=3.0, 97.5%=3.5, max=3.5

Figure 23: Junction between H13292 and the surface H13419_1m_MLLW_16of20

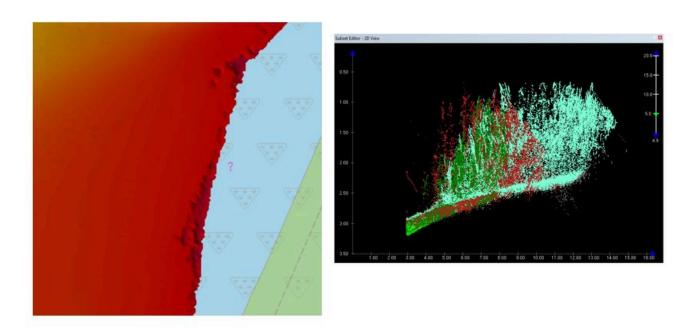
Kelp areas

Concur with clarification. Due to kelp or some other things in the water column, it is difficult to observe the real bottom of the ocean floor and to detect other objects in those areas. This impacted the survey's ability to detect the least depth and features in those areas of kelp. These areas were removed from the surface using the traditional subset data review and process in Caris Hips and Sips.

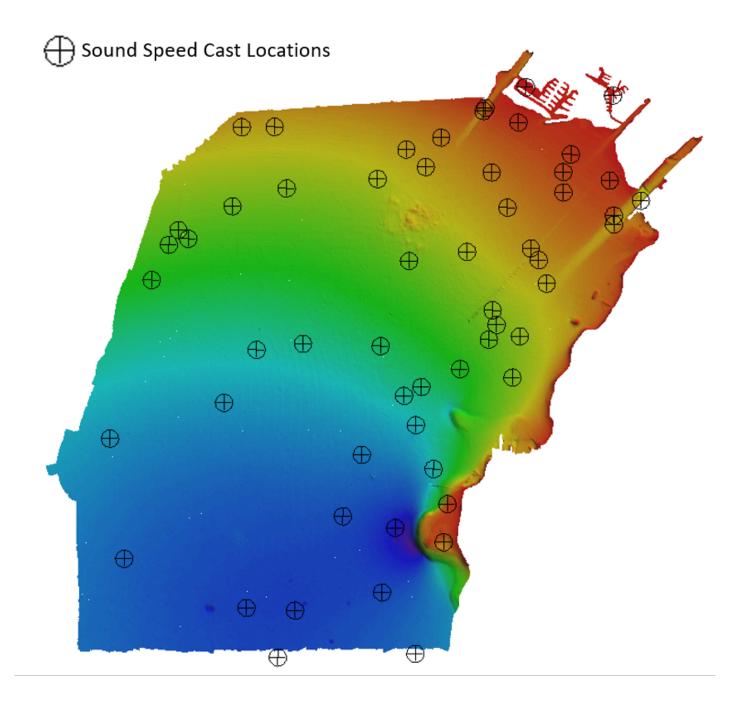
Figure 24: H13292 Sound Speed Cast Locations

Sound Velocity Profiles (SVP) casts were taken at least once every four hours in the deepest water nearest to the active survey area and when there was a change in sound speed values over varying depths (Figure 24). The SVP casts were applied to the MBES lines in CARIS using the "nearest in distance within time of 4 hours" method.

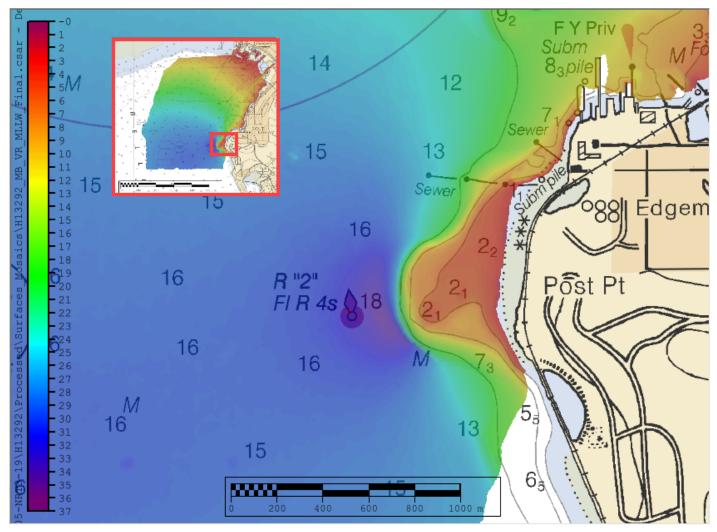
Figure 25: H13292 survey derived depths (in meters) compared to charted depths.

H13292 data included the Sqaulicum Harbor marina, a small boat marina ranging in depths of 3.9-2.9 meters. The Post Point shoal area is charted shoaler than depths retrieved from H13292 survey data (Figure 30).

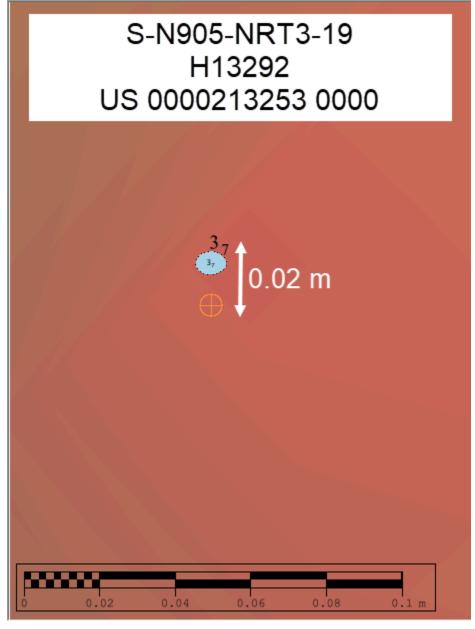
Figure 26: An example of an S-57 feature that will not import directly onto the critical sounding from the VR surface.

There are 55 new features included in the Final Feature File submitted with this report. Many of the DESCRP-New feathers are of previously charted features, with an updated location and VALSOU. Due to the nature of the Variable Resolution (VR) surface, there are two underwater obstructions where the S-57 feature will not import directly onto the critical sounding. This results in an error in Pydro Explorer's QC tools VALSOU Check. These instances are all under 0.02 meters, and should supersede previously charted data (Figure 29). NOAA's Caris liaison and QC tools development team have been made aware of this occurrence. For more information see the Appendix II, Supplemental Survey Records Correspondence.

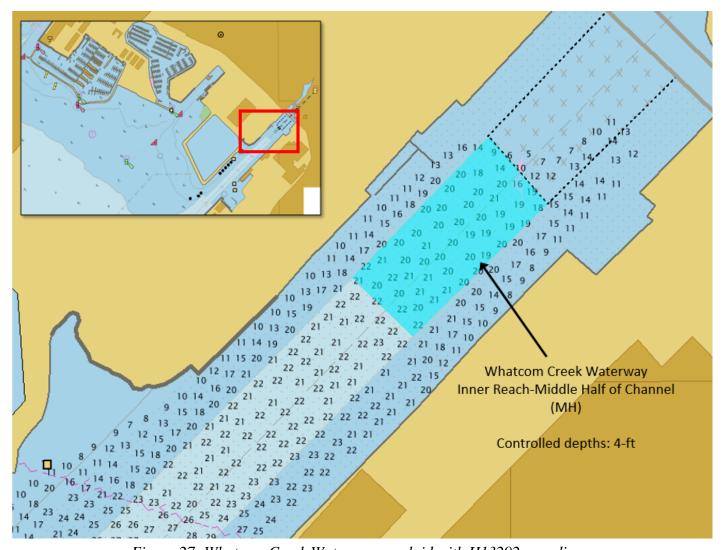
Figure 27: Whatcom Creek Waterway overlaid with H13292 soundings.

The United States Army Corp of Engineers maintain three waterways within the Port of Bellingham. H13292 depths were consisted with the charted depths in the I&J Street Waterway. The northern portions of both the Whatcom Creek and Squalicum Creek Waterways were significantly deeper compared to the tabulated depths with soundings disagreeing by more than 18 feet (Figure 31).

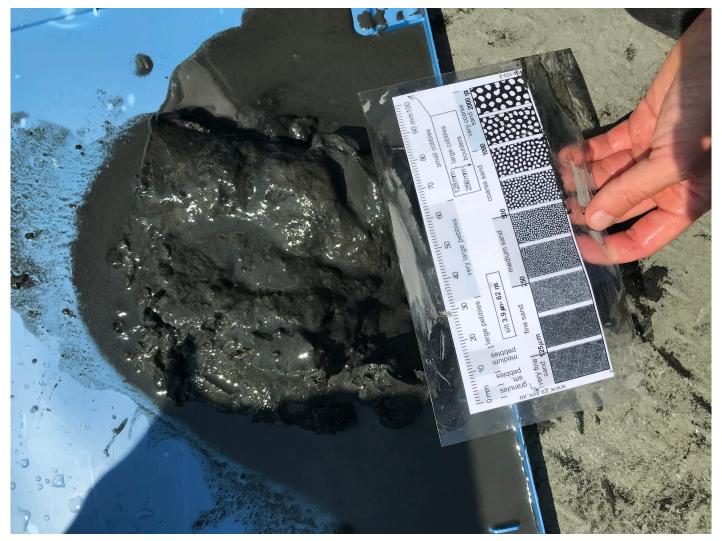
Figure 28: Example of a bottom sample collected within the H13292 survey area.

Four bottom samples were conducted in the assigned locations. There are no drop camera images submitted with these bottom samples. A sample was received for all four locations (Figure 32). Refer to the results included in the H13292 Final Feature File submitted with this report.

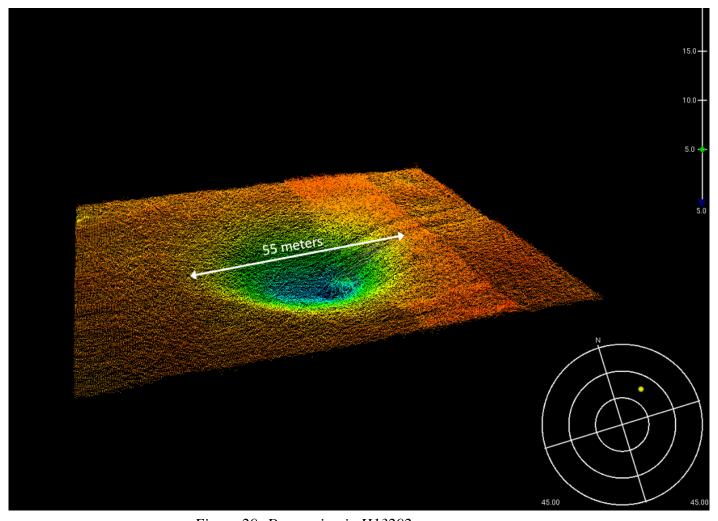
Figure 29: Depression in H13292 survey coverage.

Five large depressions exist in the southern portion of the survey that are 30-90 meters in width and 1-3 meters in depth (Figure 33). These depressions are similar to ones found in the adjacent survey H11419. Appear to be either pockmarks or micro-depressions of unknown origin.
