DESCRIPTIVE REPORT

Type of Survey: Navigable Area

Registry Number: H13388

Sub-locality: Lower Houston Ship Channel

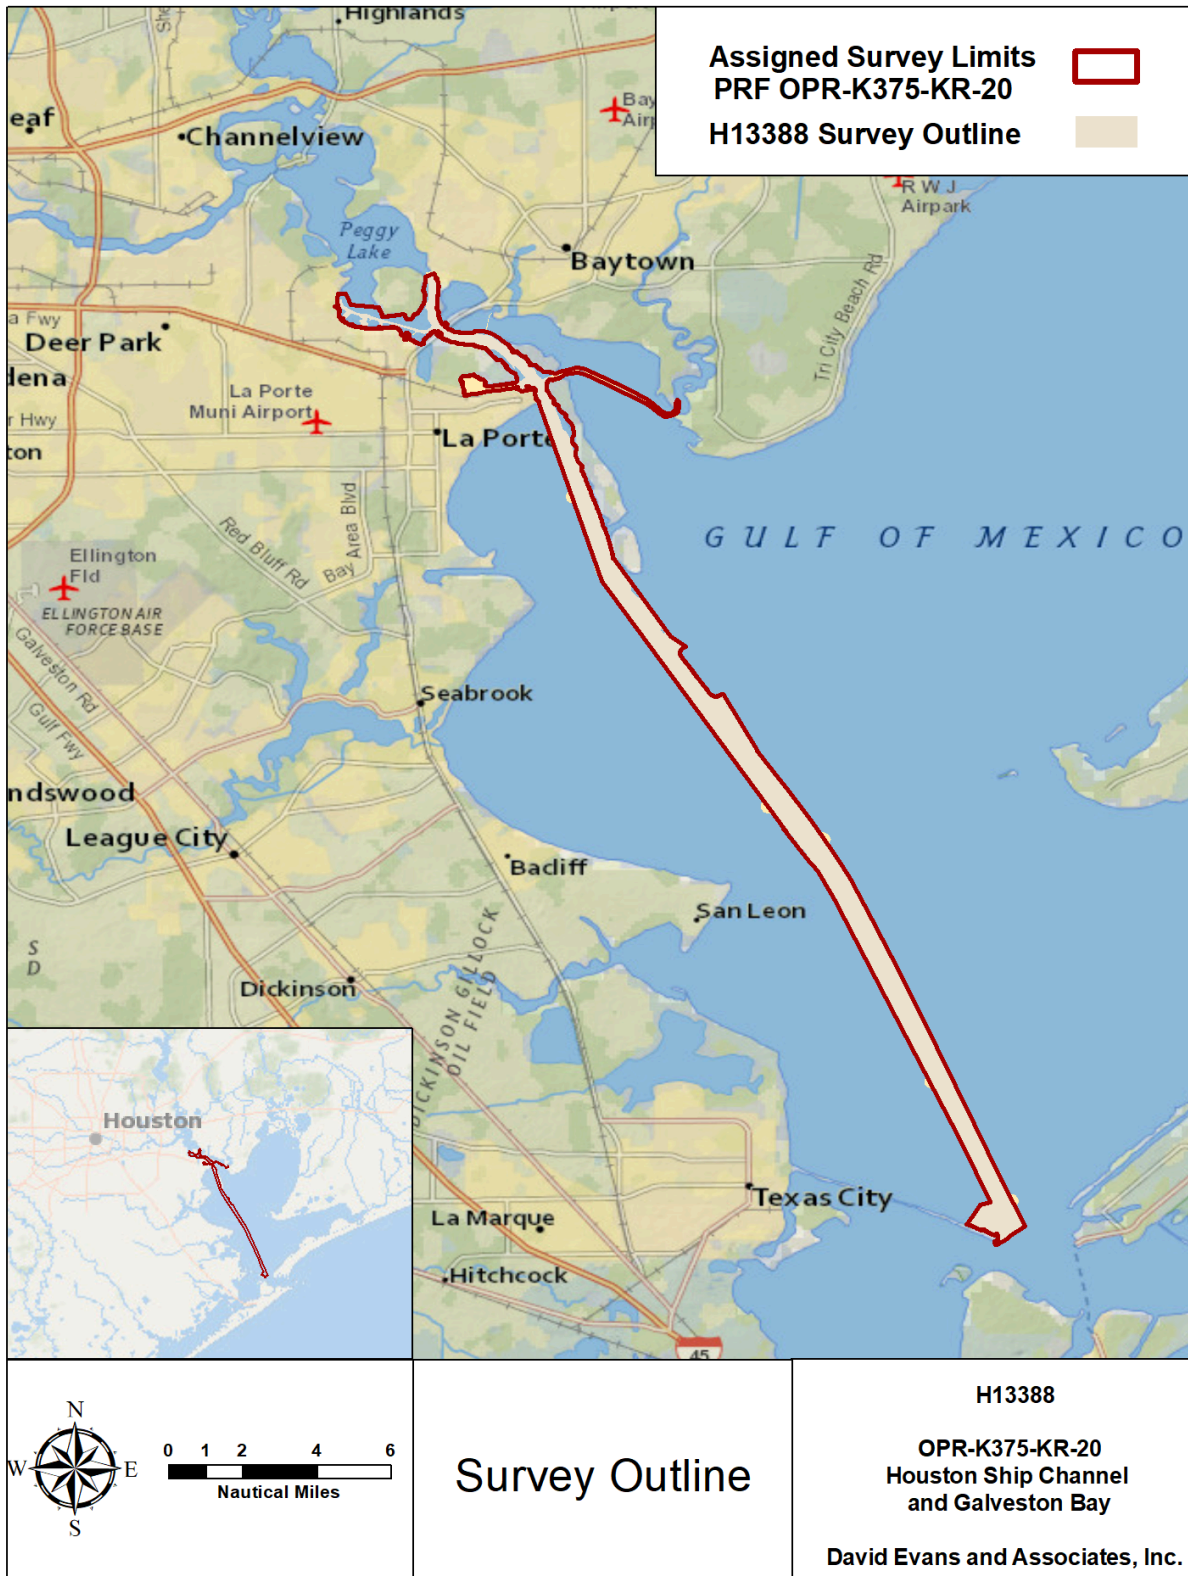
Figure 3: H13388 Survey Outline

Figure 3 depicts the H13388 survey outline.

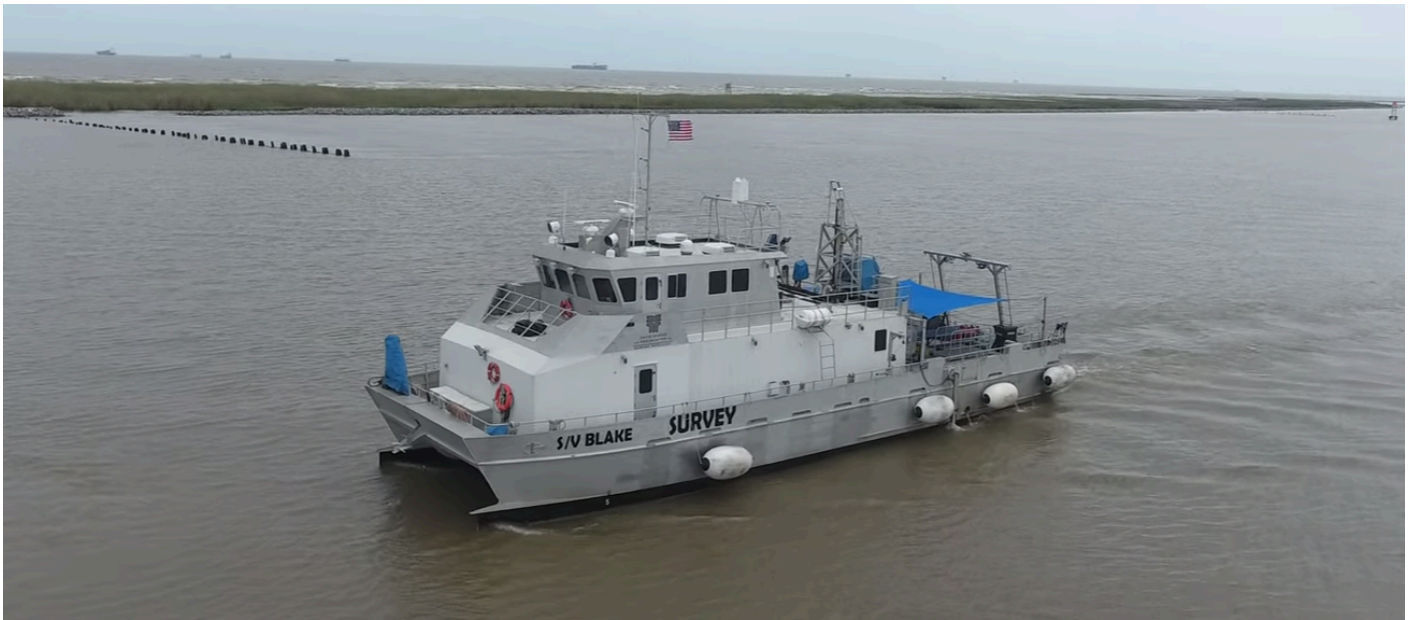
Figure 4: S/V Blake

Hull ID	<i>S/V Blake</i>	<i>R/V Broughton</i>	<i>RHIB Sigsbee</i>	<i>R/V Sea Scanner</i>
LOA	82 feet	24 feet	18 feet	26 feet
Draft	4.5 feet	2.75 feet	1 feet	2 feet

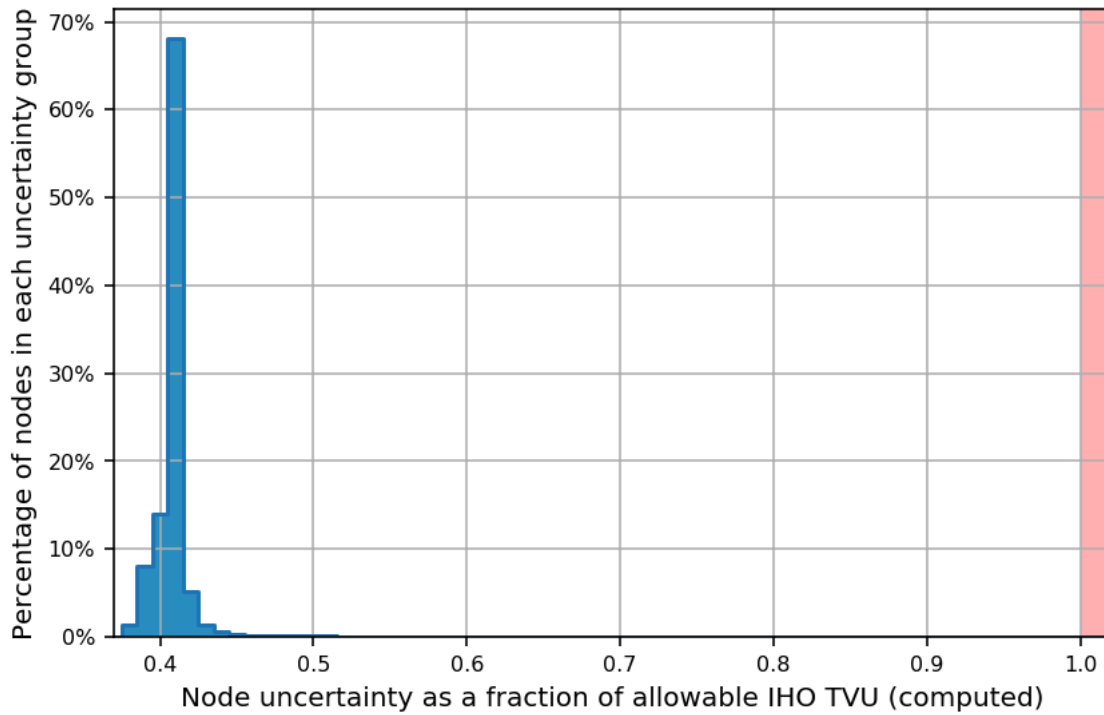
Figure 10: Node TVU Statistics - 50 centimeters, Finalized

99.5+% pass (157,411,934 of 157,421,832 nodes), min=0.37, mode=0.41, max=188.08

Percentiles: 2.5%=0.39, Q1=0.41, median=0.41, Q3=0.41, 97.5%=0.43

The finalized surface includes occasional large vertical uncertainties that exceed IHO Order 1a allowances. These high uncertainties were caused by introducing areas of high depth standard deviation associated with steep slopes or identified obstructions when finalizing surfaces with the greater-of-the-two option. It is also noted that, on occasion, the real-time uncertainty logged during acquisition included a sounding with an extremely high depth uncertainty, which was well outside of realistic values. During processing, an IHO filter was applied to all sounding data, with rejecting soundings exceeding IHO Order 1a thresholds for TVU. These rejected soundings have at times been re-accepted after thorough review by the hydrographer. This issue appears to have been caused by an unresolved software bug in either the sonar top side unit or acquisition system impacting the reported uncertainty, but not the actual depth.

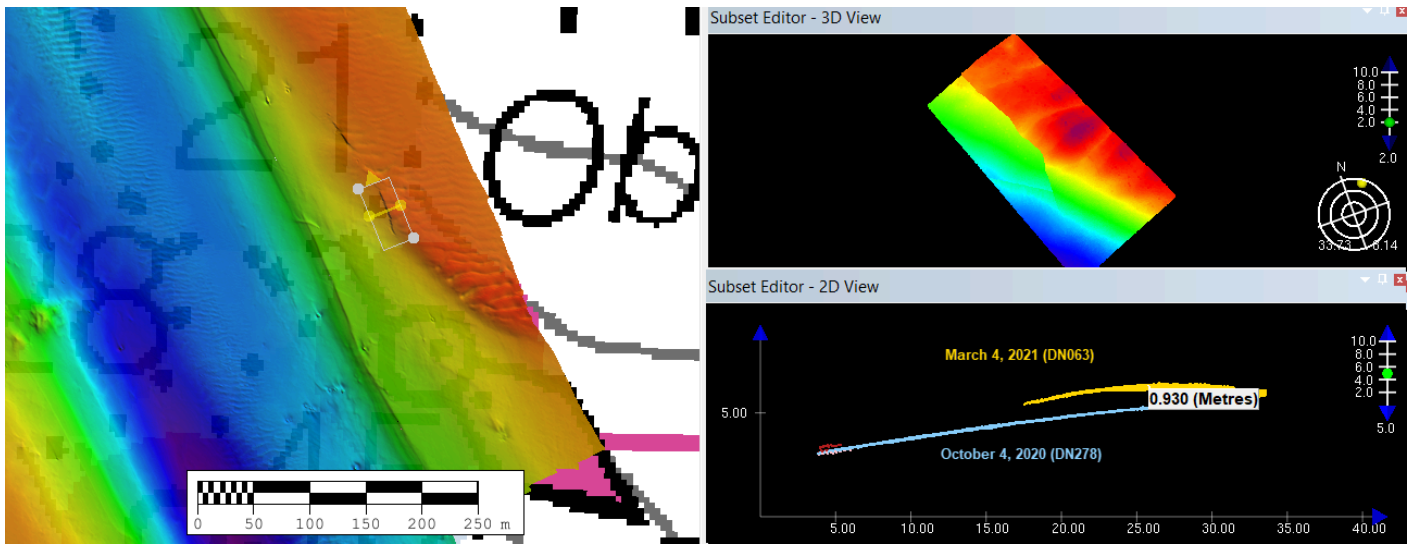
Figure 16: Sediment Migration Artifacts

cleaning the sounding data. Soundings deemed to be fliers were rejected while valid sonar returns were retained, though they may have disagreed with adjacent soundings collected at another time. The submitted surface has numerous artifacts resulting from the areas of disagreement. Figure 16 shows an example of horizontal movement (approximately 90 centimeters) in sediment waves that resulted in disagreement for H13388 bathymetric grids. Some areas of the greatest disagreement have been noted in the H13388_Notes_for_Reviewer.hob file with the SNDWAV area feature class, submitted in Appendix II of this report. This is not an exhaustive list, but highlights major surface artifacts resulting from sediment migration that are present in the bathymetric grids.

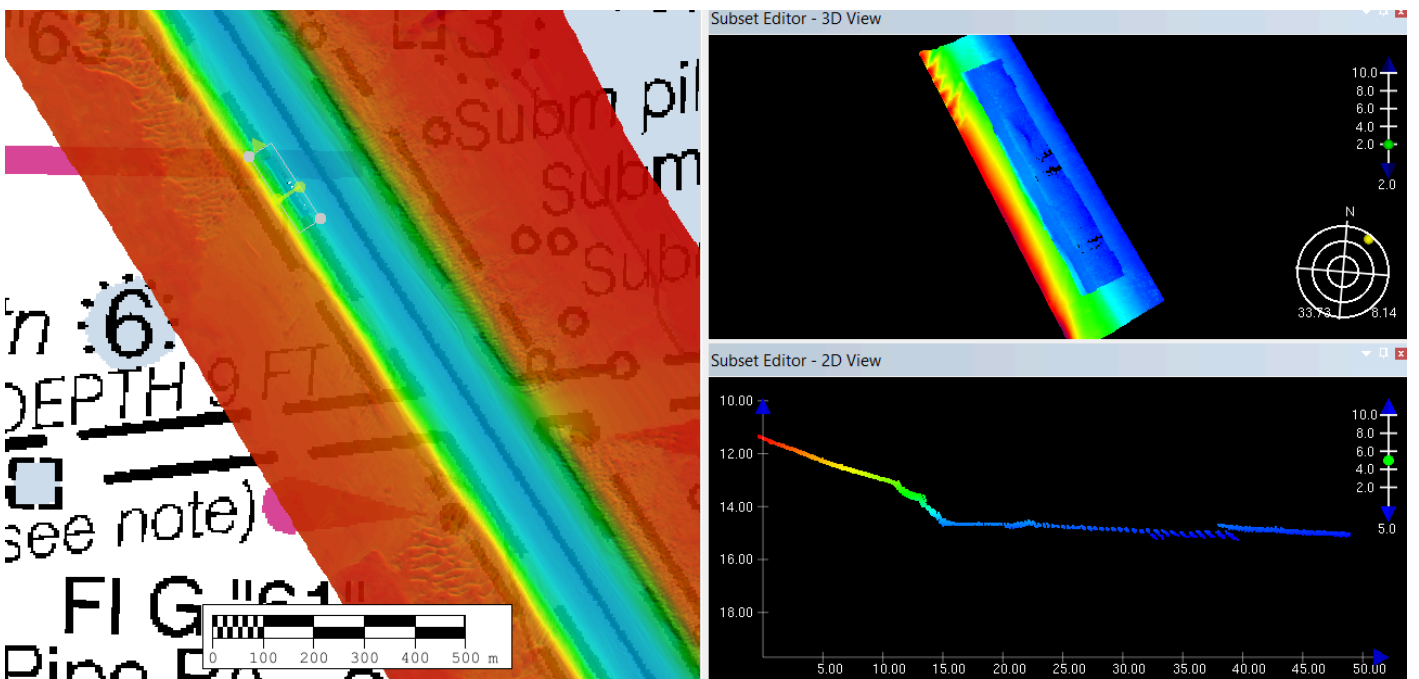
Figure 17: Post-dredge Surface Holidays in Main Channel

Changes in the bottom during survey operations caused misalignments between some sounding data. Three scenarios presented themselves when reviewing data and receiving guidance on processing from HSD Operations Branch: newer sounding data were uniformly shoaler or deeper than previously acquired data; sediment migration caused soundings to be inconsistently shoaler and deeper than overlapping data; and there were areas where overlapping data showed the bottom to be deeper than previously collected survey data due to dredging.

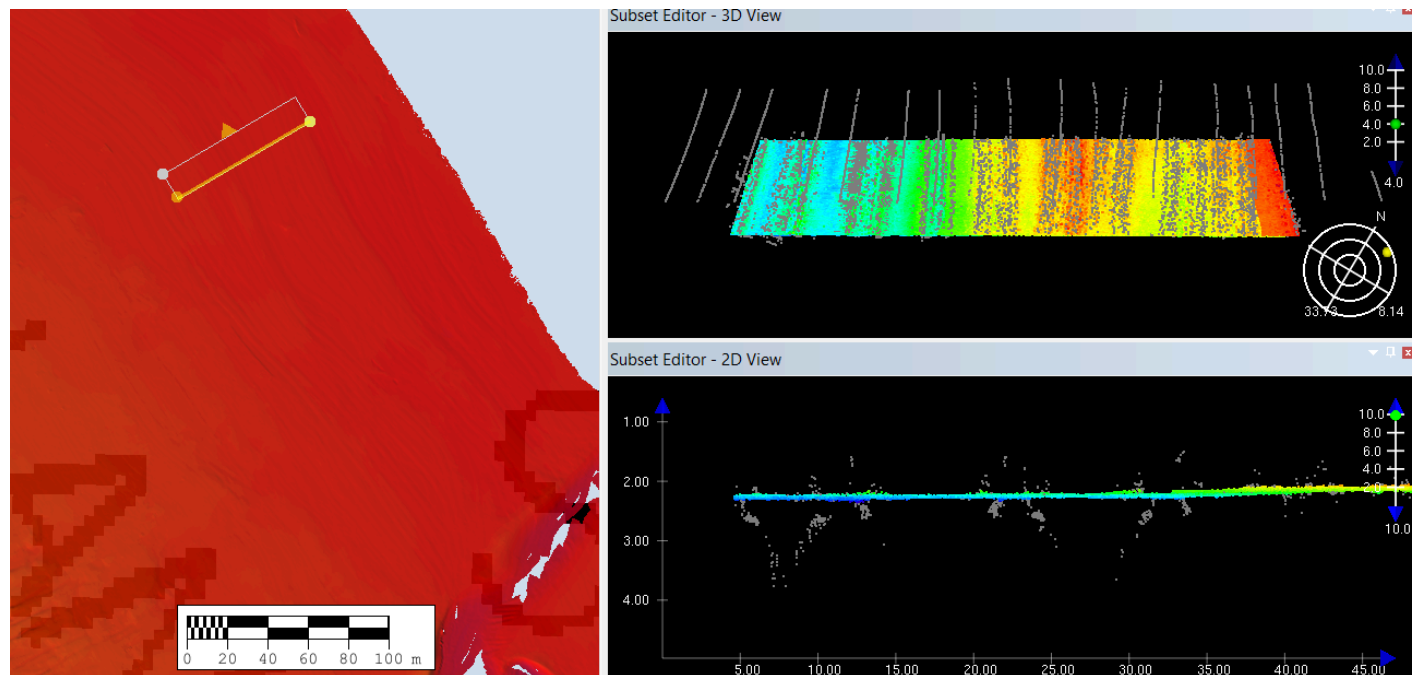
Figure 22: Example of Erroneous Bottom Tracking of Flat Shoal Areas in HDCS Data and Resultant Surface Artifact (Gray Soundings Rejected Manually by Hydrographer to Limit Effects to the Surface)

During survey acquisition, it was apparent that the combination of shallow water and the bottom type (an assumption of soft silty mud) made it difficult to get a clean bottom track return from the MBES system. This most frequently was displayed in shallow, flat areas out of the main channel current. To try to mitigate the effect, sonar settings were changed by the hydrographer during acquisition, including changing power, gain, time variable gain (TVG) settings, and pulse length. In the end, no clear solution fixed the issue and the hydrographer continuously tuned the sonar for the best return at the time. This is likely a limitation of the instrument and the acoustic properties of the sediments in the depths being surveyed. The HDCS dataset was well cleaned to mitigate the effects to the final surfaces. However, artifacts within IHO specifications will be apparent in the final delivered surface as shown in Figure 22.

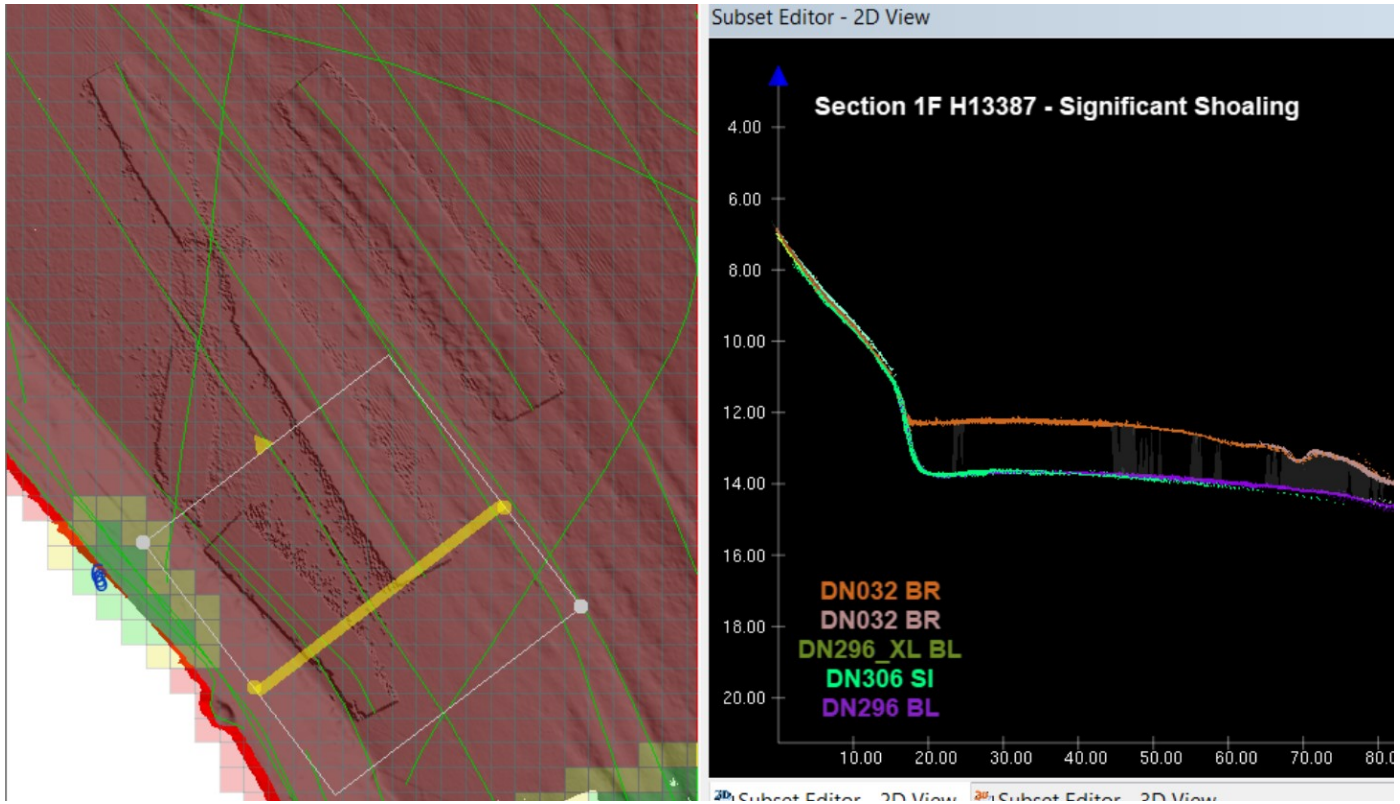
Here is an example (below) of shoaling that occurred between mainscheme acquisition and fill. In these instances, are we to manually edit out the older mainscheme data that falls under each fill line so the surface honors the newer data?

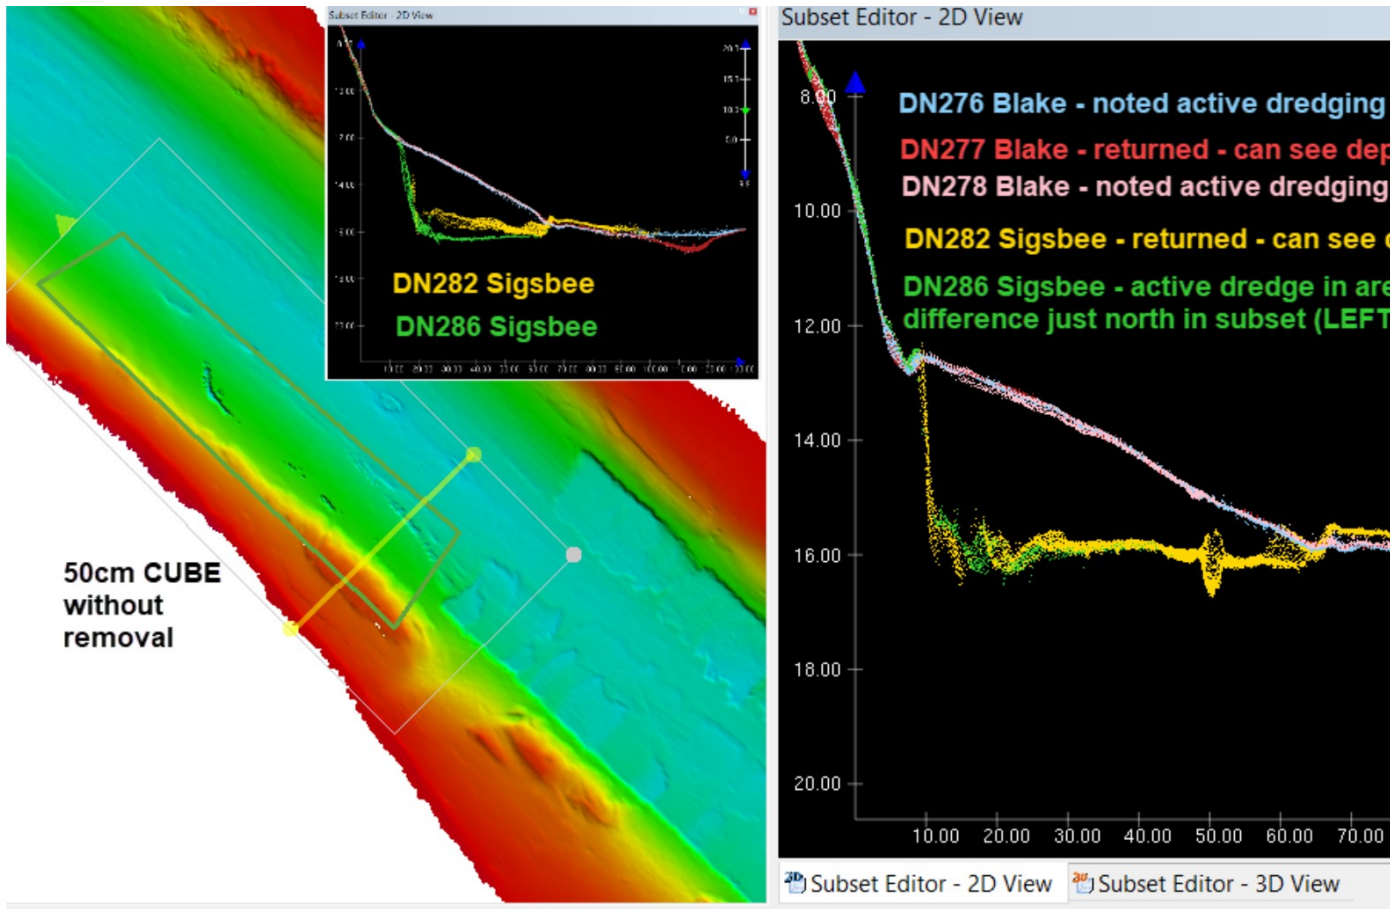
Here is another example where dredging of the channel was occurring during survey operations. In this instance swaths don't match up with neighboring lines due to all of the bottom change that occurred between passes. We can try to manually reject some data to remove the large changes but there will still be some disagreement in areas of overlap due to the bottom changes. Before proceeding with additional manual editing, we want to make sure that we are applying your guidance properly.
