**DESCRIPTIVE REPORT**

Type of Survey: Navigable Area

Registry Number: H13413

General Locality: Elliott Bay

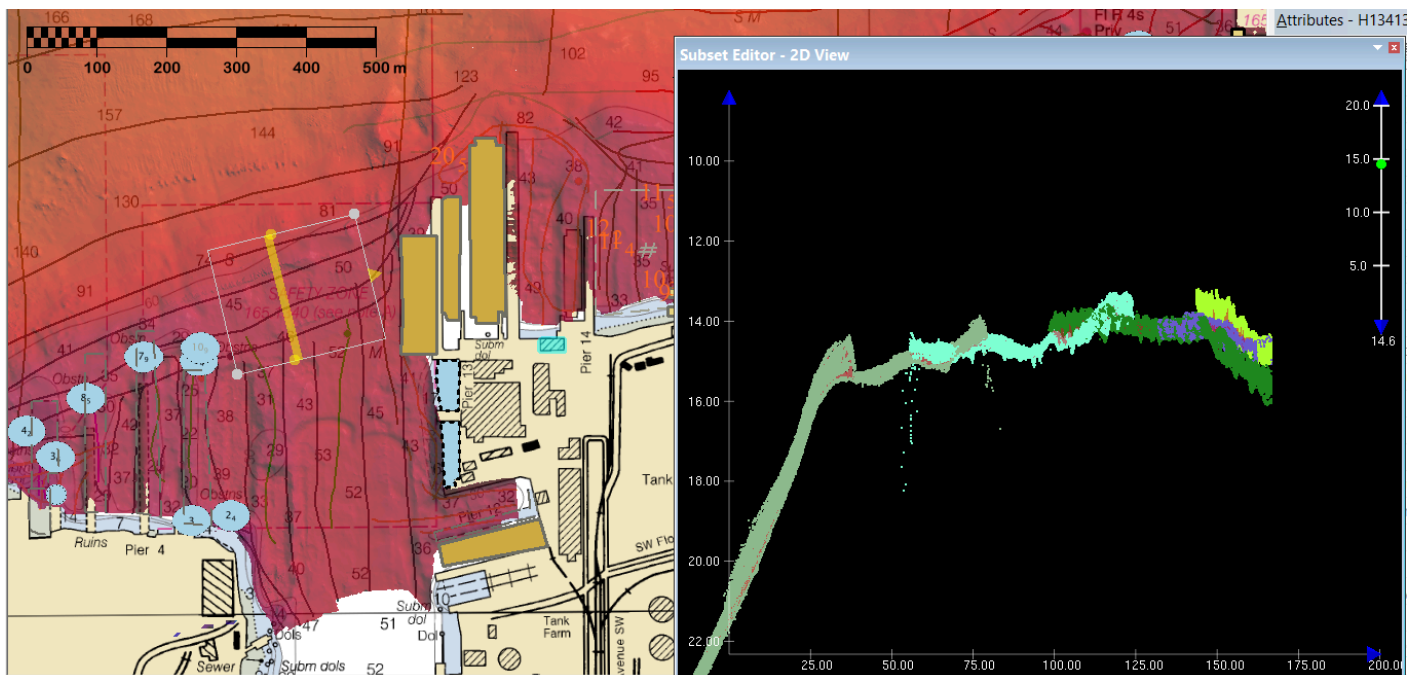
Sound speed issues were apparent across the survey area, particularly on the southern end of the sheet where the Duwamish River enters into the bay and the bathymetry drops off quickly (Figures 19-20). Surface sound speed was monitored during survey acquisition and efforts were made to take casts whenever surface sound velocity values differed significantly from the surface sound velocity value from the previous cast. However, smiles and frowns were still noted in the processed data. Some casts were extended but doing so did not significantly improve sound velocity issues in the deeper waters.

In some areas the difference between lines exceeds allowable uncertainty at that point and the difference is visible in the final surfaces, however the surfaces overall still meet NOAA allowable uncertainty parameters from HSSD Section 5.1.3, and as such, the data remain sufficient to supersede previous data.

Figure 18: Sound Velocity errors visible in subset editor near Duwamish River West Waterway entrance.

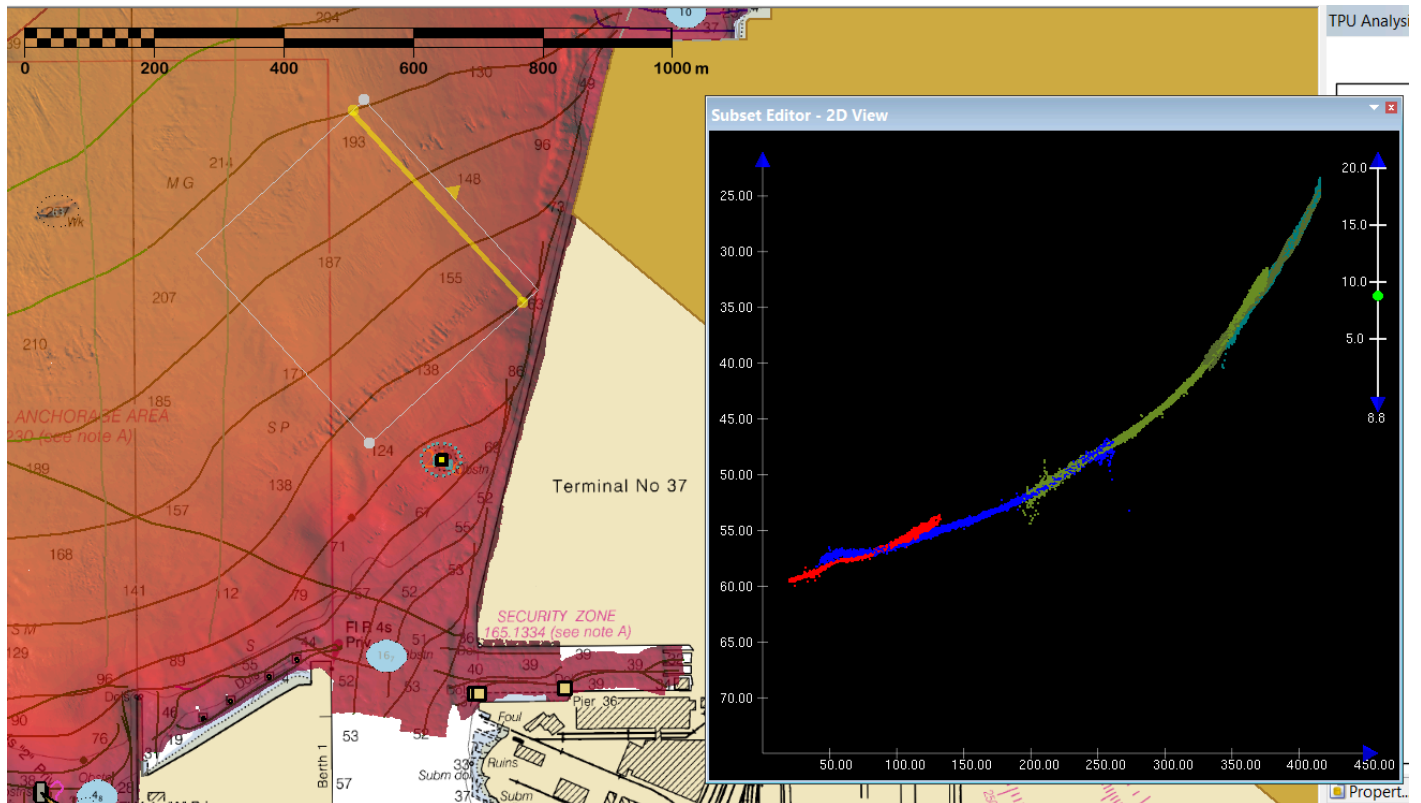
Figure 19: Sound Velocity errors visible in subset editor near Duwamish River East Waterway entrance.

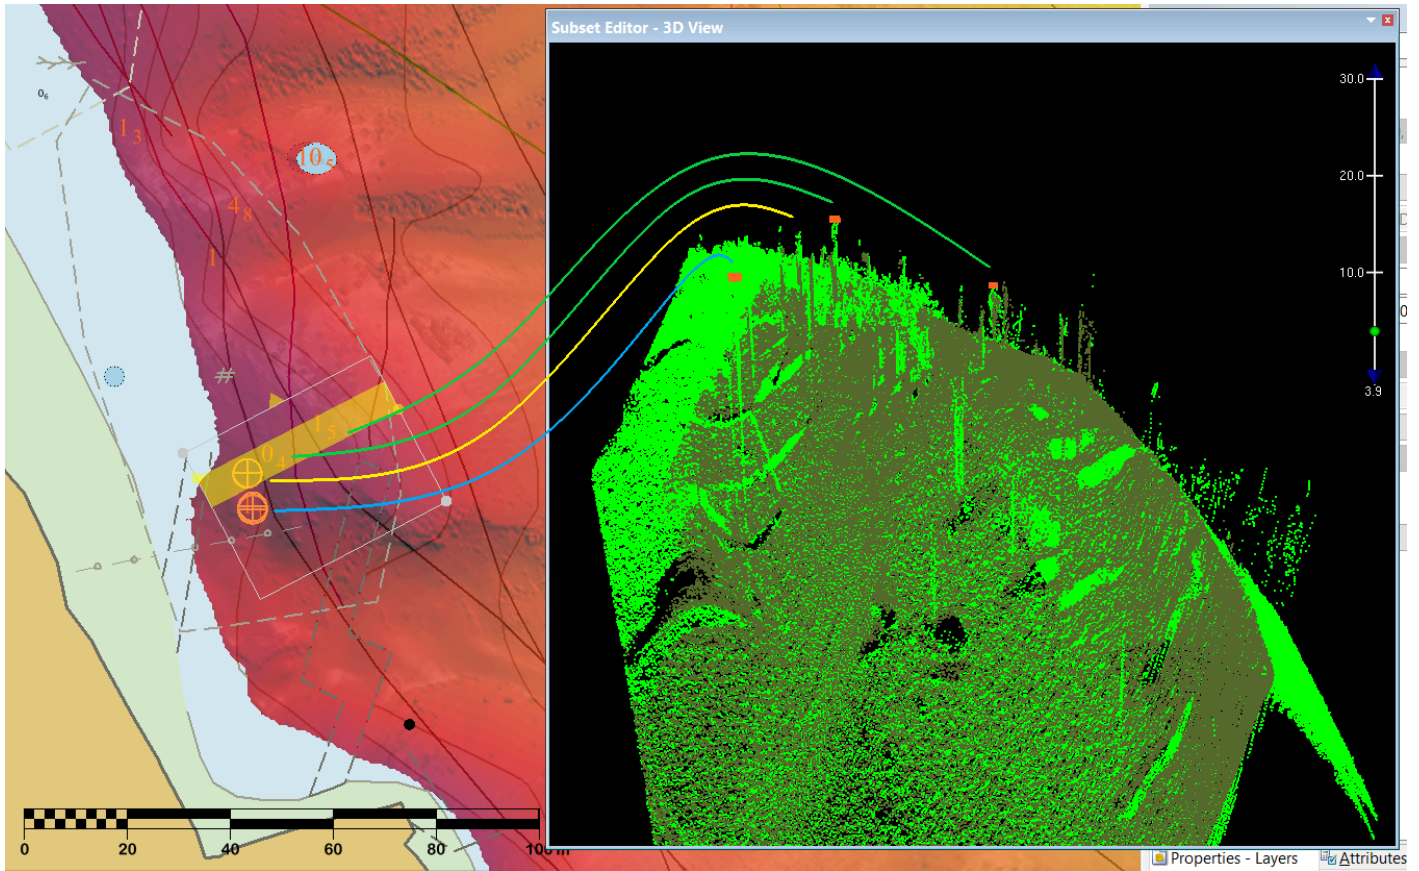
*Figure 24: Flier finder "fliers" in foul ground area. Foul ground boundary is gray dashed line. "Fliers" are orange circles with cross hairs. Designated soundings are orange numbers/dots. The Blue line shows a Flier finder "flier" and the corresponding designated point in Subset editor. The yellow line shows a "flier" and an undesignated feature due to scale. Green line show two other designated features selected at survey scale.*

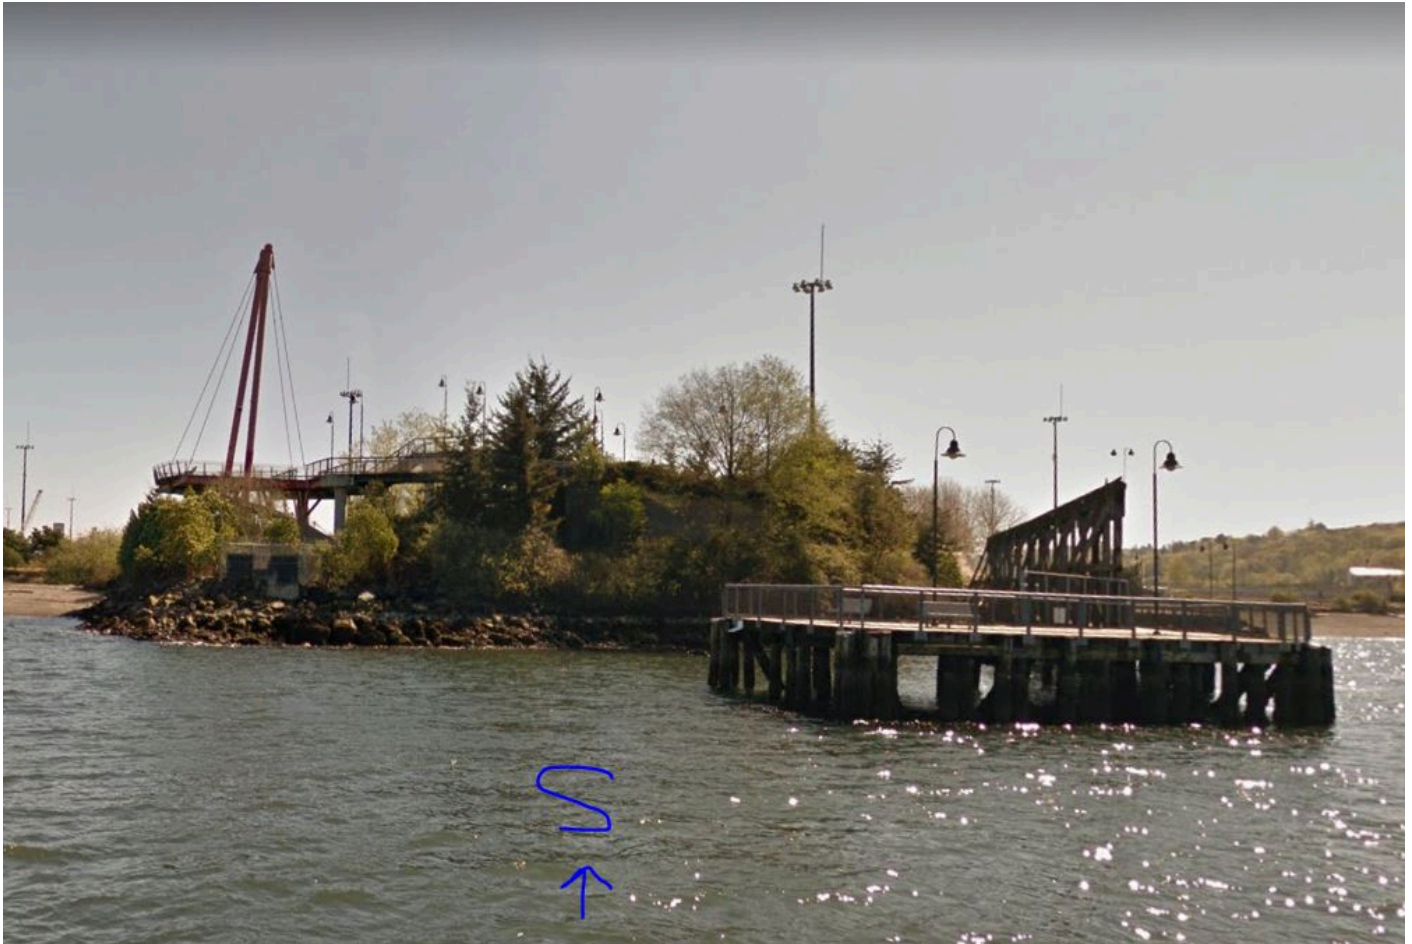
A visually conspicuous orange elevated walkway exists as part of a Joe Block Park at the NW corner of Terminal 5 on the south of the sheet in the vicinity of currently charted but non-existing tanks. A landmark feature was included for this feature in the FFF. (Figure 29)

*Figure 29: Orange Elevated walkway with tower visible on the left of the photo, looking south towards Joe Block Park.*

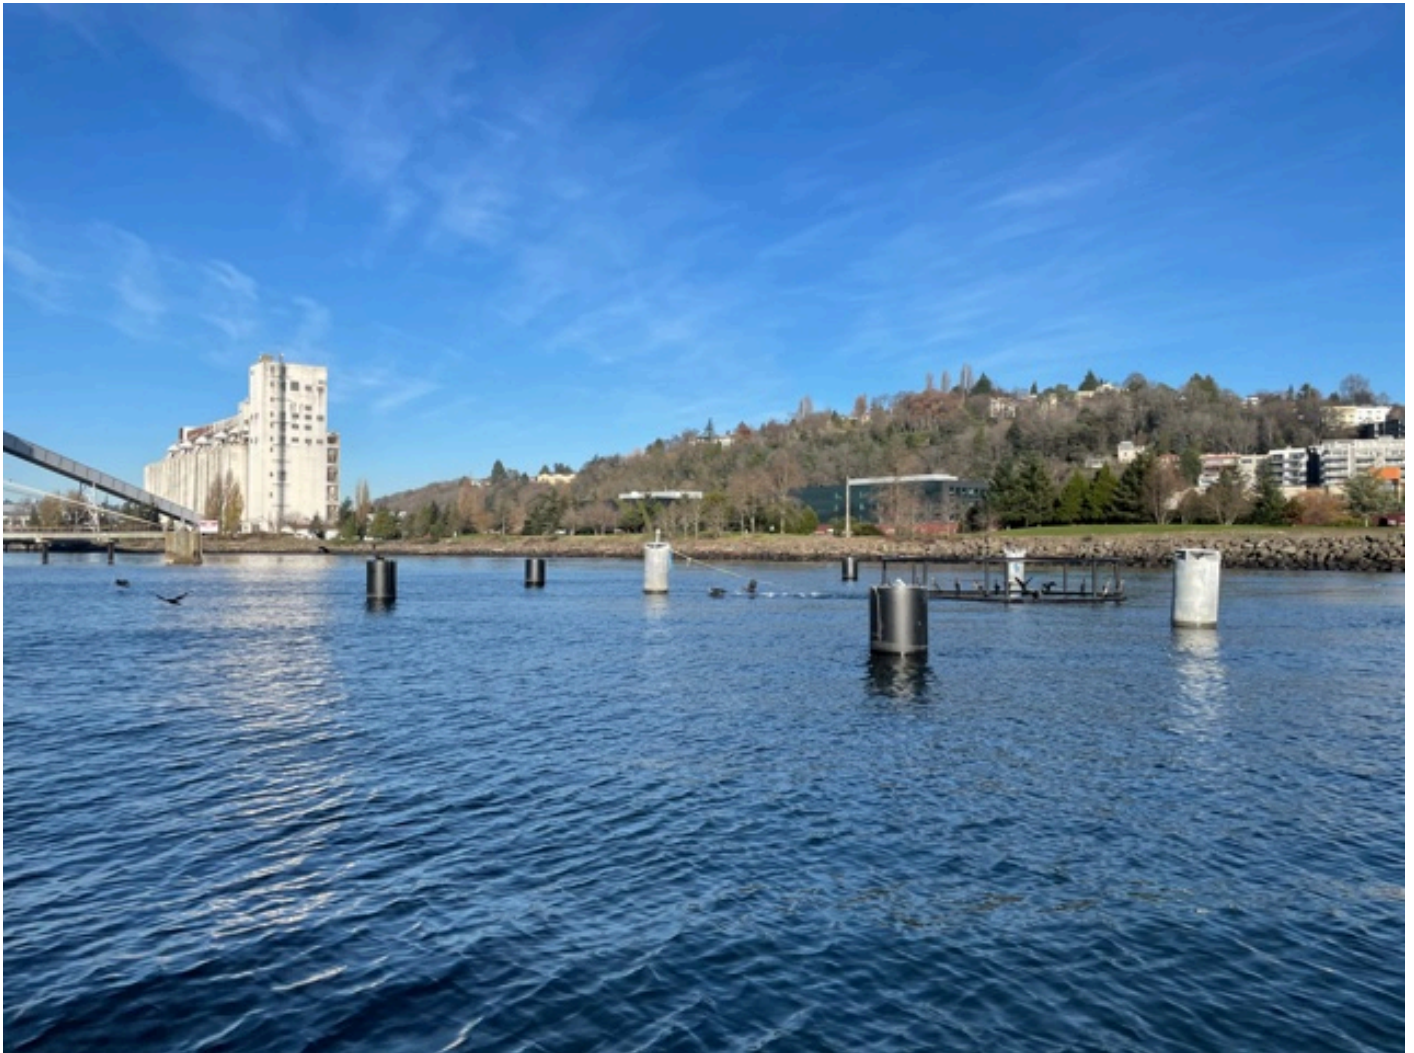
A series of black can buoys existed around the charted Fish Haven south of the grain elevator offshore Myrtle Edwards Park (Figure 30). The can buoys differ from those visible in photography from 2016 so it is likely that they are transient and vary depending on the type of fish haven being deployed. As such the can buoys are not included in the FFF. Permanent navigational lights exist at the location on piles and are charted correctly, serving their intended purpose, and included in the FFF.

*Figure 30: Black can buoys around fish haven south of the Grain Elevator off Myrtle Edwards Park.*
