DESCRIPTIVE REPORT

Type of Survey: Navigable Area

Registry Number: H13438

Sub-locality: Egegik Bay

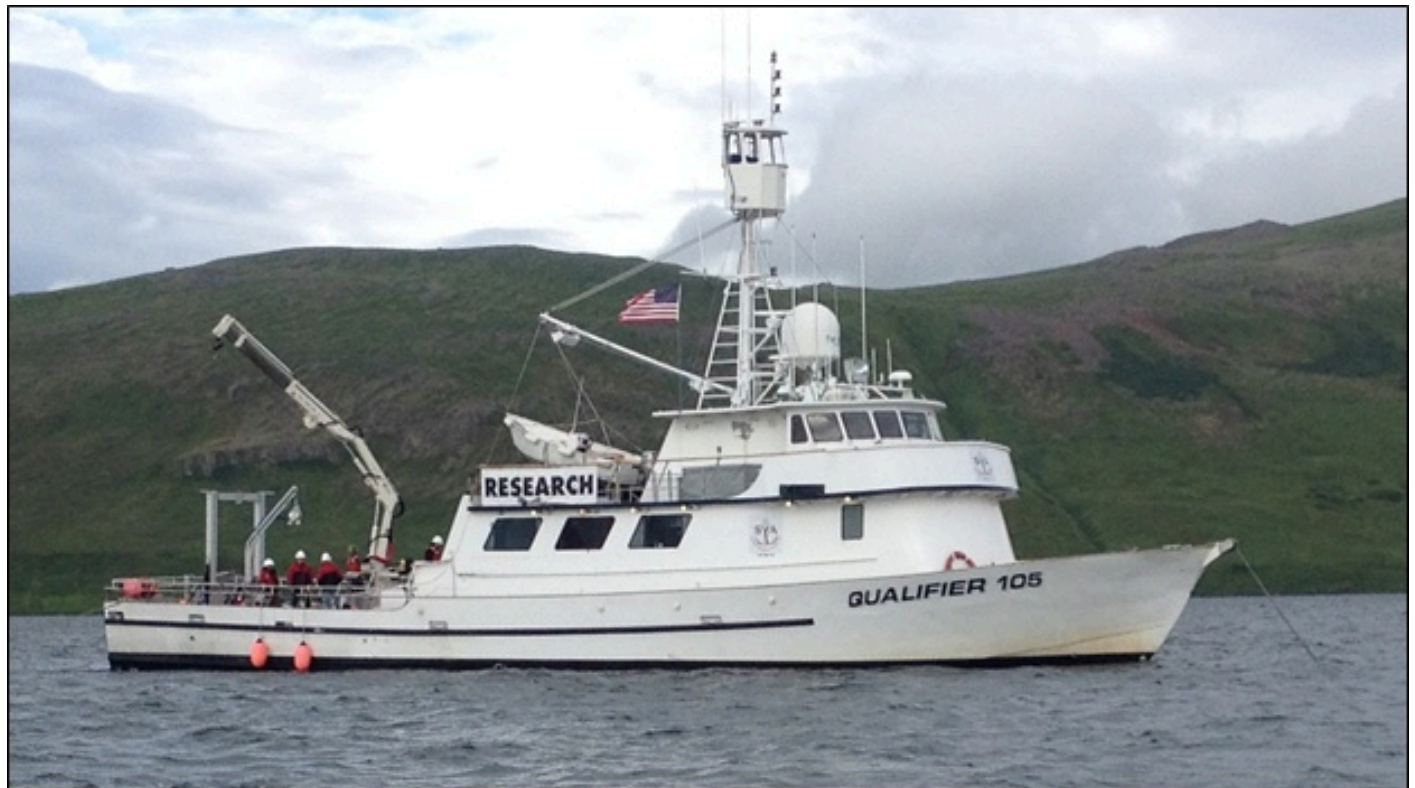
Figure 7: RV Qualifier 105 (Q105)

The Qualifier 105 (Q105) is a 105' aluminum-hull vessel owned and operated by Support Vessels of Alaska (SVA). The Q105 acquired multibeam data and provided housing and facilities for on-site data processing. The vessel was also used to collect bottom samples, deploy/recover tide buoys, conduct sound speed casts, conduct feature investigations, and deploy/support the Sealegs vessel.

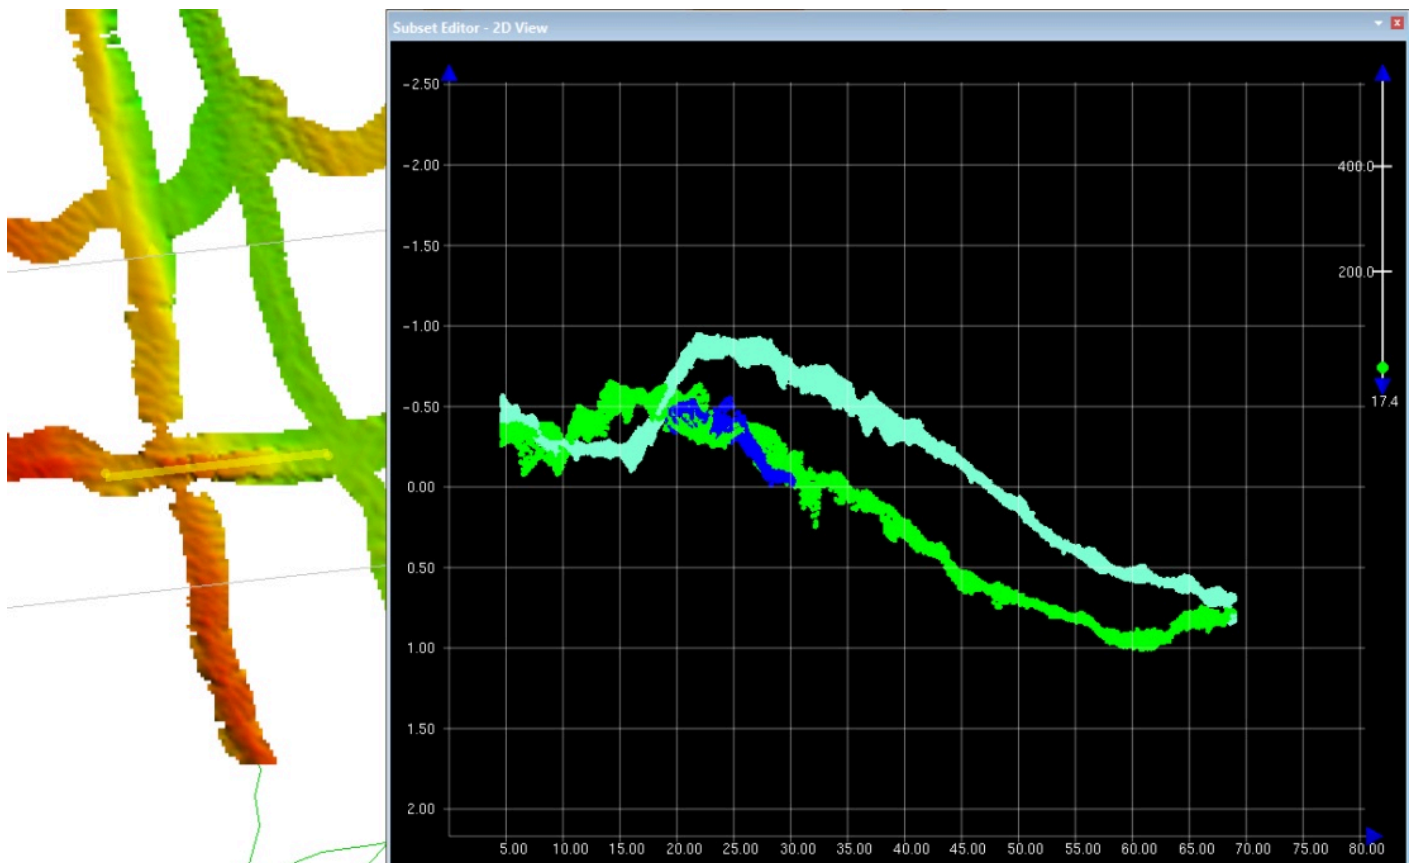
Bottom change was observed over the course of the survey, especially between lines that were run days to weeks apart. There is evidence of extreme amounts of sediment transport throughout the survey area, especially inside the bay where currents are very strong, with sandwaves visible in most areas.

Figure 10: Example of bottom change shown in CARIS HIPS subset mode. Cyan line run on JD215 has up to 0.75 m of difference from lines run on JD234 (green) and JD235 (blue). Location: 58-12-42 N, 157-23-11.6 W

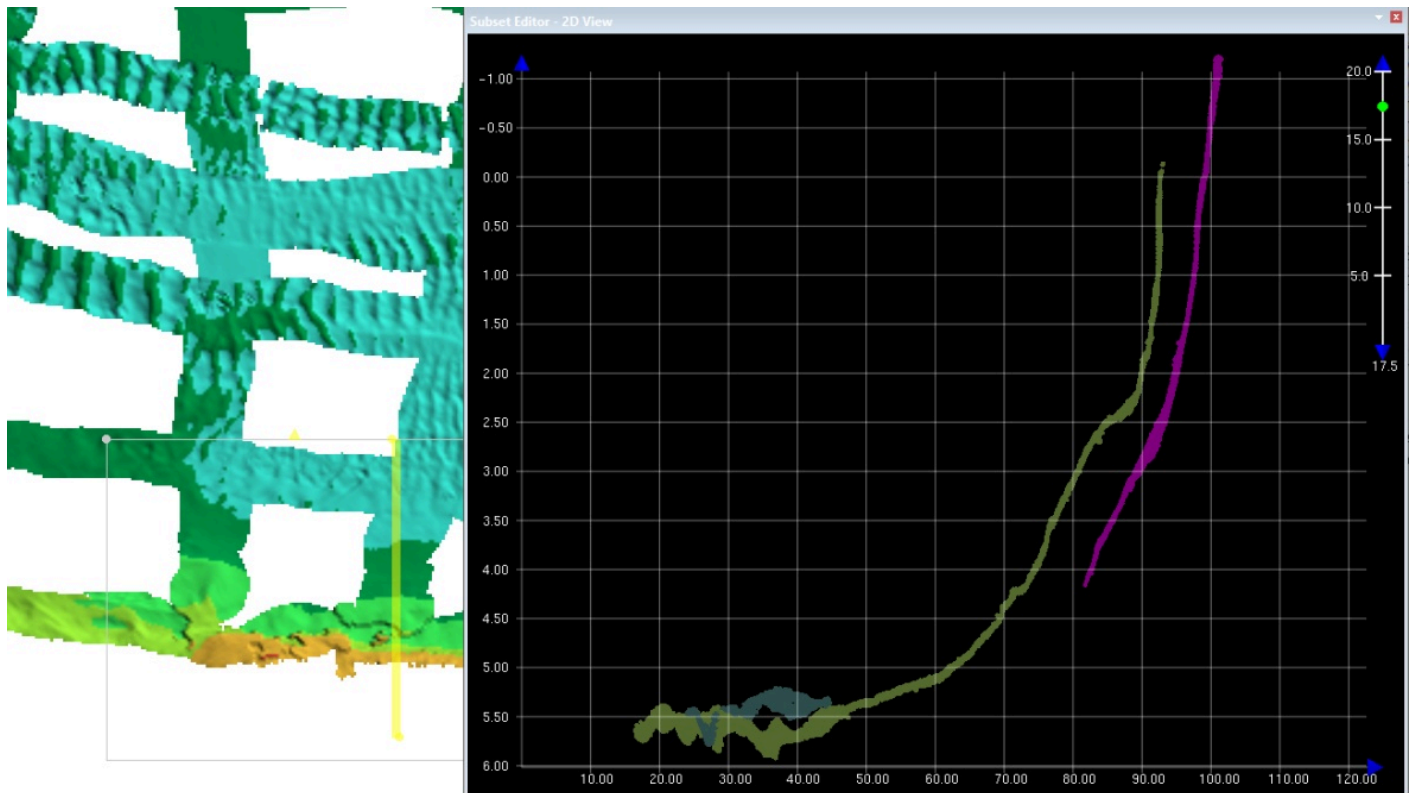
Figure 11: Example of bottom change shown in CARIS HIPS subset mode. Green line run on JD230 has up to 2.3 m of vertical change from purple line, run on JD242. It agrees better with dark green line run closer in time on JD233 but still exhibits 0.5 m of change there. This is in the area of the cut bank where current is very strong and is eroding the river edge, migrating the channel southward (to the right in this image). Location: 58-10-30.7 N, 157-27-17.9 W.

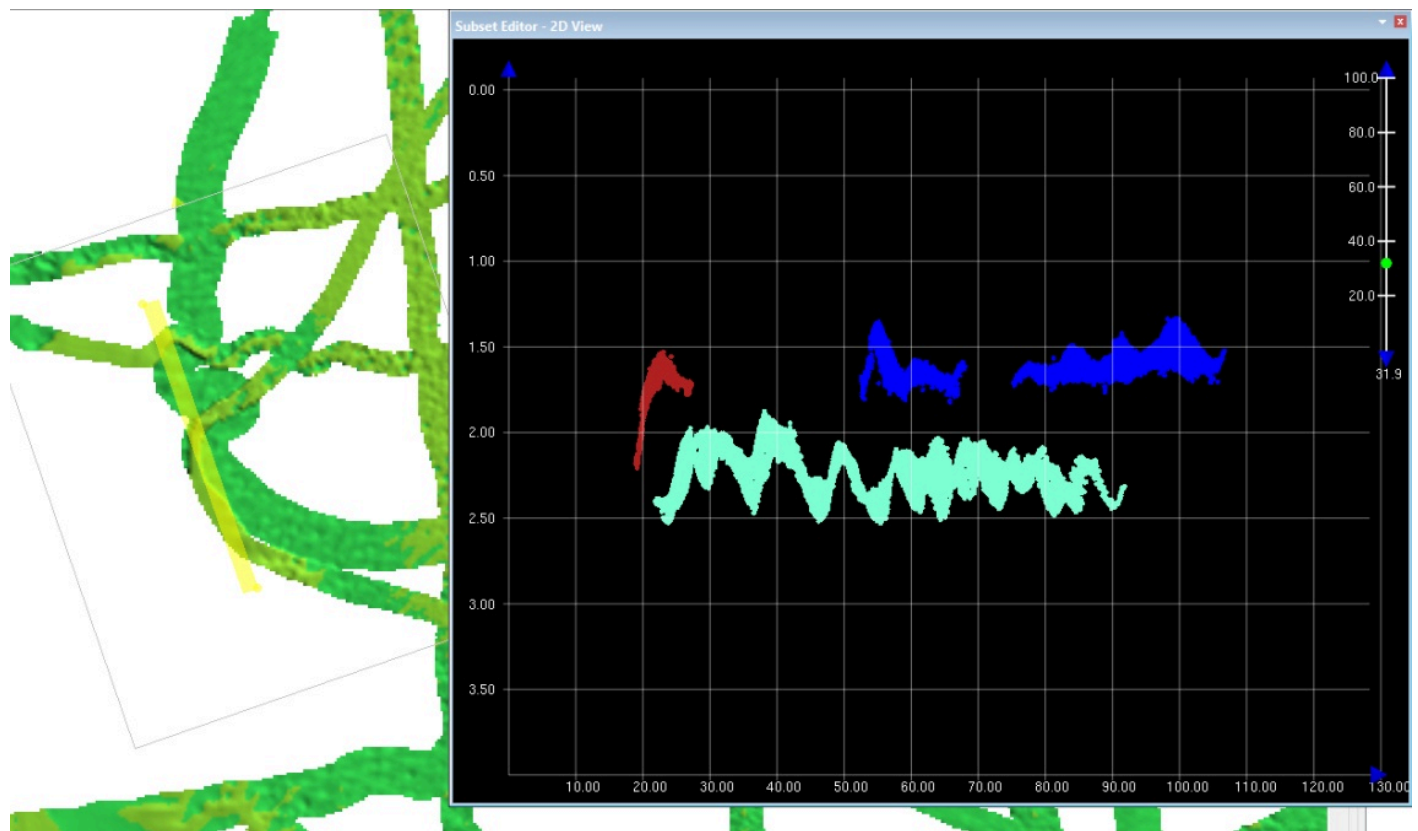
Figure 12: Example of bottom change shown in CARIS HIPS subset mode. Cyan line run on JD242 shows up to 1.0 m of change from lines run on JD215 (blue) and JD229 (red). Location: 58-12-48.5 N, 157-30-03.9 W.

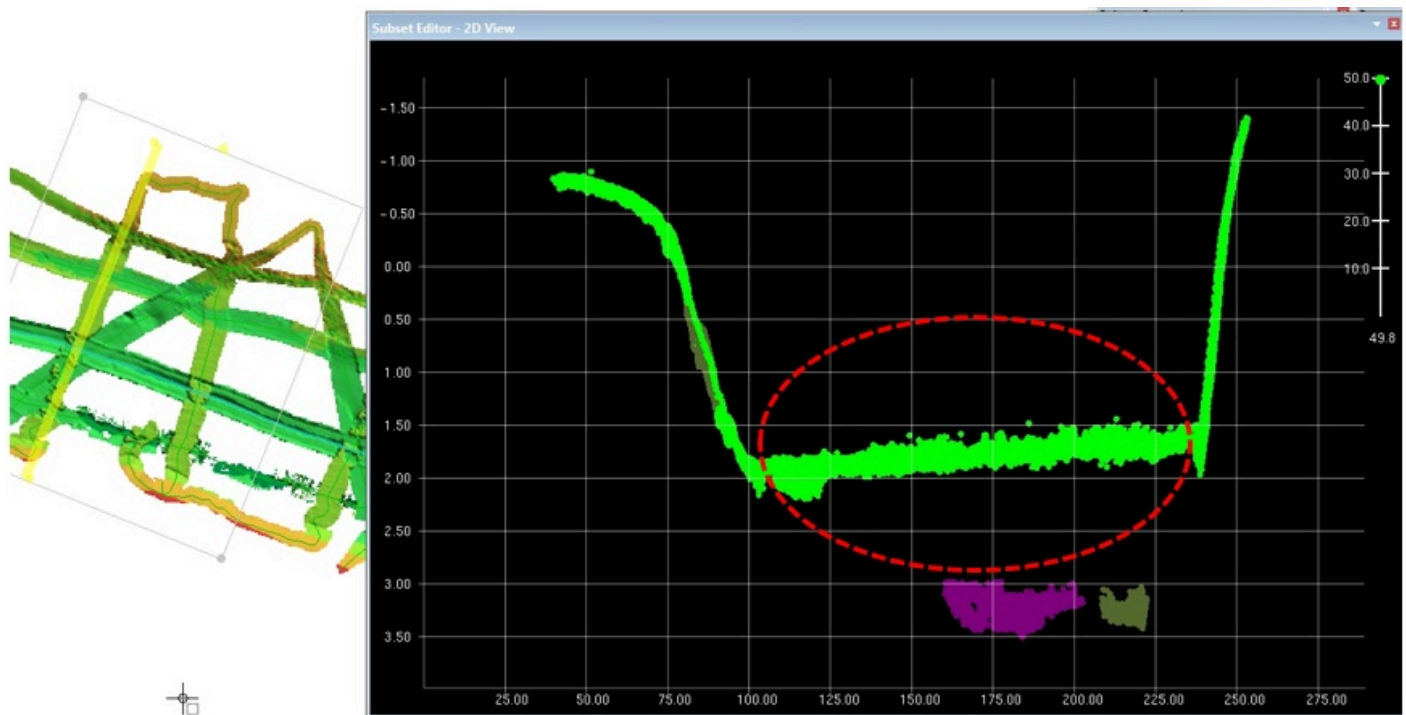
Figure 13: Example of complete loss of bottom tracking issue near Egegik (prior to editing): Green line in the circled region is tracking a softer layer by up to 1.5 m shoaler, while the purple and dark green line are tracking harder bottom. These and similar soundings where true bottom were not being tracked were manually rejected in processing.

In processing, soundings where the sounder was suspected to be tracking the incorrect layer by a significant degree were manually rejected. This had the end result of opening along-track gaps of greater than 3-nodes (12 m) on some lines, interspersed with low density / isolated nodes. However, due to additional lines collected through the areas and manual salvage of nadir data where it appeared to be tracking the correct bottom, enough bottom tracking was maintained to obtain sufficient depths in the area for the purpose of charting the channels to Egegik.

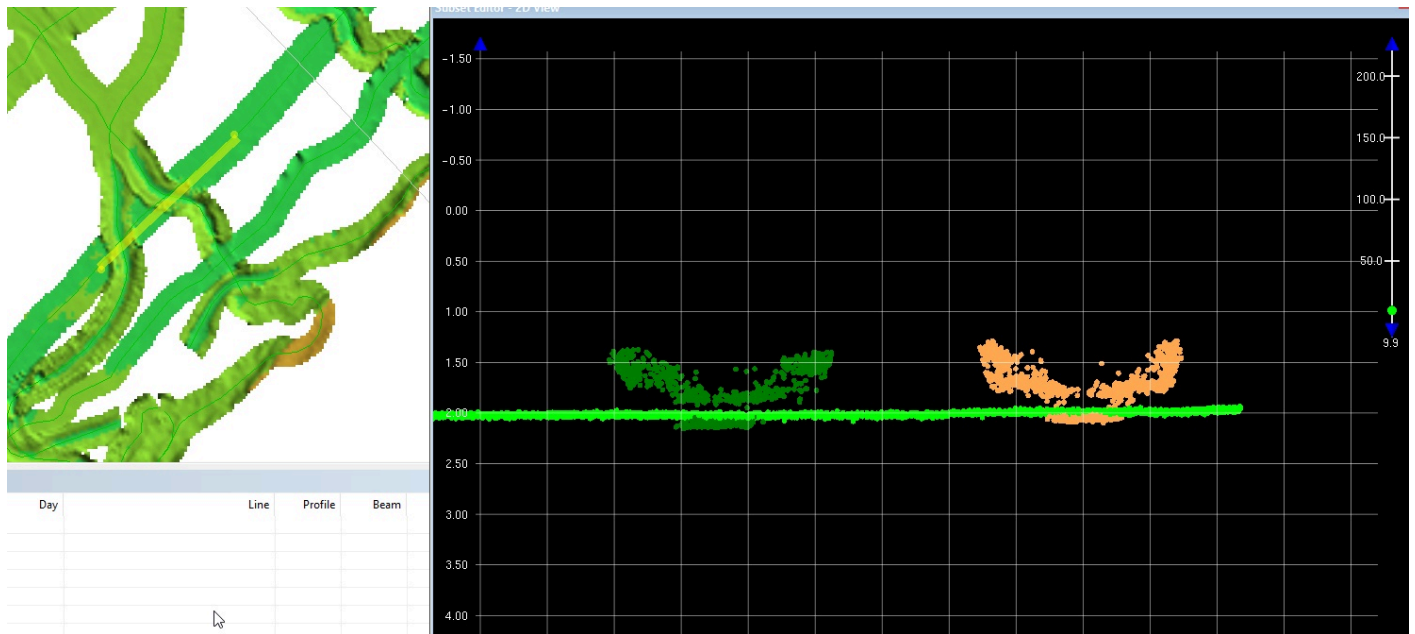
Figure 14: A similar issue, shown prior to editing, of partial bottom tracking: The dark green and orange lines are tracking correctly at nadir, but their outer beams are tracking a shoaler seafloor. Outer beams ("wings") were manually rejected, leaving only nadir and near-nadir data, in this and similar cases.

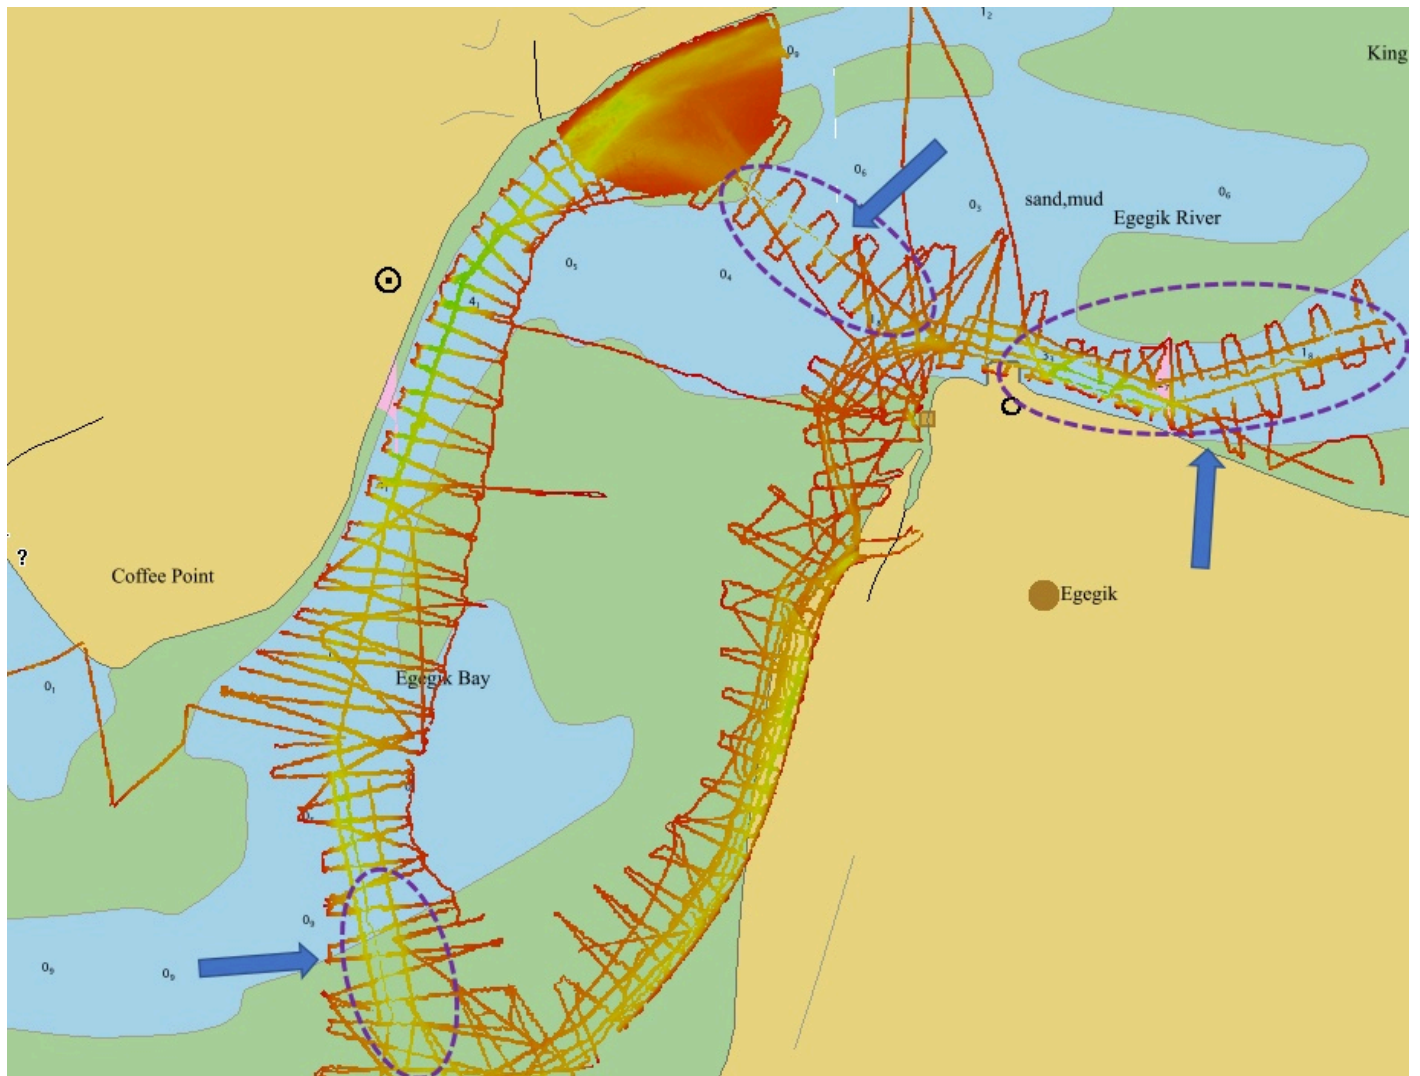
Figure 15: The entire upper river area shown in the diagram was intermittently affected by the bottom tracking issue. However, the areas circled were most affected.
