**DESCRIPTIVE REPORT**

Registry Number: H13441

General Locality: Bristol Bay

Project Number: **OPR-R340-KR-21**

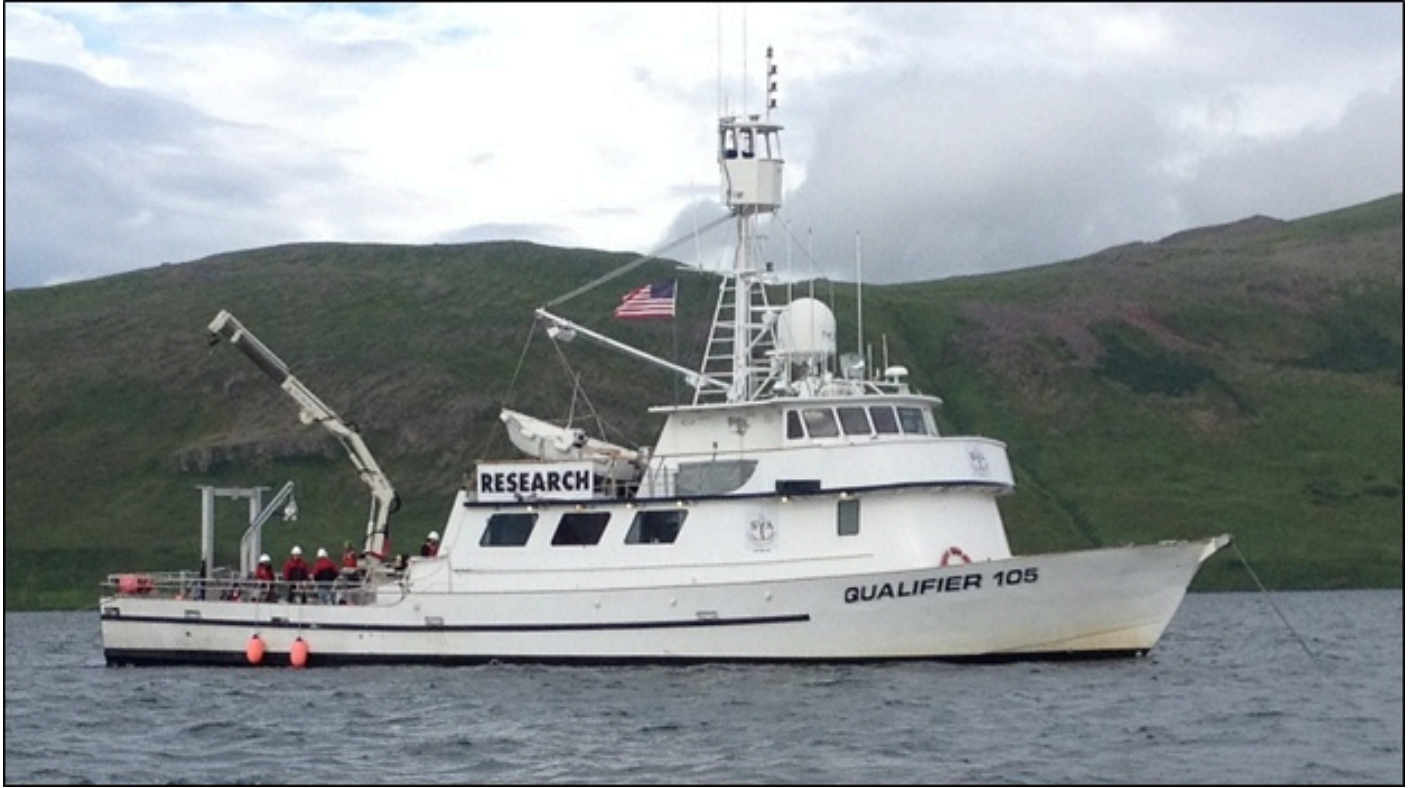
*Figure 3: RV Qualifier 105 (Q105)*

The Qualifier 105 (Q105) is a 105' aluminum-hull vessel owned and operated by Support Vessels of Alaska (SVA). The Q105 acquired multibeam data and provided housing and facilities for on-site data processing. The vessel was also used to collect bottom samples, deploy/recover tide buoys, conduct sound speed casts, conduct feature investigations, and deploy/support the Sealegs vessel.

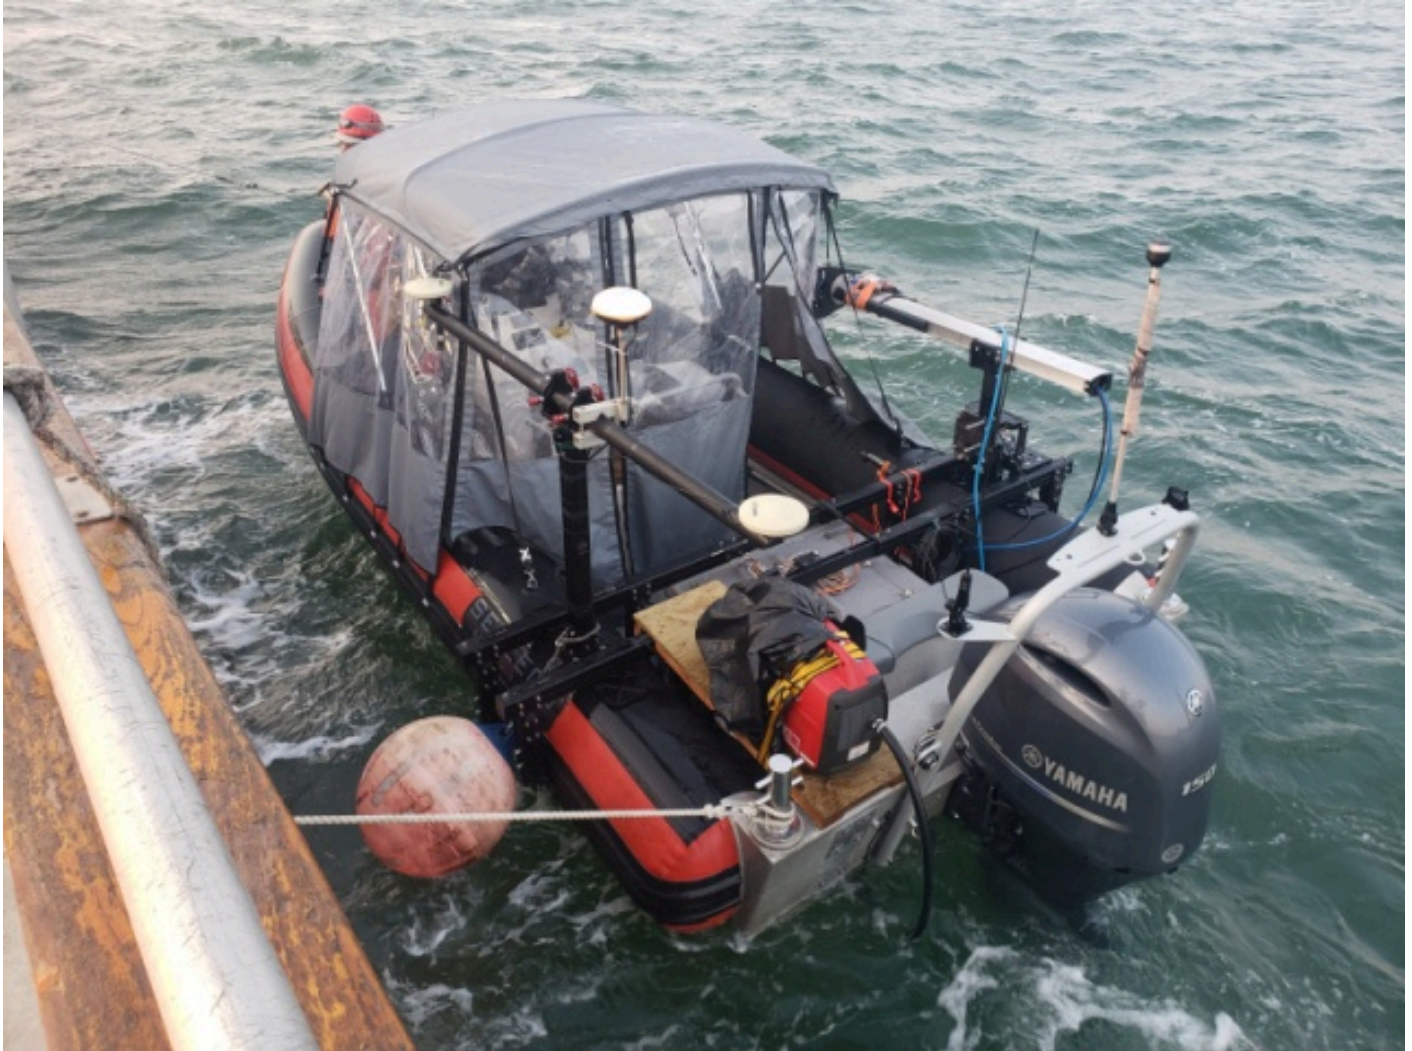
*Figure 4: Sealegs skiff*

The Sealegs is a 5.5 m RHIB-style skiff owned and operated by SVA. It was deployed via deck crane from the Q105 when conditions were favorable, and used to collect multibeam data in the shoalest portions of the survey area that were not readily accessible by the larger vessel.

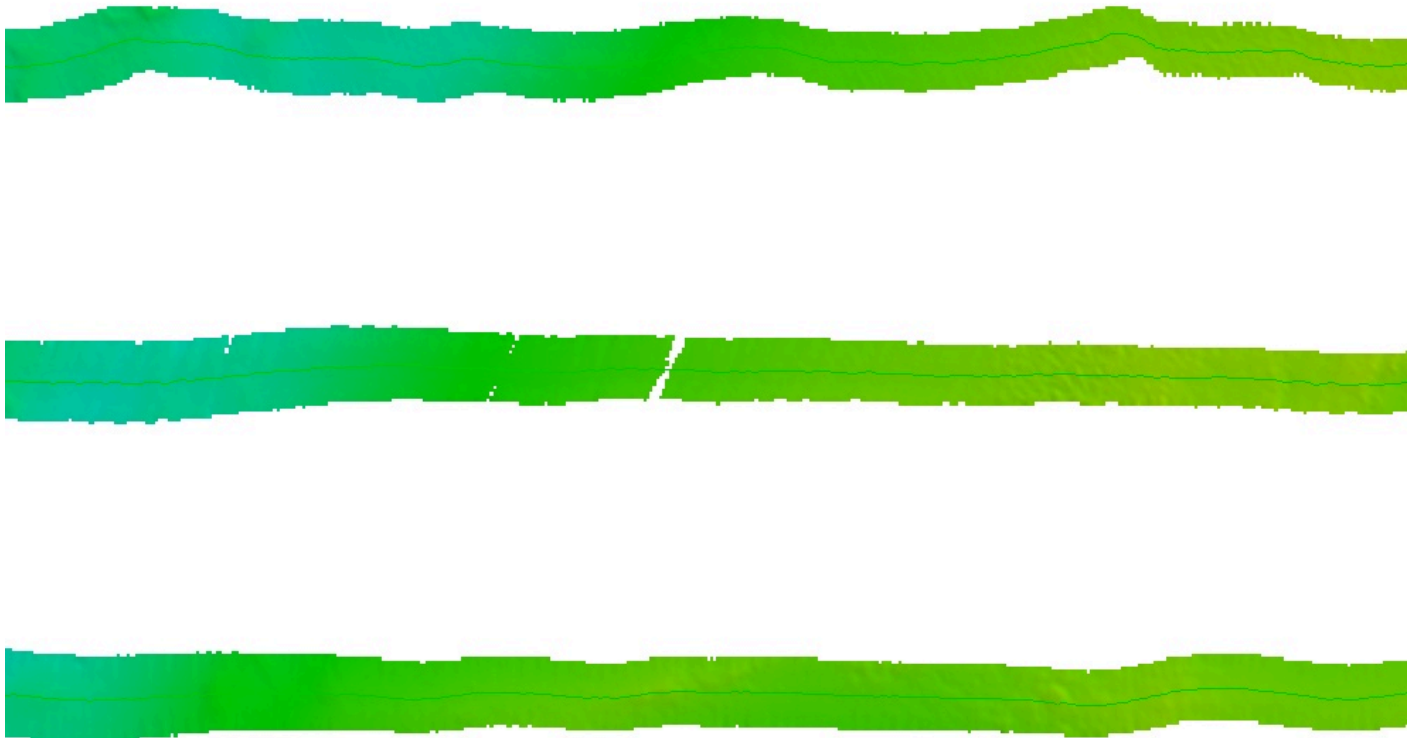
*Figure 6: Image of the final surface showing the effect of data blowouts on a line from rough weather. Line 0405-Q105-221-D3EW01600 at 58-17-49 N, 157-49-03 W.*

During rough weather conditions, especially with following seas, air bubbles would occasionally be forced under the multibeam sonar head and result in temporary loss of bottom tracking or "blowouts", sometimes causing small along-track gaps. These were examined and only reran when the gap at nadir exceeded three nodes alongtrack (12 m horizontal distance) for mainscheme lines. Final data is within specifications.
