### **DESCRIPTIVE REPORT**

Type of Survey:	Navigable Area	
Registry Number:	H13507	
	LOCALITY	
State(s):	Maryland	
General Locality:	Central Chesapeake Bay	
Sub-locality:	2NM West of Poplar Island	
	2021	
	CHIEF OF PARTY	
	Matthew J. Jaskoski, CDR/NOAA	
	LIBRARY & ARCHIVES	
Date:

## **Descriptive Report to Accompany Survey H13507**

Project: OPR-E349-TJ-21

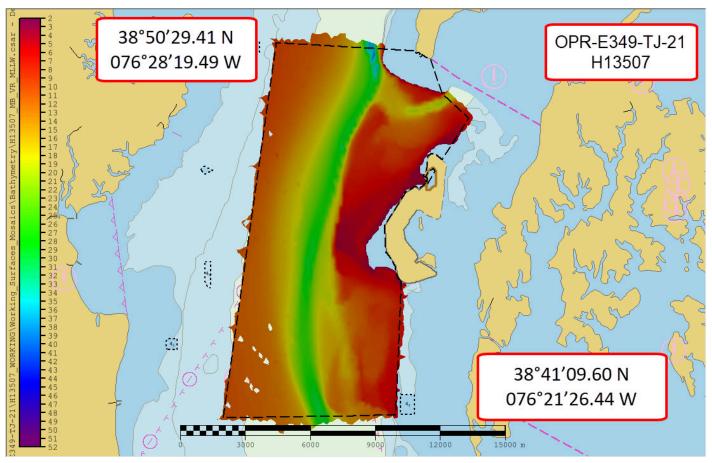
Figure 1: Survey layout for H13507, plotted over ENCs US5MD13M and US5MD16M. Black outline represents the survey limits set forth by the project instructions.

Survey data were acquired in accordance with the requirements set forth by the Project Instructions (PI) and the Hydrographic Surveys Specification and Deliverables (HSSD) dated April 2021 (Figure 1).

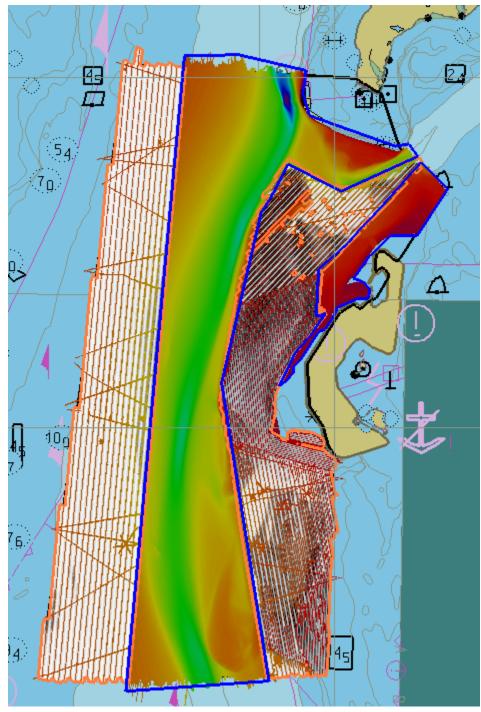
Figure 2: Coverage types used to meet complete coverage specifications. Areas of complete coverage MBES are outlined in blue and areas of complete coverage SSS with concurrent MBES outlined in orange.

Survey coverage is in accordance with requirements listed in Table 2 and in the 2021 HSSD. Coverage requirements were met with a combination of 100% complete coverage MBES coverage and 100% SSS with concurrent MBES coverage (Figure 2). Complete coverage MBES or complete coverage SSS was used to fill areas of SSS data coverage gaps. See sections B.2.6 and B.5.2 for more information.

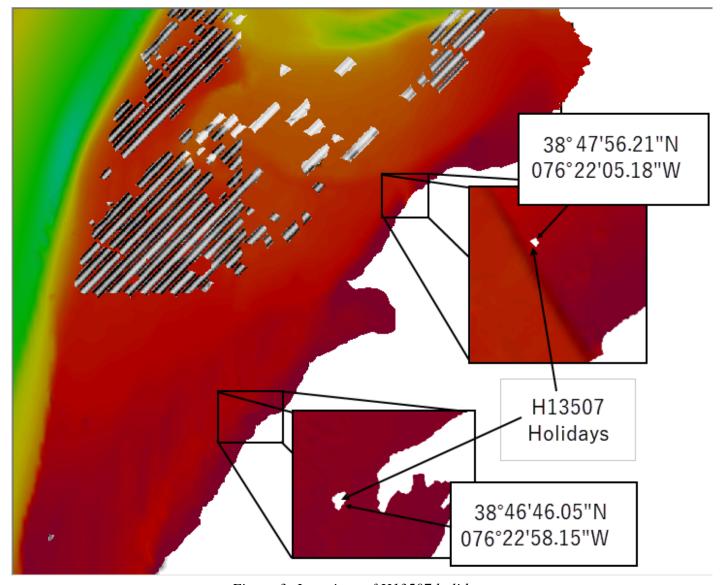
Figure 3: Locations of H13507 holidays.

Coverage was acquired to the inshore limit of hydrography, the Navigable Area Limit Line (NALL). Areas where survey coverage did not reach the 3.5-meter depth contour, nor the assigned sheet limits, were due to the survey vessel reaching the extent of safe navigation as shown in the figures below. These areas are characterized as being near shore, subject to dangerous wave action or other hazards. Due to time constraints, two MBES holidays were not able to be collected (Figure 3). After inspection of surrounding areas, these holidays do not appear to be navigationally significant.

All equipment and survey methods were used as detailed in the DAPR. Raw MBES backscatter was flagged as part of the .all file from the Kongsberg EM2040 systems. Backscatter was processed in QPS Fledermaus GeoCoder Toolbox (FMGT) software, and the exported geotiffs are include in the final processed data submission package (Figure 13). Backscatter holidays are present and co-located with MBES holidays (Figure 3).

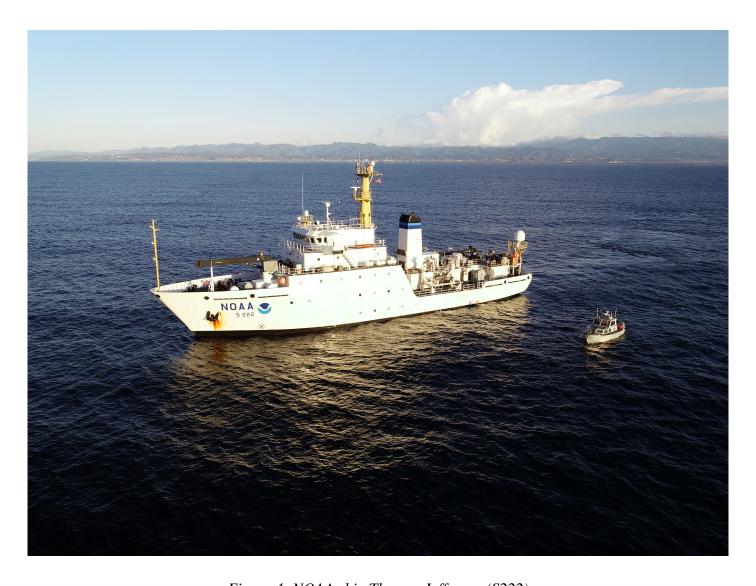
Figure 4: NOAA ship Thomas Jefferson (S222)

Hull ID	2903	2904	S222
LOA	8.5 meters	8.5 meters	63.4 meters
Draft	1.2 meters	1.2 meters	4.6 meters

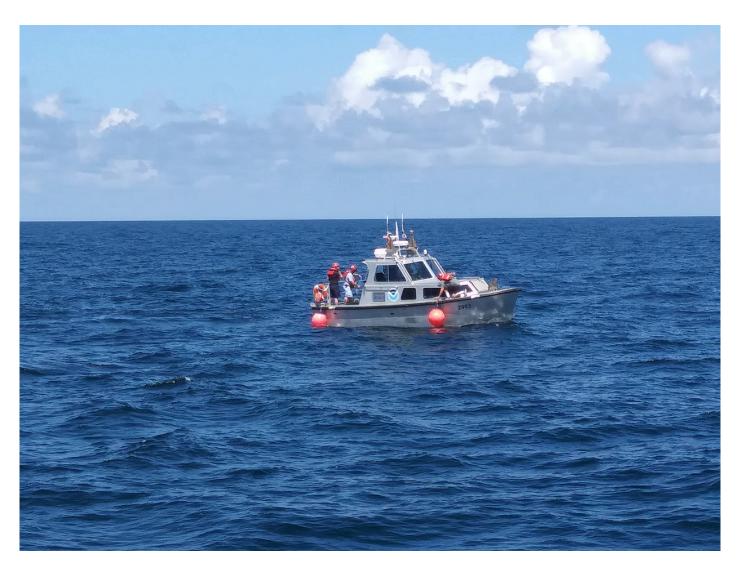
Figure 5: Thomas Jefferson Launch 2903

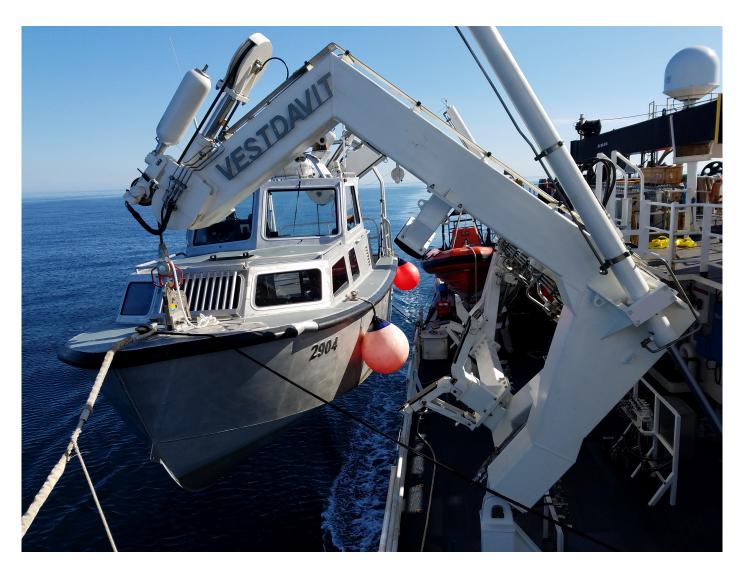
Figure 6: Thomas Jefferson Launch 2904

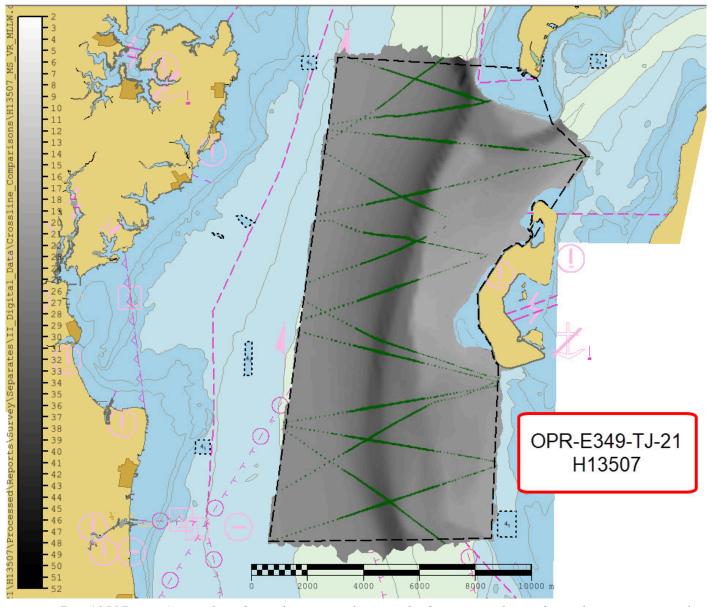
Figure 7: H13507 MBES crossline data, shown in color, overlaid on mainscheme data, shown in greyscale.

Hydrographic Survey Launch 2903 collected 67.04 linear nautical miles of MBES crosslines or 3.93% of mainscheme MBES data. Crossline data did not meet the 4% specification set by 2021 HSSD due to operational time constraints. A single resolution Combined Uncertainty and Bathymetry Estimator (CUBE) surface of mainscheme data at the 1m resolution and a single resolution CUBE surface at the 1m resolution of crossline data were differenced - the resulting mean was 0.04m with a standard deviation of 0.05m (Figures 7 and 8). Visual inspection of the difference surface indicated no systematic issues.

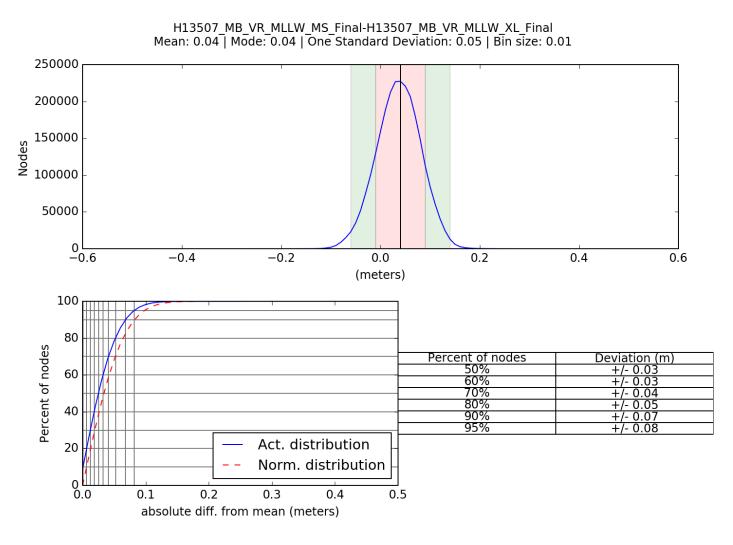
Figure 8: H13507 crossline/mainscheme comparison statistics.

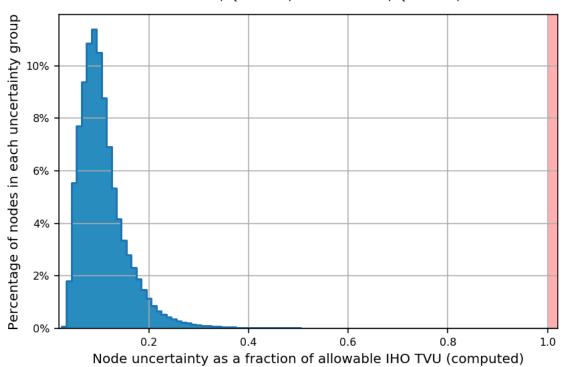
99.5+% pass (65,495,569 of 65,495,876 nodes), min=0.02, mode=0.09, max=1.93 Percentiles: 2.5%=0.05, Q1=0.08, median=0.10, Q3=0.13, 97.5%=0.24

Figure 9: H13507 uncertainty standards.

The bathymetric surface's uncertainty layer is compliant with 2021 HSSD uncertainty standards. Over 99.5% of all nodes pass uncertainty standards (Figure 9).

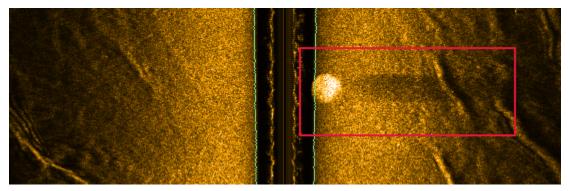
Figure 10: An example of fish school that was seen thoughout H13507.

Many large schools of fish were encountered throughout survey H13507. Some schools were dense enough to create large acoustic shadows that obscured parts of the seafloor and prevent the detection of significant features (Figure 10). These severe instances were rejected from the SSS data, creating data gaps in the mosaic. The gaps were then re-acquired using either complete coverage SSS or complete coverage MBES. However, due to time constraints data was not acquired over every encounter with fish schools.

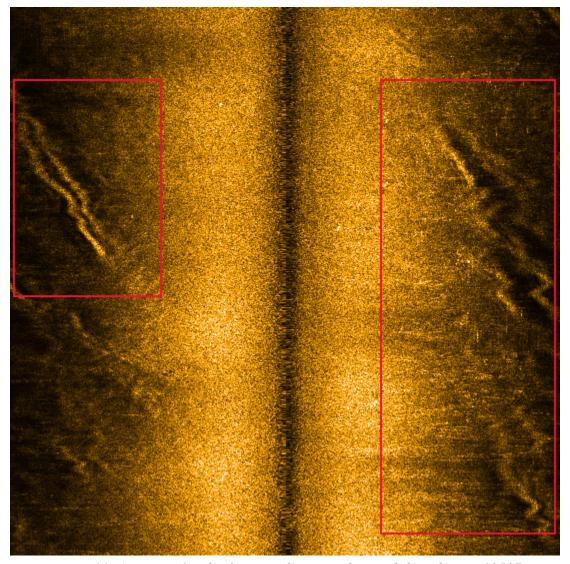
Figure 11: An example of refraction that was observed thoughout H13507.

H13507 was located in an area that frequently exhibits intense density stratification. This layering greatly affects sound speed and results in refraction that can be observed in the SSS imagery (Figure 11). The side scan towfish are hull-mounted on HSLs 2903 and 2904 and cannot be lowered below the pycnocline. Refraction was observed on both vessels on numerous days, particularly in the shallower eastern sections of the sheet. Severe instances of refraction were rejected from the SSS data, resulting in data gaps in the mosaic. The gaps were then re-acquired using either complete coverage SSS or complete coverage MBES.

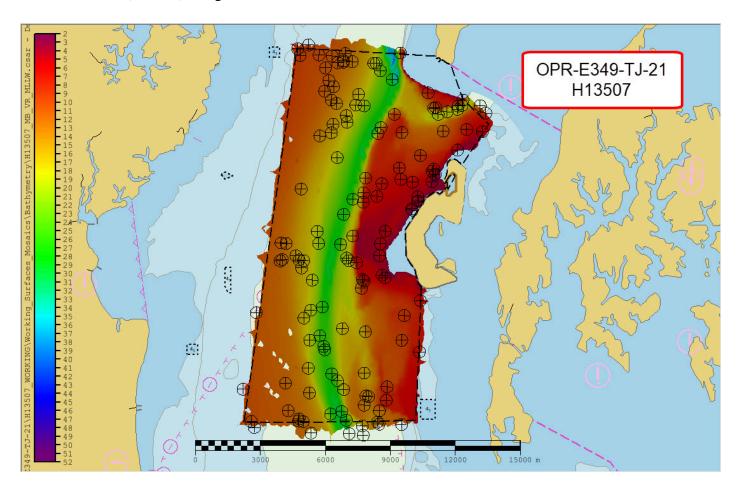
Figure 12: Overview of all SVP casts taken on H13507.

A total of 122 sound speed profiles were collected within the survey limits of H13507 and display good spatial diversity (Figure 12). An additional 11 measurements were collected outside the data extents and were included in the master file for processing. These 11 additional profiles provide data representative of the conditions found within the survey area and are appropriate for use. All sound speed profile data were

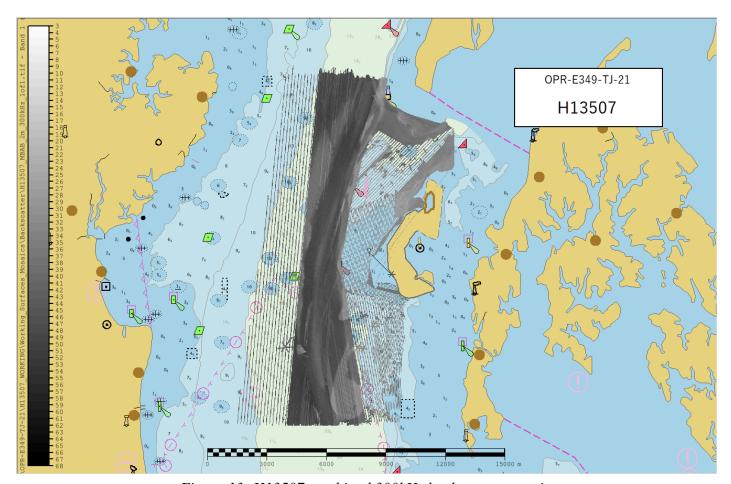
Figure 13: H13507 combined 300kHz backscatter mosaic.

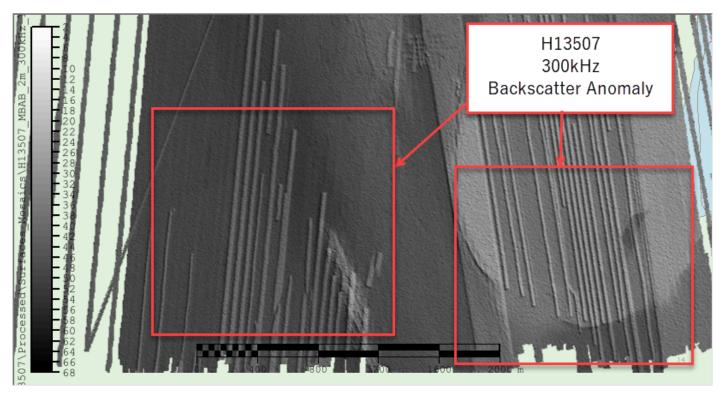
Figure 14: H13507 backscatter anomaly.

There are noticable changes in backscatter intensity in areas where MBES data was collected using HSL 2903 on days 137,145,167, and 168 (Figure 14). No cause for the changes of intensity have been found.

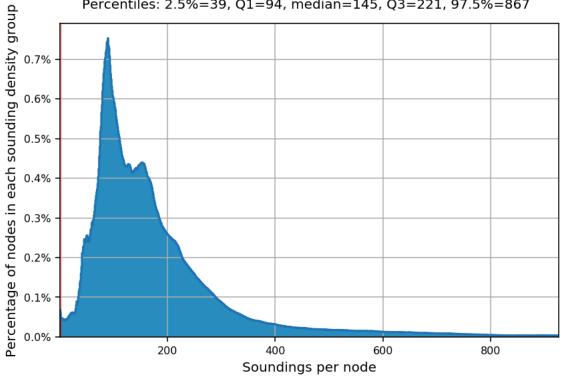
99.5+% pass (65,349,776 of 65,495,876 nodes), min=1.0, mode=90, max=38354.0 Percentiles: 2.5%=39, Q1=94, median=145, Q3=221, 97.5%=867

Figure 15: H13507 data density standards.

Complete coverage requirements were met by 100% SSS coverage with concurrent MBES and 100% complete coverage MBES as specified under section 5.2.2.2 of the 2021 HSSD. All bathymetric grids for H13507 meet density requirements per the 2021 HSSD (Figure 15).

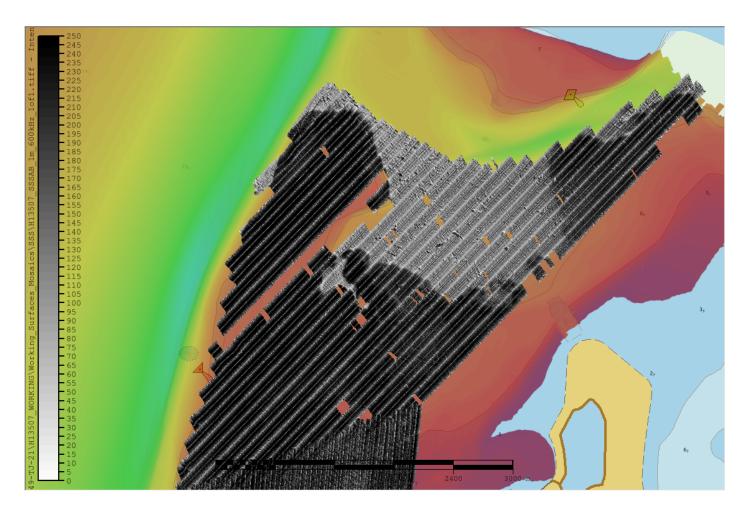
Figure 16: H13507 SSS mosaic holidays that were covered using 100% complete coverage MBES.

Two holidays are present in the submitted MBES surface (see section A.4). Multiple holidays exist in the SSS mosaic that were created by the rejection of poor quality data (see Section B.2.6). These holidays were re-acquired using complete coverage MBES to meet complete coverage requirements as specified in the in the 2021 HSSD (Figure 16).

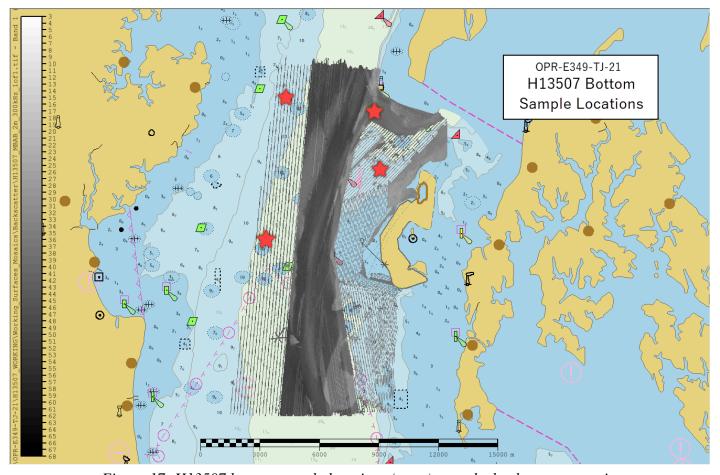
Figure 17: H13507 bottom sample locations (stars) over the backscatter mosaic.

A total of four bottom samples were collected, investigated and are included in the Final Feature File. See Figure 17 for a generalized view of H13507 bottom sample locations.

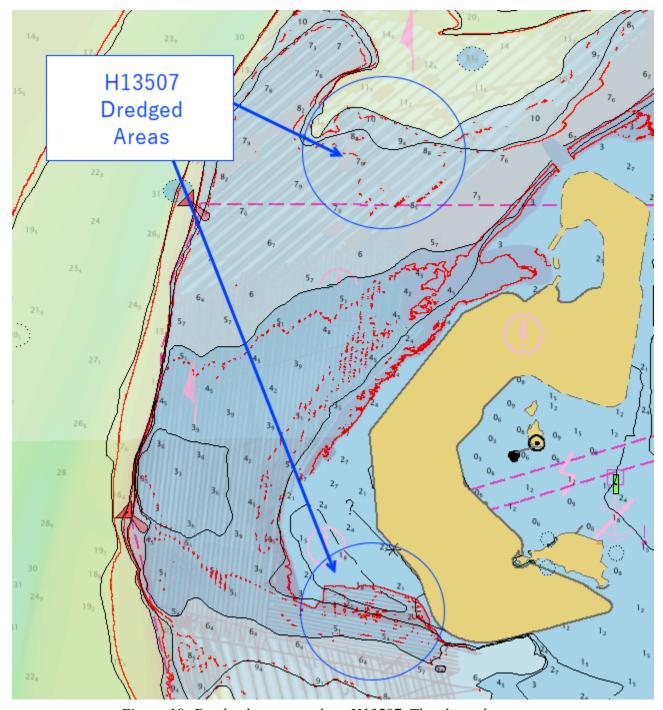
Figure 18: Dredged areas on sheet H13507. The charted contours are shown in black and the observed contours are shown in red.

Two areas of dredging were identified on the north eastern part of sheet H13507 (Figure 18). These areas are deeper and vary from the charted bathymetric contours. They are a result of an ongoing Army Corps of Engineers project on Poplar Island. No DToNs were identified in these areas.
