DESCRIPTIVE REPORT

Type of Survey: Navigable Area

Registry Number: H13608

Sub-locality: 6 NM Northeast of Cleveland

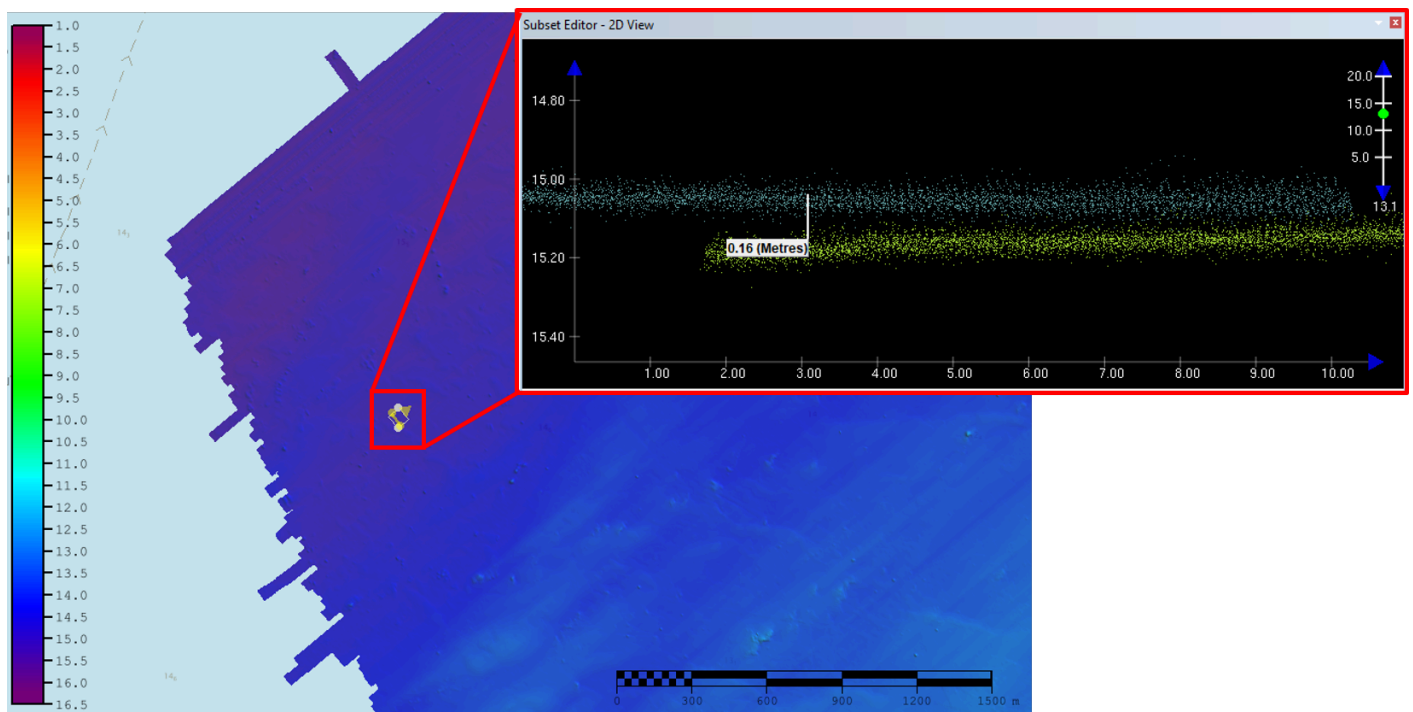
Figure 17: Example of the impact of sound speed seen throughout H13608 in Caris subset editor.

H13608 is located in an area that exhibits intense thermal stratification in the water column. This thermal layering greatly affects sound speed and results in refraction that can be observed in the MBES surface (Figure 17). The impacts on sounding depth accuracy are within allowable uncertainty standards, as outlined in the 2022 HSSD.

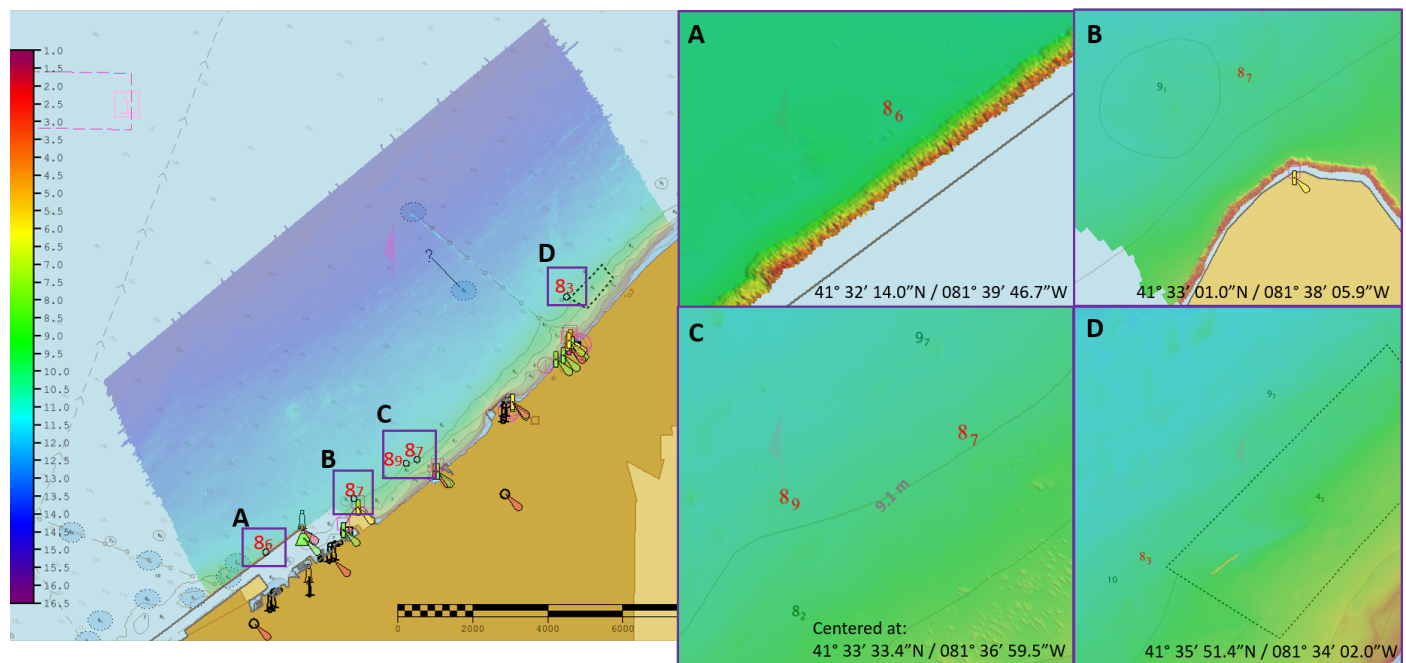
Figure 23: Isolated features with least depth less than the surrounding depth area - 9.1 - 36.5 m.

Several isolated, natural features exist that are shallower than their corresponding depth area. These features were not considered to be DtoNs based on the area's Category Zone of Confidence (CATZOC) their proximity (within 100 m) to other charted features such as fish havens, breakwaters, and the 9.1 m contour (Figure 23). They have been designated per Section 5.2.1.2.3 in the 2022 HSSD and are represented in the final submitted surface.
