**H13609**

**DESCRIPTIVE REPORT**

Type of Survey: Navigable Area

Project Number: **OPR-W386-TJ-22**

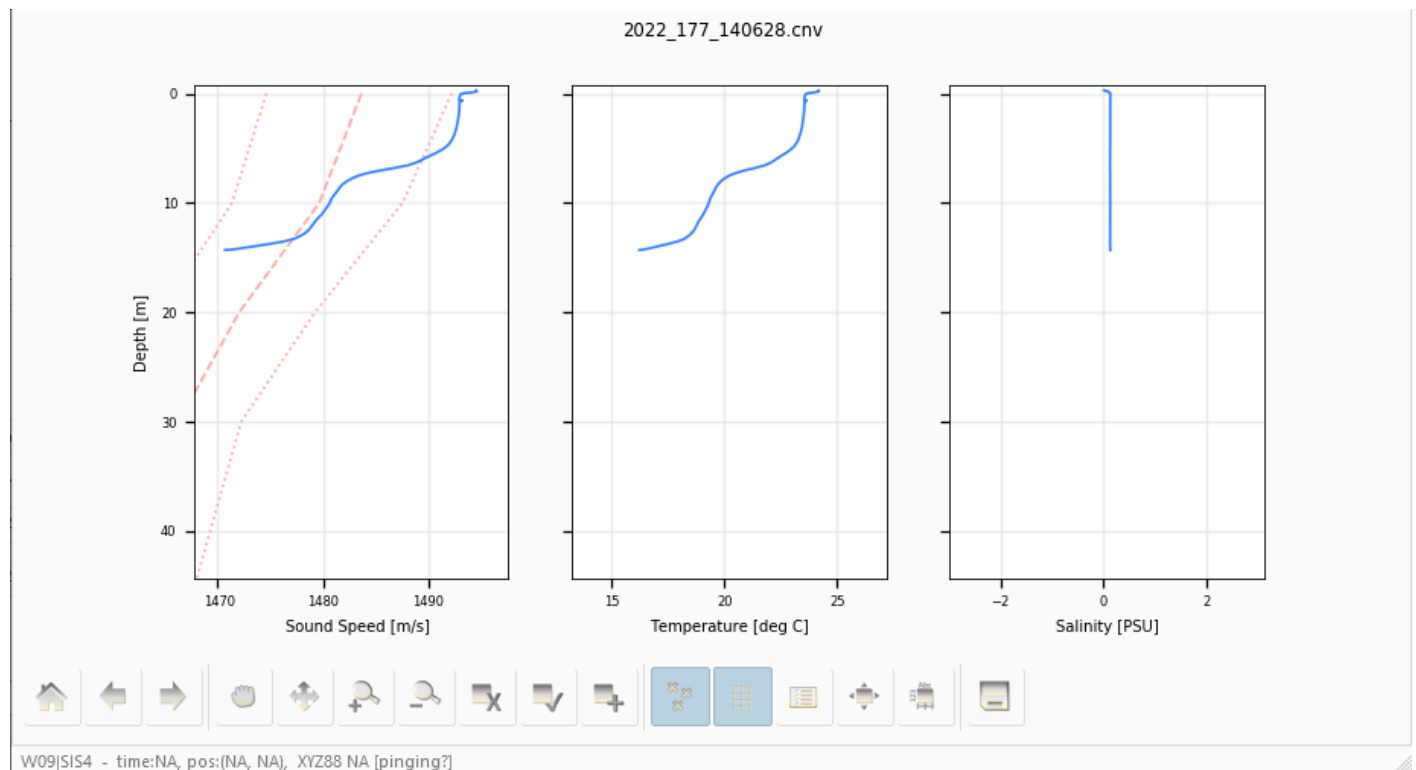
*Figure 13: Example of conductivity, temperature, and sound speed profiles collected on H13609 showing the effect of temperature on sound speed.*

H13609 is located in an area that exhibits intense thermal stratification. This layering greatly affects sound speed (Figure 13) and results in refraction that can be observed in the SSS imagery (Figure 14). The side scan towfish are hull-mounted on the launches and cannot be lowered below the thermocline. Varying degrees of refraction were observed in SSS data collected by HSL 2903, however the hydrographer determined that all data are of acceptable quality to be able to discern contacts on the lake bed.

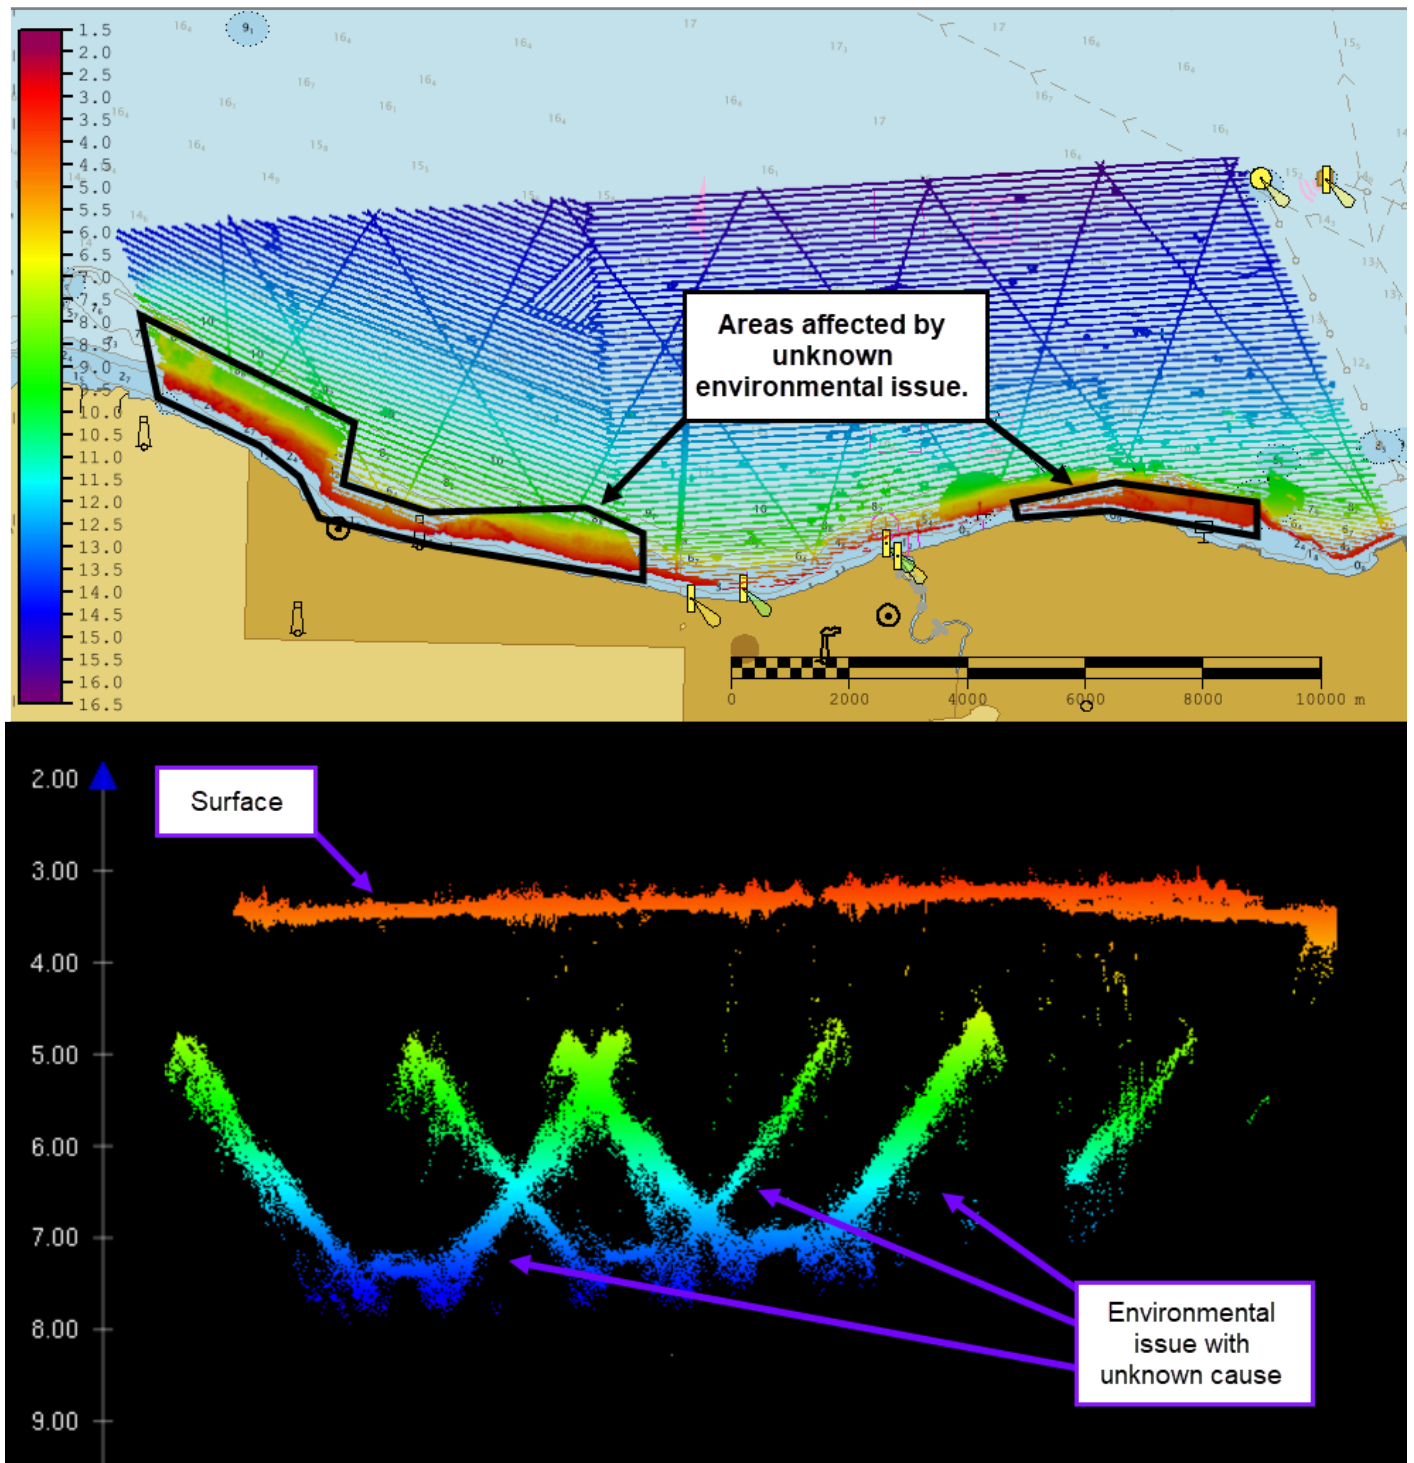
Figure 15: Areas in H13609 with an the displayed "V" shape soundings

The nearshore area of H13609 is made up of what appear to be rocky ledges. In the area of these rocky ledges, the Kongsberg 2040 sonars on HSLs 2903 and 2904 had trouble bottom tracking throughout the swath which created soundings below the CUBE surface in a "V" shape (Figure 15). This issue occurred only in the rocky ledge area of the sheet and with both sonars suggesting an environmental issue rather than one with the equipment. The erroneous data were rejected from the CUBE surface and the field unit

attempted to reacquire over the area using adjusted settings in the Kongsberg MBES system. However, the problem persisted and no further re-acquisition efforts were made.
