DESCRIPTIVE REPORT

Type of Survey: Navigable Area

Registry Number: H13611

Sub-locality: 2 NM North of Presque Isle

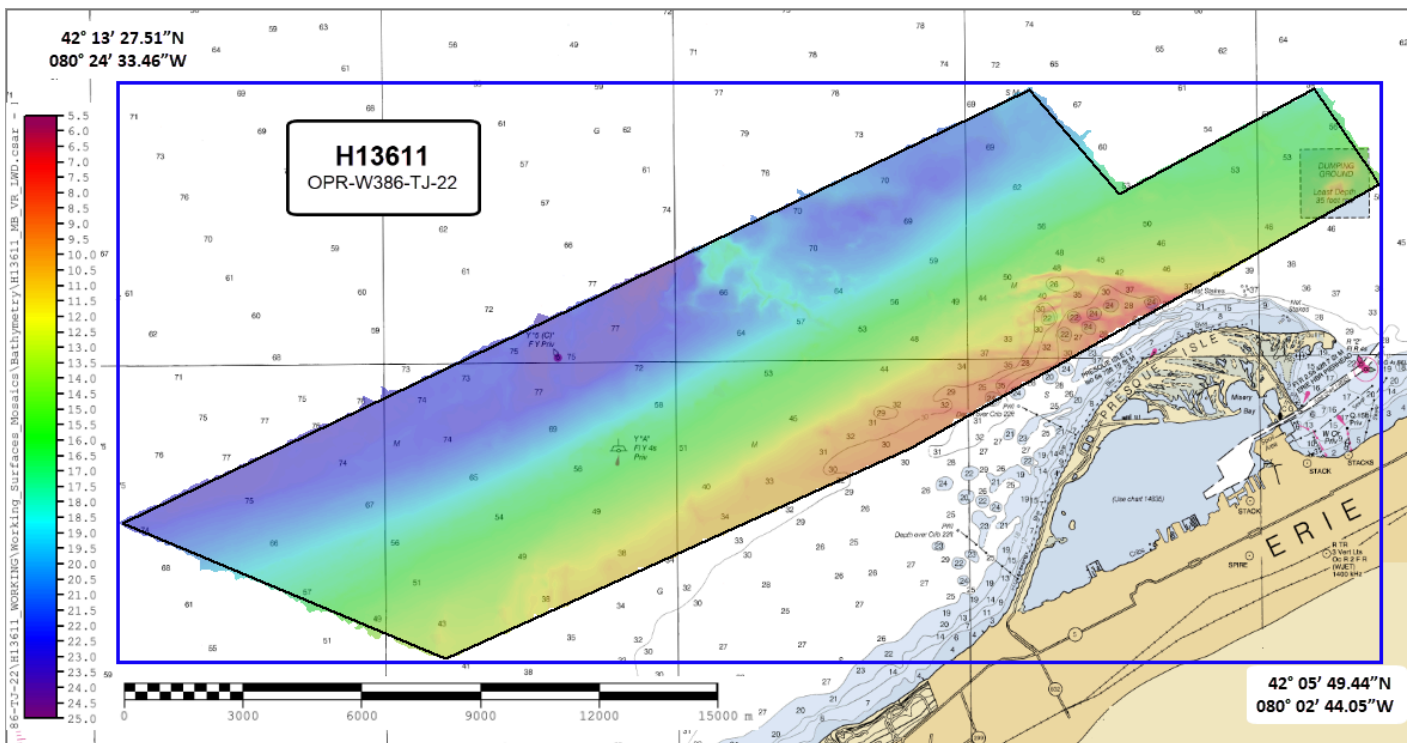
Figure 2: Survey layout for H13611, plotted over RNC 14824. The solid black outline represents the survey limits set forth by the Project Instructions. Multibeam coverage shown in color.

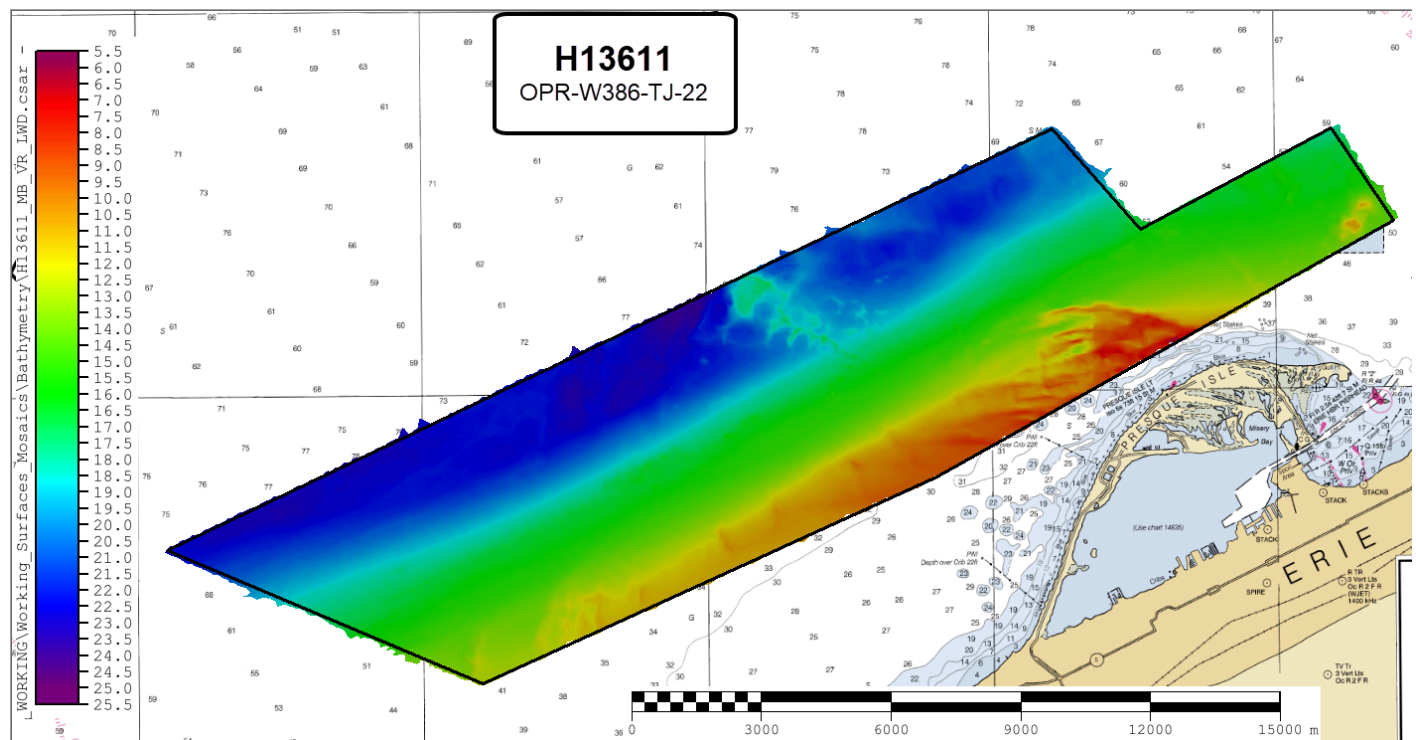
Figure 3: MBES coverage achieved for H13611 shown in color overlaid on RNC 14824. The black outline represents the assigned survey limits.

Survey coverage is in accordance with requirements listed in section 5.2.2 of the 2022 HSSD. Coverage requirements were met with 100% complete coverage MBES (Figure 3).

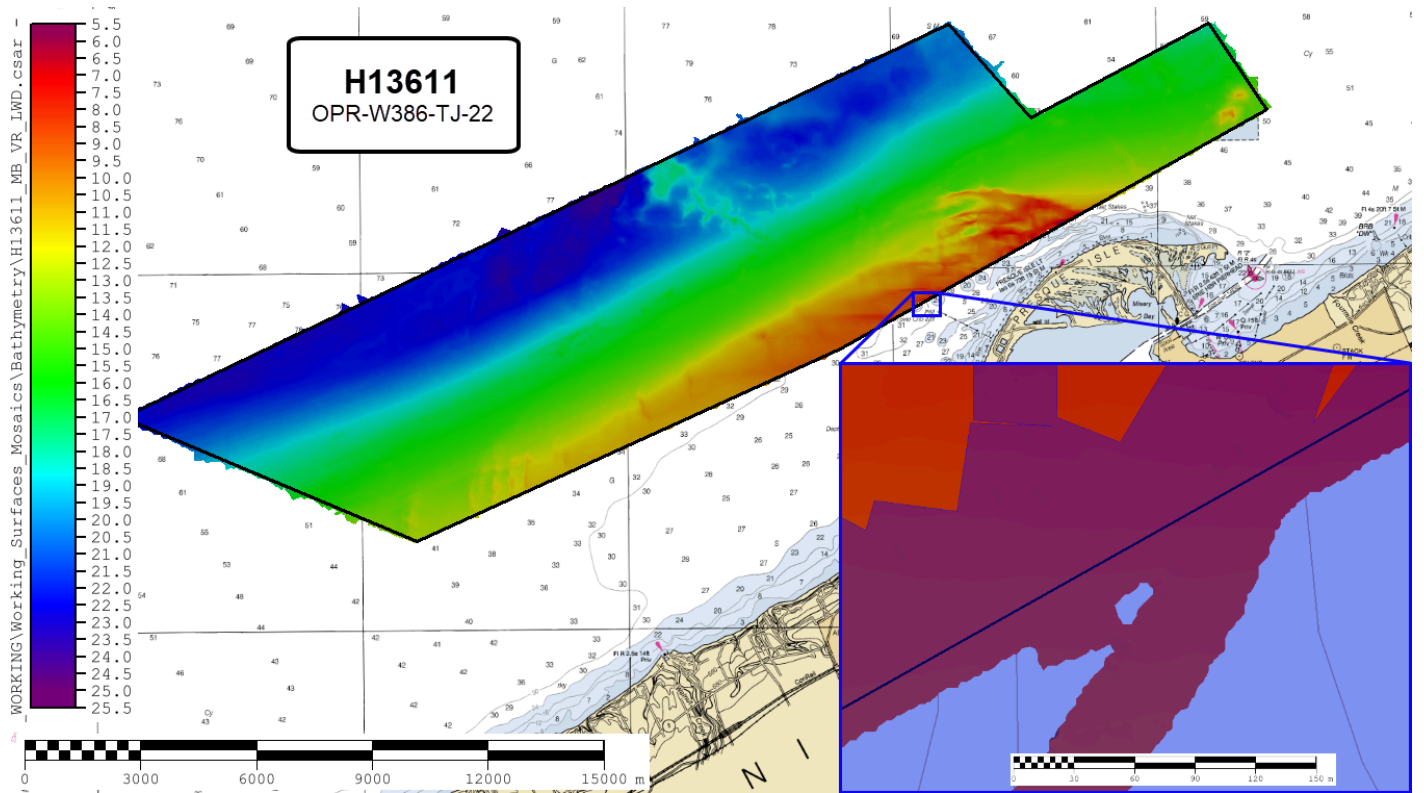
Figure 4: Holiday outside of sheet limits, located at 42° 09' 31.27"N 080° 09' 23.98"W, with coverage from junctioning sheet H13610 overlaid in transparent blue.

Two holidays exist in the 100% complete coverage MBES achieved for H13611. Both are located on the southern sheet edge outside of the assigned survey limits. One holiday is completely covered by MBES from junctioning sheet H13610 and no significant features or shoaling were observed in the area (Figure 4). The second holiday does not have coverage from a junctioning survey (Figure 5). While there is no guarantee of the absence of significant features, the hydrographer does not see evidence of hazardous shoaling based on trends in the surrounding bathymetry.

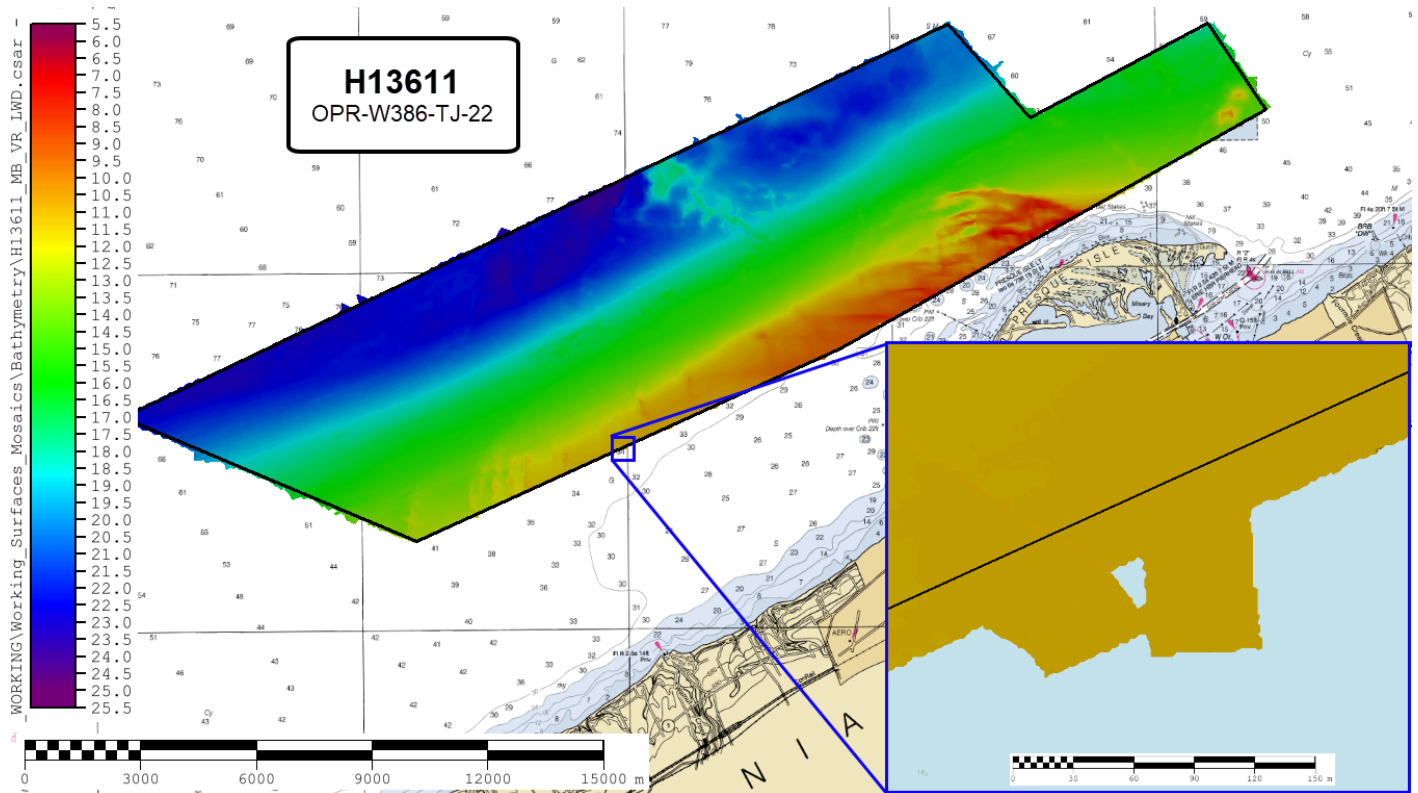
*Figure 5: Holiday outside of sheet limits, located at 42° 07' 31.23"N
080° 15' 03.80"W, without coverage from an adjoining sheet.*

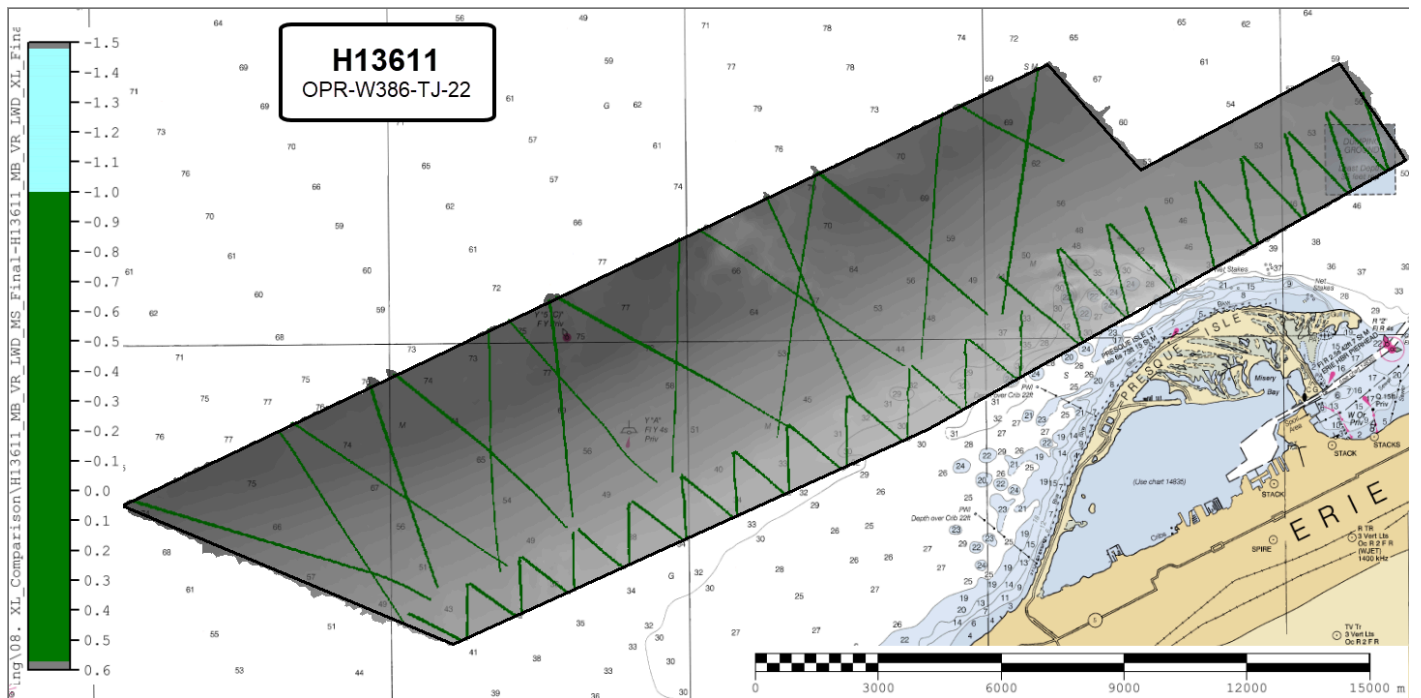
Figure 8: H13611 crossline fraction of allowable error shown in color, overlaid onto survey data shown in greyscale.

S-222 and 2903 collected a total of 87.86 linear nautical miles of MBES crosslines, or 4.06% of mainscheme MBES data. The crosslines acquired represent good spatial and depth diversity for this survey area (Figure 8).

A variable resolution Combined Uncertainty and Bathymetry Estimator (CUBE) surface of mainscheme data and a variable resolution CUBE surface of crossline data were differenced - the resulting mean was 0.01m with a standard deviation of 0.06m (Figure 9). Over 99.5% of nodes are compliant with fraction of allowable error standards (Figure 10). Visual inspection of the difference surface indicated no systematic issues.

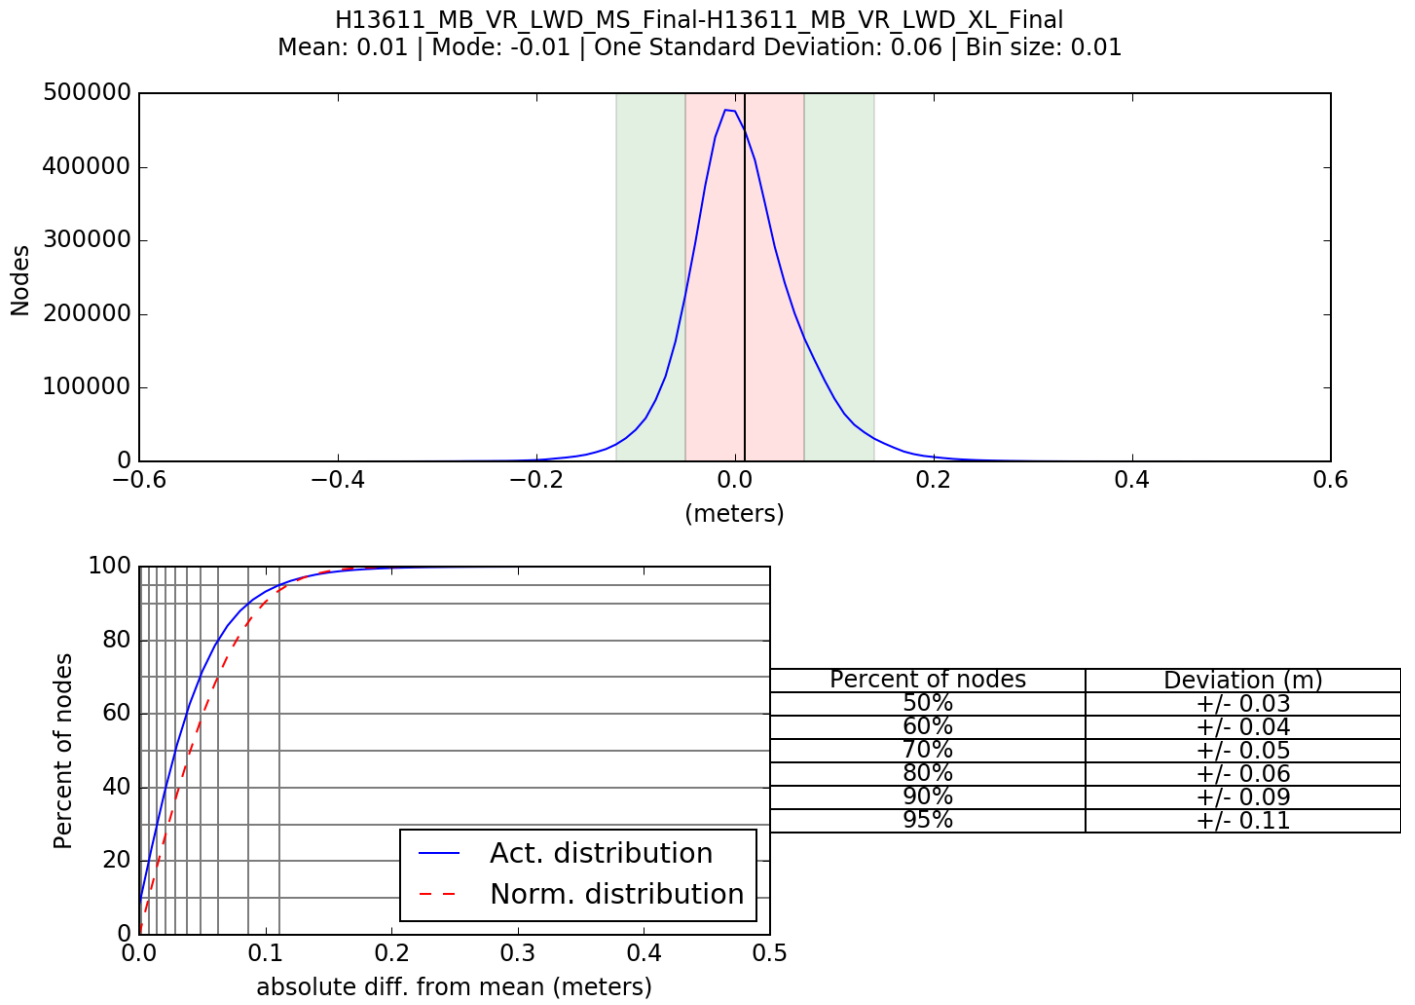
Figure 9: H13611 crossline and mainscheme comparison statistics.

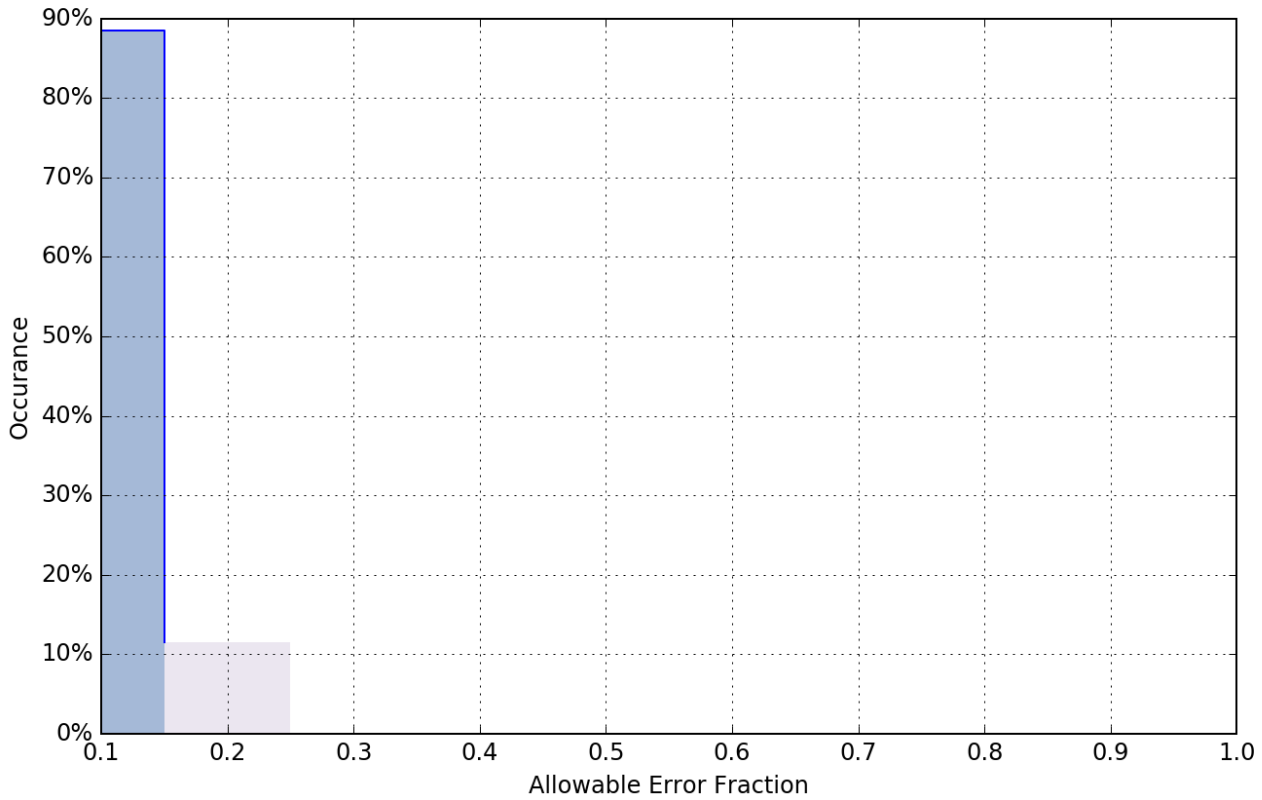
99.5+% nodes pass (5601172), min=0.0, mode=0.1 mean=0.1 max=1.8

Percentiles: 2.5%=0.0, Q1=0.0, median=0.0, Q3=0.1, 97.5%=0.2

Figure 10: H13611 fraction of allowable error node distribution.

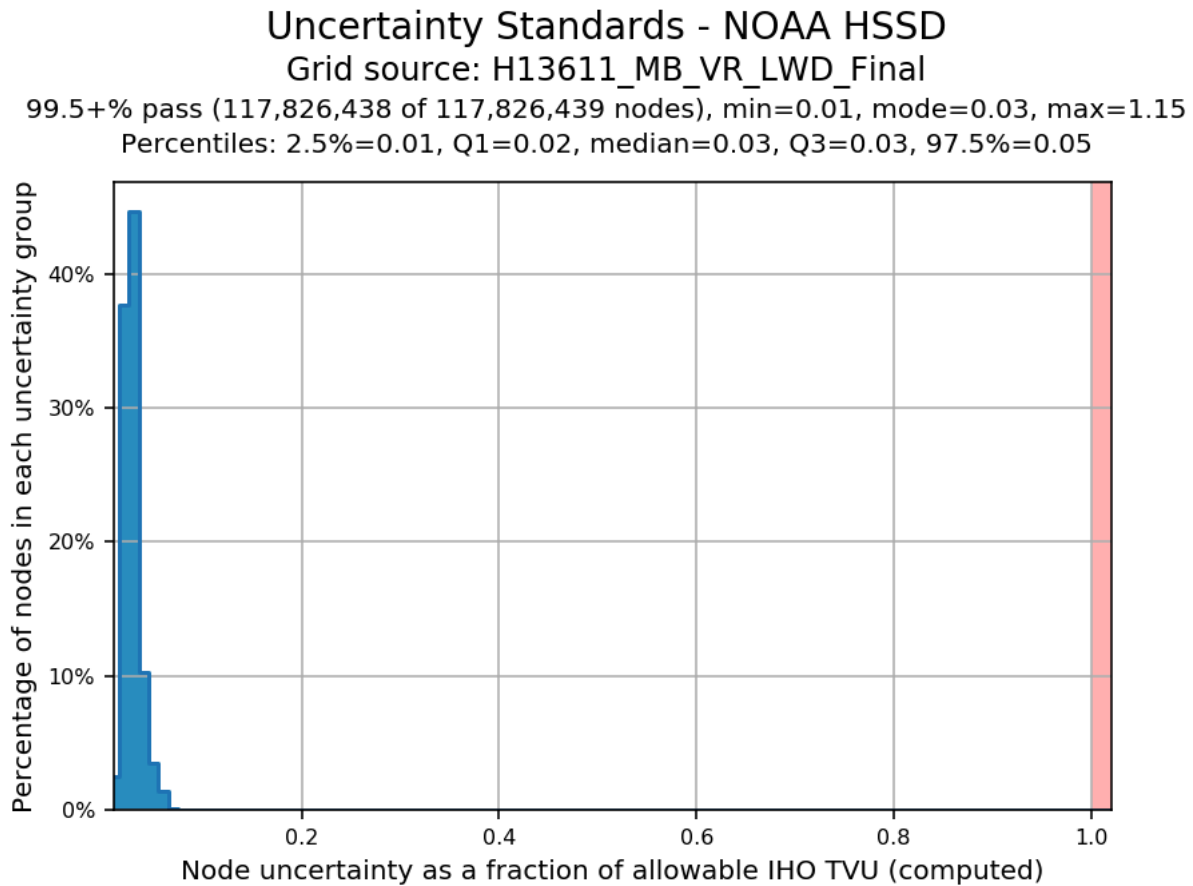
Figure 11: H13611 uncertainty standards.

The bathymetric surface's uncertainty layer is compliant with 2022 HSSD uncertainty standards. Over 99.5% of all nodes pass uncertainty standards (Figure 11).

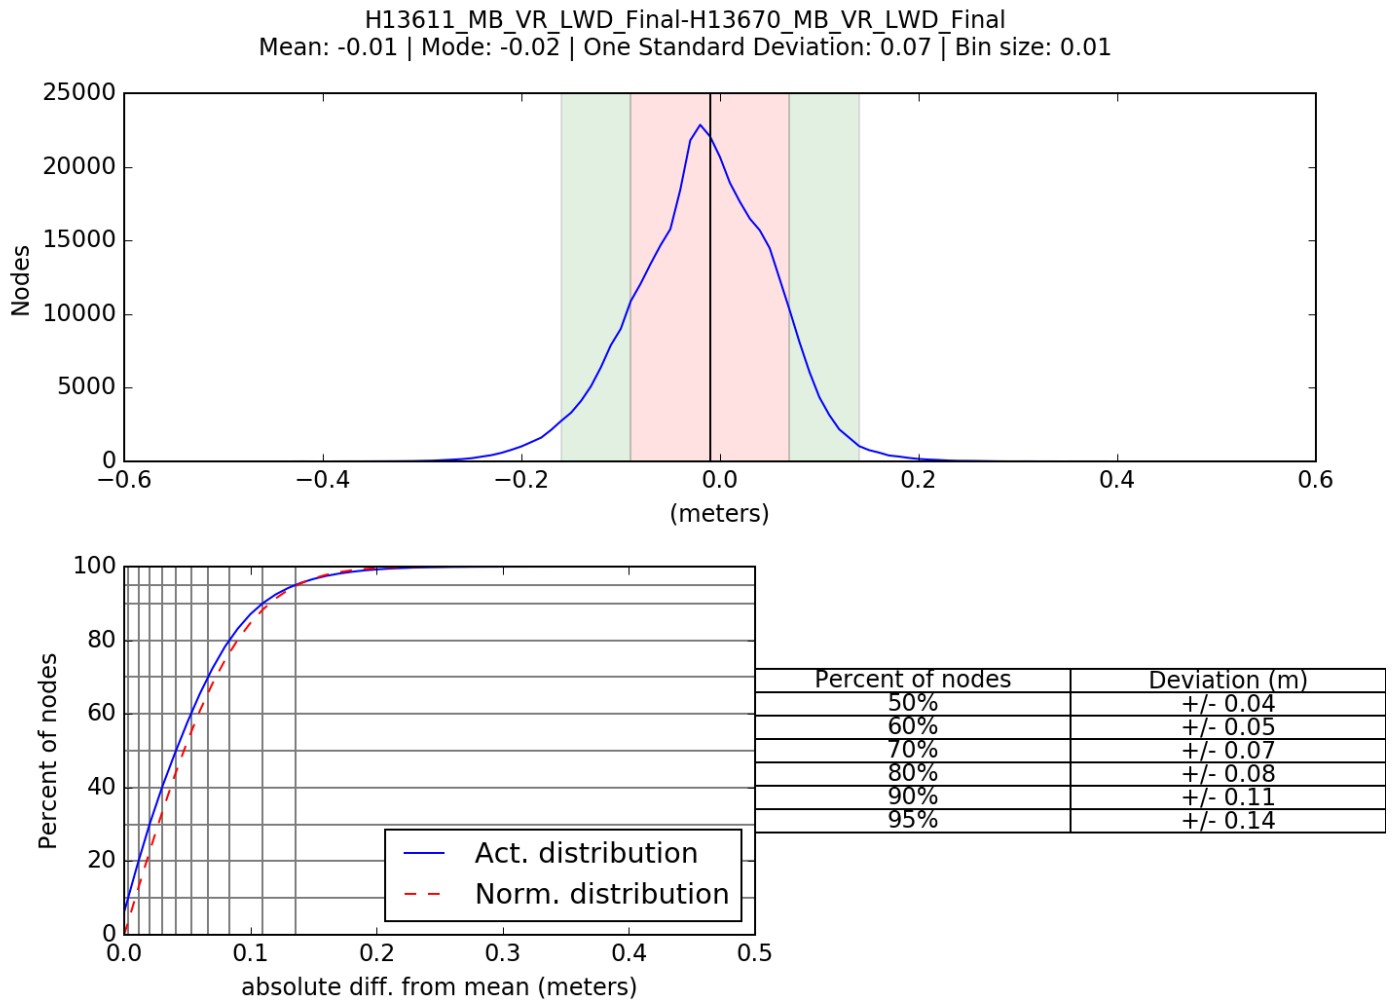
Figure 14: H13611 and H13670 surface difference comparison statistics.

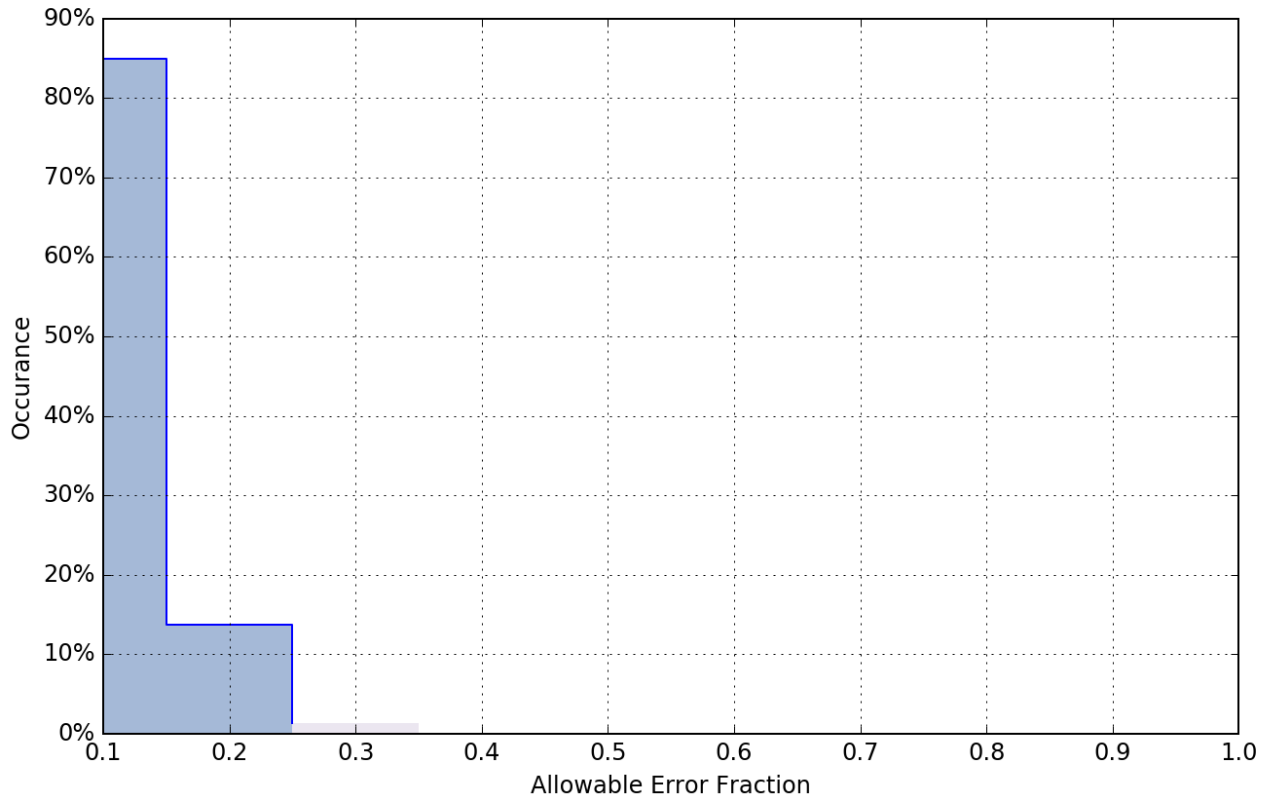
100% nodes pass (355420), min=0.0, mode=0.1 mean=0.1 max=0.5

Percentiles: 2.5%=0.0, Q1=0.0, median=0.1, Q3=0.1, 97.5%=0.2

Figure 15: H13511 and H13670 fractional allowable error node distribution comparison stats.

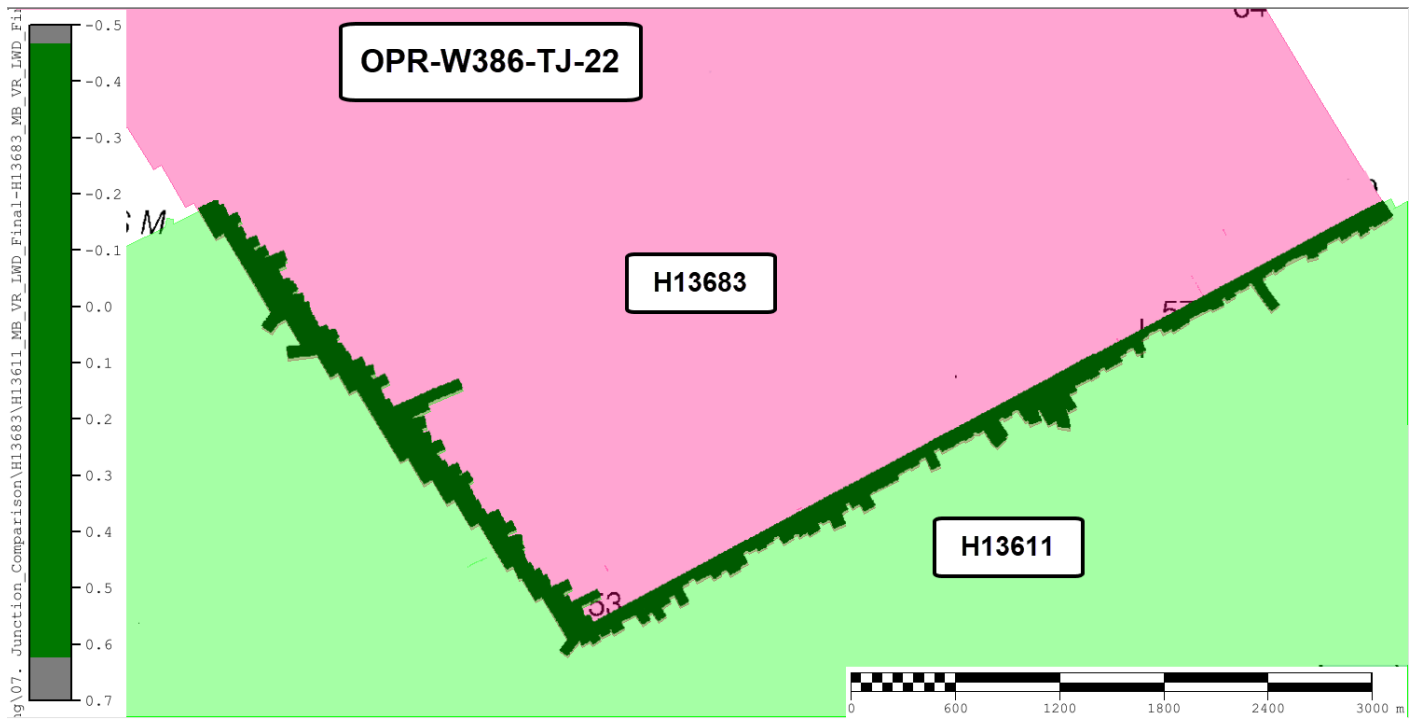
Figure 16: Fraction of allowable error surface difference comparison in color between H13611 and H13683.

The northeastern edge of H13611 junctions with sheet H13683. A variable resolution (VR) CUBE surface of H13611 data and a VR CUBE surface of H13583 data were differenced (Figure 16). The mean difference between bathymetric surface nodes was 0.03m with a standard deviation of 0.06m (Figure 17). 100% of the compared nodes meet fraction of allowable error standards (Figure 18). Statistics and visual inspection indicate that surveys H13611 and H13683 are in general agreement.

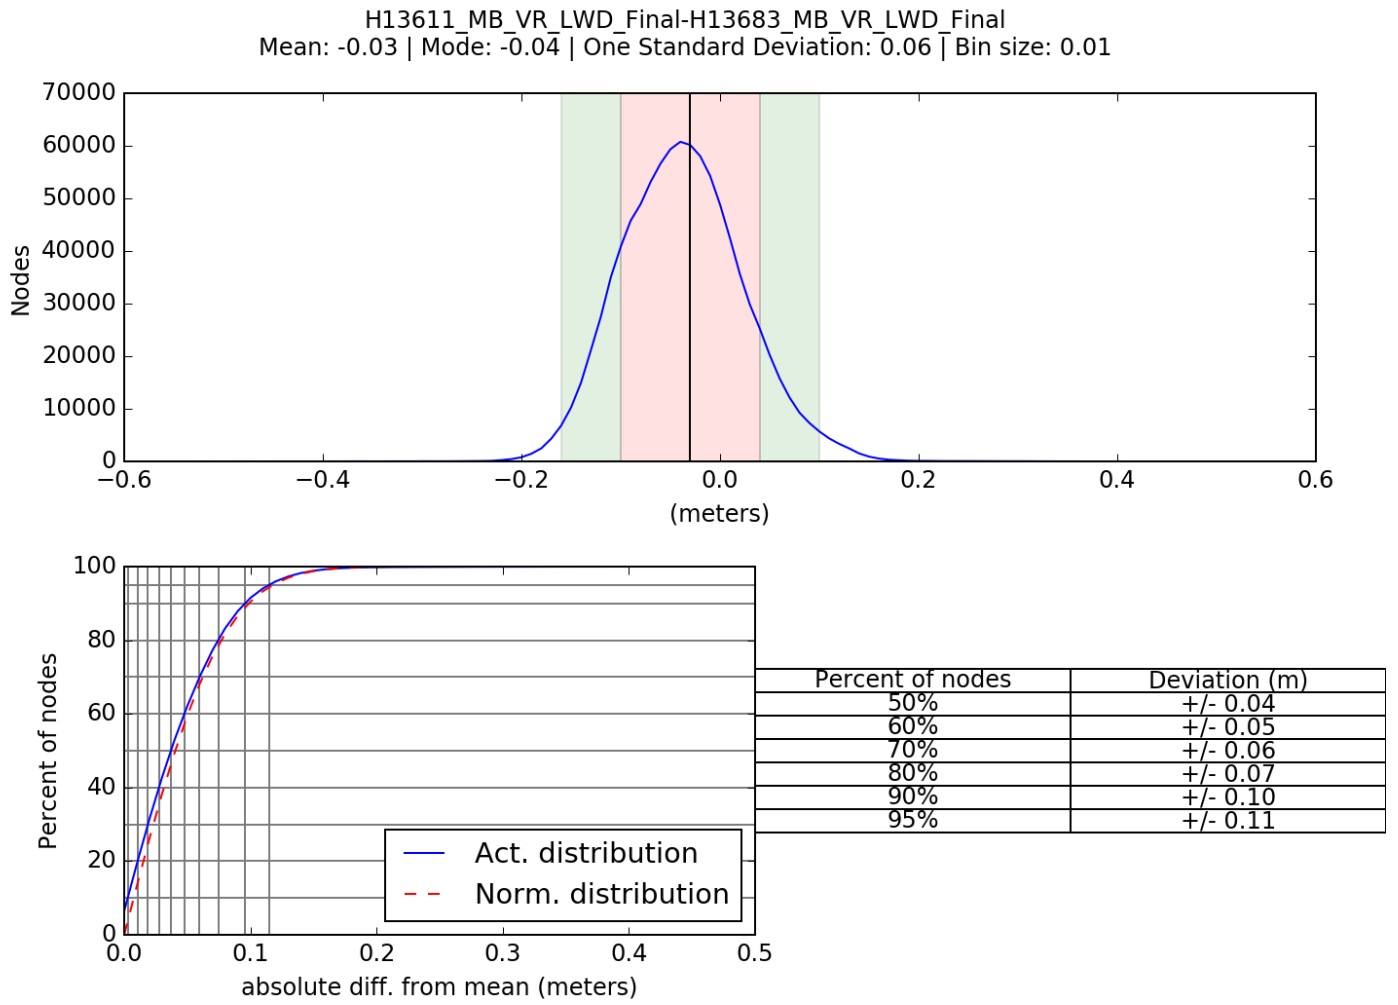
Figure 17: H13611 and H13683 surface difference comparison statistics.

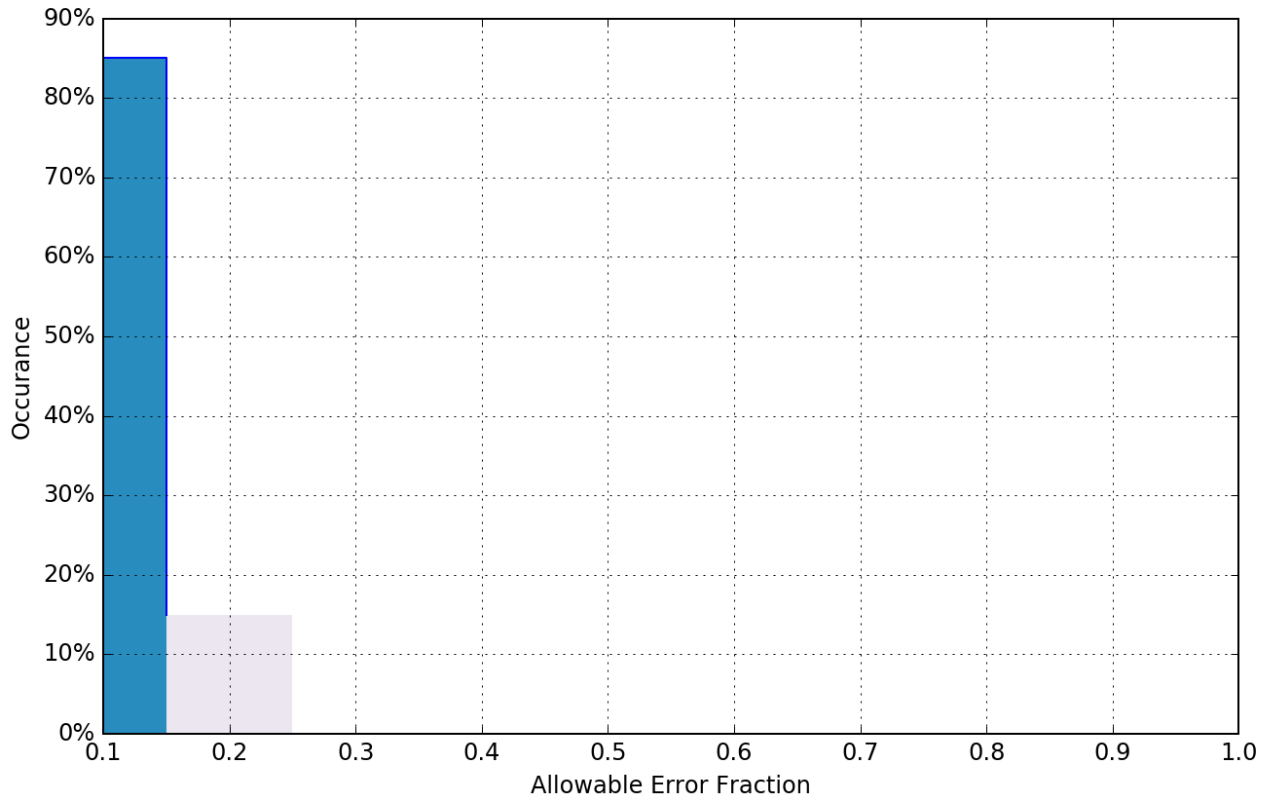
100% nodes pass (930843), min=0.0, mode=0.1 mean=0.1 max=0.7

Percentiles: 2.5%=0.0, Q1=0.0, median=0.1, Q3=0.1, 97.5%=0.2

Figure 18: H13511 and H13683 fraction of allowable error node distribution comparison stats.

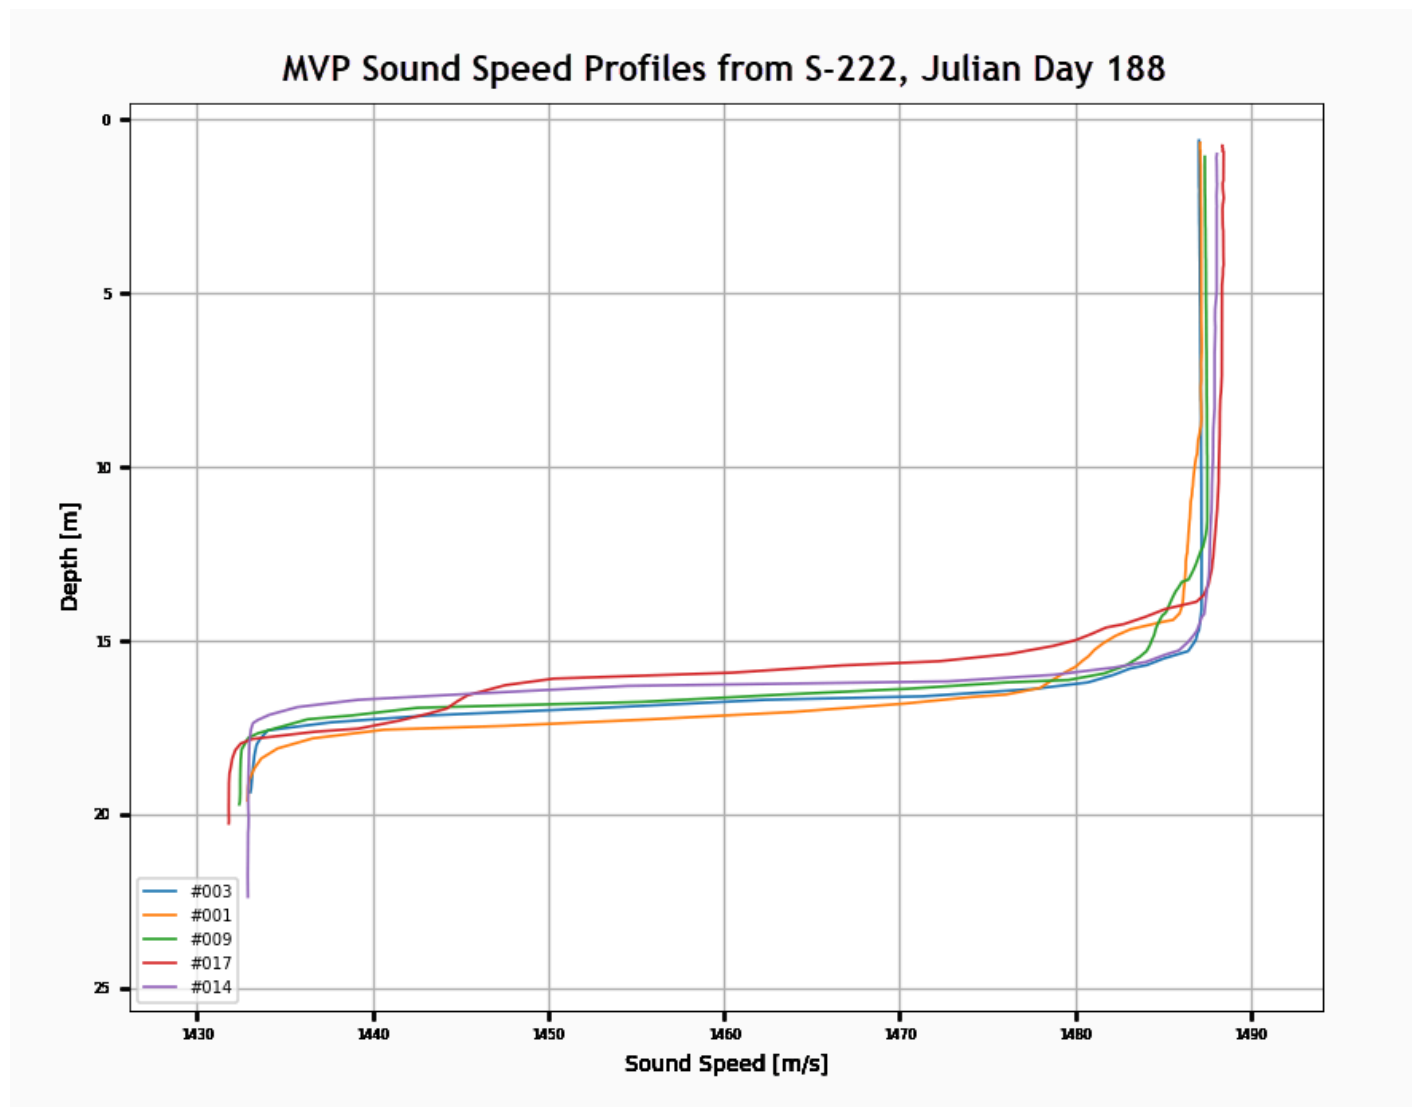
Figure 19: Sound speed profiles from MVP casts that represent typical conditions in the survey area.

Thermal stratification is a persistent environmental condition encountered in the project area and was present for the duration for the survey. This stratification was identified in the MVP and CTD sound speed profiles (Figure 19) and resulted in varying degrees of refraction of the outer MBES swath. However, this refraction did not result in vertical displacement of soundings that was greater than the maximum allowable total vertical uncertainty (TVU) at any depth (Figure 20). The final delivered surfaces meet NOAA allowable vertical uncertainty parameters from the 2022 HSSD (Figure 11). As such, the data remain sufficient to supersede previous data.

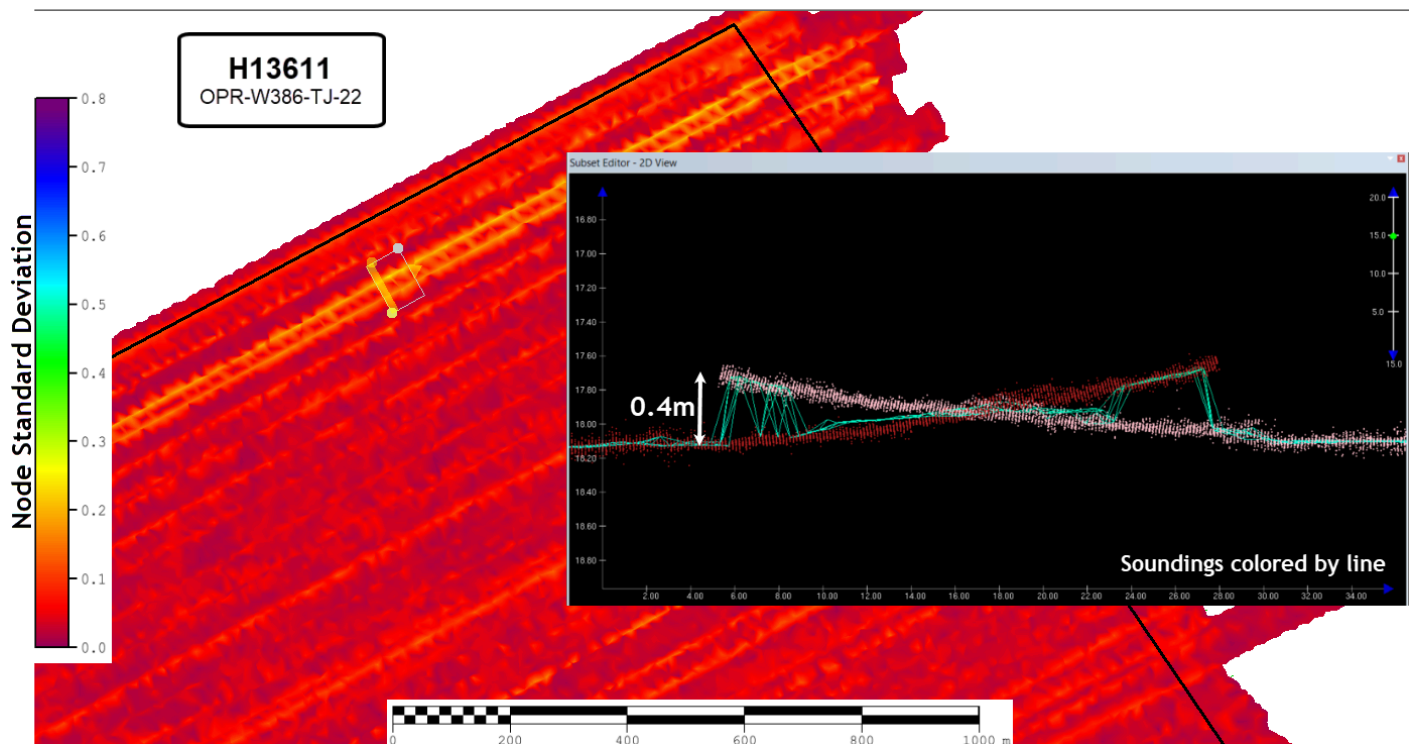
Figure 20: 2D view of survey data showing upturn in the outer swath likely caused by sound speed issues. 2D view exaggeration 15x.

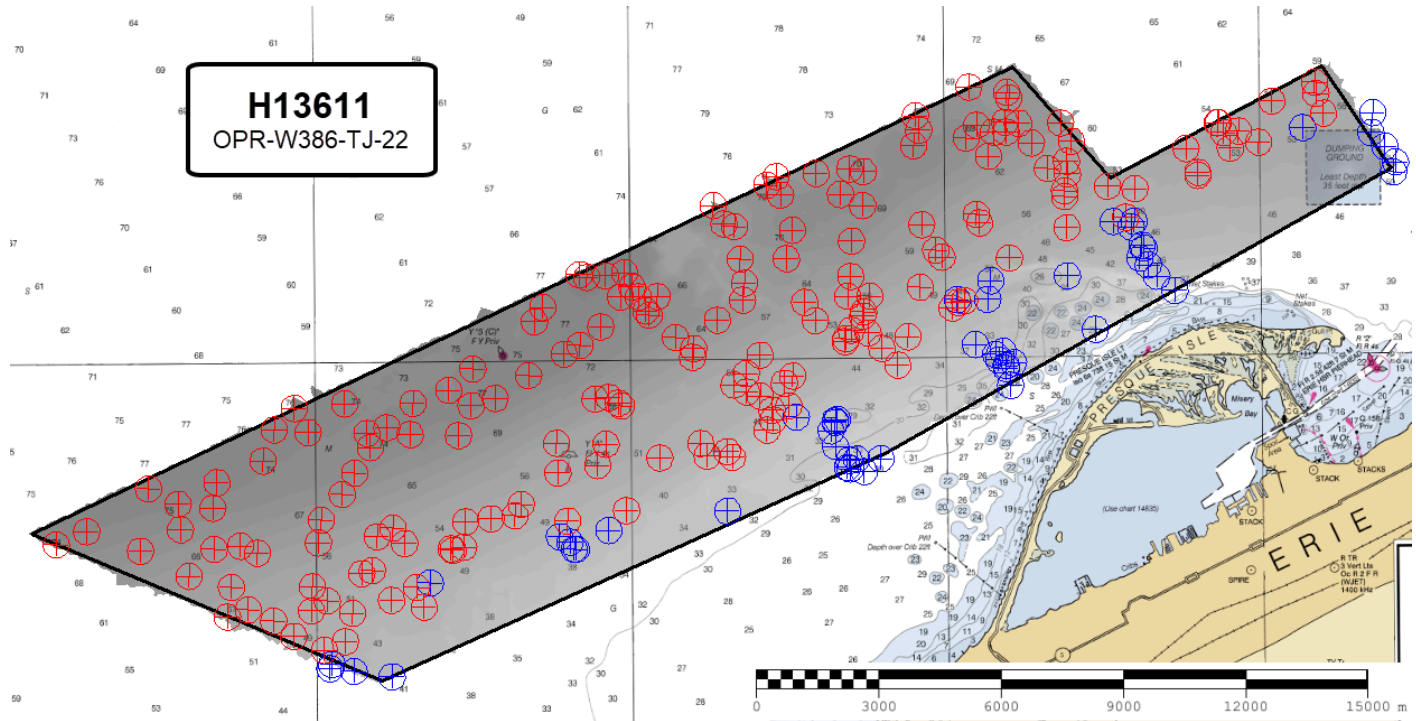
Figure 21: Overview of H13611 sound speed profile locations plotted over greyscale MBES coverage. Profiles collected by S-222 shown as red targets, profiles collected by 2903 shown as blue targets.

A total of 233 sound speed profiles were collected as part of acquisition of H13611 and display good spatial diversity (Figure 21). Twenty of these profiles were collected outside of the assigned survey limits but not more than 350m away. The casts display profiles representative of the survey area and have been retained for data processing. All sound speed profile data were concatenated into a master file for the sheet. MBES data were corrected by applying profiles nearest in distance in time (4 hours) using this master file.

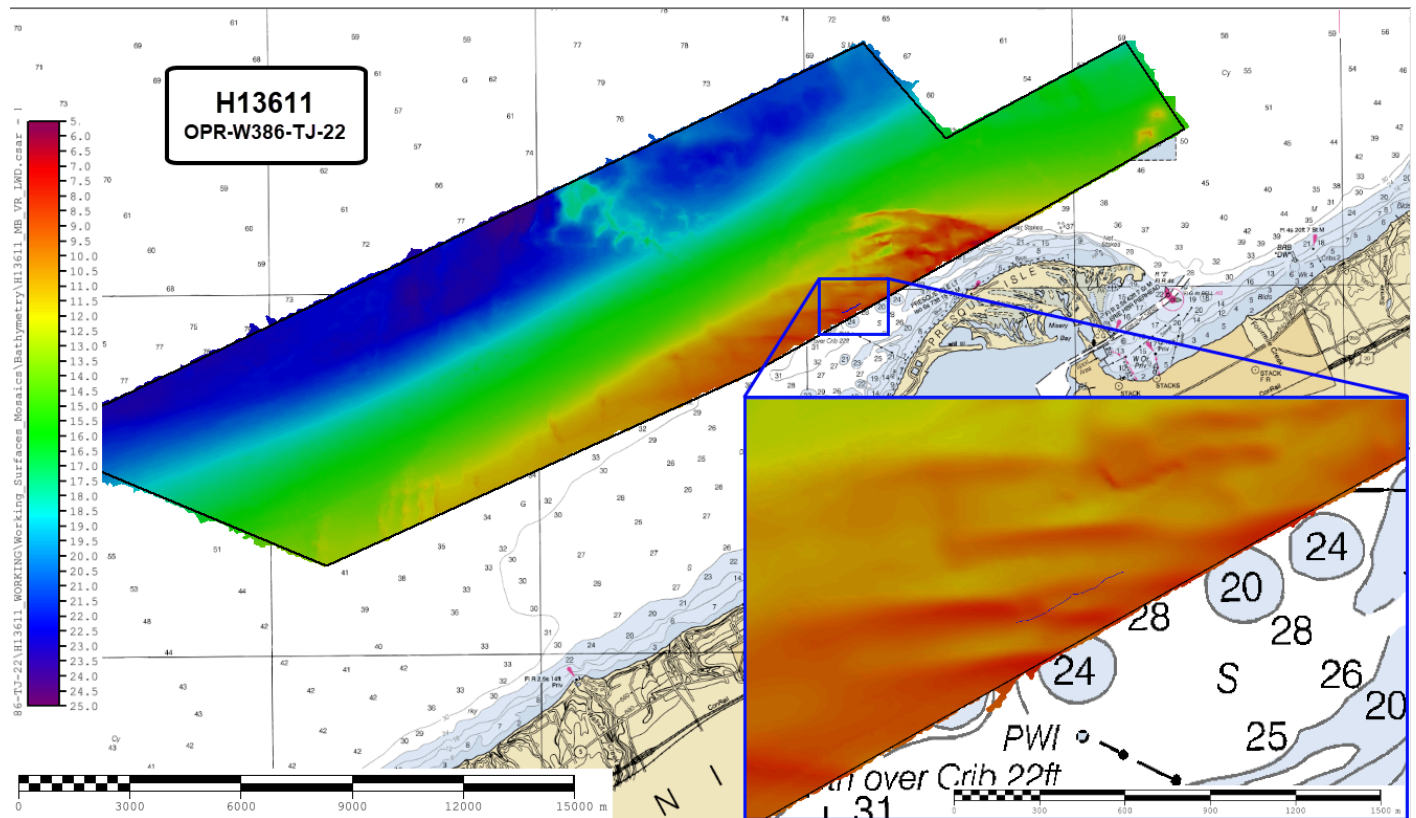
Figure 22: Location of line 0131_20220728_163417_2903_EM2040 acquired on Julian Day 209 by HSL 2903.

On Julian Day 209, HSL 2903's Applanix POS/MV positioning and attitude system experienced IMU data gaps that resulted in the inability to apply Delayed Heave using procedures outlined in the DAPR. The affected survey lines were removed from the project and re-acquired. However, during post-acquisition processing QC review, one line was found to not have Delayed Heave applied (line 0131_20220728_163417_2903_EM2040, Figure 22). Further investigation of POS data revealed an IMU data gap of 292 seconds for a period of time covering the line. This problem was not identified until after the field unit had departed the area, so the line was not able to be re-acquired. Inspection of the data and of the surface revealed no vertical offsets being present with the absence of Delayed Heave. The line was re-processed allowing a time gap of 293 seconds which successfully applied Delayed Heave to the rest of the line. The line has been retained as part of the final delivered surfaces so as not to create a holiday.

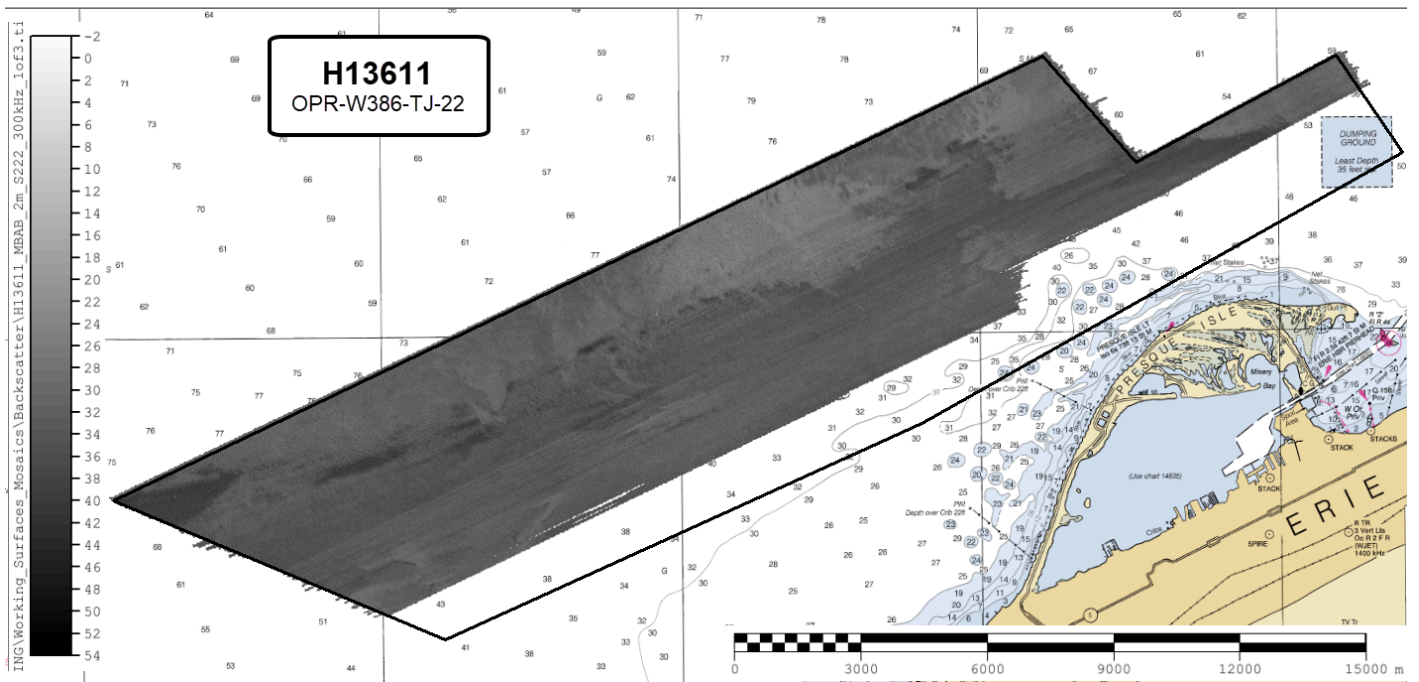
Figure 23: 300kHz backscatter mosaic from data acquired by S-222.

All equipment and survey methods were used as detailed in the DAPR. Raw MBES backscatter was flagged as part of the .all file from the Kongsberg EM2040 systems. Backscatter was processed in the QPS Fledermaus GeoCoder Toolbox (FMGT) software, and the exported geotiffs are included in the final processed data submission package (Figures 23, 24, and 25).
