DESCRIPTIVE REPORT

Type of Survey: Navigable Area

Registry Number: H13611

Sub-locality: 2 NM North of Presque Isle

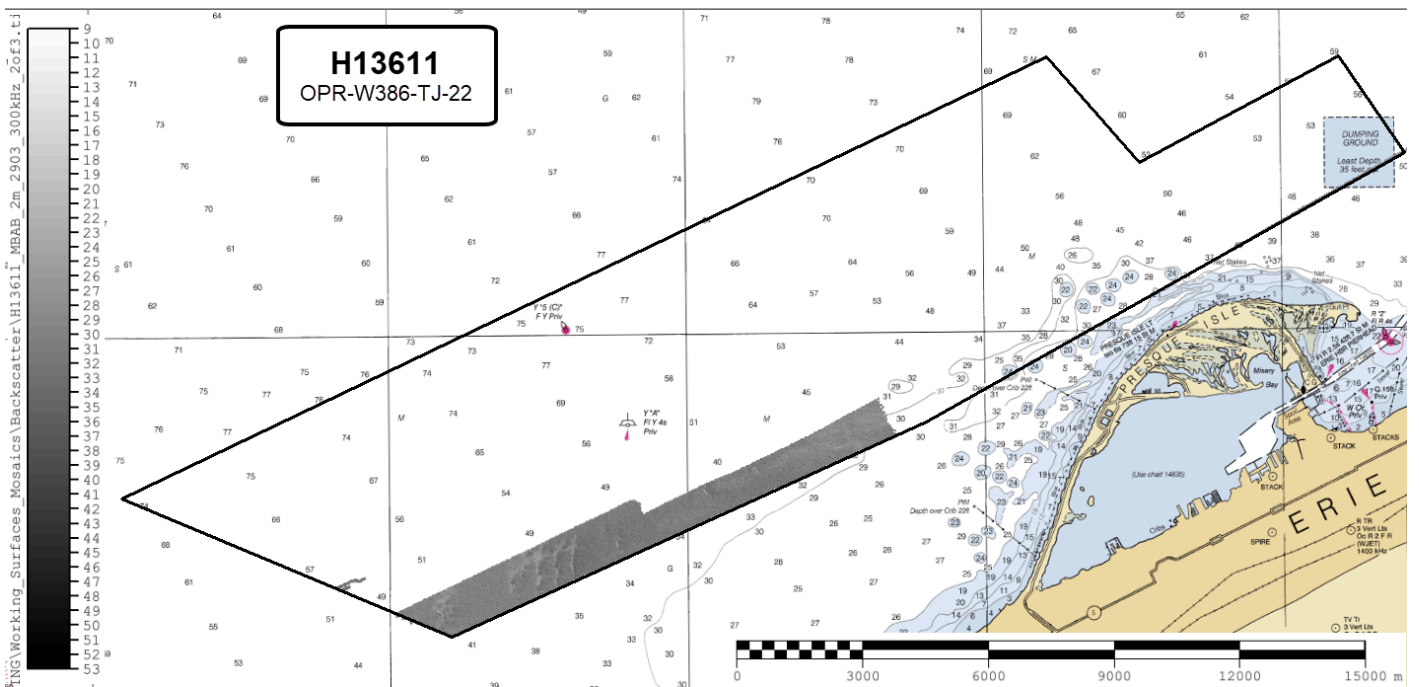
Figure 24: 300kHz backscatter mosaic from data acquired by 2903.

All equipment and survey methods were used as detailed in the DAPR. Raw MBES backscatter was flagged as part of the .all file from the Kongsberg EM2040 systems. Backscatter was processed in the QPS Fledermaus GeoCoder Toolbox (FMGT) software, and the exported geotiffs are included in the final processed data submission package (Figures 23, 24, and 25).

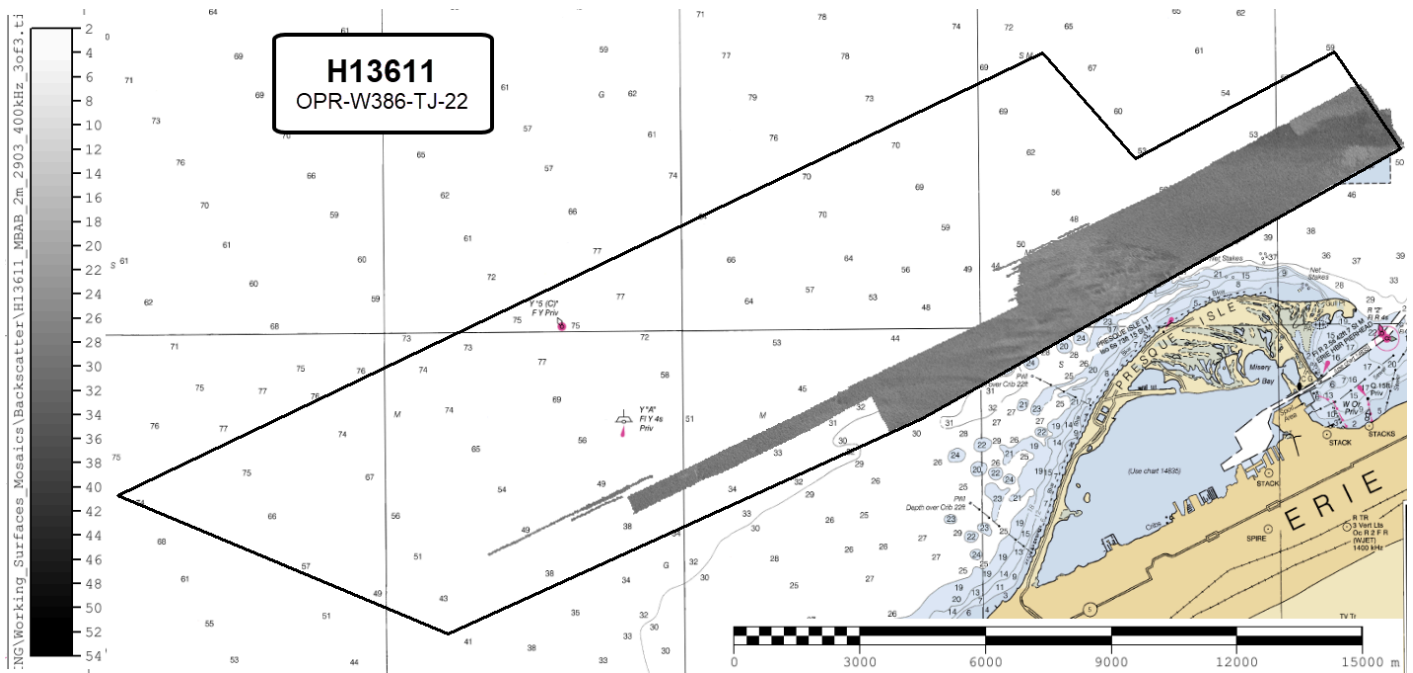
Figure 25: 400kHz backscatter mosaic from data acquired by 2903.

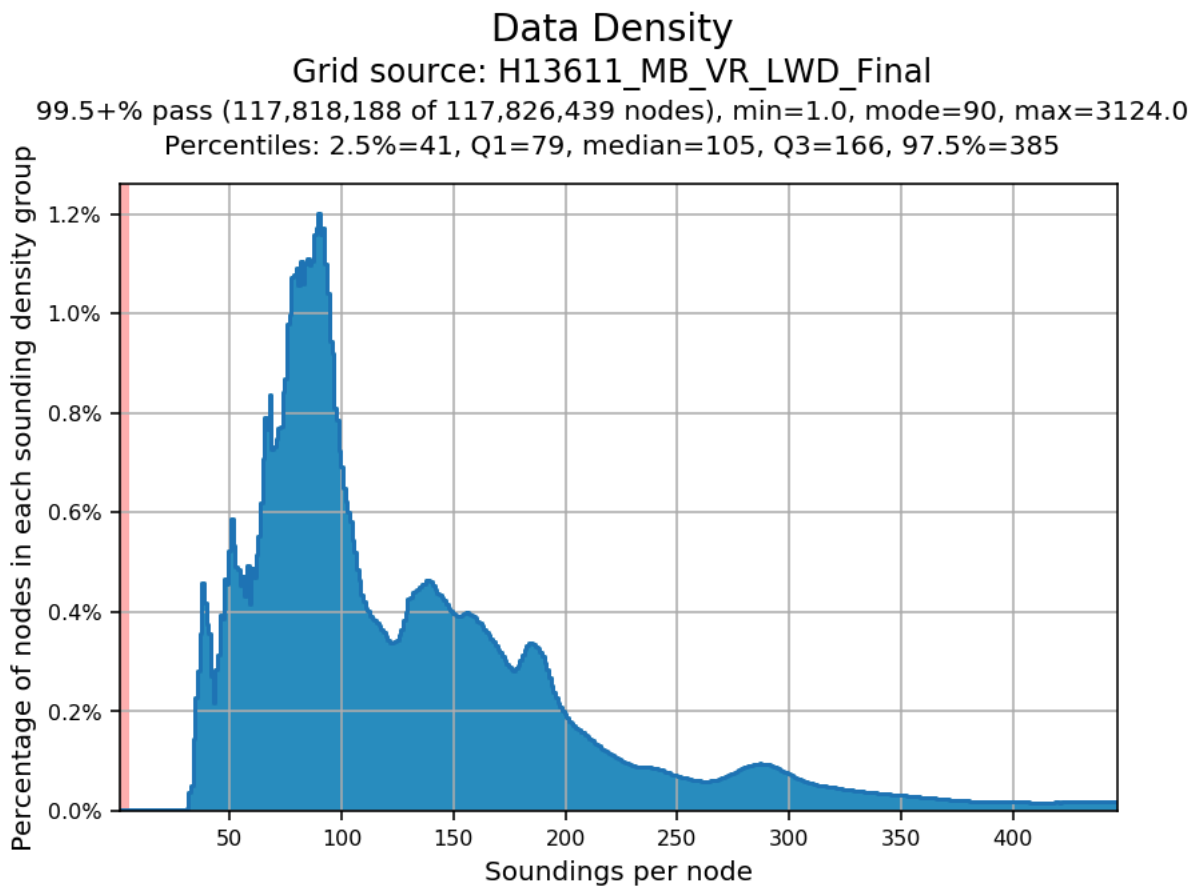
Figure 26: H13611 data density standards.

Complete coverage requirements were met by 100% complete coverage MBES as specified under section 5.2.2.2 of the 2022 HSSD. All bathymetric grids for H13611 meet density requirements per the 2022 HSSD (Figure 26). There are two holidays within the coverage achieved for H13611 as discussed in Section A.4.

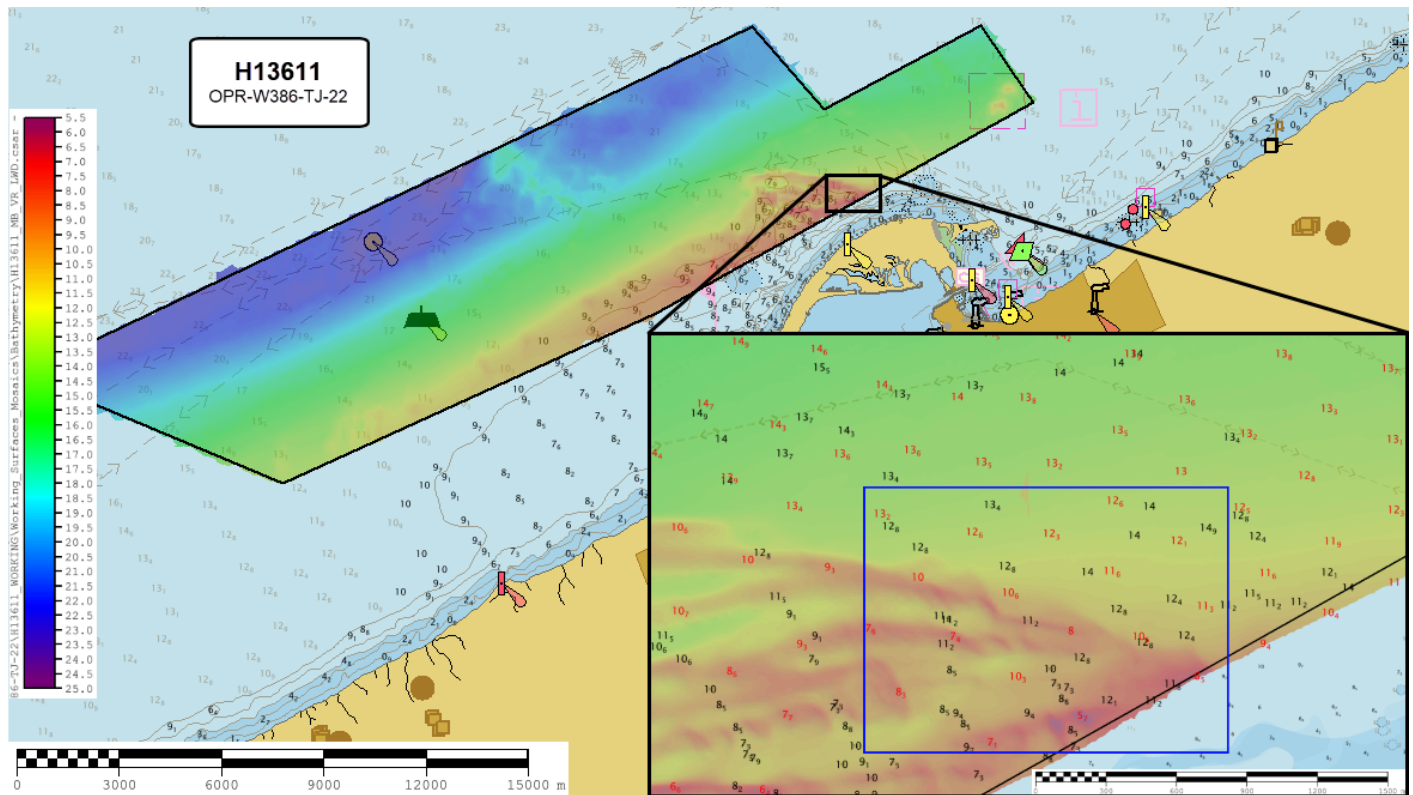
Figure 27: Comparison of charted soundings in black with surveyed soundings in red. Recommended traffic routes shown in grey dashed arrows. Area within the blue box showed greatest difference but is not considered a navigational hazard.

Surveyed soundings and contours were compared against previously charted data on ENC's US4PA21M and US5PA22M. Depth values were found to be in general agreement with previously charted soundings across most of the survey area. However, differences in soundings and contours were observed over the shoal located offshore of the northwest edge of Presque Isle. The largest discrepancies in soundings were found on the eastern edge of the shoal, but are outside of the recommended traffic routes (Figure 27). The hydrographer does not believe these changes pose an immediate danger to navigation.

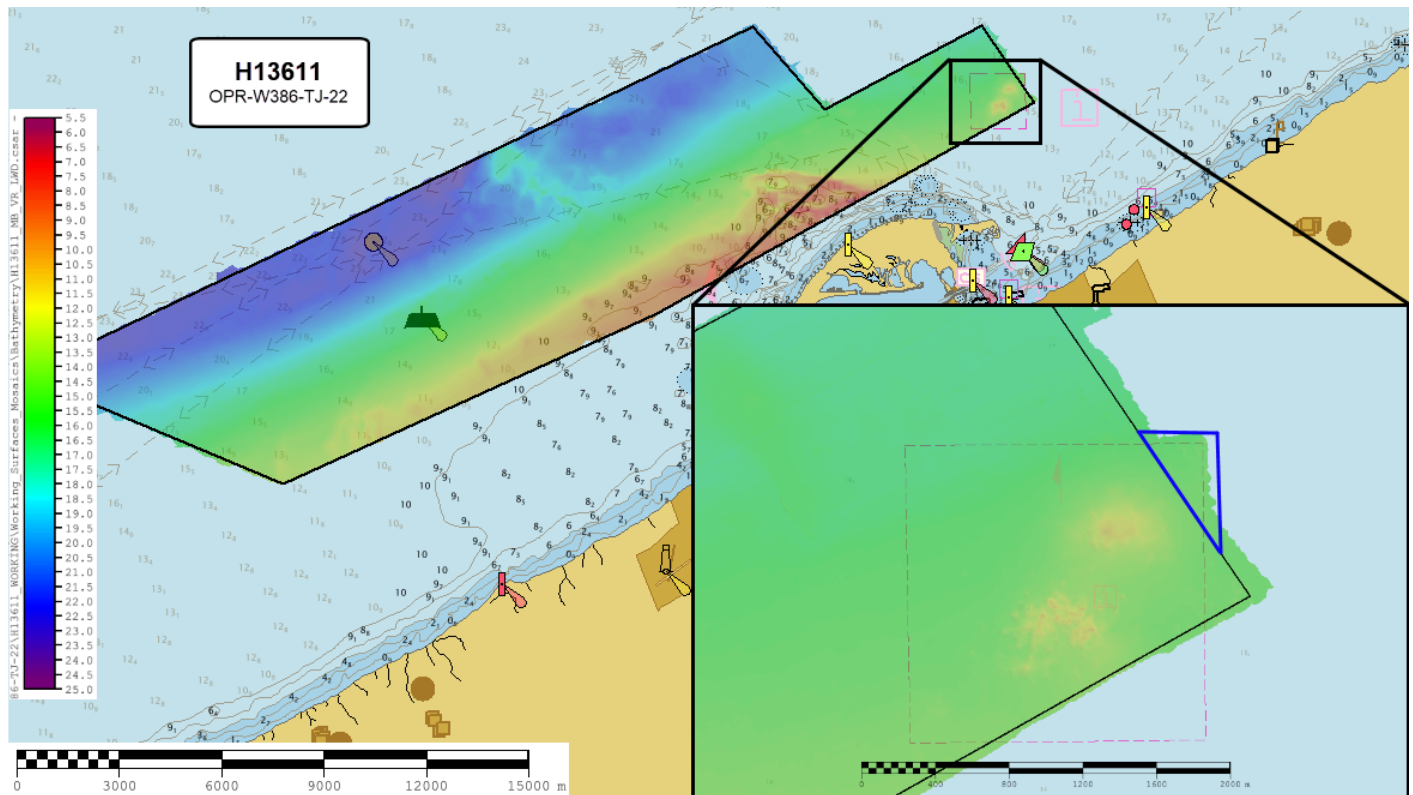
Figure 28: Additional coverage, outlined in blue, acquired outside of sheet limits to confirm least depth over charted dumping ground.

No previously charted features were assigned for investigation. However, the field unit decided to acquire additional coverage outside of the sheet limits over a charted dumping ground to confirm the least depth (Figure 28). The south east corner of the dumping ground has coverage from survey H13610.

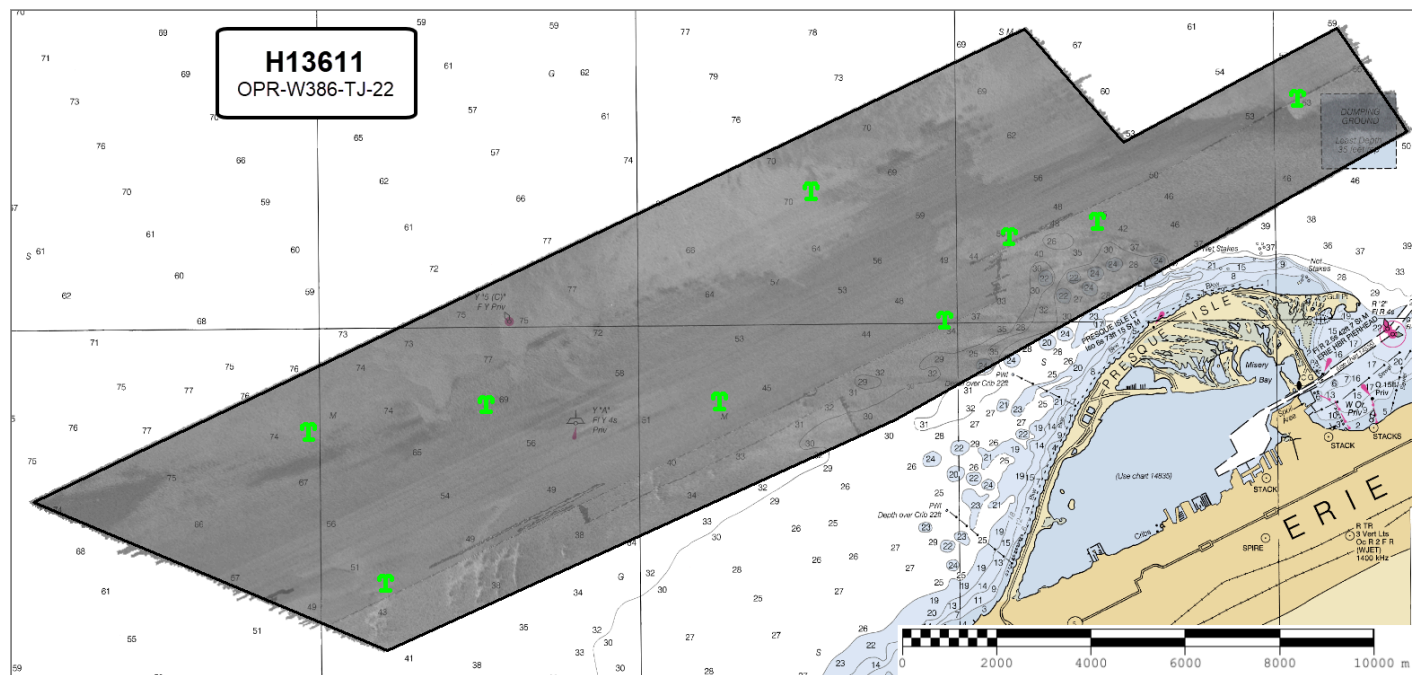
Figure 29: H13611 bottom sample locations in green plotted over the 2m resolution backscatter mosaics.

Nine bottom sample locations were assigned for investigation (Figures 29 and 30). Details regarding bottom sample attribution can be found in the Final Feature File.

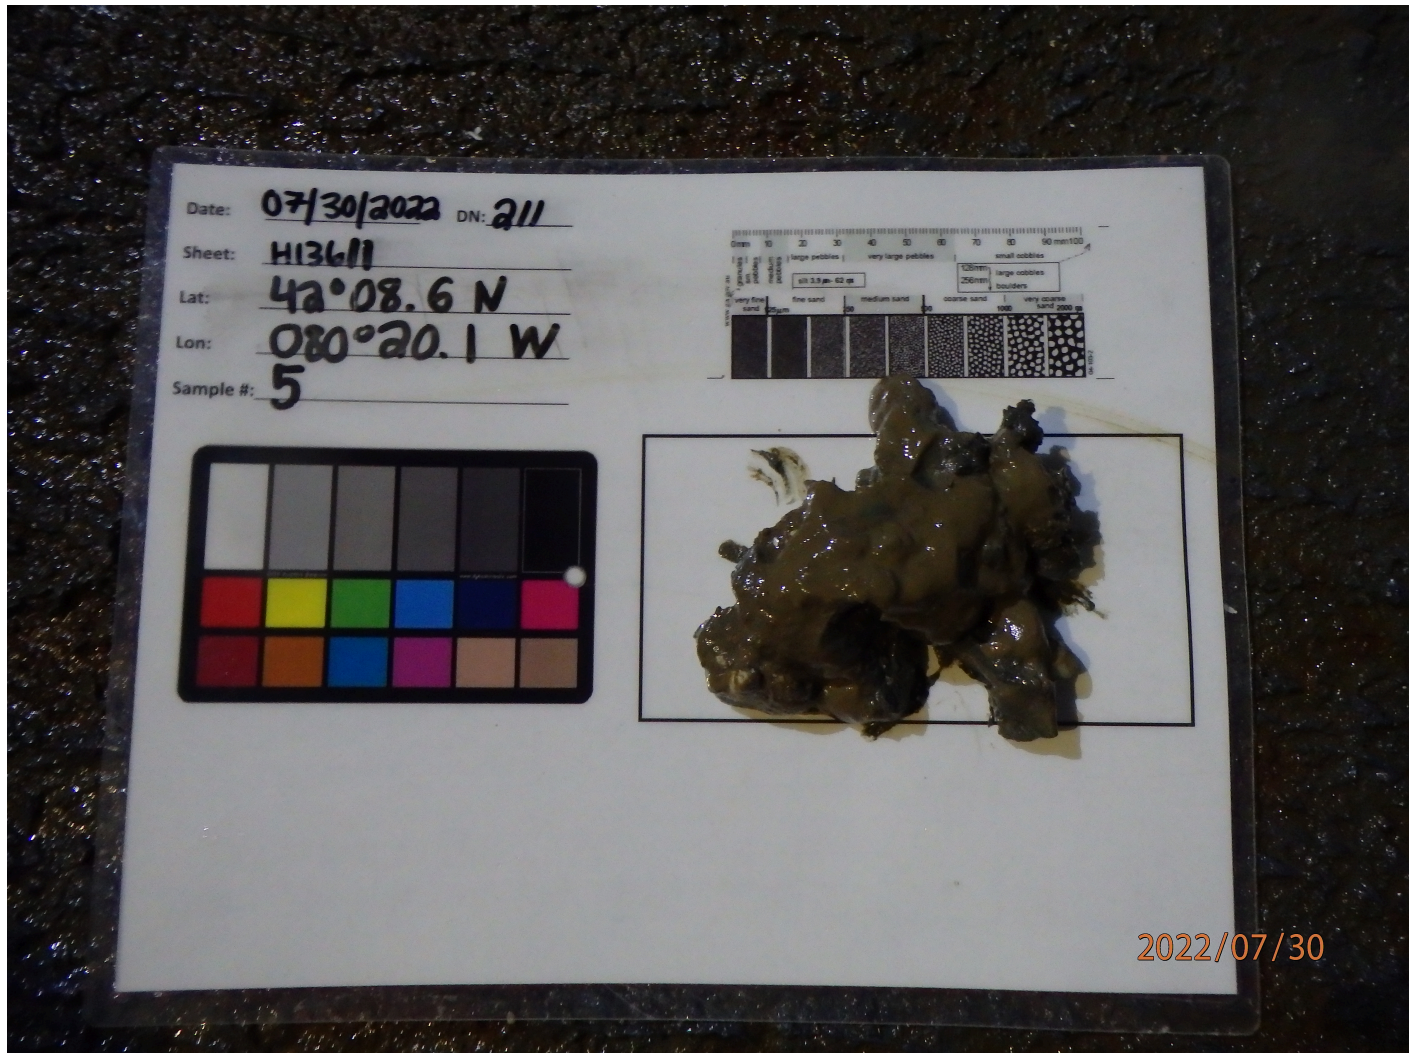
Figure 30: Example bottom type collected for H13611.
