DESCRIPTIVE REPORT

Type of Survey: Navigable Area

Registry Number: H13613

Sub-locality: Vicinity of Kelleys Island

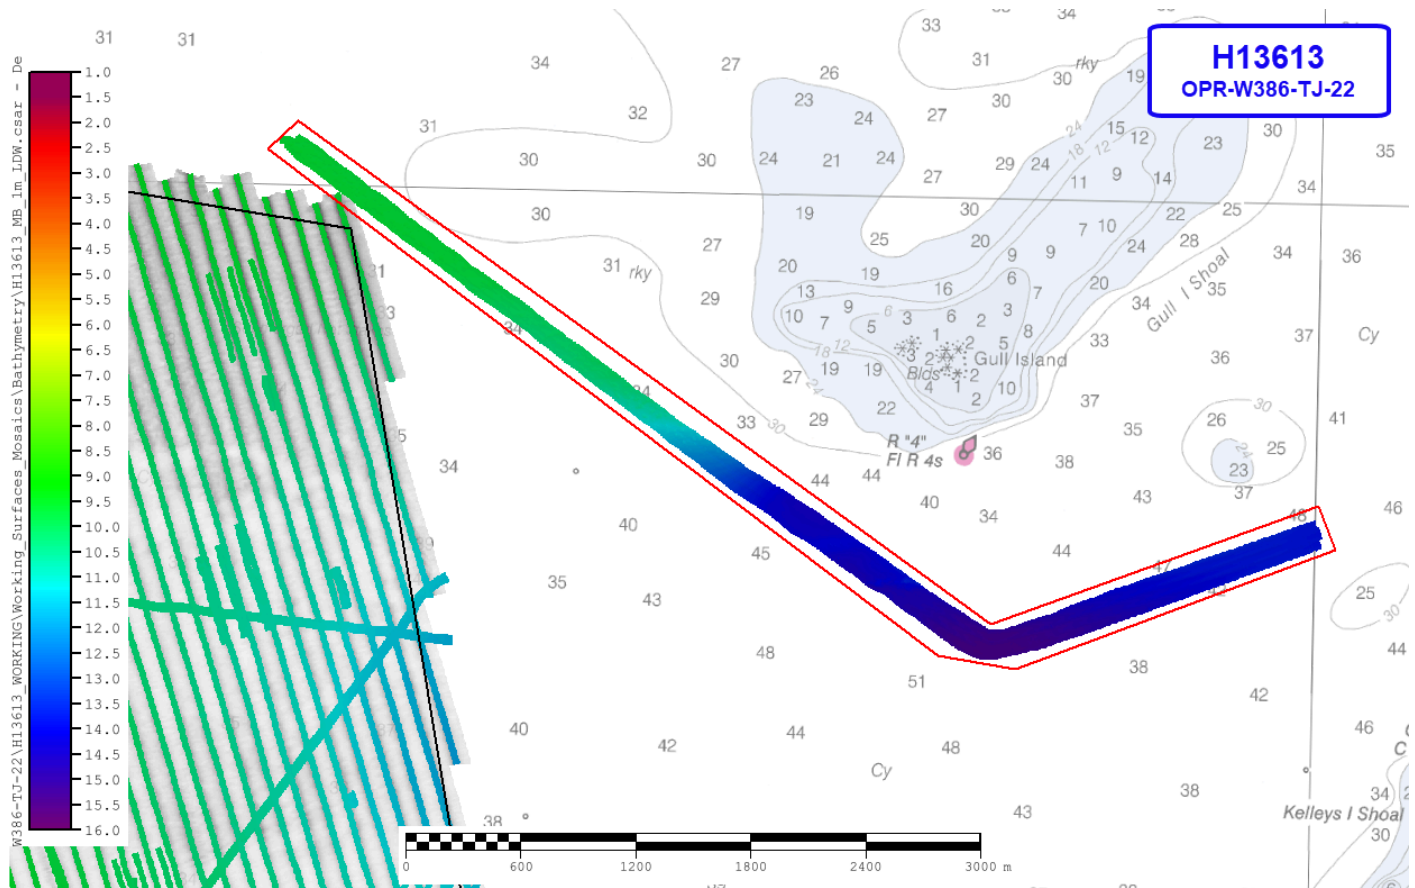
Figure 5: Area outside of assigned sheet limits surveyed as reconnaissance prior to ship transit outlined in red.

Additional MBES coverage was acquired outside of the assigned limits as reconnaissance over an area in which the ship would transit (Figure 5). These additional data are included in the submitted surfaces and in the final delivery package.

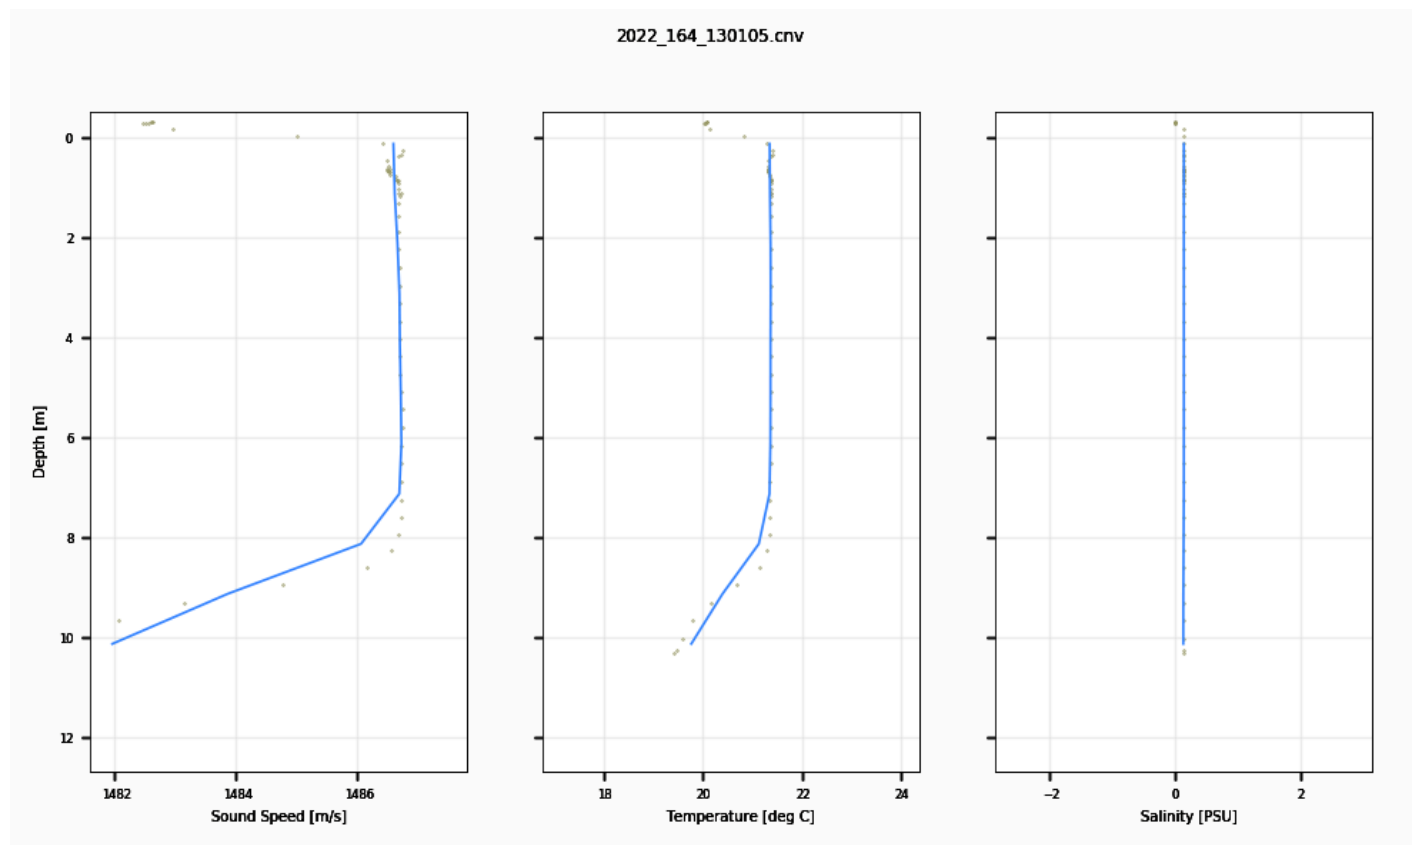
Figure 14: Example of conductivity, temperature, and sound speed profiles collected on H13613 showing the effect of temperature on sound speed.

H13613 is located in an area that exhibits intense thermal stratification. This layering greatly affects sound speed (Figure 14) and results in refraction that can be observed in the SSS imagery (Figure 15). The side scan towfish are hull-mounted on the launches and cannot be lowered below the thermocline. Varying degrees of refraction were observed in SSS data collected by HSL 2903, however the hydrographer determined that all data are of acceptable quality to be able to discern contacts on the lake bed.

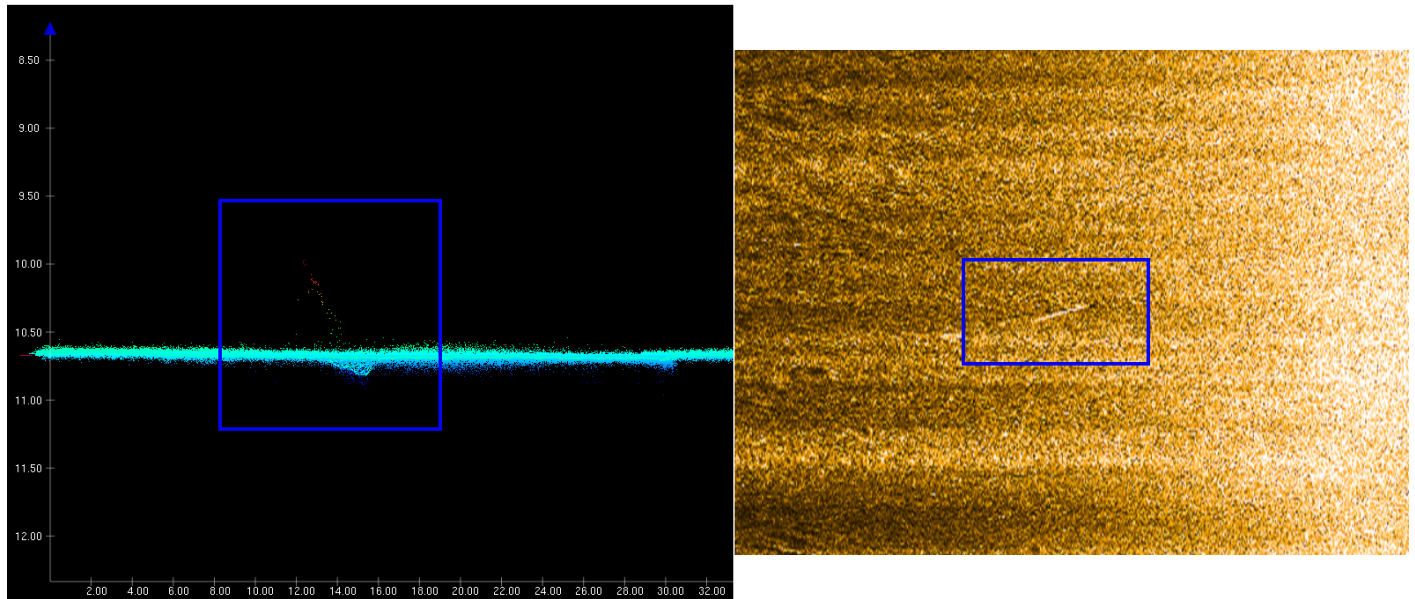
Figure 22: Example of a fishing stake seen in MBES data (right pane) and SSS imagery (left pane).

A total of 125 charted features were assigned for investigation. 19 were not addressed due to being inshore of the NALL. 42 fishing stakes were designated as Unverified Charted Features (UCFs). Following a consultation with the project manager, a 150m search radius was created around each feature and 200% SSS with concurrent MBES was used to conduct a feature search (see DR Appendix II). Upon reviewing the SSS and MBES data, the hydrographer observed some stakes being present but their appearance is very slender in nature and difficult to detect (Figure 22). The hydrographer's opinion is that complete coverage MBES with watercolumn data should be used to conduct formal feature disprovals for the stakes, but limited operational time did not allow the field unit to conduct further investigation. Assigned features where stakes were observed in SSS and/or MBES coverage within the search radii are recommended to be 'retained as charted', while the rest are designated as 'un-addressed' since a more thorough search is recommended for full disapproval. Reference the FFF for more information.
