DESCRIPTIVE REPORT

Type of Survey: Navigable Area

Registry Number: H13617

Sub-locality: 4 NM North of Lorain Harbor

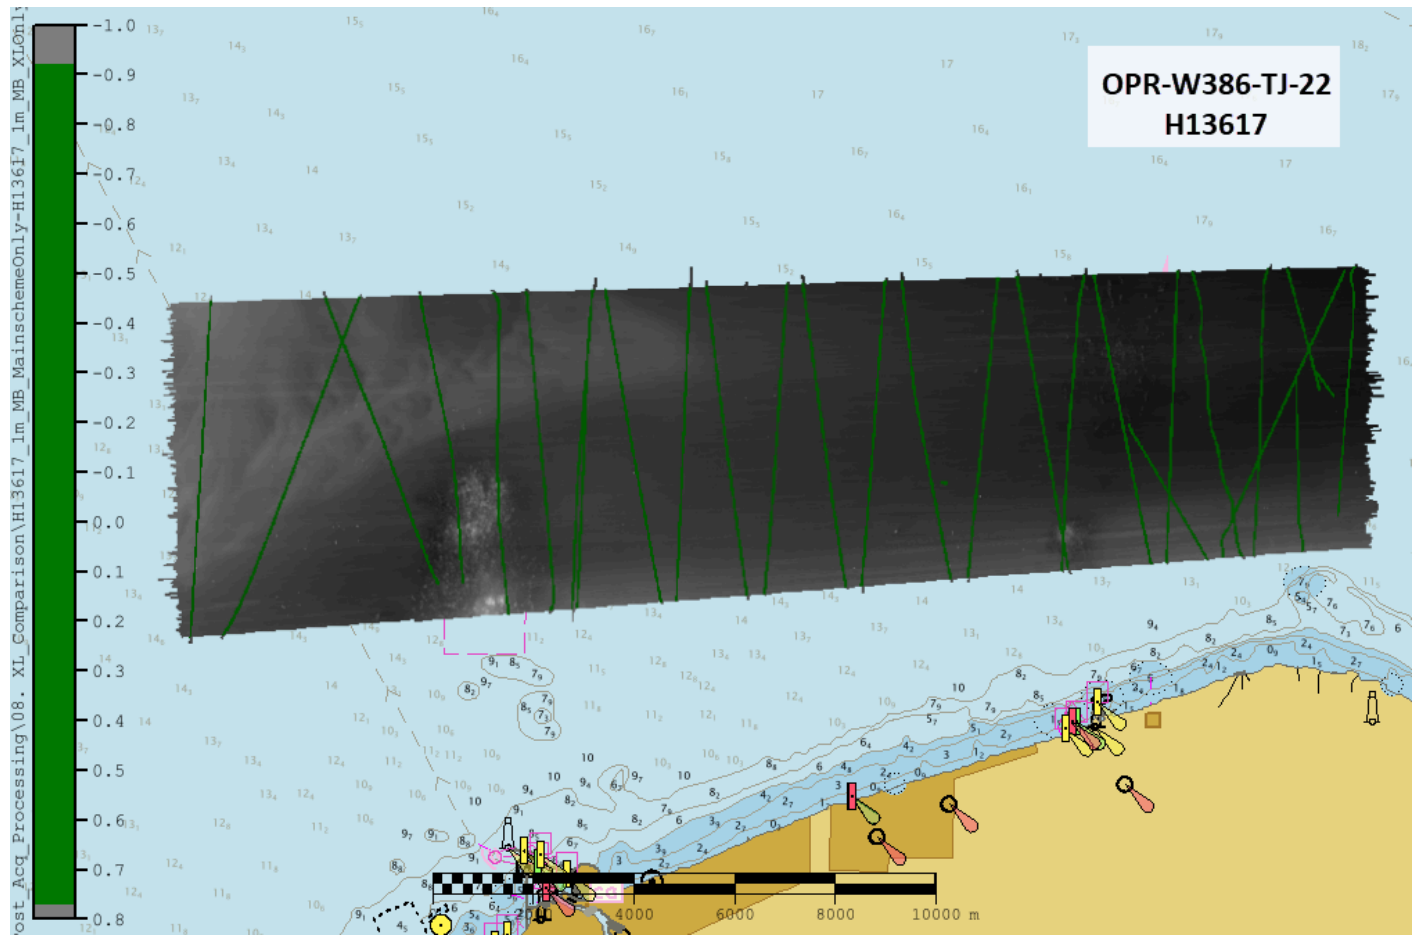
Figure 4: H13617 MBES crossline data, shown in fraction of allowable error difference statistics, overlaid on mainscheme data, shown in greyscale, plotted on ENC US4OH01M.

Hydrographic survey vessel S222 collected 86.45 linear nautical miles of MBES crosslines, or 3.91% of mainscheme MBES data. The crosslines acquired represent good spatial diversity for this survey area (Figure 4). A 1m gridded Combined Uncertainty and Bathymetry Estimator (CUBE) surface of mainscheme data and a 1m gridded CUBE surface of crossline data were differenced; the resulting mean was 0.02m with a standard deviation of 0.07m (Figure 5). 100% of nodes are compliant with fraction of allowable error standards (Figure 6). Visual inspection of the differenced surfaces indicated no systematic issues.

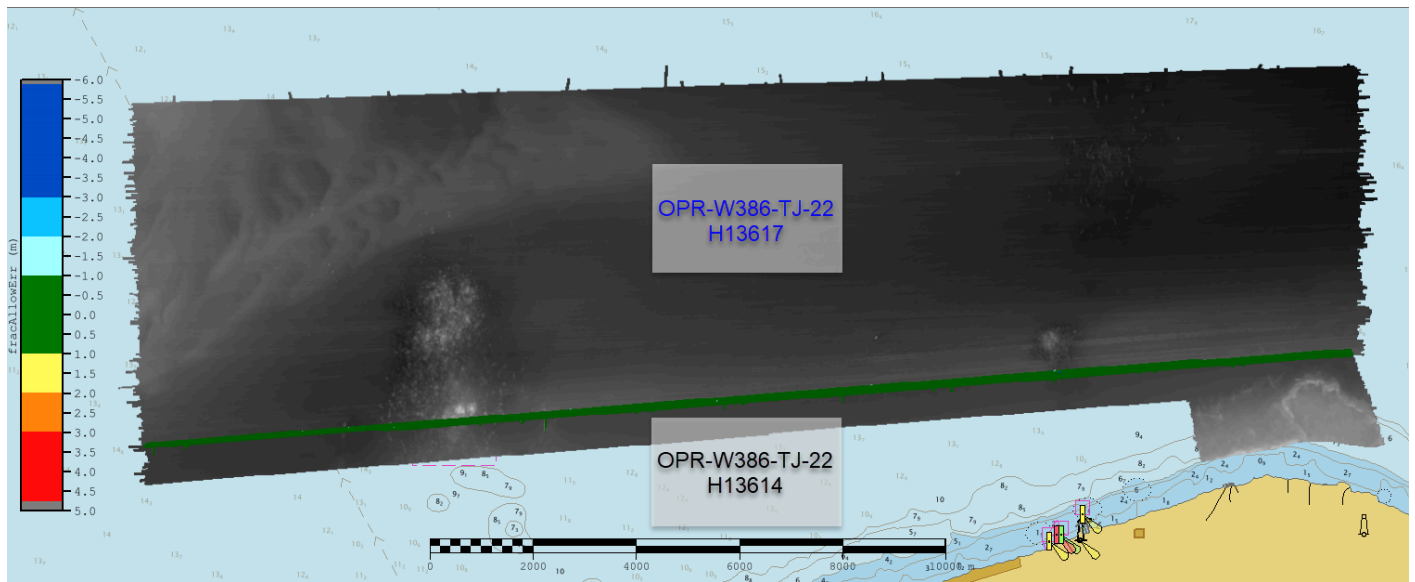
Figure 11: Fraction of allowable error surface difference comparison in color between H13617 and H13614, plotted over ENC US4OH01M.

The southern edge of sheet H13617 junctions with sheet H13614. A 1m SR CUBE surface of H13617 data and a 1m SR CUBE surface of H13614 data were differenced (Figure 11). The mean difference between bathymetric surface nodes was 0.06m with a standard deviation of 0.06m (Figure 12). 99.5+% of nodes are compliant with fraction of allowable error standards (Figure 13). Statistics and visual inspection indicate that surveys H13617 and H13614 are in general agreement.
