DESCRIPTIVE REPORT

Type of Survey: Navigable Area

Registry Number: H13619

General Locality: Detroit River

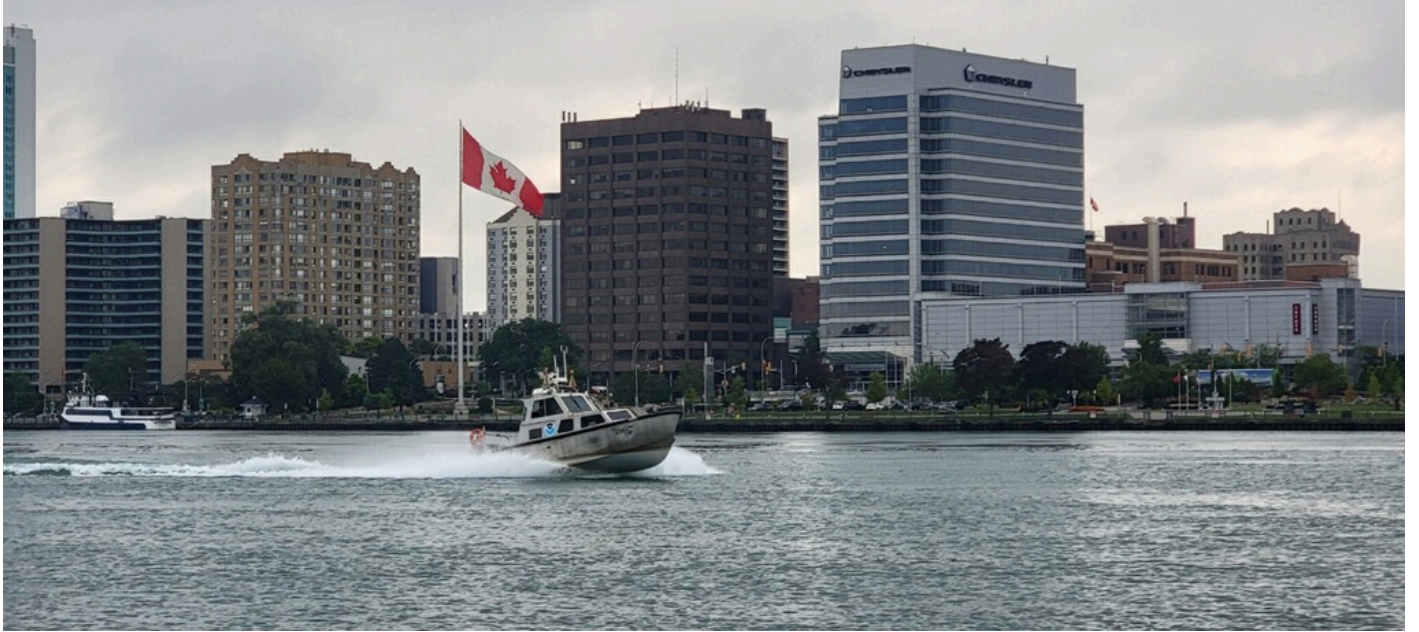
Figure 5: Thomas Jefferson Launch 2904

Hull ID	<i>2904</i>	<i>S3007</i>
LOA	8.5 meters	10.38 meters
Draft	1.2 meters	0.6 meters

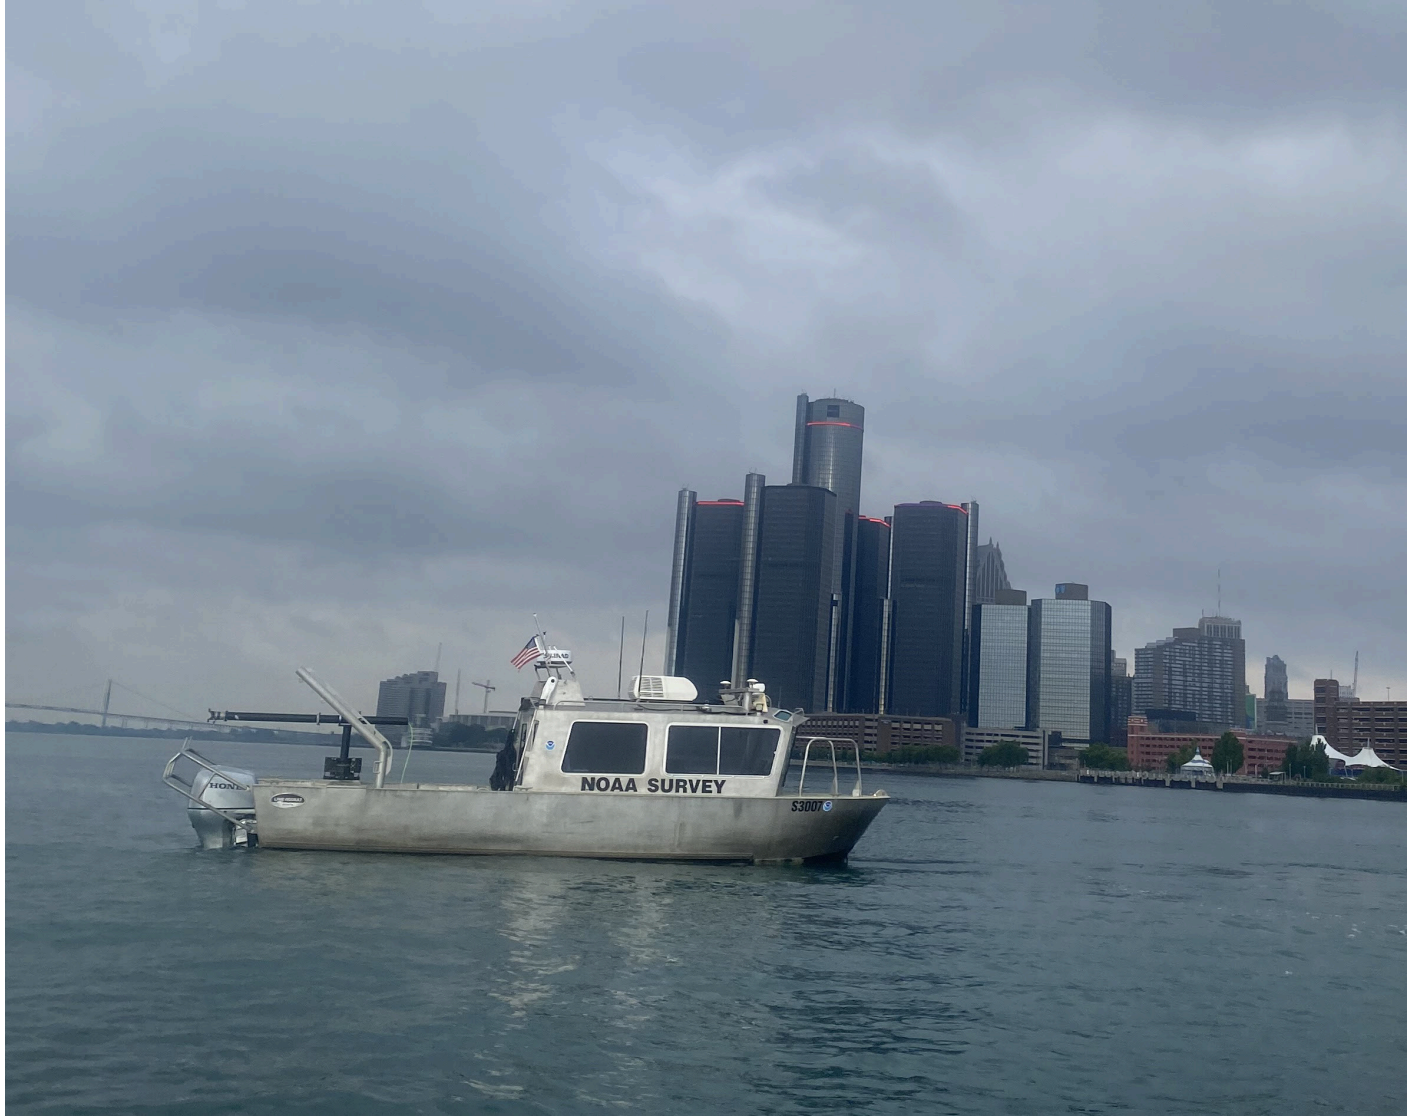
Figure 6: NRT-5 vessel S3007

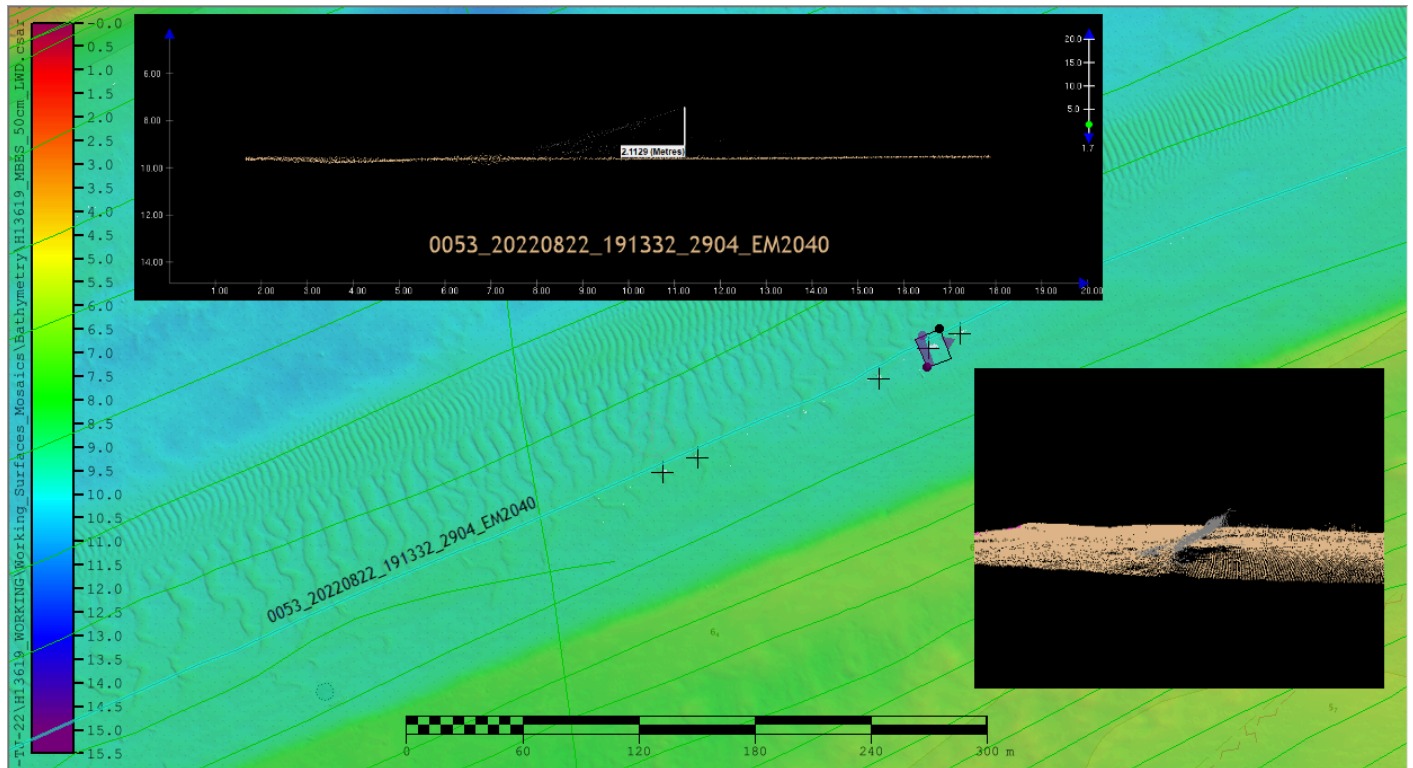
Figure 15: The location of holidays, represented by black targets, after the artifacts were deleted out of line 0053_20220811_191332_2904_EM2040. The 3D and 2D view show the rejected (gray) data being approximately 2m off the river floor.

nadir. Although the data initially looked normal in the waterfall during acquisition, this abnormality resulted in multiple one to two meter artifacts on the starboard side of each line (Figure 14). These artifacts were deleted out of the data resulting in holidays in the MBES coverage (Figure 15). The hydrographer does not think the holidays contain hazards to navigation. This abnormality was not observed in any other lines or days of MBES data collected on H13619.
